FIELD OBSERVATION REPORT

2018.02

■ TO:	Kenton County Board of Education 1055 Eaton Drive Ft. Wright, KY 41017	■ DATE:	2018.02.20
ATTENTION:	Mr. Rob Haney		
■ FROM:	Mark Perry mperry@pca-arch.com 1881 Dixie Highway, Suite 130 Fort Wright, KY 41011 V: 859.431.8612 • F: 859.431.8611	■ PROJECT:	Kenton County School District Ft. Wright Elementary
COPIES TO:	Mr. Danny Mann	PROJECT NO.:	2014-112

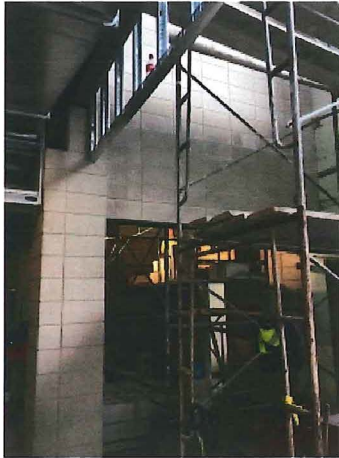
09.01: 2018.01.30 – Cold form metal framing for bulkheads at the new interior entry space was in place. Gypsum board finishing in the new admin area was progressing.

2018.01.30 – Bulkhead framing at entry interior.

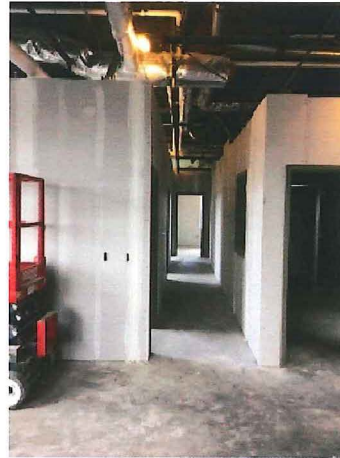
2018.01.30 – Drywall finish in admin area.

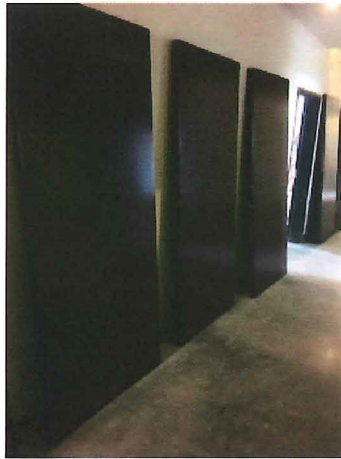
09.02: 2018.01.30 – Hollow metal door slabs were set up in several classrooms for painting, which appeared complete. Finish coats of paint were applied to some lower level, first floor, and second floor masonry walls.

2018.01.30 – Painted door slabs.

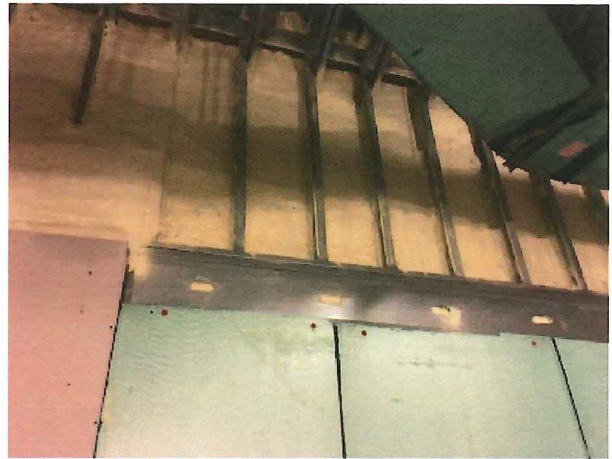
07.01: 2018.01.30 – Several areas of missing intumescent paint at spray foam fire proofing were observed and reported to Monarch for correction before the subcontractor leaves the site.

2018.01.30 – Spray insulation needing intumescent paint.

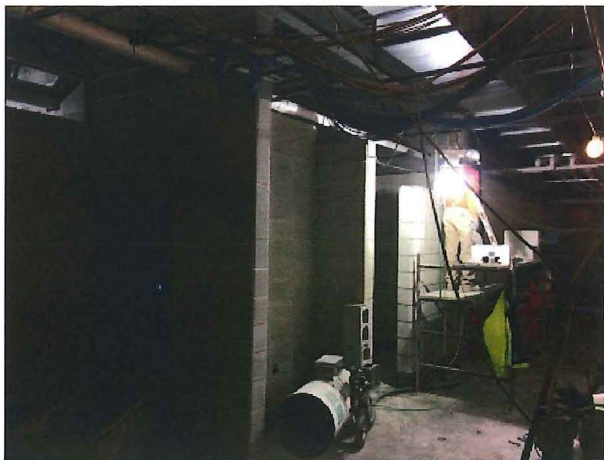
04.01: 2018.01.30 – Masons were wrapping up masonry work at the central restroom core.

2018.01.30 – Mason working at first floor restroom.

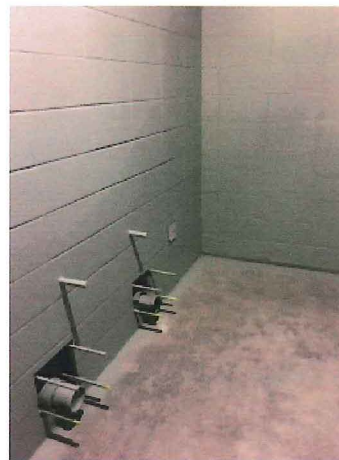
2018.01.30 – Finish paint in lower level restroom.

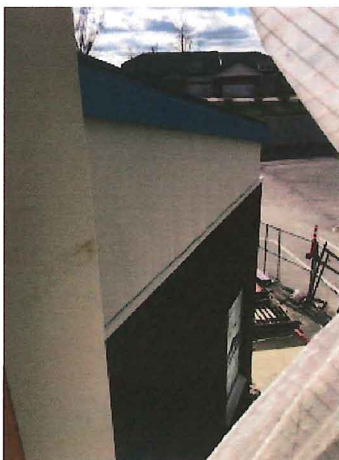
07.02: 2018.01.30 – Metal siding was being installed on exterior walls, starting at the south end of the new second floor. Corrections to Phase 1 fascia panels had also been completed.

2018.01.30 – New metal siding at former admin.

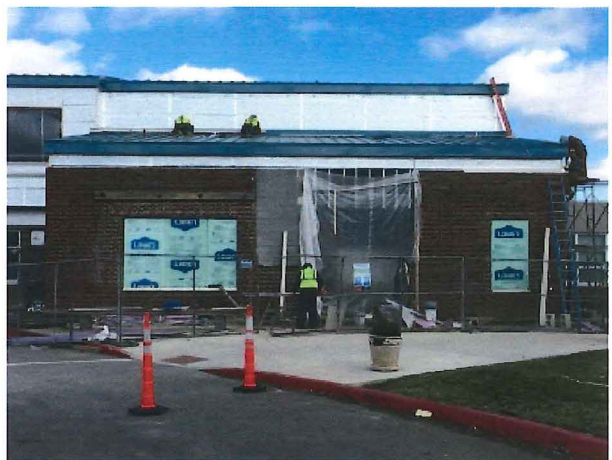
2018.01.30 – Metal installer working on base of wall flashing.

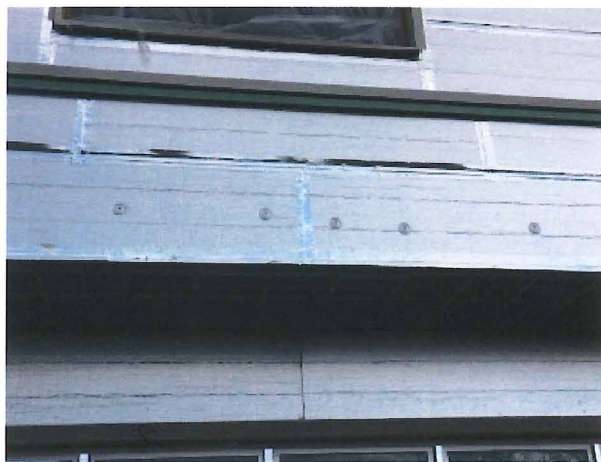
07.03: 2018.01.30 – Monarch was advised to direct the metal siding installer to correct deficient tape at the exterior wall insulation as the tape serves as a key component of the exterior weather barrier.

2018.01.30 – Example of taped joint needing correction.

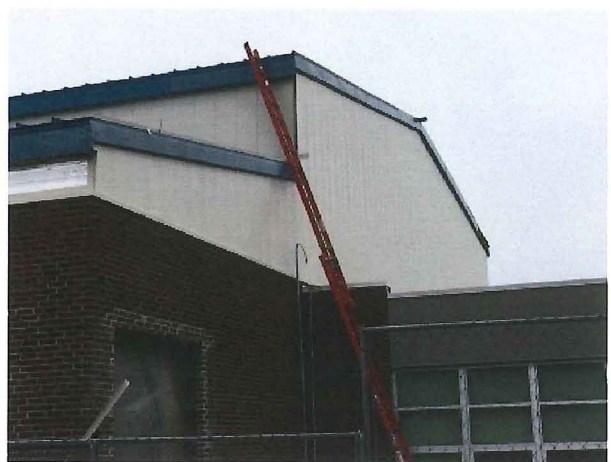
2018.02.02 – South wall of 2nd floor addition.

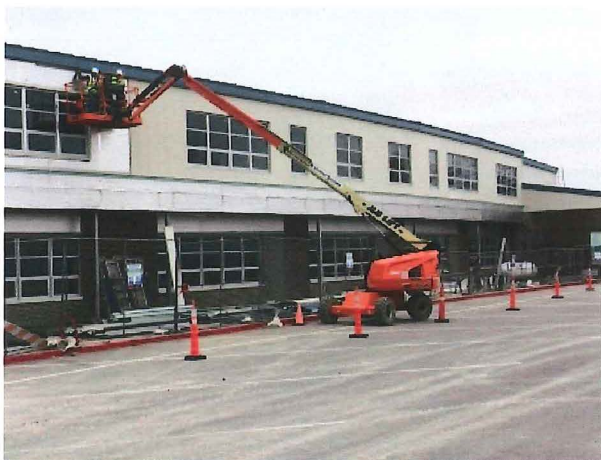
07.04: 2018.02.13 – Metal siding installation had progressed to only the midpoint of the west 2nd floor wall. Delay caused by a lack of trim pieces in the correct color.

2018.02.13 – Siding progress at west elevation.

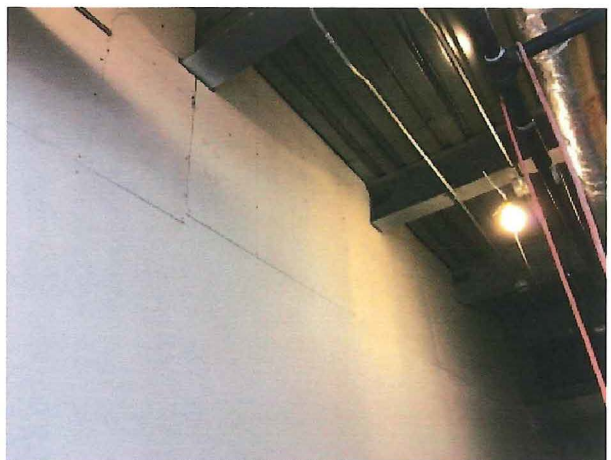
2018.02.13 – Recently installed gypsum board at ICF.

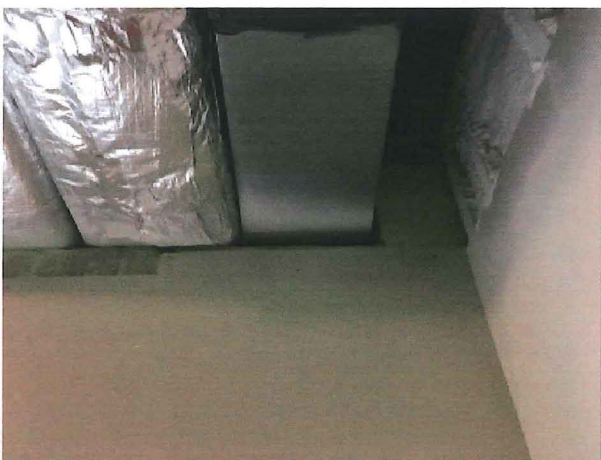
09.04: 2018.02.13 – First floor areas of exposed ICF needing gypsum board cover had been mostly addressed, though some areas and the second floor were still in need of cover. Monarch was so advised.

2018.02.13 – Patches of ICF foam still exposed.

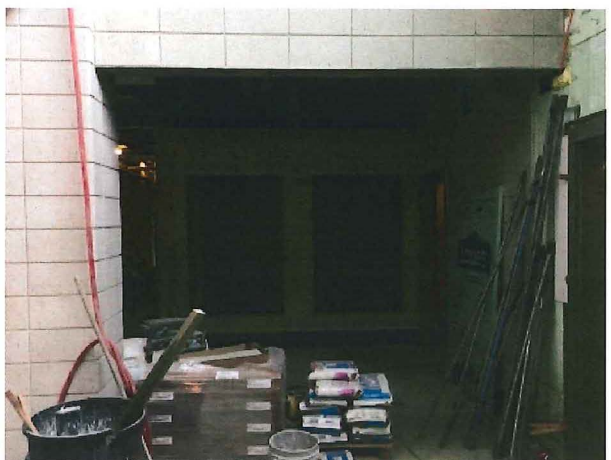
2018.02.13 – Looking towards display cases in entry lobby.

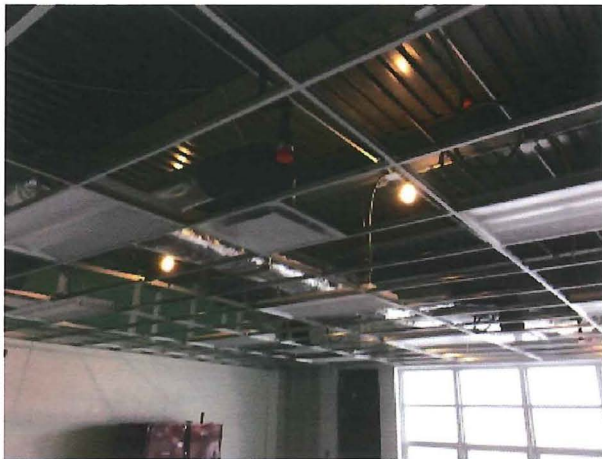
20-28.01: 2018.02.13 – Light fixtures were being installed in classroom ceilings.

2018.02.13 – Light fixtures in a first floor classroom.

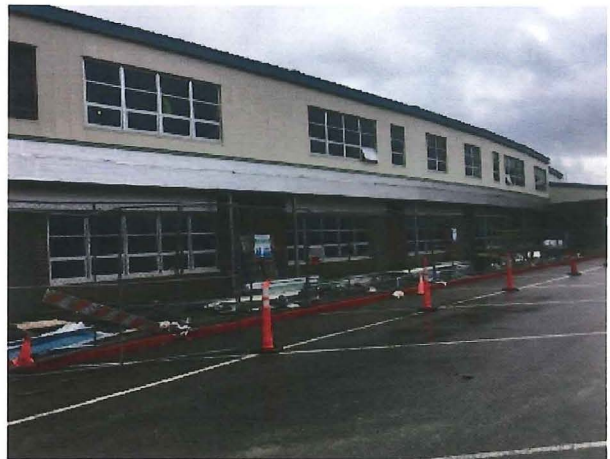
07.05: 2018.02.15 – Metal siding at the west elevation of the second floor was complete down to the temporary 2nd floor access cutout. The east elevation was half finished.

2018.02.15 – Metal wall panel at west elevation.

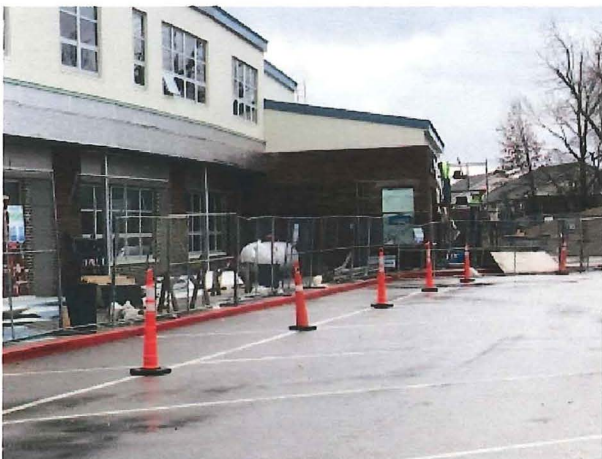
2018.02.15 – Looking towards former entry.

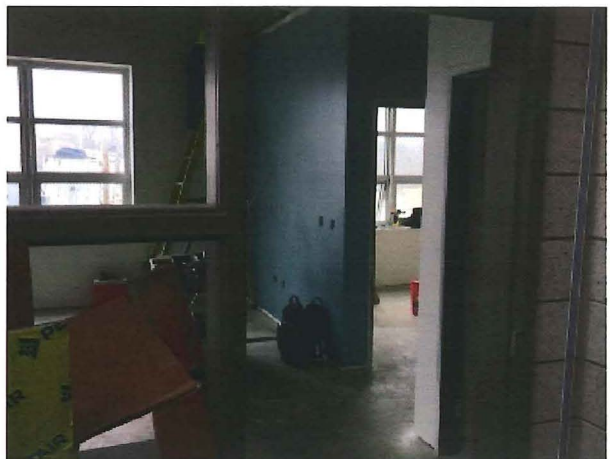
09.06: 2018.02.15 – Finish paint was observed on some gypsum board walls in the admin area as well as the first floor corridor.

2018.02.15 – Finish paint in admin area.

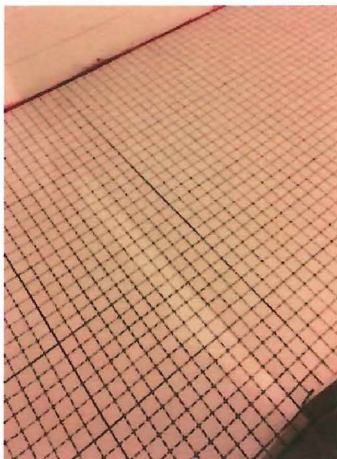
09.07: 2018.02.15 – Mosaic floor tile was observed in several first floor restrooms and was actively being installed at the second floor.

2018.02.15 – Mosaic tile in a first floor staff restroom.

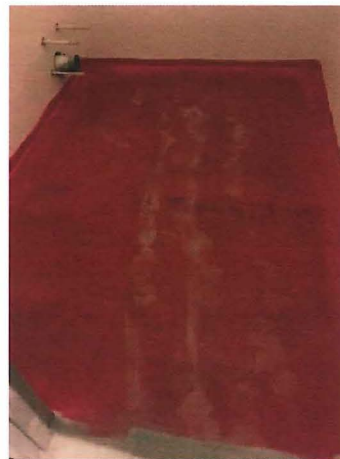
2018.02.15 – Crack isolation membrane in a first floor staff restroom.

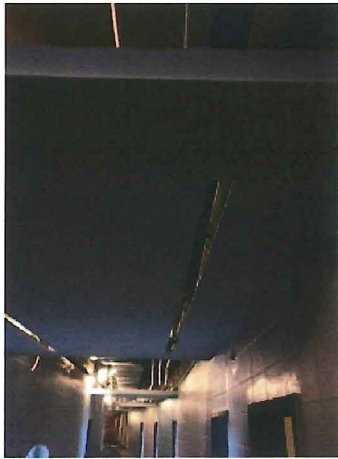
2018.02.15 – Finish paint at first floor hard ceiling.

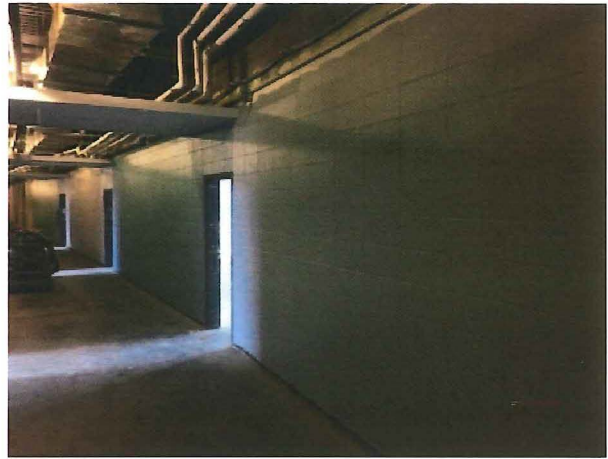
2018.02.15 – Finish paint at original corridor wall.

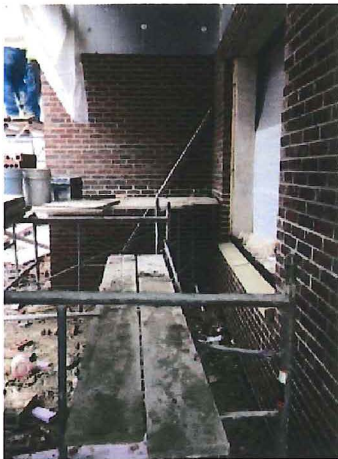
04.02: 2018.02.15 – Masons were wrapping up exterior brick at the former main entrance. Interior ground face block had been washed and most had been sealed.

2018.02.15 – New brick at former main entrance.

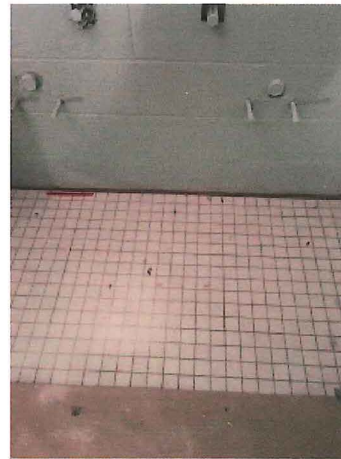
2018.02.15 – Mosaic tile at first floor restroom.

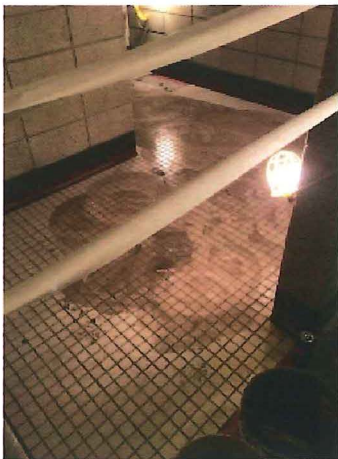
2018.02.15 – Mosaic tile grouting in progress at second floor restroom.

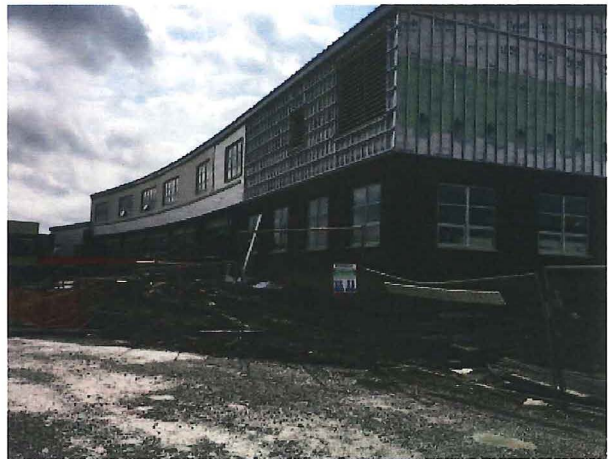
2018.02.15 – East elevation from NE corner.
