**FIELD OBSERVATION REPORT****2018.06**

■ TO:	Kenton County Board of Education 1055 Eaton Drive Ft. Wright, KY 41017	■ DATE:	2018.06.21
ATTENTION:	Mr. Rob Haney		
■ FROM:	Ralph Cooper rcooper@pca-arch.com 1881 Dixie Highway, Suite 130 Fort Wright, KY 41011 V: 859.431.8612 • F: 859.431.8611	■ PROJECT:	Kenton County School District Hinsdale Elementary
COPIES TO:	Mr. Danny Mann	PROJECT NO.:	2017-074

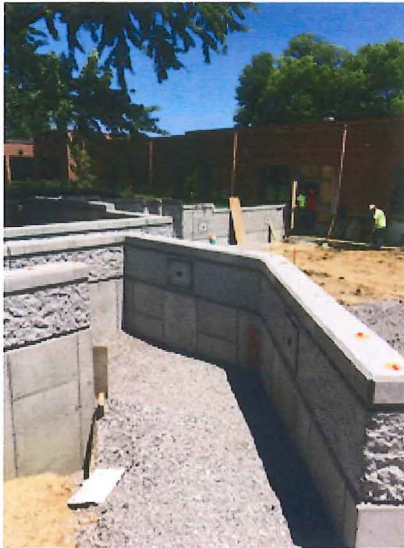
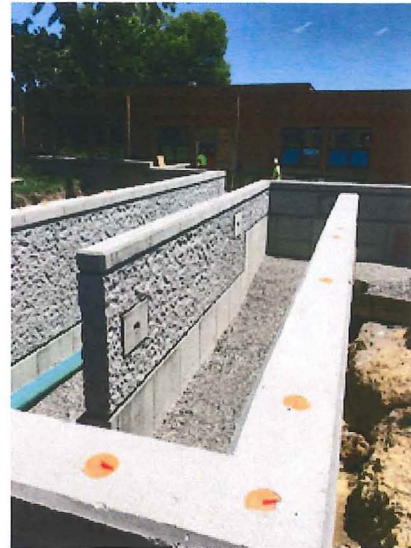
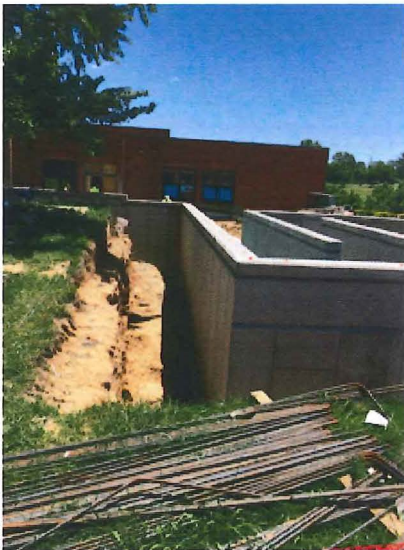
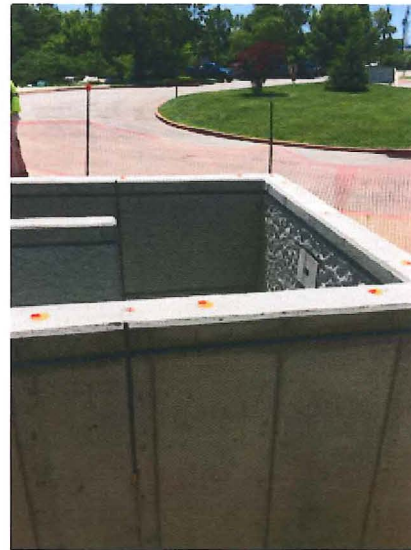
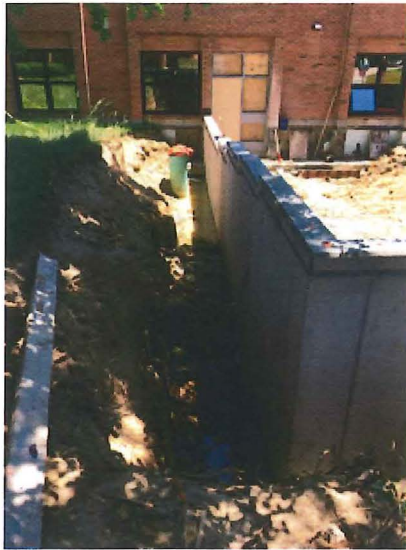
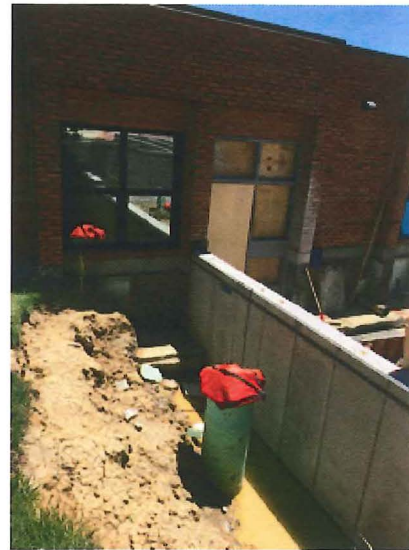
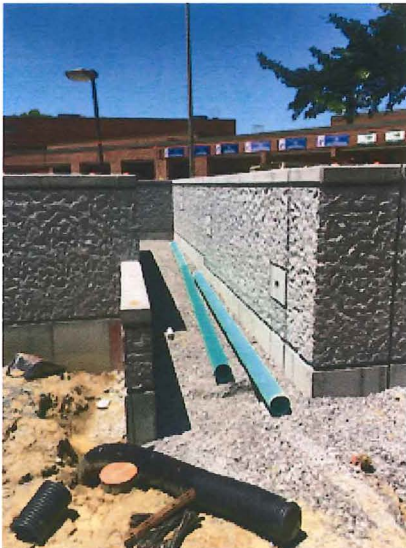
03.01: 2018.06.04 – Installation of the ramp and site walls continue. The form liners for the textured surfaces and block-outs for the exterior wall light fixtures are being installed.

2018.06.04 – Installation of the exterior site and ramp walls continues.

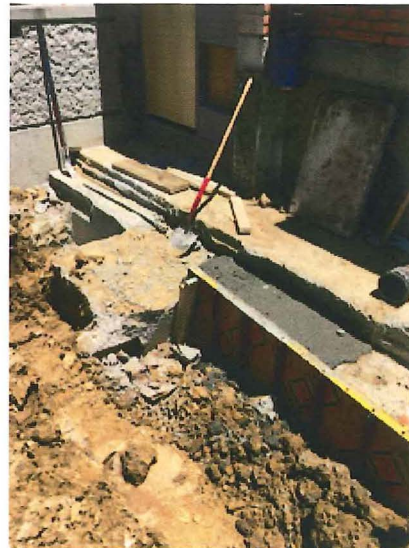
03.02: 2018.06.04 – Underpinning of the foundation outside of Rooms No. 113 and 114 is in progress.

2018.06.04 – Underpinning outside Room No. 113 and 114 is in progress.

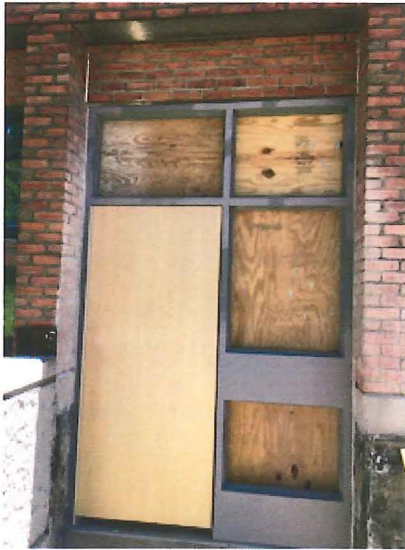
08.01: 2018.06.04 – The door frame has been installed for the temporary exit from Room No. 114. A temporary door has been installed.

2018.06.04 – The door frame for the temporary exit from Room No. 114 has been installed.

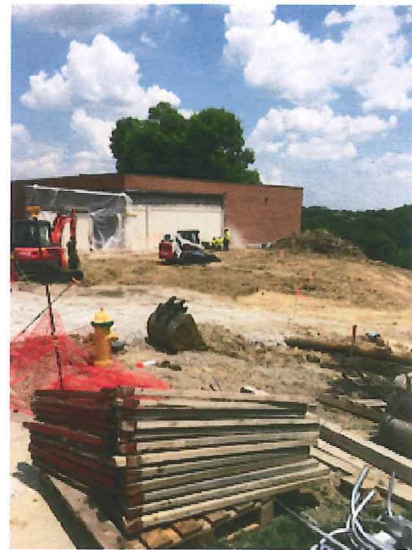
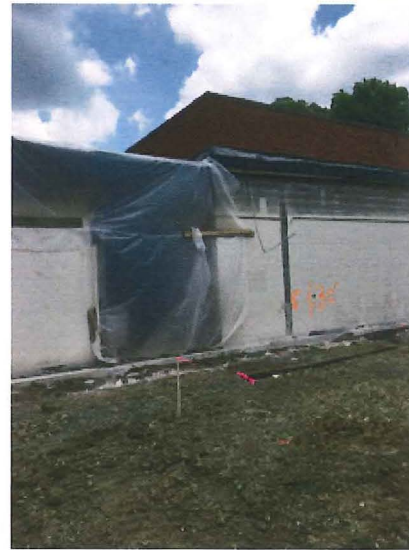
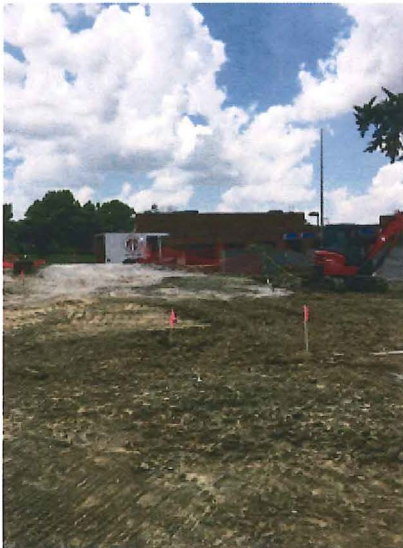
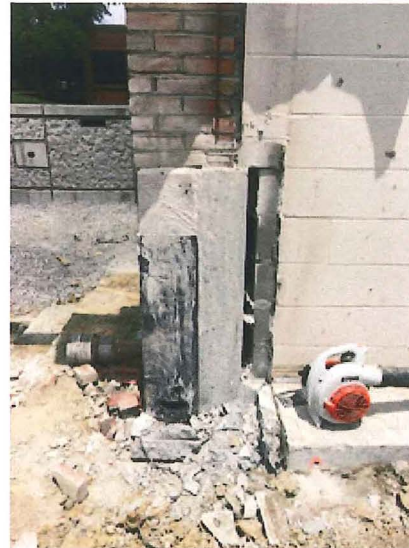
02.03: 2018.06.18 – Demolition of a portion of the existing building is complete. The razed materials have been removed from the site.

2018.06.18 – Demolition of the existing building has been completed.

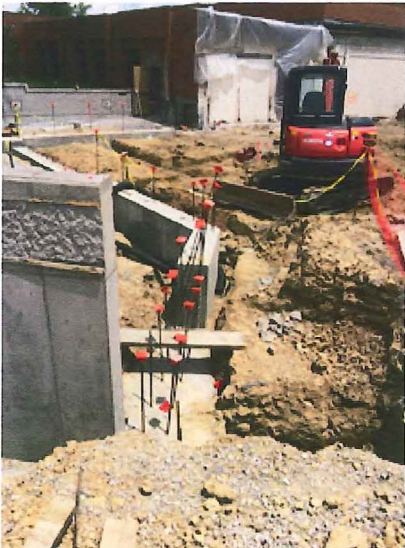
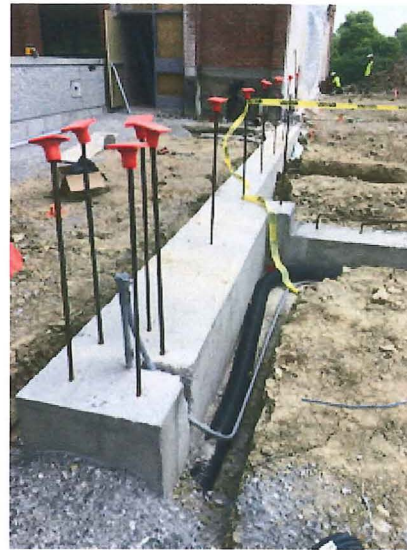
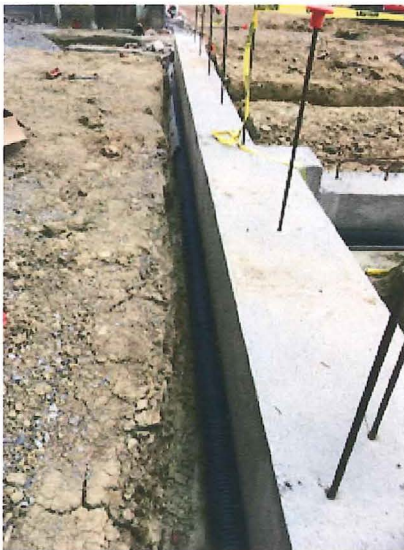
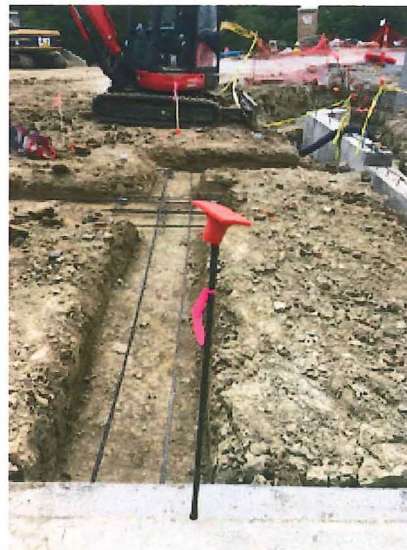
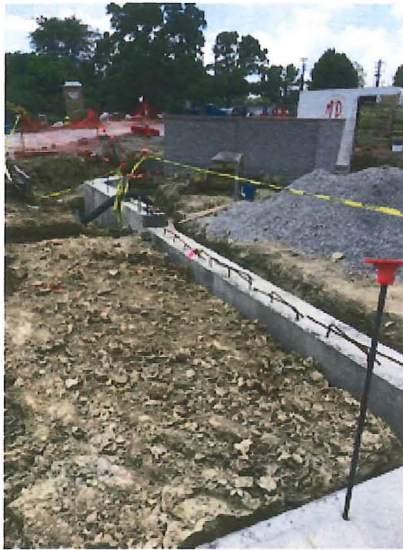
03.04: 2018.06.18 – Installation of the foundations and stem walls along the west side of the new addition have been started.

2018.06.18 – Installation of the building footings and stem walls for the new addition has started.

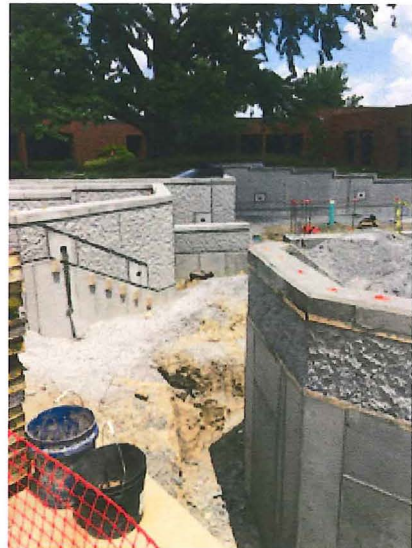
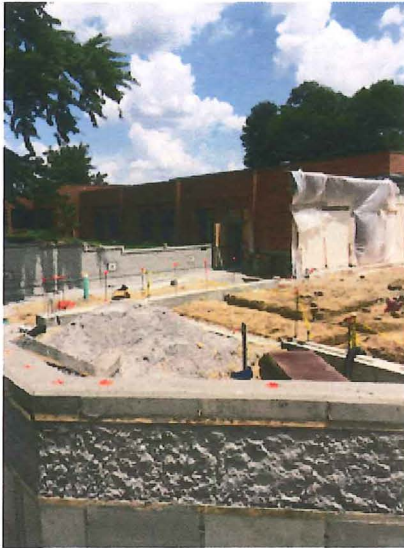
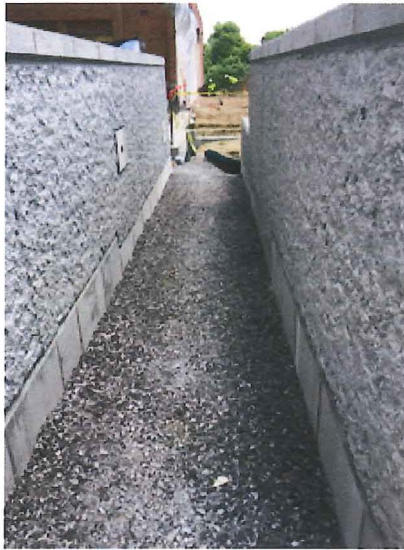
2018.06.18 – Installation of the exterior site and ramp walls continues.

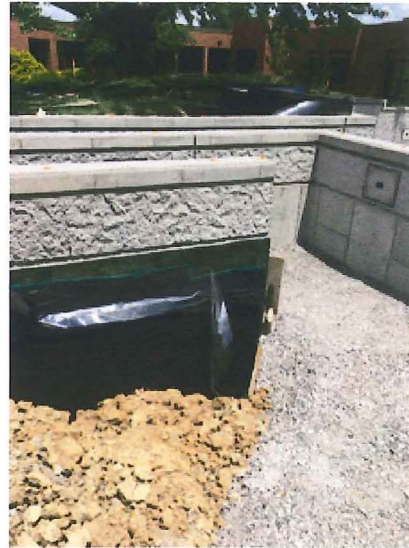
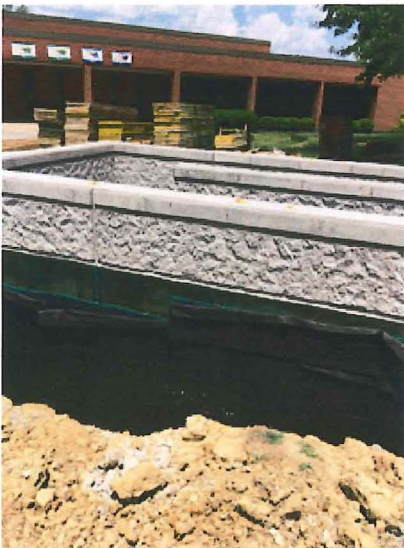
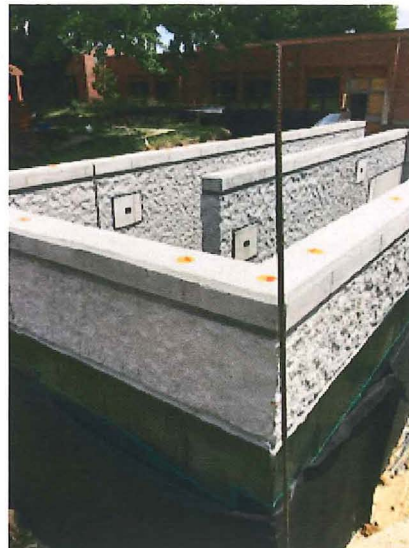
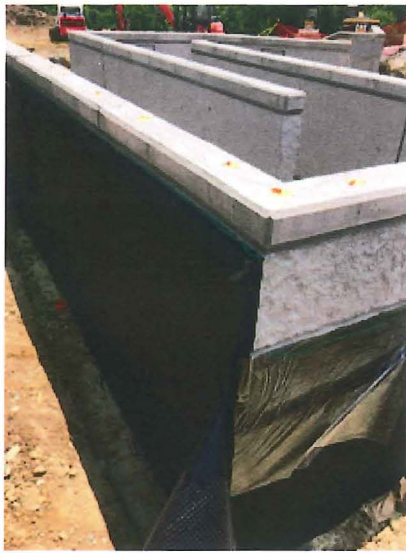
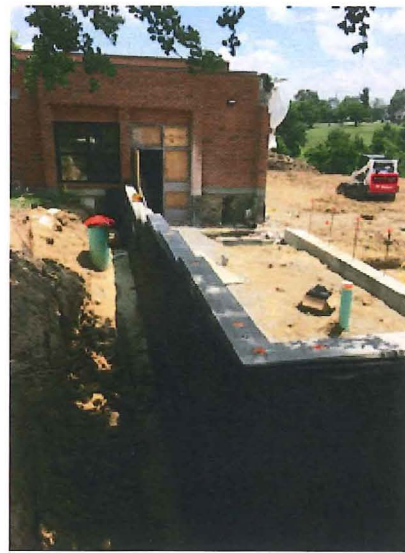
07.01: 2018.06.18 – Installation of the waterproofing and protection board has been installed on a number of the exterior site walls. In some areas the waterproofing primer and waterproofing has been installed too high. The Contractor was notified of this condition and the Contractor stated it would be cleaned.

2018.06.18 – Waterproofing and protection board has been installed on the exterior site and ramp walls. Where the material is too high it will be cleaned off.

2018.06.18 – Waterproofing and protection board has been installed on the exterior site and ramp walls. Where the material is too high it will be cleaned off..

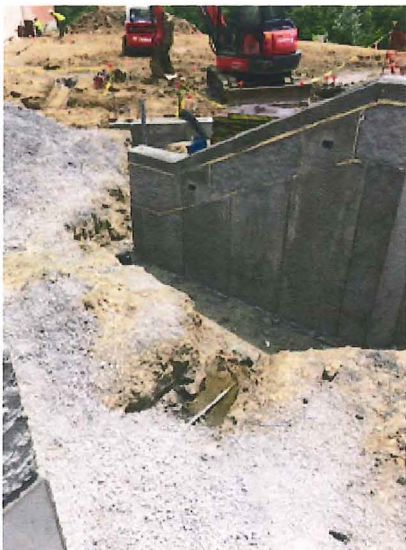
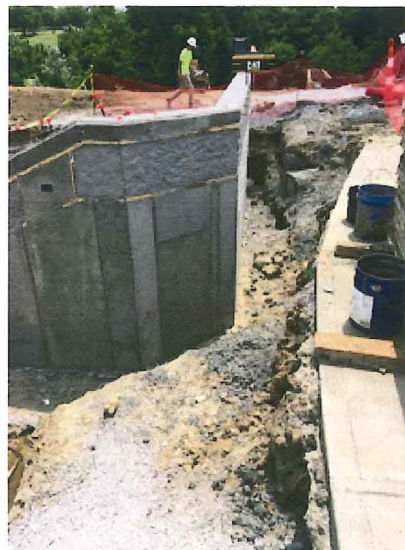
03.03: 2018.06.18 – Construction of the exterior site walls south of the new exterior stairs have been completed.

2018.06.18 – Installation of the exterior site and stair walls continues.

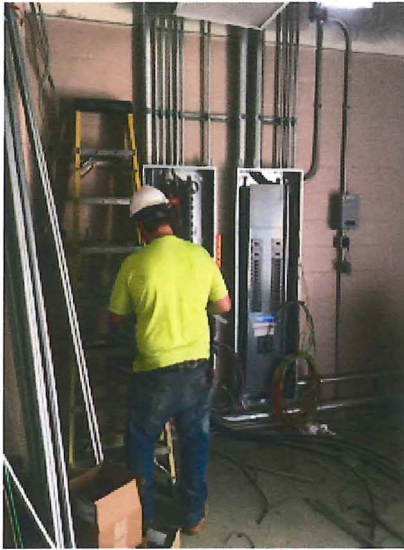
16.02: 2018.06.18 – Installation of the new electrical panels continues in Room No. 113.

2018.06.18 – The electrical panels are being installed in Room No. 113.

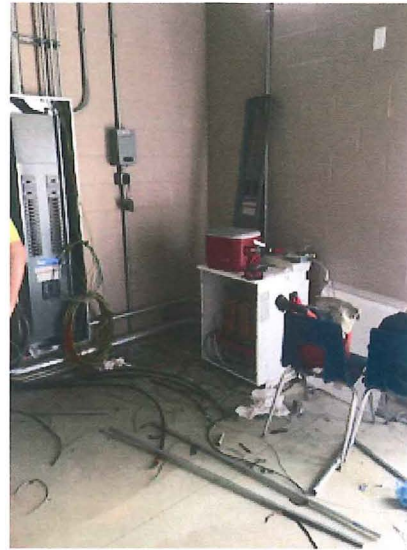
16.03: 2018.06.18 – The new electrical transformer has been set in Room No. 113.

2018.06.18 – The transformer is being installed in Room No. 113.

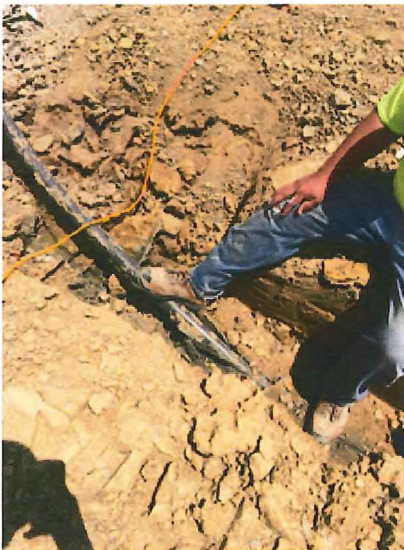
16.04: 2018.06.18 – An electrical conduit with cabling was uncovered on the south side of the building. The MEP engineer looked into the matter and was able to determine it apparently was a feed for a former sewage treatment station. The feeder is shown as 3#8 and 1#6 ground, which looks like what was found. Presumably, this has been long abandoned.

2018.06.18 – An abandoned underground electrical cable was discovered.

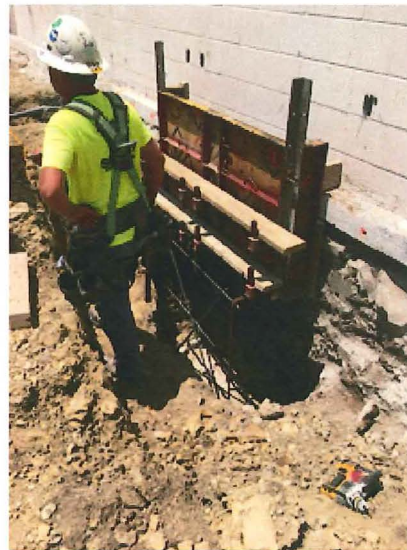
03.05: 2018.06.18 – Installation of under-pinning along the wall of the existing building has started.

2018.06.18 – Underpinning of the existing building wall is in progress.
