FIELD OBSERVATION REPORT 2016.12

■ TO:	Kenton County Board of Education 1055 Eaton Drive Ft. Wright, KY 41017	■ DATE:	2016.12.13
ATTENTION:	Mr. Rob Haney, Mr. Danny Mann		
■ FROM:	Mark Perry mperry@pca-arch.com 1881 Dixie Highway, Suite 130 Fort Wright, KY 41011 V: 859.431.8612 • F: 859.431.8611	■ PROJECT:	Kenton County School District Ft. Wright Elementary
COPIES TO:	PROJECT NO.: 2014-112

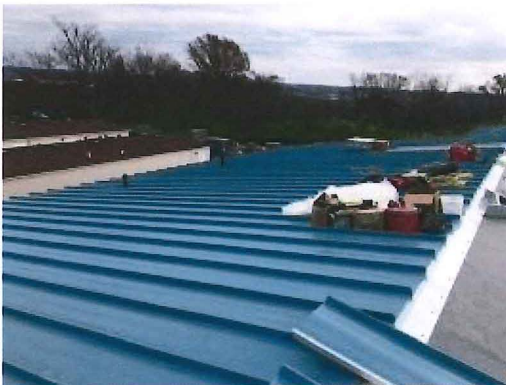
07.01: 2016.12.01 – The roofing subcontractor was actively installing the standing seam metal roof at the cafeteria addition.

2016.12.01 – Metal roof installation

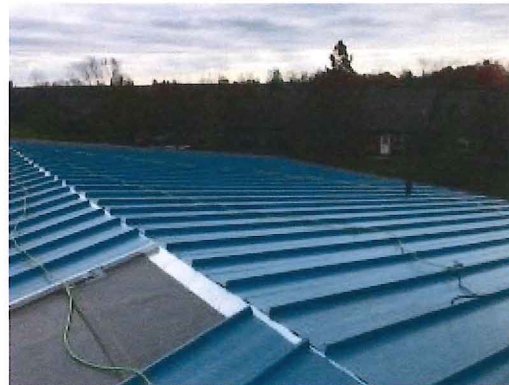
2016.12.01 – Metal roof installation

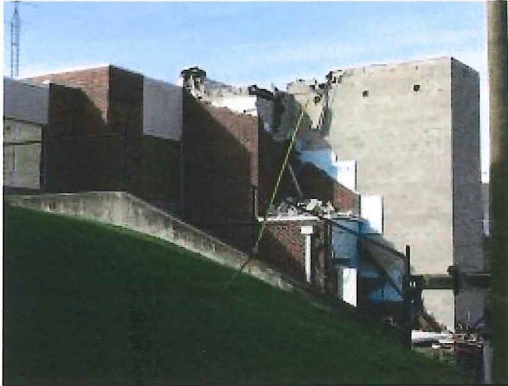
02.01: 2016.12.05 – Demolition of the 1995 stair tower / elevator addition was underway.

2016.12.05 – Demolition of existing stair tower.

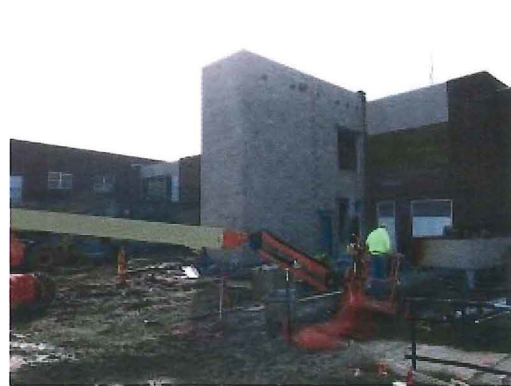
2016.12.05 – Demolition of existing stair tower.

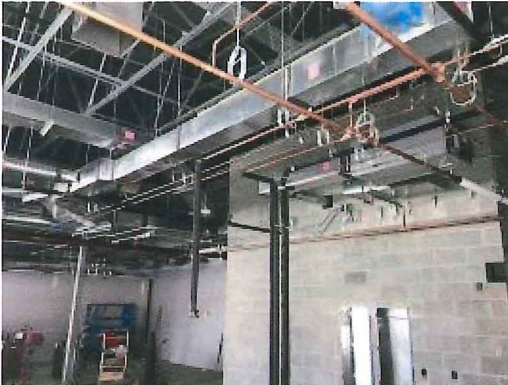
20-28.01: 2016.12.05 – Installation of above ceiling ductwork and piping was largely complete in the kitchen. Pipe insulation installation was underway.

2016.12.05 – Above ceiling mechanicals in the kitchen.

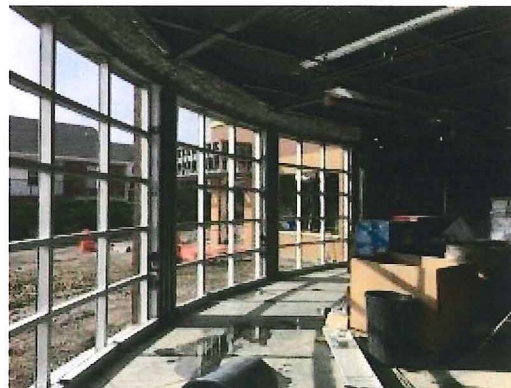
08.01: 2016.12.05 – Three of the four bays of storefront at the curved cafeteria wall had been framed.

2016.12.05 – Storefront framing.

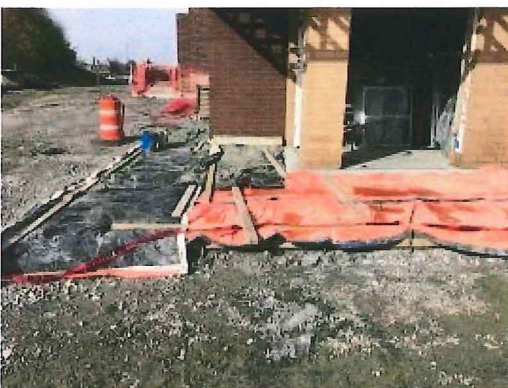
03.01: 2016.12.05 – The contractor had poured the sidewalk at the playground entrance earlier in the day.

2016.12.05 – Slab protection at playground entrance.

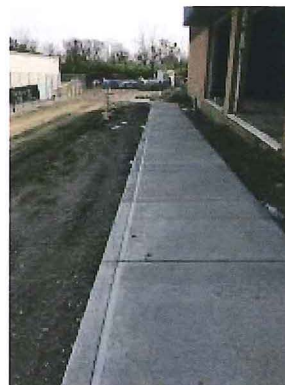
03.02: 2016.12.05 – Sidewalks along the east side of the existing gymnasium and cafeteria addition were complete.

2016.12.05 – Sidewalk east of cafeteria.

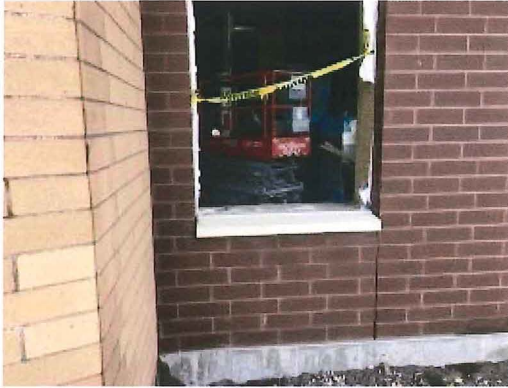
04.01: 2016.12.05 – Cast window sills had been installed.

2016.12.05 – Cast sill in place.

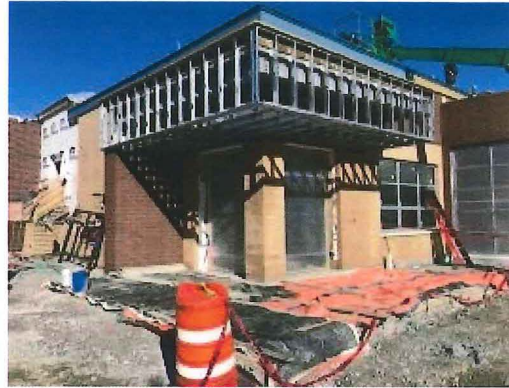
2016.12.08 – Playground entrance.

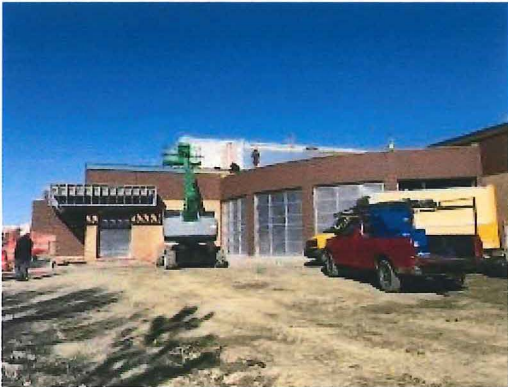
07.02: 2016.12.08 – The roofing / metal siding subcontractor was actively sheathing the exterior walls of the mechanical platform and had installed some gutter board and rake board wraps.

2016.12.08 – Weather enclosure and crew working at platform enclosure above.

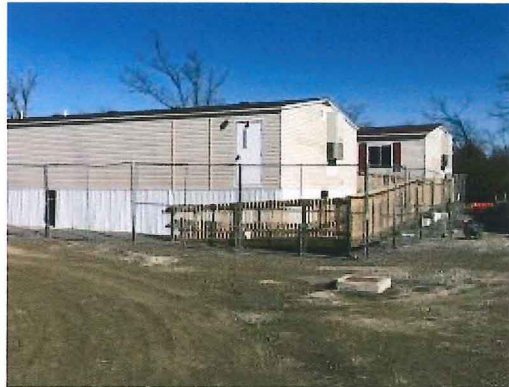
01.01: 2016.12.08 – Temporary fence was in place around the temporary mobile classrooms. The deck, stairs, and ramp were 95% complete.

2016.12.08 – Temporary classroom ramp and fence.

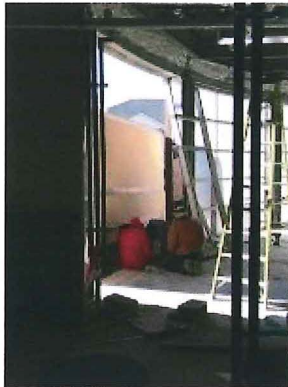
08.03: 2016.12.08 – The subcontractor was actively installing storefront framing at the final opening.

2016.12.08 – Crew installing storefront frame.

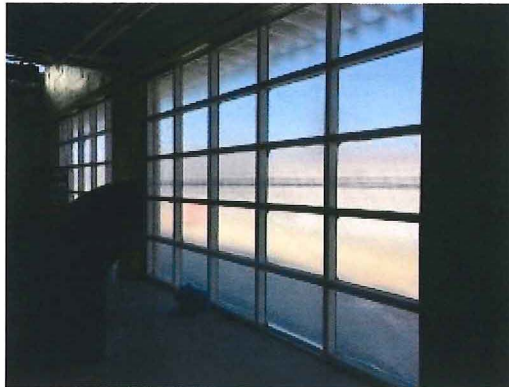
Storefront framing had been installed at all by one opening and weather protection installed to allow temporary heat inside the cafeteria addition.

2016.12.08 – Weather enclosure at storefront.

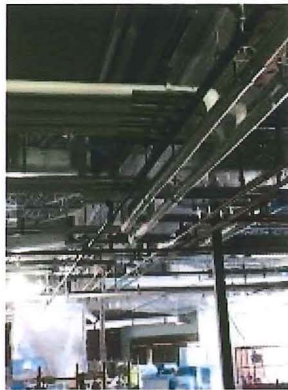
20-28.03: 2016.12.08 – Pipe insulation had progressed.

2016.12.08 – Insulated piping @ kitchen.

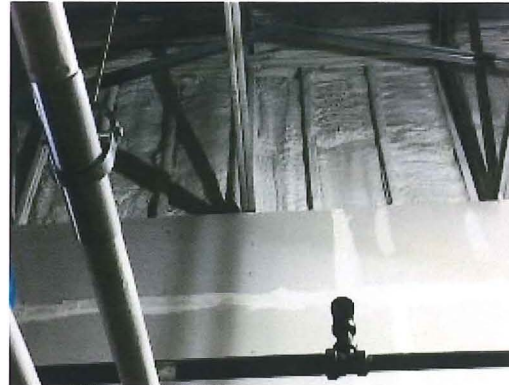
07.03: 2016.12.08 – Spray foam insulation and intumescent coating had been installed at metal stud bays in the cafeteria / kitchen areas.

2016.12.08 – Spray foam insulation at truss end wall.

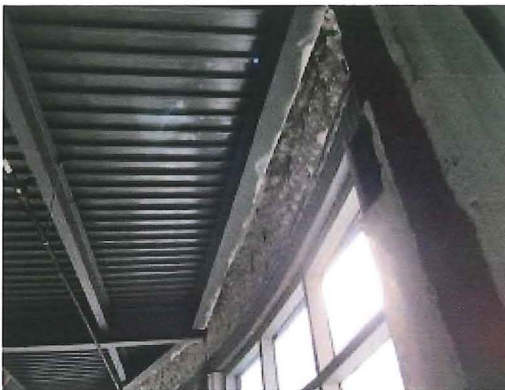
2016.12.08 – Spray foam above curved storefront.

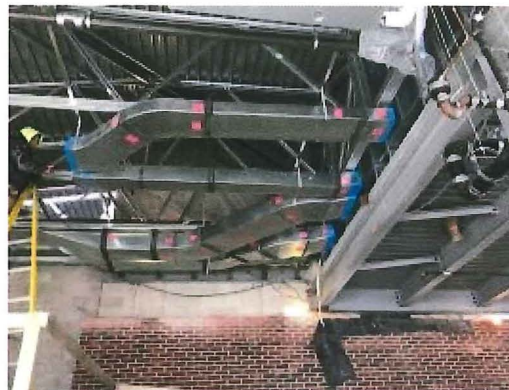
2016.12.08 – Ductwork leading to mechanical platform.

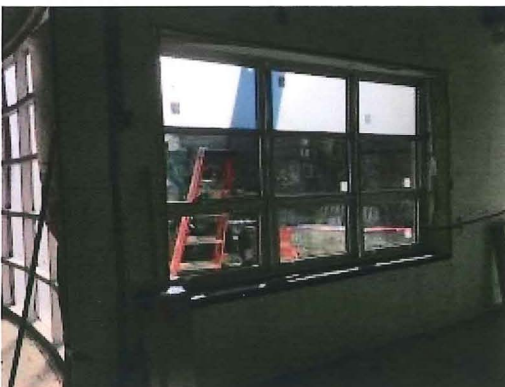
08.02: 2016.12.08 – Glass had been installed in the window adjacent to the playground entrance.

2016.12.08 – Glass installed.

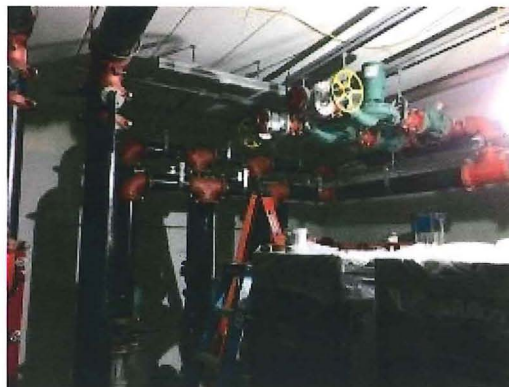
20-28.02: 2016.12.08 – Hydronic piping to and from the lower level heat exchanger had been installed.

2016.12.08 – Hydronic piping.
