**FIELD OBSERVATION REPORT**

■ TO:	Kenton County Board of Education 1055 Eaton Drive Ft. Wright, KY 41017	■ DATE:	2018.07.20
ATTENTION:	Mr. David Lloyd		
■ FROM:	Mark Perry mperry@pca-arch.com 1881 Dixie Highway, Suite 130 Fort Wright, KY 41011 V: 859.431.8612 • F: 859.431.8611	■ PROJECT:	Kenton County School District Scott High School – Phase IV
COPIES TO:	Mr. Rob Haney, Mr. Danny Mann	PROJECT NO.:	0000-000

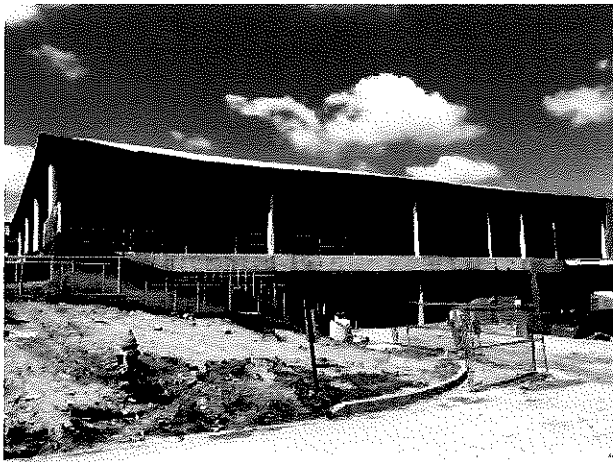
2018.06.28 – Exterior skin removed at East elevation.

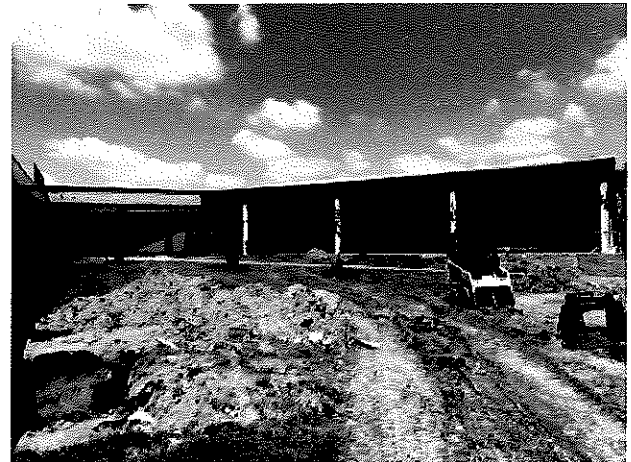
2018.06.28 – Looking towards former main entrance.

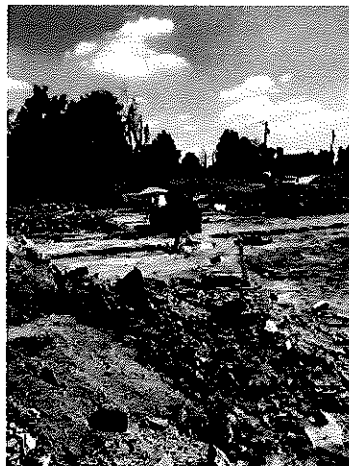
20-28.02: 2018.06.28 – Geothermal piping was being assembled inside the building while boring under Lonneman was occurring so the boring machine could pull the pipe through after completing the first bore hole.

2018.06.28 – Boring machine

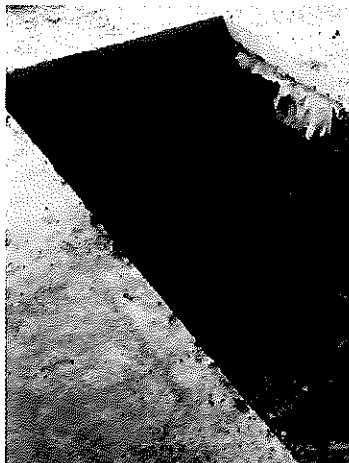
2018.06.28 – Target trench inside the building awaiting the boring bit.

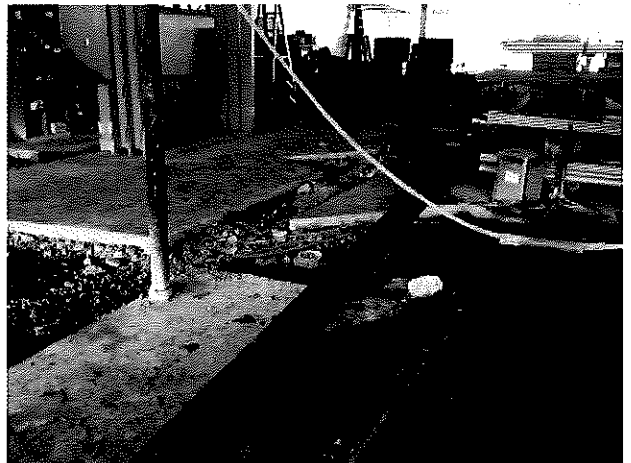
2018.06.28 – Geothermal piping to be pulled back through the bored hole.

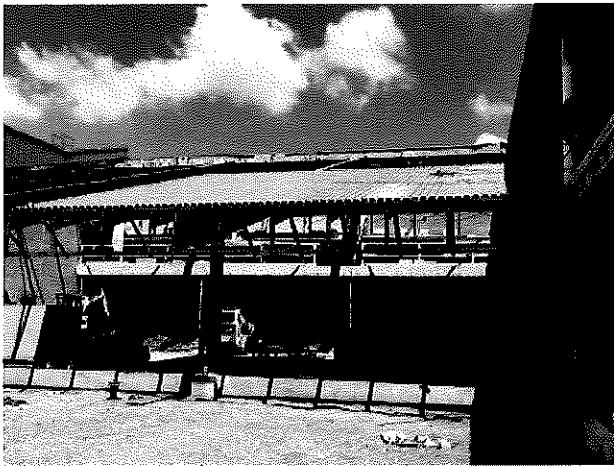
05.01: 2018.06.28 – New roof deck was actively being installed at the sloped roof.

2018.06.28 – New roof deck.

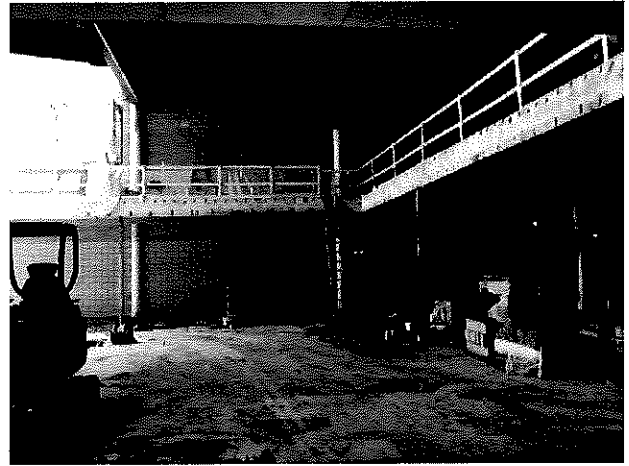
01.01: 2018.06.28 – Temporary safety rail was in place at the interior and exterior perimeters of the 2<sup>nd</sup> floor where fall hazards exist.

2018.06.28 – Temporary safety railing.

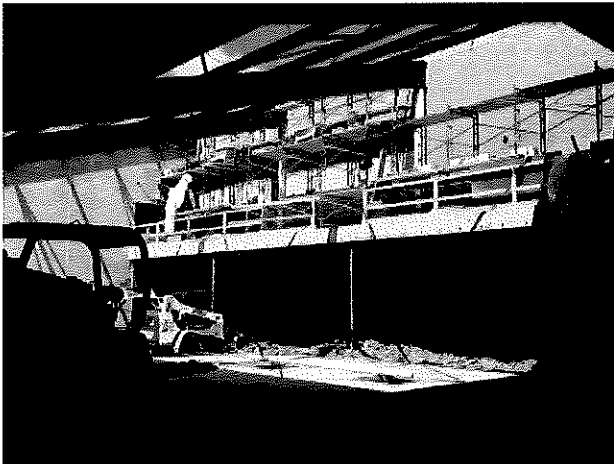
04.01: 2018.06.28 – New fire wall construction had moved to the second floor and was up to the underside of existing roof steel at two bays in the former commons area. Scaffolding was in place along the length of the sloped roof.

2018.06.28 – New fire wall progress.

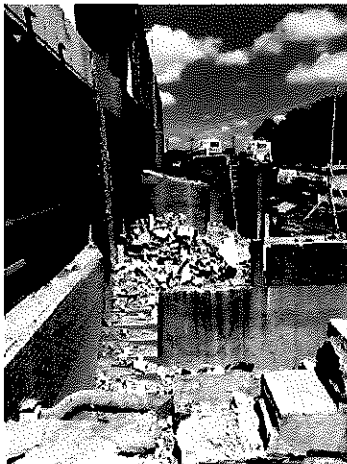
2018.06.28 – Debris at former loading dock.

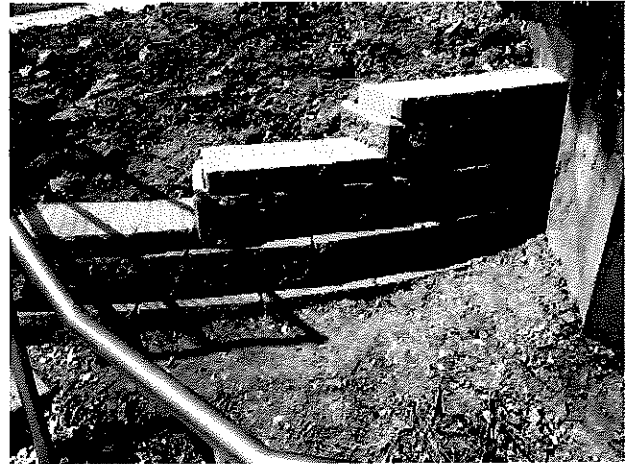
32.01: 2018.06.28 – The new, small, modular retaining wall at the existing site steps was installed.

2018.06.28 – Modular retaining wall.

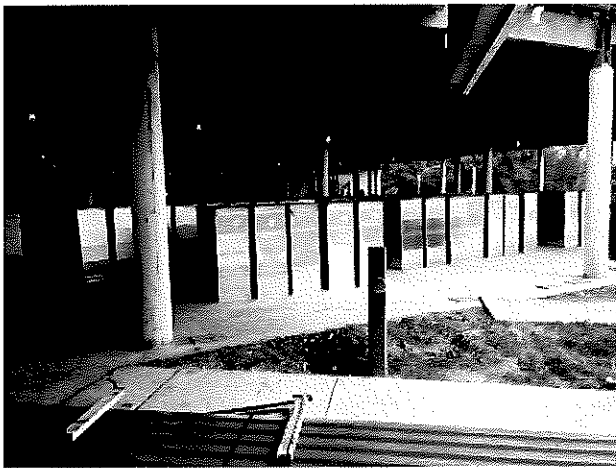
20-28.03: 2018.06.28 – Ductwork for early completion areas was on-site awaiting relocation and installation.

2018.06.28 – Ductwork.

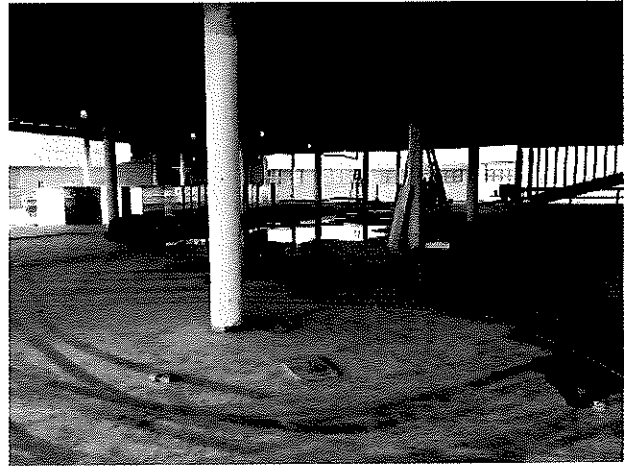
2018.06.28 – 2<sup>nd</sup> floor following demolition.

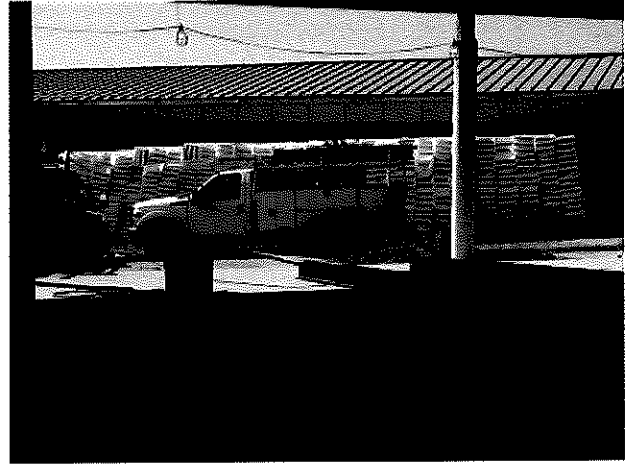
03.01: 2018.07.03 – ICF Formwork was actively being delivered.

2018.07.03 – ICF forms.

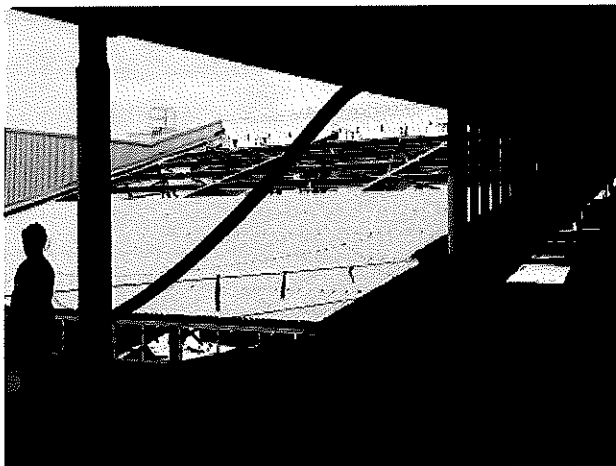
05.02: 2018.07.03 – Roof deck installation at the sloped roof was on-going. Assorted early completion steel members had been delivered.

2018.07.03 – Metal deck progress.

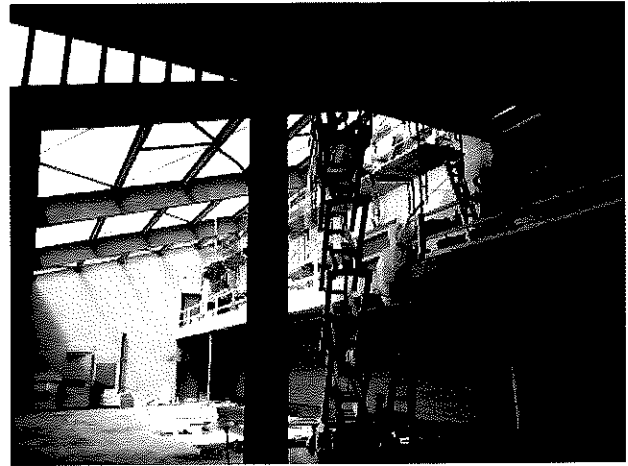
04.02: 2018.07.03 – Fire wall construction was actively occurring at a third bay at the 2<sup>nd</sup> floor.

2018.07.03 – Fire wall progress.

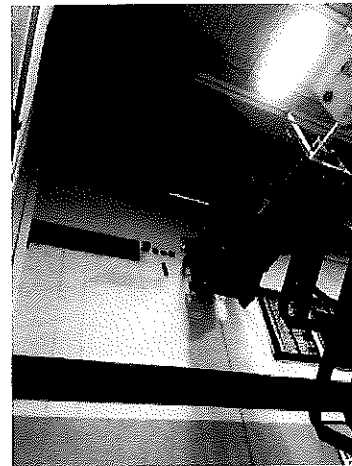
2018.07.03 – Selective demolition inside the gym.

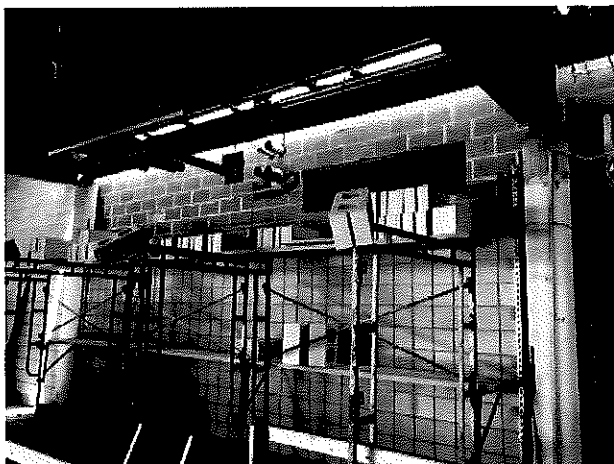
04.03: 2018.07.13 – Fire wall construction was actively occurring at a fourth bay at the 2<sup>nd</sup> floor. An issue with masonry fire wall construction to date was observed and the G.C. was notified. The mason's proposed solution was deemed acceptable.

2018.07.13 – Fire wall progress.

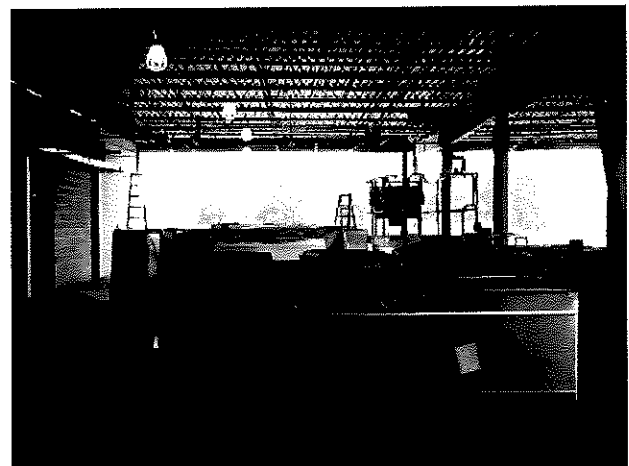
20-28.06: 2018.07.13 – Ductwork for the new roof top units was staged for installation.

2018.07.13 – Gym RTU ductwork staged for installation.

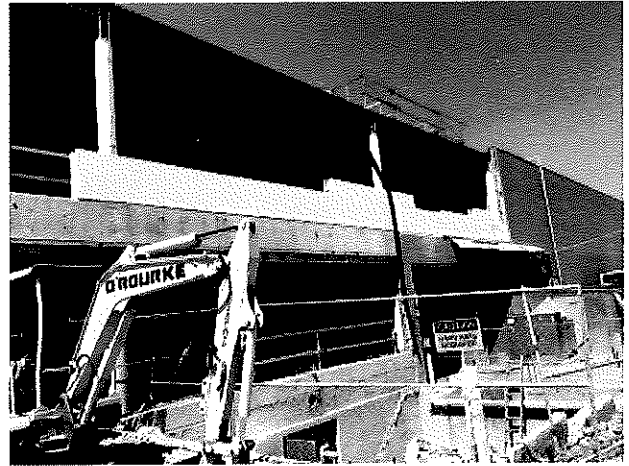
2018.07.13 – ICF installation at East elevation.

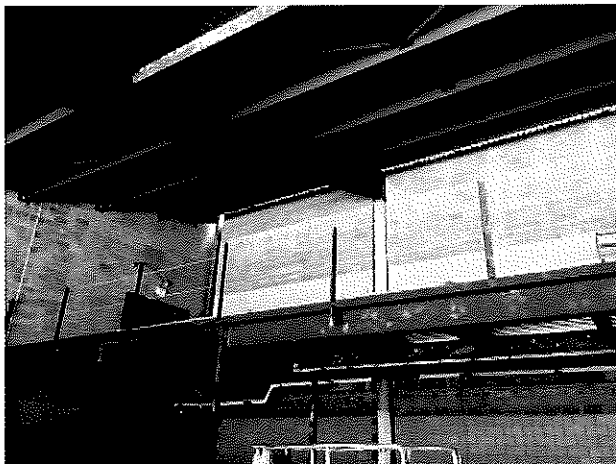
2018.07.13 – New floor structure at west end of former Commons.

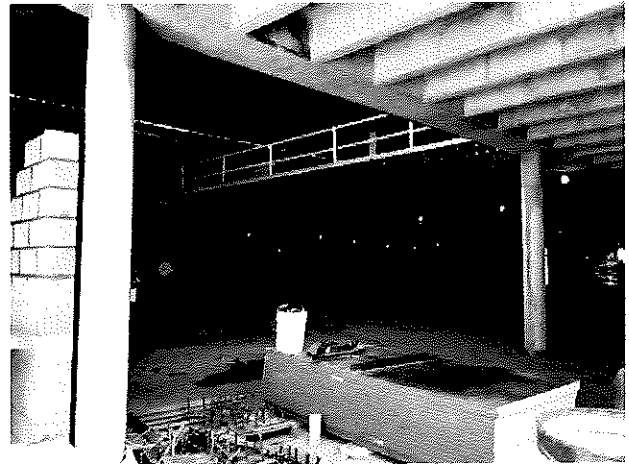
2018.07.17 – Channel steel at flooring infill.

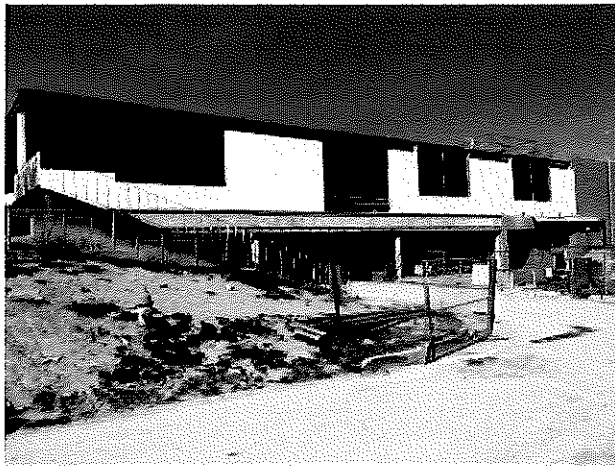
2018.07.17 – East elevation.

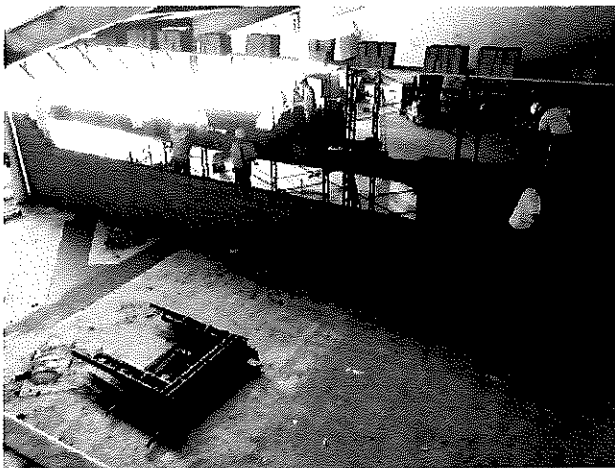
04.04: 2018.07.17 – Fire wall construction was complete at the 2<sup>nd</sup> floor building interior (minus column surrounds and the door vestibule). The mason was actively working on the bearing wall for the infill flooring at the east end of the former Commons.

2018.07.17 – Mason installing bearing wall.

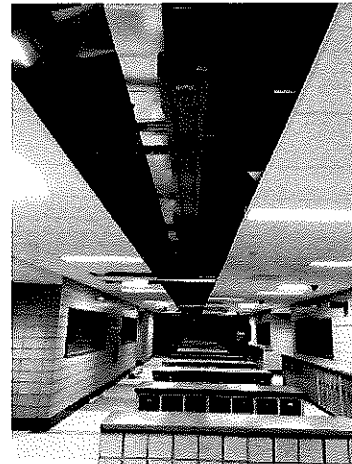
2018.07.17 – Buss duct above Phase 2B ceiling.

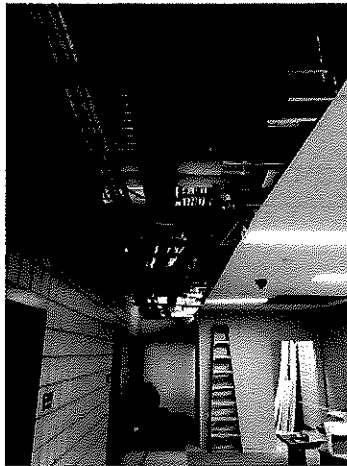
2018.07.17 – Buss duct above Phase 2B ceiling.

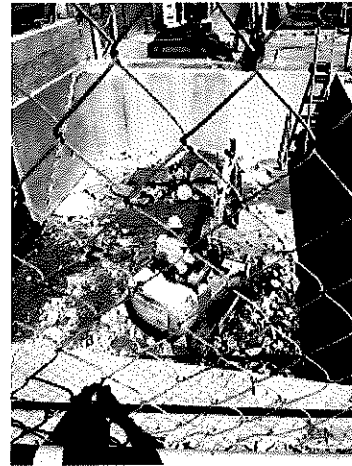
2018.07.17 – Slab demo in area well.

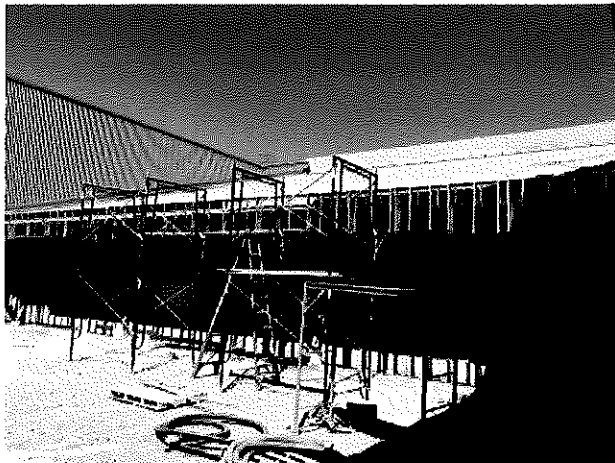
2018.07.17 – Fascia framing at courtyard.

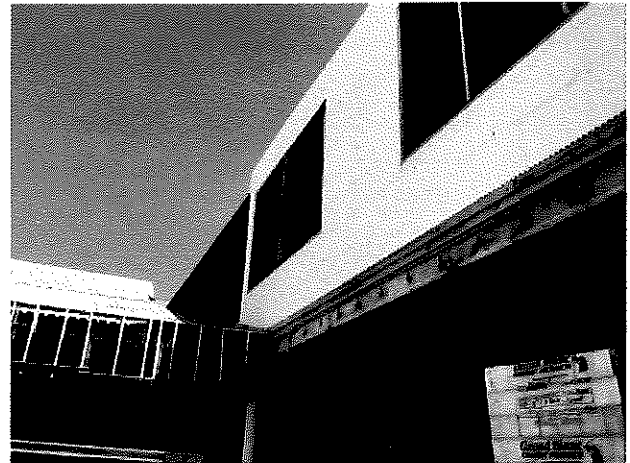
2018.07.17 – ICF at courtyard.
