## FIELD OBSERVATION REPORT

East Hardin Middle School, Hardin County Schools, Elizabethtown, KY 201752.01 - CA8

Date: 3/4/2021

Report No: 45

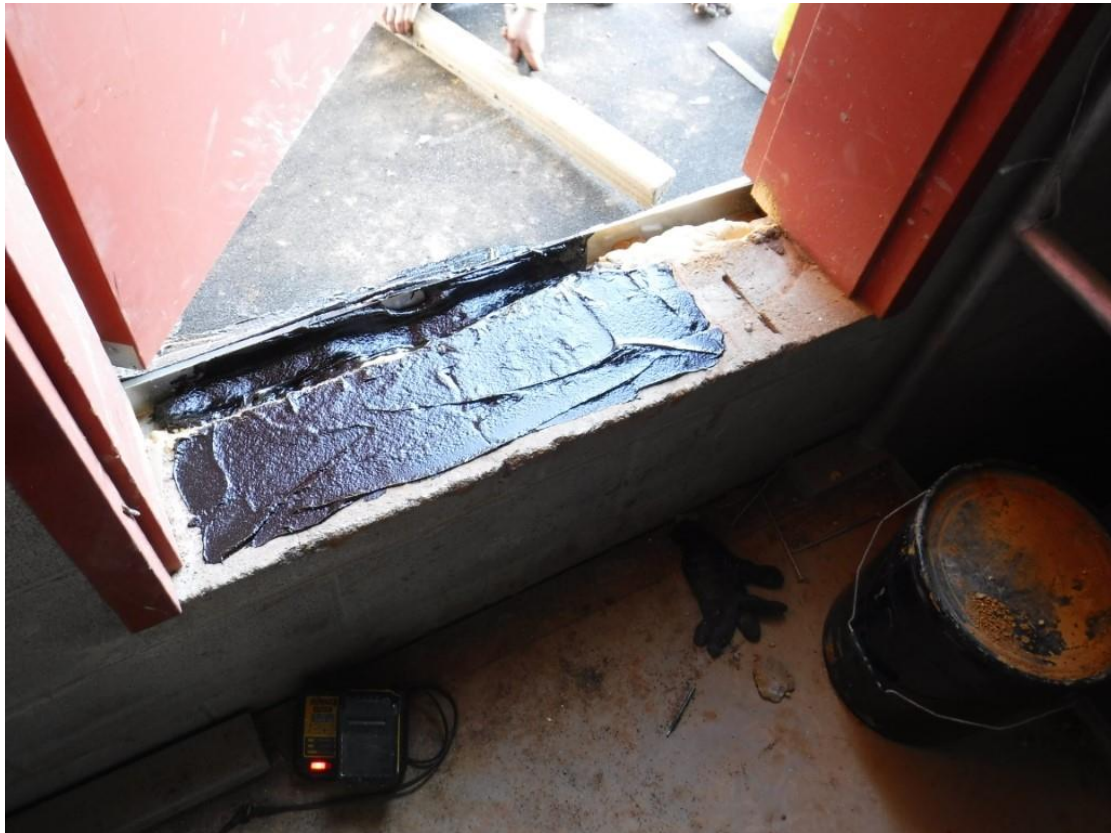
- b) Doyle had recommended that the head of the door leading to the kitchen roof be lowered due to the overhang of the roof. It was agreed that the door and frame would be cut down. The intent was that the frame would remain a four-sided frame and the door would be replaced with one to fit or a new bottom installed on the cut door. Thus far, these repairs have not been done. Joe Stuecker noted that the bottom hinge was cut in half. The bottom of the frame needs to be reinstalled over the roof flashing, the door repaired, and a new hinge prep installed for a full hinge.

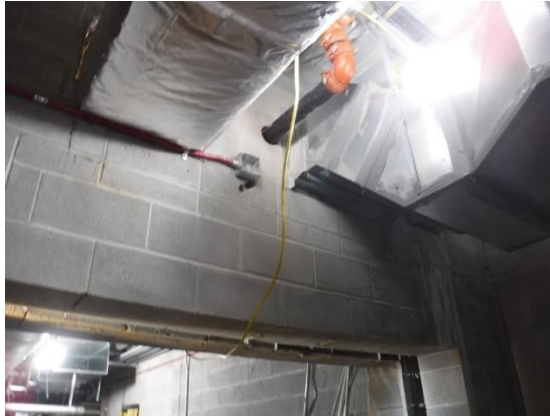
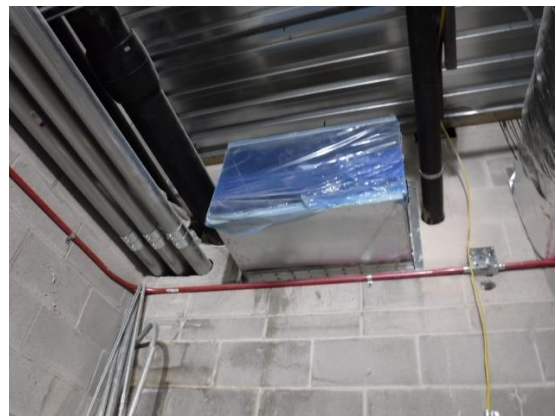
- c) Michael Warren confirmed with GBMC that 2 hour fire rated dampers with access panels will be installed in the ductwork penetrating the two hour fire resistant rated firewalls above the mechanical platforms on both sides of the Gym.

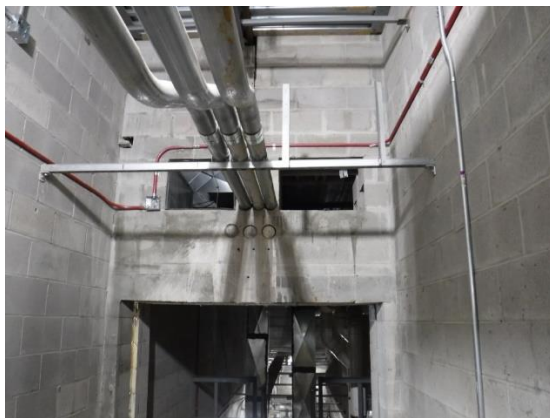
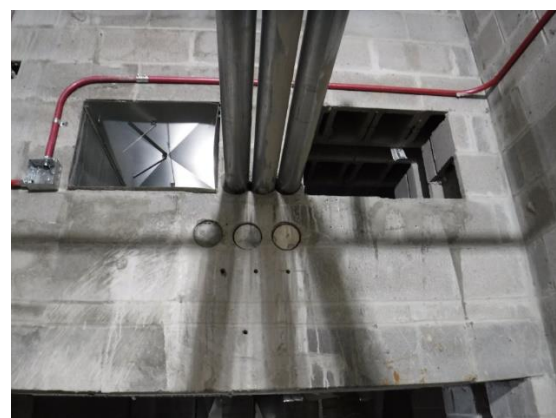
- d) Doyle confirmed that the electrical conduits passing through the two-hour fire resistive rated fire walls would be sealed with fire resistive sealant. The sealant must be installed based on a U/L fire resistant rated assembly for the spacing and size of the conduits.

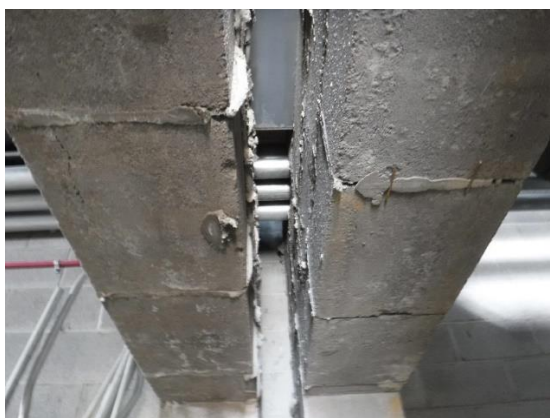
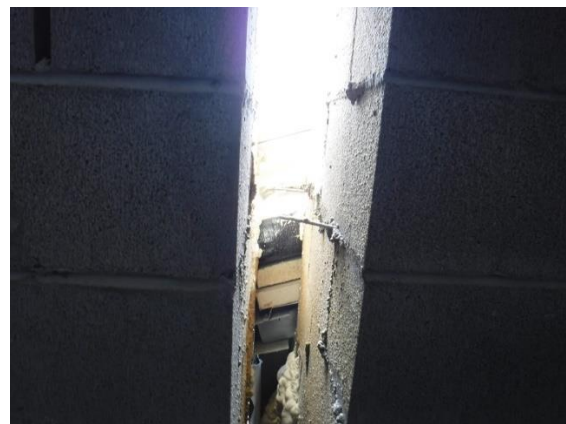
- e) The building expansion joints on the mechanical platforms require covers as specified.

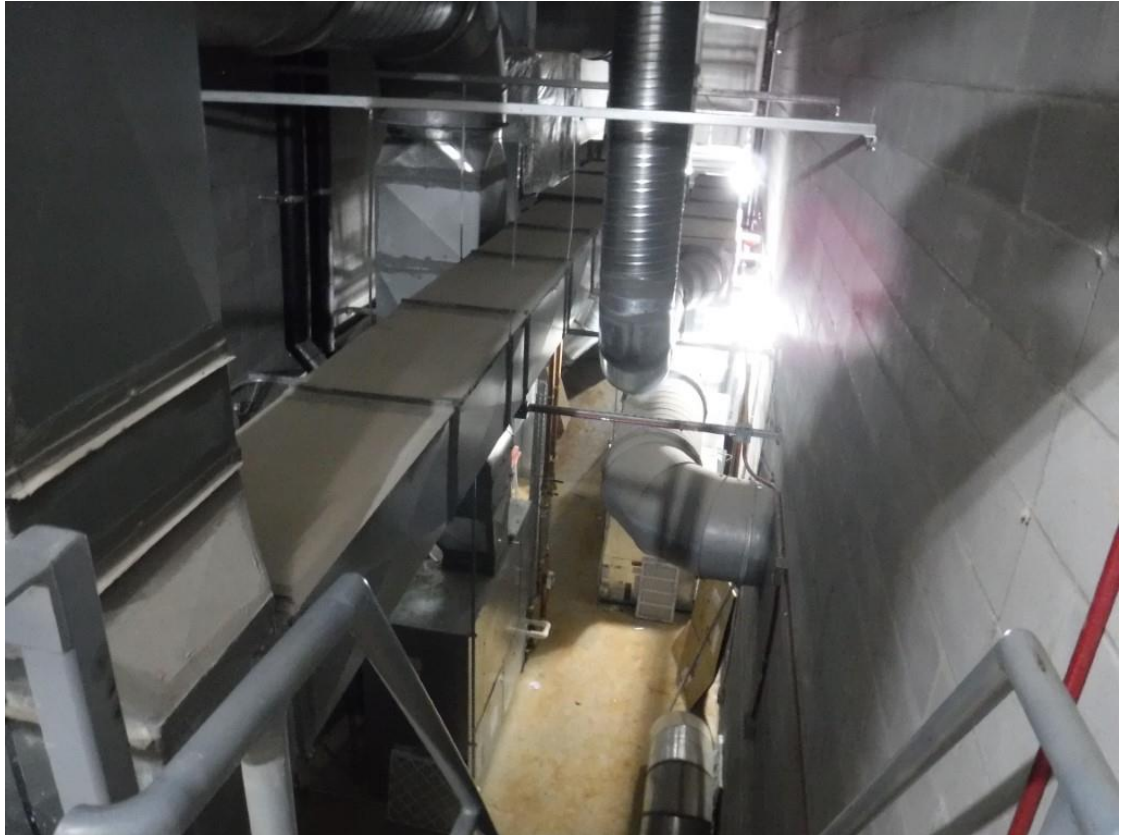
- f) Joe Stuecker stated that even though the mechanical platforms provide general access for mechanical and electrical devices, elbows, boxes, etc. the stacking of these has made it difficult to service these in the upper reaches of the space around the gym. STW will review the conditions to determine if better access can be made to as many of the components as possible.

5. Gypsum board soffits to cover conduits and pipes exposed on the Cafeteria walls.
- b. STW to review serviceability of devices, boxes, etc. in the mechanical room and on the mechanical platform around the Gym.

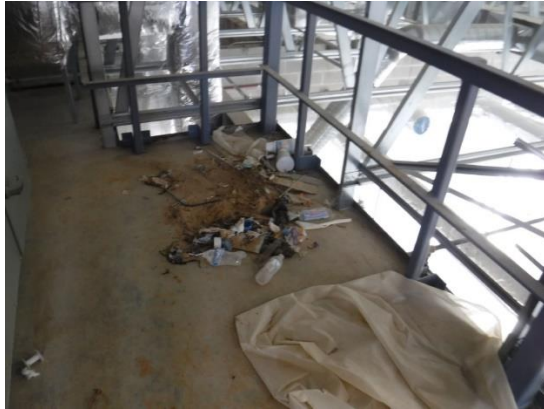
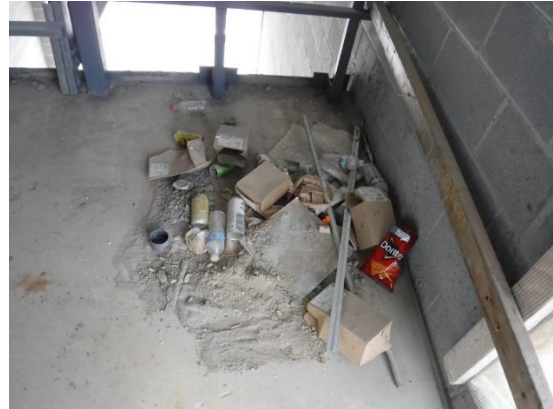
- h) While the accumulation of trash and debris during construction is never a good thing, it becomes more of a problem as the project nears completion. Doyle stressed that all the trade contractors need to do their part to avoid dumping construction and personal item waste on the floors of the building. As finishes are installed these things affect the quality of the work. That is not acceptable to the owner.

- c. Maintain the Skudo system so that it protects the corridor slabs.
- d. All trades shall keep the building and site clean by properly disposing all bottles, bags, wrappers, trash, debris, etc.

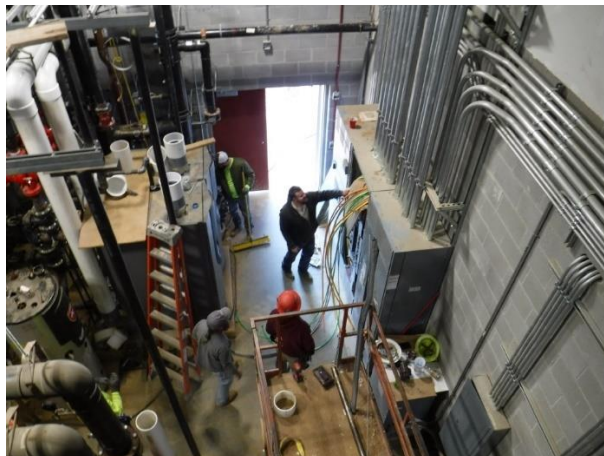
- j) Another concern that Joe Stuecker has is the tight spaces in the mechanical room. STW will review the locations of serviceable items to make sure they are reachable.

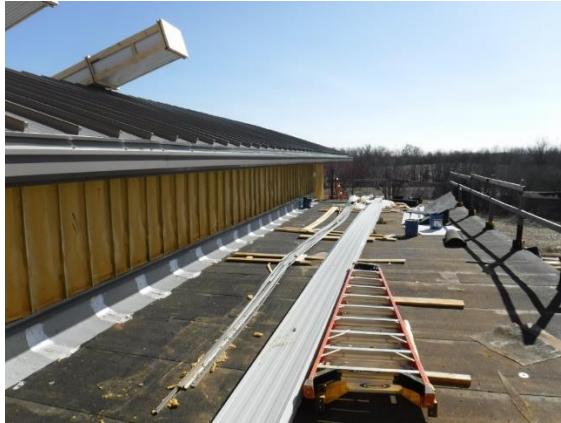
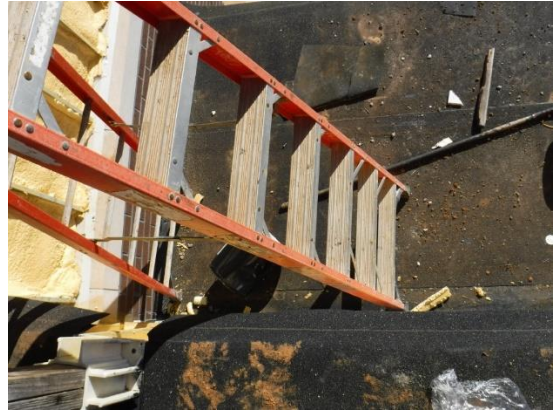
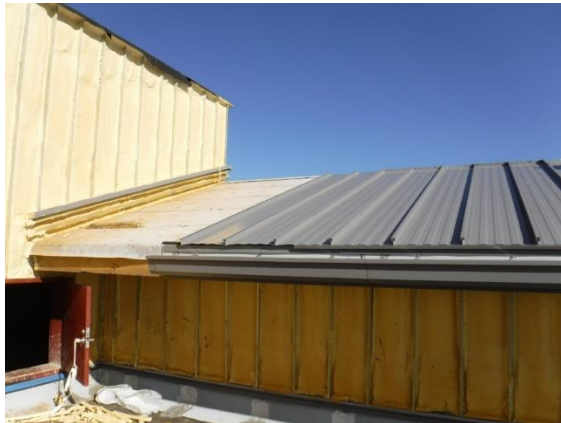
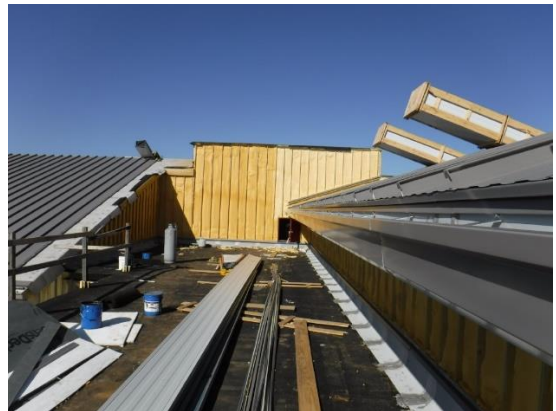
- k) The membrane roof over the rear entrance is in place. The metal roof over the resource room in Area B has been started. The spray foam contractor dented the gutter while applying the foam. I continue to see ladders, materials and equipment on the membrane roof setting directly on the roof membrane and not on protection boards. All trades must protect the roofs and sheet metal trim, gutters and downspouts.

- e. Provide protection board for all ladders, equipment and materials staged on the low sloped built up roofing areas. Remove all screws, nails, sheet metal and other sharp objects from these roof areas ASAP.

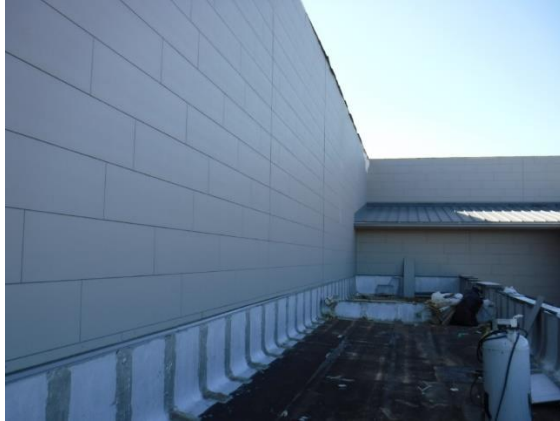
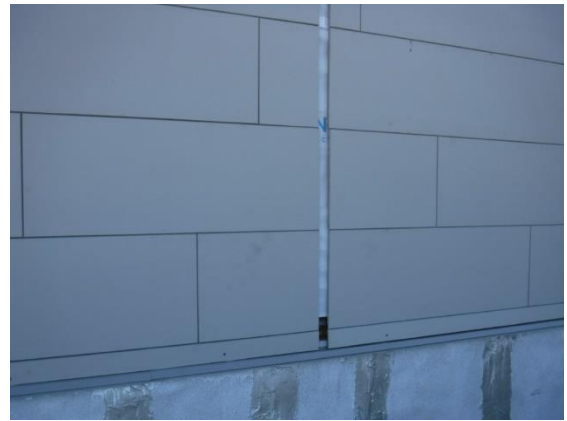
- m) We discussed the condition at the bottom of the composite panels with Dixie Roofing. They agreed to cover the screws at the bottom of the panels with sheet metal trim painted to match the panels. They will also use this trim to cover most of the through wall flashing behind the panels. The panels must be cut so they are 2" above where the flashing forms a bench because snow could fill that area and saturate the bottom of the panels. The wide joint is for the building expansion joint. Dixie will use sheet metal trim to finish both sides of the joint. Corrugated EPDM expansion joint material will then be pushed into the joint.

2. Locations of level 5 finish on gypsum panels.
  3. Trim detail at the bottom of composite panels.
  4. Substitution of countertop in the Music Room.

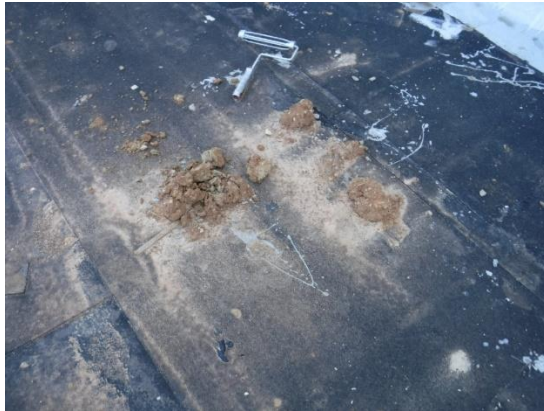
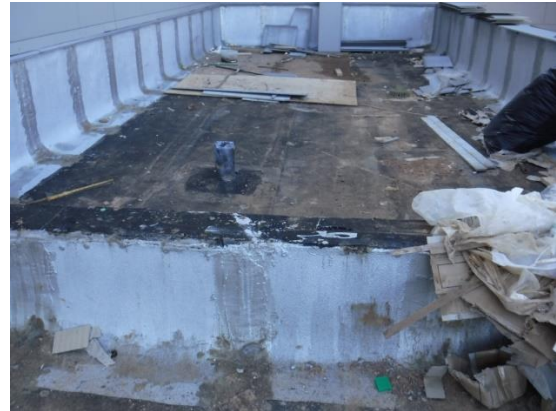
- o) The roof over Area D in front of the gym was covered with mud and debris from the spray foam and panel installation process. We discussed the need to prevent this from happening again. Workers will change shoes when moving from the ground to roof areas and materials will be cleaned before they are raised to the roof.

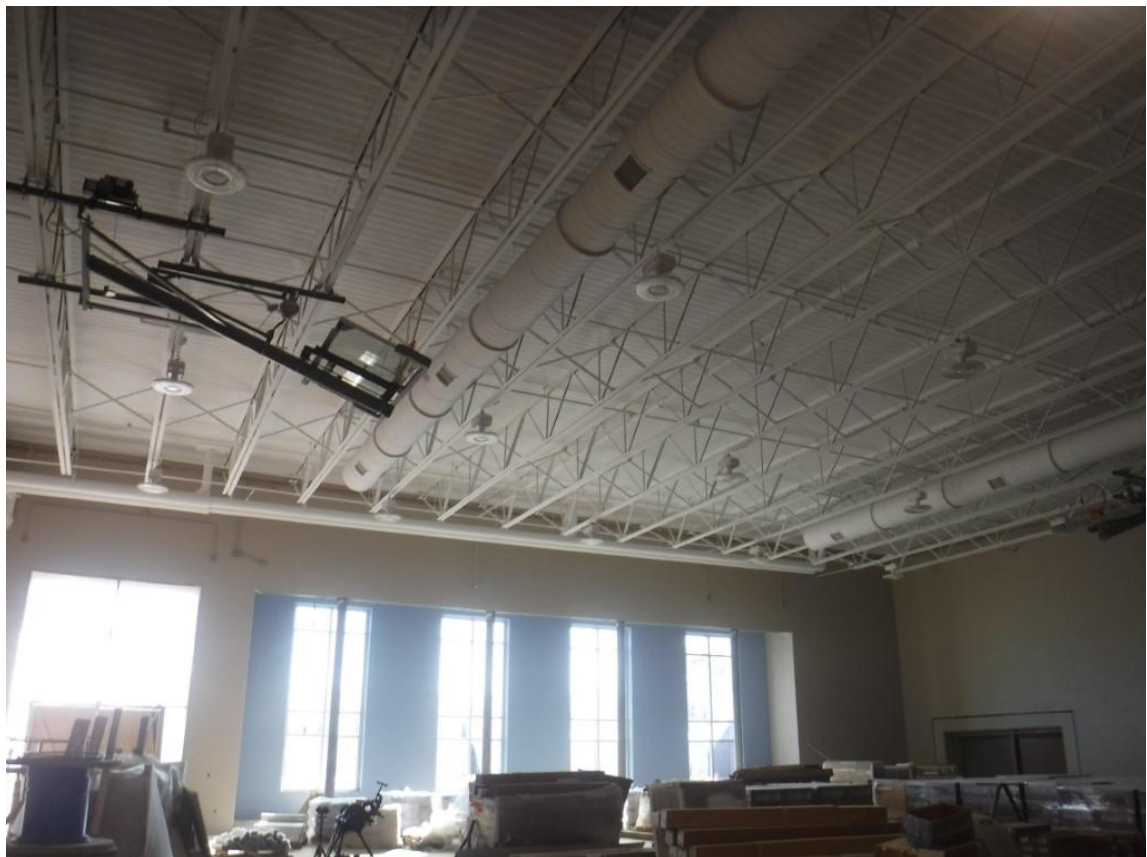
- p) Though it is difficult to see in the image, conduits and pipes have ended up exposed on the walls around the cafeteria. Doyle recommended that drywall soffits be added to cover these.

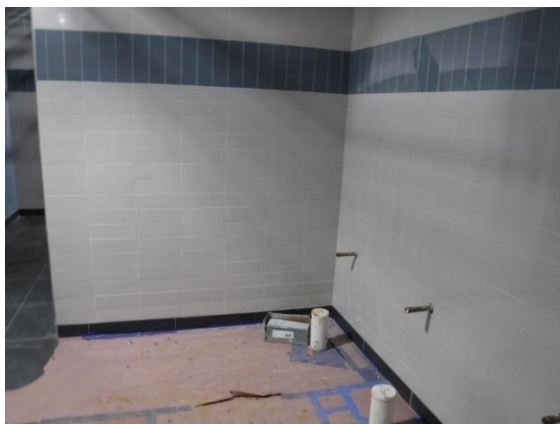
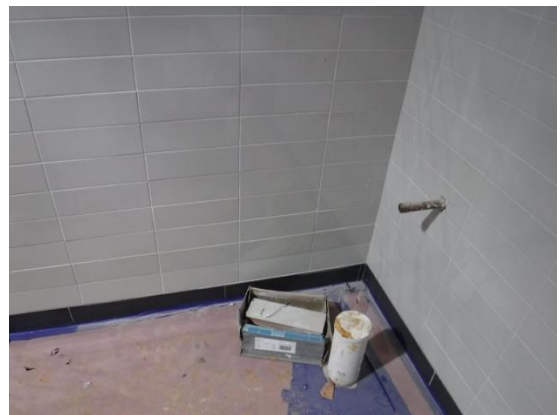
- s) We decided that at the other student toilets the wall tile will be set in plane which will result in it being about 1/8" back from the front edge of the metal trim on top of the base tile. We agreed that the toilets in Area D can remain as installed.

- a. Confirm that RFIs were submitted for changes to the details as requested while I was on site. These include:
  1. The arrangement of ceramic wall tile to set back on the metal trim above the tile base.

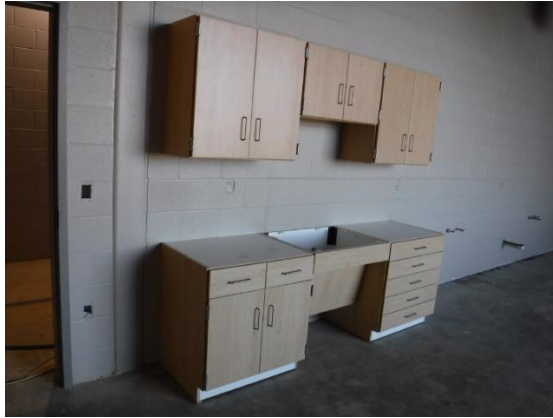
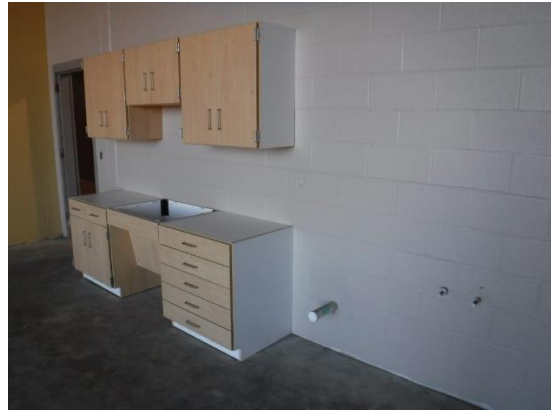
- t) We were told that the countertop for the cabinets in the Music Classroom has been backordered. Atlas reported that they can get the matching solid surface top from a local source. We agreed to make this change.

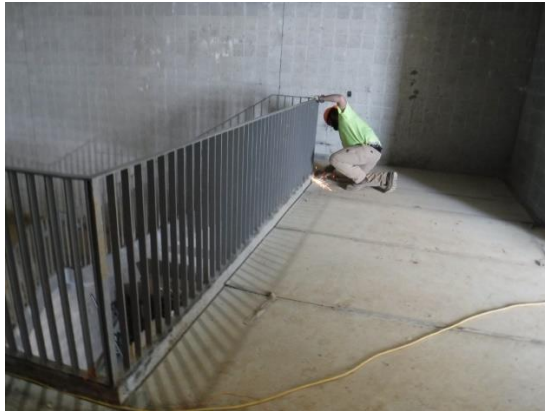
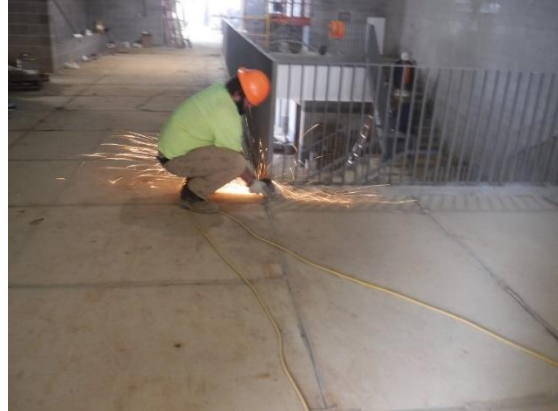
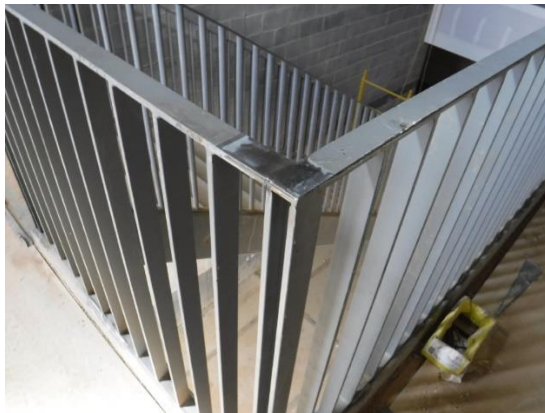
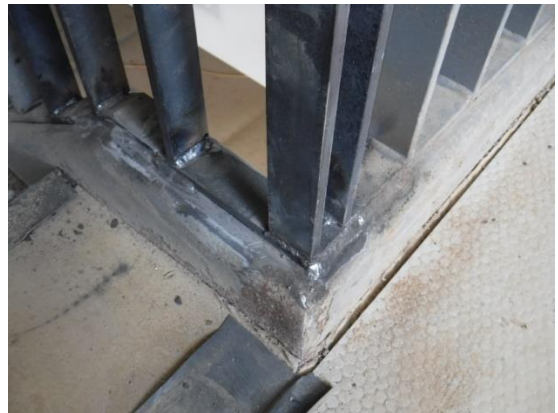
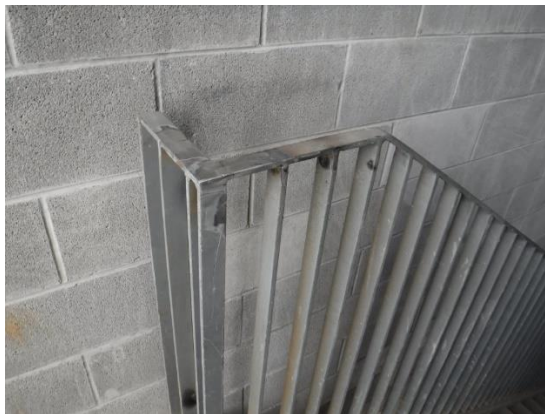
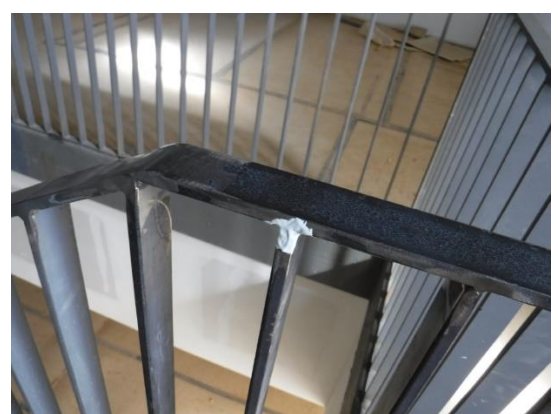
- w) Stewart-Richey's crews were detailing the steel stairs. Doyle said that the interior rated seam sealer for the open joints will be on site in 10 days. We agreed that they can proceed with this product.
