FIELD OBSERVATION REPORT

East Hardin Middle School, Hardin County Schools, Elizabethtown, KY 201752.01 - CA8

Date: 3/17/2021

Report No: 46

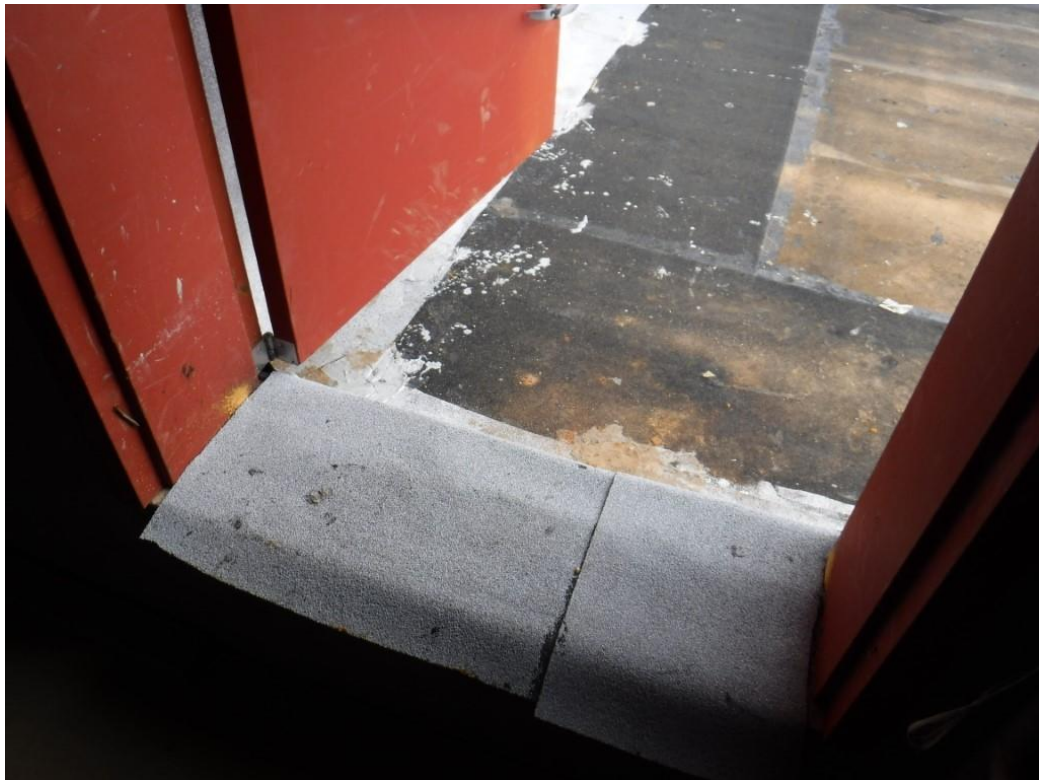
- b) Doyle gave me an update on the door to the kitchen roof. He said that Atlas will return to the site when they hang the wood doors. They have ordered a door bottom for the door and will install it at that time. They will also install an aluminum threshold that will be coordinated with the roof flashing to create a waterproof sill condition. The hinge will also be reworked at that time.

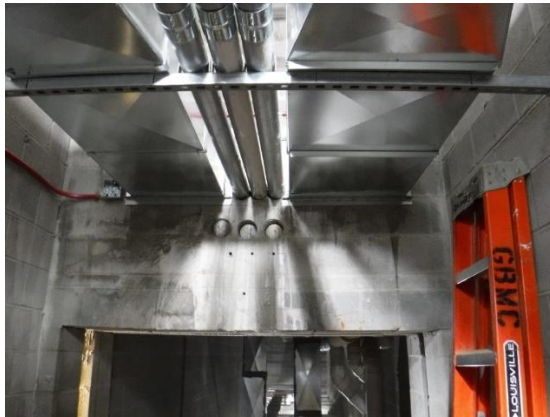
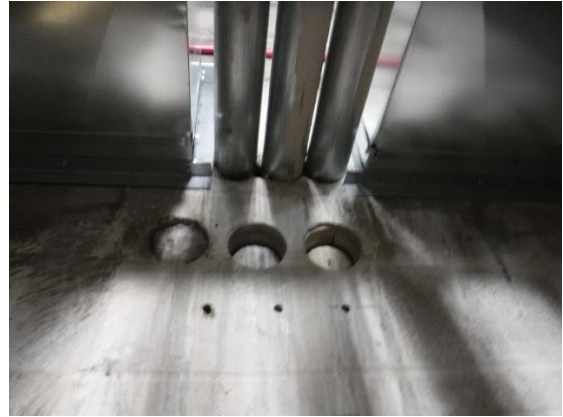
- c) GBMC has done additional work at the 2 hour fire rated walls over the mechanical platforms. The dampers appear to be in place but I did not see the access panels.

As noted previously, the electrical conduits passing through the two-hour fire resistive rated fire walls would be sealed with fire resistive sealant. The sealant must be installed based on a U/L fire resistant rated assembly for the spacing and size of the conduits. It also appears that holes were started through the wall and were stopped. All damage to the fire walls must be repaired to restore the integrity of the two hour fire resistive rating.

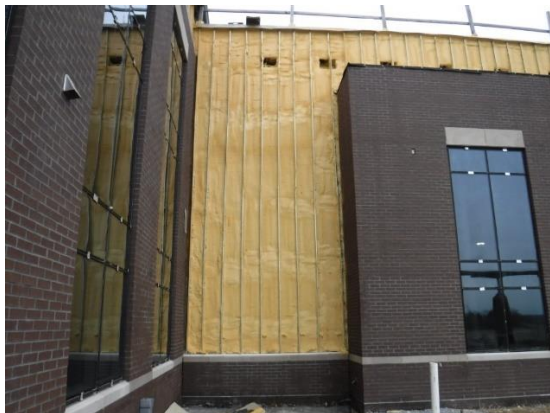
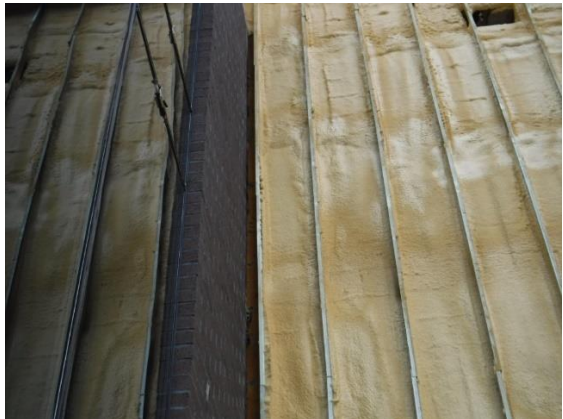
- d) The building expansion joint at the rear of the building between Areas B and C has not yet been incorporated in the construction. I reviewed this with Doyle. The masonry needs to be cut to create the 2" wide joint. The joint also needs to be incorporated in the composite panel system and the roof coping at that point. Insulation needs to be applied to the building construction so that it is continuous as detailed.

- 2. Trim detail at the bottom of composite panels.
 - 3. Gypsum board soffits to cover conduits and pipes exposed on the Cafeteria walls.
- b. STW to review serviceability of devices, boxes, etc. in the mechanical room and on the mechanical platform around the Gym.

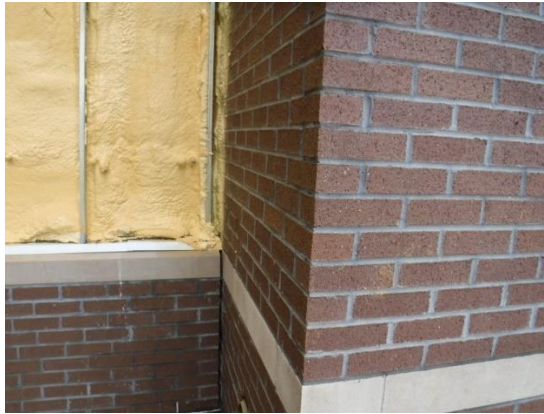
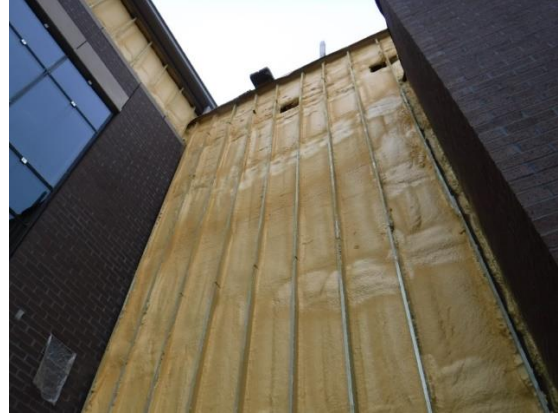
- e) Spray foam insulation was not applied in the corner between the last "Z" and the brick returns at the cafeteria. This is also the case on the other side of this wall where the expansion joint is to be installed as noted above.

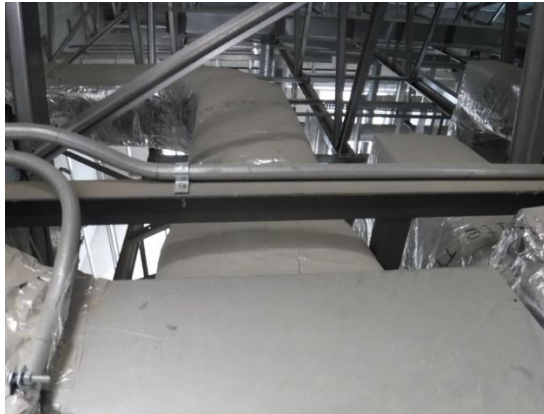
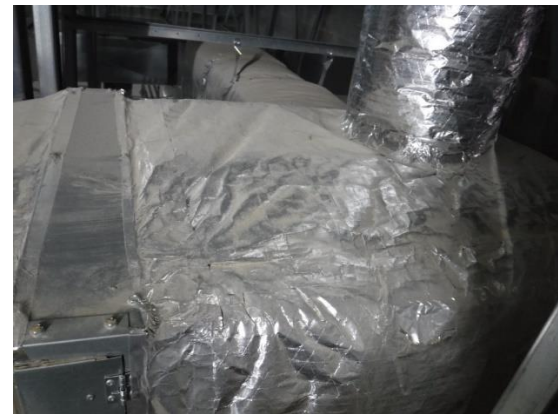
Doyle reported that Edgar Belle will bring in the cleaning contractor to get the building ready for finishes. I noted a considerable amount of dust on the ductwork at the mechanical platforms. Obviously, the duct openings will need to be protected with filter material before the HVAC units are started.

- f) I observed a considerable amount of construction dust on the ductwork over the mechanical platforms in the classroom wings. This needs to be removed.

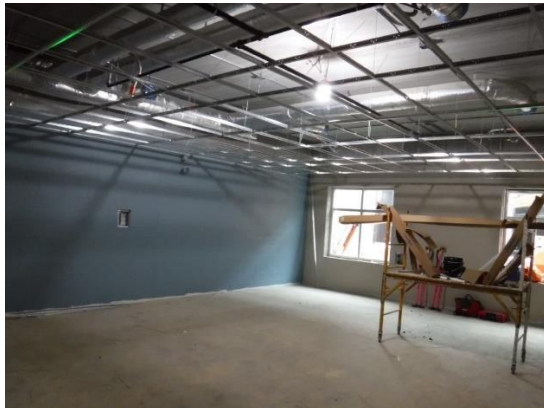
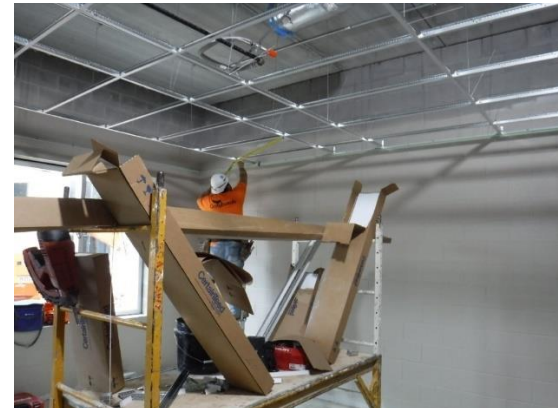
- g) Ceiling grid was being installed in the classroom wings. They were using laser levels to insure levelness of the ceilings. I stressed to Doyle that work above the grid be reduced to a minimum before the grid was installed to avoid damage to the grid. Doyle reported that most of the rough ins are complete.

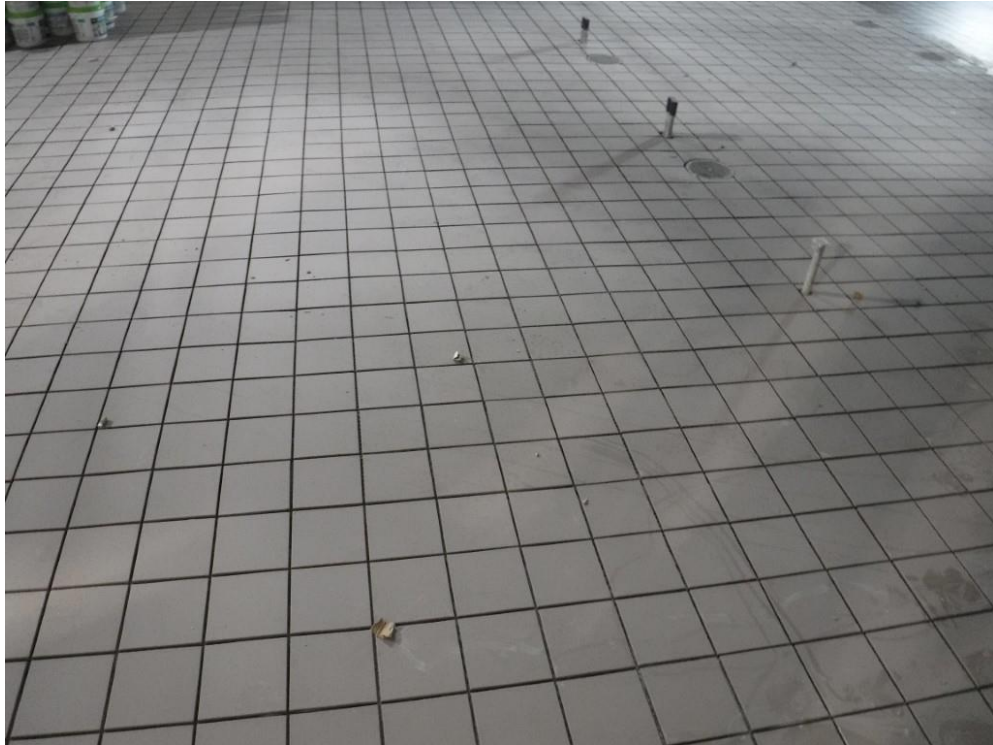
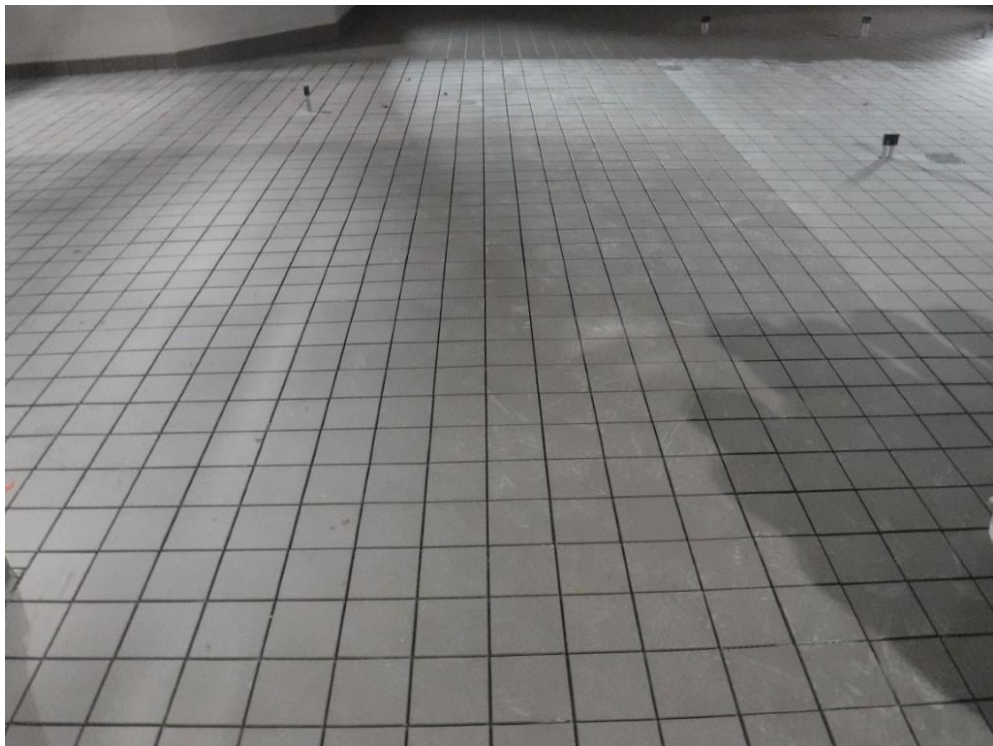
- h) Much of the quarry tile floors in the Kitchen have been laid. Some areas have grouted joints. The tile appears to be level with straight joints. Due to lighting conditions and status of cleaning, it is difficult to tell whether the grout from the joints is on the face of the tile as occurred at Lincoln Trail Elementary. Final cleaning will be necessary to determine quality of the installation.

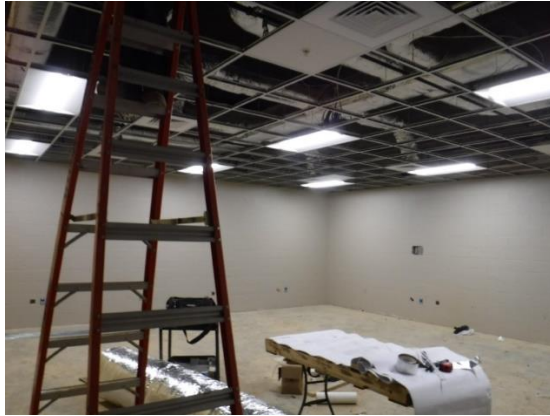
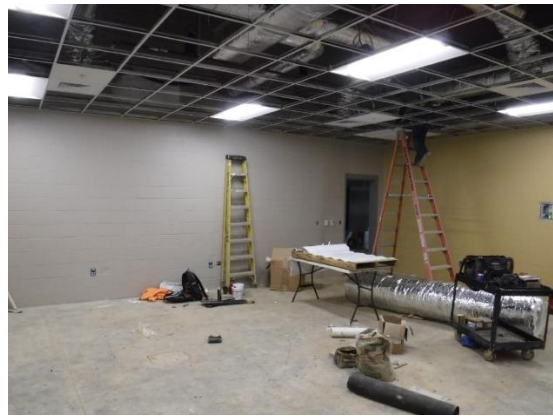
- i) Ceiling grid, light fixtures, grilles registers and diffusers and sprinkler heads are being installed in ceiling grid in Area D. These images were of the Technology Computer Classroom.

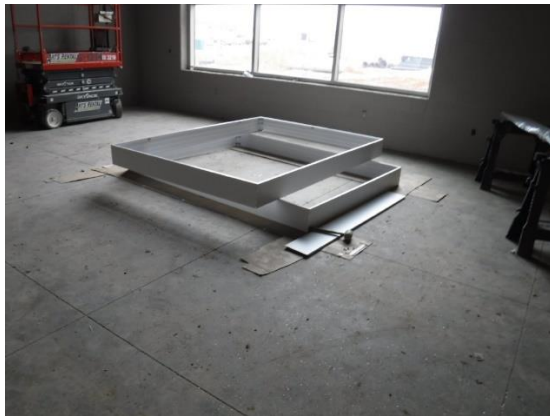
- j) The edge trim for the ceiling clouds has arrived on site. Ceiling installers were assembling the clouds on the floors of the rooms prior to lifting them into place.

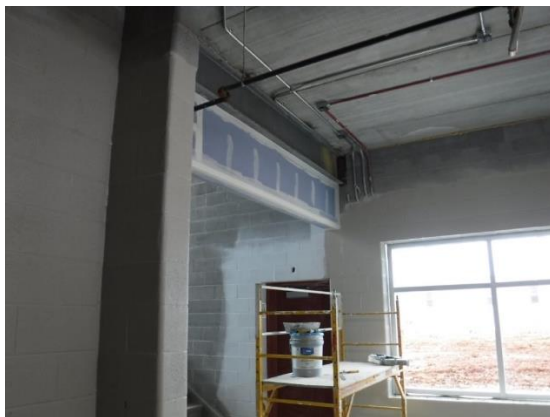
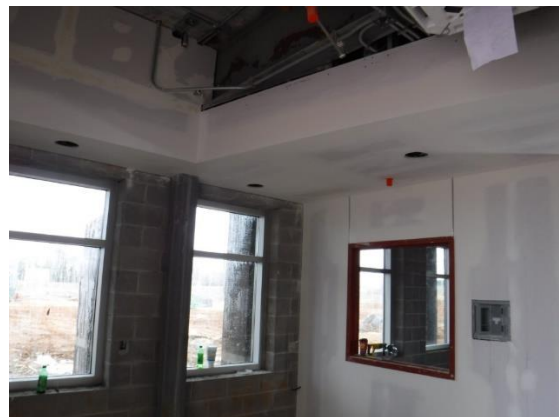
- k) Work continues for the installation of gypsum board soffits. These along with the walls will define the edge for lay in ceilings.

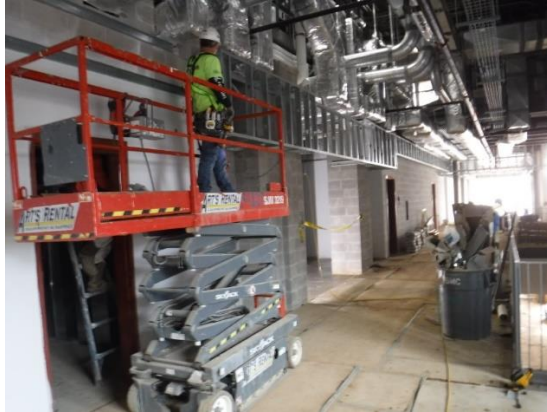
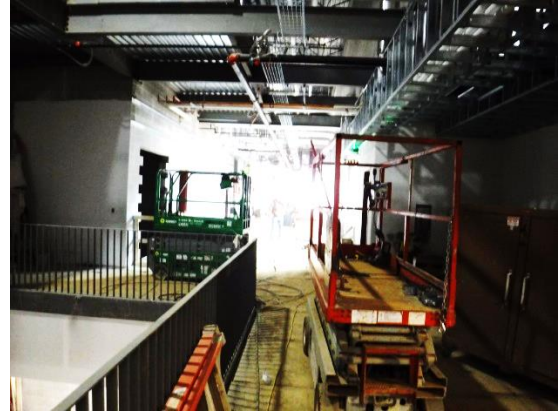
- l) Light gauge metal framing was being installed along the walls on the second floor of the main corridor.

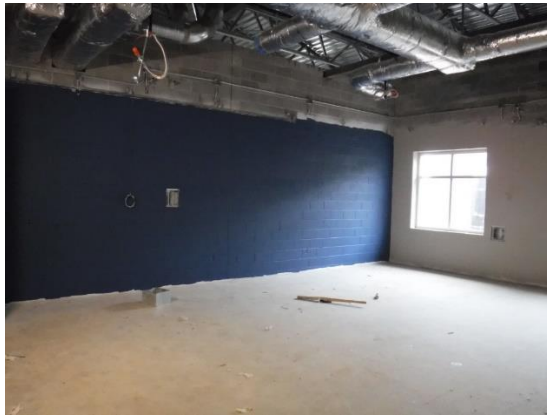
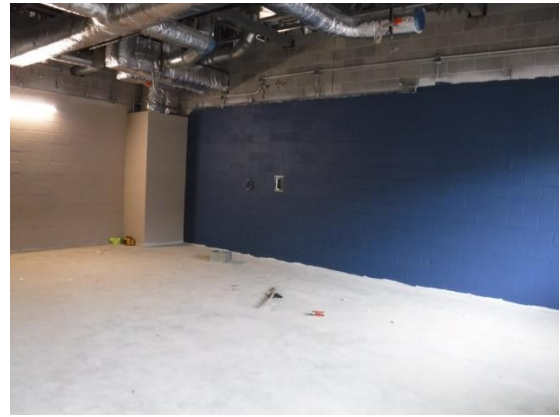
- m) The painters are staying ahead of the ceiling grid installers in the classroom wings.

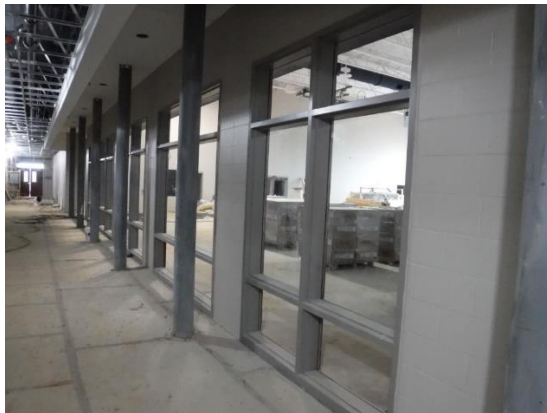
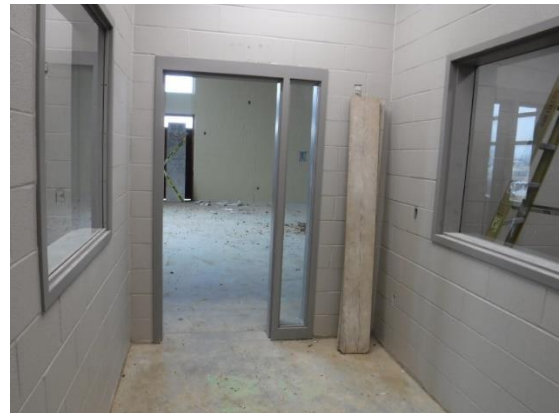
- n) The painters have started painting hollow metal door and window frames in Areas C and D. Some of the interior windows now have glass in them. I did not observe scratches on the glass.

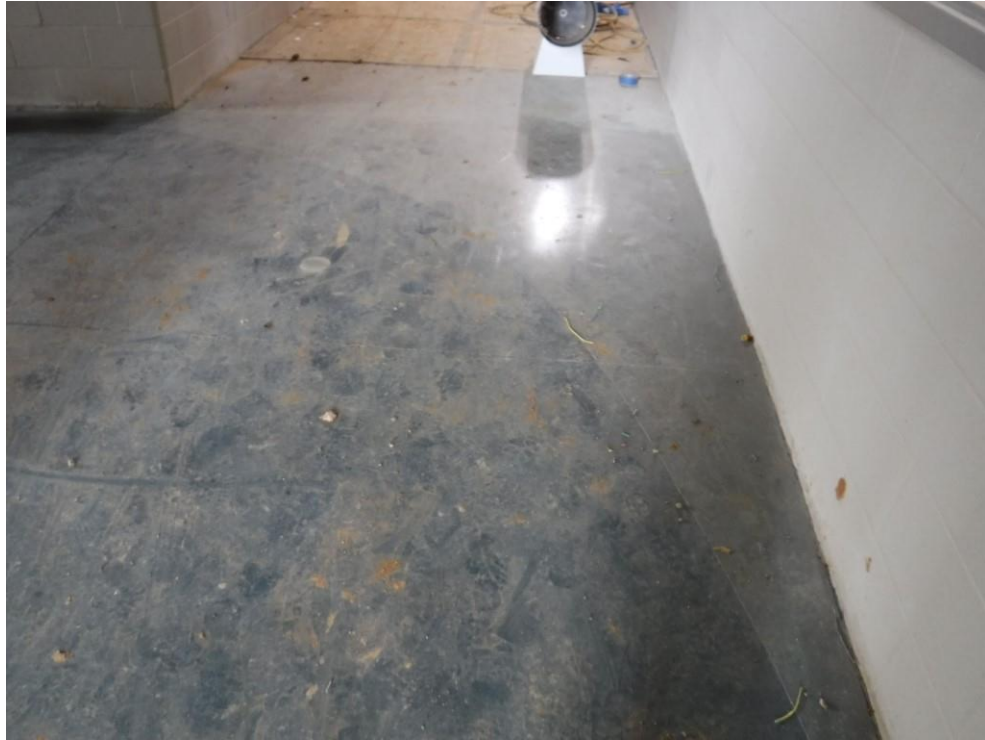
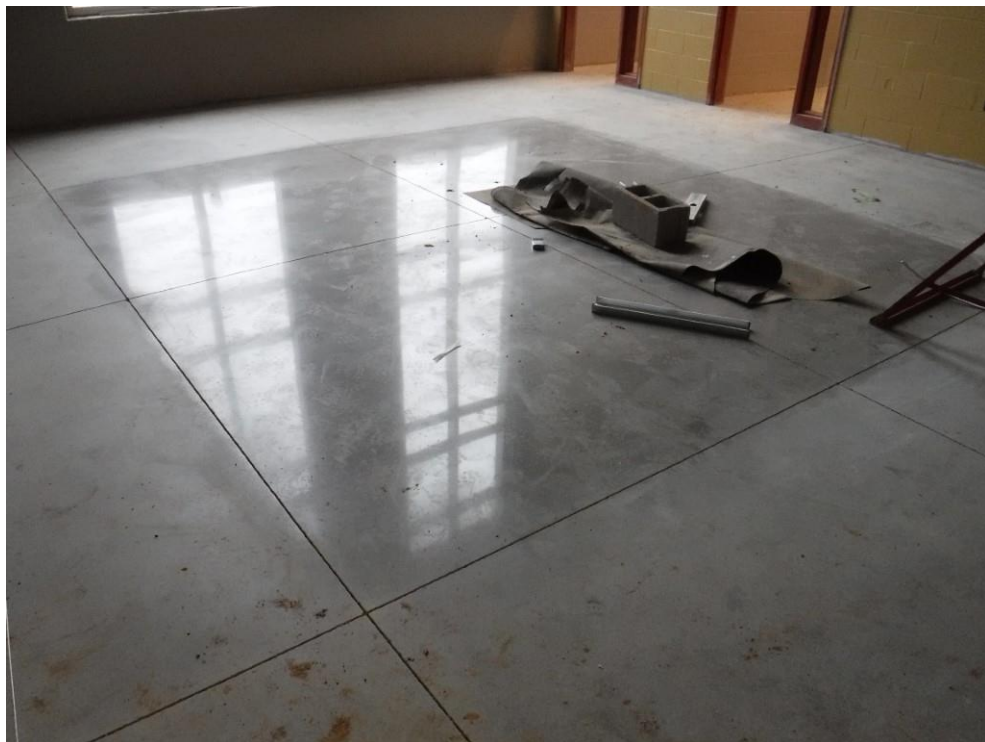
Doyle reported that Extreme Polishing will return next week to prepare additional mockup slabs and repair the slab that was improperly polished in the corridor. These mockups must be approved by John and JRA before additional areas can be polished.

- o) Neither of the polished slab mockup areas were acceptable to John and Rob. The arch in the corridor was not in a true radius. They used dry polishing procedures instead of wet as specified. The floor in the Art Room is not in good condition. It was decided that a deeper grind, exposing the aggregate in the concrete will be used in this room. Extreme will prepare another mockup for approval.

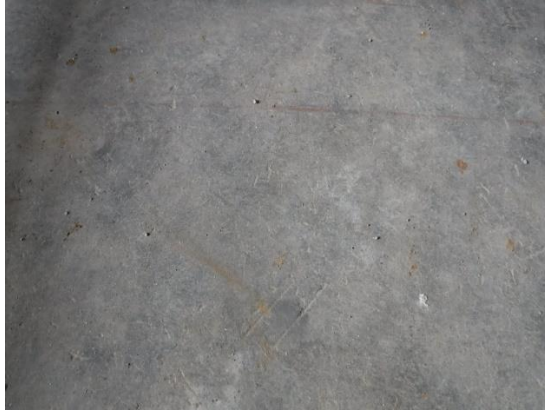
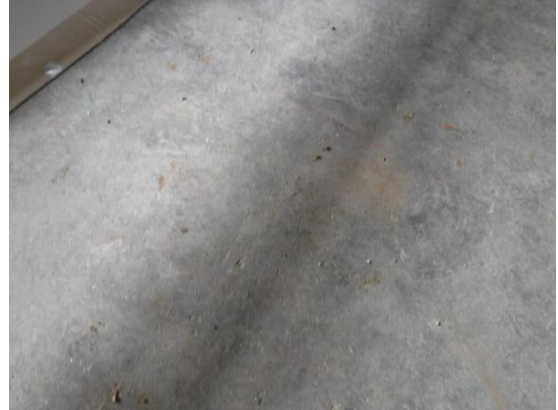
- p) Some of the concrete slabs received damage during masonry construction. These must be repaired as the floors are polished.

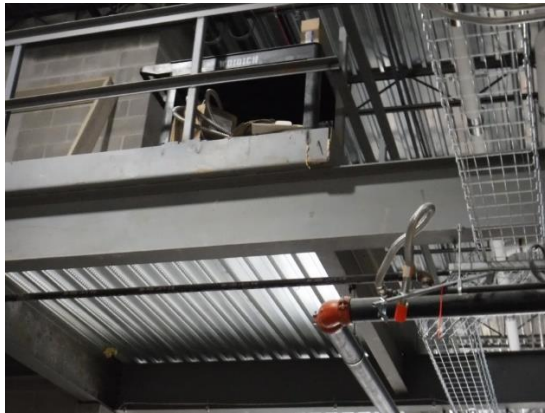
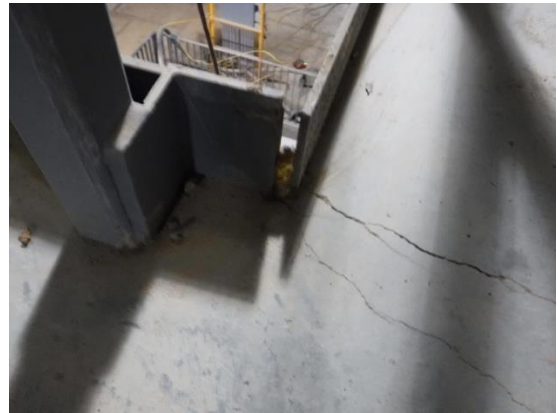
- q) The joints in the steel toe guard around the entire mechanical platform must be welded closed to provide some degree of protection from leaks on the platform. The longer that Stewart-Richie waits, the more construction will be in their way.

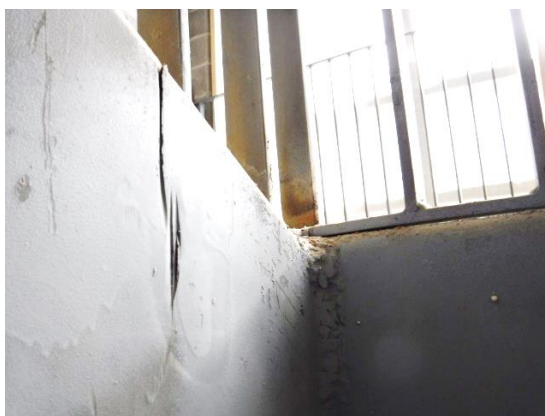
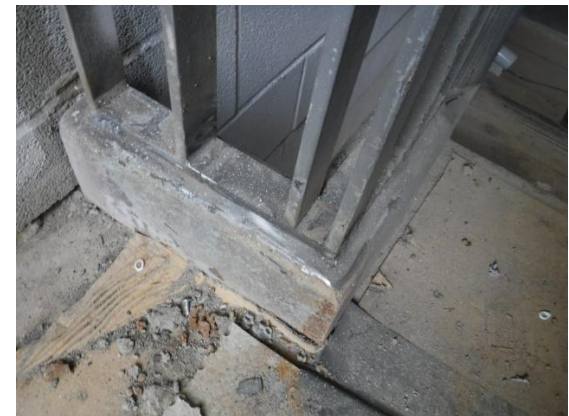
- r) While detail work has been done on the steel stairs and railings, a significant amount remains before the stairs can be painted.

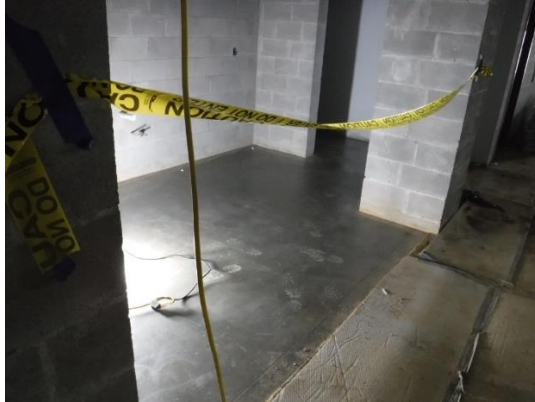
- s) Vesta has prepared the slabs and the walls in the student toilets along the main corridor for tile work.

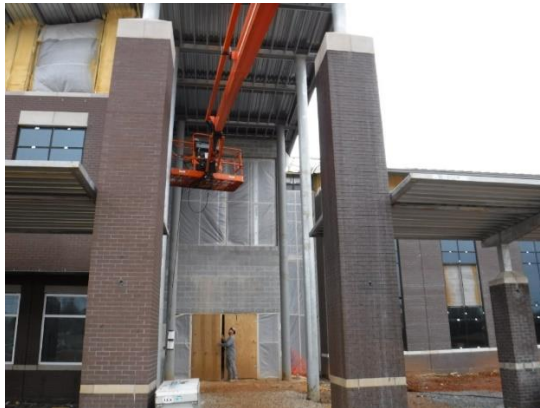
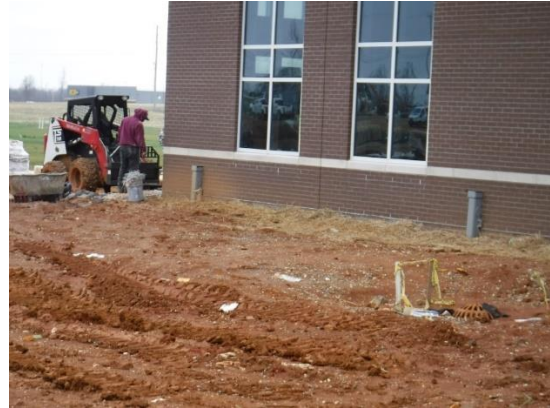
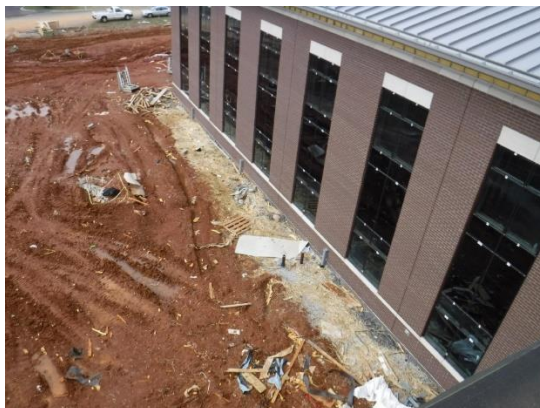
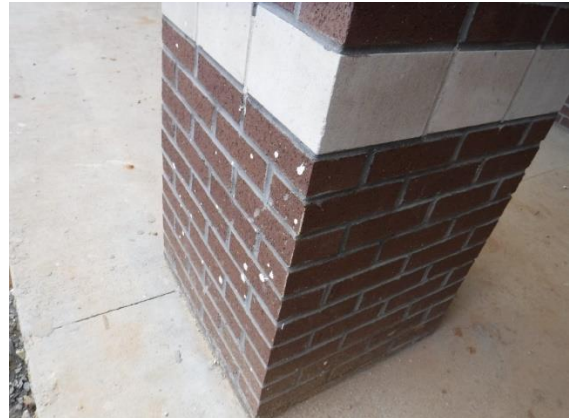
- t) Brick washers were cleaning the brick at the front entrance. Straw has been placed in areas that have been washed. There are some areas where mud is on the washed areas. These will need to be recleaned. Some brick has been stained from overspray and splashing from work done by other trades. These stains must be cleaned off the brick.

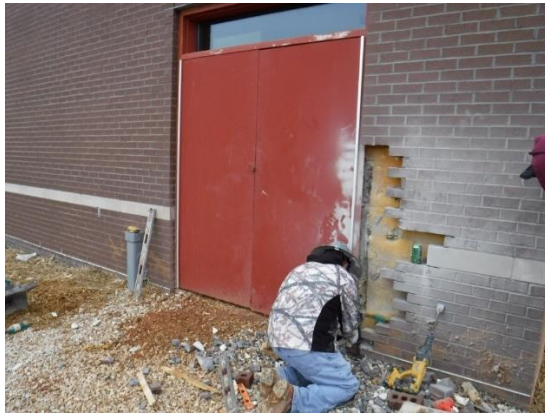
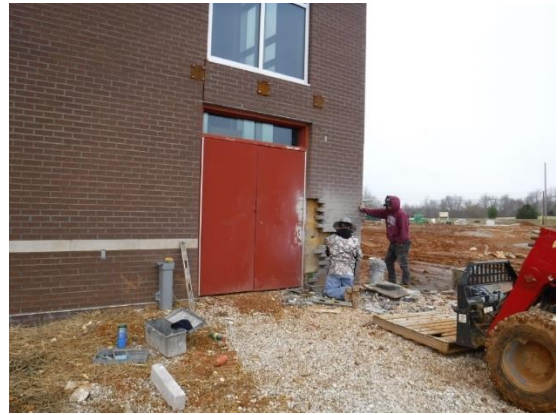
Masons were detailing block joints that needed work after painting revealed defects. Masons were also reworking the masonry opening at the exterior door frame to the Band Room which had been deformed thus not allowing the doors to shut properly. Their cleaners were washing brick walls on the front side of the building.

- u) Brick had been removed to correct the distorted door frame into the Band Room.

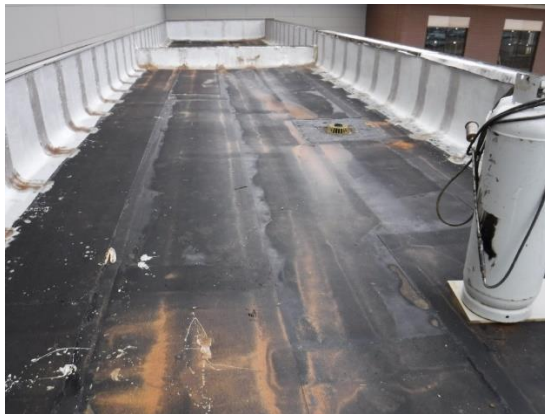
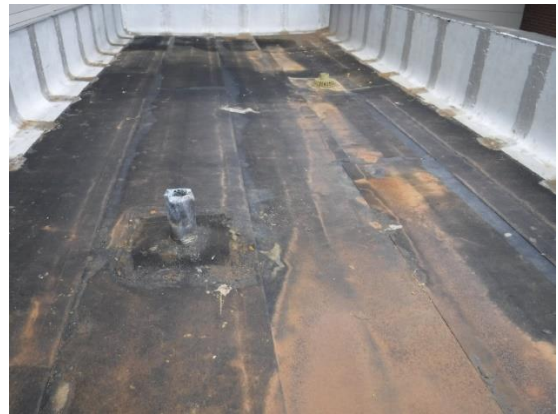
The mud on the roof over Area D in front of the Gym had been cleaned. Refer to the recent inspection reports from Zack Hadden.

- v) As noted by Zach Hadden, most of the mud on the roof in front of the Gym has been removed.

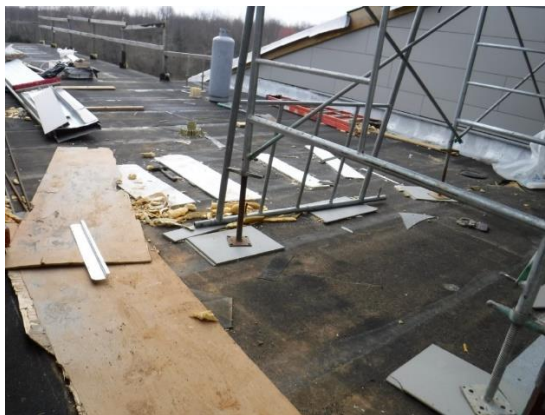
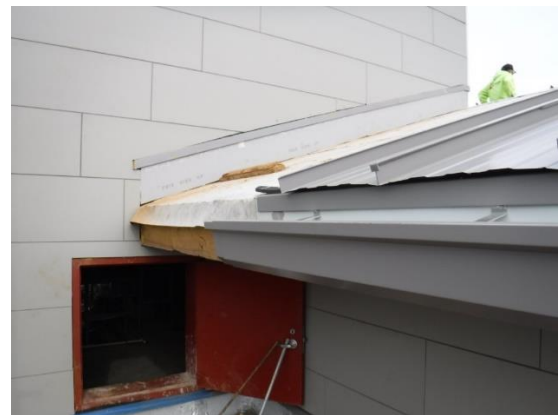
- w) I appreciated that Dixie Exteriors had placed protection panels under the feet of their scaffolding as they installed composite panels over walls above Area b.

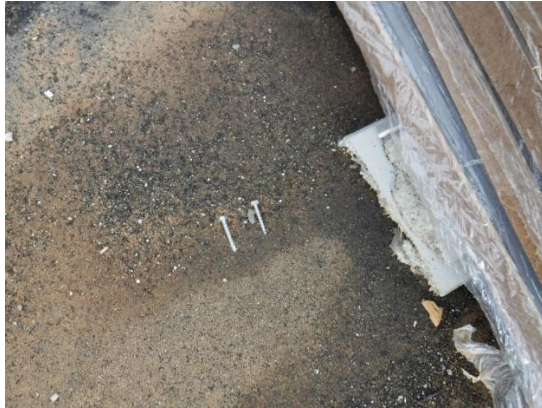
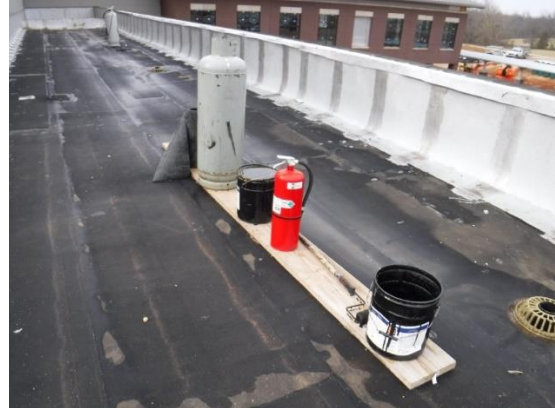
- x) Kalkreuth has placed their equipment on protection boards. All trades need to be careful not to drop fasteners on the roof membrane.

- e. Provide protection board for all ladders, equipment and materials staged on the low sloped built up roofing areas. Remove all screws, nails, sheet metal and other sharp objects from these roof areas ASAP.

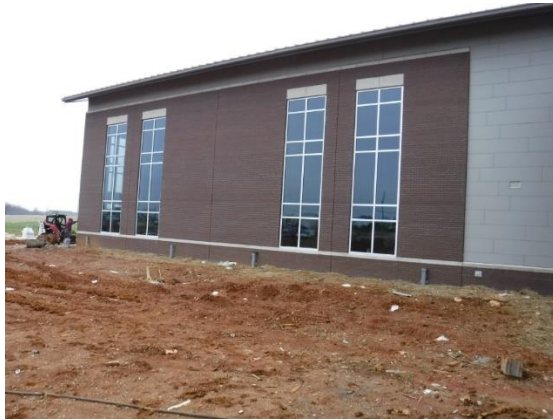
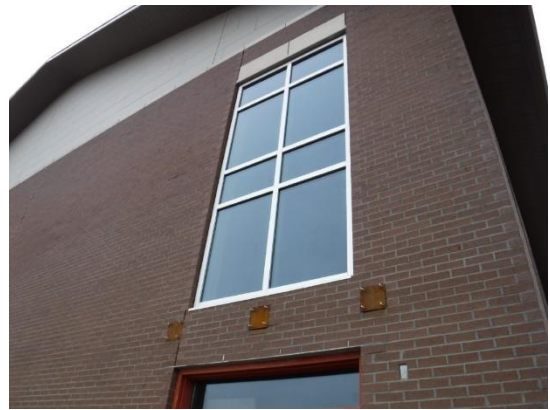
- y) Glazers were installing aluminum face caps on the curtainwalls around Areas C and D. With this, we are beginning to see the final appearance of the exterior of the building.

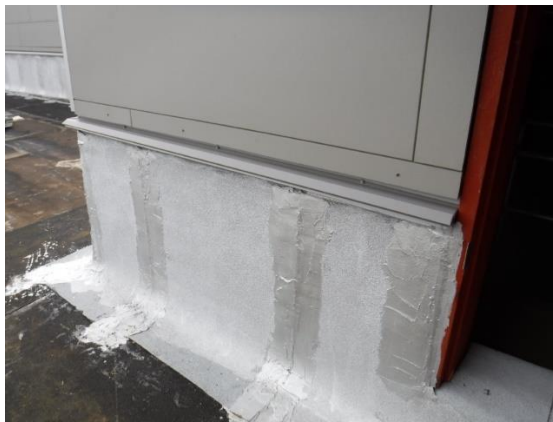
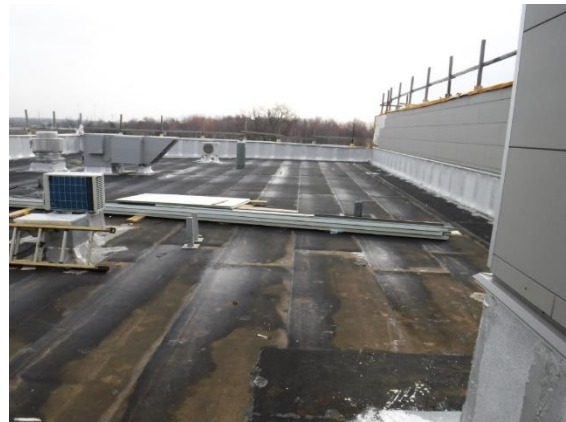
- z) Dixie Exteriors needs to install the metal trim along the bottoms of the composite panels where they are above the metal flashing over the membrane roofs.
