## FIELD OBSERVATION REPORT

East Hardin Middle School, Hardin County Schools, Elizabethtown, KY 201752.01 - CA8

Date: 5/13/2021

Report No: 50

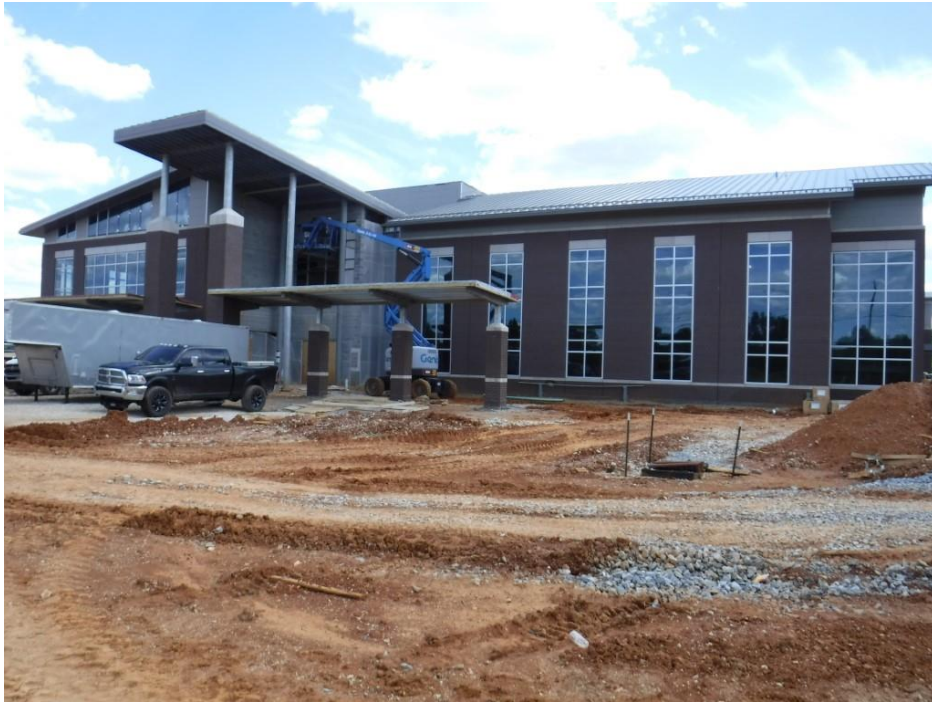
- b) Work is beginning on the aluminum curtainwall at the main entrance. With the windows in place at the Library/Media Center, this elevation is nearing completion. There is still a significant amount of work remaining to complete this area. Kalkreuth must install some of their metal soffit panels before the curtainwall can be installed.

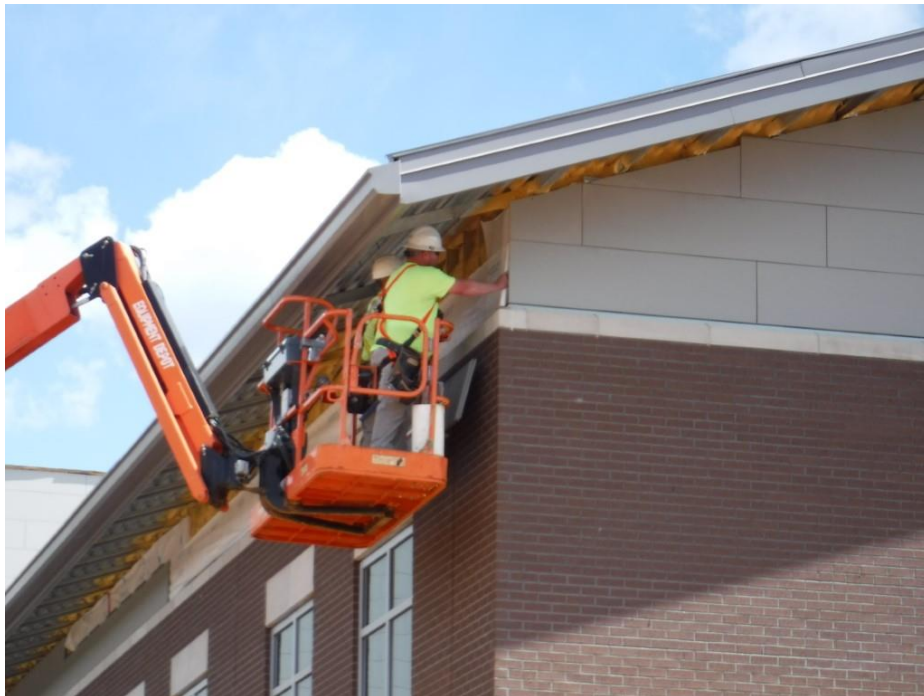
- c) Now that Dixie Exteriors is back on site from a standdown due to a COVID – 19 outbreak in their crew, they are completing the installation of the fiber cement panels under the roof soffits on the classroom wings.

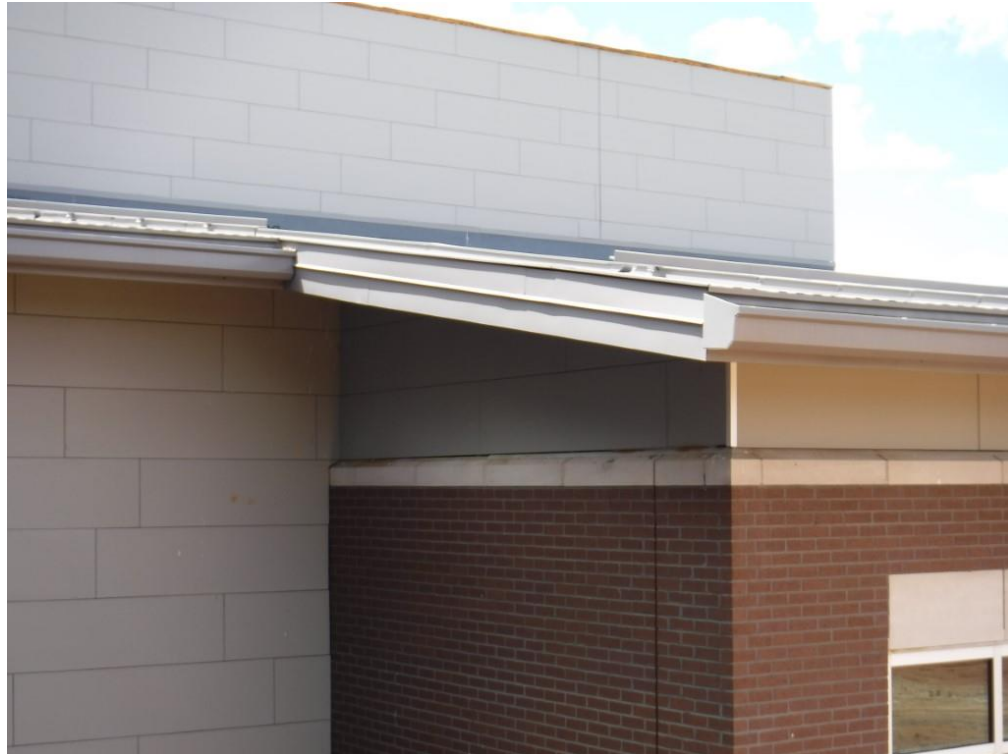
- d) Kalkreuth had installed snow guards on the metal roofing over the Library/Media Center. They had also installed eave trim and soffit panels.

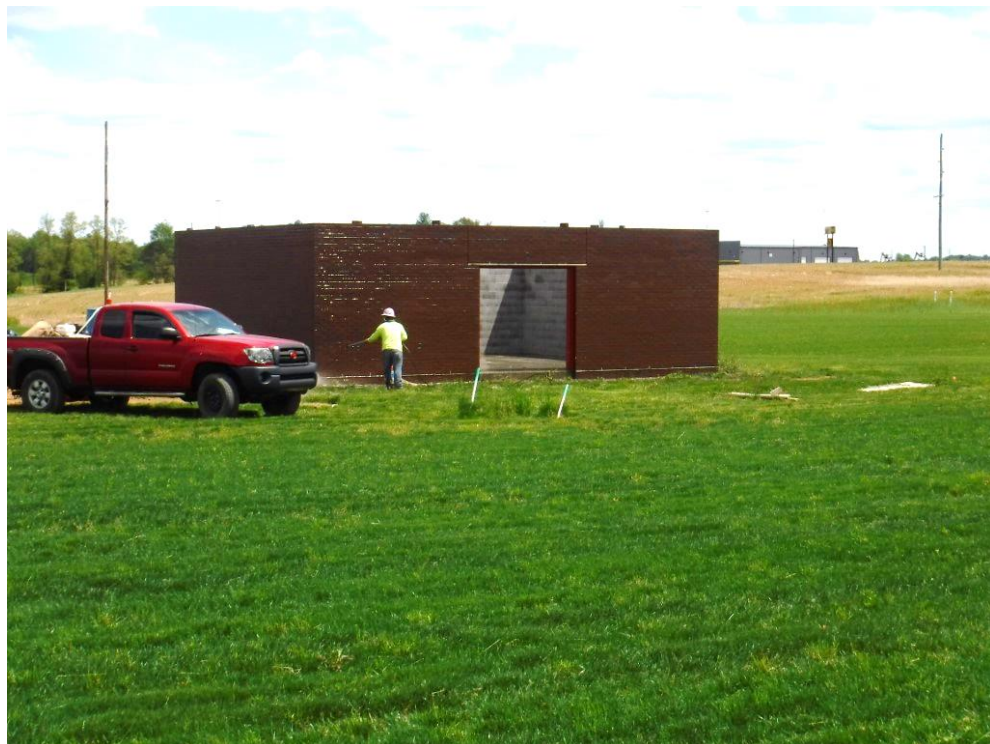
- e) Carmicle's brick washer was cleaning the brick on the field maintenance building.

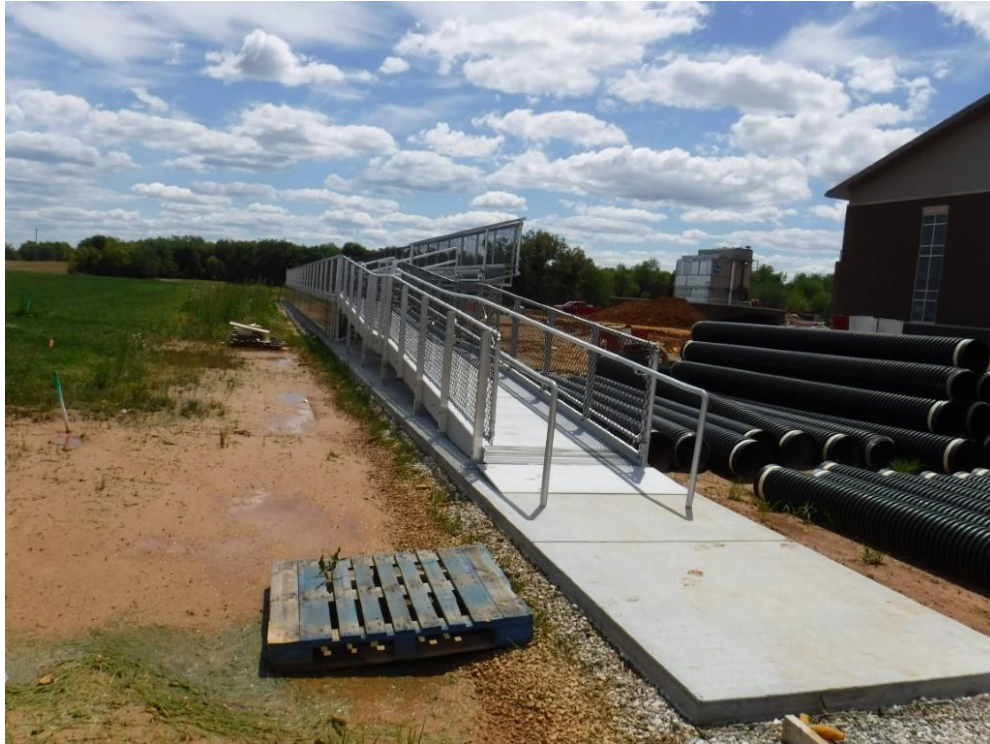
- f) The bleachers at the football field are in place.

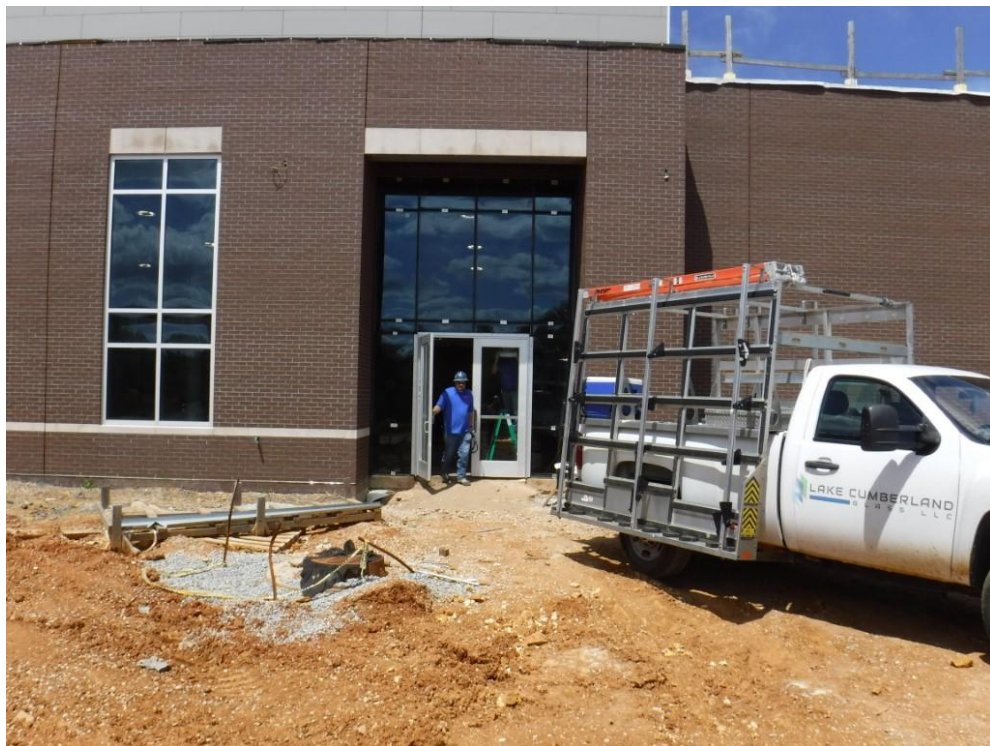
- g) Lake Cumberland Glass has installed the curtainwall and entry doors to the Cafeteria. The face caps were not yet in place. Billy Parson stressed to the contractors that their crews must not damage the doors and frames as they pass through them.

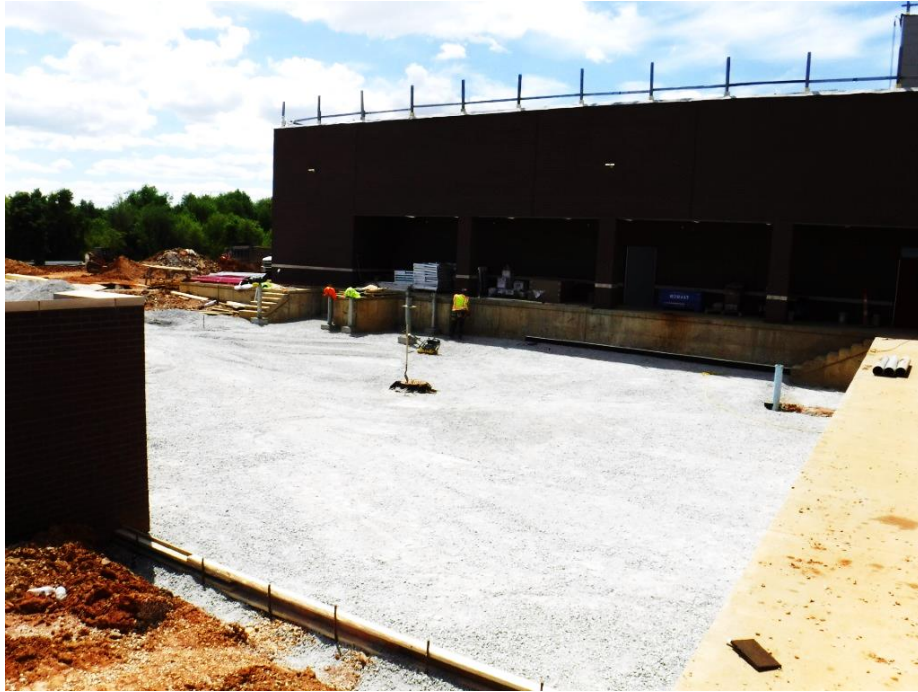
- h) Scotty's crew was preparing the subbase for the concrete paving at the loading dock. This area needs to be poured and up to full strength before the kitchen equipment is delivered.

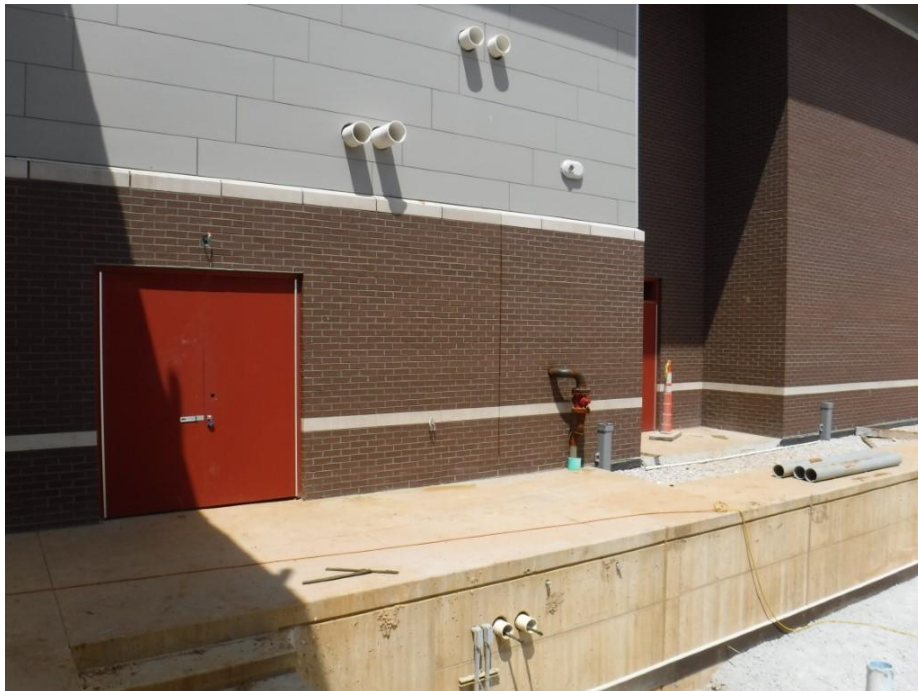
- i) Where pipes were installed in holes cut through the fiber cement panels, most of the dust has been removed from the brick below. Contractors must protect the brick and other materials when cutting the panels. All residues must be removed.

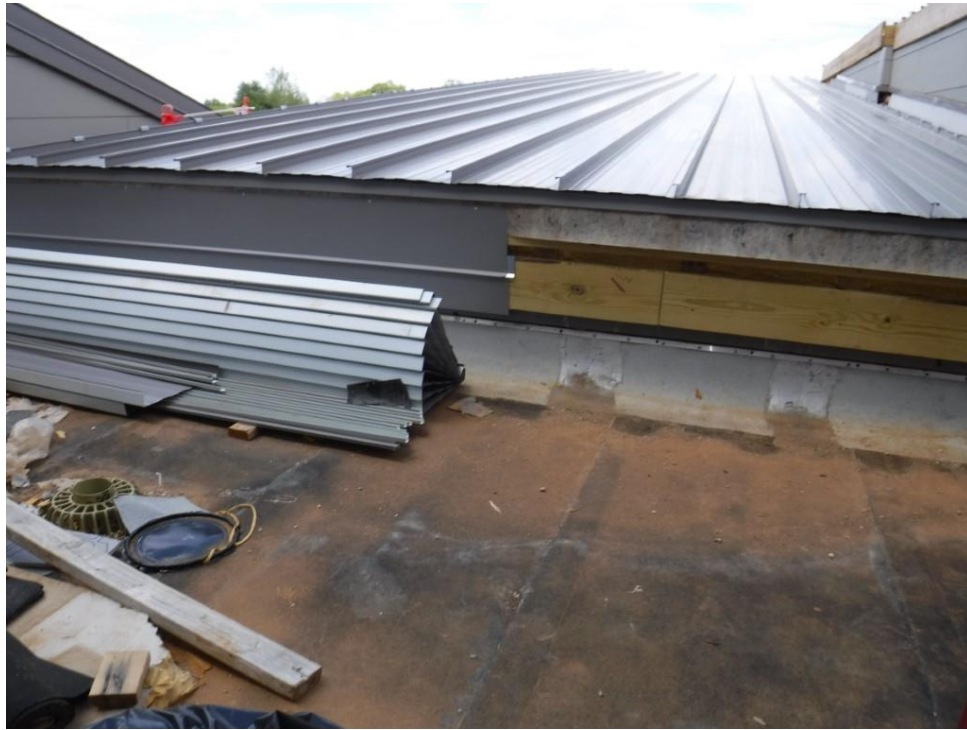
- j) The sheet metal roofing panels have been installed over the main entrance.

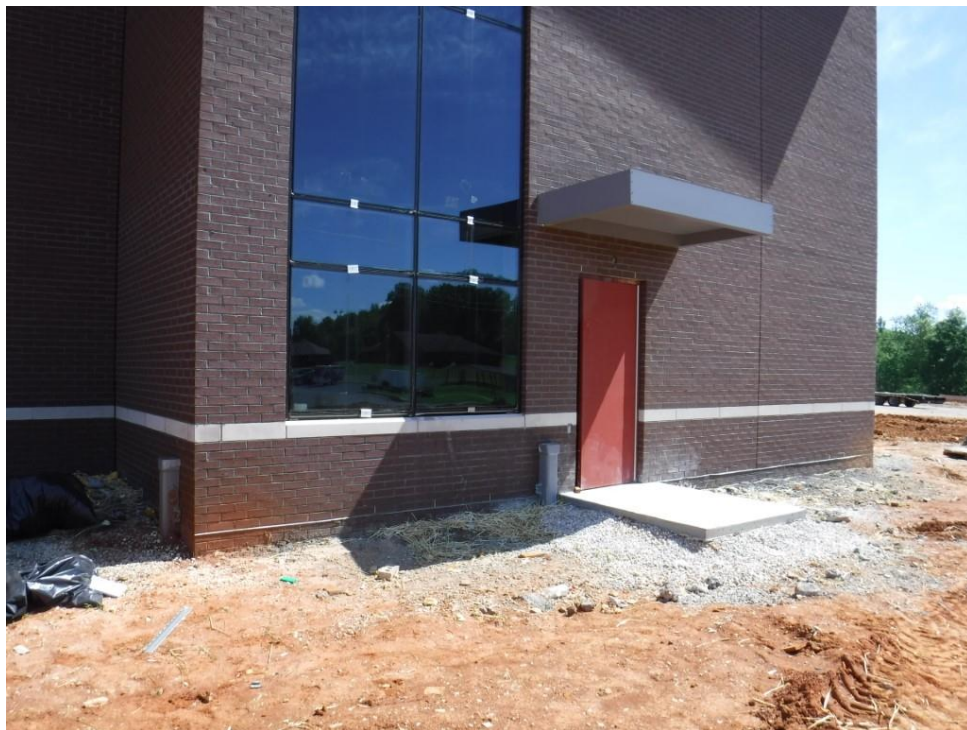
- k) Exterior metal canopies and concrete stoops have been installed at the doors at the ends of the classroom wings. All cement dust/ splatters created when installing concrete or cutting materials must be removed from the brick.

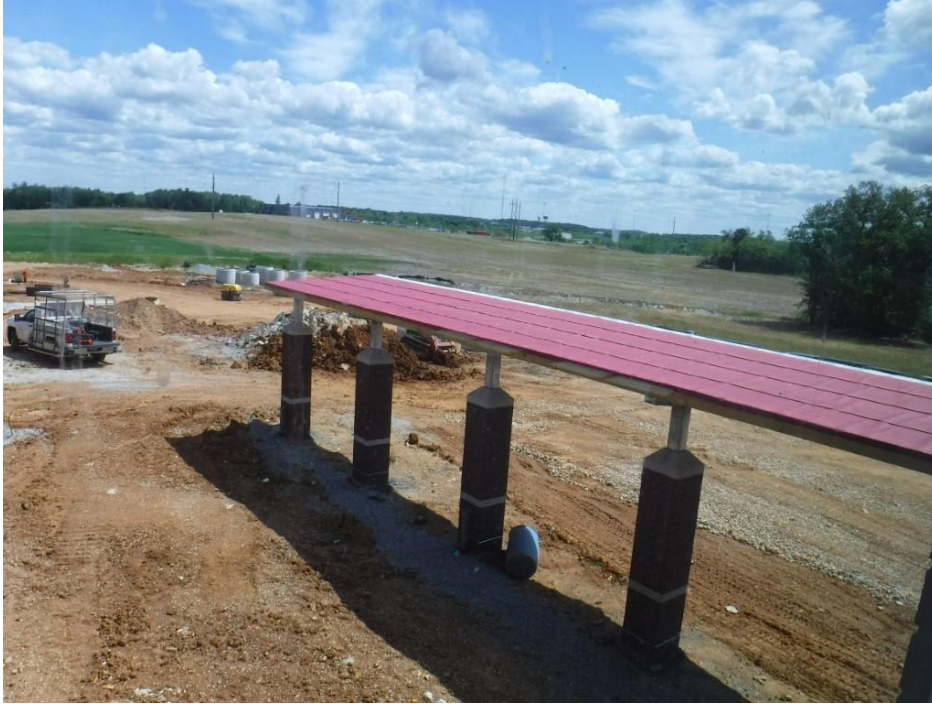
- l) Red rosin paper has been installed on the bus canopies ahead of the metal roofing panels.

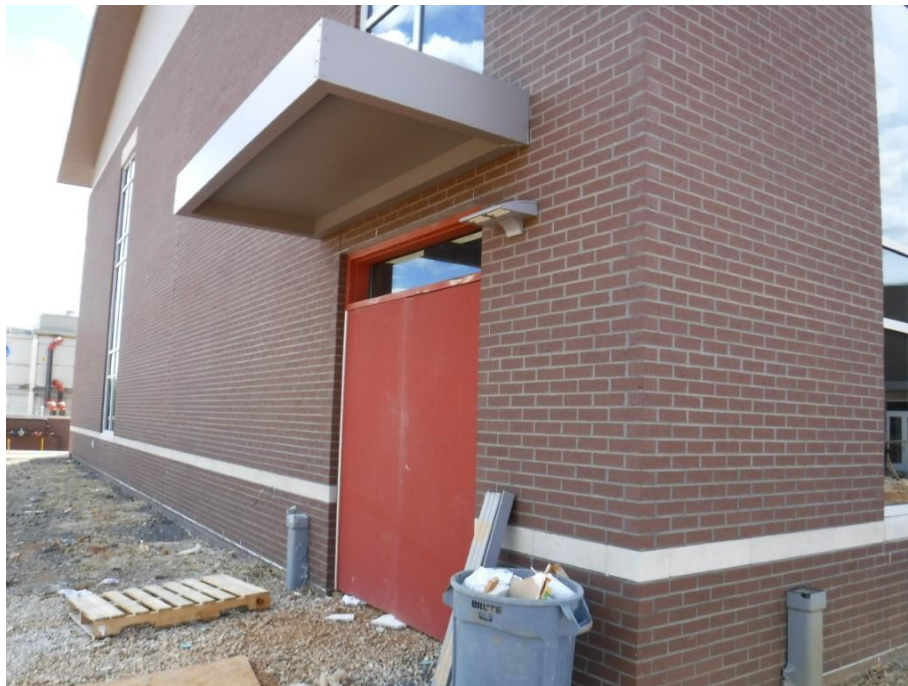
- m) Cast iron boots have been installed at the downspout locations around the building. The exterior door frame and masonry at the Band Room has been reworked so that the door hangs properly in the frame.

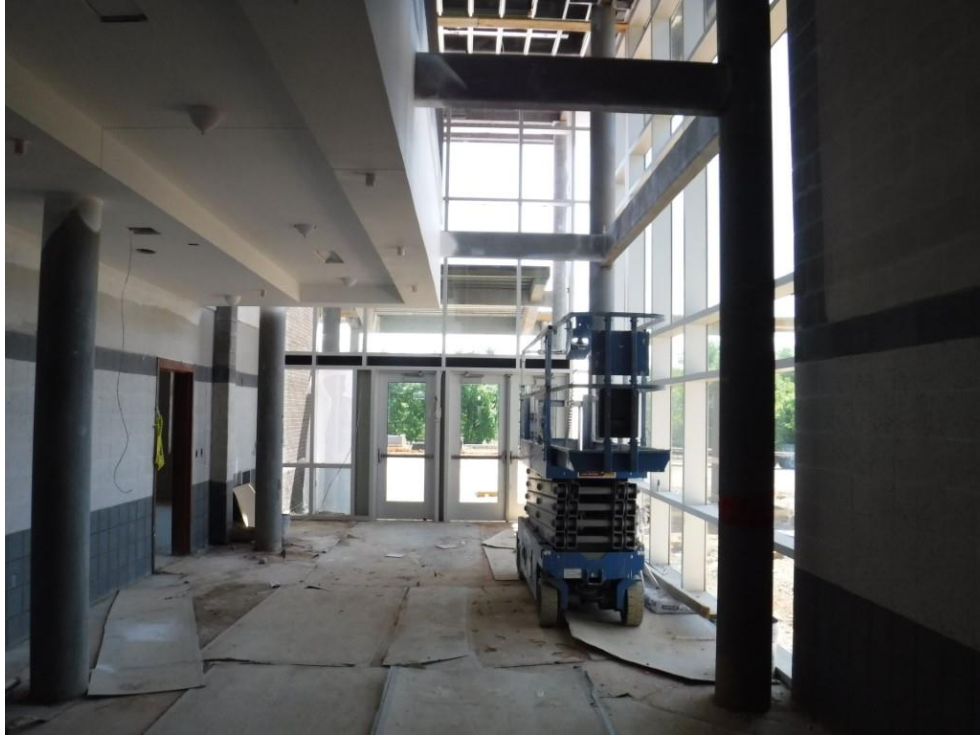
- n) The rear lobby is now enclosed with the aluminum curtainwall and the doors have been installed.

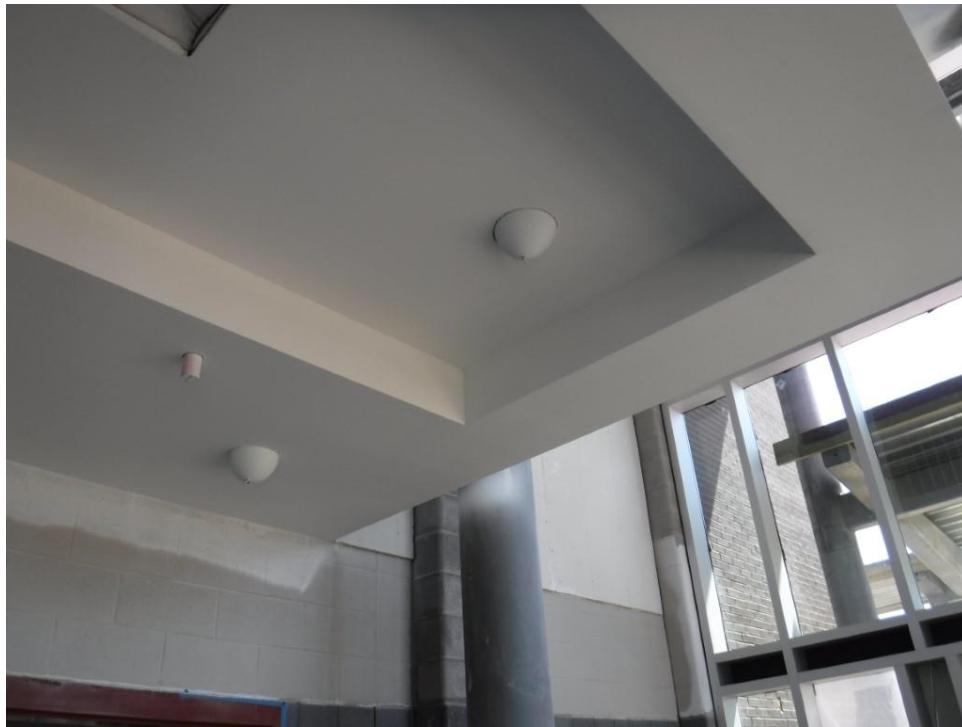
- o) Conley Painting used balloons to mask the can lights as they sprayed painted the ceilings and soffits over the main corridor.

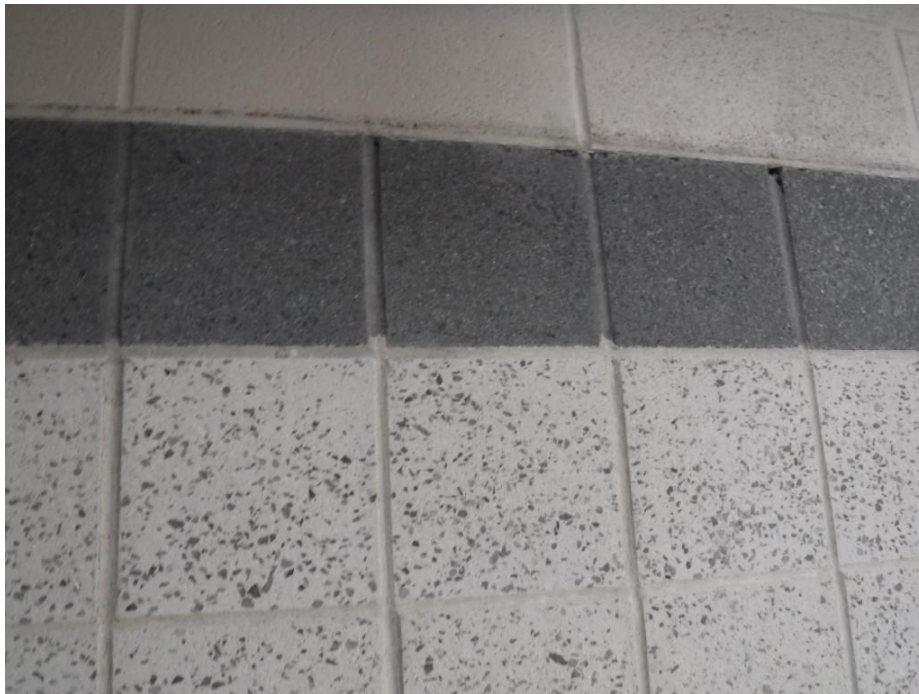
Masonry cleaners were washing the ground faced block in the main corridor using brushes and the recommended cleaning solution. We had a meeting after the progress meeting with Brandon Carmicle. We made it clear that there shall be no mortar streaking on the face of the block, that the light and dark mortar shall only occurs in the corresponding block colors and the light mortar shall be consistent with no darker white mortar mixed with the predominate white mortar. Once all these are corrected, a sample panel for approval shall be prepared.

- p) While the ground faced block has an improved appearance from our previous observation, the dark mortar in the white joints needs to be replaced. The white mortar in the dark block needs to be replaced. The streaks of white mortar on the light block needs to be removed.

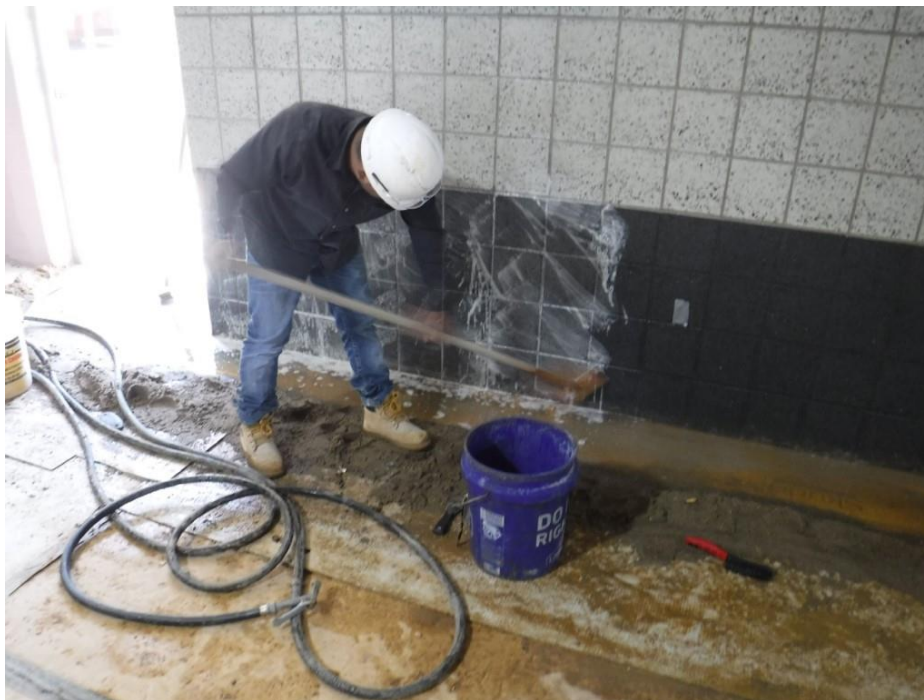
- q) Carmicle's washers continue to clean the ground faced block.

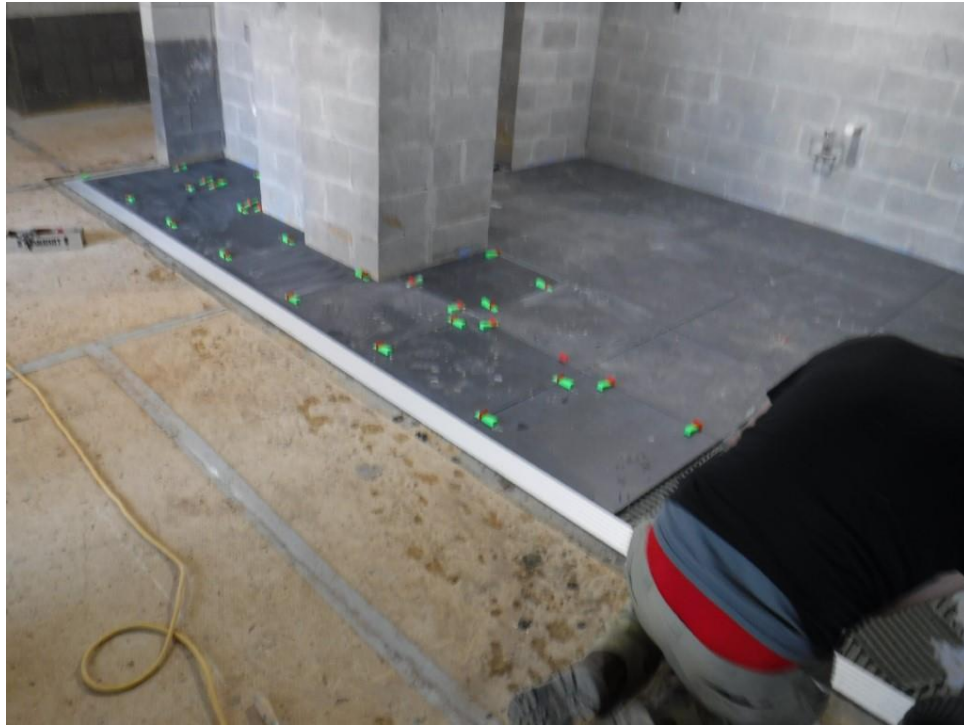
- r) Vesta Tile's crews were installing tile pavers on the floors of the student toilets on the first floor. They were using the specified long ramp trim strips.

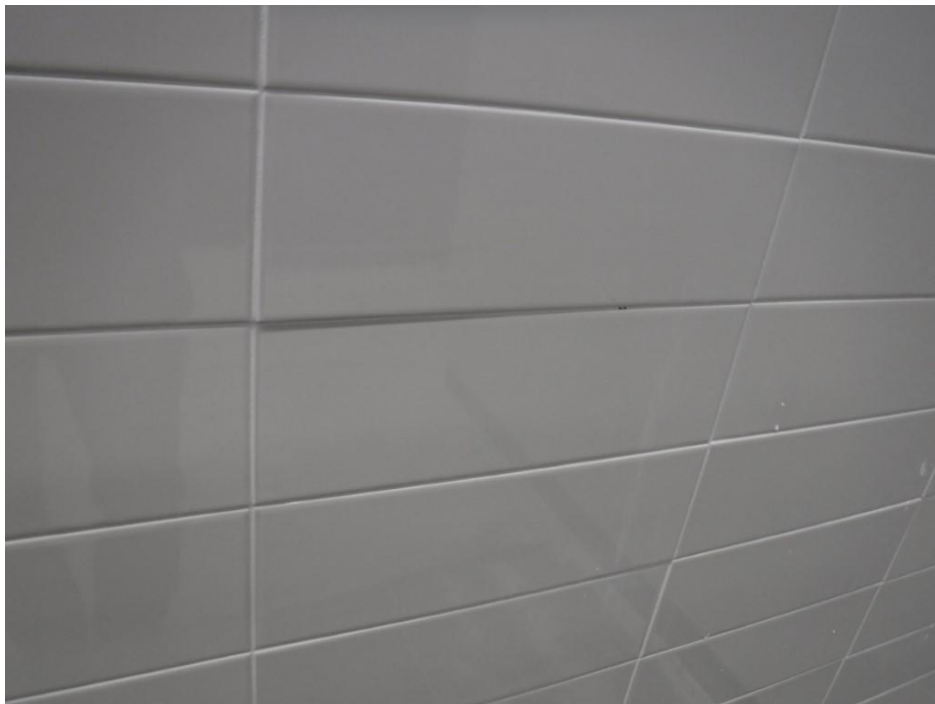
Ceramic tile floor installers were installing the pavers in the student toilets on the first floor. We had a meeting with Vesta, the tile installer, after the project meeting. We pointed out unacceptable tiles that are out of plane in the student toilets in Area D, and in the faculty toilets. Vesta will make corrections on walls with these conditions.

- s) Some of the wall tiles in the student toilets and faculty toilets are not in plane with the wall. These must be replaced.

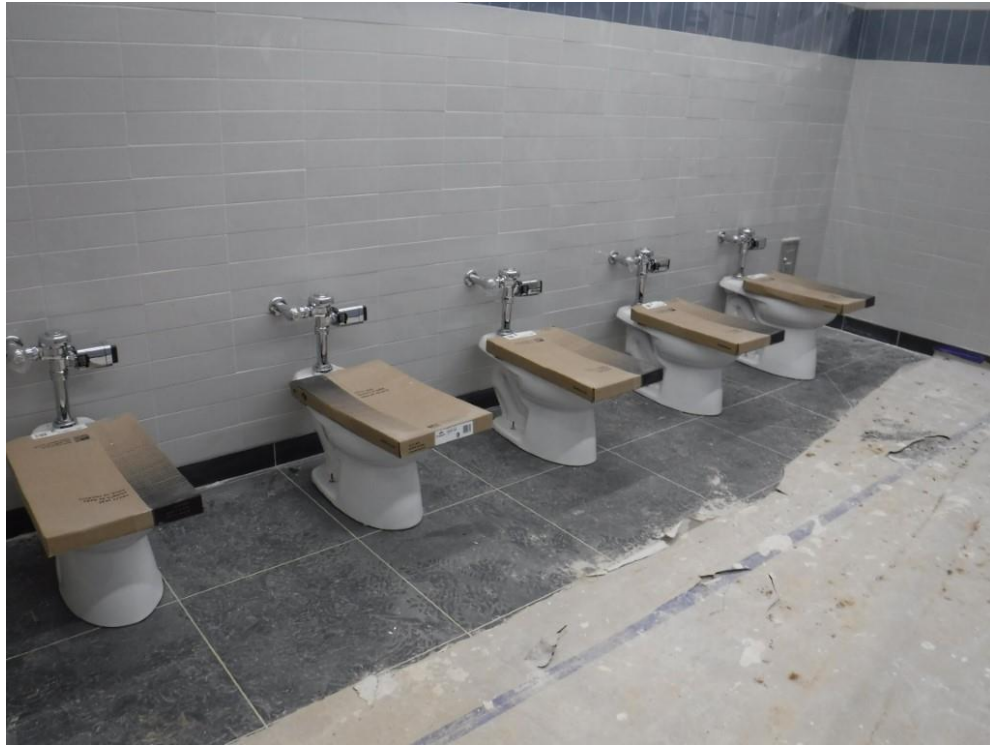
- t) GBMC's plumbers had installed fixtures in the toilets in Areas C and D. It was stressed in the progress meeting that workers shall not use the fixtures.

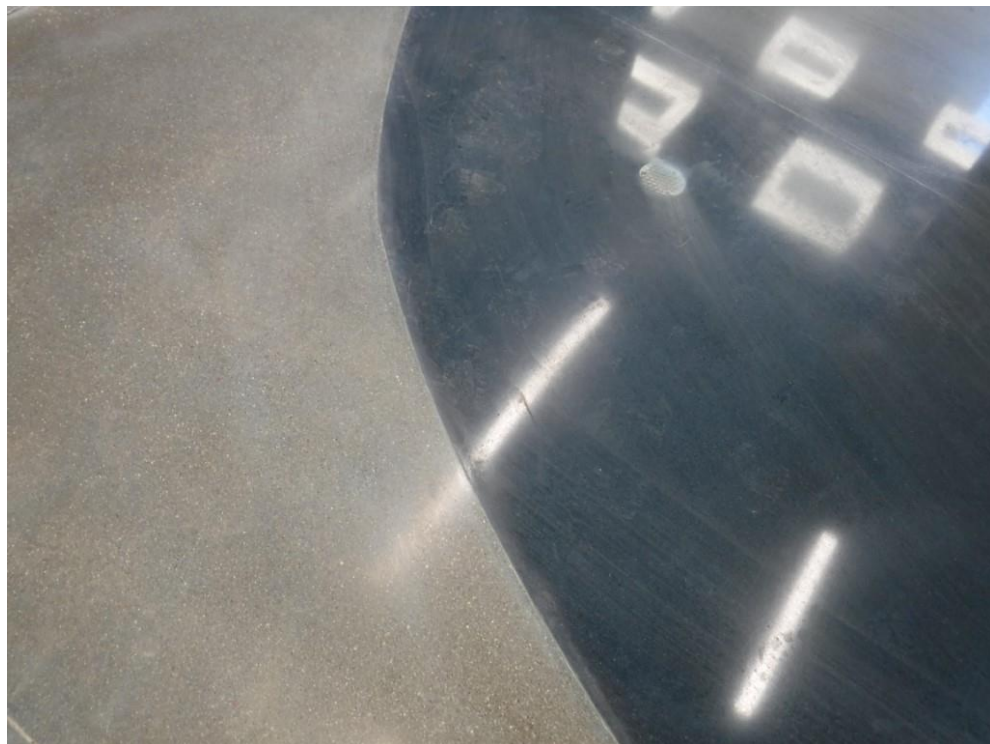
- u) The sample panel of polished flooring showing the stained concrete and the curve had been corrected. The key cut was corrected to have a uniform appearance.

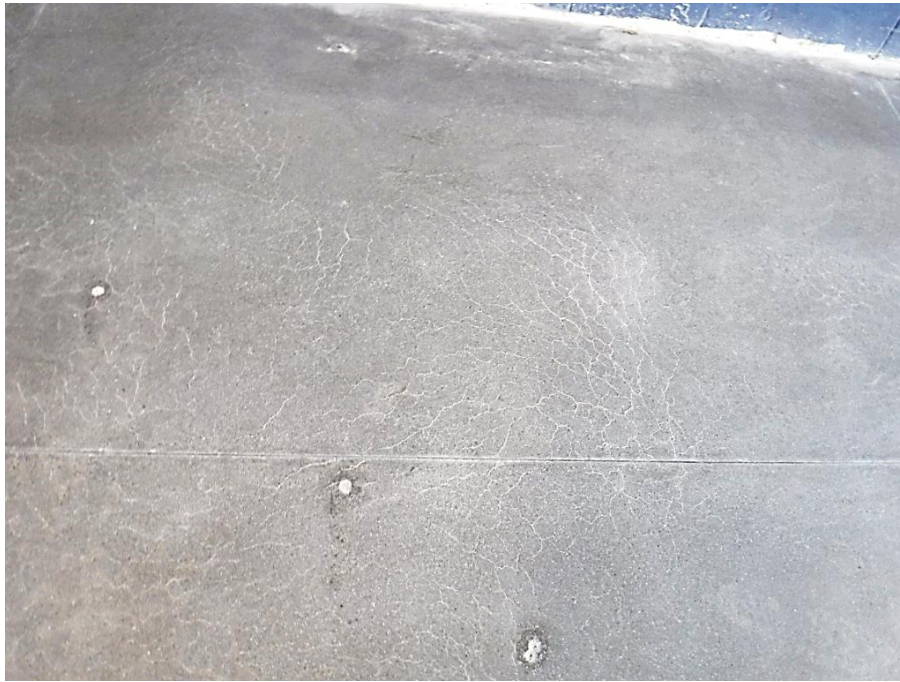
Floor polishers were finalizing work they had been doing on the second floors of the classroom wings. John had noticed some issues with the slabs in these areas. As I walked through the area, I observed numerous places where the polishing process had revealed crazing in the top of the concrete slabs. We had a meeting with Extreme Polishing after the progress meeting. Their foreman said that he could add a grout coat to see if this would mask the crazing. If he has time, he will attempt to prepare a sample of this process for inspection to determine if it will solve the problem. If he does not have time on 5/14/21, he will prepare the mockup when he returns to the site.

- v) After the concrete slabs on the second floor of the classroom wings have been polished and finished, there is a significant amount of crazing in the finish on many of the panels. We are looking to Whittenberg and Extreme Polishing for corrections for this issue. John also noted that the epoxy filler is more of a green hue in many of the patches and does not match the rest of the floor. The same filler in the crack control joints is typically in the same range as the concrete. We also noted that shrinkage cracks occur in many places between the crack control joints.

5. Method for correcting crazing in polished concrete slabs.
- b. STW to report on the closure of mechanical/electrical openings passing through corridor and party walls especially in classroom areas.

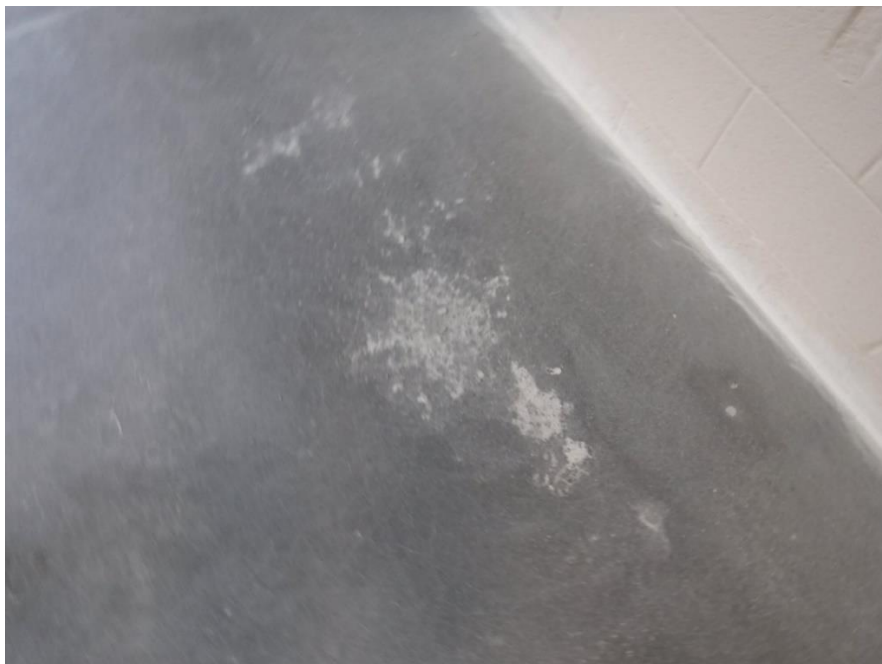
- w) Some slab areas have had significant damage. With the contrasting repair, these areas are emphasized.

3. Gypsum board soffits to cover conduits and pipes exposed on the Cafeteria walls.
  4. Changes to the materials and methods for polishing concrete slabs to make corrective repairs to damaged slabs caused by other trades.

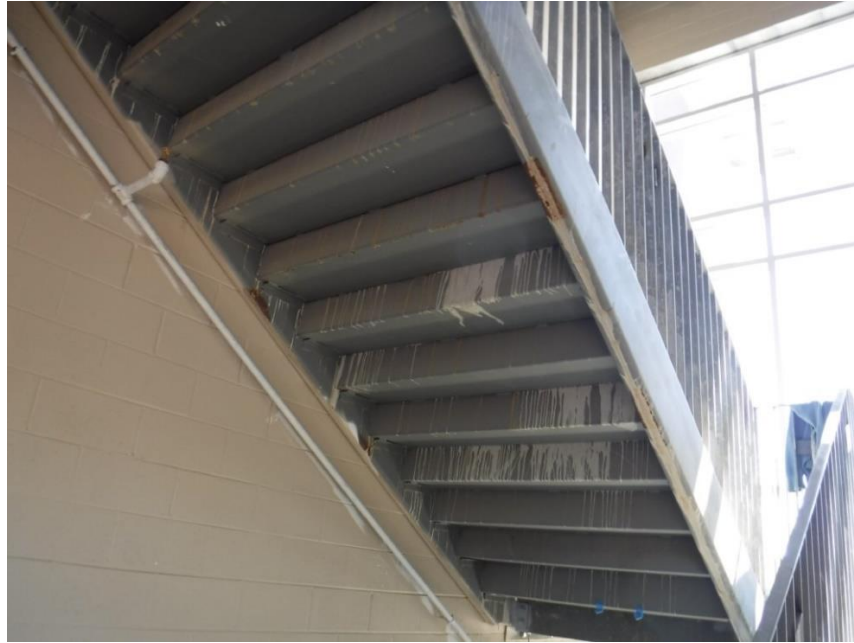
- x) The seam sealer at weld joints appears to have corrected the rough appearance of the stairs from above, but nothing has been done to address the roughness of the joints below the treads and risers. HCS has agreed to consider having Stewart - Richey cover these areas with gypsum board soffits. This far, nothing has been done to prepare the stairs for this work.

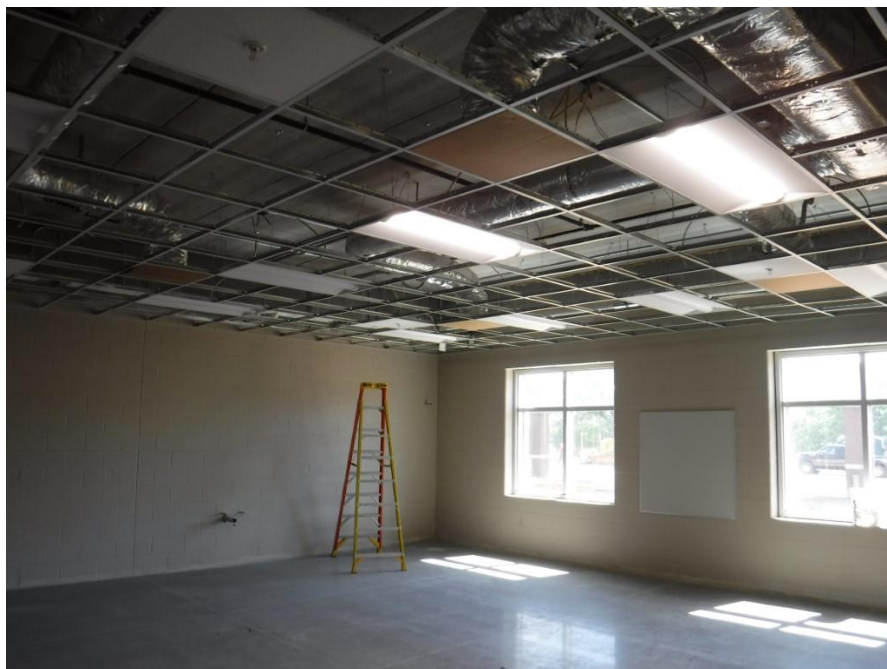
- y) Where ceiling grids are in place, sprinkler heads, light fixtures, grilles and diffusers have been installed in the grids. Some of these areas do not have permanent wiring to the light fixtures. Any electrical work through the grid must be done without damaging the grid.

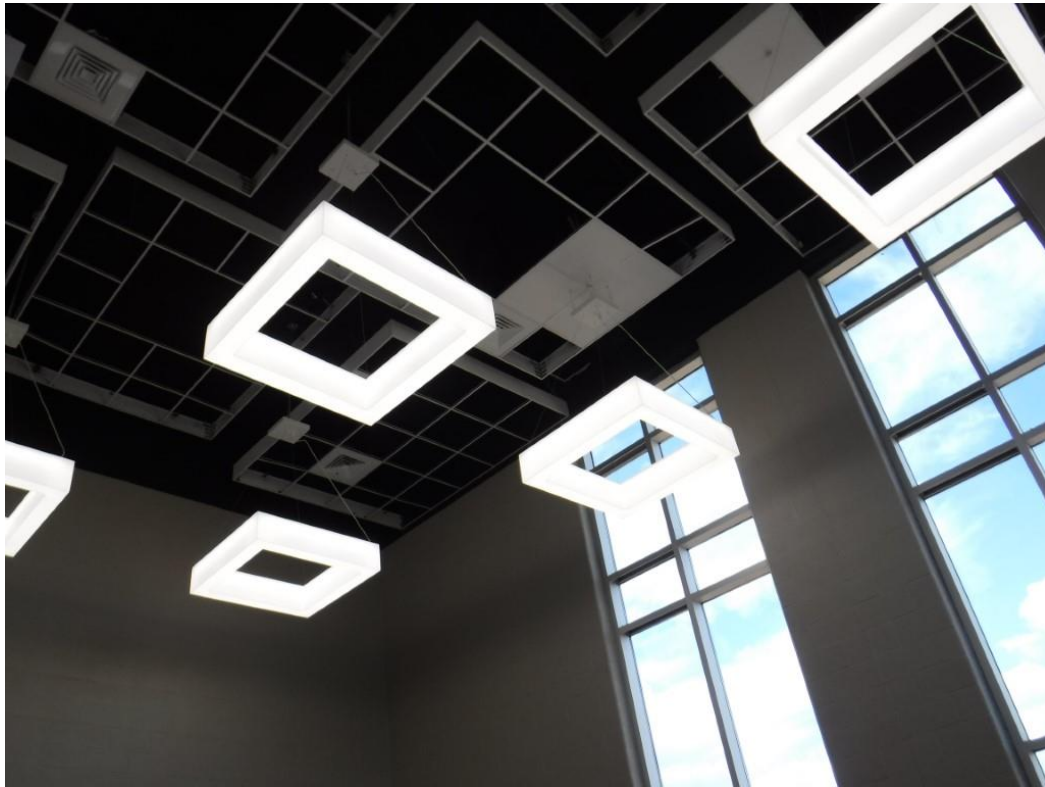
- z) The specialty light fixtures in the Band Room have been installed, however the suspending conduits have not been painted flat black. These must be painted, and the clouds must not be displaced and damaged.
