FIELD OBSERVATION REPORT

East Hardin Middle School, Hardin County Schools, Elizabethtown, KY 201752.01 - CA8

Date: 6/10/2021

Report No: 54

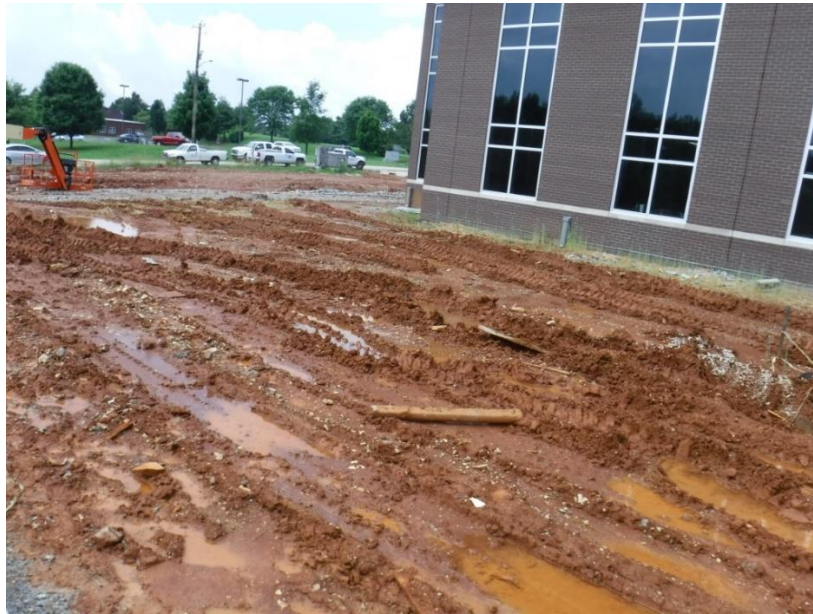
- b) The site was wet from a rain earlier in the week. Very little exterior work was taking place.

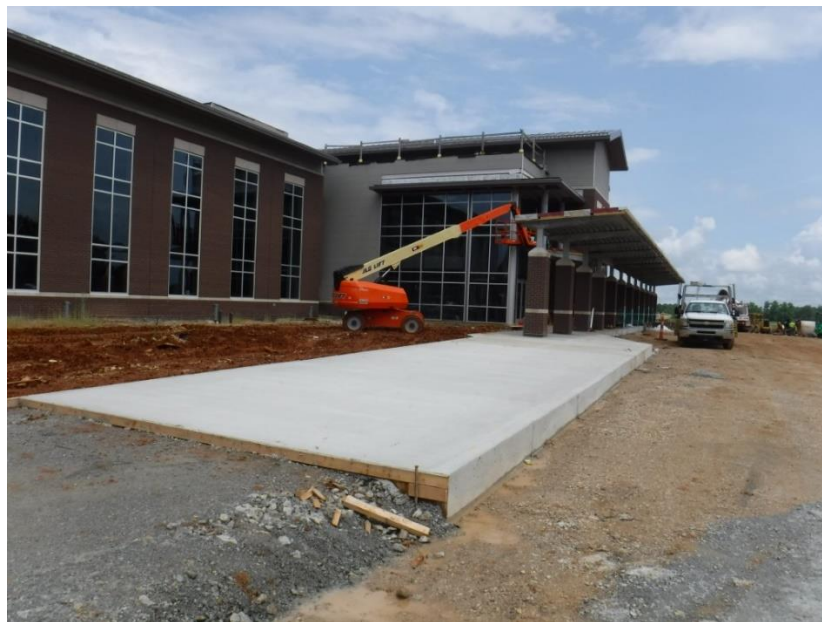
- c) The southern portion of the concrete sidewalk at the bus loading area had been placed. The curb was being formed.

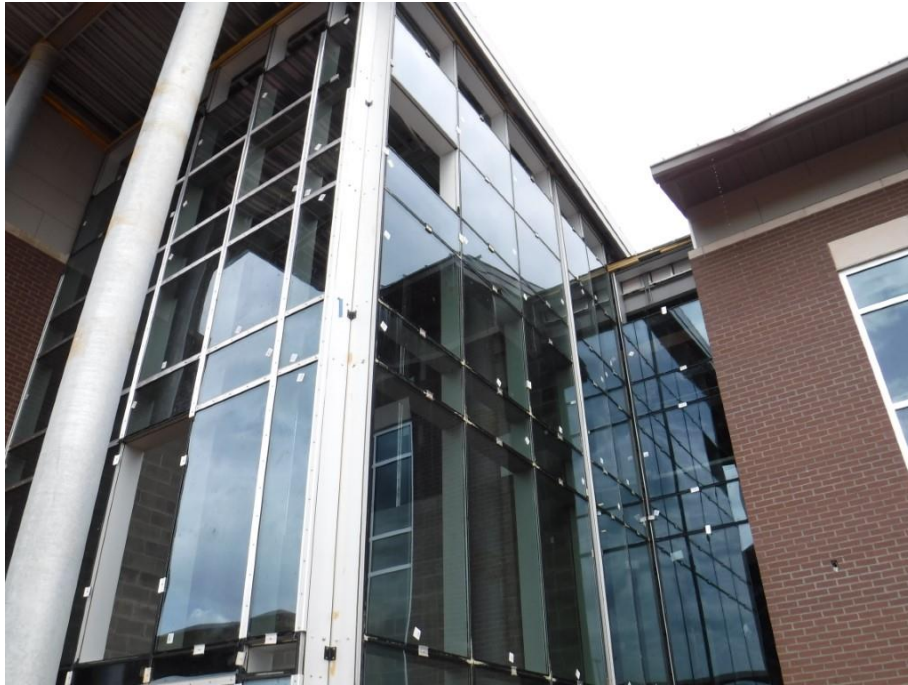
- d) The west entry to the main corridor is nearing completion. Expose structural steel needs to be cleaned and made smooth prior to painting. Some of the upper glass units will be changed to spranrel glass units to block the view of structural steel above the ceiling over the lobby.

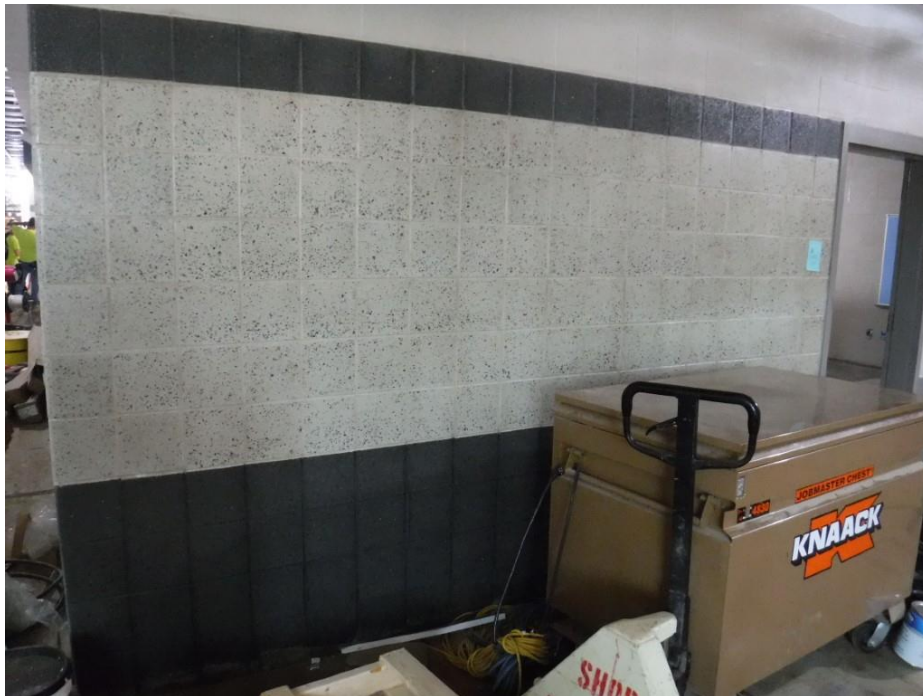
Carmicle's masons had sealed the sample panel. It was approved by representatives of HCS and JRA. In the progress meeting, Rob Deal commented that the beam pockets in the fire walls must be filled with mortar. Here again, this work must be done before the ceiling tiles are installed at these locations.

- e) A sample panel of the ground faced block had been prepared as a sample. The block was clean, mortar streaks were barely visible, the correct mortar colors were in the proper locations. HCS and JRA representatives reviewed the sample and approved it.

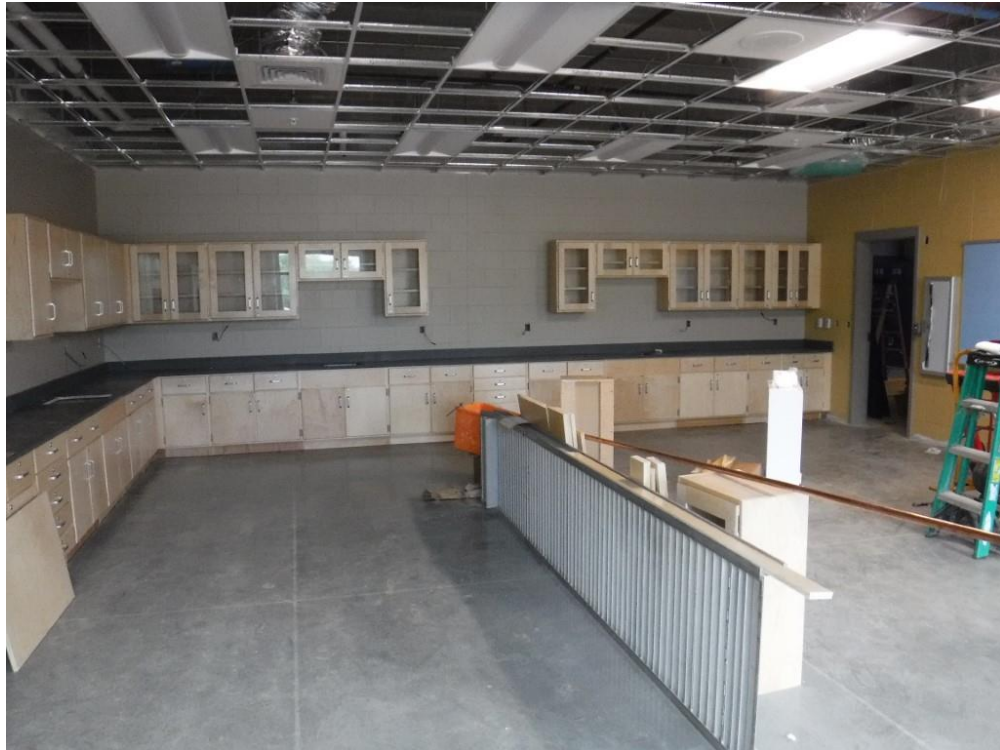
- f) One science classroom had most of the cabinets installed. The countertops, sinks and specialty items were being installed.

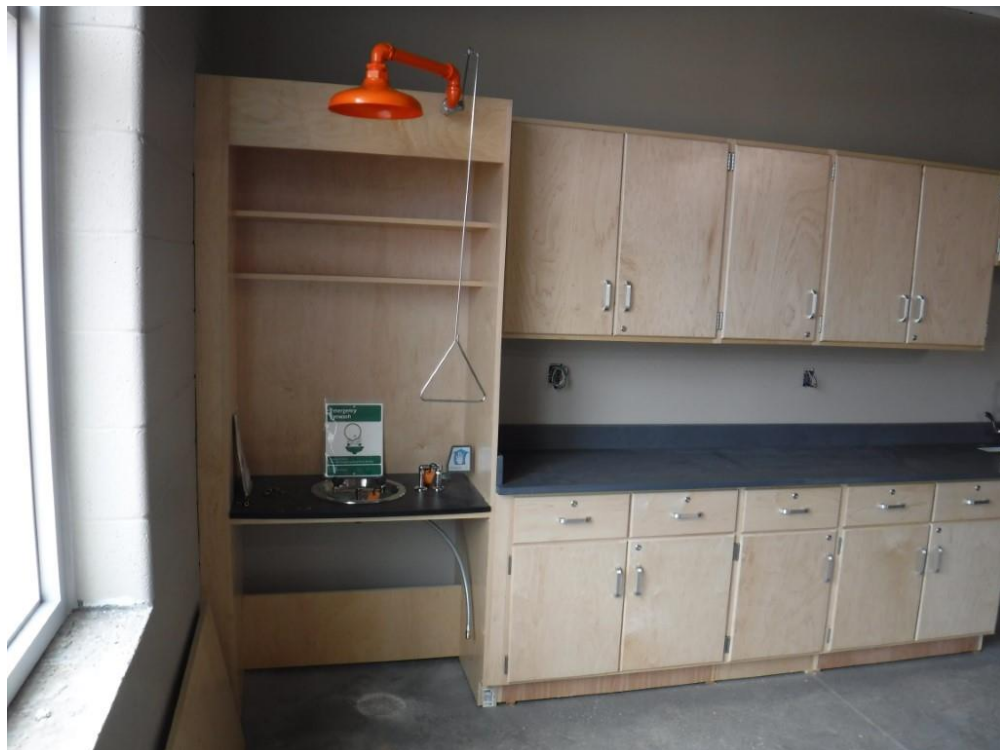
- g) The emergency eyewash/shower fixtures were in place.

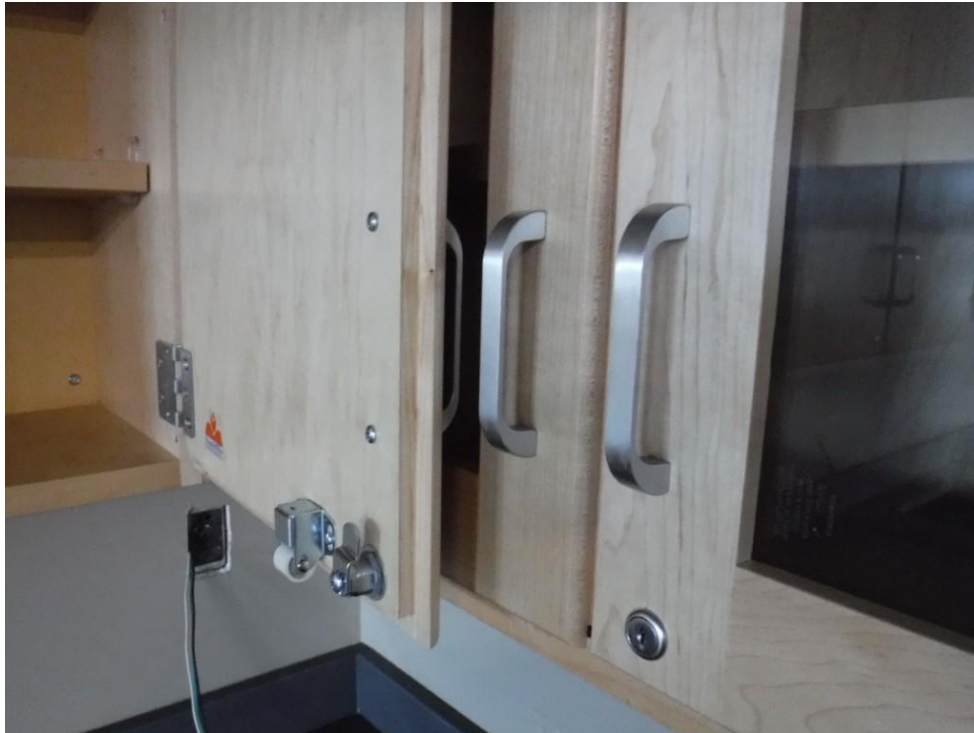
- h) Chain stops need to be installed in the corner cabinets to keep the handle from hitting the glass in the door of the adjoining cabinet.

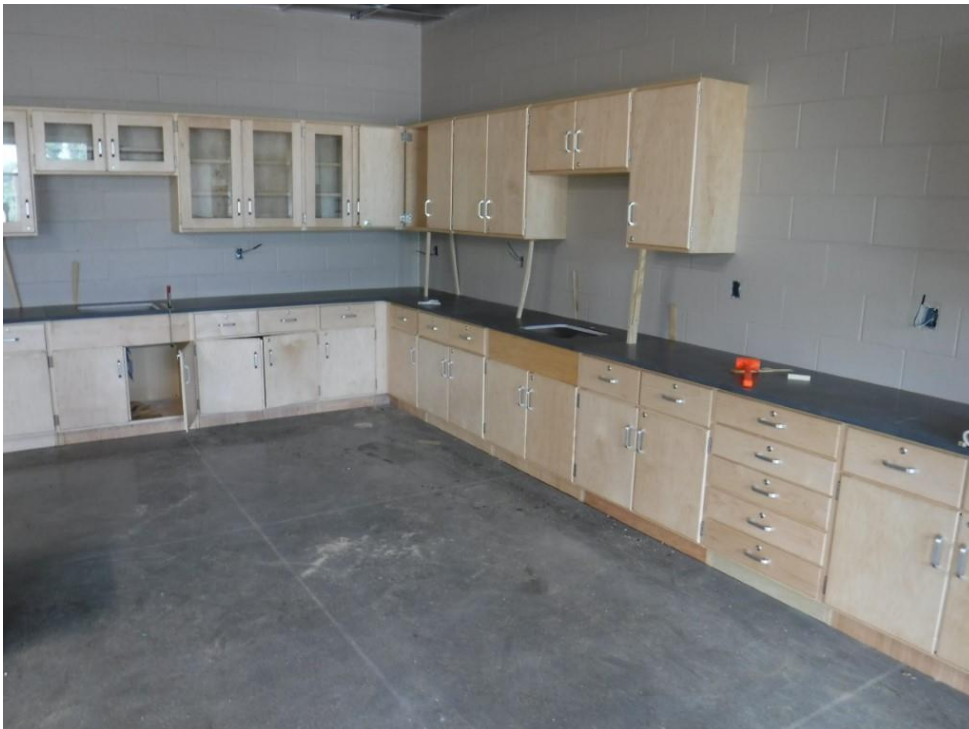
- i) Cabinets were also installed in the Prep Room.

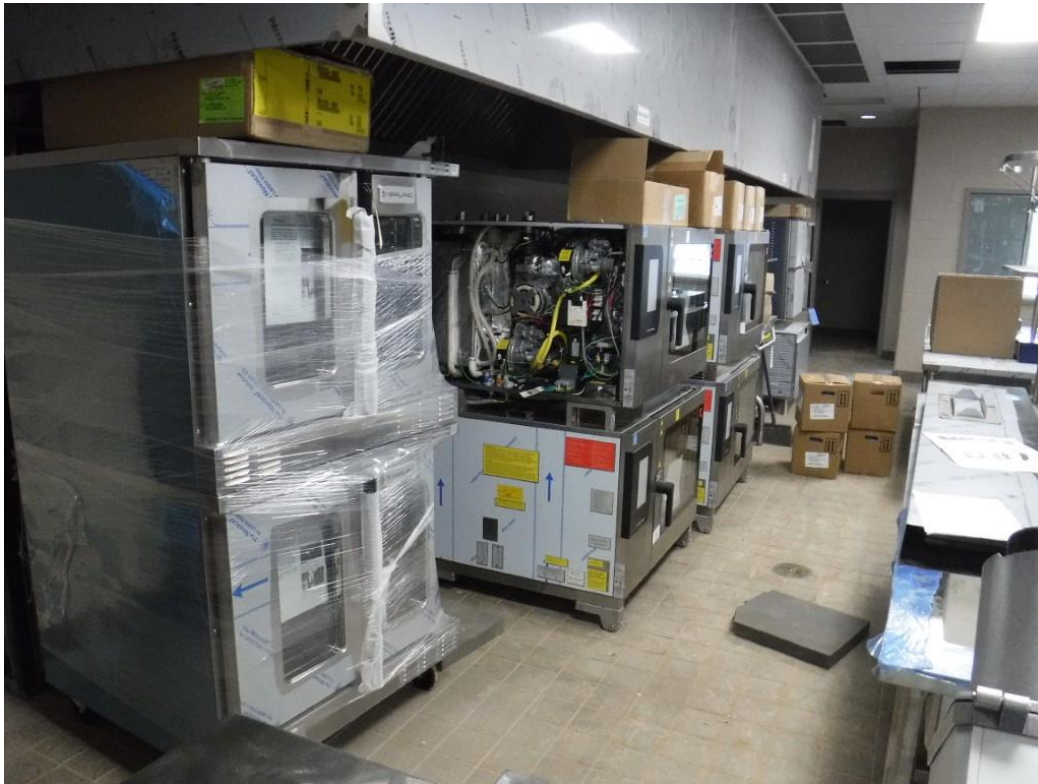
- j) Kitchen equipment is being prepared for connections to utilities.

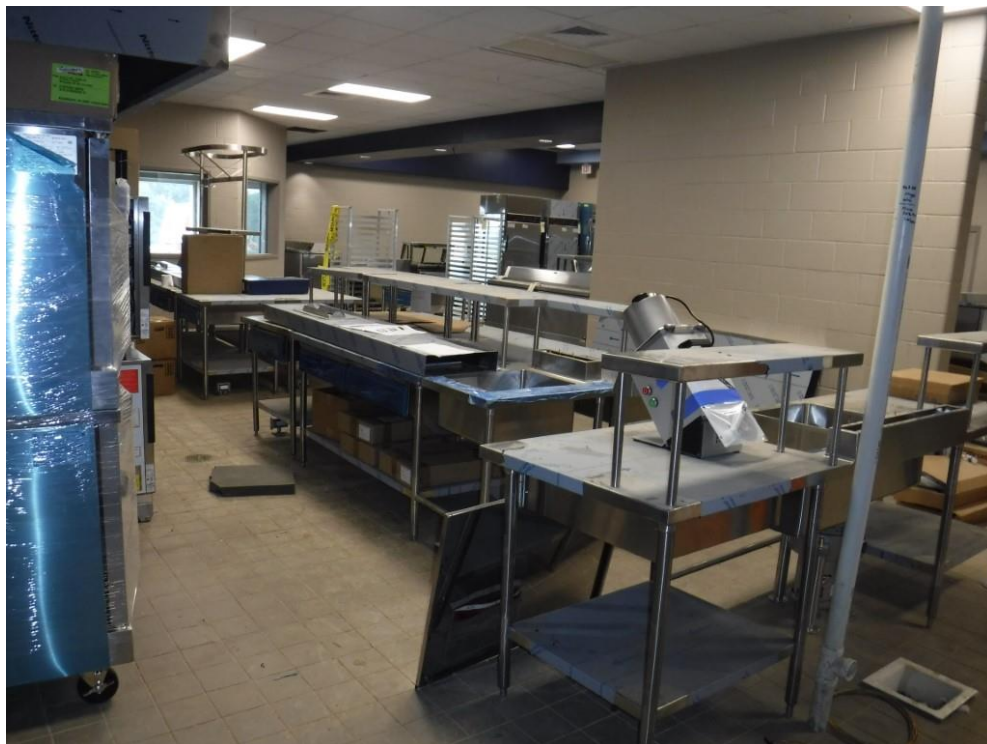
- k) We still need to evaluate the quarry tile in the Kitchen to see if epoxy grout has been left on the face of the tile. Tiles that cannot be cleaned must be replaced.

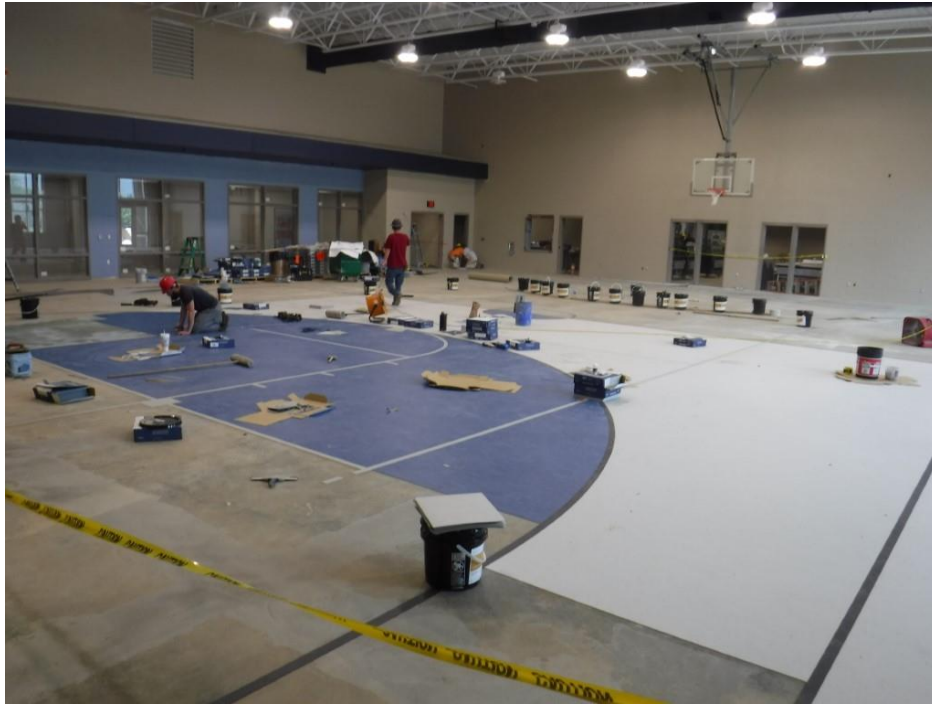
Ted McClain's crew was installing the sheet vinyl flooring in the Cafeteria. This includes the striping and lane areas for a basketball court.

- l) Sheet vinyl flooring was being installed in the Cafeteria. Striping and lane areas were being cut into the field tile. It has been discovered that the wrong blue material was installed in the Cafeteria. Workers used the material that was indicated to be installed in the Band Room.

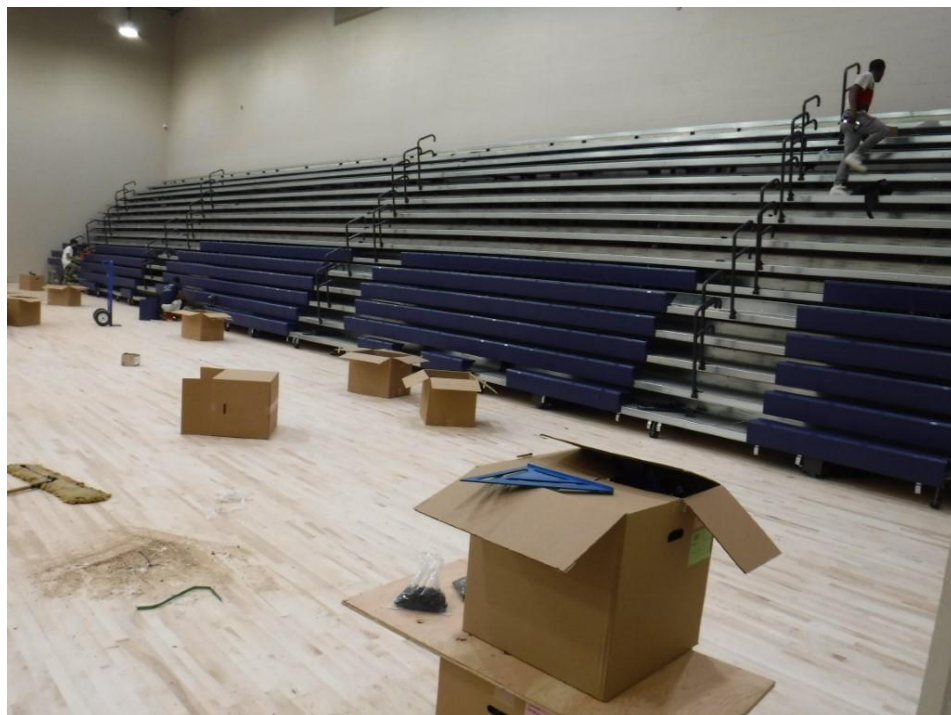
Toadvine's crew was installing the movable bleachers. They were about 70% complete while I was on site. Gerald has told all other workers that they are to stay out of the Gym if they have no work to do in the space.

- m) The movable bleachers were being installed in the Gym.

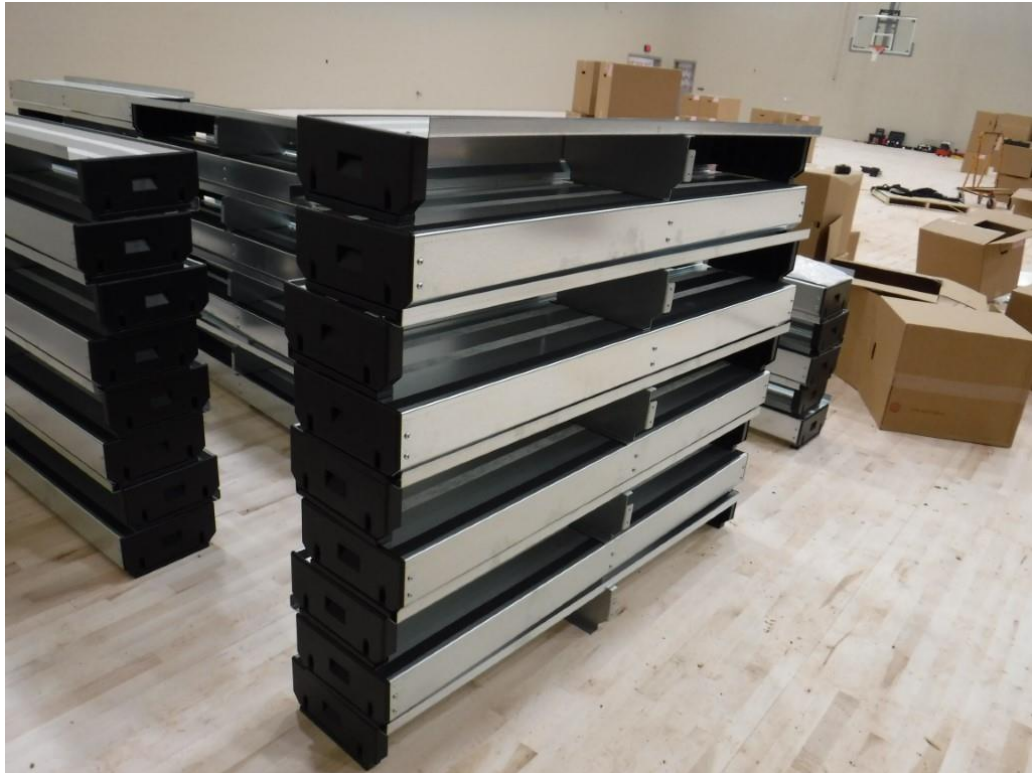
- n) The gym floor needs to be striped and finished after the movable bleachers are installed.

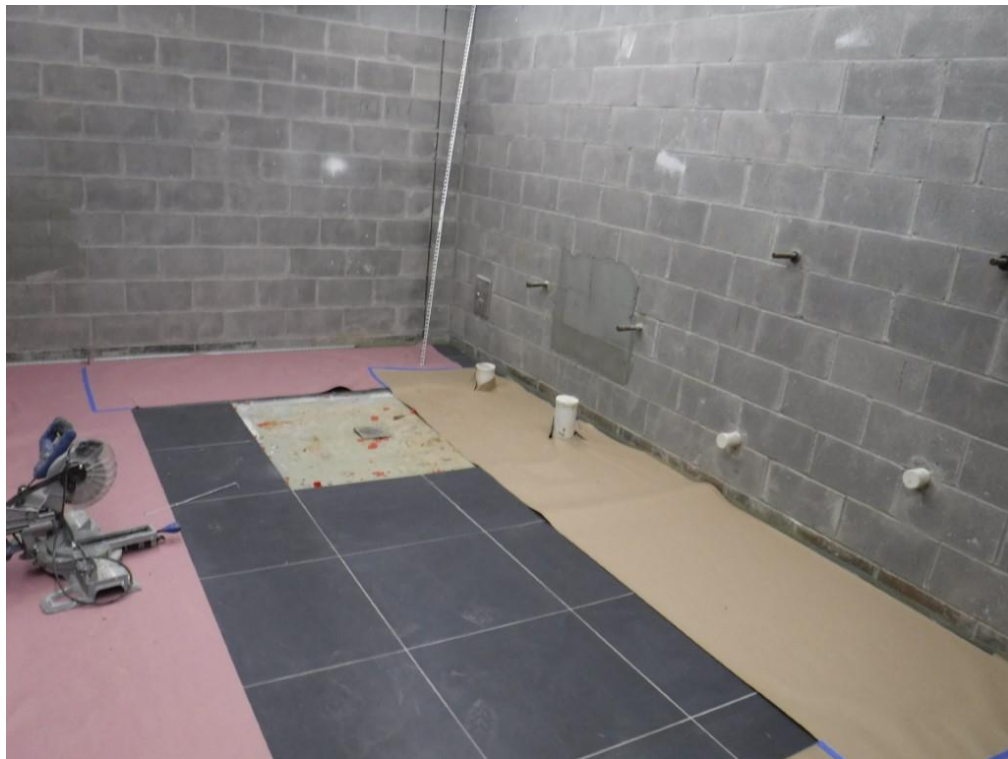
Tile floor installers had been installing the tile in the student toilets on the first floor.

- o) Tilework was being installed in the student toilets on the first floor.

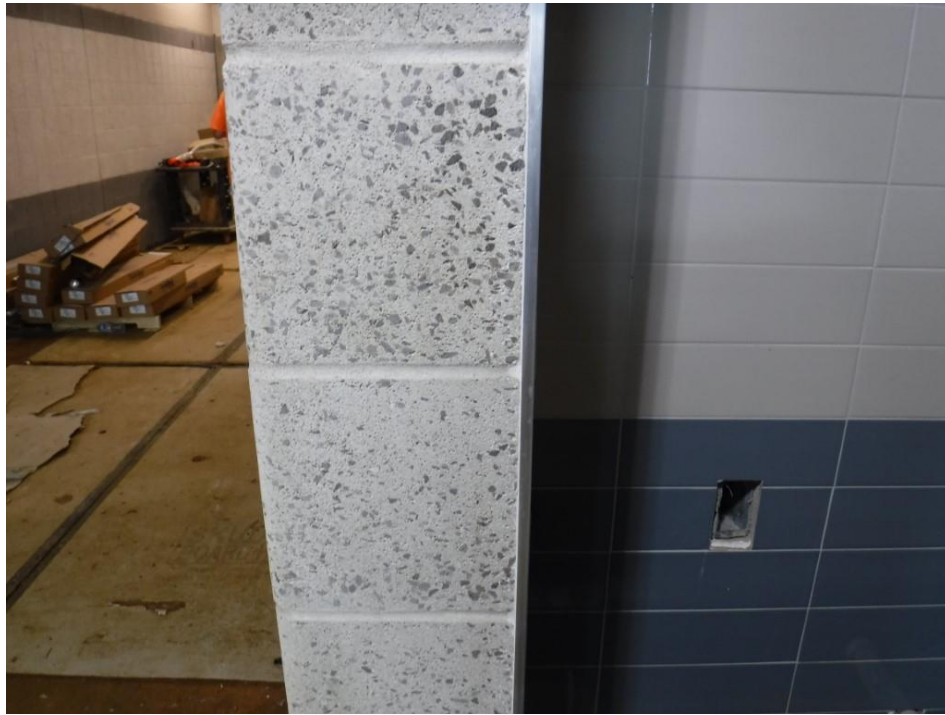
- p) In this image, the wall tile termination strip and the ground faced CMU are finished such that a straight caulk joint could be installed. This is expected at all similar tile to block joints.

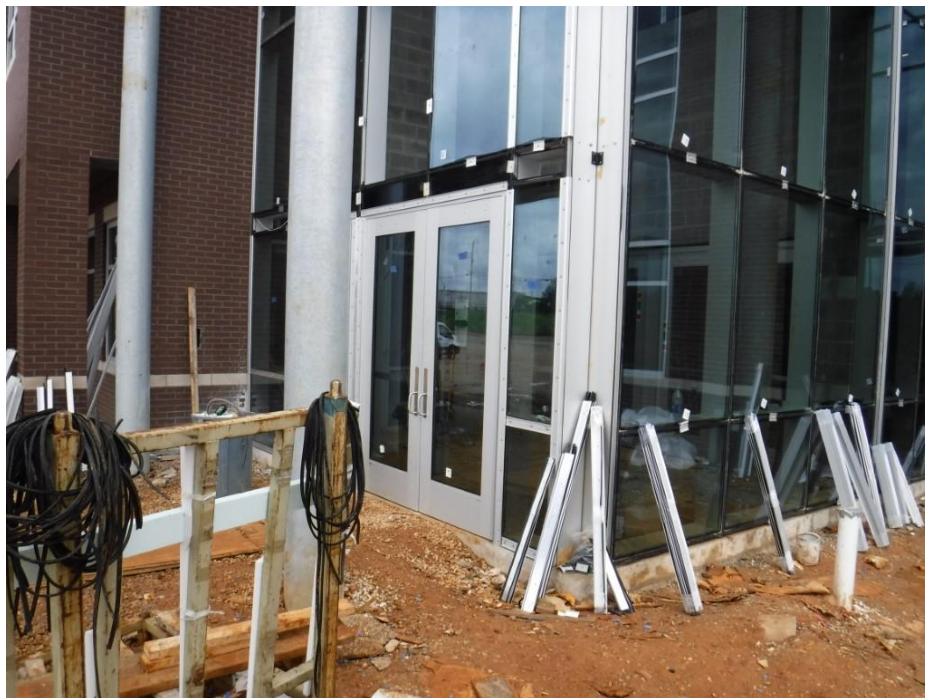
Lake Cumberland's glazers had been installing the main entrance curtainwall assembly almost completing the main framing. The glass and doors were in place. The face caps and sealants remain to be done.

- q) Aluminum doors have been installed at the main entrance. The building is very close to being total enclosed.

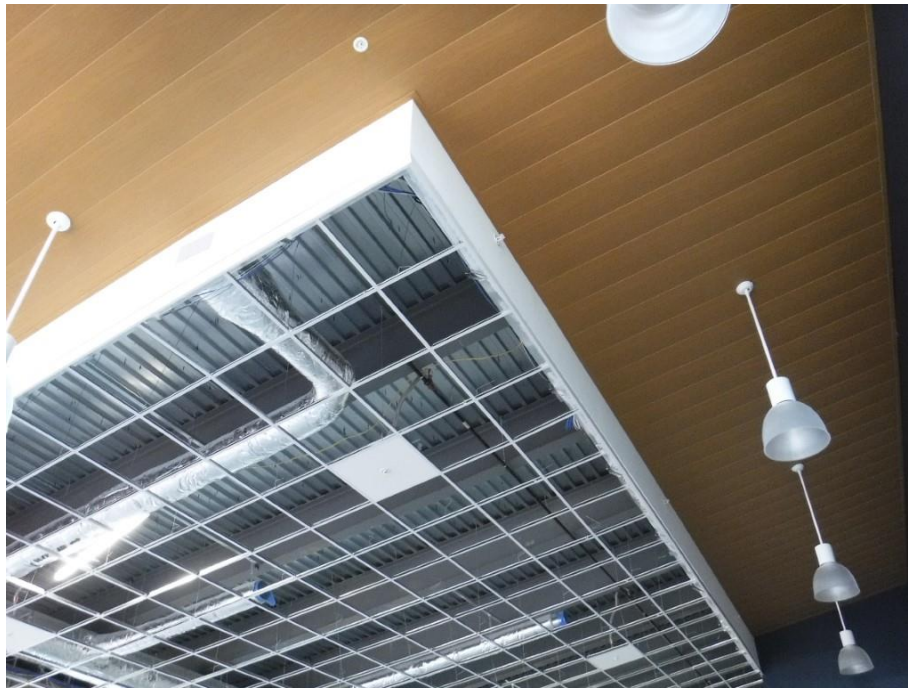
Kalkreuth's sheet metal installers had installed the wood grained sheet metal ceilings in the Library/Media Center and at the west entry to the building. They have a good deal of work to do on the metal and flat roof areas, soffits, and the metal roofing on the canopies and maintenance building when the weather permits. Apparently, they do not yet have all the materials that they need to do this work.

- r) The wood grain sheet metal ceiling was installed in the Library/Media Center. The Axium ceiling trim at the bottom of the gypsum board fascia has prefabricated corners as directed at the bottoms of the gypsum board fascia. Note that light fixtures have also been installed.

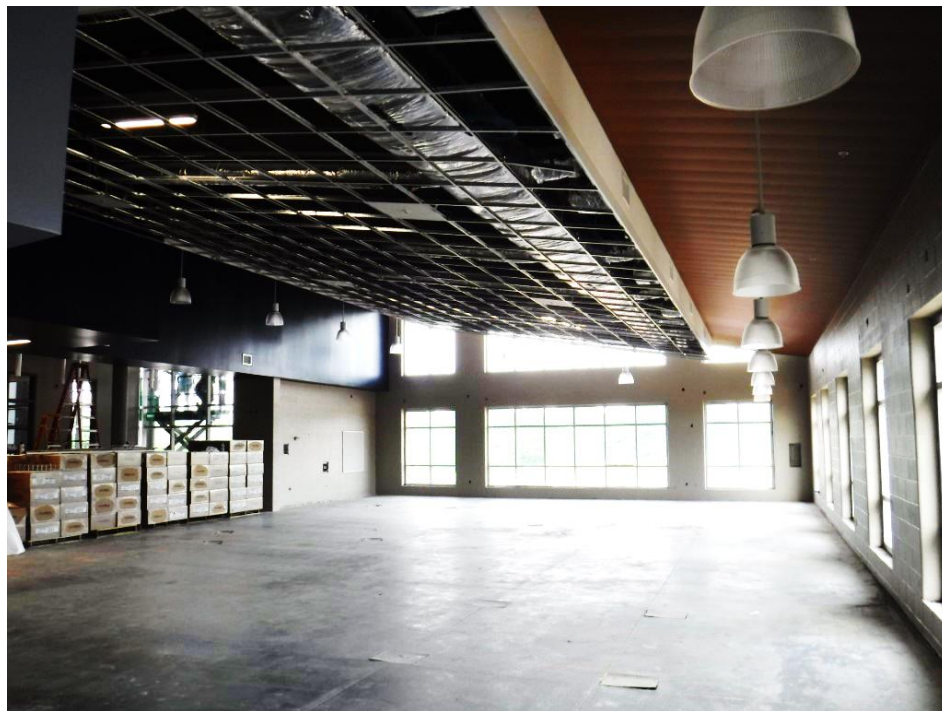
- s) With most of the overhead work complete and the floor cleaned, the LMC is ready to have carpet installed.

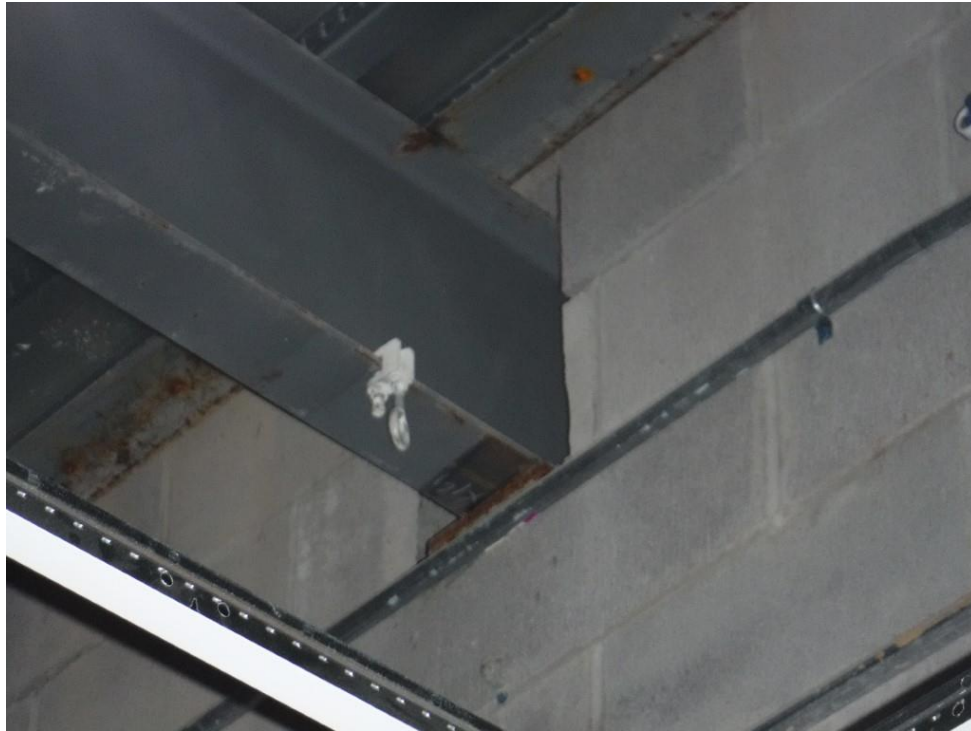
- t) Beam pockets such as this one that occurs in the fire wall must be filled with mortar to maintain the integrity of the fire resistive rating of the fire wall.

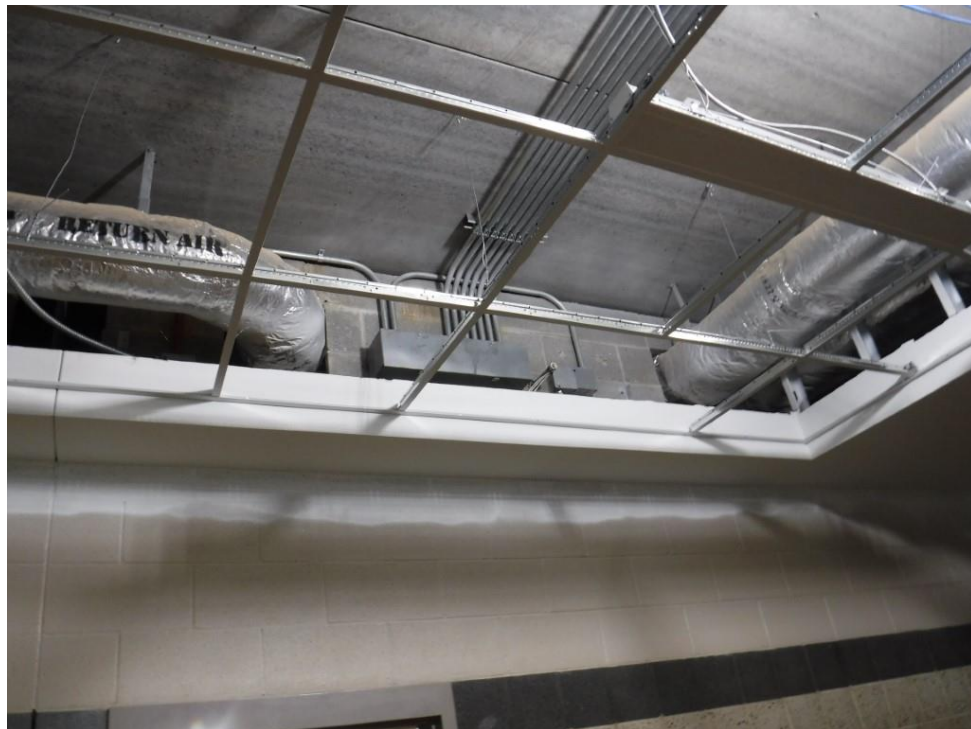
Shane Krutz and I discussed the absence of lateral wall bracing on non-load bearing walls with J.W. Minton of Stewart Richey since their scope of work included providing and the installation of the bracing. Shane surveyed the building and found that one, incomplete brace was installed on the free-standing CMU wall in the Kitchen. J.W. was going to discuss the installation of the bracing with his foreman. Obviously, this work needs to be done before ceiling tiles are installed along these walls.

- u) At non-load bearing masonry walls intersecting the structure above such as this area, there should be braces installed as detailed on the structural drawings. These have not yet been installed.

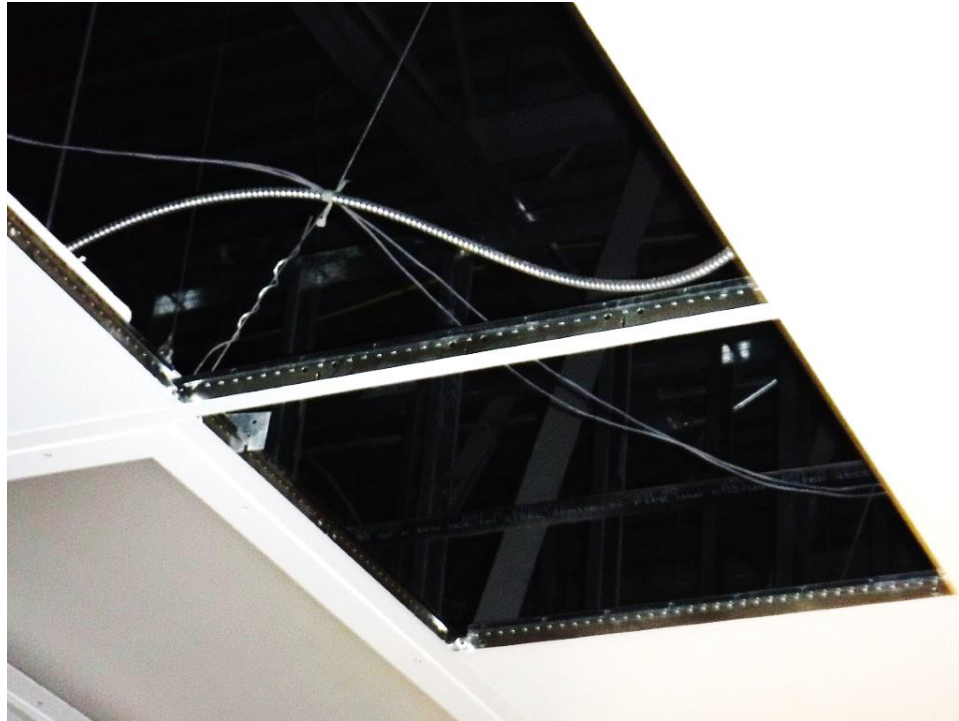
- v) One steel brace was installed at the free-standing wall in the Kitchen. This does not appear to be installed as detailed on the structural drawings.

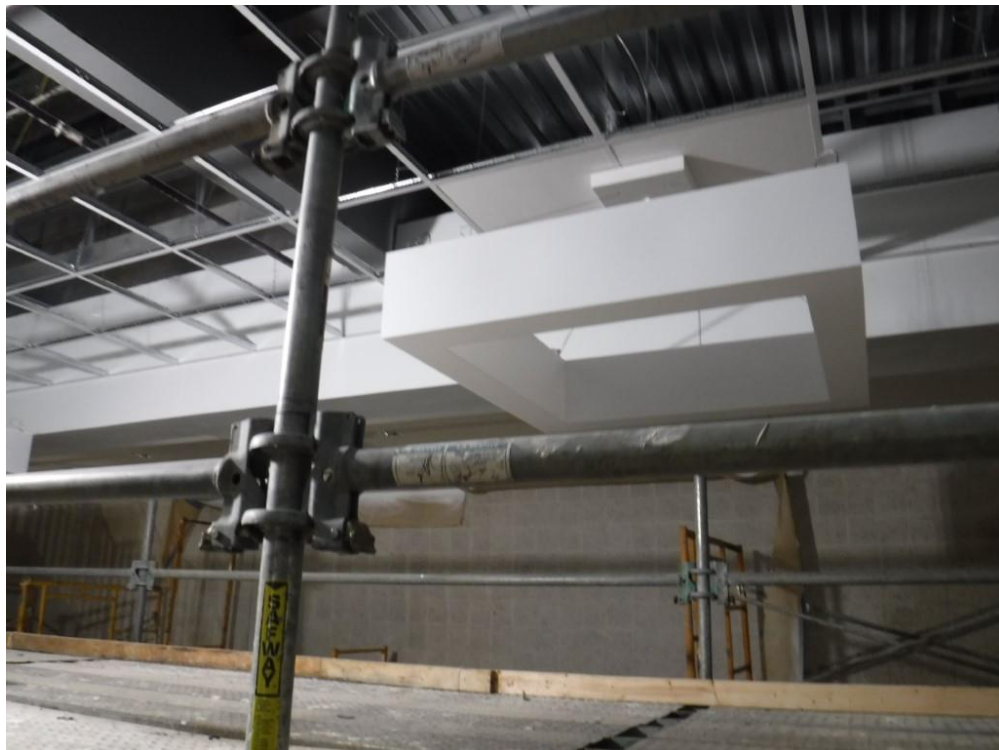
- w) D&M installed the suspended light fixtures over the central stair. It has been discovered that this was the wrong fixture with the wrong mount. This must be corrected.

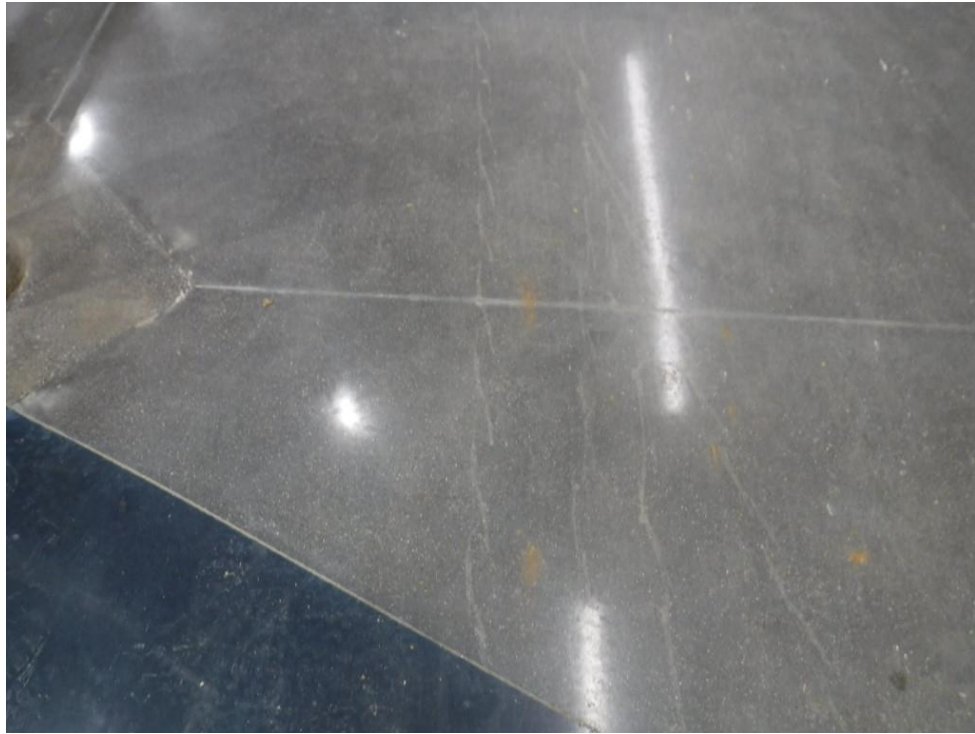
Extreme Polishers were finishing concrete slabs including the stained blue accent areas in the corridors. Unfortunately, someone had damaged the finished corridor by the Cafeteria. There was a long scratch extending over several of the panels in the slab. We decided that to have them grind deeper to remove the scratch but to leave the

- x) The finished surface of the polished concrete floor in the corridor by the Cafeteria was recently damaged by someone dragging material over the floor and scratching several polished concrete panels. These panels will be ground deeper to remove these scratches.

stained areas as was. The scratch did not show as much where the concrete was stained.

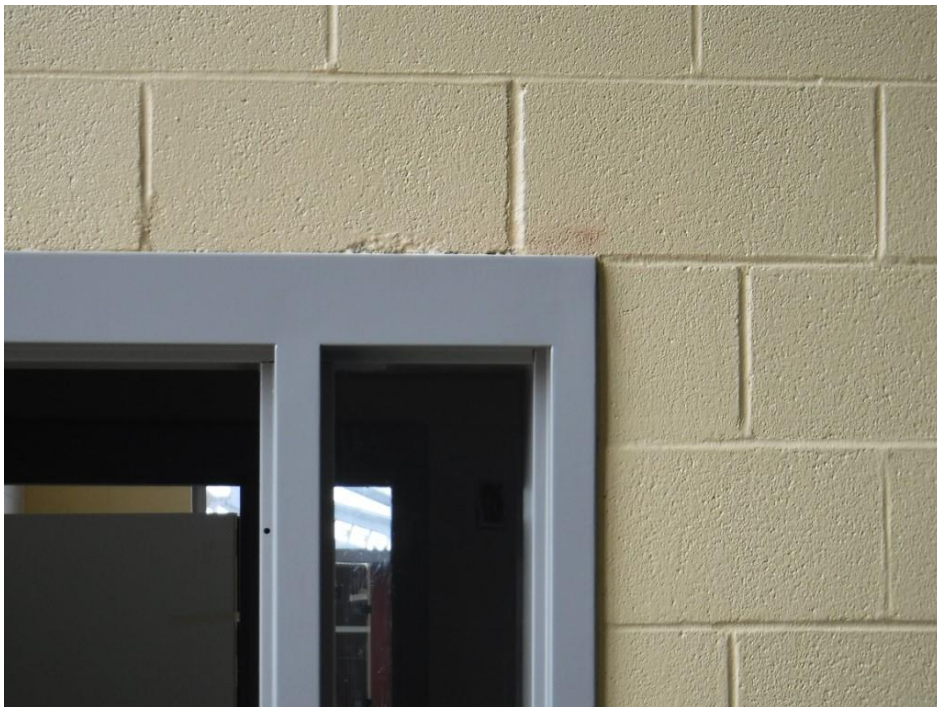
The painters were continuing to apply paint to the block and gypsum panels along the main corridor in Areas A and B. They are required to repair all the damaged door frames before they apply final coats. They also are required to finish the joint between the CMU walls and the door frames before they are painted. All exposed structural steel and stair framing is required to be smooth before paint is applied. All exterior sealants must be applied such as in masonry joints.

- y) The joint between the block and the tops of hollow metal door frames must be made smooth before final coats of paint are applied.

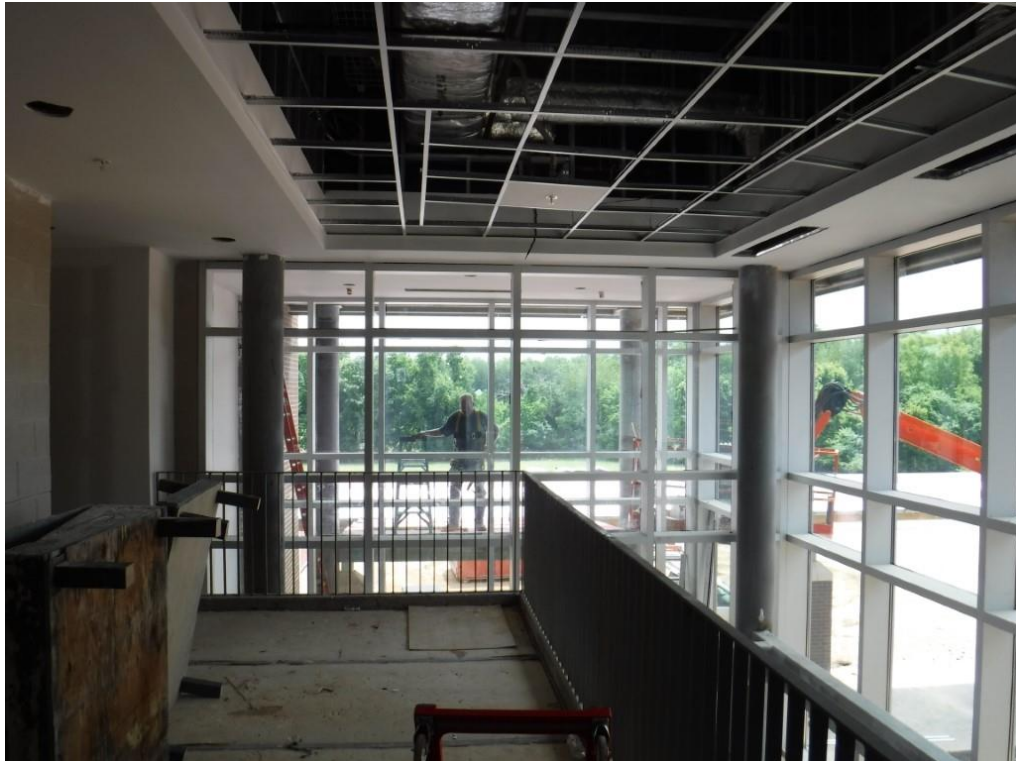
- z) Exposed structural steel must be made smooth before the final coats of paint are applied.

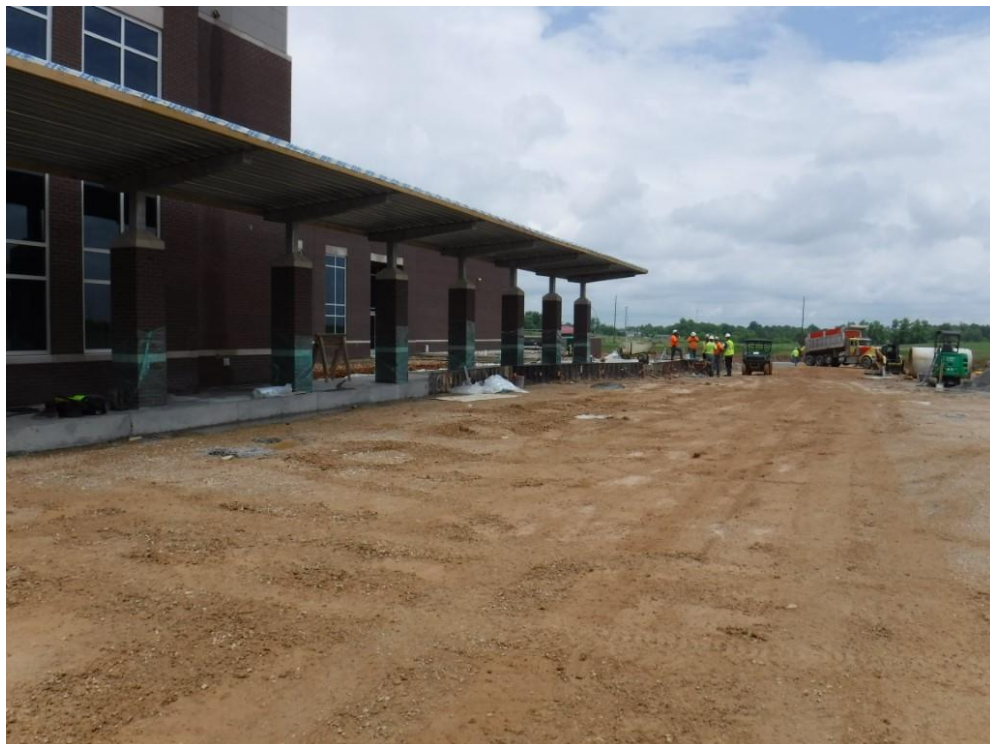
- aa) It was good to see that the brick columns at the canopy were protected before the concrete walk was poured.
