FIELD OBSERVATION REPORT

East Hardin Middle School, Hardin County Schools, Elizabethtown, KY 201752.01 - CA8

Date: 7/8/2021

Report No: 58

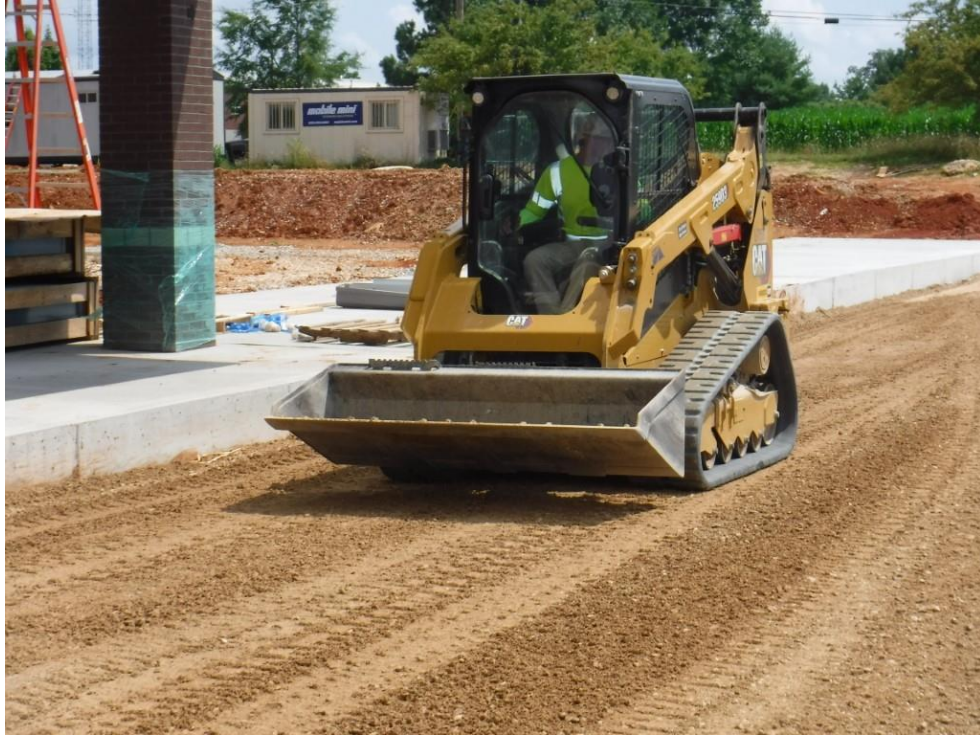
- b) The west parking lot was being prepared for rock in anticipation of laying asphalt paving by the first of next week.

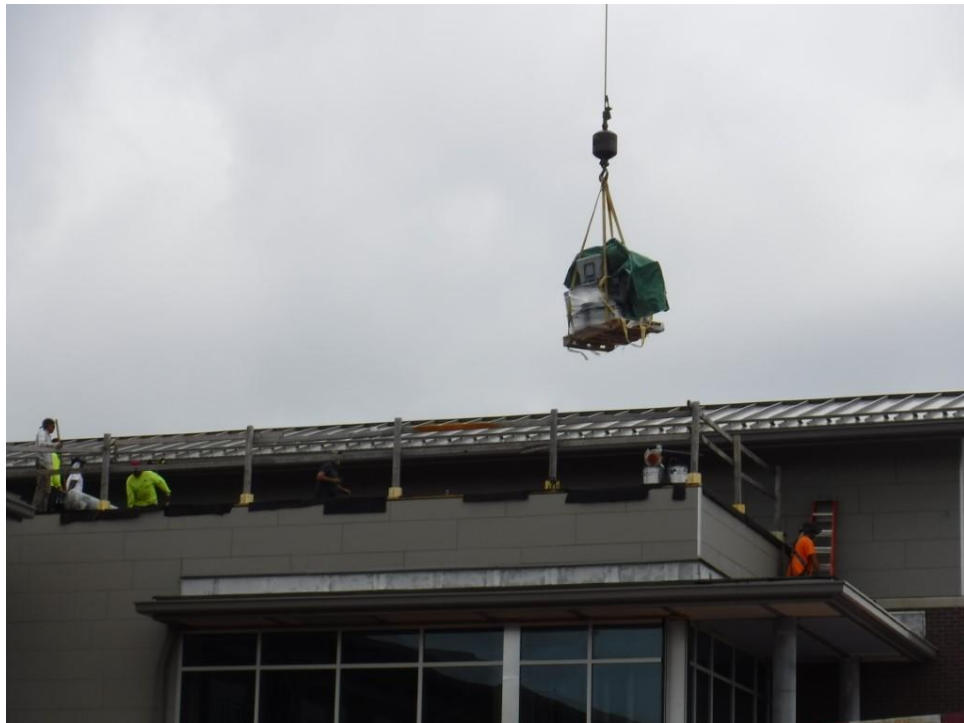
- c) Gravel was being lifted to the low sloped roof areas to be placed on the flood coat.

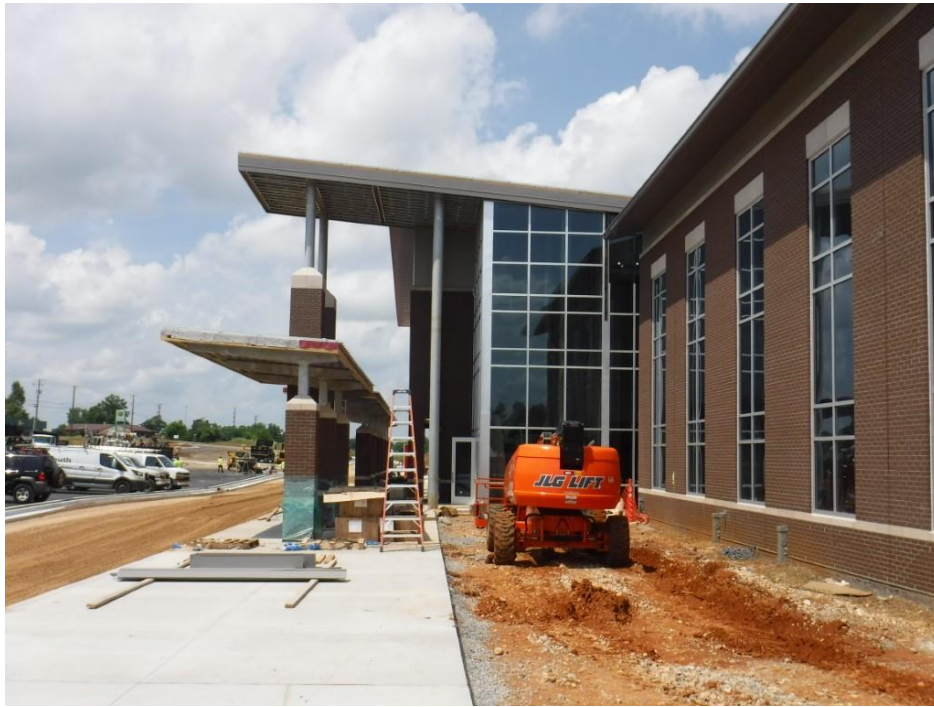
- d) The landscaper is preparing lawn areas for sod and seed. Seed will be delayed until the fall. Sod will be placed when water is available for irrigation. Sheet metal roofing was being applied to the west canopy.

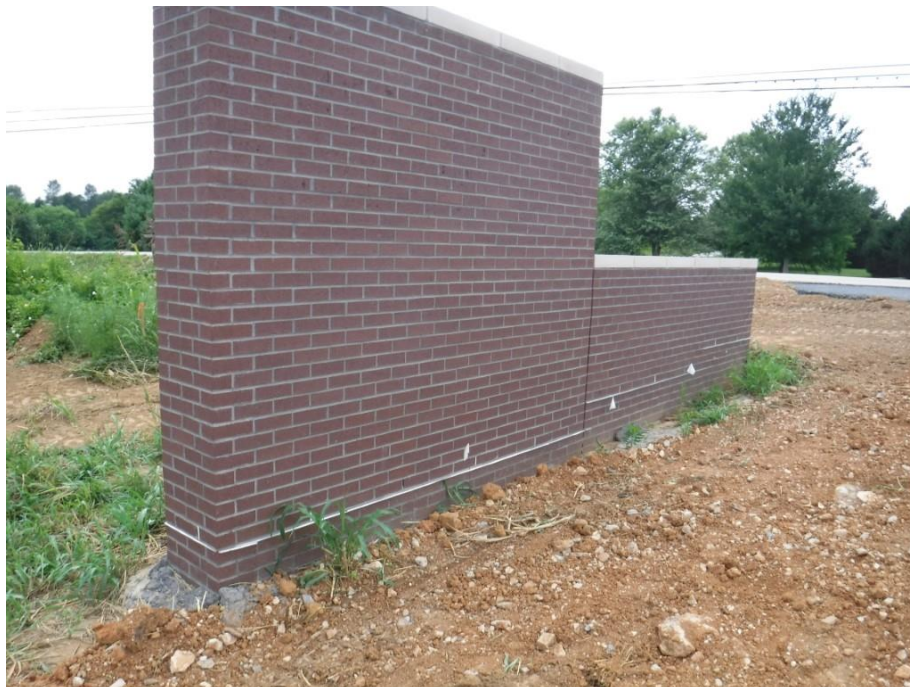
- e) Mike Billings and I discussed the location and heights of the light bases for the building signage. The ground is not at the finished elevation. It will be flat at the base of the brick walls. JRA will issue instructions concerning the earth being placed over the through wall flashings.

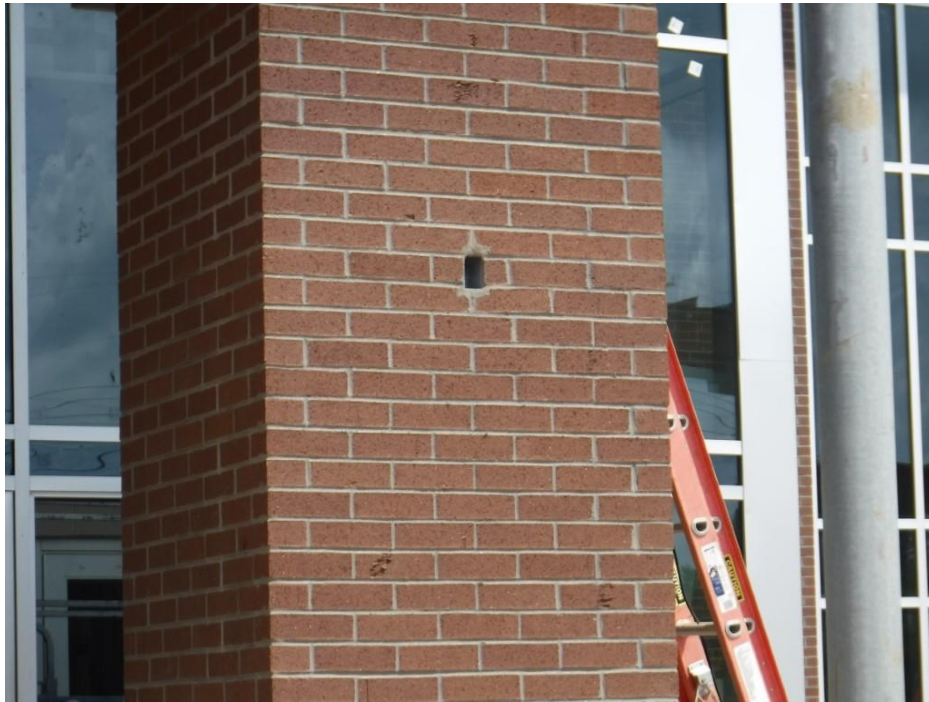
- f) The brake metal corners at the entries were being reworked. Images of the corrective work were sent to JRA. From the images, it appears that the corrective work follows the details on the drawings.

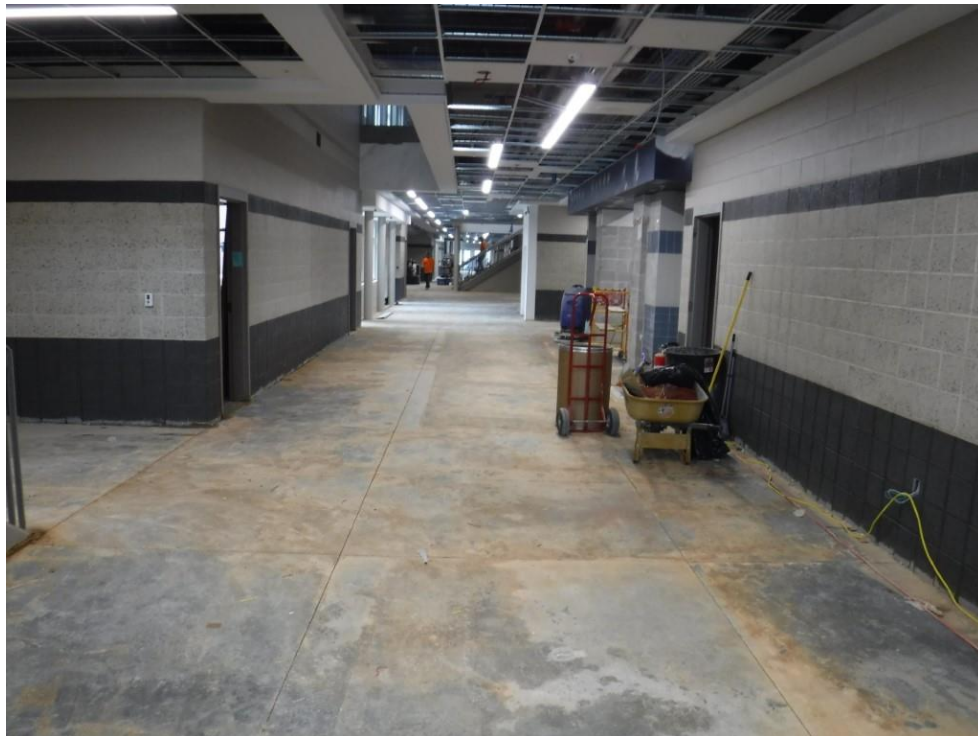
- g) The protective board was removed from the first-floor main corridor. When the polishing of the east half of the main corridor is complete, most of the polishing for the building will be complete.

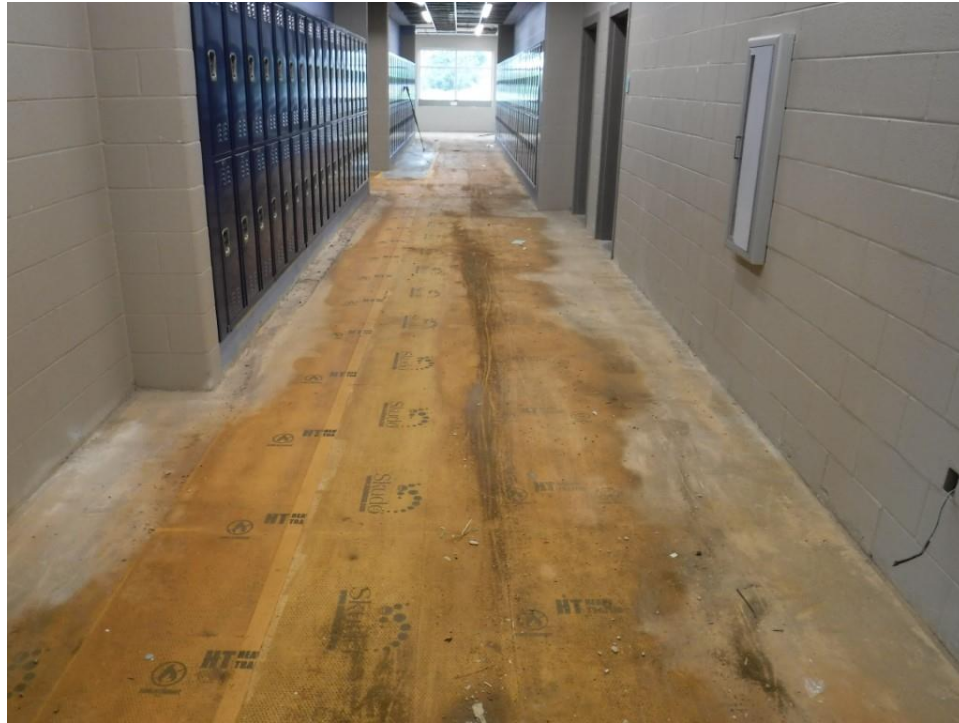
- h) The last floor area to be polished will be the first-floor of the B Area classroom corridor. This was the first area to be covered with the Skudo system.

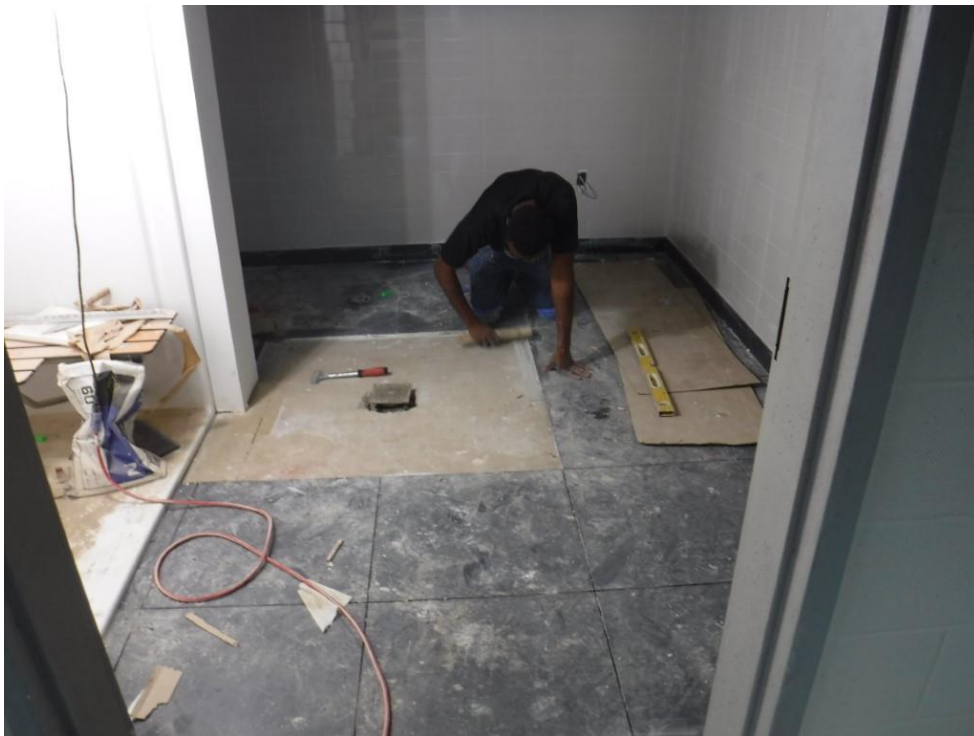
- i) The last toilet to receive tile pavers is in the FMD Classroom.

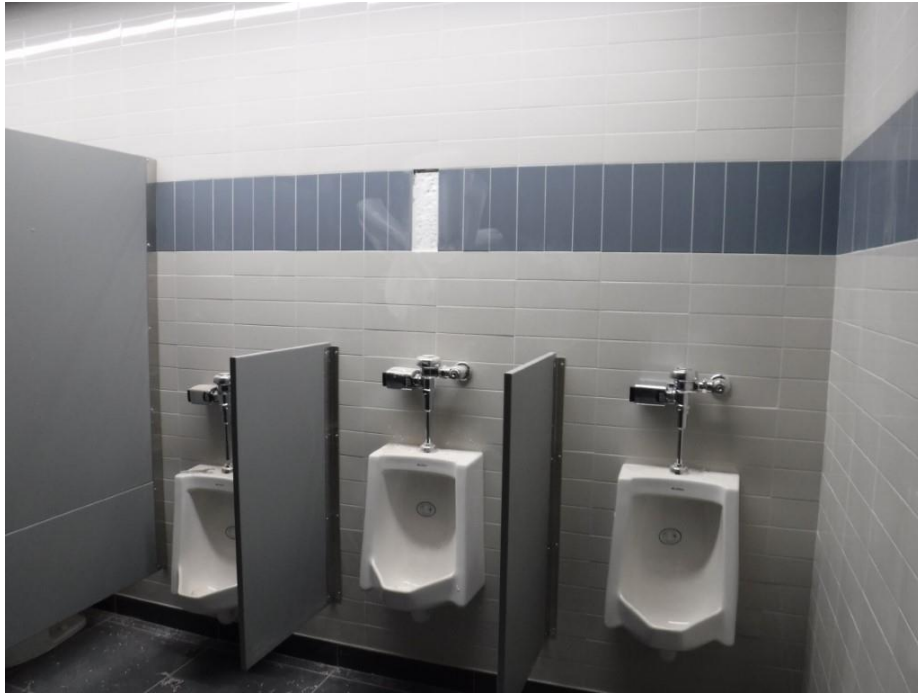
- j) The wall tile in the middle of the image has been removed for replacement. This is typically done because the tile was out of plane, or it was damaged.

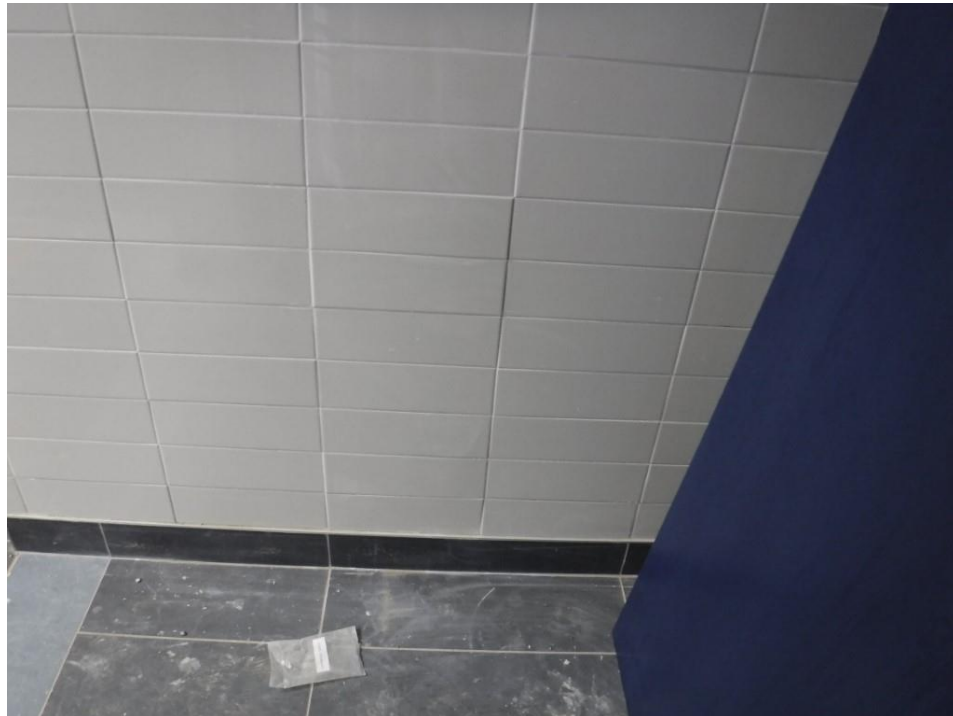
- k) A significant number of wall tiles are not in plane with the rest of the wall. These must be replaced.

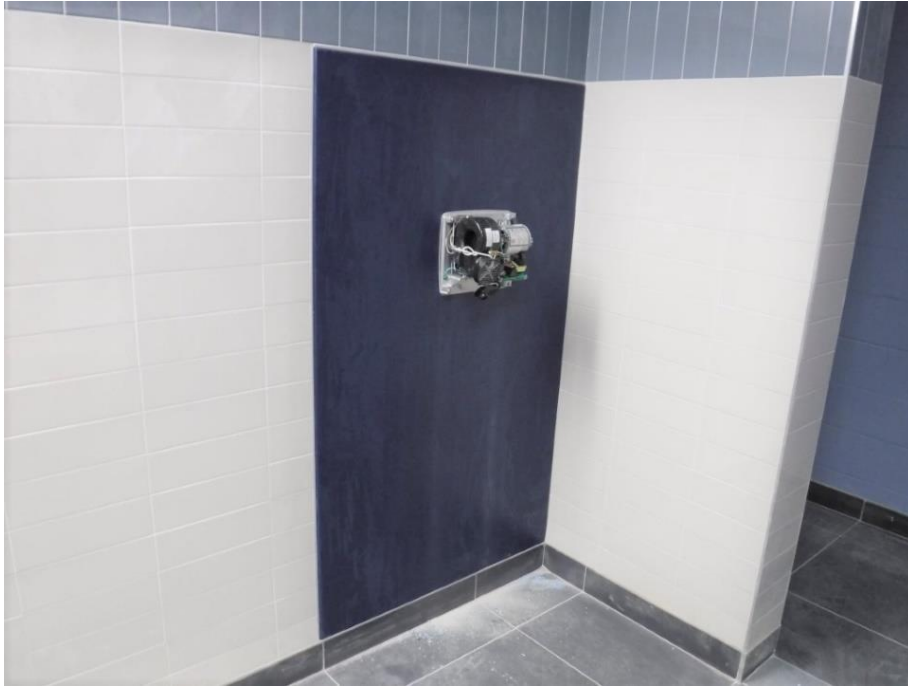
- l) The solid surface material behind this hand dryer is streaked. It appears that this is from the release adhesive for the protection material. This must be completely removed, and the finish made to conform to other similar material on the project.

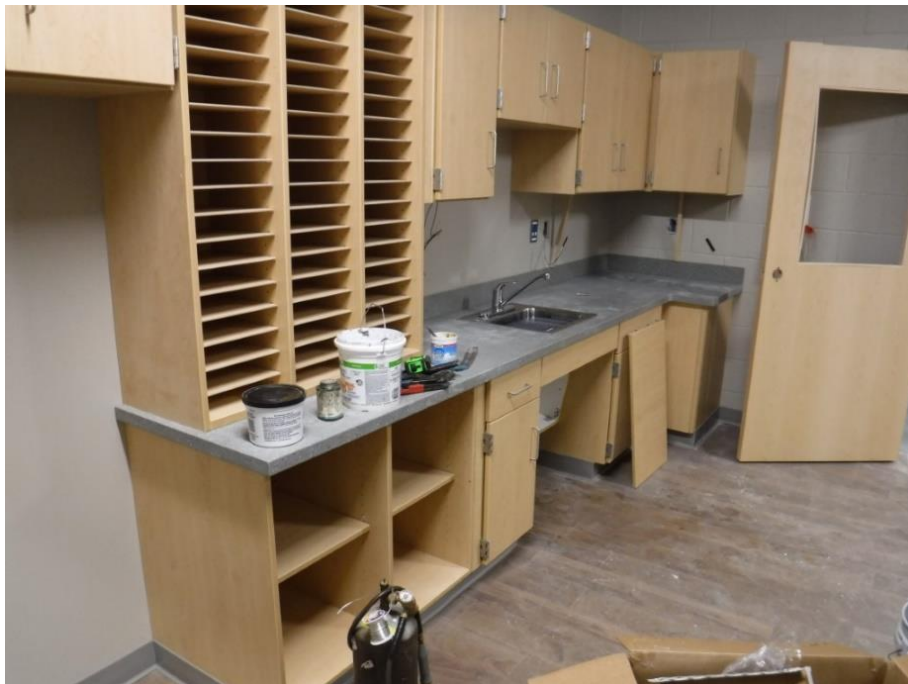
- m) The solid surface countertop in the workroom was scratched and chipped. The contractor has made repairs to this material.

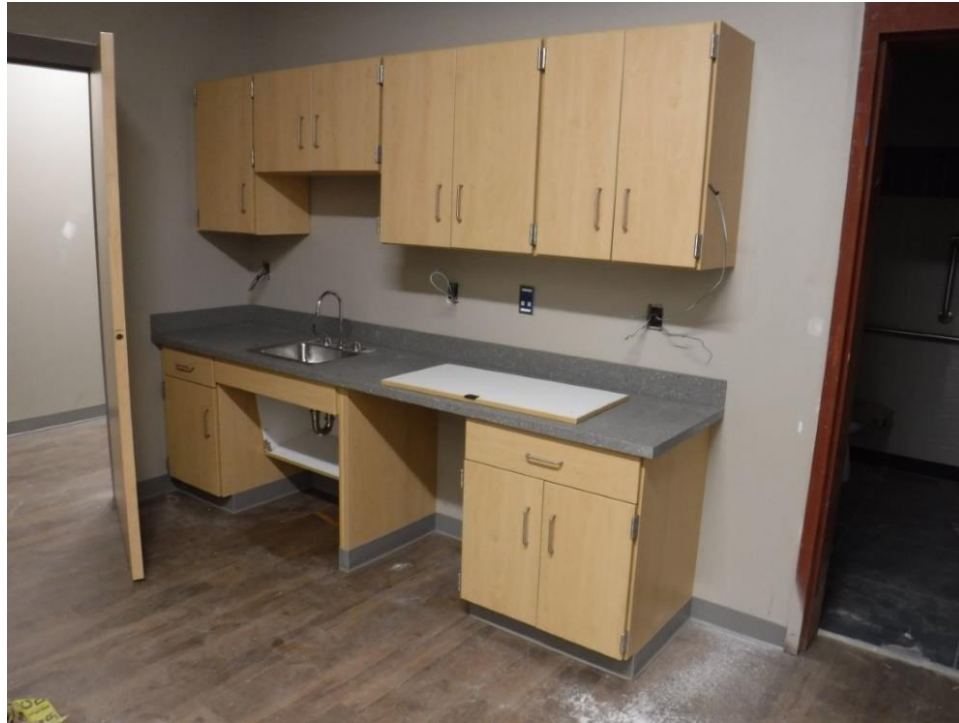
- n) Casework is going into the administrative area. The floors are covered with LVT, and the wall base is in place.

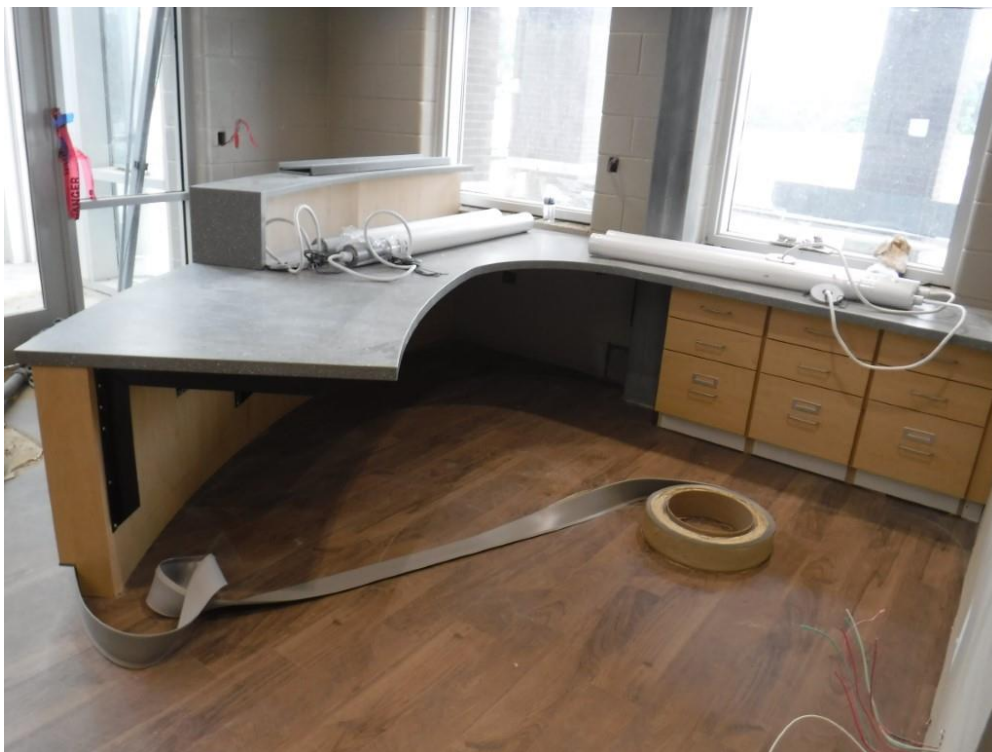
- o) The casework and countertop in reception were installed. Coordinate the location of grommets cut into the countertop with HCS.

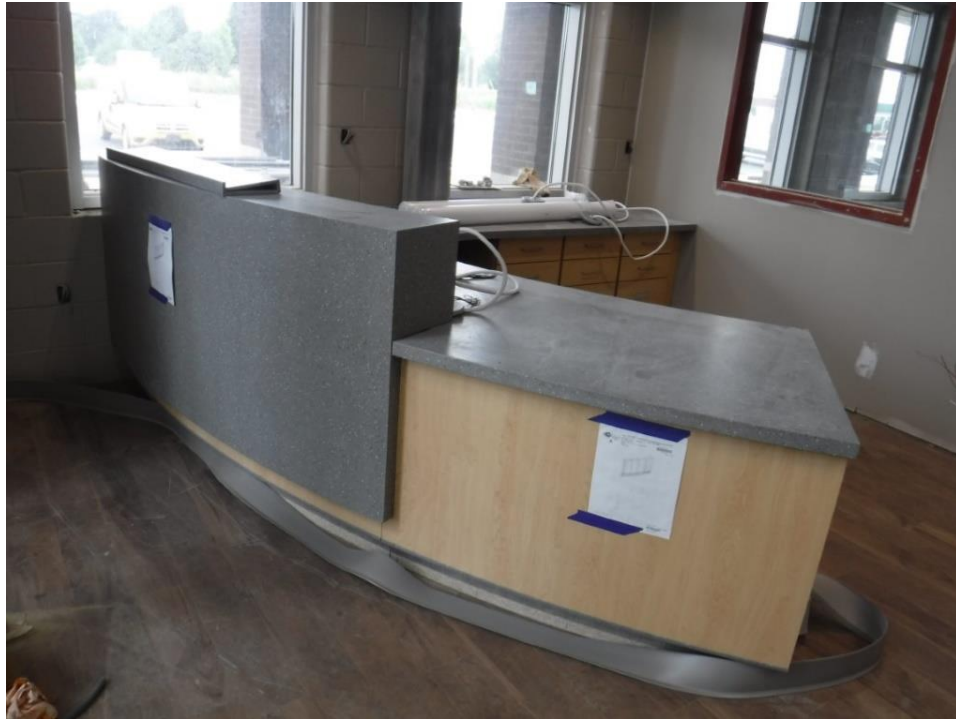
- p) Protect the countertops and casework from damage until the project is occupied by the owner.

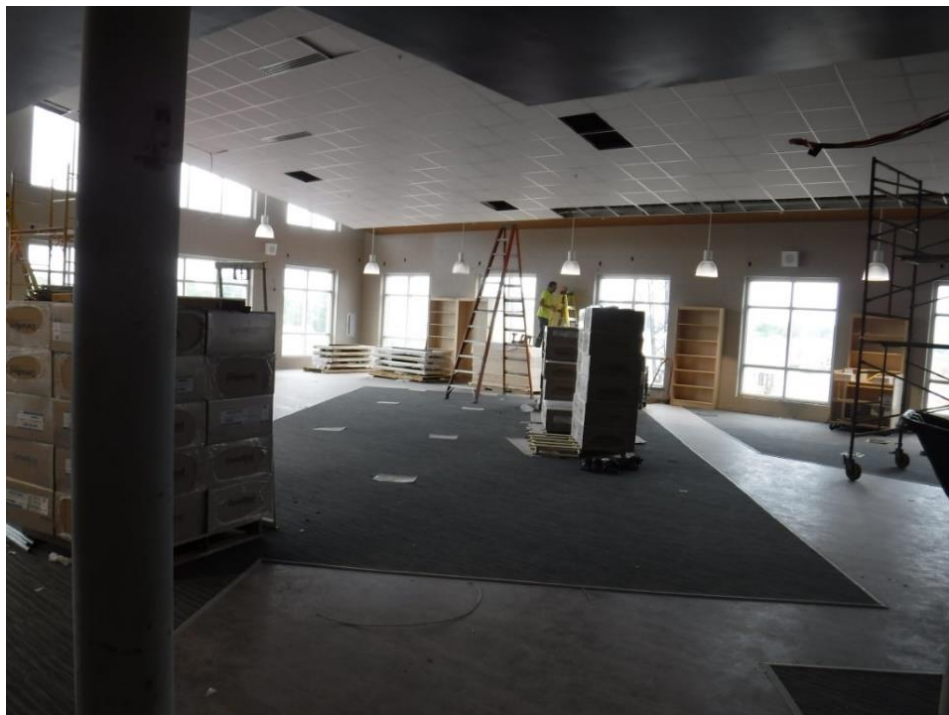
- q) Acoustical ceiling tile has been dropped in the Library/Media Center. The electrician needs clips to install the light fixtures to the grid. These are scheduled to be on site in the next ten days. The lighting must be in place before the library furniture is installed.

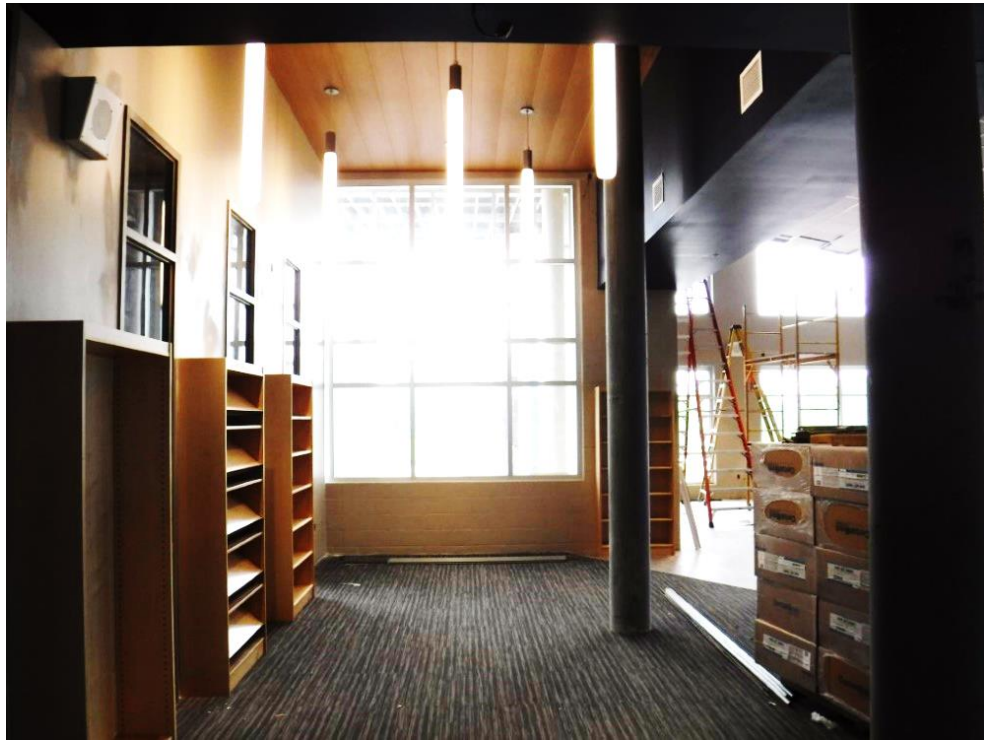
- r) Some of the light fixtures and library furniture is installed under the sheet metal ceilings.

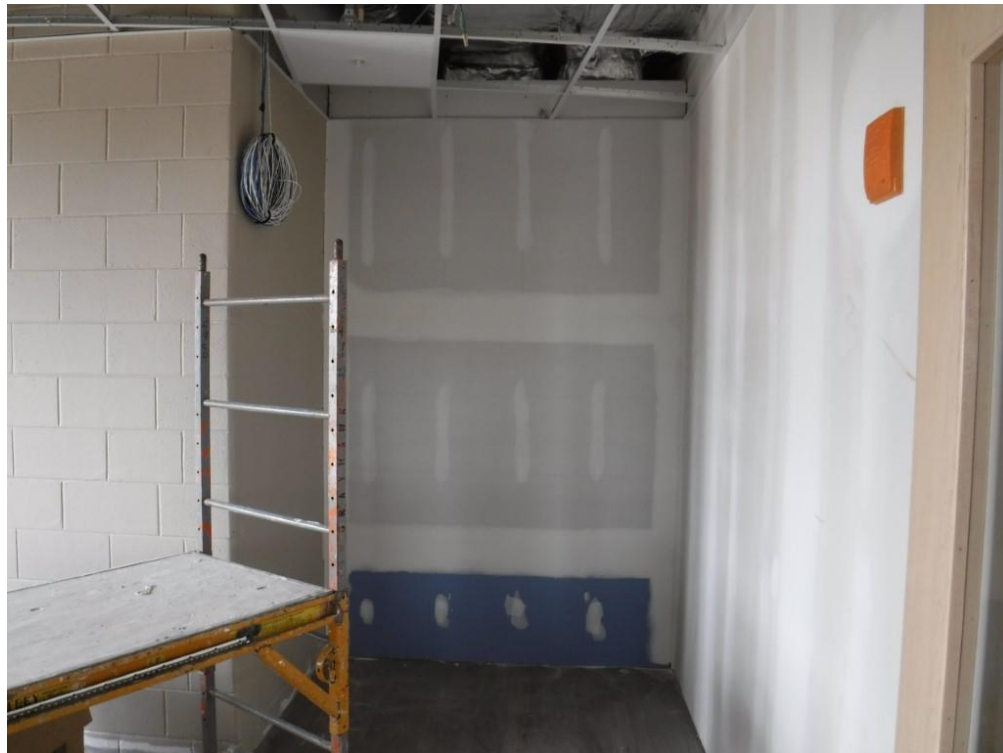
- s) The gypsum board chase wall has been installed to cover the ductwork in the Library Office/ Storage Room.

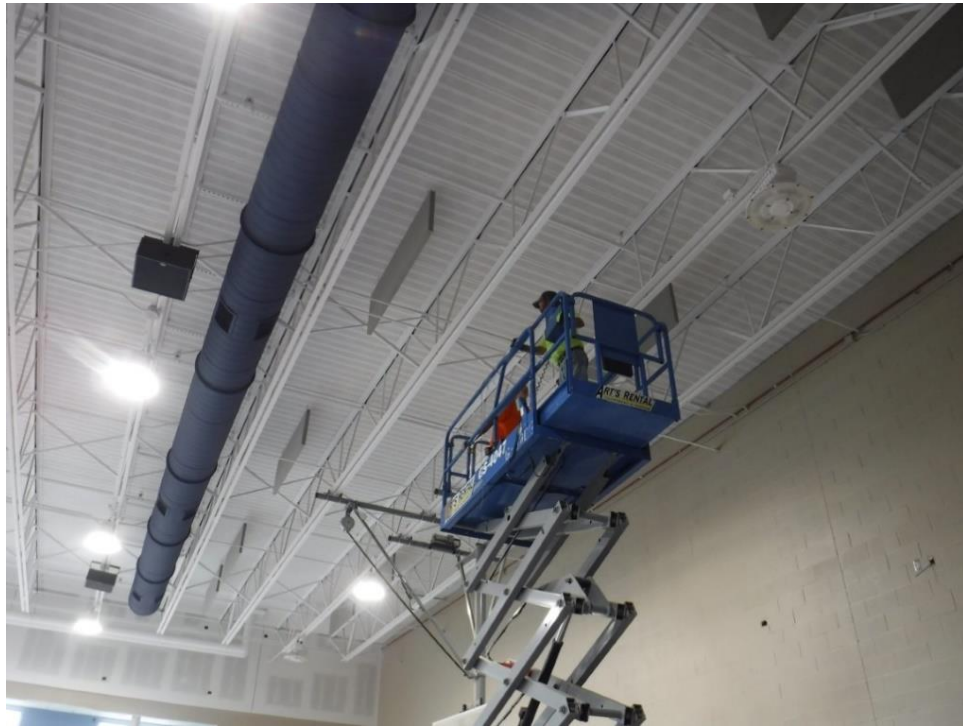
- t) The acoustical panels were being installed in the Cafeteria. After these are completed, the panels will be installed in the Gym.

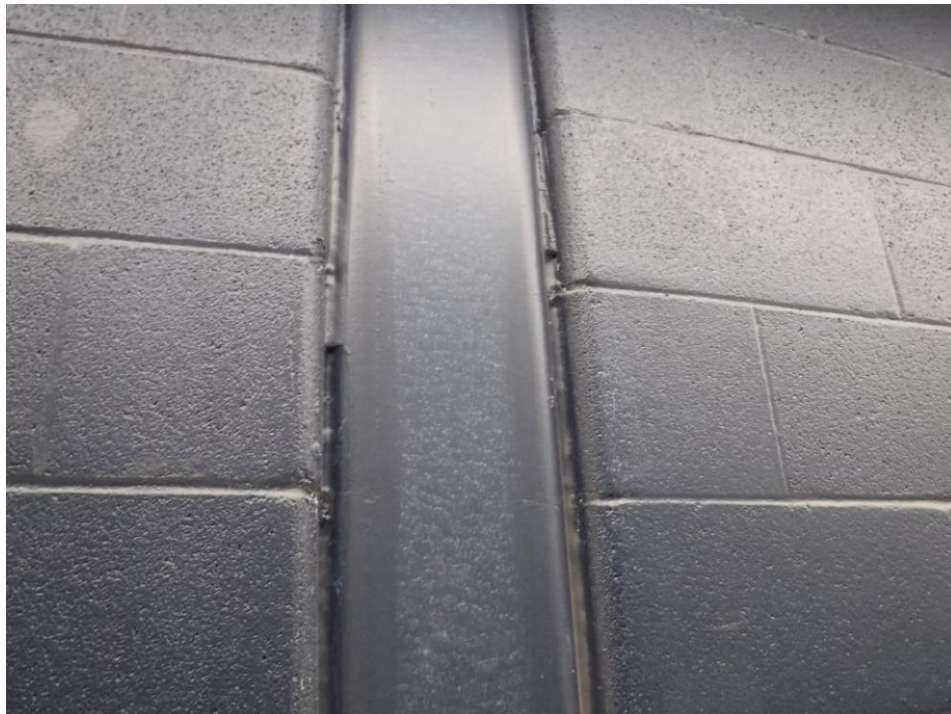
- u) While most of the interior caulking is acceptable, this caulking between the block wall and the steel column is uneven and is not acceptable.

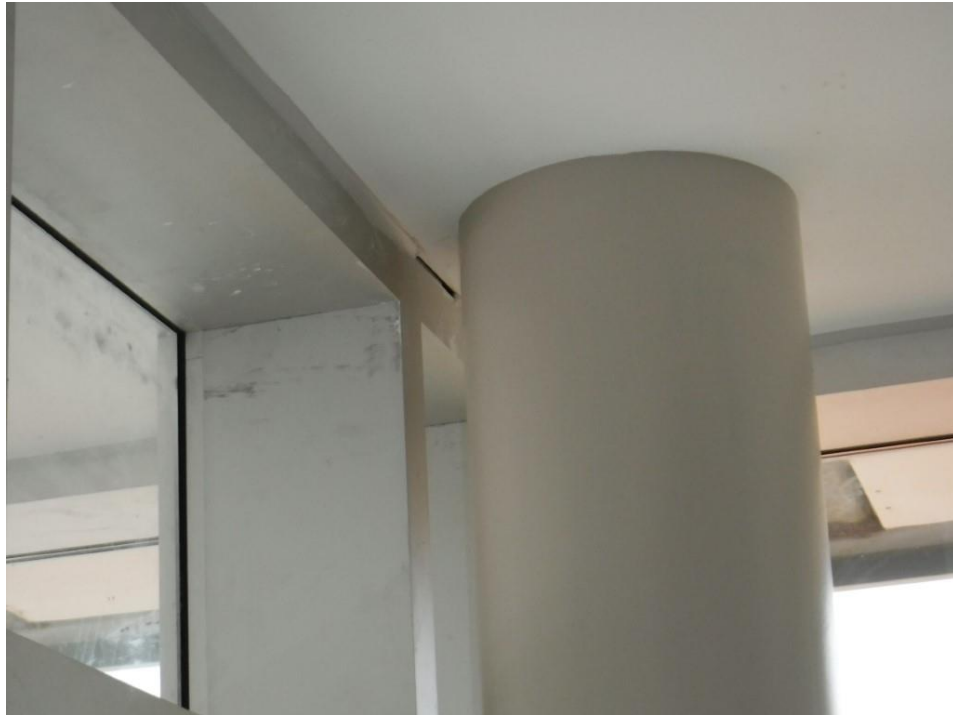
- v) There are visible places where the caulker did not apply caulking. These must be caulked.

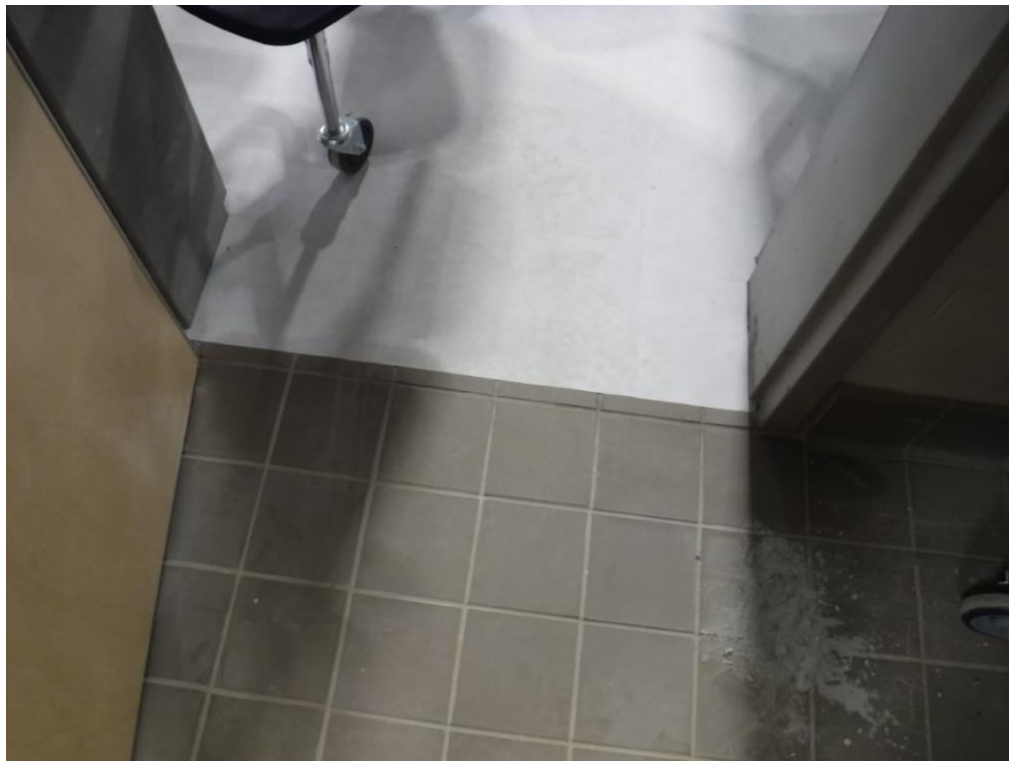
- w) Install the floor transitions between the LVT and the quarry tile at the Kitchen to Cafeteria door openings.

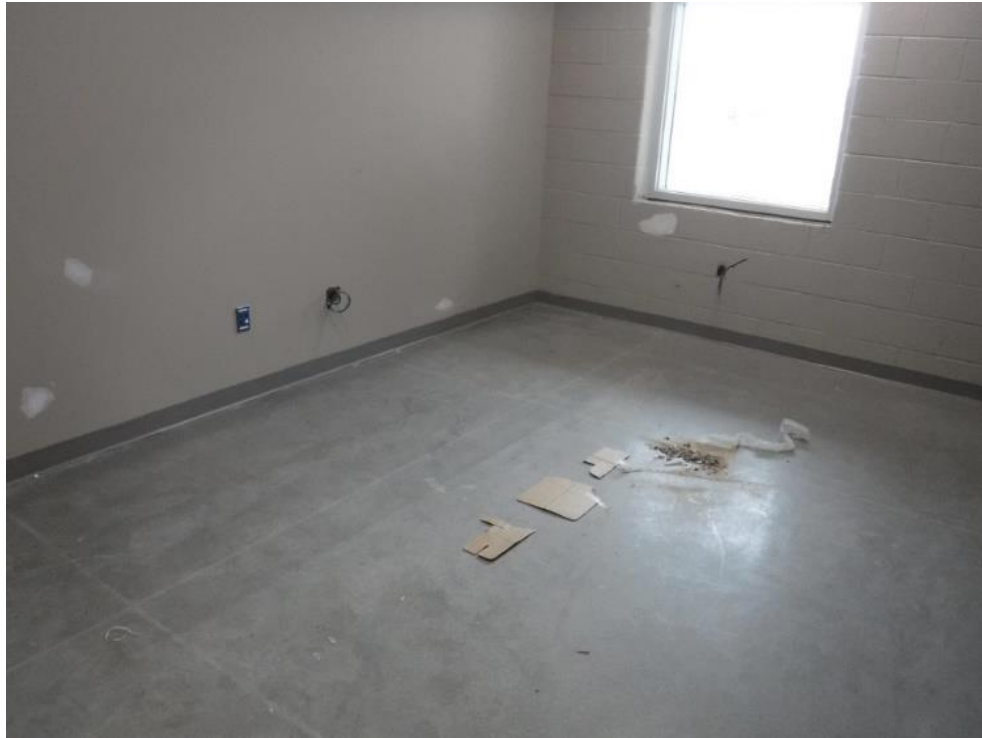
- x) Some slabs on the second-floor in the classroom wing are being repaired by regrouting and regrinding.

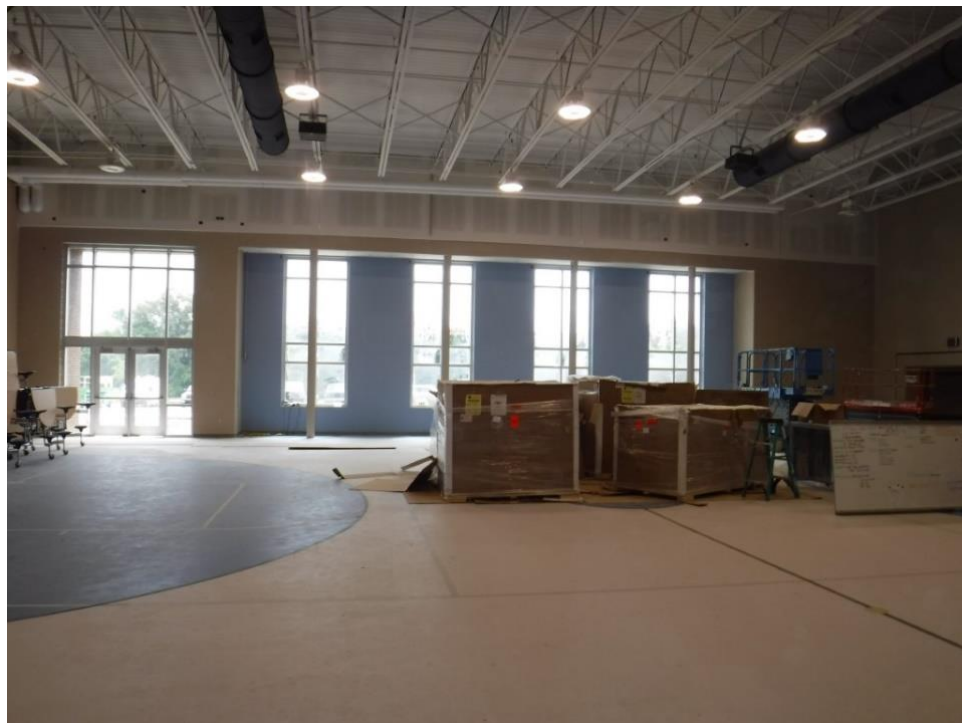
- y) The gypsum board fascia added to cover conduits in the Cafeteria, is ready for paint.

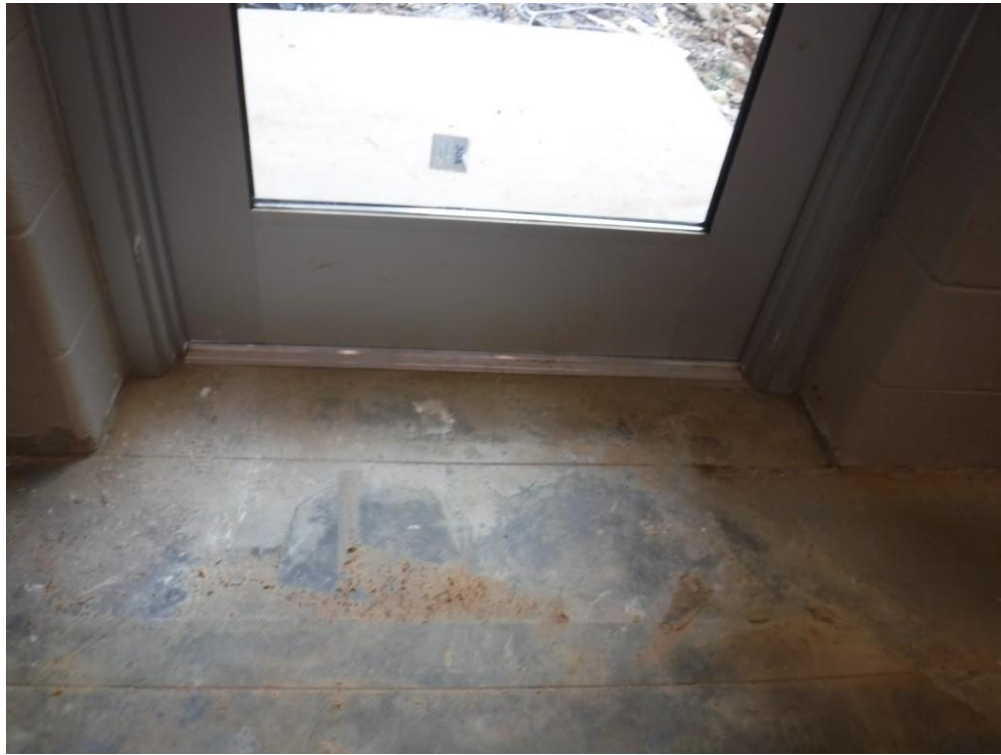
- z) Thresholds under exterior doors such as this one must be light and airtight.

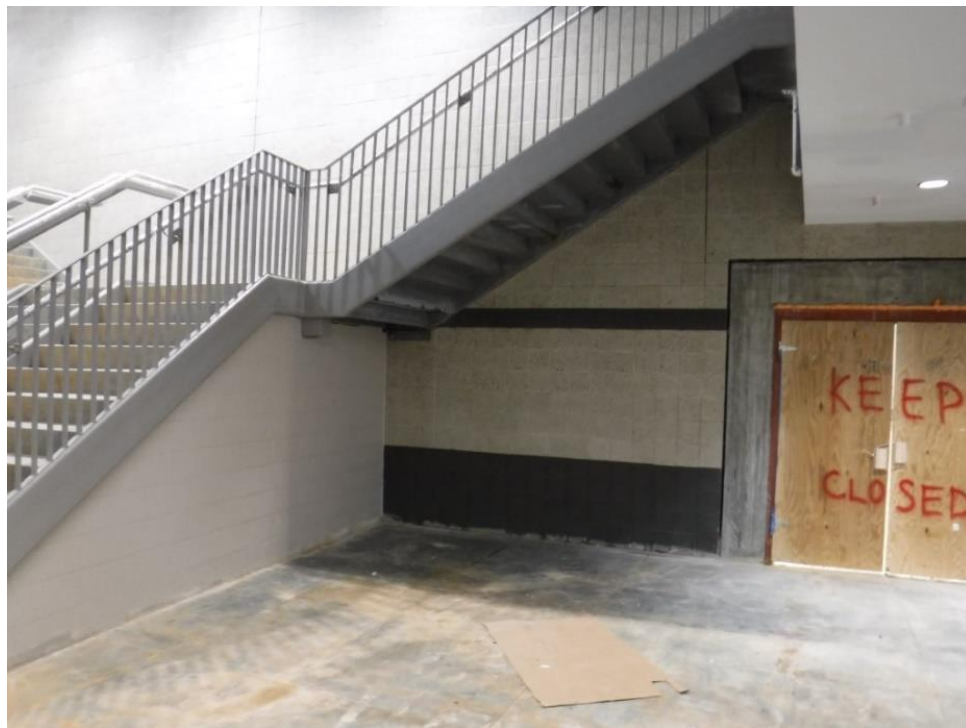
- aa) The concrete arches in the fire wall must be rubbed to create a paintable finish.
