Roof Analysis Report
Woodford County Schools
330 Pisgah Pike
Versailles, KY 40383

Inspection Date: 01/12/21
Building Name: Woodford County High School
Roof Name: Ag Extension Roof
Square Footage: 2,811 sq. ft.
Site Address: 180 Frankfort St. Versailles KY

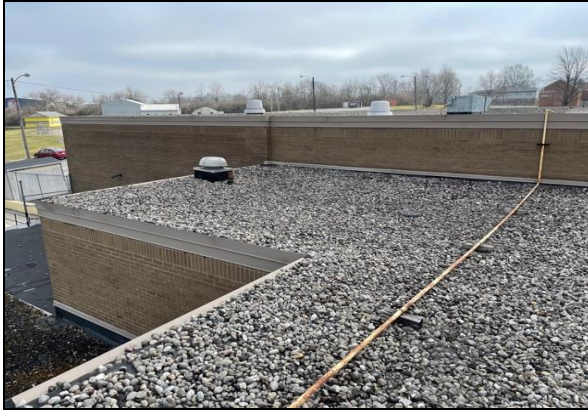
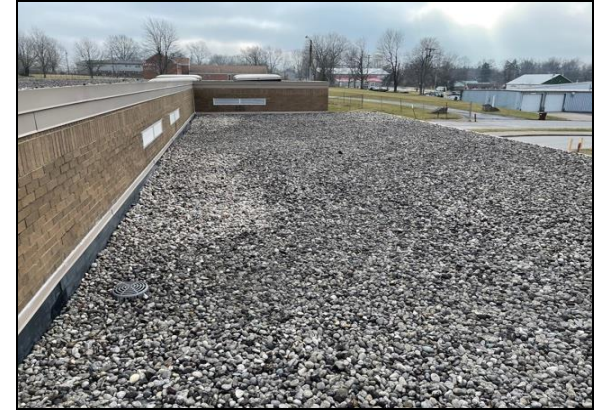
- Counterflashing caulking deteriorating in spots.

Overall the roof is in fair condition. The roof has good slope allowing for good drainage. The flashing at the walls will need to be monitored in years to come to watch for shrinking. Some areas of counterflashing could be re-caulked as a preventative maintenance measure.

- Re-caulk counterflashing in areas where the caulking has deteriorated.

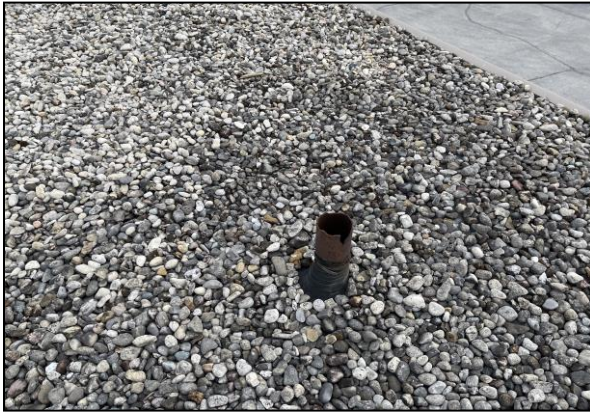
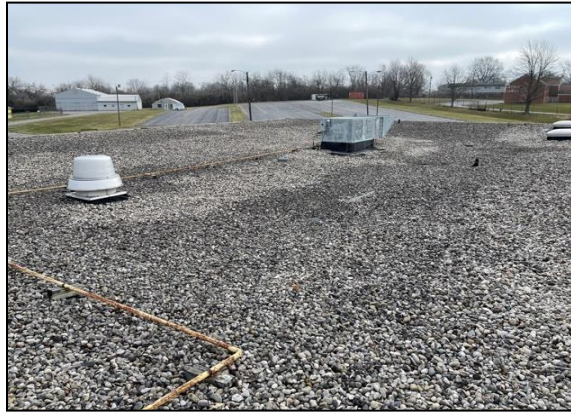
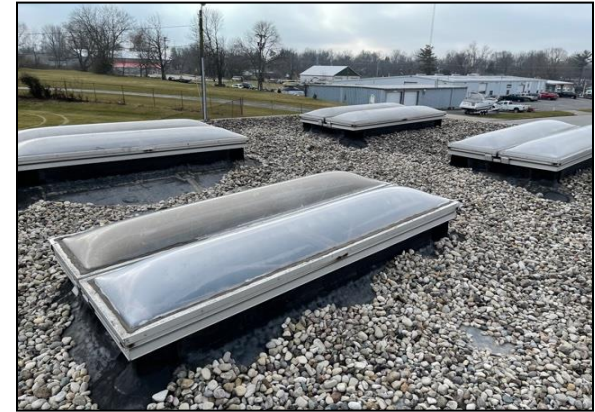
- Flashing at soil stack deteriorated.
- Edge flashing is open in spots.
- Previous repairs around skylights are deteriorating.

Overall the roof is in fair condition for its age. The roof has good slope to the drains. There are some minor maintenance issues that need addressed to extend the life of the roof.

- Rework flashing at the soil stack where previous flashing is deteriorated.
- Strip in edge flashing where EPDM is deteriorated.
- Touch up previous repairs that are deteriorating.

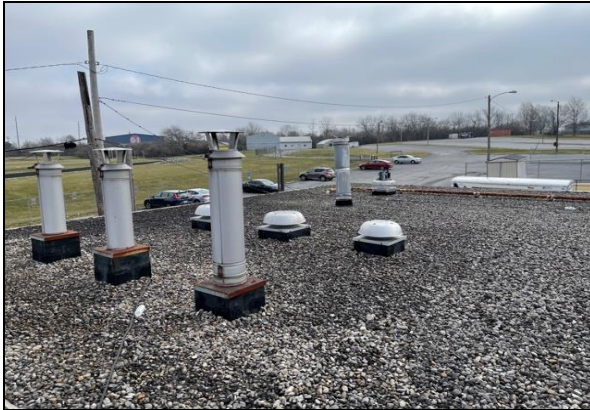
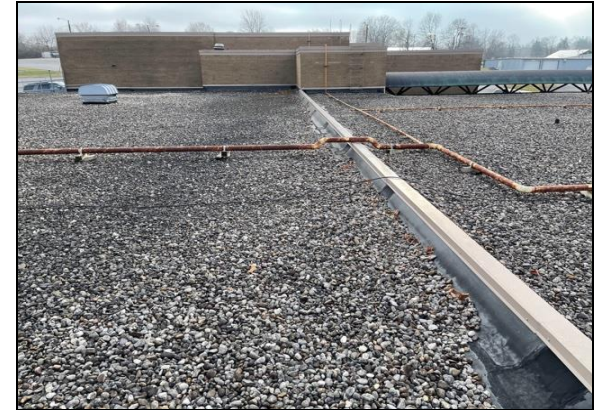
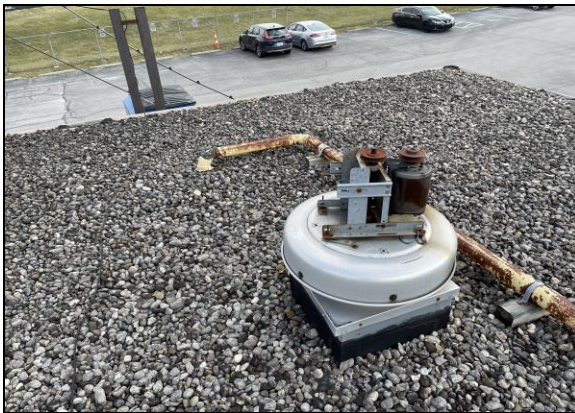
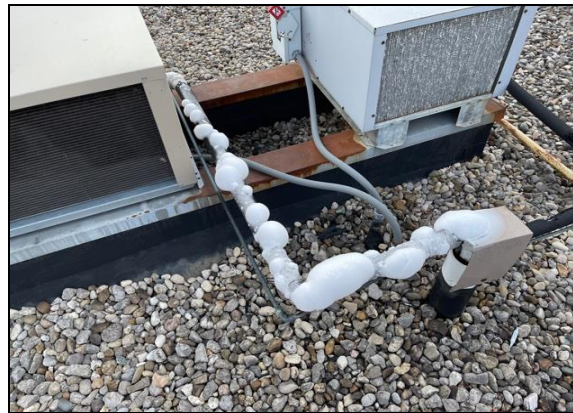
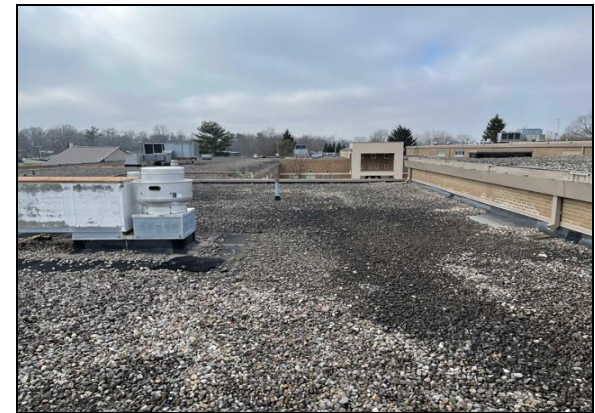
- Major “tenting” in the flashing seen.
- Hood motor is missing a cover.
- HVAC unit on the roof is freezing.

Overall the roof is in fair to poor condition. There is major tenting along the flashing due to shrinkage of the membrane. A moderate amount of repairs have been done on this roof previously due to aging of the roof.

Notes: Replace the roof as budget allows.

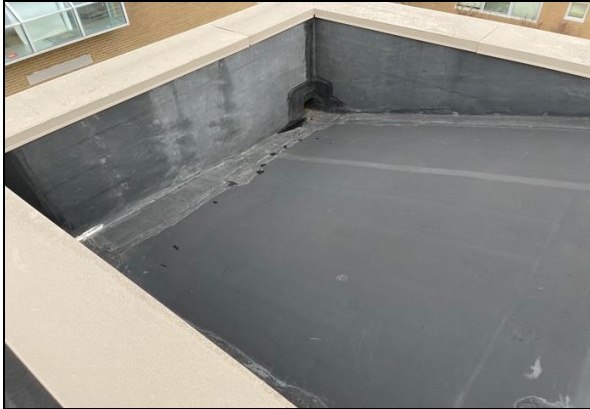
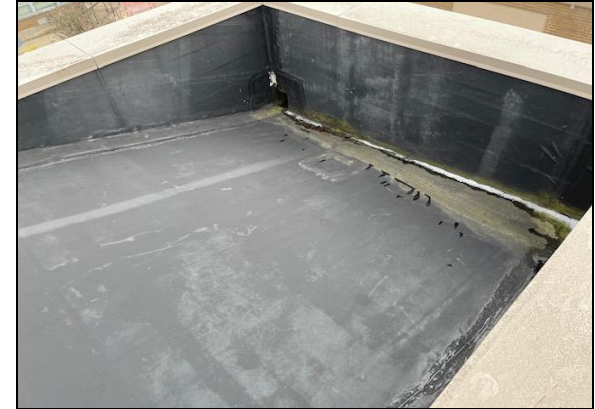
- Minor deterioration in flashing laps.

Overall the roof is in fair condition based on the inspection. The roof has good slope and drainage and is somewhat protected from the environment and would be a good restoration candidate in the future.

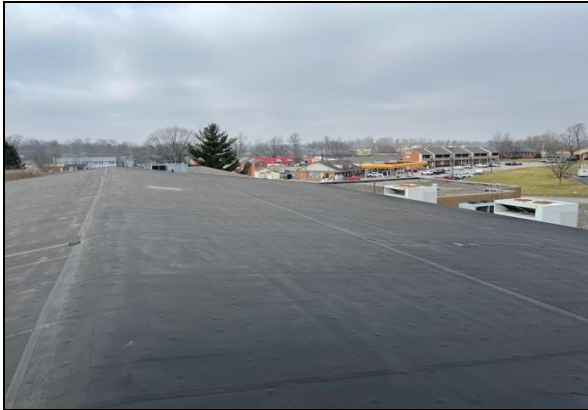
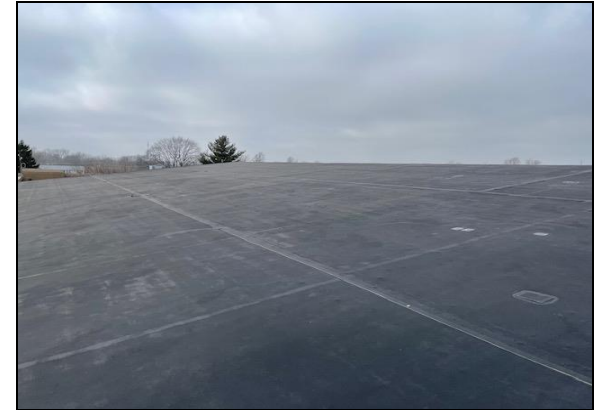
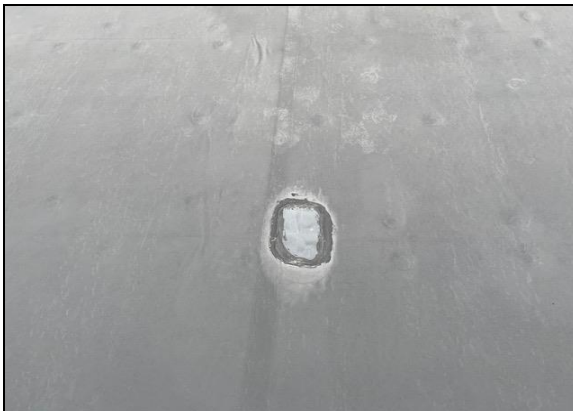
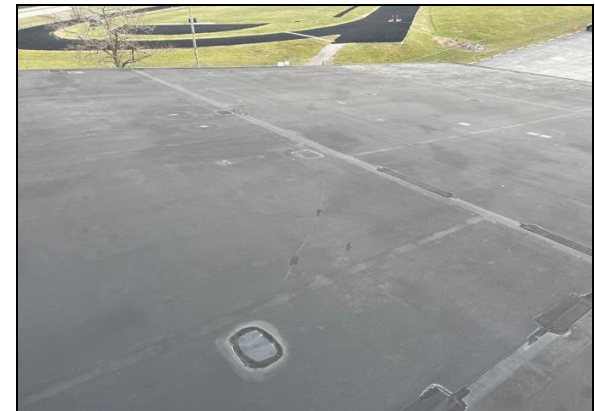
- Previous patches showing signs of minor deterioration.

Overall the roof is in fair condition. The roof good slope. Previous repairs that were done after storm damage need touched up.

- Touch up previous repairs that are deteriorating.

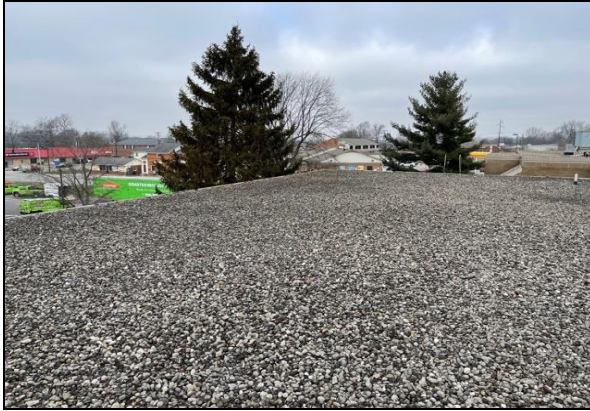
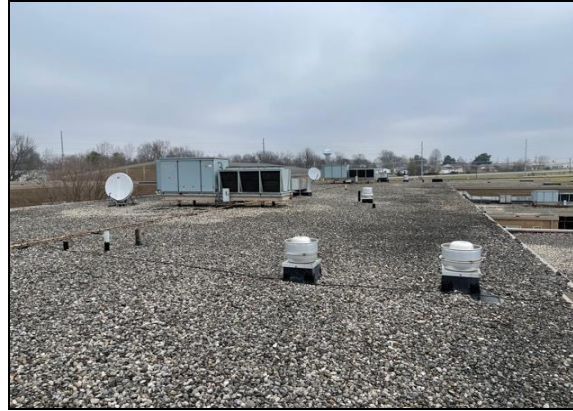
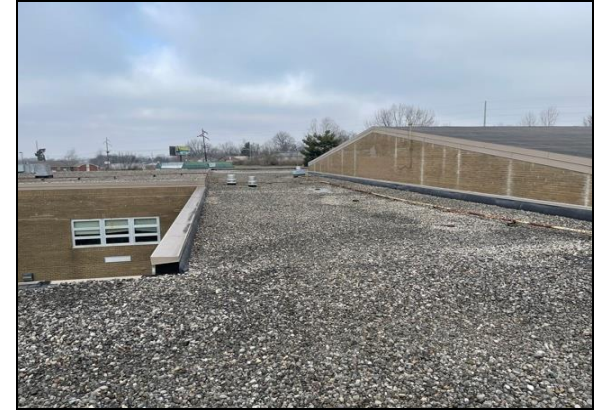
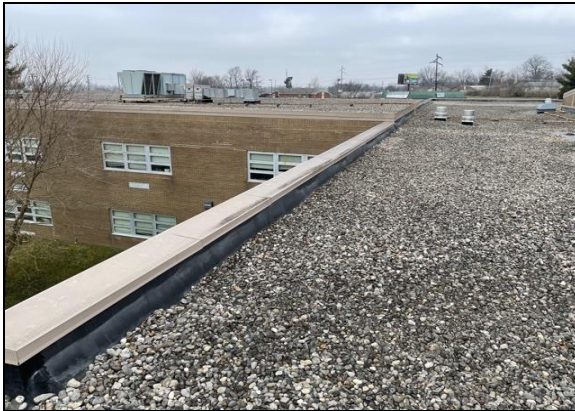
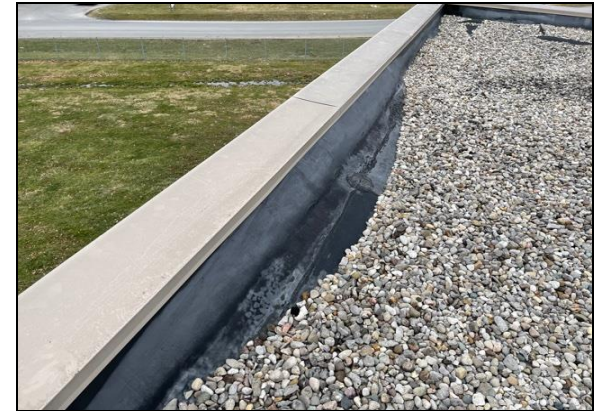
- Edge flashing is pulling.
- Major tenting on multiple walls and flashing.
- Flashing at unit is deteriorated.

Overall the roof is in poor condition. There are major tenting issues that need addressed along with membrane issues along the edge. This roof is near the end of its service life.

- Cut and relax all tenting along the flashing.
- Strip in the edge of the membrane where it is deteriorated.
- Make repairs to deteriorated membrane around units.

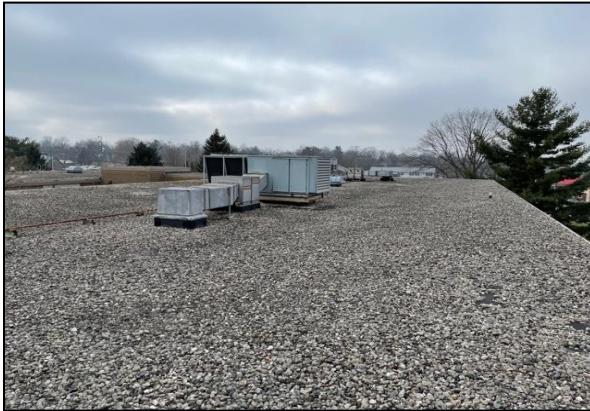
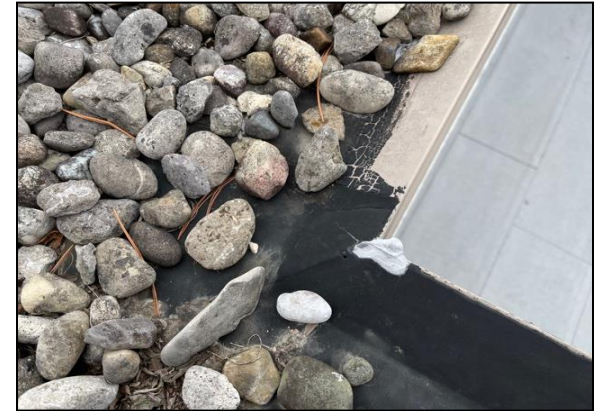
- Vegetation growing on the roof.
- Corner of the membrane has a hole.
- Lots of previous repairs around units on the roof.

Overall the roof is in fair/poor condition. The roof has had many previous repairs based on leaks and there is a hole in the membrane currently. There is also a fair amount of moss growing on the roof.

- Repair the hole in the membrane to keep moisture out of the roof.
- Touch up previous repairs.

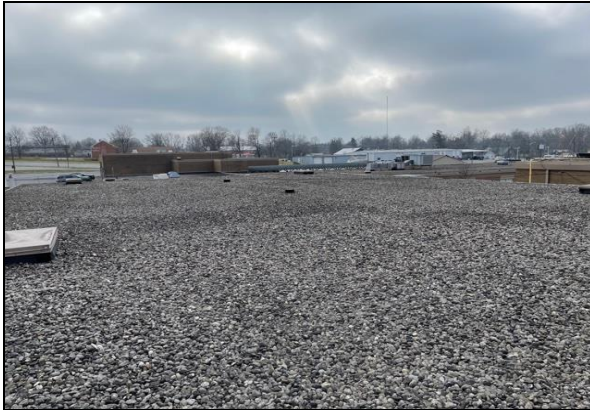
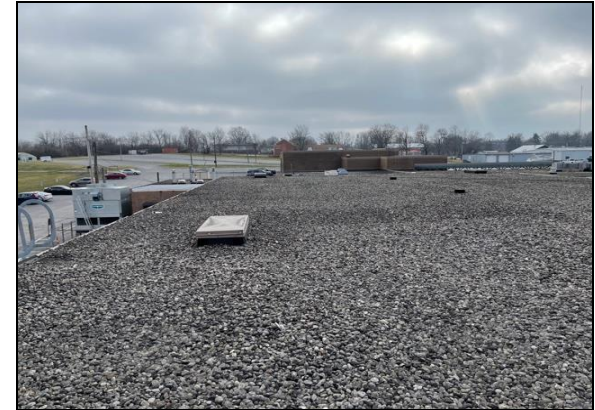
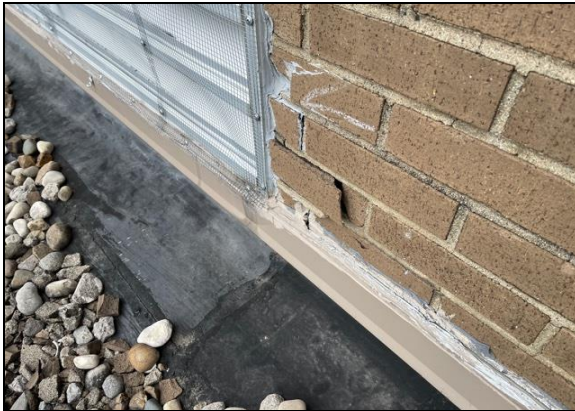
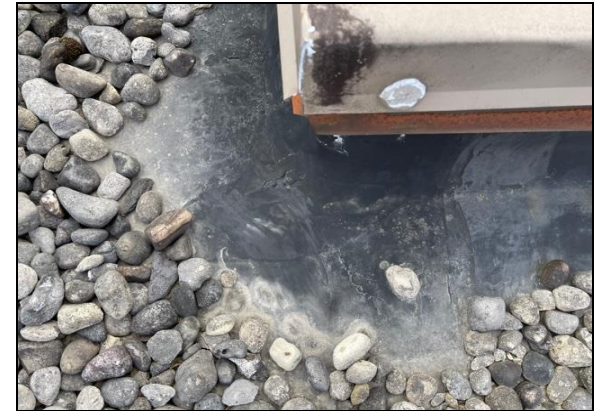
- Flashing membrane is open.
- Brick and mortar is deteriorating in spots.
- Old penetrations not in use on the roof.

Overall the roof is in fair/poor condition. The membrane is showing signs of deterioration in the flashing. The old penetrations on the roof that aren't in use should be removed from the roof during replacement.

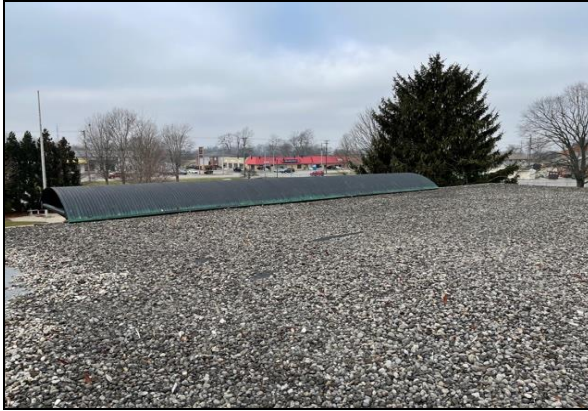
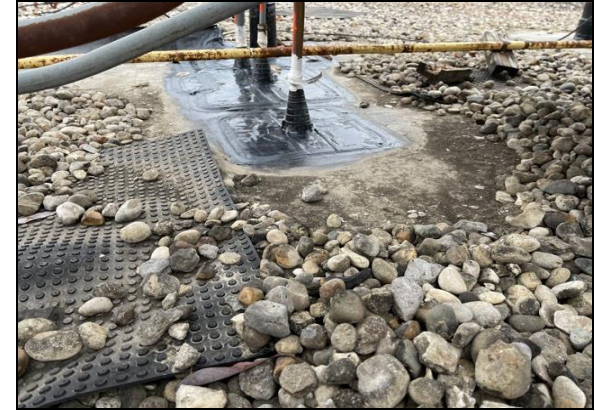
Overall the roof is in fair/poor condition. There is major tenting along the flashing, along with poor drainage and areas that have had multiple repairs done recently.

Notes: Replace the roof as the budget allows.

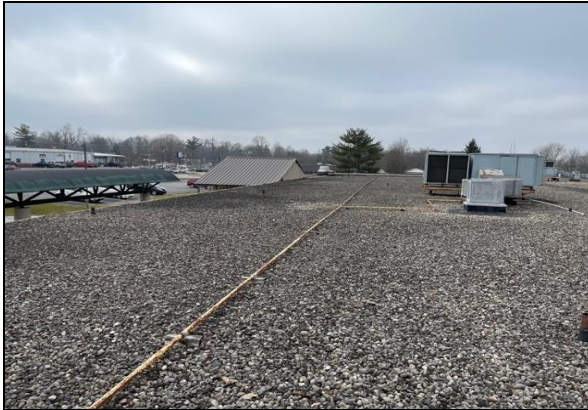
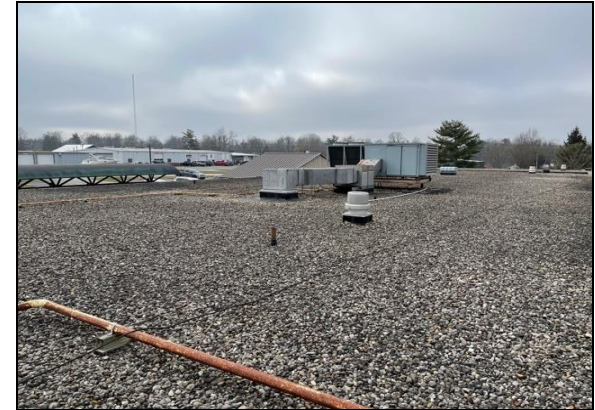
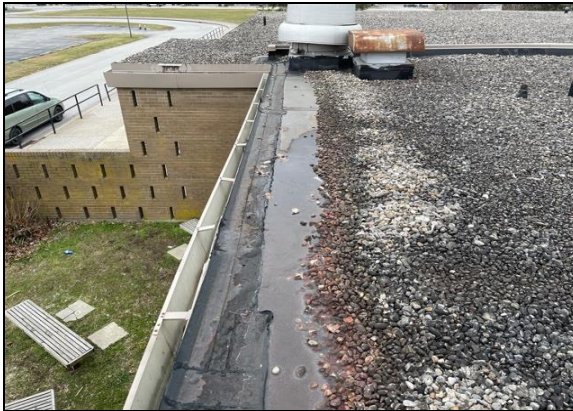
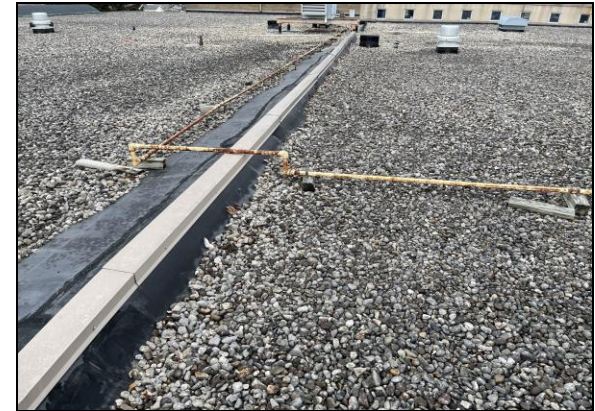
- Major tenting noted at wall flashings.
- Edge membrane is deteriorating.
- Ponding along the edge of the roof.

Overall the roof is in fair/poor condition. The roof has major tenting along wall flashings, along with ponding and edge membrane deteriorating.

- Cut and relax areas of flashing where tenting is occurring.
- Strip in the edge of the roof with EPDM where the cover strip is deteriorating.
