## FIELD OBSERVATION REPORT

East Hardin Middle School, Hardin County Schools, Elizabethtown, KY 201752.01 - CA8

Date: 8/5/2021

Report No: 62

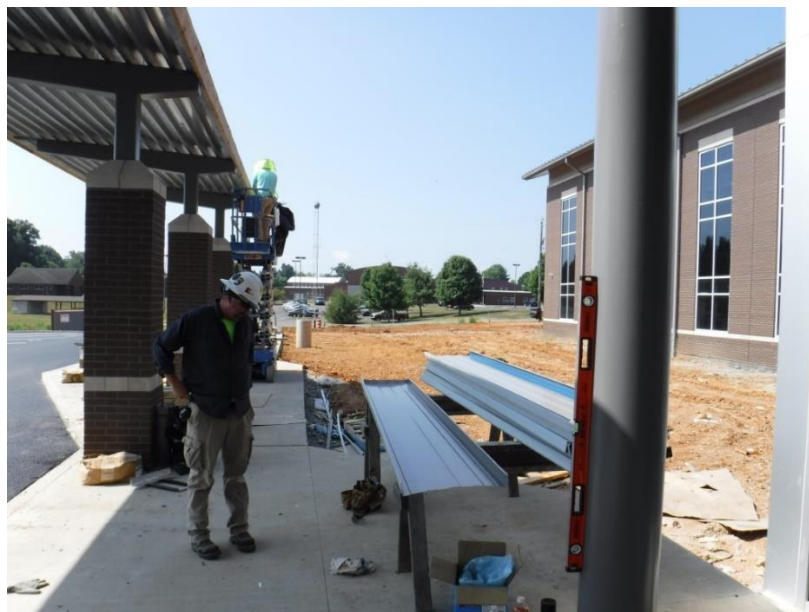
- b) Kalkreuth must complete the bus loading canopy.

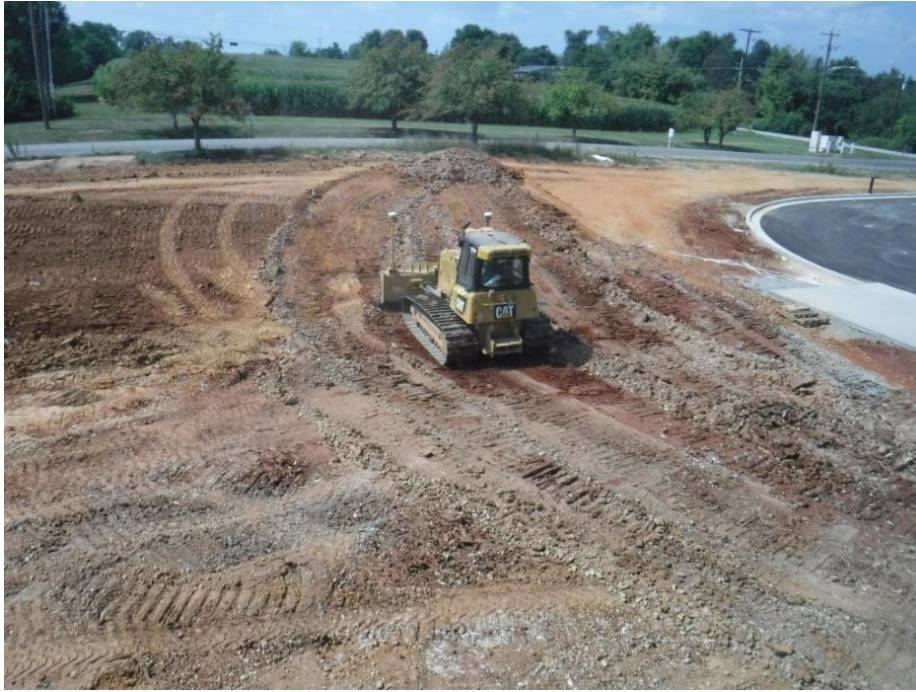
- c) The lawn area to the south of the site is one of the last areas to be brought to finished grade. Once grade is established, topsoil needs to be spread and then the lawn seeded and sodded.

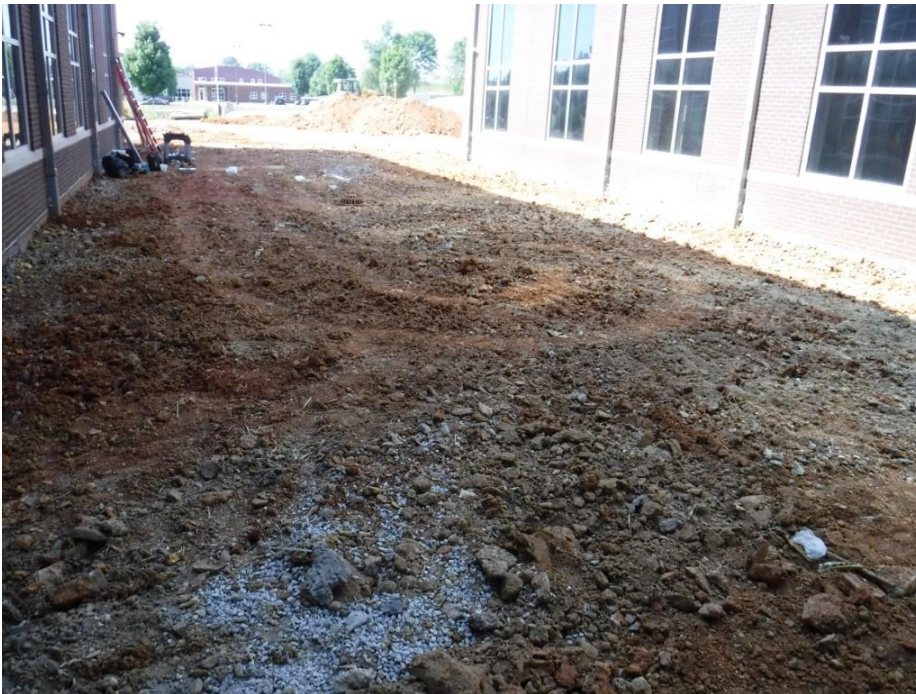
- d) The area between the classroom wings has been rough graded after the storm piping was installed. The landscaper must apply the topsoil and the lawns in these areas.

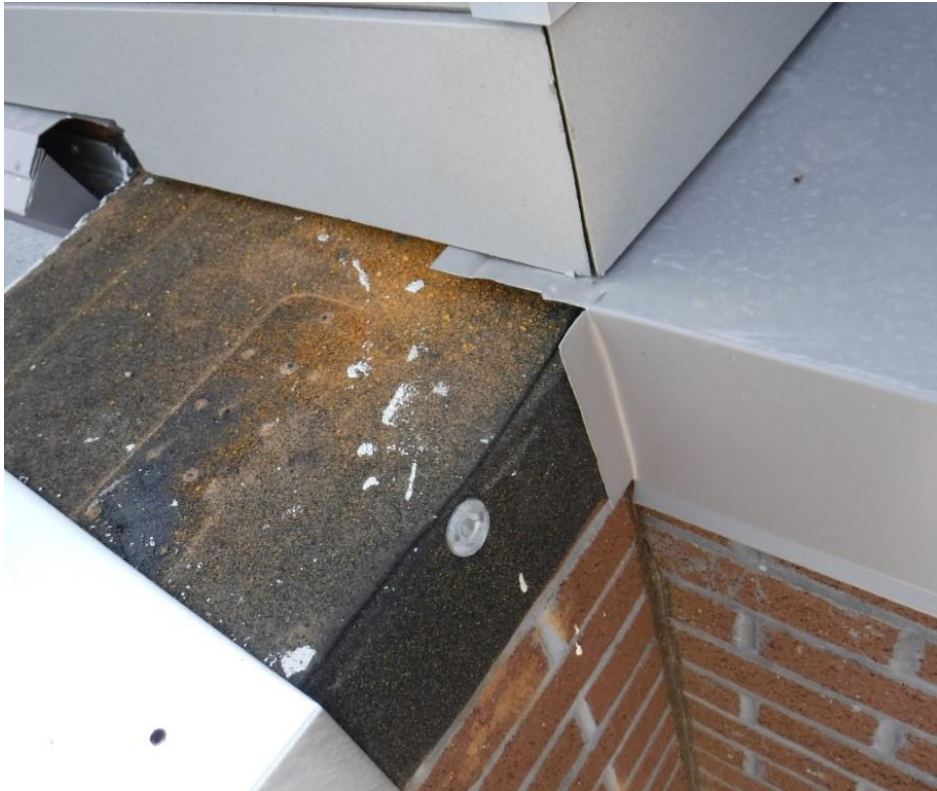
- e) Kalkreuth must complete trim work such as these copings. Dixie Exteriors must install a flashing through the spray insulation to the block wall backup wall. Kalkreuth can then extend the copings over these flashings.

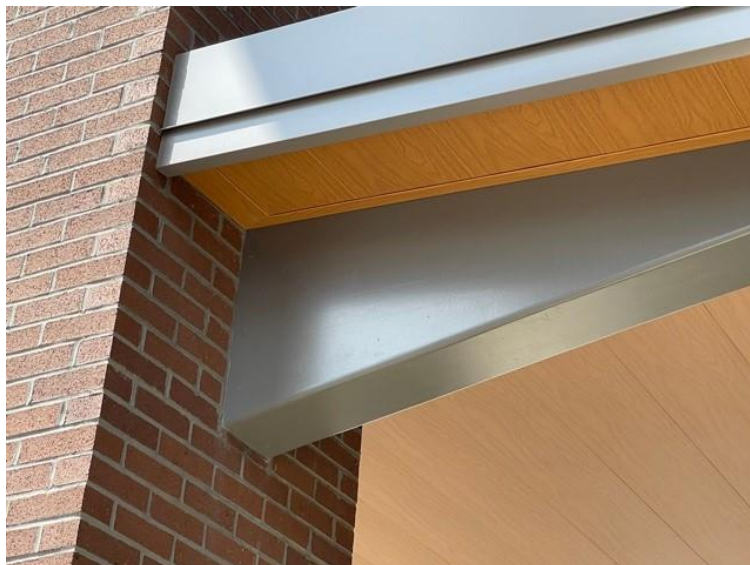
- f) The joint between the brick pier and the structural steel canopy support has a mortar joint. As temperature change the steel will expand at a different rate than the masonry. The mortar must be removed in the joint between the steel and masonry and a soft sealant joint installed.

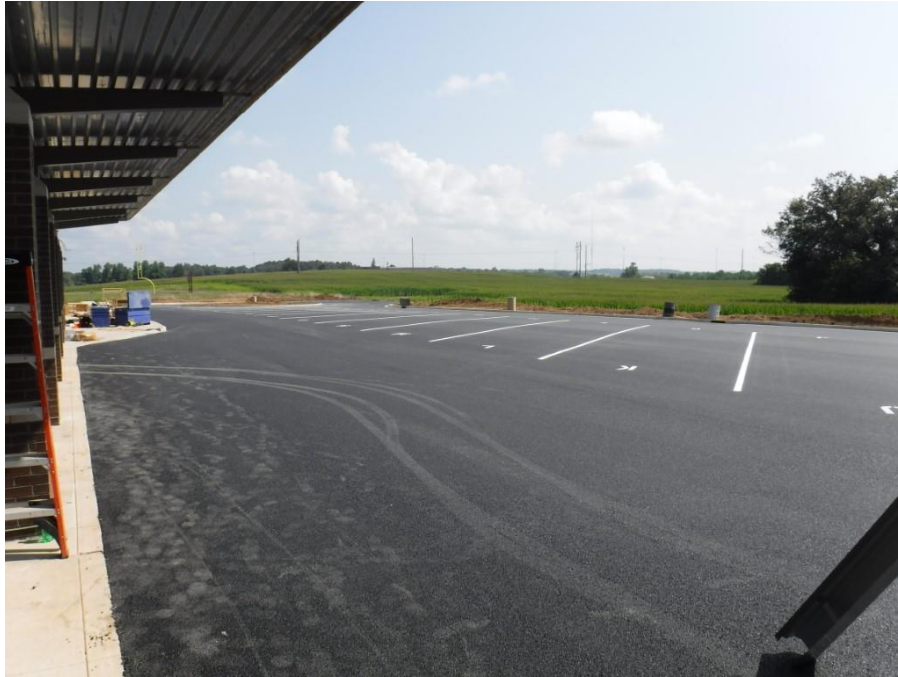
- g) The rear parking area has been paved and striped. The light pole bases are in place but the wiring has not been pulled and the poles and fixtures installed. The electrician must put protection board down before they run their trucks on the paving.

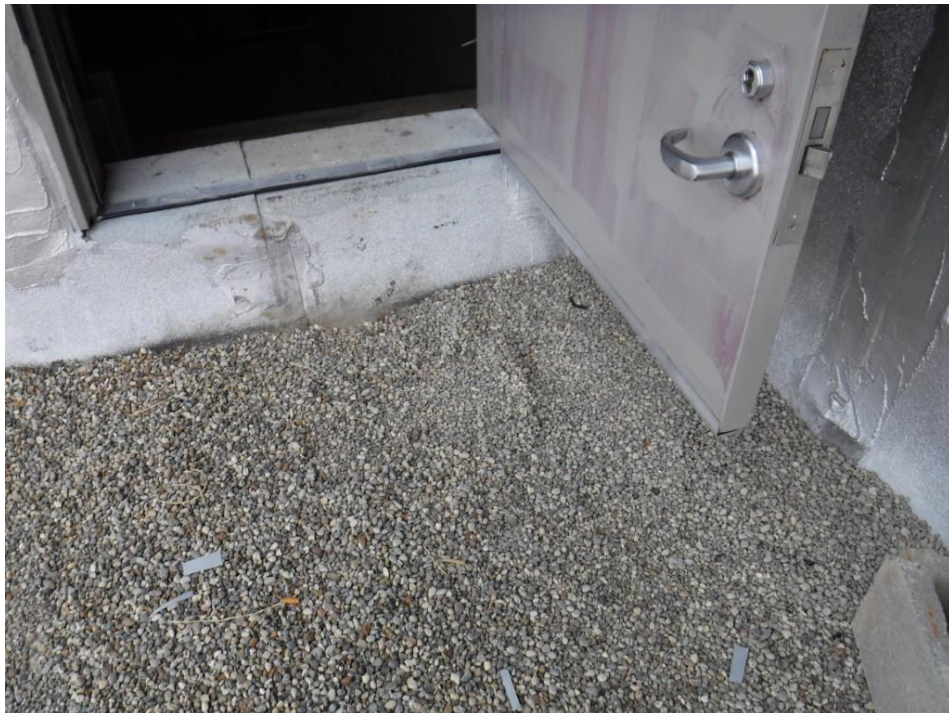
- h) A temporary weatherstrip was installed at the door to the kitchen roof. A door bottom was installed on the door. The cut hollow metal frame must be repaired with the same section as the rest of the frame. The door will need to be cut to fit in the frame. The hinge needs to be changed to a continuous hinge.

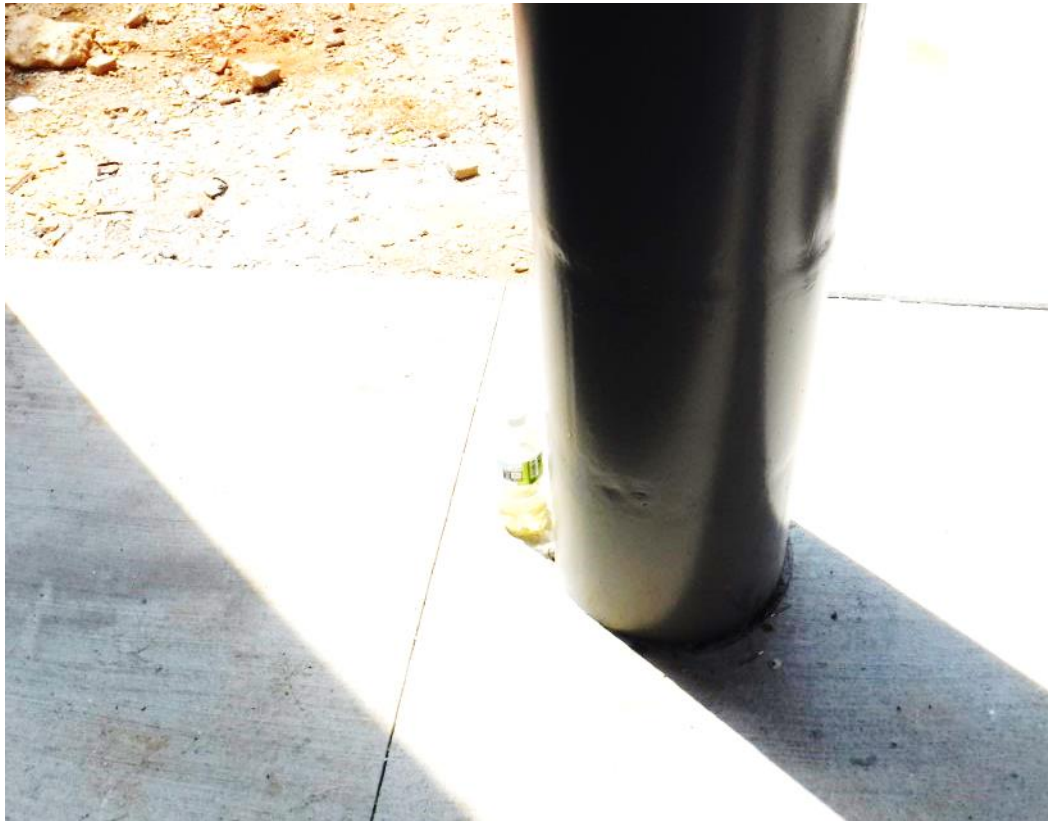
- i) The structural steel pipe columns at the main entrance are not continuously smooth. Body filler must be applied to the rough joints near the bottom and tops, sanded and repainted to create a smooth continuous appearance.

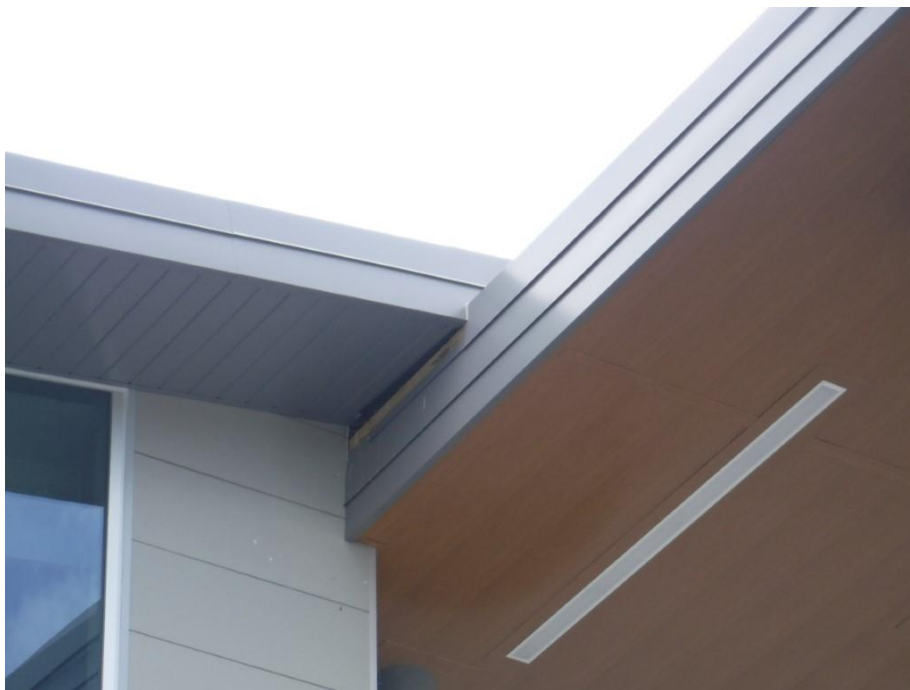
- j) Kalkreuth needs to install all metal trim such as the missing piece at the main entry.

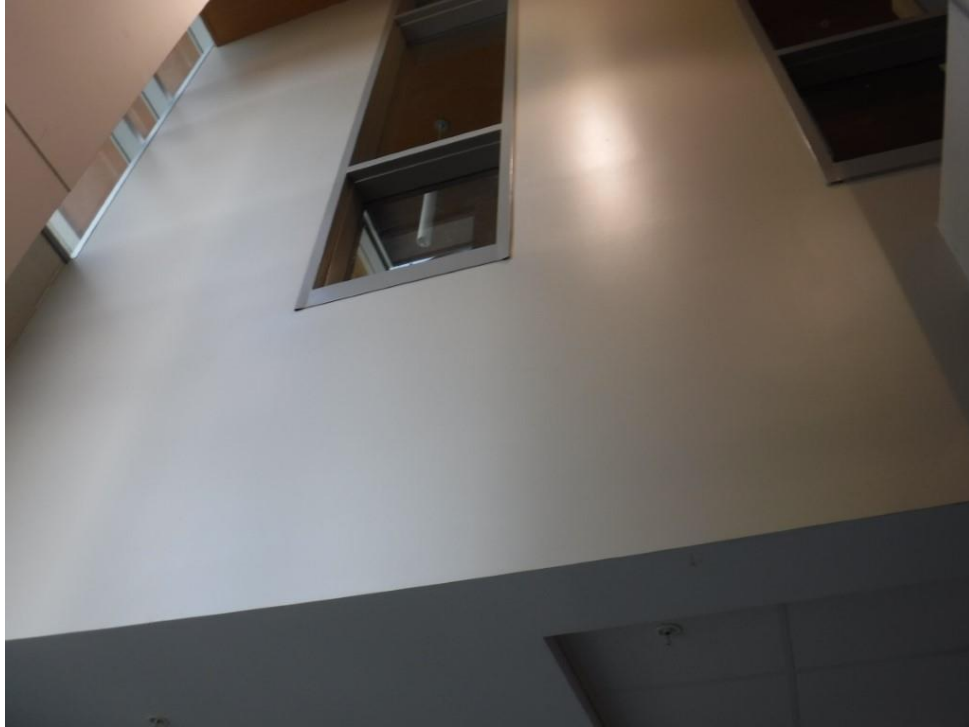
- k) The sill of the first window at the entry is bent in at the bottom. This must be straightened so the frame matches the other window frames.

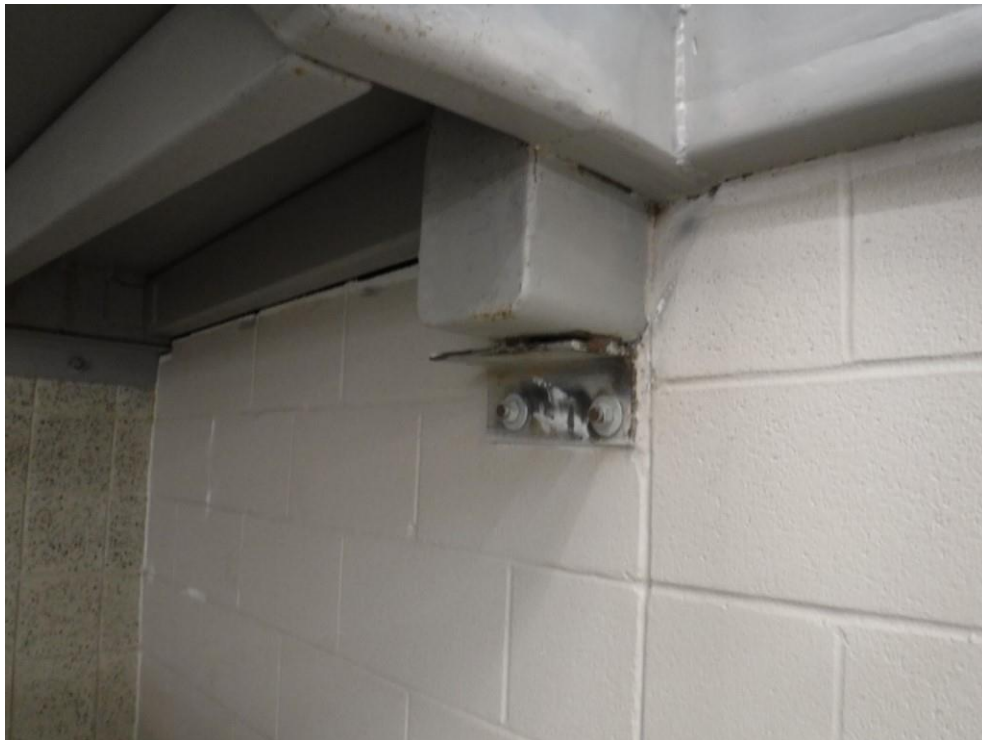
- l) At the middle stair in the main corridor, this angle and the bolts create a hazard to the building occupants. It must be covered, and the cover painted to match the stair.

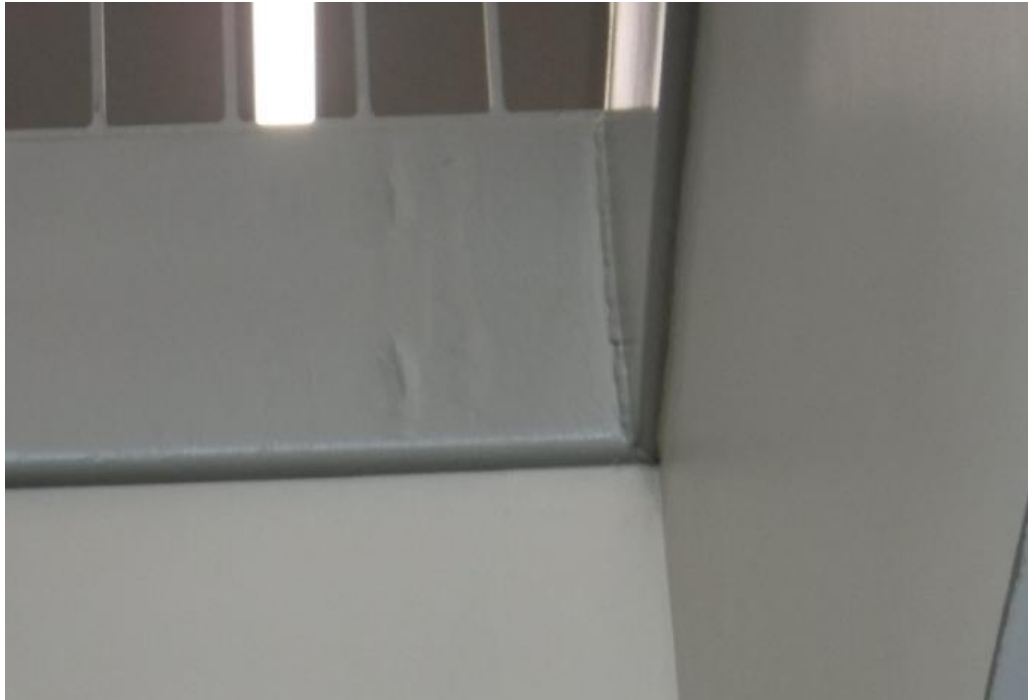
- m) Dents in structural steel and stair components such as these, must be filled with body filler and sanded smooth.

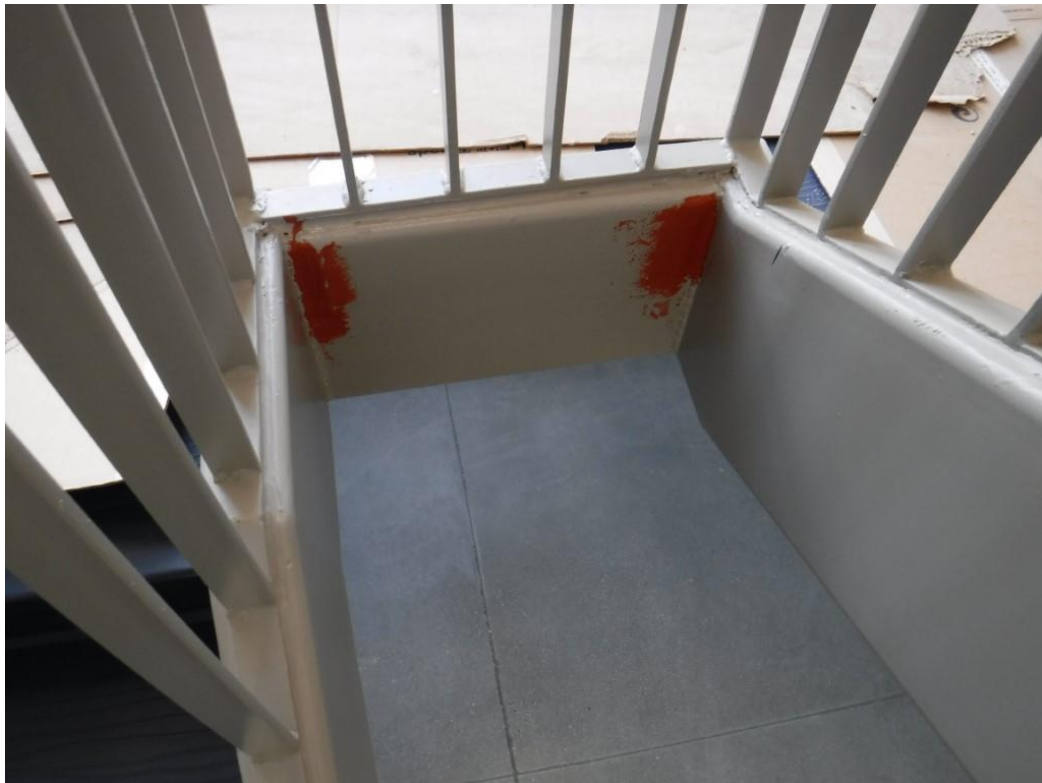
- n) All body filler must be sanded smooth and painted.

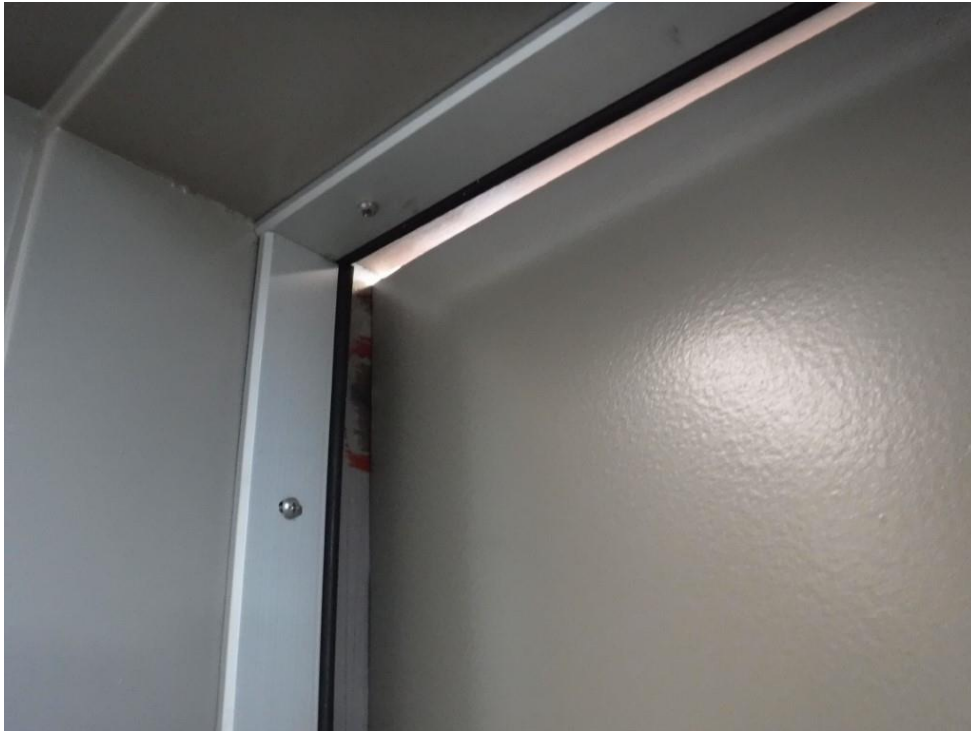
- o) Exterior hollow metal doors must not bind on the frames and must be able to be closed by the closer with the specified pressure.

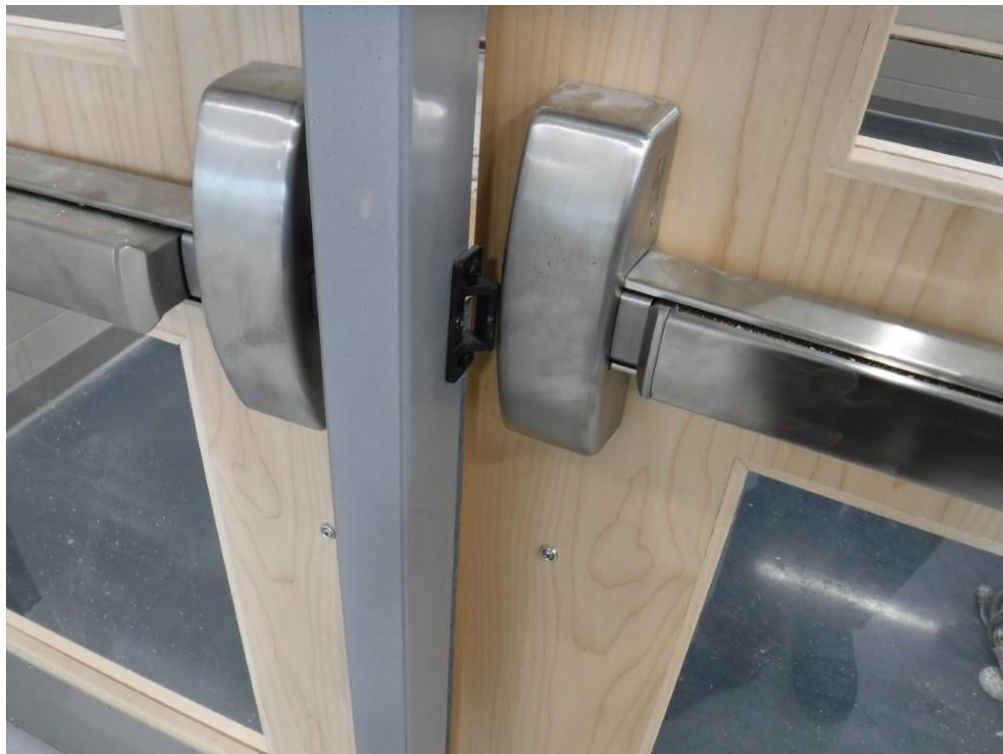
- p) All wood doors such as these at the cafeteria must close without binding on the frames.

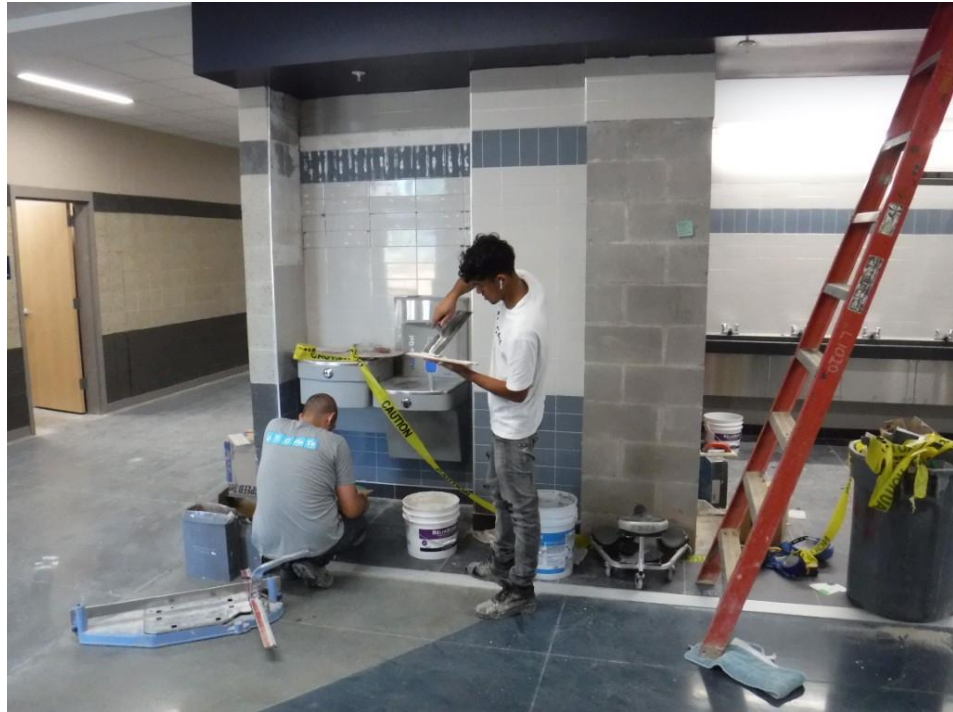
- q) The revised blue band tile must be straight and intersect with the dark ground faced block at the same elevation.

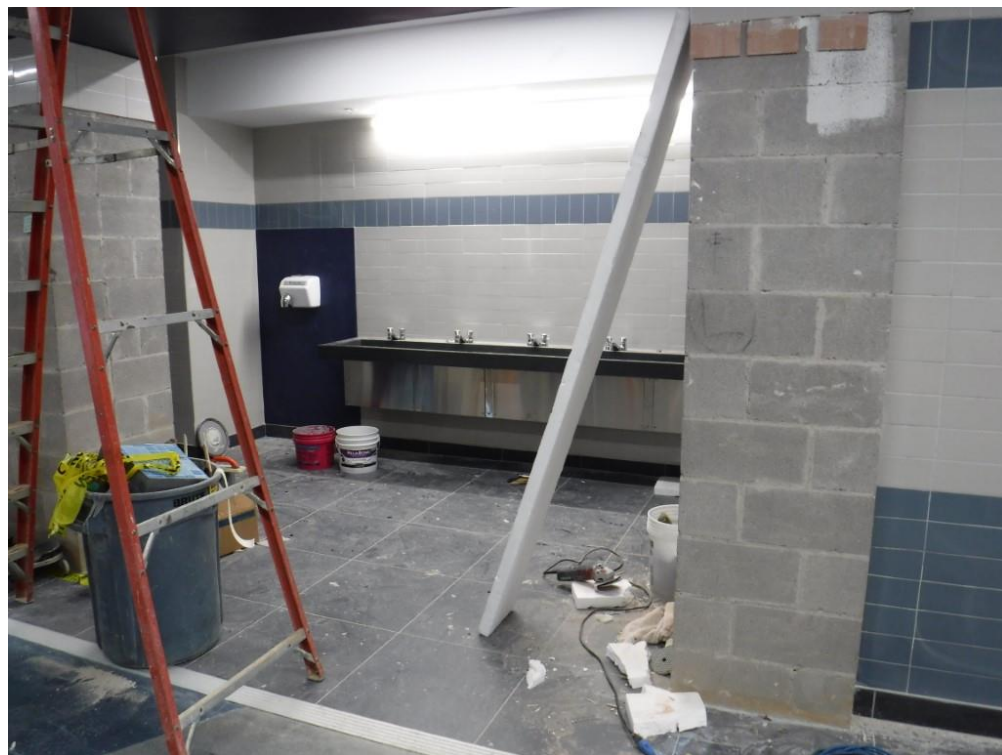
- r) The PR included raising the height of the blue tile above the wash station to match the raised blue band on the corridor walls. The blue band must be raised as indicated on the PR drawing.

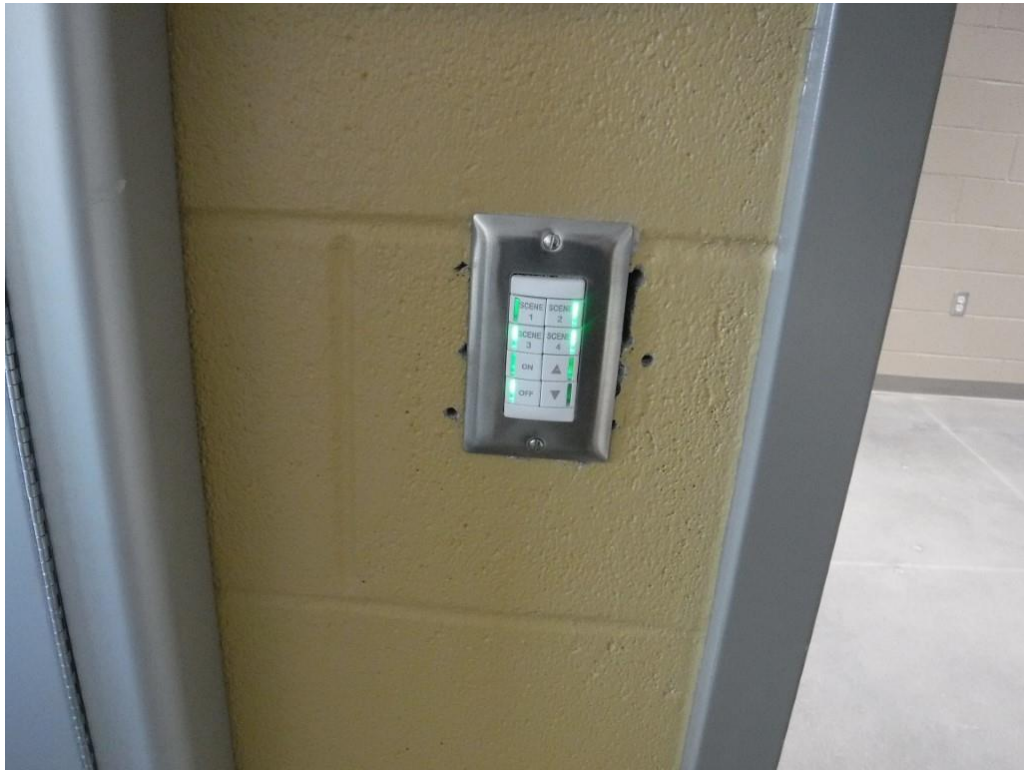
- s) All device plates must completely cover the opening in the block or drywall wall.

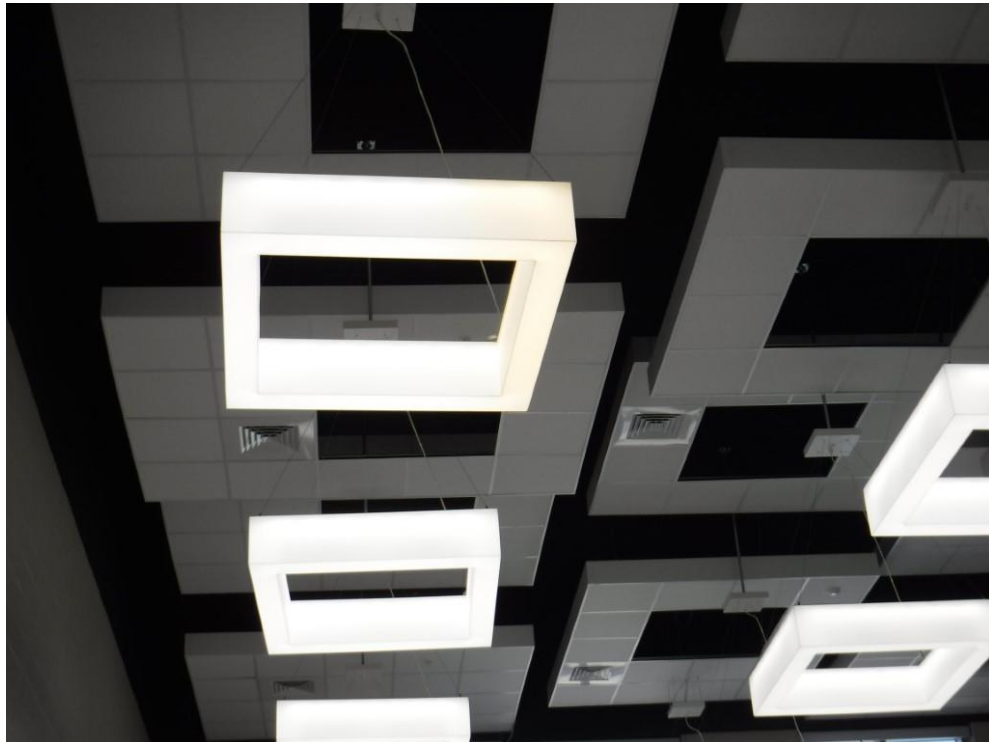
- t) The fixture in the foreground is dirty and must be cleaned or replaced.

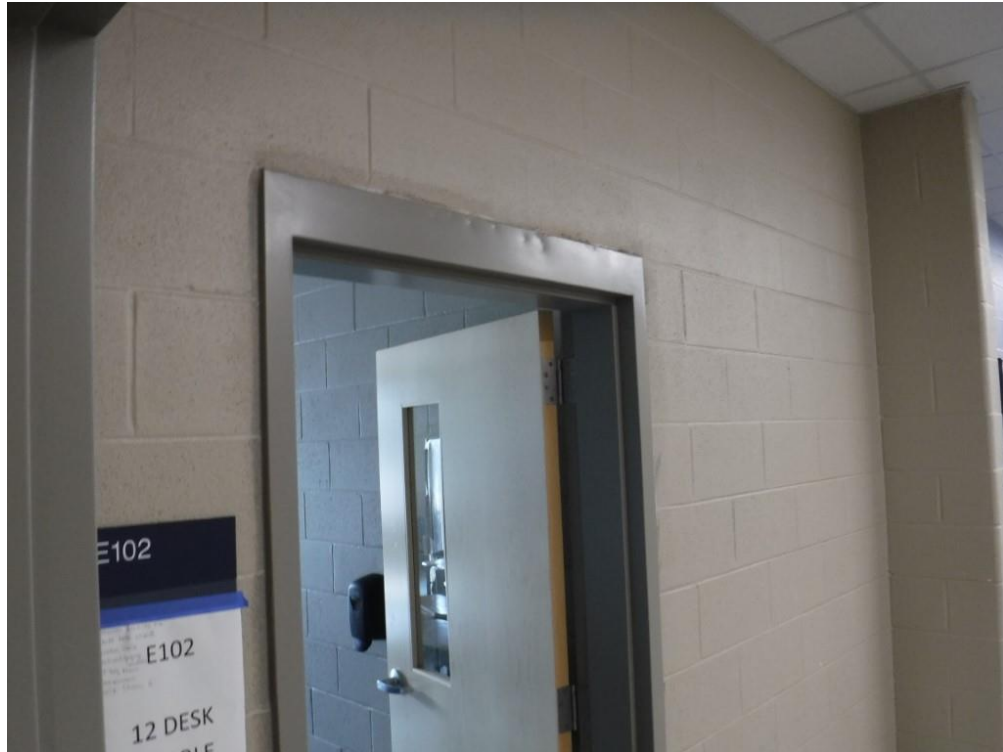
- u) This frame and several others have dents that must be corrected by applying body filler, sanding and then painting.

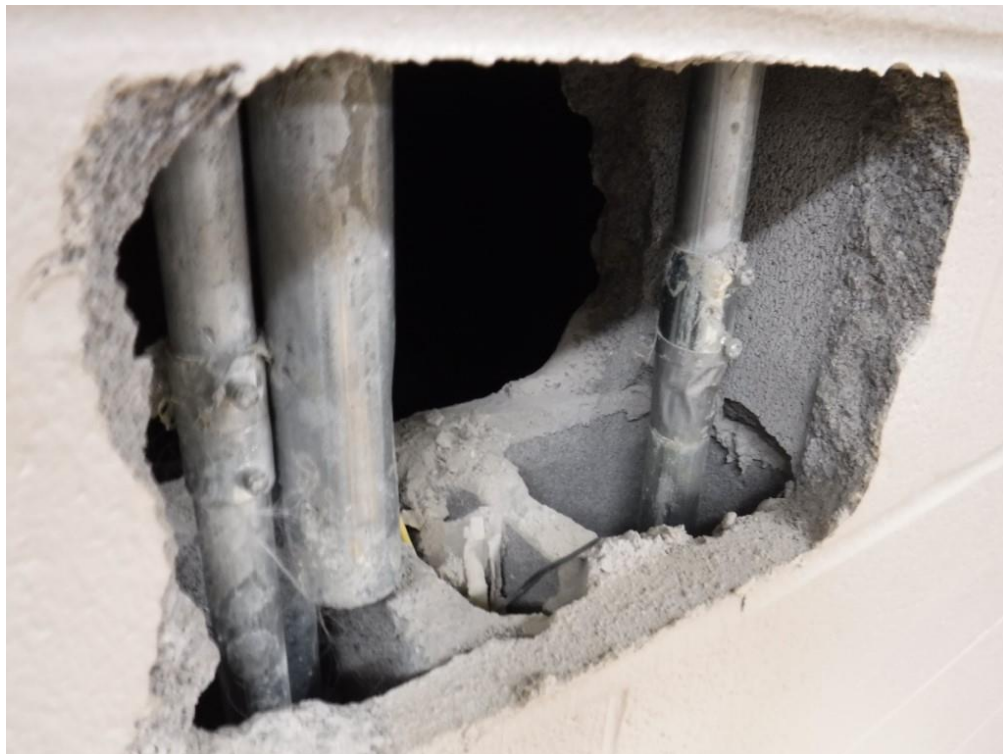
- v) Conduits that have been filled with grout must be cleaned and the conduit repaired.

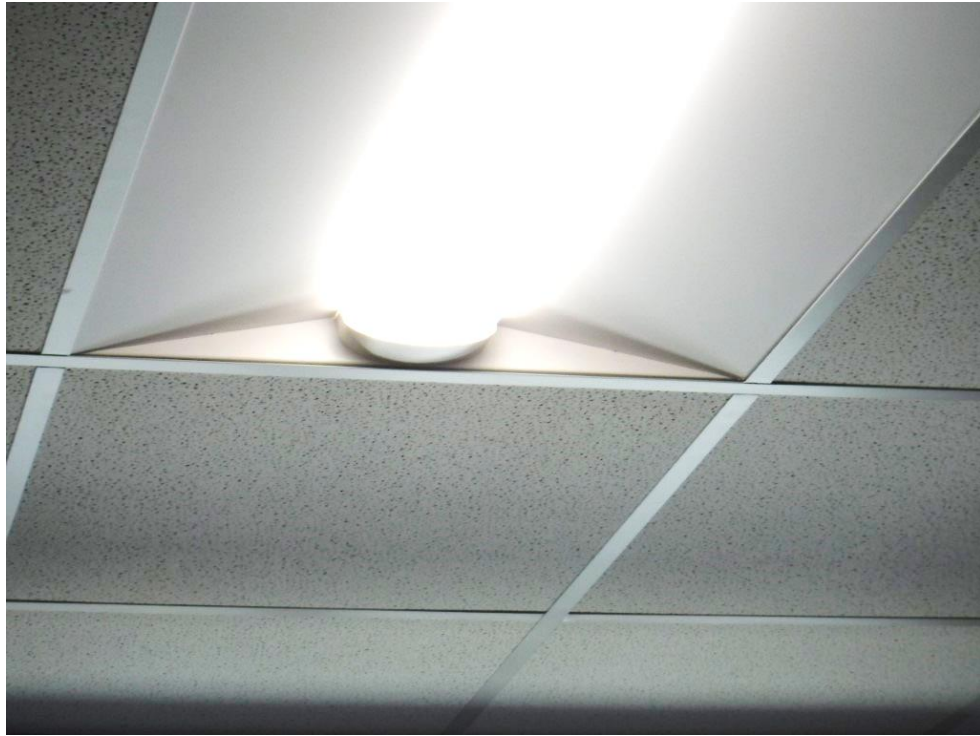
- w) Light fixture must be fully seated in ceiling grids so there are no gaps between the perimeters of the fixtures and the grid.

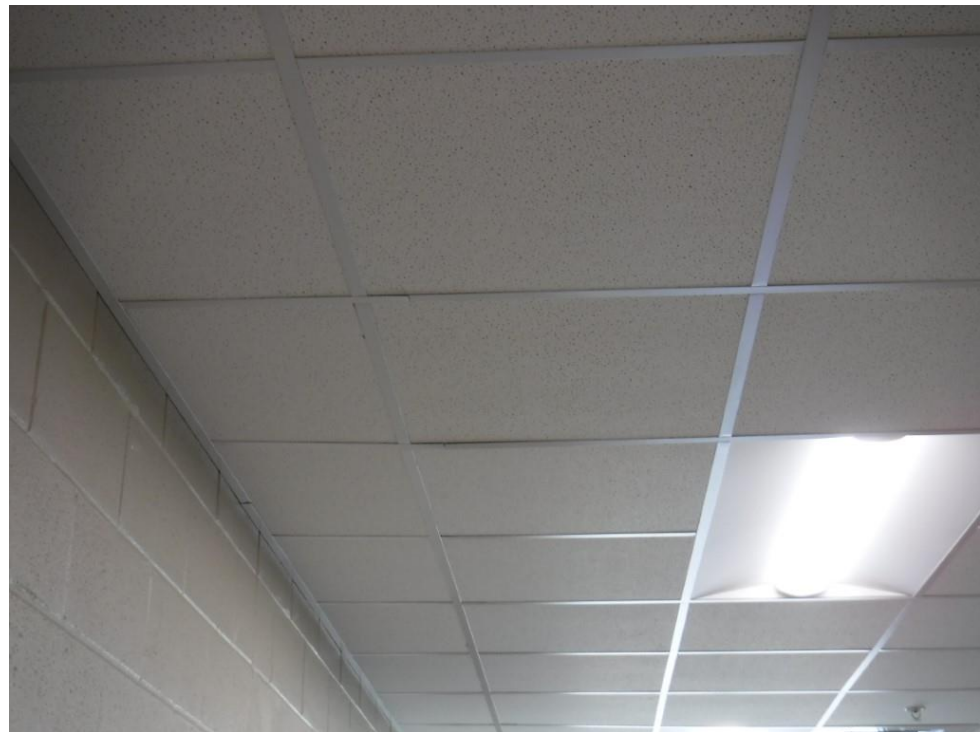
- x) Ceiling grid must be straight, and the tiles must be fully seated in the grids.

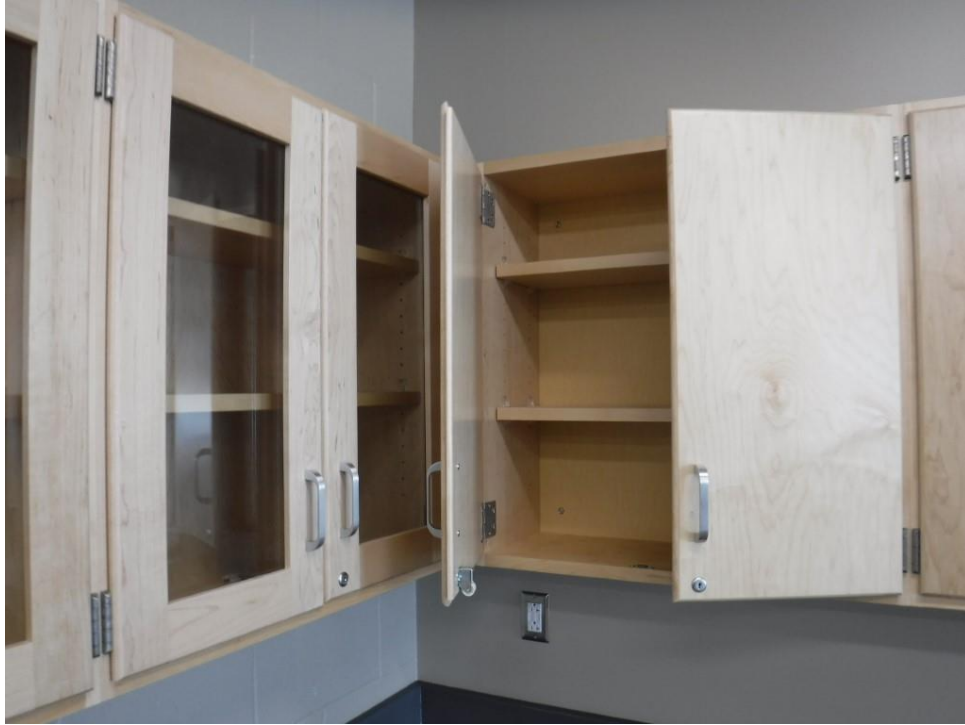
- y) A chain retaining stop must be applied on doors that can swing into glass doors in corner.

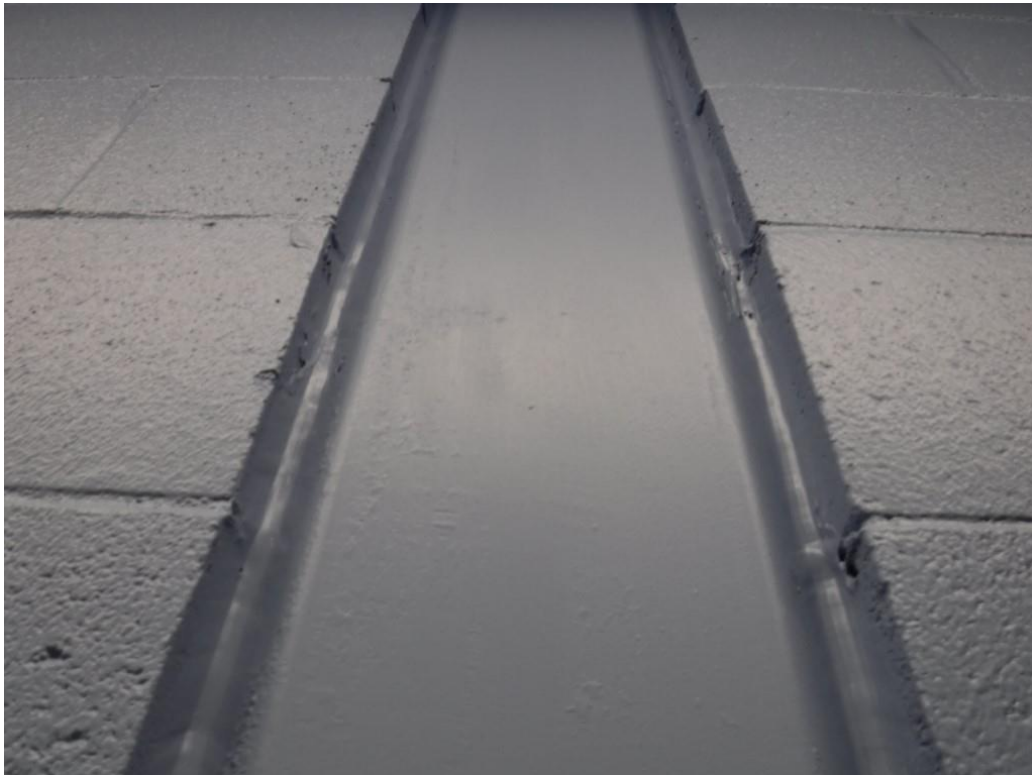
- z) Rework interior caulk so it fills the joints and is continuously smooth.

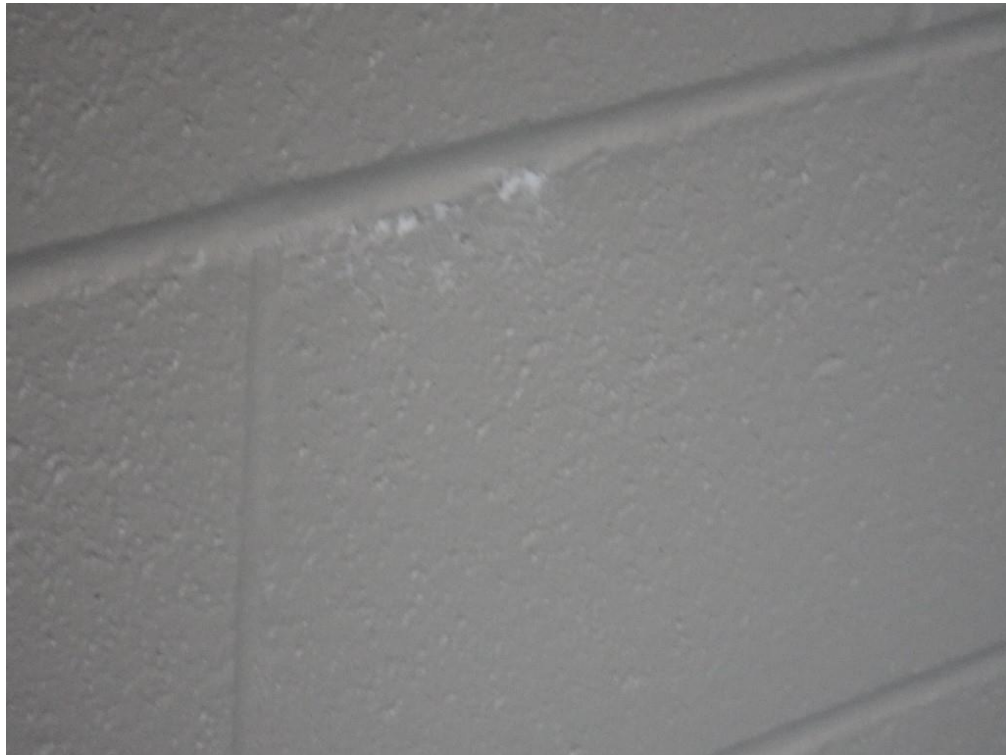
aa) Paint must cover all repairs to block and drywall walls.

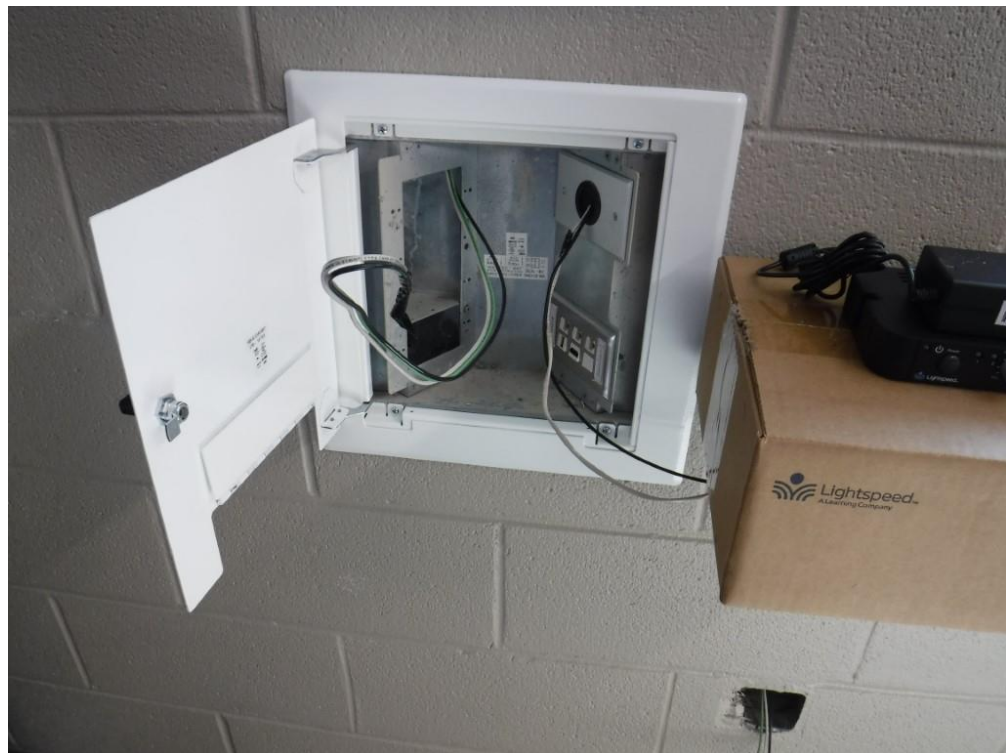
bb) Clean the outside and inside of all A/V and electrical boxes.
