FIELD OBSERVATION REPORT

2019-01 (Scott HS)

■ TO:	Kenton County Board of Education 1055 Eaton Drive Ft. Wright, KY 41017	■ DATE:	2019.01.22
ATTENTION:	Mr. Rob Haney		
■ FROM:	Mark Perry mperry@pca-arch.com 1881 Dixie Highway, Suite 130 Fort Wright, KY 41011 V: 859.431.8612 • F: 859.431.8611	■ PROJECT:	Kenton County School District Scott High School – Phase IV
COPIES TO:	Mr. David Lloyd, Mr. Danny Mann, Ms. Carrie Hooten	PROJECT NO.:	2016-124

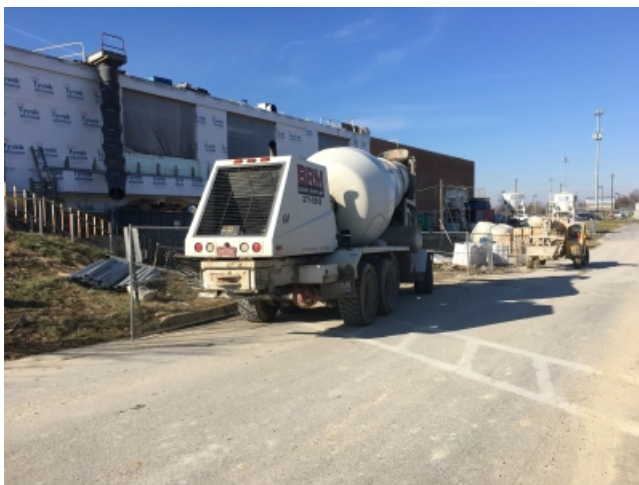
03.01: 2018.12.18 – All colored concrete except under the west shade canopy had been poured. The final section was being poured later that morning. Concrete curbs at seat alcoves had been installed.

2018.12.18 – Concrete truck delivering the last of the colored concrete.

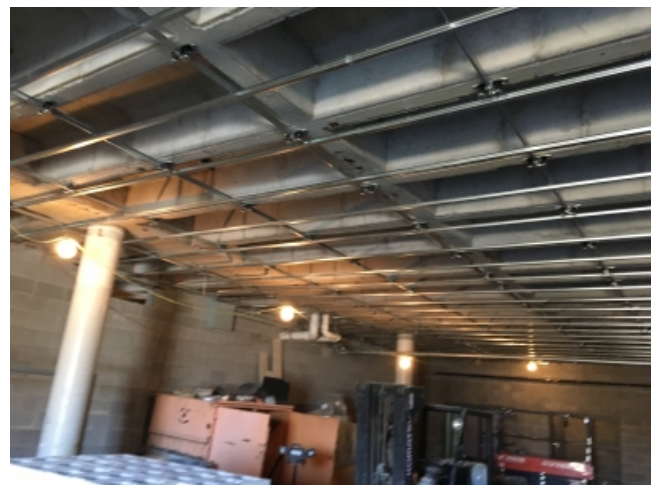
09.01: 2018.12.18 – Acoustic isolators and cold form metal framing was in place in the band room.

2018.12.18 – Band room sound isolating ceiling framing.

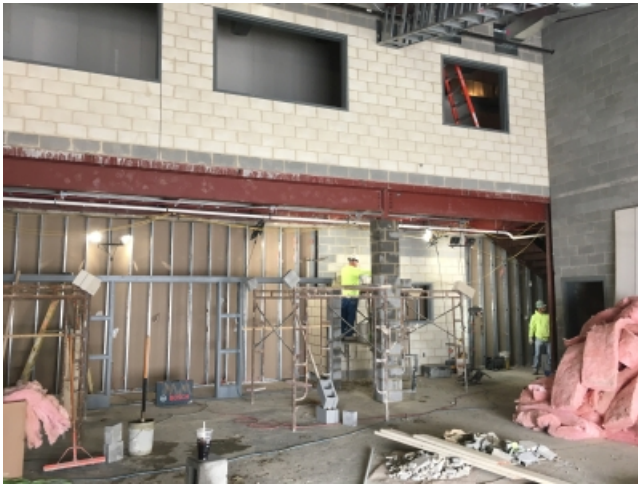
04.01: 2018.12.18 – Masons were actively working at column surrounds in the multi-purpose room and at the large door frame from the corridor.

2018.12.18 – Mason working in multi-purpose.

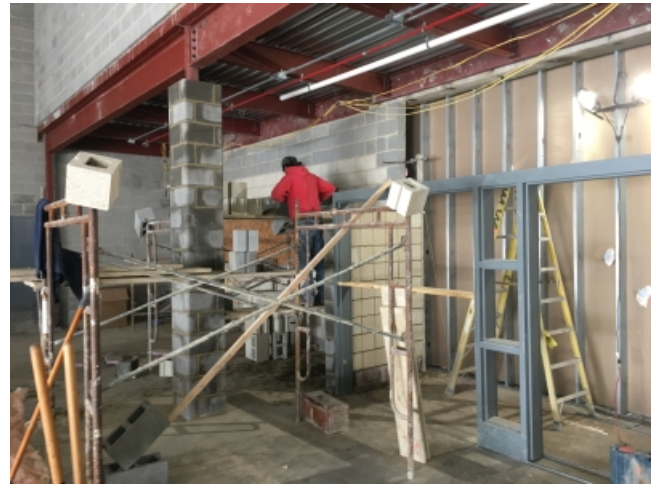
2018.12.18 – Mason working in multi-purpose.

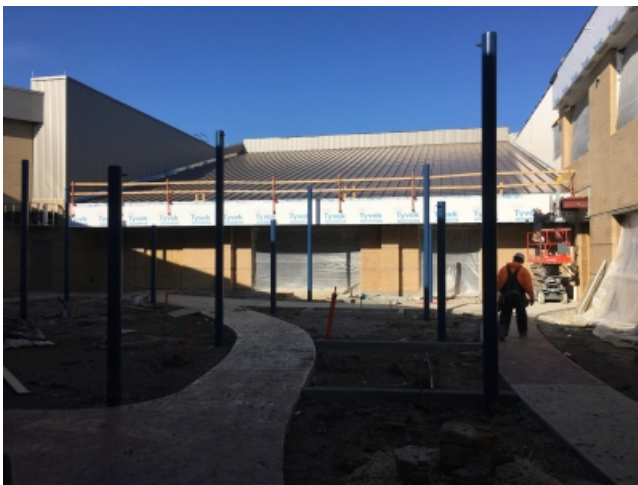
07.01: 2018.12.18 – Metal roof installation above the multi-purpose room was complete.

2018.12.18 – Metal roof.

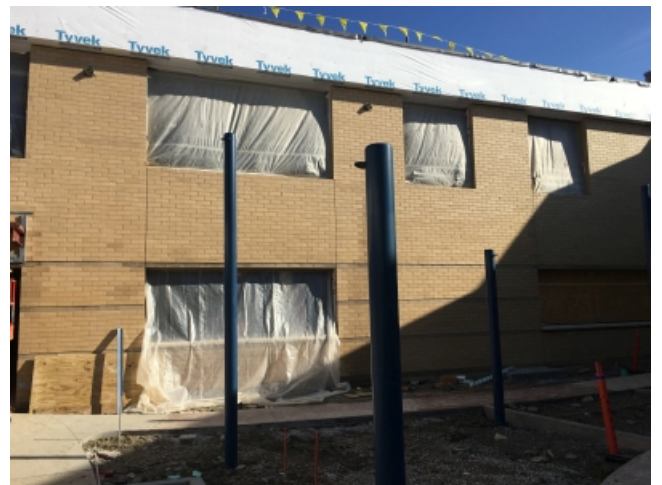
2018.12.18 – East wall of courtyard.

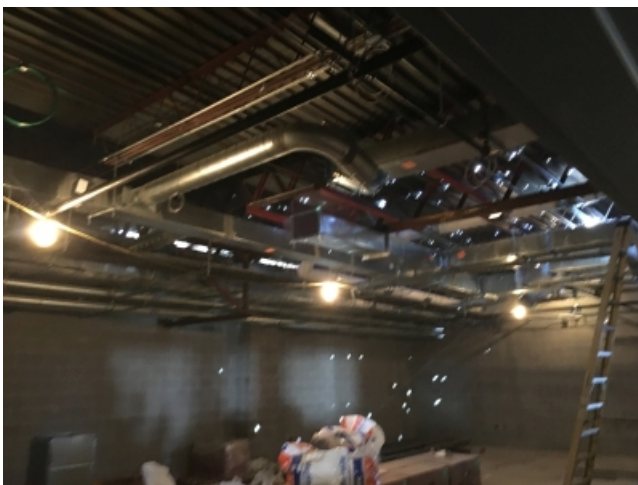
07.02: 2018.12.18 – Re-roof was taking place above northernmost classrooms.

2018.12.18 – Re-roof occurring overhead.

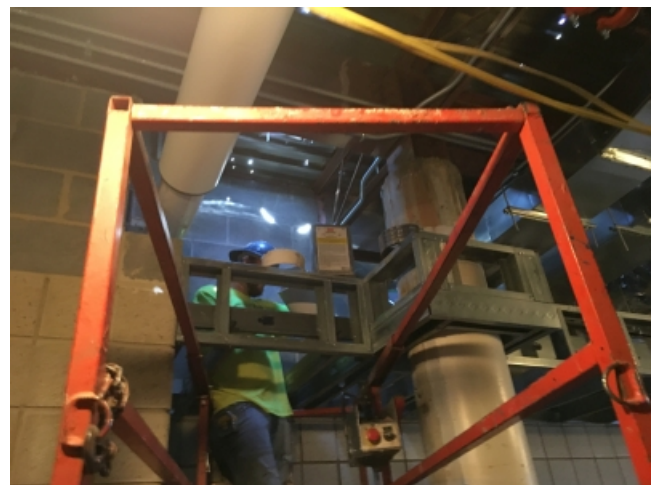
20-28.01: 2018.12.18 – The plumber was working in concert with re-roof activities, setting and connecting roof drains.

2018.12.18 – Plumber working on roof drain.

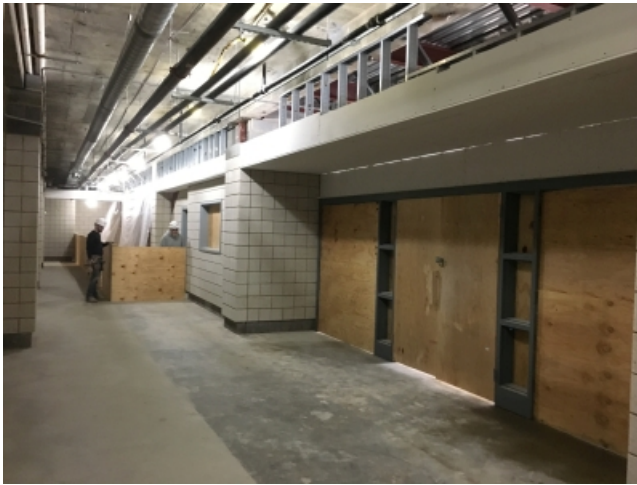
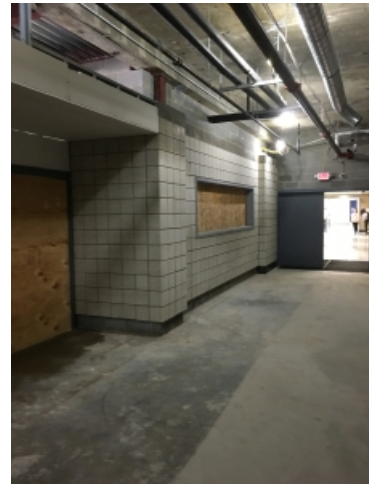
09.02: 2019.01.03 – Gypsum board soffits and bulkheads had been installed along the south edge of the main east/west corridor. Gypsum board installation in the multi-purpose room was progressing.

2019.01.03 – East/west lower level corridor

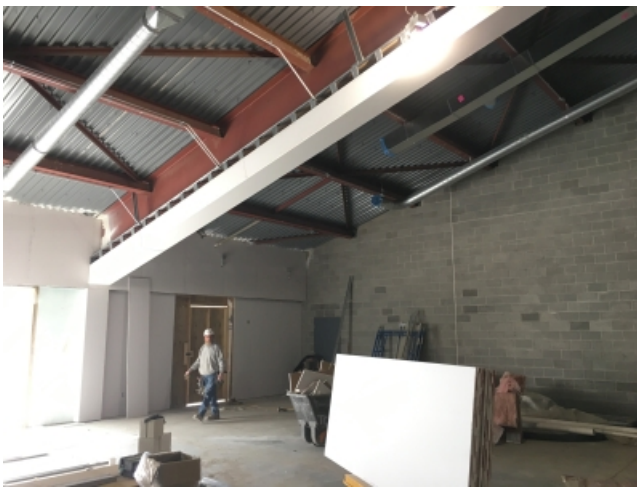
2019.01.03 – Multi-purpose room.

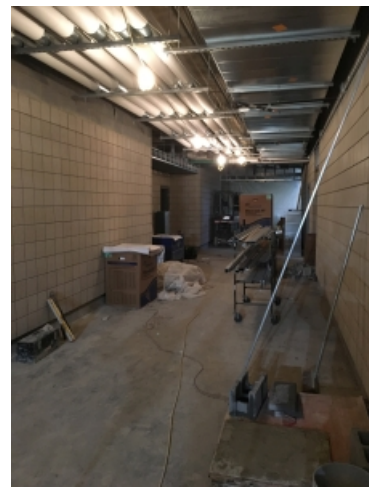
04.02: 2019.01.03 – Masons were actively working along the north/south corridor at the lower level. All of the lower level classrooms and spaces were defined by walls except for the last practice room.

2019.01.03 – North/south lower level corridor.

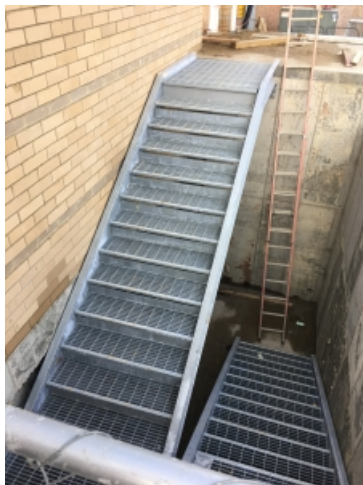
05.02: 2019.01.03 – Exterior stairs to the basement fire pump had been installed.

2019.01.03 – Stairs to fire pump room.

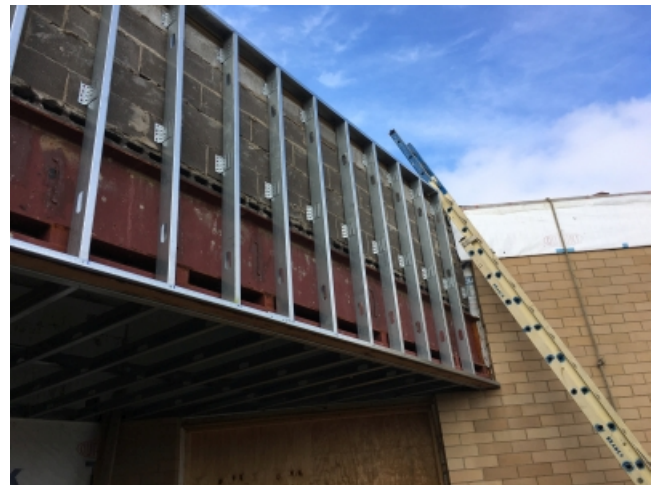
05.03: 2019.01.03 – Metal framing had been installed at the former main entrance.

2019.01.03 – Framing at former main entrance.

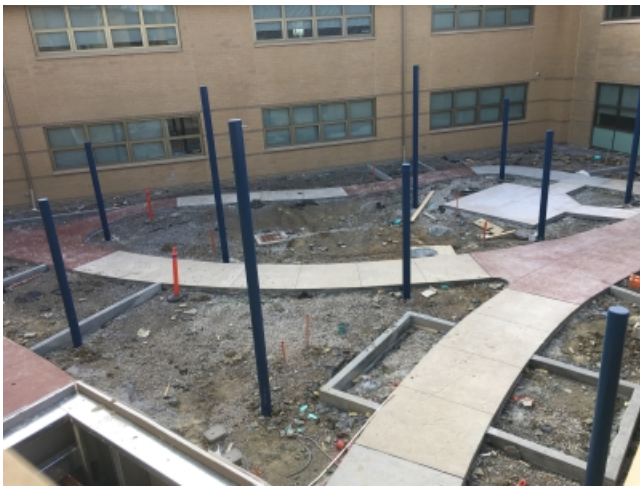
2019.01.03 – Courtyard.

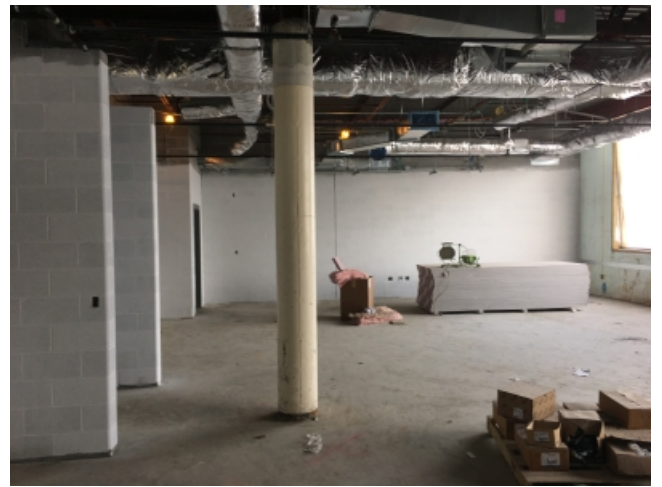
09.03: 2019.01.03 – Gypsum board was staged at upper level classrooms for installation on ICF walls and bulkheads.

2019.01.03 – Upper level classroom.

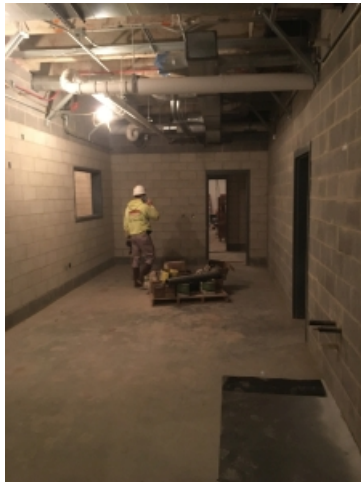
2019.01.15 – Performing arts collaboration room.

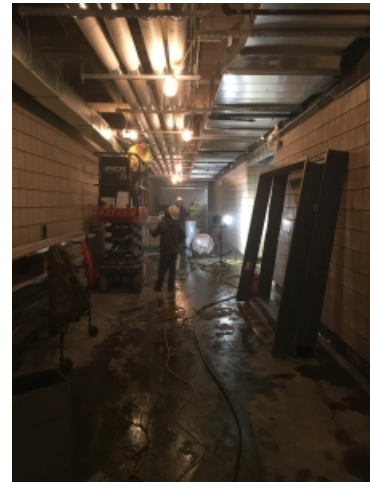
04.03: 2019.01.15 – Interior masonry wall construction was complete. Cleaning was on-going in advance of applying sealer to unpainted walls. Structural glazed tile base installation had occurred at some upper level locker bases.

2019.01.15 – Cleaning masonry at lower level.

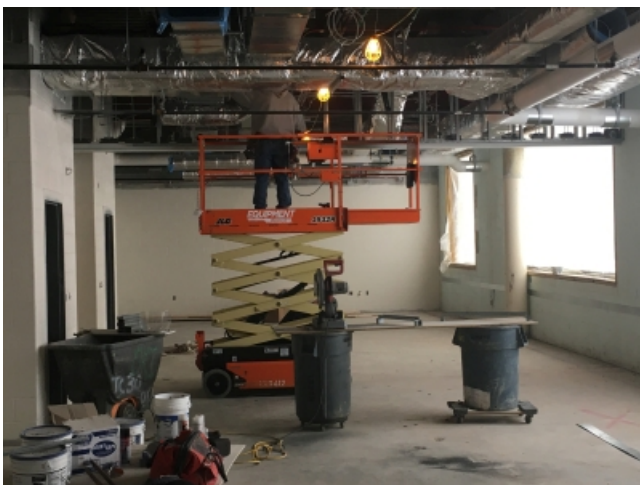
10.01: 2019.01.15 – Operable partition tracks were being installed at upper level classrooms.

2019.01.15 – Installing operable partition track.

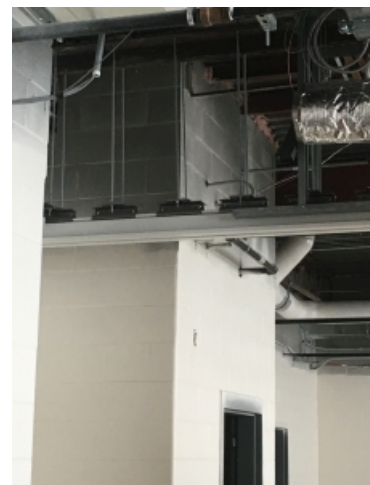
2019.01.15 – Operable partition track.

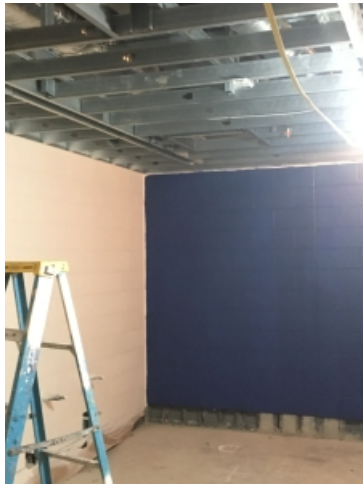
09.05: 2019.01.15 – Block-fill had progressed to additional upper level classrooms. Paint application had also occurred at previously filled walls.

2019.01.15 – Painted masonry.

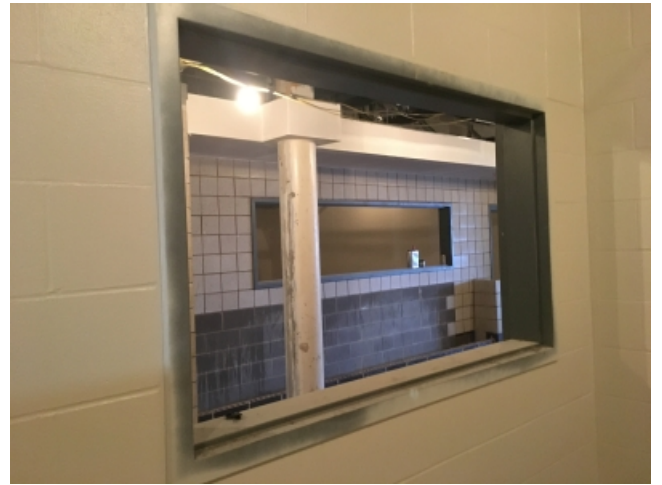
2019.01.15 – Corridor from upper level collaboration room.

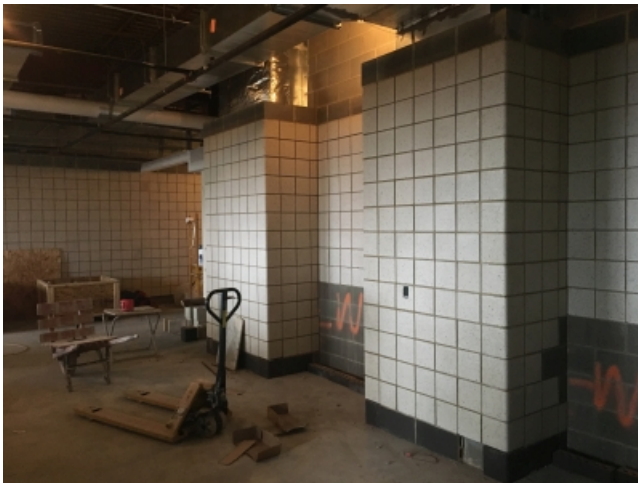
2019.01.15 – Upper level corridor.

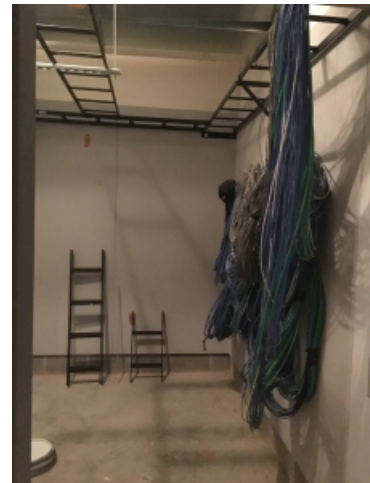
2019.01.15 – IDF room.
