FIELD OBSERVATION REPORT

2019-02 (Scott HS)

■ то:	Kenton County Board of Education 1055 Eaton Drive		■ DATE:		2019.02.14
	Ft. Wright,	Ft. Wright, KY 41017			
ATTENTION:	Mr. Rob H	aney			
FROM:	Mark Perry	Mark Perry		:	Kenton County School District
	mperry@p	ca-arch.com			Scott High School – Phase IV
	1881 Dixie	1881 Dixie Highway, Suite 130			
	Fort Wrigh	Fort Wright, KY 41011			
	V: 859.431	.8612 • F: 859.431.8611			
COPIES TO:	Mr. David Lloyd, Mr. Danny Mann,		PROJECT NO.:		2016-124
	Ms. Carrie	Hooten			
■ WE TRANSMIT THE ATTACHED ITEMS VIA: EMAIL					
PURPOSE	☐ For y	our use	DISPOSITION		No exceptions noted
	☐ As re	equested			Exceptions noted,
	☐ For r	eview and comment			Revise as indicated.
	☐ For i	nformation			REJECTED:
	⊠ For r	ecord			REVISE AND RESUBMIT
	☐ For a	approval			
COPIES DA	ATE	DESCRIPTION			PAGES
1 2	019-02	Field Observation Report			6

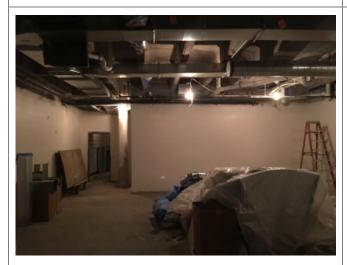
2019.01.29 – Applying mud outside choral room.

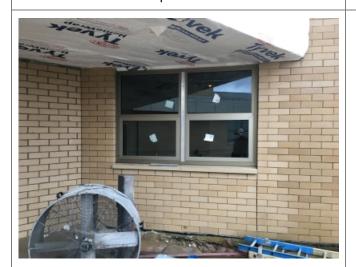
2019.02.12 - Roofing billets.

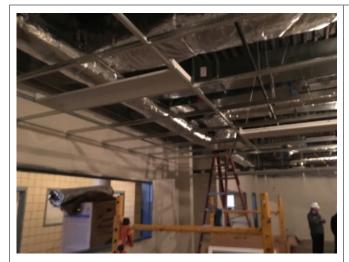
2019.02.12 – Upper level north/south corridor.
