## FIELD OBSERVATION REPORT

# **2022-02 (Scott Phase V)**

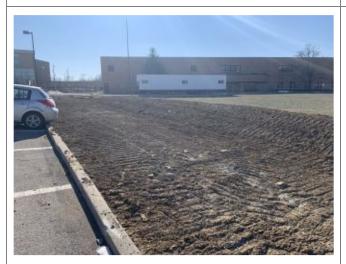
2022.01.26 - Lay-down area.

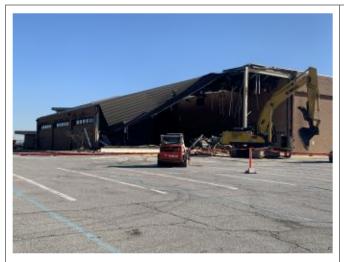
2022.01.26 - Temporary perimeter fence.

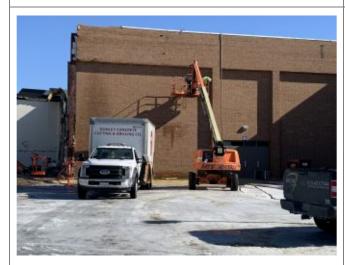
02.02: 2022.02.09 – Saw-cutting of the western wall of the gym mezzanine was actively occurring. The exterior walls and overhead structure of the pool had been removed with the exception of the eastern most exterior wall. The saw-cutting crew was moving to that location next. The mechanical mezzanine framing had been removed. Removal of electric buss duct inside the building was actively occurring.

2022.02.09 - Demolition at pool.

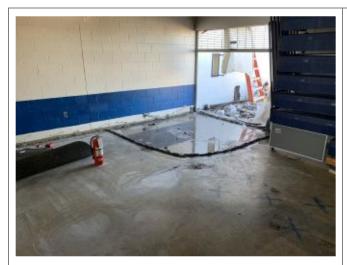
2022.02.09 - Temporary partition at gym mezz.
