## FIELD OBSERVATION REPORT

Central Hardin High School, Cecilia, KY

Date: 3/3/2022

Report No: 9

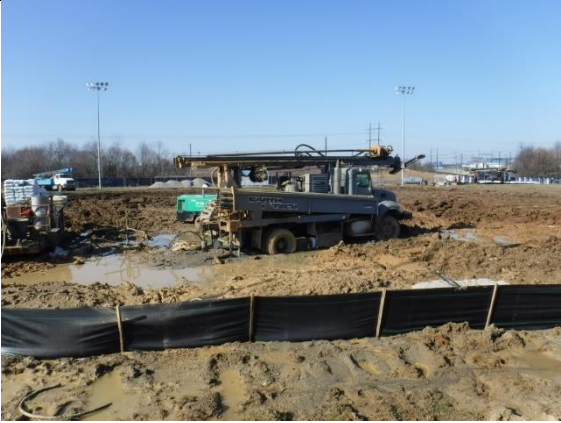
Item No.	Location	Description/Correction	Image	Action
1	Well Field	Even though the weather has been dry, the drilling process has placed water from the wells on the topsoil which is easily softened by the moisture. With these conditions, the drillers are having difficulties moving their equipment.

Address issues with water and soils so progress can be made with the geothermal wells. Provide drilling and casing logs for every well.
2	Well Field	Due to equipment breakdowns and other issues, drilling is falling behind schedule.

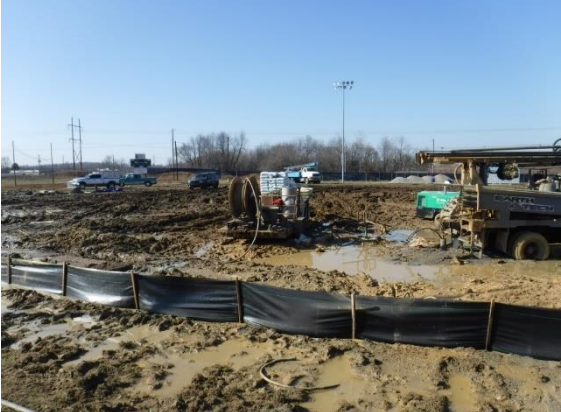
Address issues with equipment, staffing, etc, so progress can be advanced.
3	Well Field	Maintain soil erosion measures to stay in compliance with regulations of AHJs.

Correct erosion measures as required by AHJs.

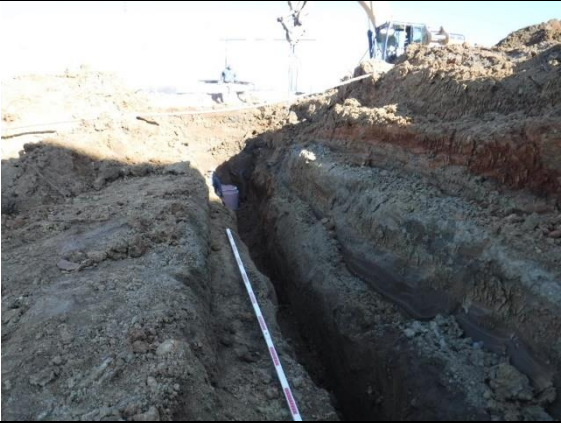
Item No.	Location	Description/Correction	Image	Action
4	North of Area A	Sanitary sewer line and manhole to new work.

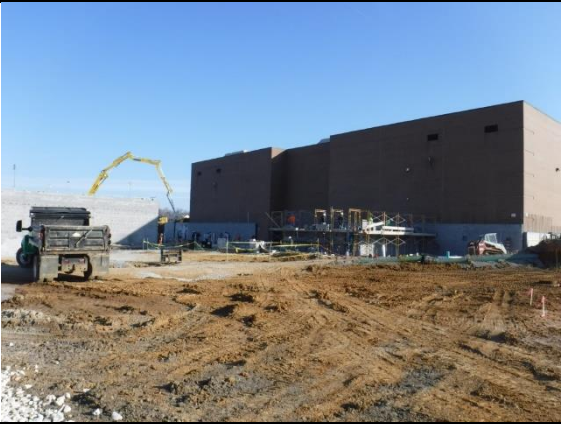
None
5	Areas A and B	Concrete pump boom and scaffolding for masonry work.

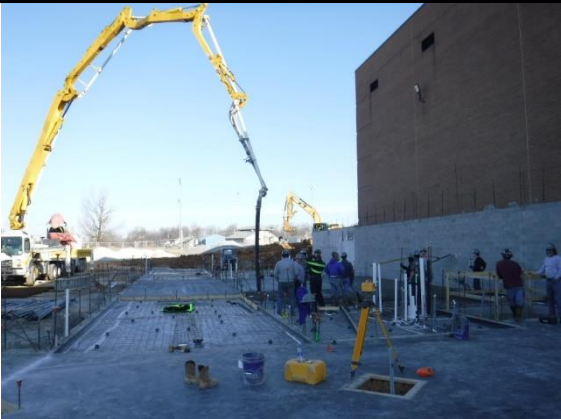
None
6	Area A	Alliance was placing concrete as it was pumped to the slab areas in the north end of Area A.

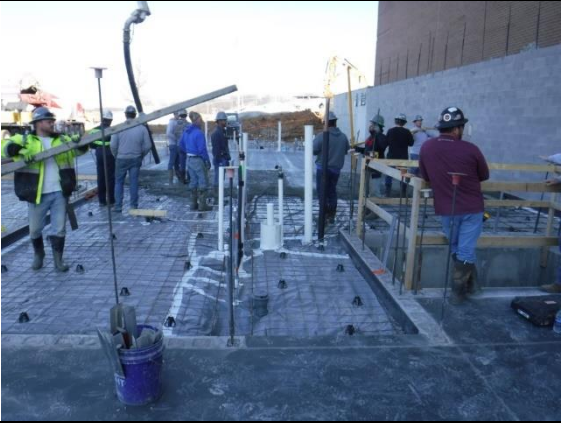
Item No.	Location	Description/Correction	Image	Action
7	Area A	Alliance was placing the slab at the underslab piping for the concession area and also the weight room and corridor.

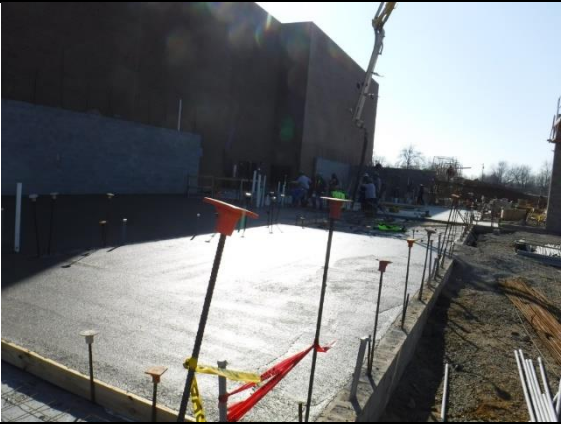
None
8	Area A	The concrete slab was ready for finishing in the north end of the area.

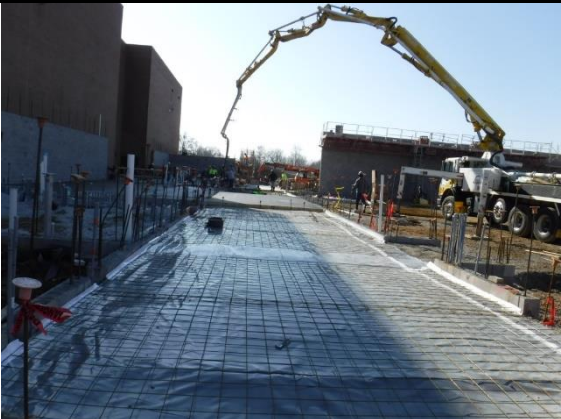
None
9	Area A	Additional areas were prepared for concrete slabs with welded wire fabric and vapor barrier material in place.

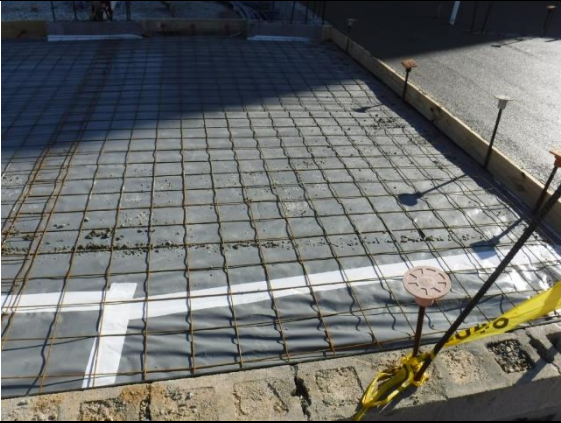
Item No.	Location	Description/Correction	Image	Action
10	Area A	The vapor barrier appeared to be properly taped at joints and penetrations. Refer to the SPIN report for more details.

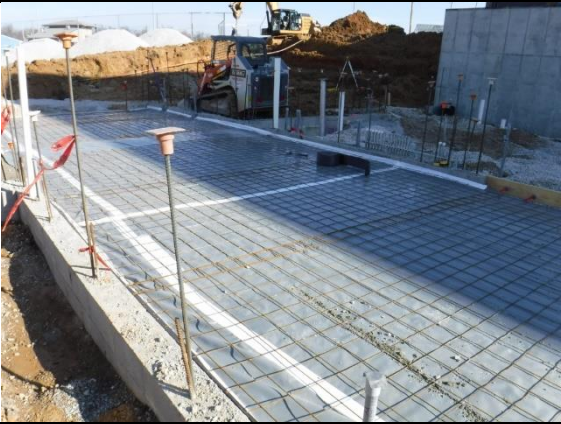
None
11	Area A	The main geothermal line stub in needs to be installed so the slab can be poured in the mechanical room.

Install stub-in.
12	Area A	Penetrations for electrical conduits have been placed through the concrete retaining wall at the mechanical room. These serve the main switchgear for the additions.

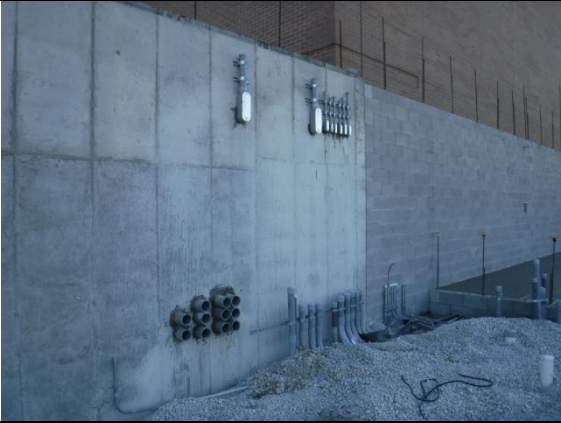
Item No.	Location	Description/Correction	Image	Action
13	Area A	Electrical rough-ins have been placed in the retaining wall at the mechanical room for the main switchgear.

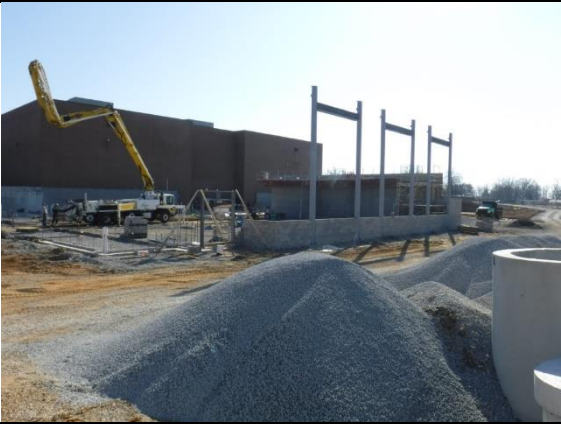
None.
14	Area A	Steel columns and beams have been erected at the west wall of the auxiliary gym.

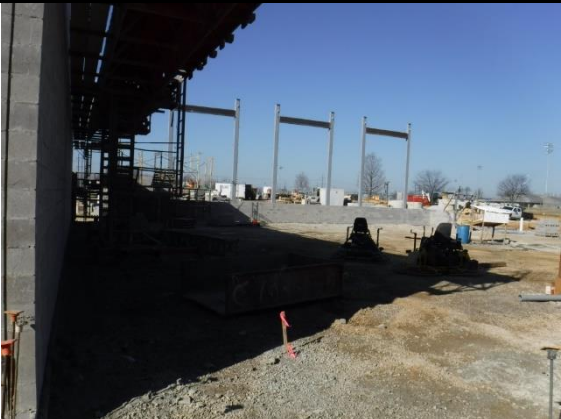
None
15	Area A	The first few courses of the concrete block in the auxiliary gym have been laid on the west, exterior wall.

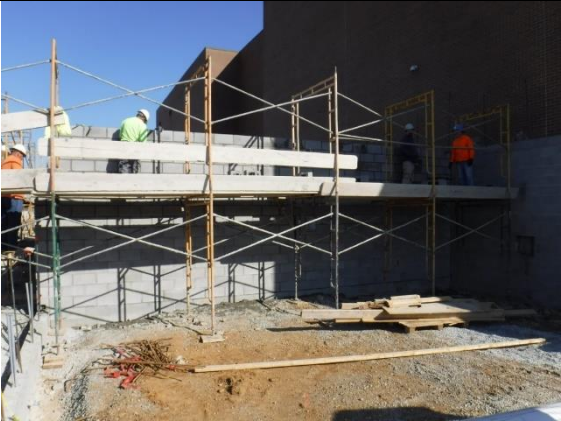
Item No.	Location	Description/Correction	Image	Action
16	Area A	Masons were laying concrete block at the south end of the toilets in Area A.

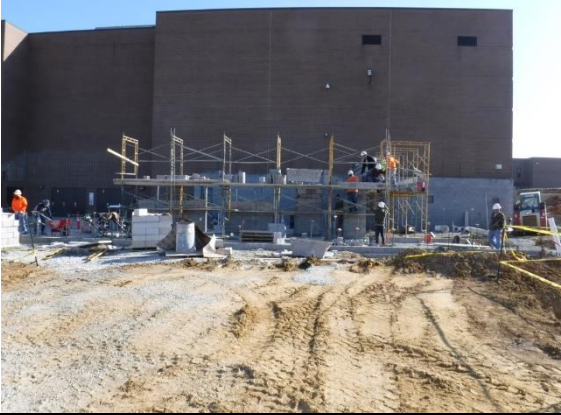
None
17	Area A	Masons were laying the west wall of the toilets at the south end of Area A.

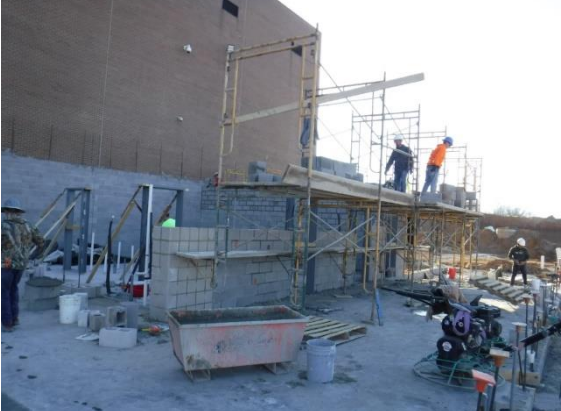
None
18	Area A	As the walls around the toilets at the south end of Area A are being laid, interior spaces are being defined. The work appears to be satisfactory.

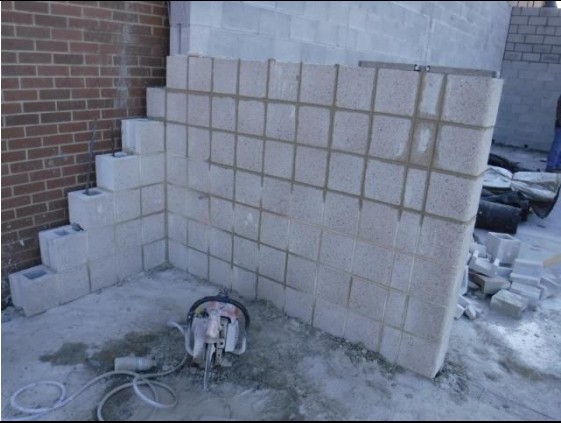
Item No.	Location	Description/Correction	Image	Action
19	Area A	Ground face block is being laid at the entrance walls into the toilets.

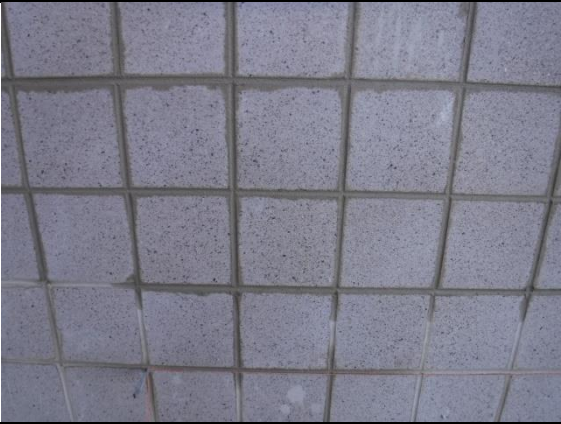
None
20	Area A	With mortar on the faces of the ground face block it is difficult to determine if any of the block edges are chipped. Chipped block need to be culled.

Inspect the block after the mortar is cleaned off the faces.
21	Area A	Hollow metal frame at the toilets in Area A. Protect frames from damage as walls are being laid and then until end of the project.

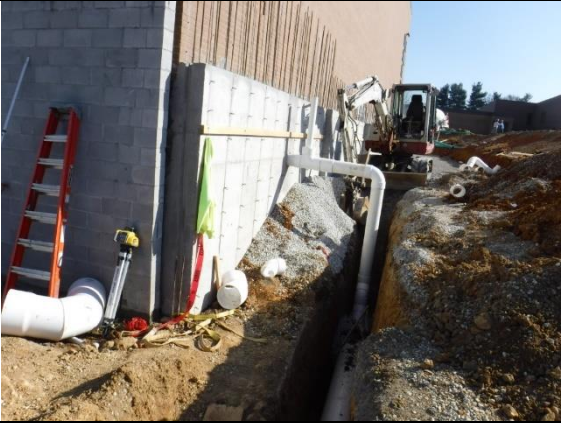
Item No.	Location	Description/Correction	Image	Action
22	Area B	Plumbers were back filling the trench for the new storm line from Area C under Area B.

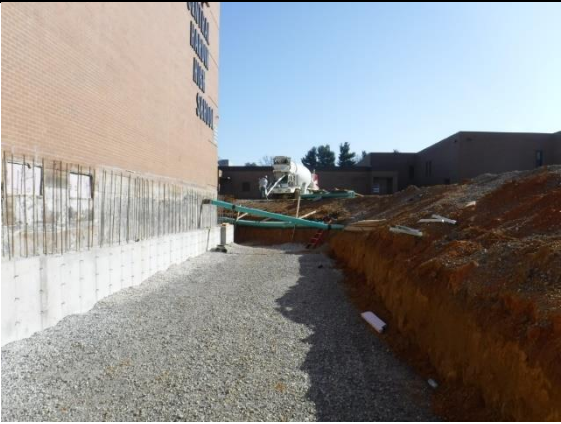
None
23	Area E	Crushed stone has been placed in the excavation for Area E. The existing storm line (in green) needs to be replaced before work can be completed in this area.

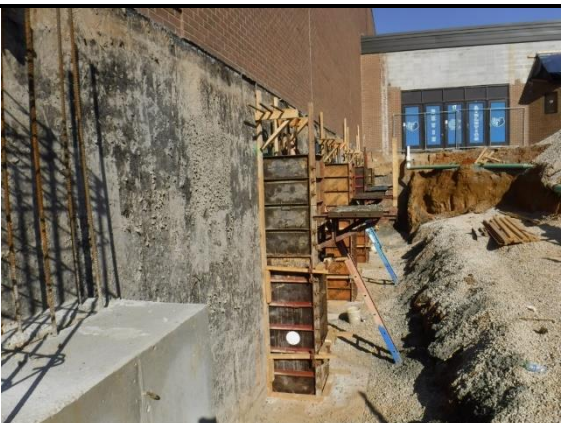
None
24	Area E	Concrete piers had been formed against the existing retaining wall for Area C.

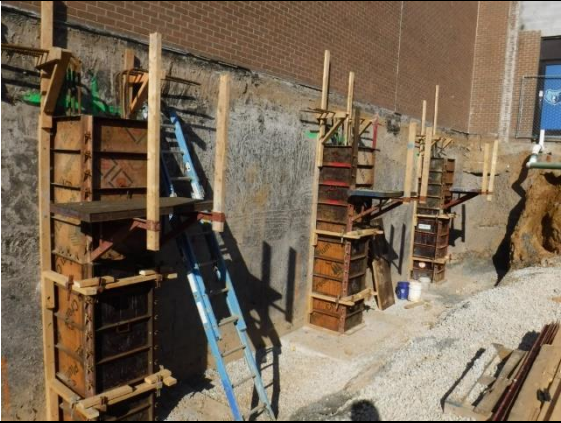
Item No.	Location	Description/Correction	Image	Action
25	Area E	The formwork has been prepared to receive concrete.

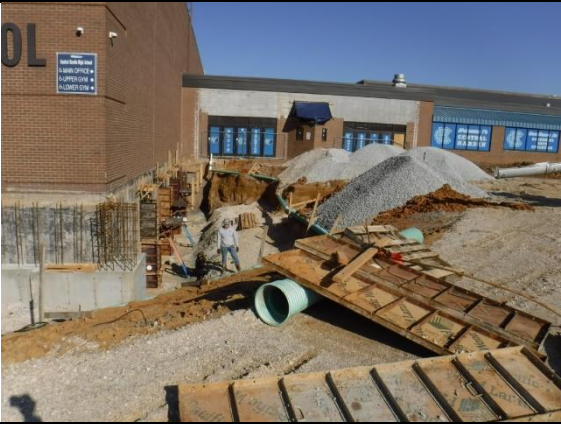
A photograph showing a complex wooden formwork structure built against a brick wall. A blue ladder is leaning against the structure. The ground is covered with gravel and construction debris.	None
26	Area E	The storm line (in green) must be replaced before the foundation work along the east wall of Area E can be installed.

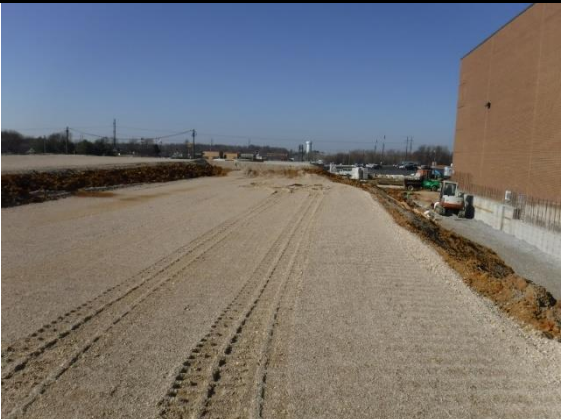
A photograph of a construction site. In the foreground, there is a large pile of gravel and a green pipe. In the background, a brick building with blue windows is visible. A person is standing near the gravel pile.	None
27	Area E	Crushed stone has been placed on the subgrade for the first floor levels in Area E.

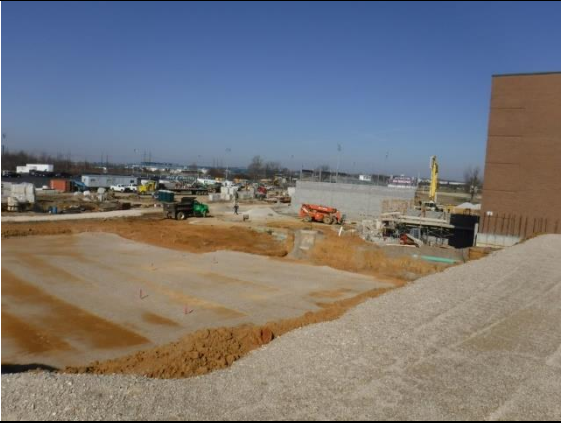
Item No.	Location	Description/Correction	Image	Action
28	Area B	The excavation for the lower level of Area B can be seen in relation to the first floor level in the foreground.

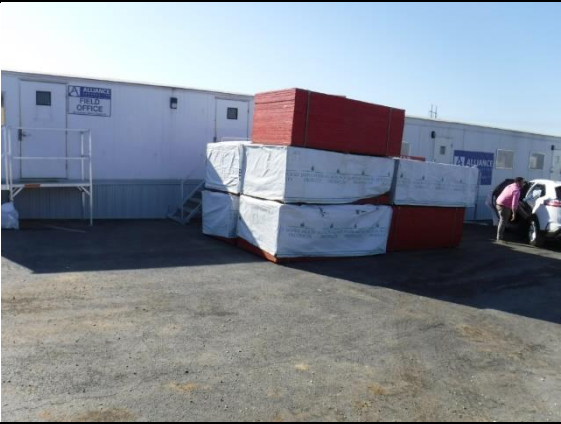
None
29	Stored Materials	The plywood protection board for the existing gym floor arrived on site. Two layers of the plywood be laid with staggered joints to protect the wood flooring.

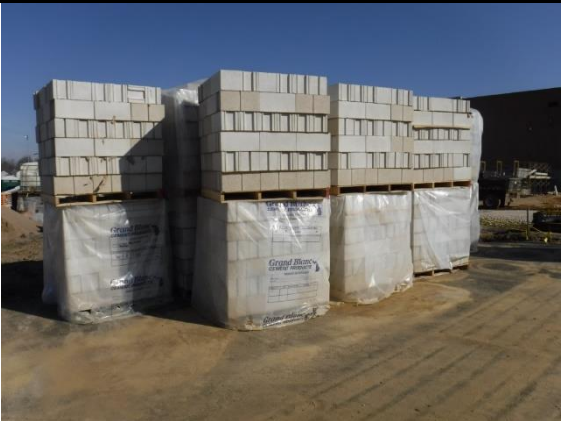
None
30	Stored Materials	Concrete block and ground face concrete block are on site.

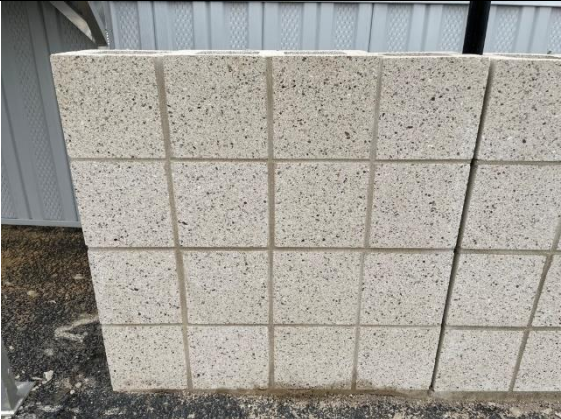
Item No.	Location	Description/Correction	Image	Action
31	Ground Face Block Sample	The ground face block sample with the lighter mortar that is close to the cement color in the block was approved on site.

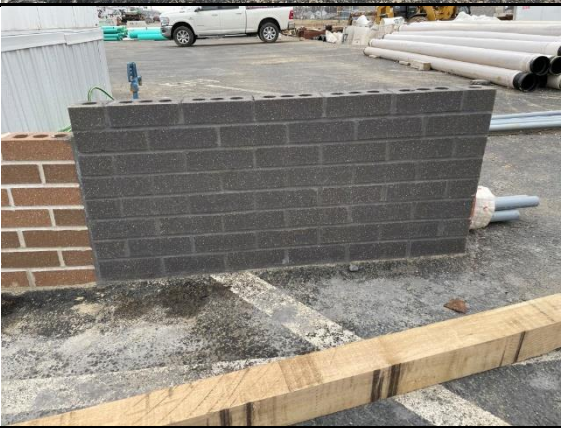
Document
32	Black Brick Sample	The black (dark gray) brick sample with dark gray mortar was approved on site.

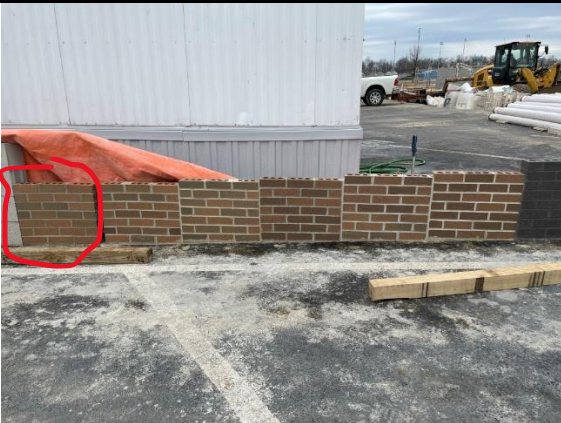
Document
33	Brick Sample	The brick and mortar sample on the left side facing the samples was approved on site. The brick is the lighter of the two considered. The mortar is a natural gray.
