# FIELD OBSERVATION REPORT

# 2022-006 (RC Hinsdale Phase 1)

■ то:	105	nton County Board of Education 5 Eaton Drive Wright, KY 41017	■ DATE:		2022.06.14
ATTENTIO	ON: Mr.	Rob Haney			
FROM:	ROM: Ralph Cooper		■ PROJECT:		Kenton County School District
	rco	oper@pca-arch.com			Phase 1 - RC Hinsdale
	906	Monmouth Street			
	Nev	vport, KY 41071			
	V: 8	359.431.8612 • D: 859.578.6013			
COPIES T	ro: Mr.	Kevin Pfefferman; Ms. Carrie Hooten	PROJECT N	10.:	2021-005
■ WE TRANSMIT THE ATTACHED ITEMS VIA: eComm					
PURPOSE	E 🖂	For your use	DISPOSITION		No exceptions noted
		As requested			Exceptions noted,
		For review and comment			Revise as indicated.
		For information			REJECTED:
	$\boxtimes$	For record			REVISE AND RESUBMIT
		For approval			
COPIES	DATE	DESCRIPTION			PAGES
1	2022-06	Field Observation Report			9

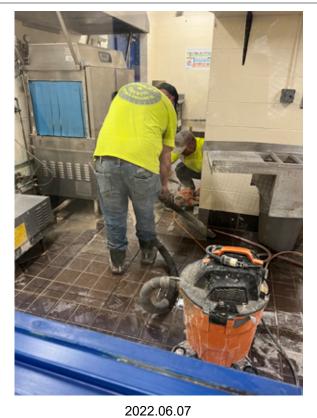
Sawcutting was in progress in the Kitchen for the sewer line repairs.
