Engineering Observation Report

Project **Woodford Co. High School**
Emergency Structural Repairs

Project No. **2021-179**

Date Observed **June 8, 2022**

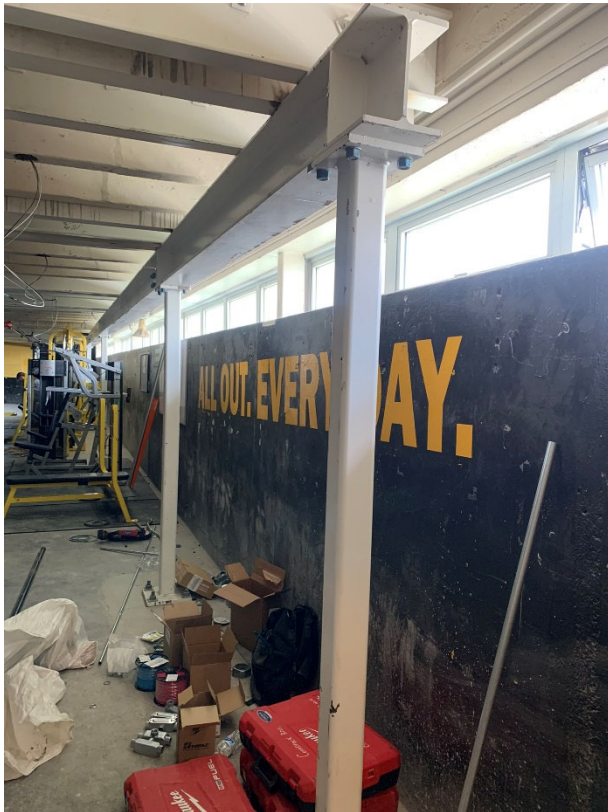
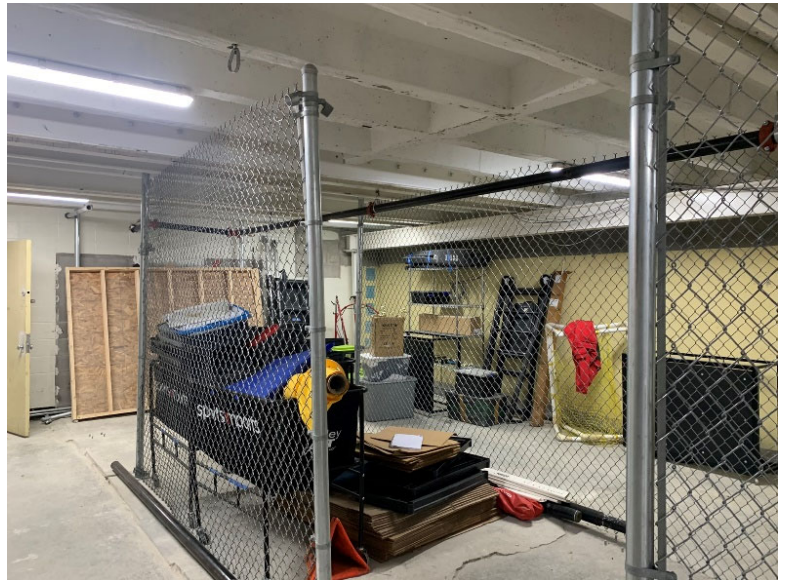
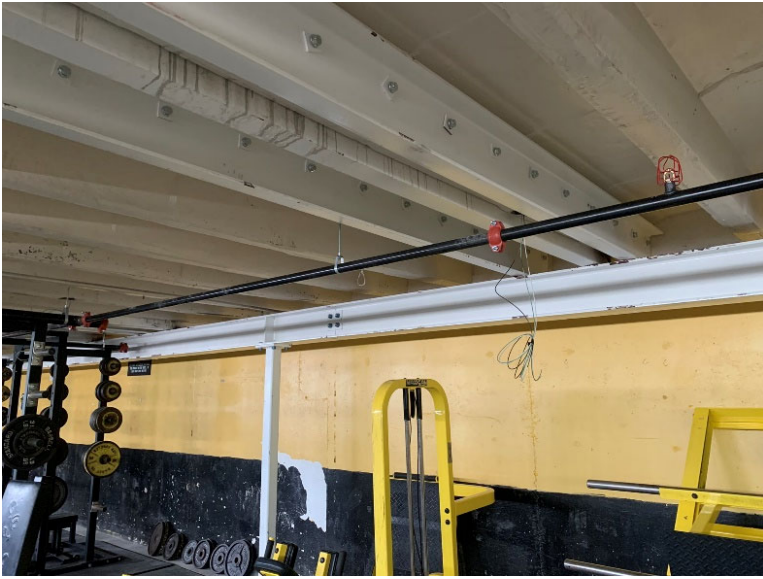
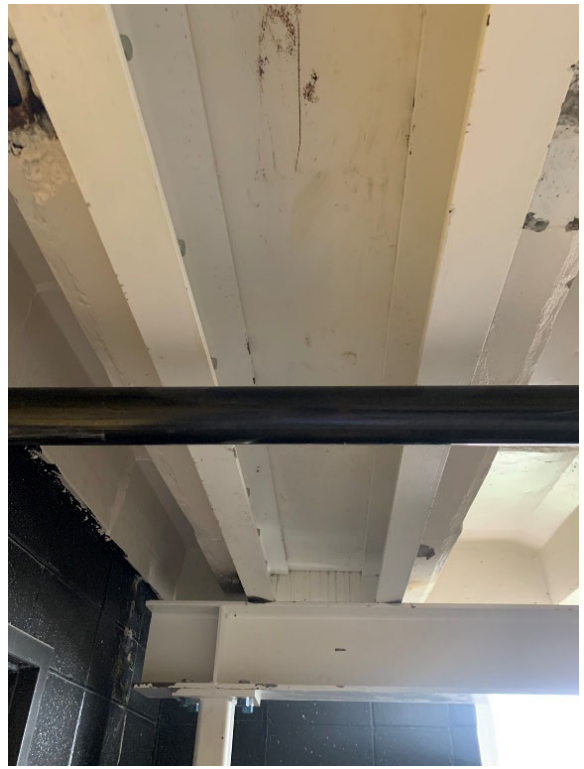
1. Please see the photos below. The new support framing and concrete infill was complete.

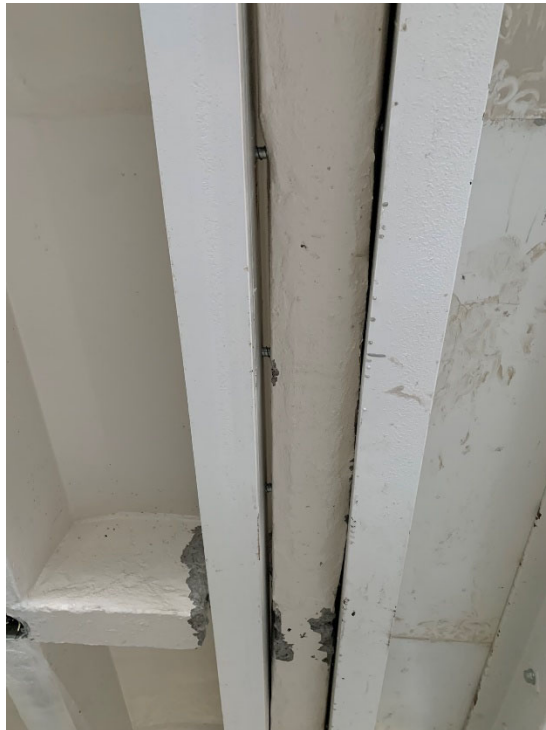
2. The gap between the channels and the existing concrete joists were within an acceptable limit.

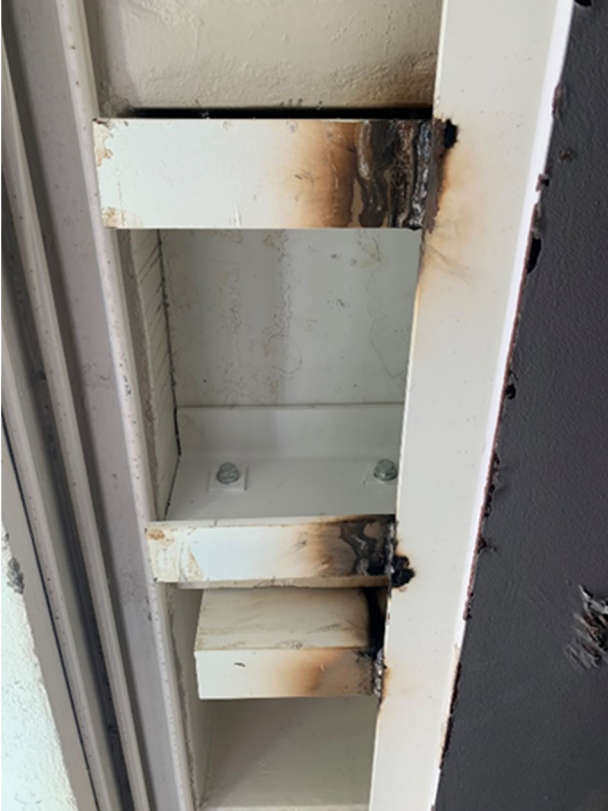
3. Refer to the photo on the left below. The channels have been welded to the supporting beam. It is not a structural concern, but the Architect should review the aesthetics of the welds.

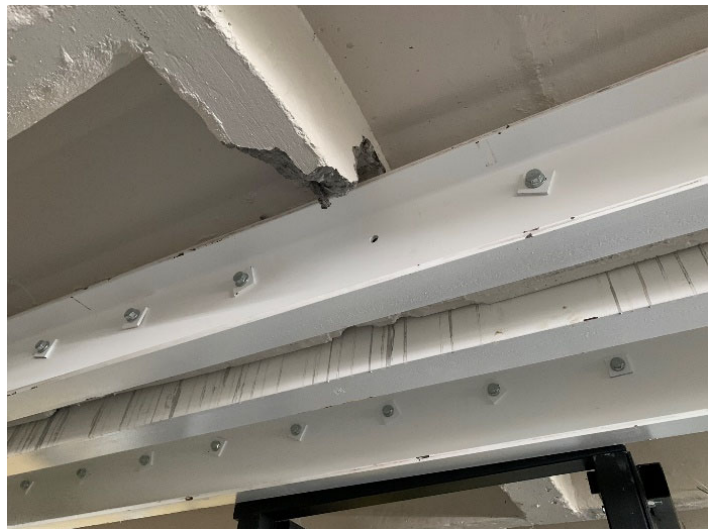
4. See the photo on the right above. The Contractor did not install the screw anchor at mid-span where the stiffening infills were removed. It is structurally acceptable to leave one screw anchor out at each side of the concrete joist at this location.
5. In general, the project appears to be going well.
