PROJECT  
Woodford Co. HS Emergency Structural Rep  
RTA 2133

VISIT NAME  
220614 FIELD OBSERVATION REPORT

REPORT NO  
002

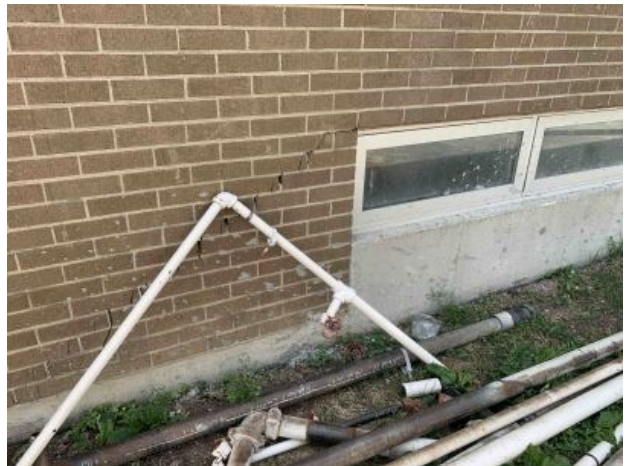
ITEM: 002-001

REMARKS: Concrete splatter needs to be cleaned from exterior wall and windows.

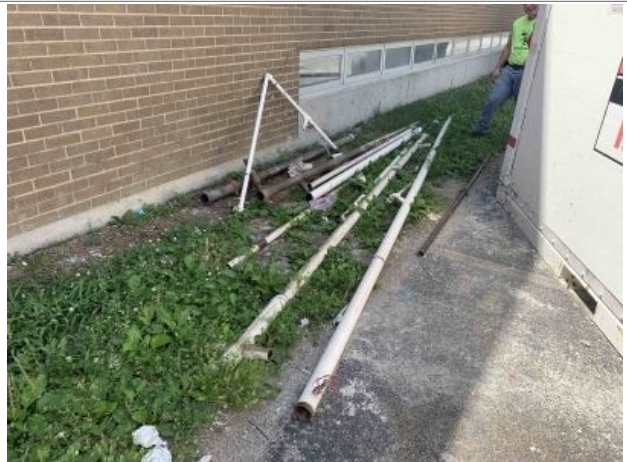
ITEM: 002-002

REMARKS: Demolished sprinkler system on exterior needs to be cleaned up.

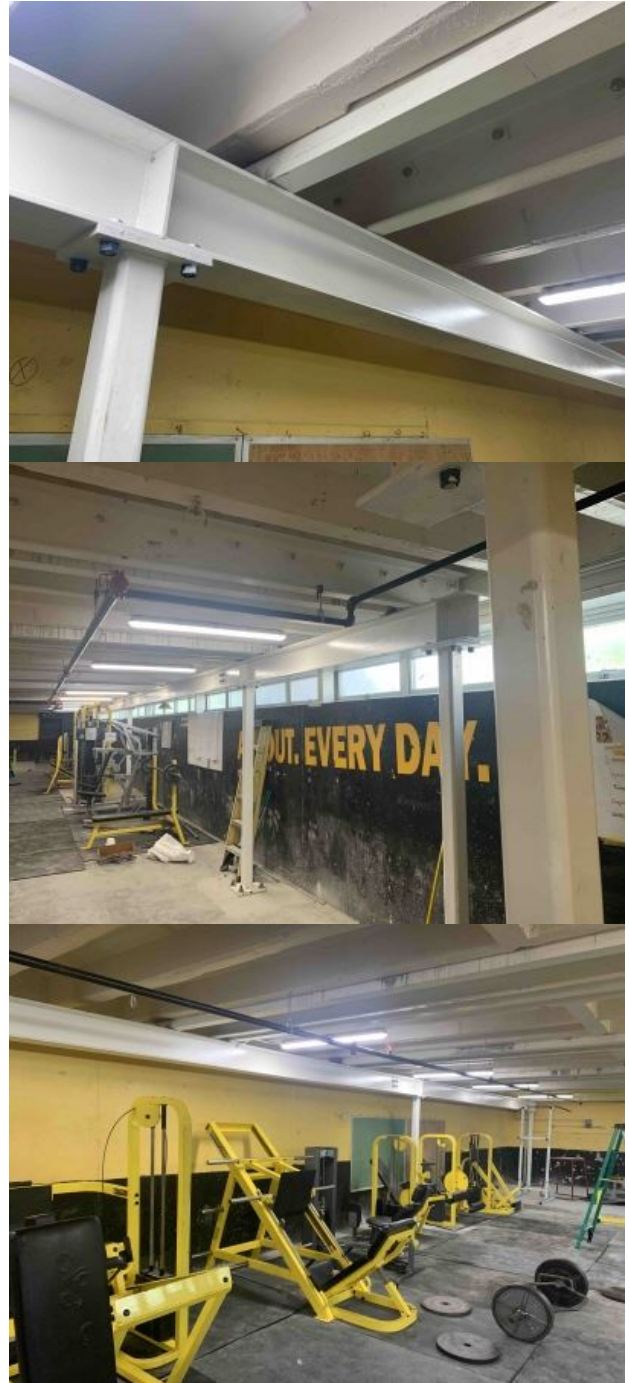
ITEM: 002-003

REMARKS: Steel column, beam and channel  
installation is complete.

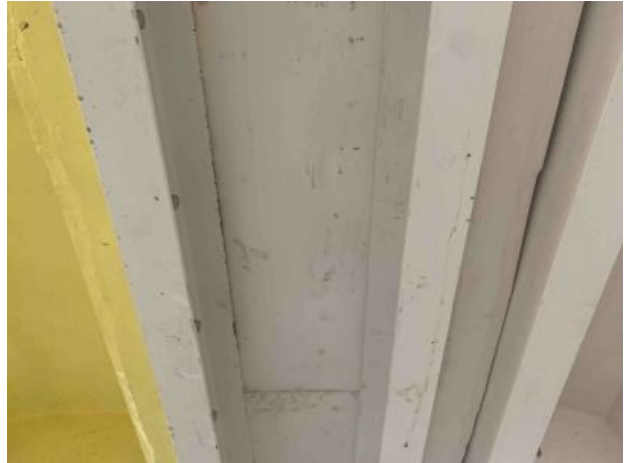
ITEM: 002-004

REMARKS: Steel plate and concrete installation is complete.

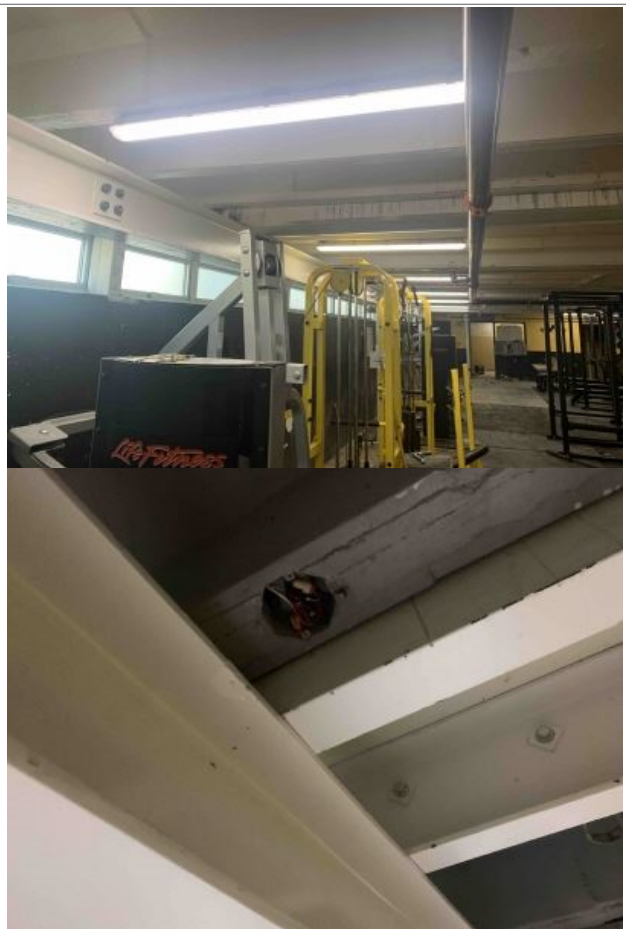
ITEM: 002-005

REMARKS: Lighting installation is near completion.  
Missing fixtures in both storage rooms.

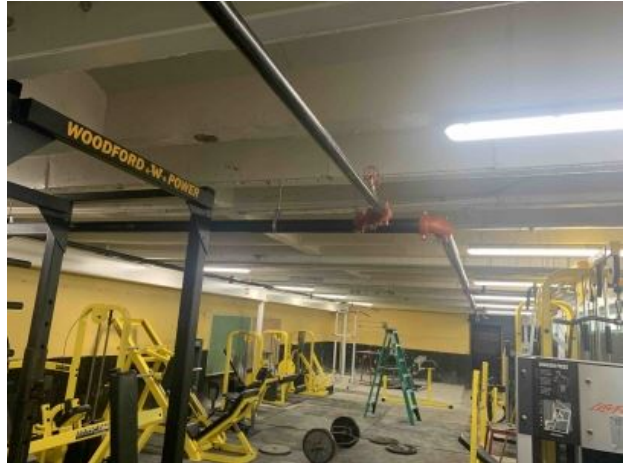
ITEM: 002-006

REMARKS: Sprinkler system installation is complete.

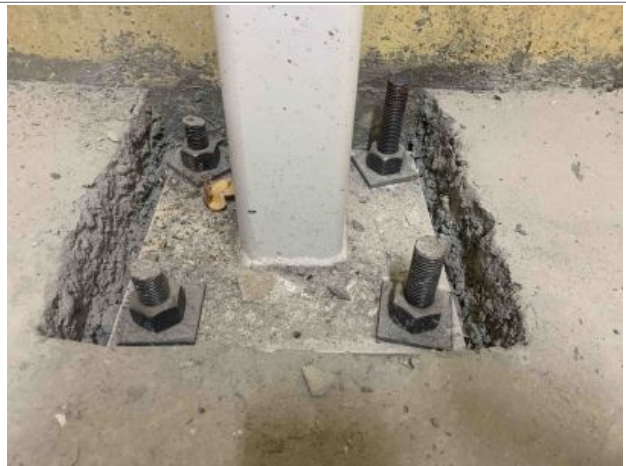
ITEM: 002-007

REMARKS: Anchor bolts in office to be cut below level of floor.

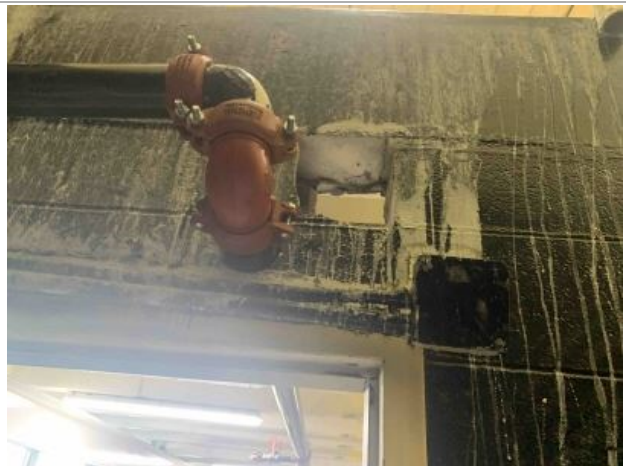
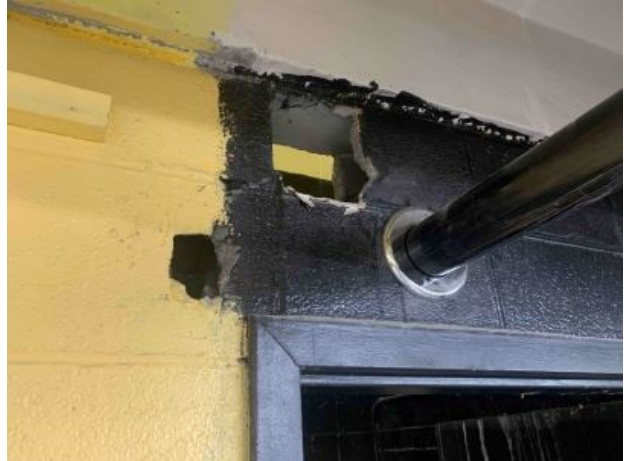
ITEM: 002-008

REMARKS: Fill in hole in CMU wall and paint to match existing.

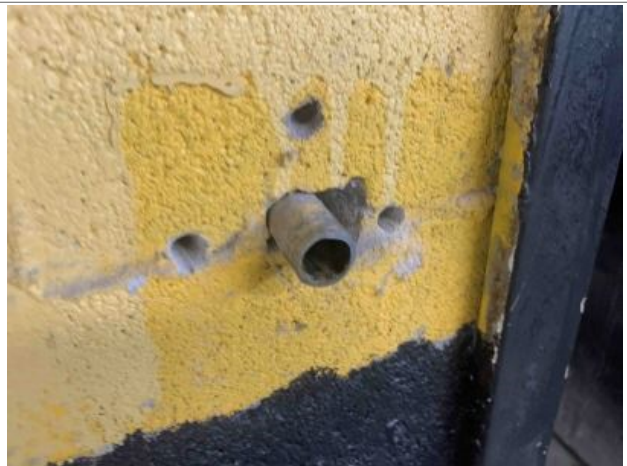
ITEM: 002-009

REMARKS: Cut abandoned conduit flush with wall.  
Fill with grout so it is smooth.

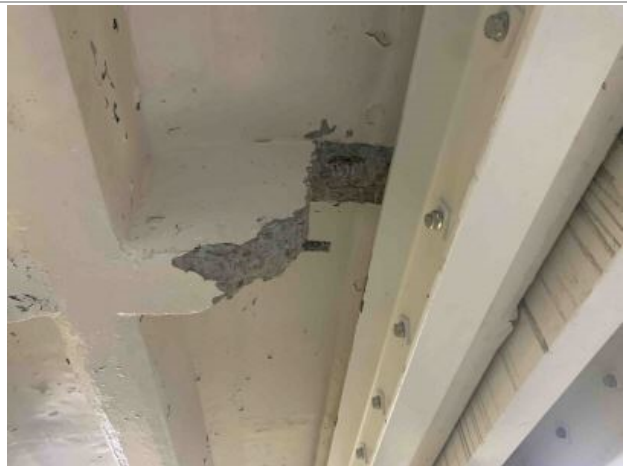
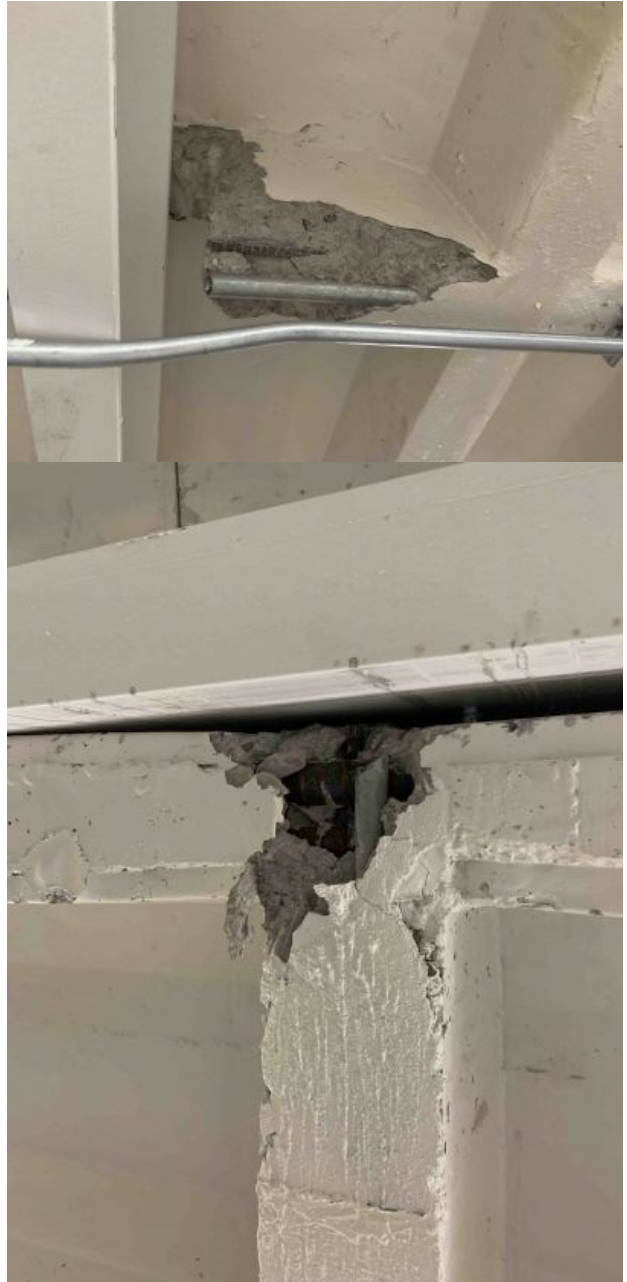
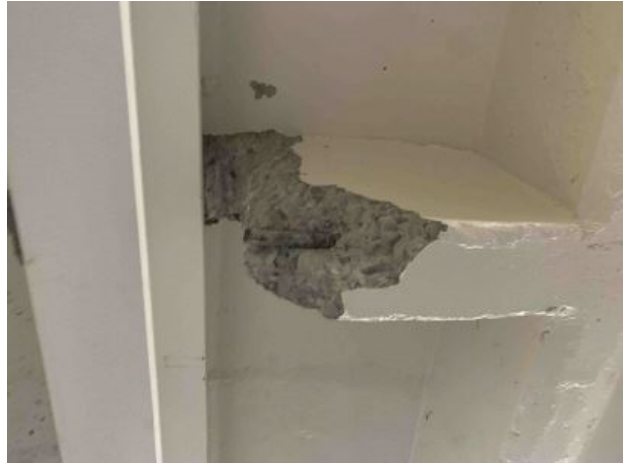
ITEM: 002-010

REMARKS: Patch demolished concrete joist with  
grout/concrete so there is a reasonably square and  
finished edge at all locations. Rebar should not be  
exposed.

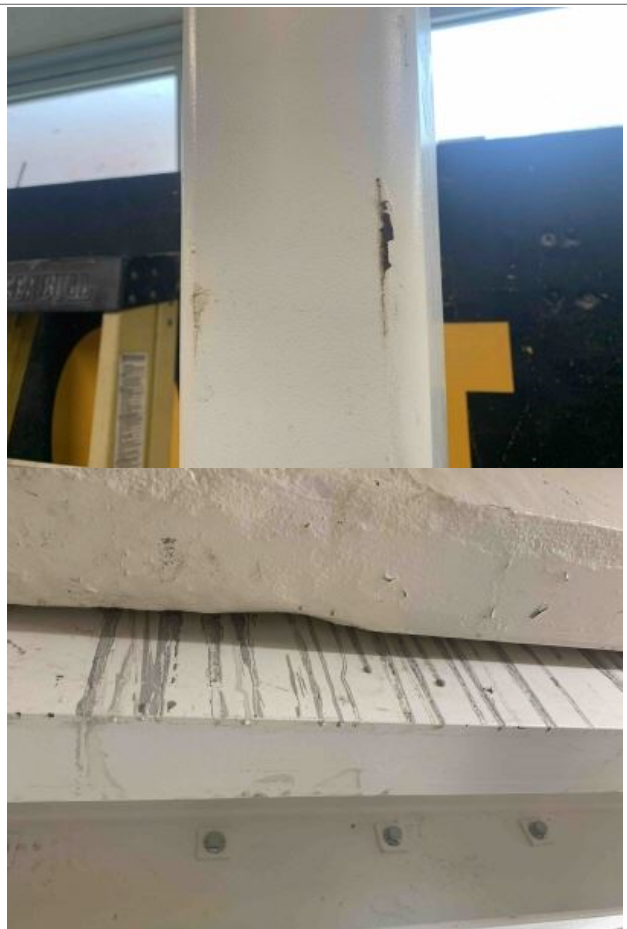
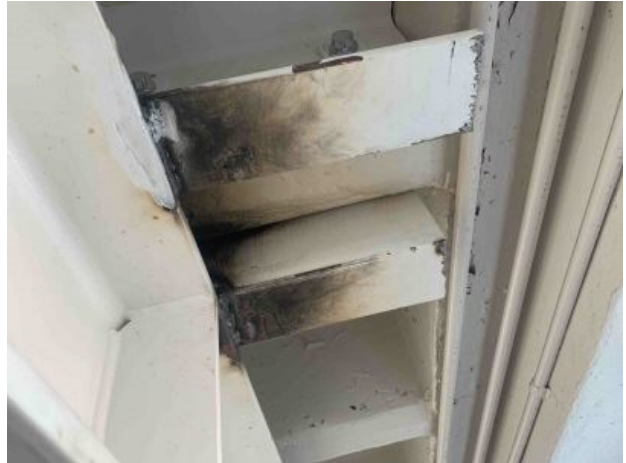
ITEM: 002-011

REMARKS: Paint all steel members. Paint should cover scrapes, welds, and slurry overflow from concrete pour.

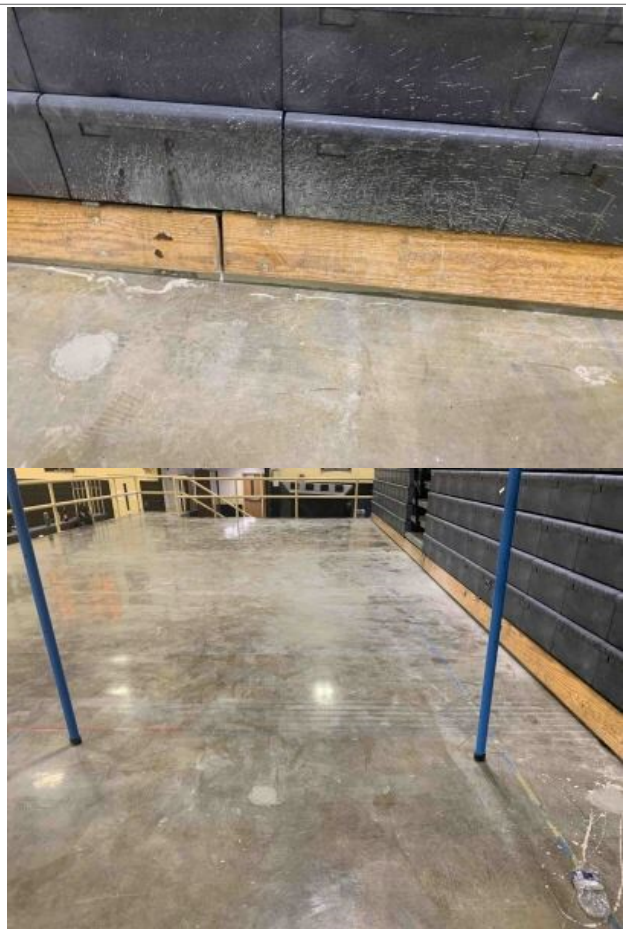
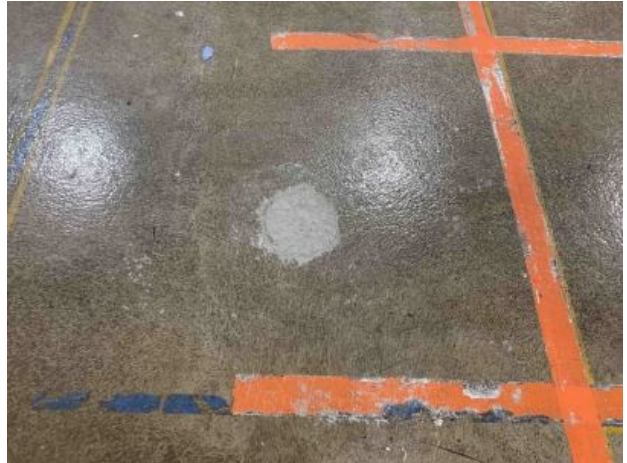
ITEM: 002-012

REMARKS: Concrete placed in holes from the upper levels. Finish is acceptable. This level and the bleachers need to be cleaned free of cement and dust.

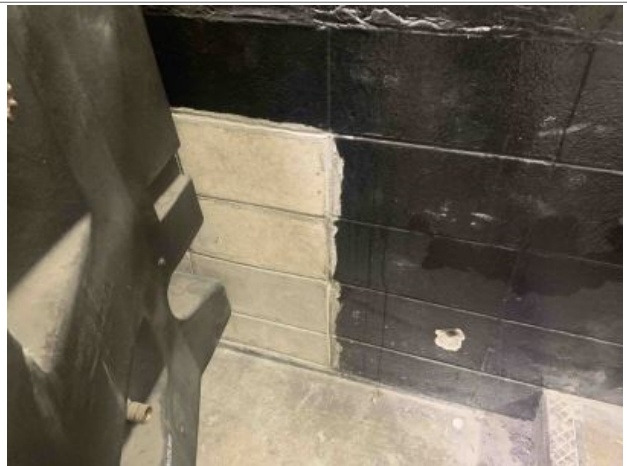
ITEM: 002-013

REMARKS: Patched CMU the contractor used to get the steel beams into the spaces needs to be painted to match existing.

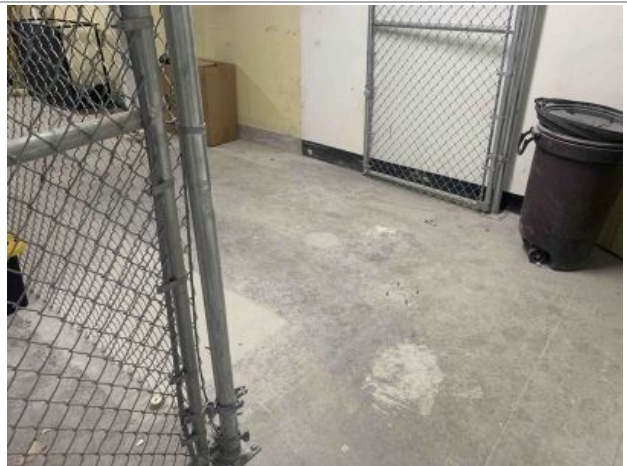
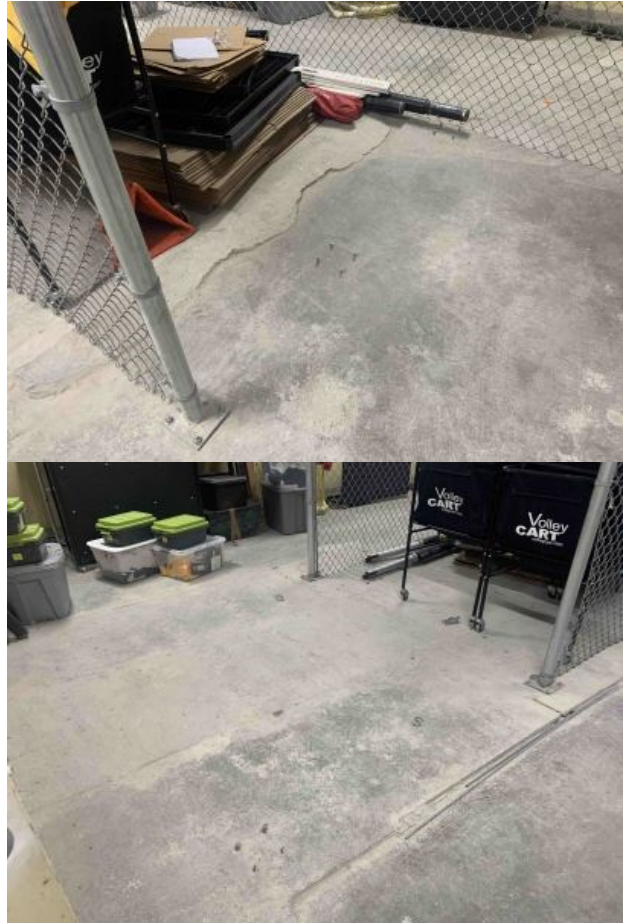
ITEM: 002-014

REMARKS: Additional chain link fencing to be installed back to its original conditions. Please consult with Kody Reed, the custodian, or the architect as required.

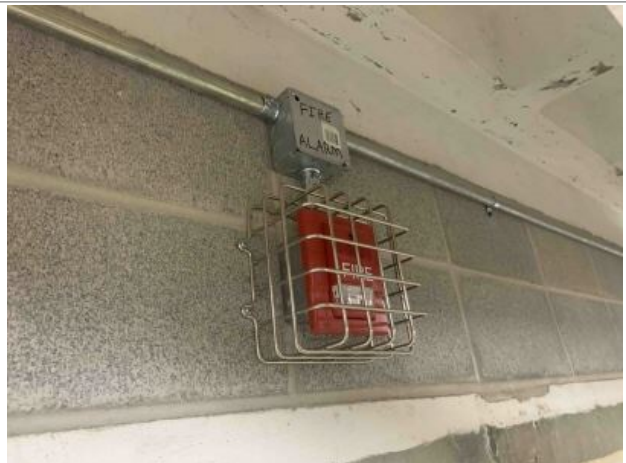
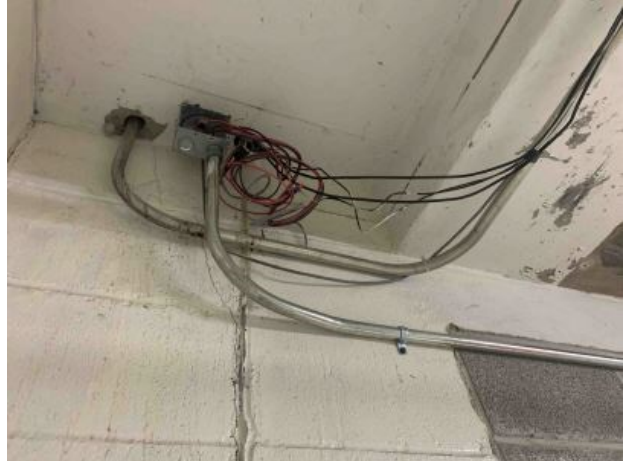
ITEM: 002-015

REMARKS: Fire alarm installation is near completion.  
Final installation is planned for tomorrow.

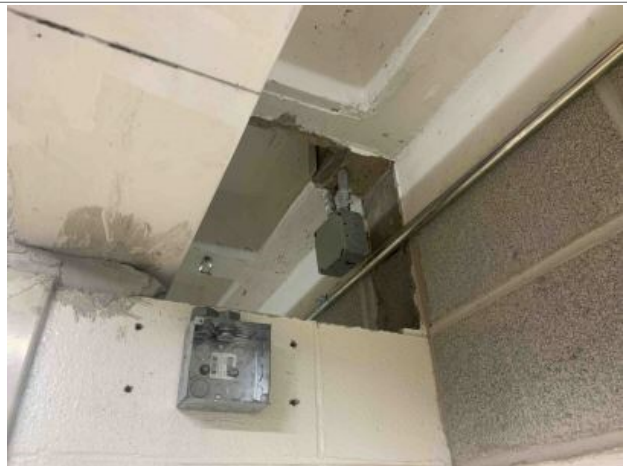
ITEM: 002-016

REMARKS: New junction box to be moved outside of wall so CMU can be patched.

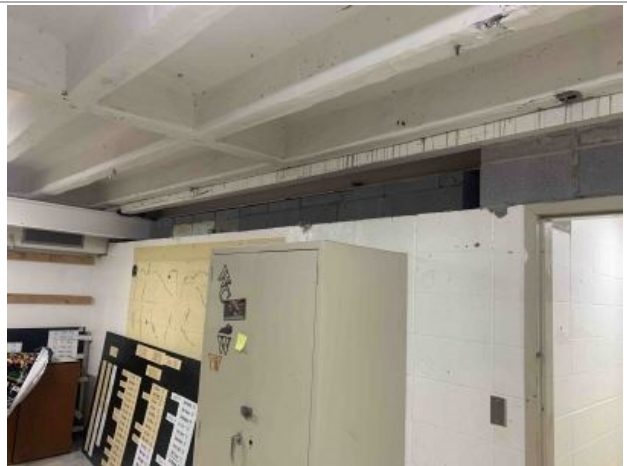
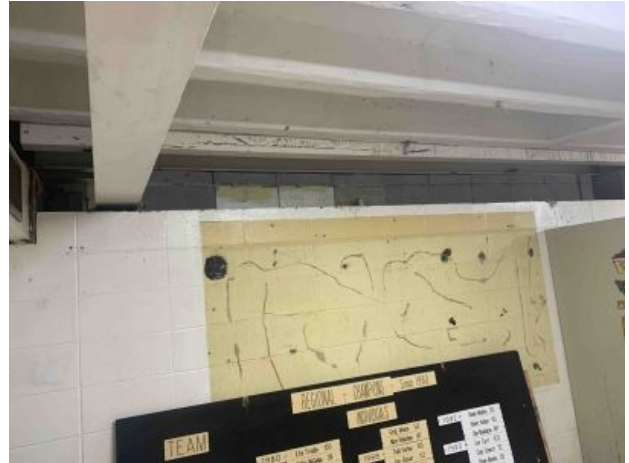
ITEM: 002-017

REMARKS: Replace upper portion of wall with new 6" CMU.
