## FIELD OBSERVATION REPORT

Central Hardin High School, Cecilia, KY

2019111 - CA8

Date: 6/2/2022

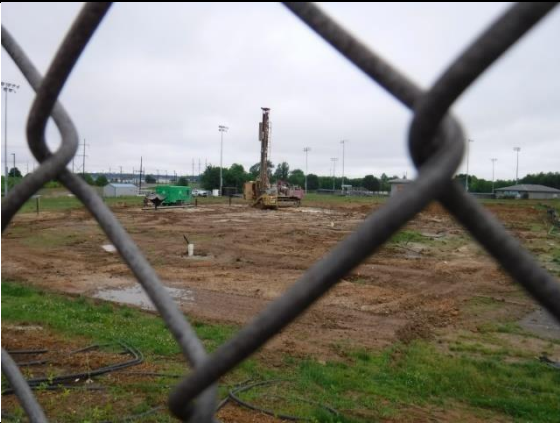
Item No.	Location	Description/Correction	Image	Action
1	Geo-thermal Well Field	The new driller was on site and was drilling wells and placing steel pipe casings down to 105'. A crew will follow up to drill to the design depth and install the loop piping.

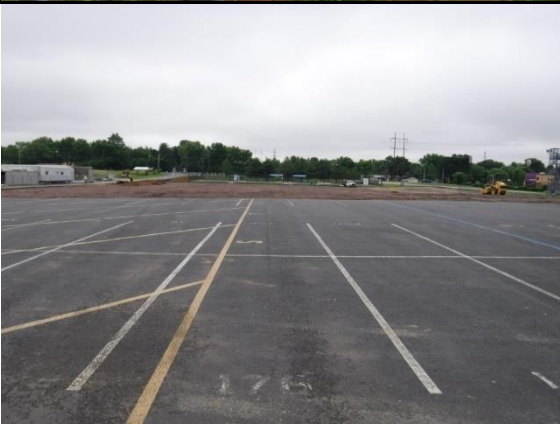
None
2	Student Parking Area	The southern portion of the parking lot had been stripped of the asphalt paving. The crushed stone will be removed next to prepare for the regrade.

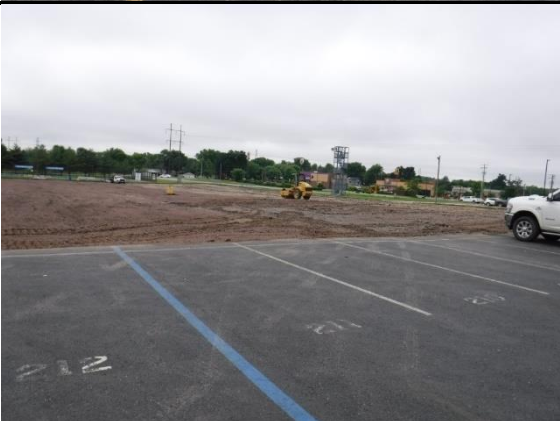
None
3	Student Parking Area	The lot was stripped to the western side of the site.

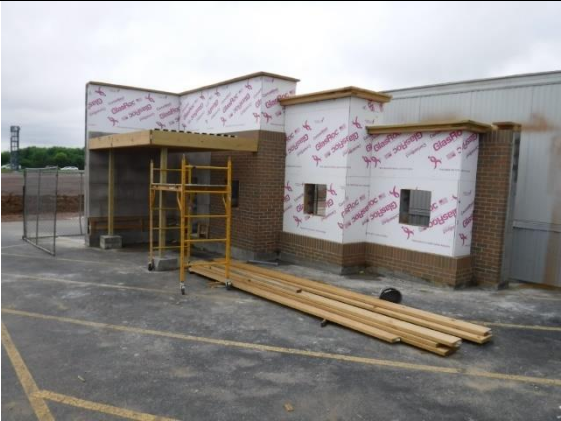
Item No.	Location	Description/Correction	Image	Action
4	Mockup Wall	Gypsum sheathing had been installed over the metal framing.

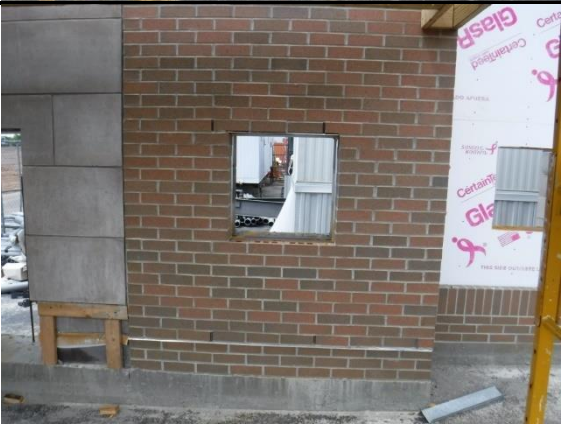
None
5	Mockup Wall	The initial cleaning of the brick had been done. Now that the brick has been cleaned, the blend from dark to light appeared to acceptable the Owners Reps and Architects reviewing it.

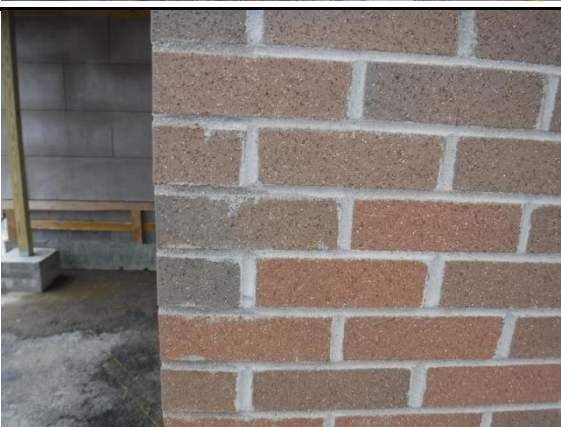
Final approval of the brick will occur after the entire mockup wall is complete.
6	Mockup Wall	The initial cleaning did not remove all the mortar on the face of the brick.

Remove all mortar from the face of the brick.

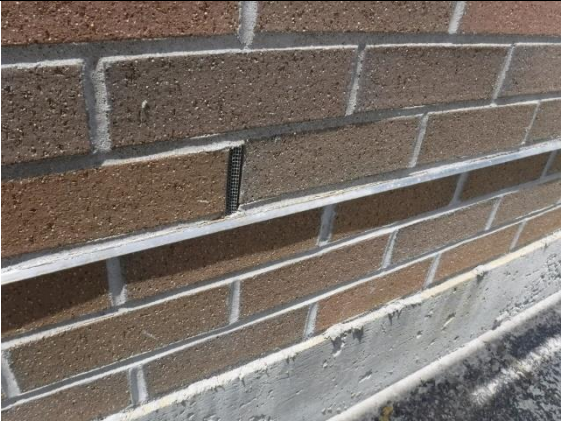
Item No.	Location	Description/Correction	Image	Action
7	Mockup Wall	The flexible flashing had been cut at the face of the brick over the metal drip strip.

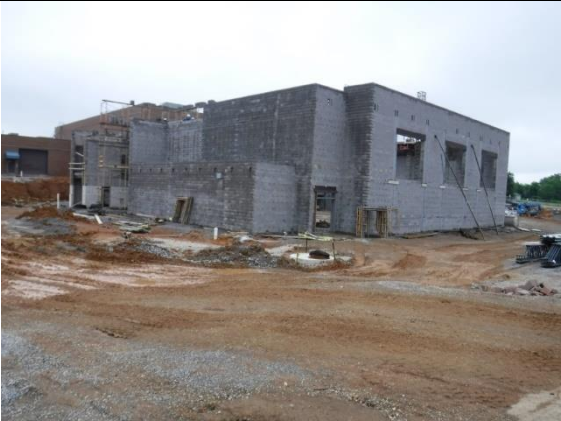
Item No.	Location	Description/Correction	Image	Action
10	Area A	The block at the auxiliary gym is topped out except at the east side on the second floor and the northeast corner that was left out for crane access. The masons have had to move around due to the shortage of grout.

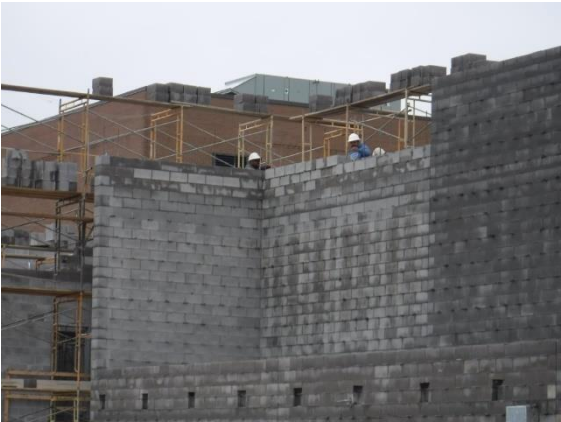
Refer to the response from BKSE for the proper placement of grout.
11	Area A	Concrete block was complete on the west and south sides of the auxiliary gym except at the southeast corner.

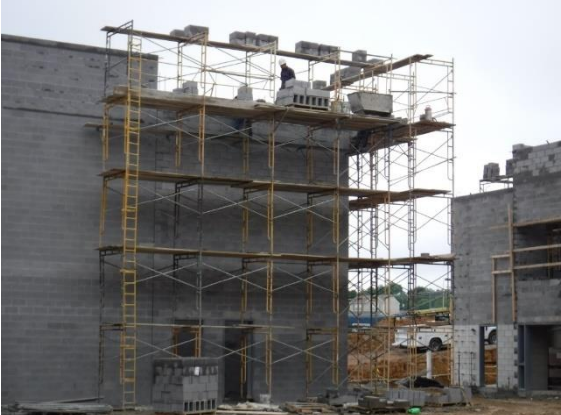
None
12	Area A	Concrete block was being topped out on the north side of the auxiliary gym.

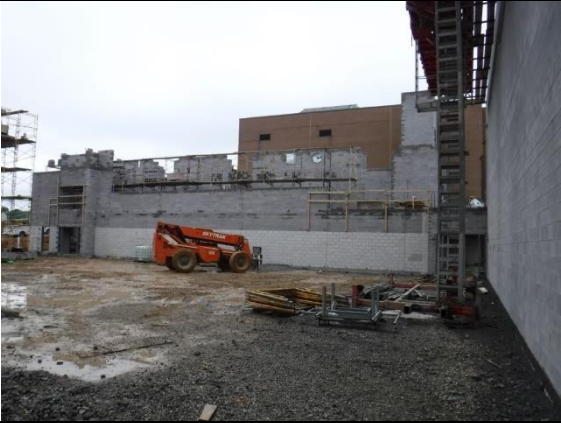
Item No.	Location	Description/Correction	Image	Action
13	Area A	Block walls were being laid above the second-floor level for the east side of the auxiliary gym.

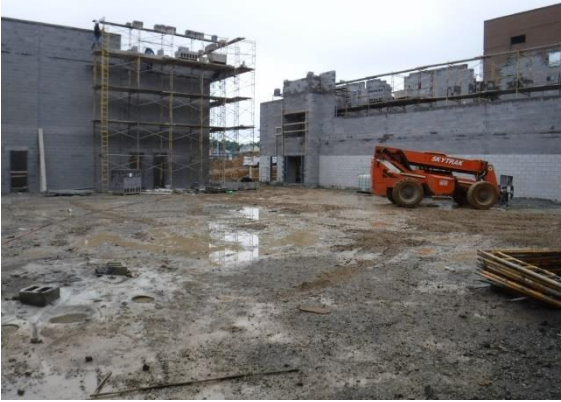
None.
14	Area A	Due to the shortage of concrete, the floor slab for the auxiliary gym will probably be poured after the roof structure is place.

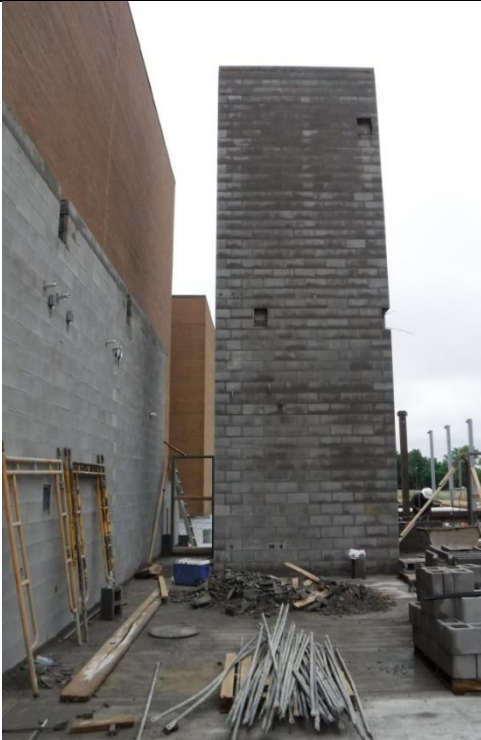
None
15	Area A	The elevator shaft was topped out.

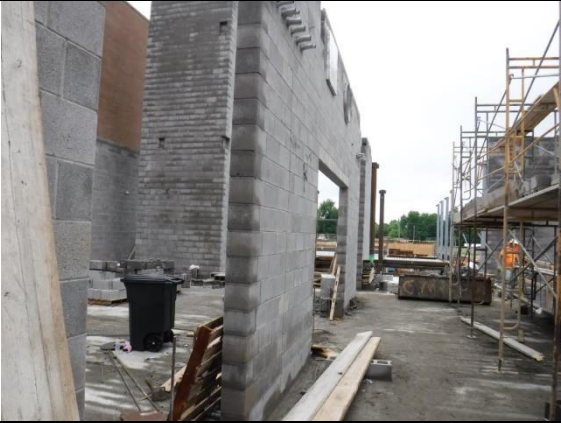
Item No.	Location	Description/Correction	Image	Action
16	Area A	Block walls above the second-floor forming the corridor and rooms in the area.

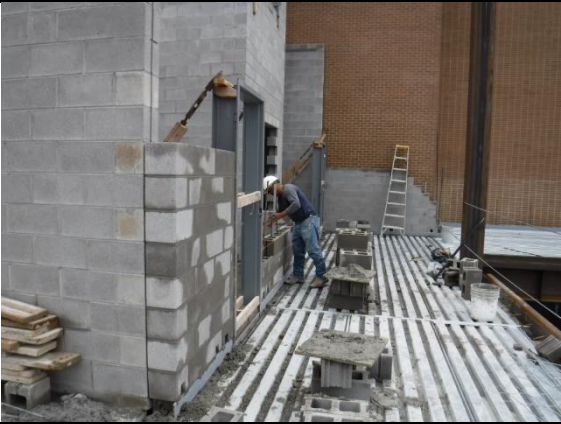
None
17	Area A	Block was being extended to the lobby area on the second floor.

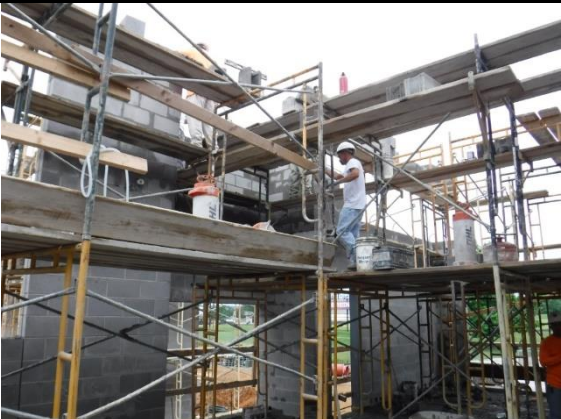
None
18	Area A	Concrete block was being extended to the roof level.

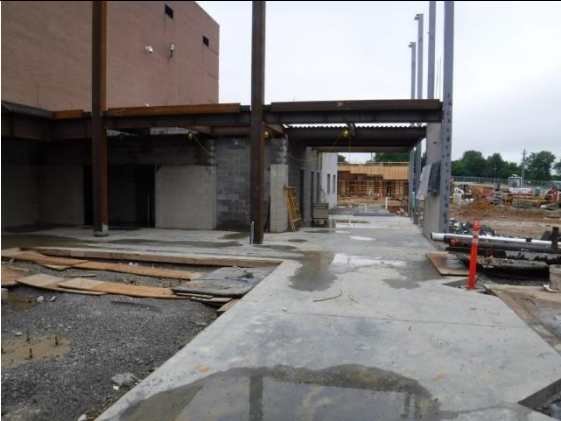
Item No.	Location	Description/Correction	Image	Action
19	Area A and B	The next area for the masons to lay concrete block walls will be the south side of the lobby.

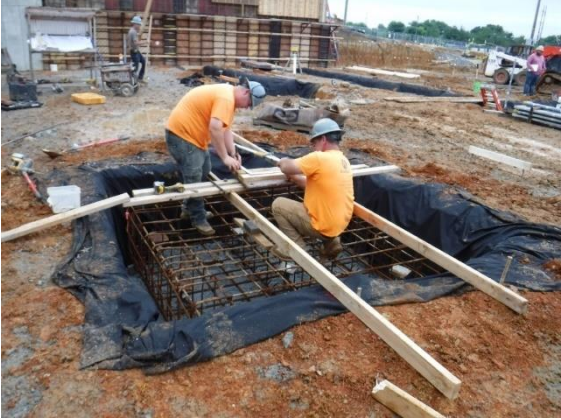
None
20	Area B	Steel reinforcing was being placed in footing excavations for concrete when it is available. Note: Felts were being used to keep footing excavations free from mud.

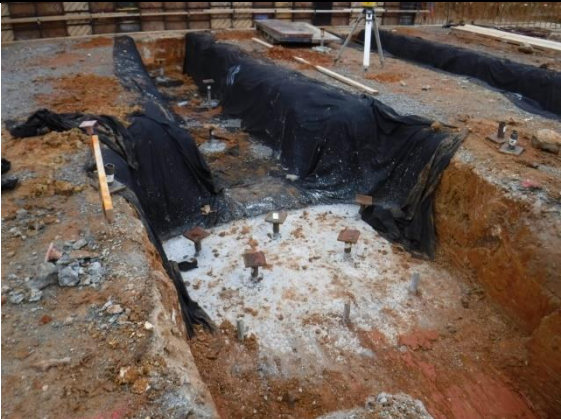
None.
21	Area B	Helical piles were in place for additional footings.

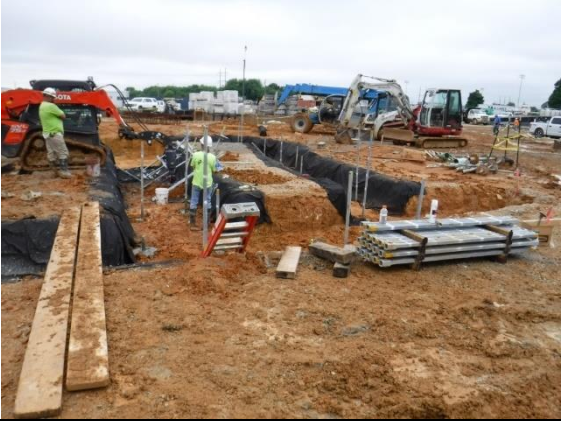
Item No.	Location	Description/Correction	Image	Action
22	Area B	Helical piles were being installed. Refer to the SPIN report from Solid Ground for the status of the piles.

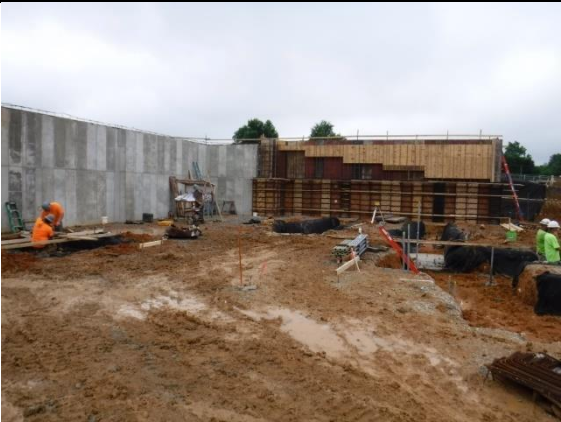
None
23	Area B	The steel reinforcement and forms were being placed for the south retaining wall for the area.

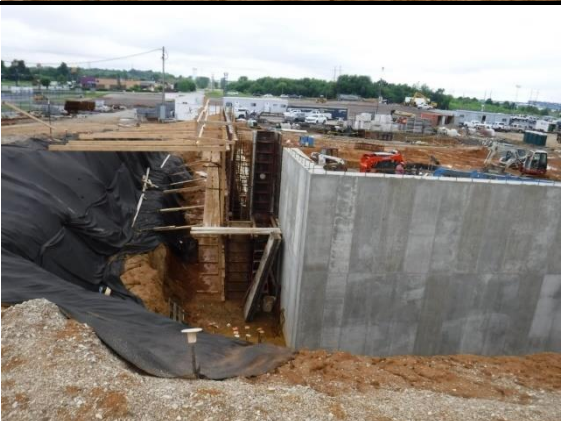
None
24	Area B	The retaining wall will be poured when concrete is available.

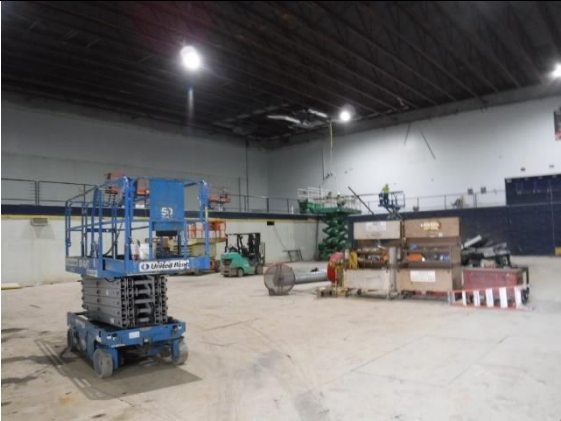
Item No.	Location	Description/Correction	Image	Action
25	Area C - Gym	The bleachers have been removed from the north side of the upper level. The sprinkler contractor was removing existing piping.

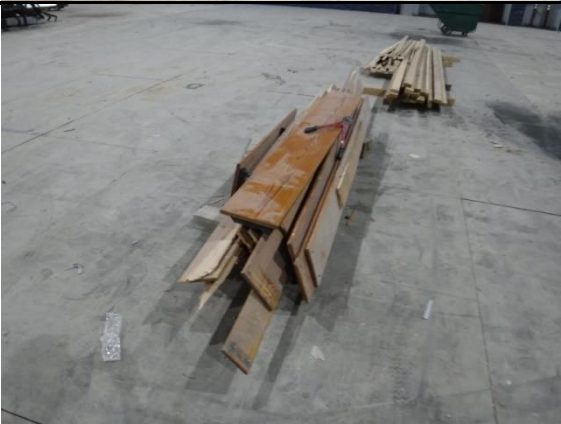
None
26	Area C - Gym	The last of the wood from the bleachers was ready for removal.

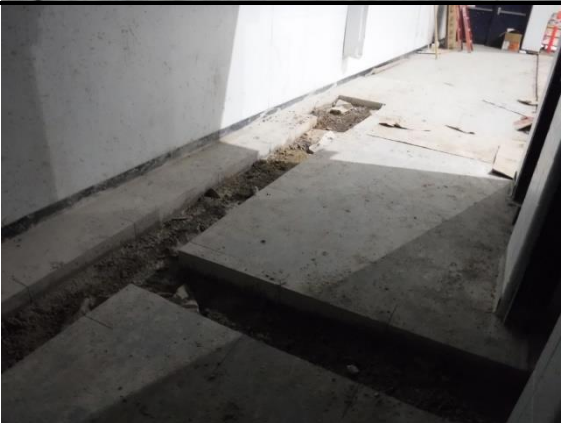
None
27	Area C - Gym	Trenches have been cut on the south side of the gym lower level for plumbing.

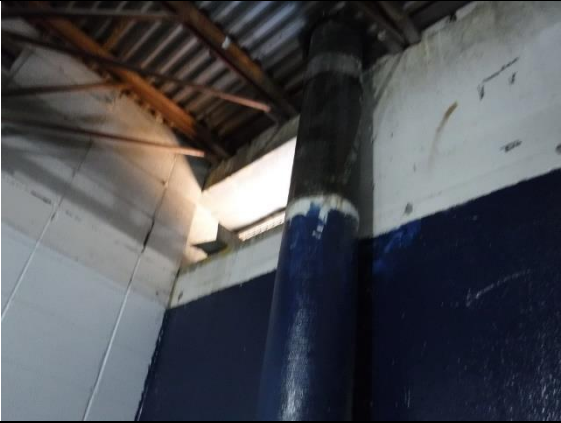
Item No.	Location	Description/Correction	Image	Action
28	Area C - Gym	The ductile iron pipe is an existing roof leader that needs to be connected to the site storm line in the area.

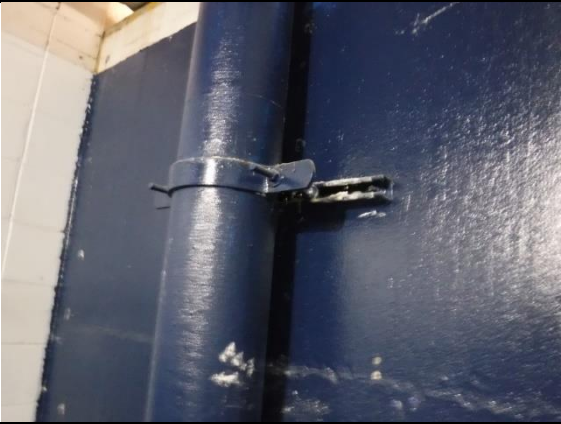
Provide pricing to cut the pipe and extend it out the existing louvered opening in the training room.
29	Area C - Gym	When the roof leader is cut, the existing pipe needs to be resupported.

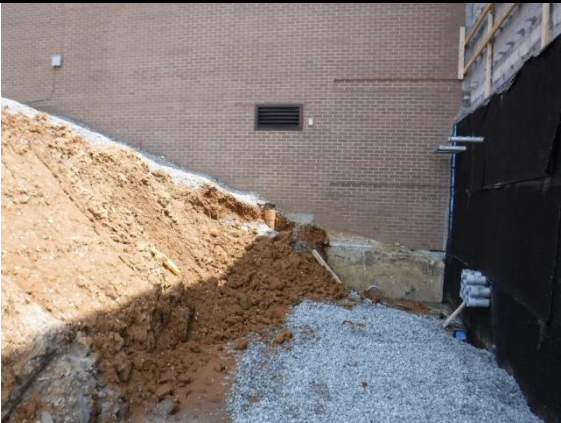
Follow the directions of the PR.
30	Site	The area outside the training room in the gym will be back filled. The storm piping will be routed through the louvered opening. A dryer vent also needs to be extended through the wall.

Follow the directions of the PR.
