# FIELD OBSERVATION REPORT 11

■ TO:	Rob Haney Kenton County Schools 1055 Eaton Drive Fort Wright, Ky 41017	■ DATE:	8/30/22
ATTENTION:			
■ FROM:	Jim Kaiser jkaiser@pca-arch.com 1881 Dixie Highway, Suite 130 Ft. Wright, KY 41011	■ PROJECT:	Addition & renovation to Ryland Heights Elementary
COPIES TO:	Mr. Chad Atchley, Ms. Carrie Hooten	PROJECT NO.:	2021-001
■ WE TRANSMIT THE ATTACHED ITEMS VIA: <b>EMAIL</b>			
PURPOSE	<input type="checkbox"/> For your use <input type="checkbox"/> As requested <input type="checkbox"/> For review and comment <input type="checkbox"/> For information <input type="checkbox"/> For record <input type="checkbox"/> For approval <input type="checkbox"/>	DISPOSITION	<input type="checkbox"/> No exceptions noted <input type="checkbox"/> Exceptions noted, Revise as indicated. <input type="checkbox"/> REJECTED: REVISE AND RESUBMIT <input type="checkbox"/>

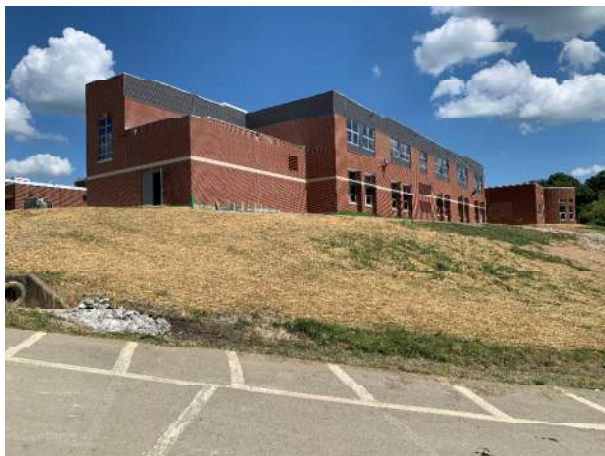
Classroom wing addition

07.02: Metal wall panels are complete on classroom wing addition

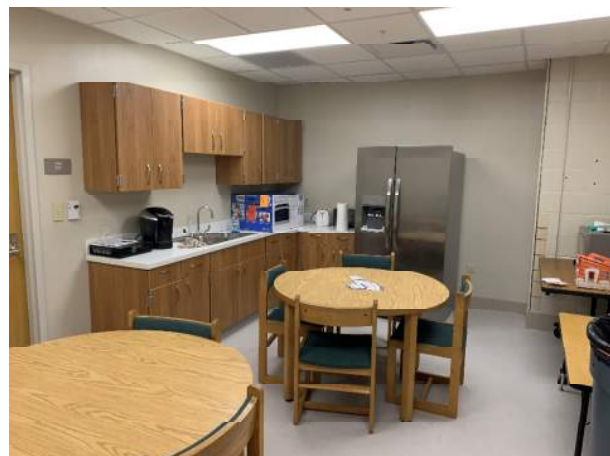
Teacher's Lounge

06.01: Cabinet/counter have been installed in new art classroom and teacher lounge

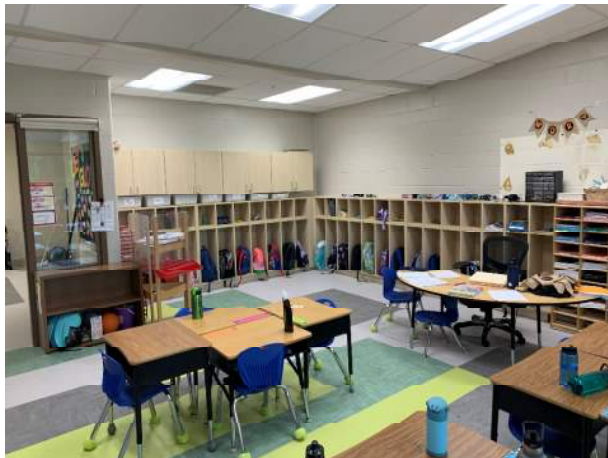
Typical restored first floor classroom

06.02: New cubbies and wall cabinets have been installed in first floor classrooms damaged by water during construction

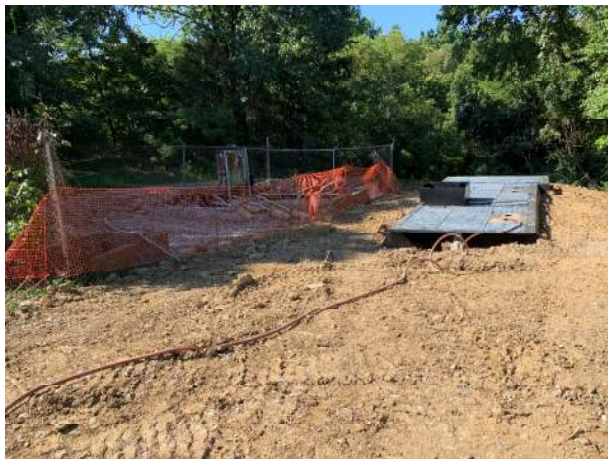
32.04 Wastewater treatment plan installation is progressing. New tank is installed

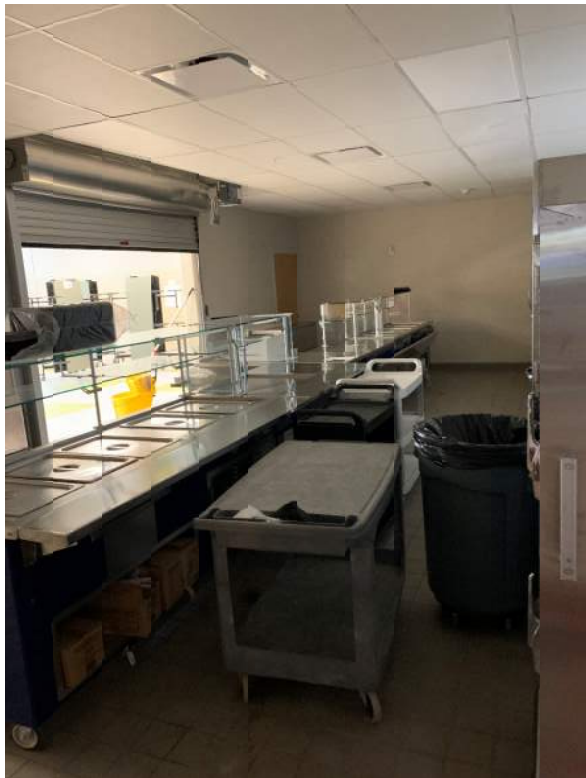
New Servery

11.02 Kitchen equipment is installed in new Servery
