# Memorandum

Date: September 28, 2022  
Project Number: 22103.02  
Project Location: Newport, Kentucky  
Subject: Newport High School Stadium Seating  
Preliminary Findings  
 For Review  
From: C. Casey Hitter P.E.  
Client: Robert Ehmet Hayes and Associated, PLLC.  
Attention: Noah Onkst

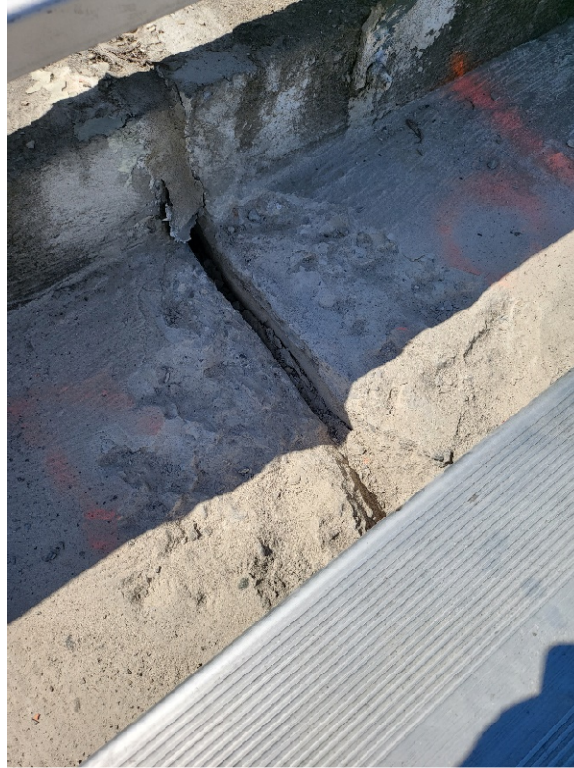
*Photo 1: This photo is one of three expansion joints that run from the bottom of the stands to the top. The existing joint material was removed for further observation. These joints will need to be replaced their entire length.*

- There are expansion joints in the slab that run the bottom of the seating to the top. These joints need to be completely removed and then resealed their entire length.

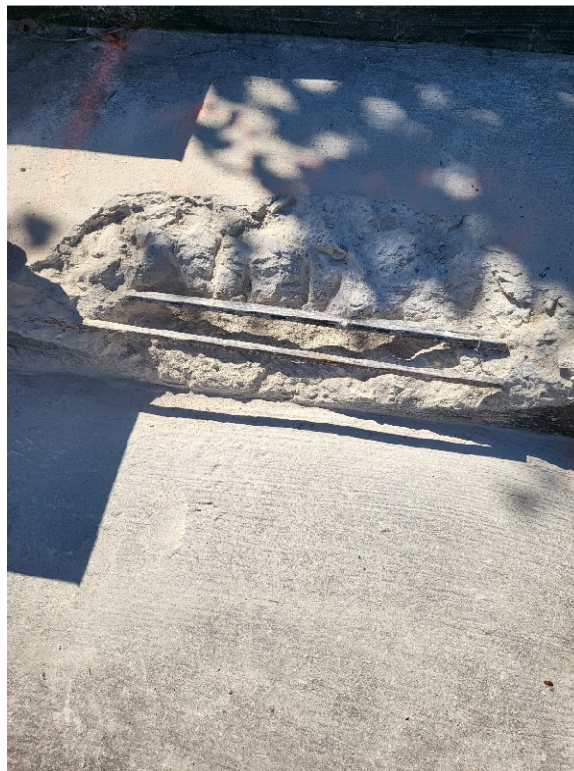
*Photo 2: Exposed reinforcing at the top of the stands. The reinforcing was found to be 1/2", square bars with deformations and signs of corrosion or rust. The concrete was also found to be in good condition. This condition is typical at the top of the stands.*

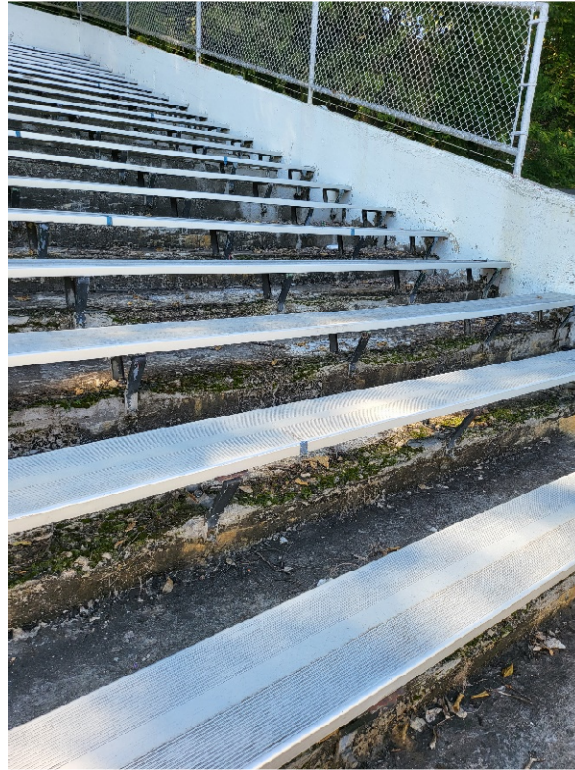
*Photo 3: Typical conditions of the lower portion of the stands. This photo was taken at the north of the stands. Note the cracking at the face of each step and the moss growth indicating that this area is subjected to continuous moisture conditions.*

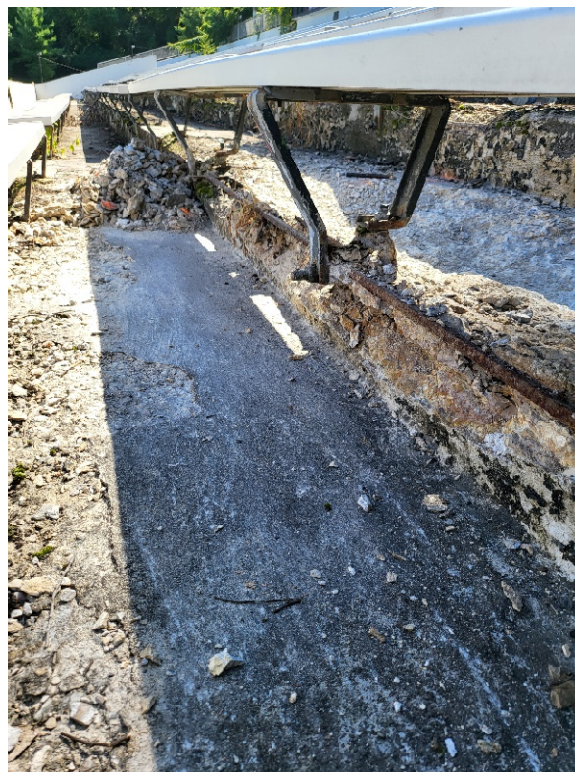
Carbonation in concrete is the result of un-hydrated cement in concrete reacting with carbon dioxide in the air. Over long periods of time carbon dioxide will begin to breakdown the concrete, causing it to become soft and crumble. This reaction starts at the surface of the concrete but slowly migrates deeper into the slab. Older concrete structures (60+ years) that are exposed to exterior conditions are especially susceptible to this. There is strong evidence of carbonation in the core taken at the lower portion of the stands. This core has a "chalky" feel to it at the top near the exposed surface but does improve near the bottom; also, SSRG noted that this core broke apart as it was being cut, further confirming the presence of carbonation. Laboratory testing can help verify the depth of carbonation, which may help to determine how much concrete must be removed and then repaired. This type of testing must be performed by a qualified laboratory and may require more cores to be taken.

*Photo 4: Typical conditions at the lower portion of the stands. Note the rusted reinforcing bar and "chalky" concrete texture indicating significant carbonation in the concrete.*

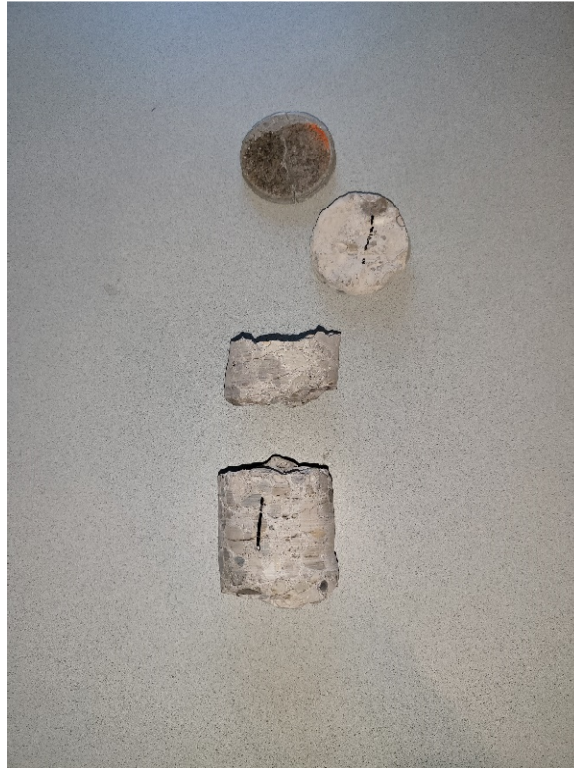
*Photo 5: Core 1, taken at the lower portion of the stands on the north end. The top of the core is up in this photo and was falling apart as it was being drilled. The top portion also appears soft, indicating a significant amount of carbonation.*

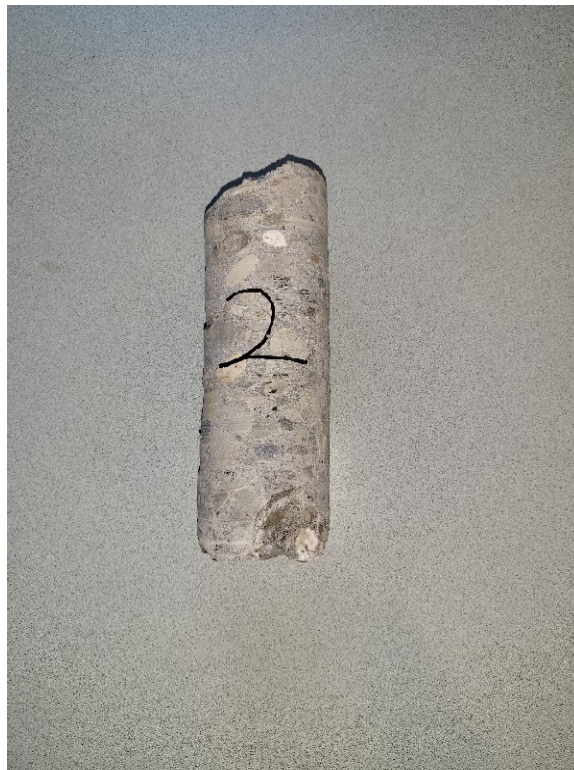
*Photo 6: The second core was taken in the middle of the seating. The top of the core is soft similar to the first but does penetrate the depth of the concrete more than two inches.*

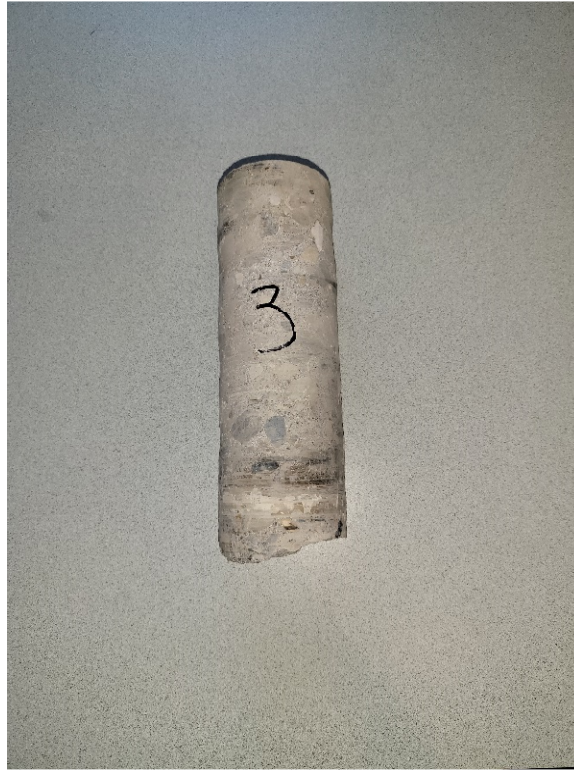
*Photo 7: The third core was taken at the top of the sands on the south end. There are no visible signs of carbonation, and the concrete appears to be in very good condition.*
