FIELD OBSERVATION REPORT

2022-10 (Scott Phase V)

■ то:	Kenton County Board of Education 1055 Eaton Drive Ft. Wright, KY 41017	■ DATE:	2022.10.26
ATTENTION:	Mr. Rob Haney		
FROM:	Mark Perry mperry@pca-arch.com	■ PROJECT:	Kenton County School District Scott Phase V
	906 Monmouth Street		
	Newport, KY 41071		
	V: 859.431.8612 • D: 859.578.6013		
COPIES TO:	Mr. Kevin Pfefferman; Ms. Carrie Hooten	PROJECT NO.:	20-032
■ WE TRANSMIT THE ATTACHED ITEMS VIA: eComm			
PURPOSE		DISPOSITION	No exceptions noted
	☐ As requested		Exceptions noted,
	For review and comment		Revise as indicated.
	☐ For information		REJECTED:
			REVISE AND RESUBMIT
	☐ For approval		
COPIES DA	TE DESCRIPTION		PAGES
1 20	22-10 Field Observation Report		11

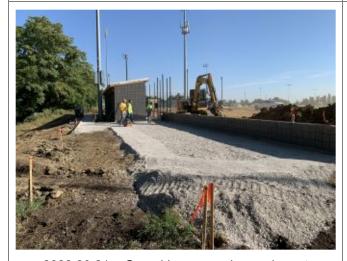
2022.09.21 – Bleacher seating area East of visitor dugout

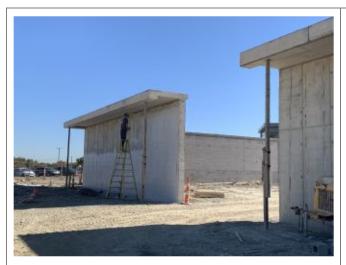
2022.10.05 - Pool entry

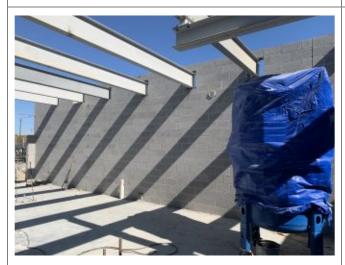
2022.10.15 - Looking toward pool equipment room

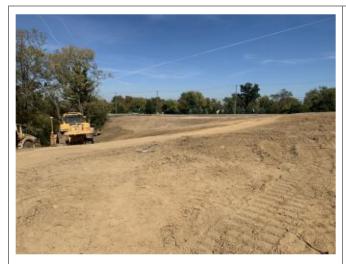
2022.10.15 - Taylor Mill site work

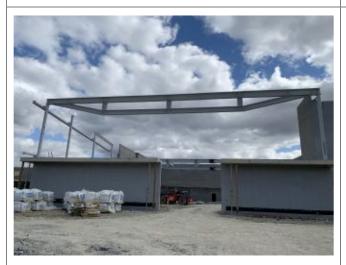
2022.10.17 - Practice gym roof

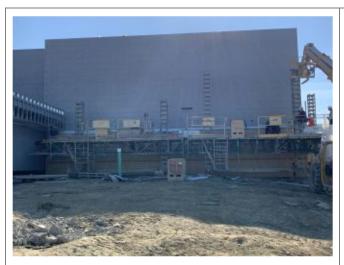
2022.10.17 - Tennis courts

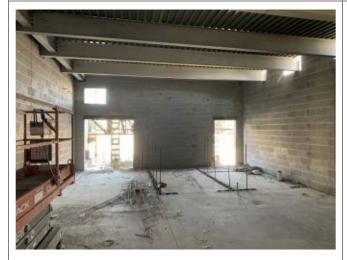
2022.10.19 - Corridor 1900C

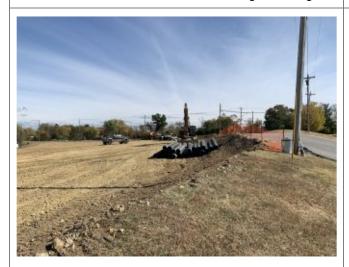
2022.10.19 - Taylor Mill detention basin
