FIELD OBSERVATION REPORT

2022-11 (Scott Phase V)

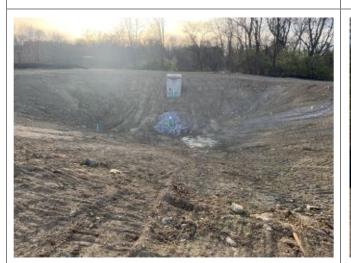
2022.11.09 – Taylor Mill detention basin

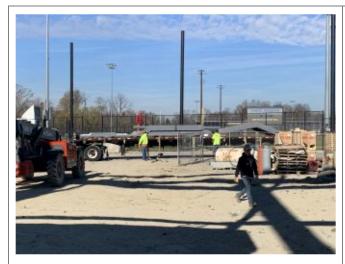
2022.11.09 - Monumental stair arriving

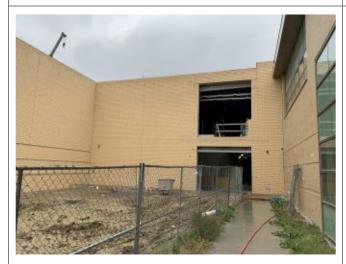
2022.11.16 – Exterior of monumental stair
