FIELD OBSERVATION REPORT

2023-04 (Scott Phase V)

■ TO:	Kenton County Board of Education 1055 Eaton Drive Ft. Wright, KY 41017	■ DATE:	2023.04.17
ATTENTION:	Mr. Rob Haney		
■ FROM:	Mark Perry mperry@pca-arch.com 906 Monmouth Street Newport, KY 41071 V: 859.431.8612 • D: 859.578.6013	■ PROJECT:	Kenton County School District Scott Phase V
COPIES TO:	Mr. Kevin Pfefferman; Ms. Carrie Hooten	PROJECT NO.:	20-032

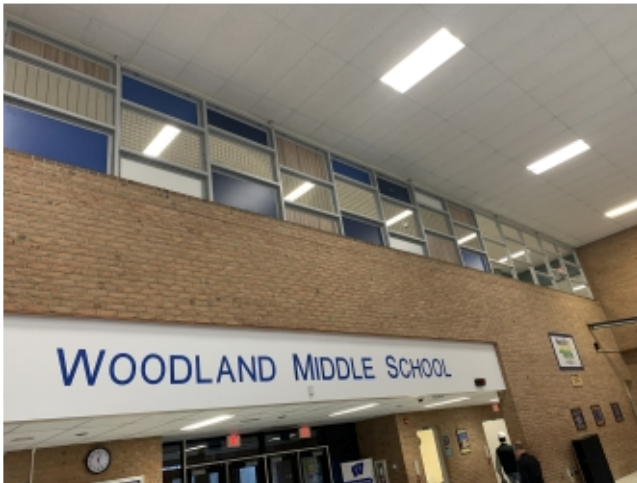
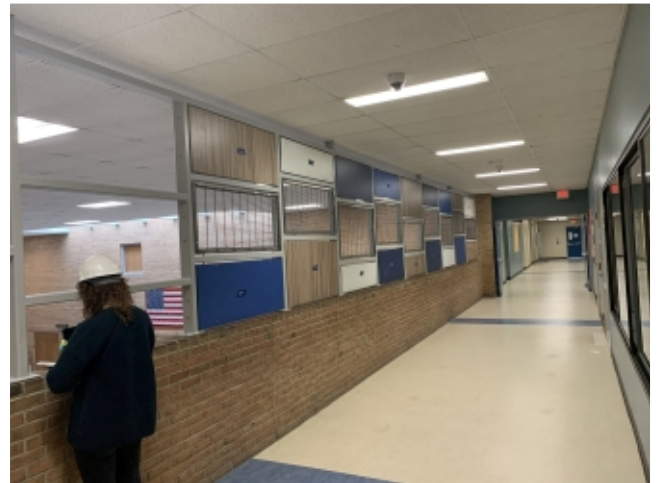
06.01: 2023.03.22 – The 2nd floor screening at Woodland was reviewed for detailing and craftsmanship at the request of Morel. Several panels were identified as being out of plumb. One panel was identified as

having wood grain pattern in the wrong direction. Several more panels were identified as being scratched / damaged.

2023.03.22 – Woodland 2nd floor screen.

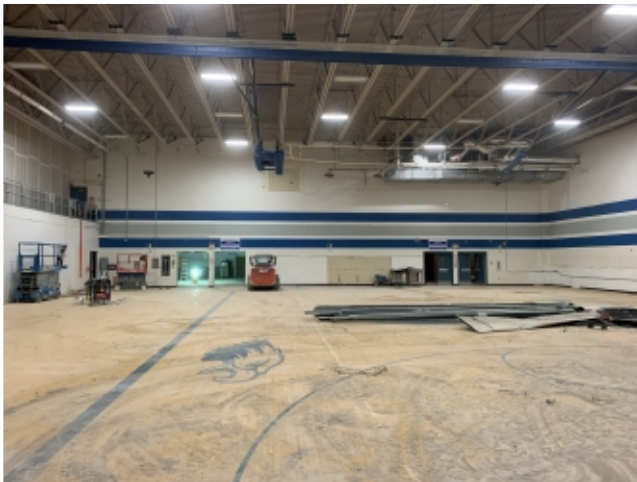
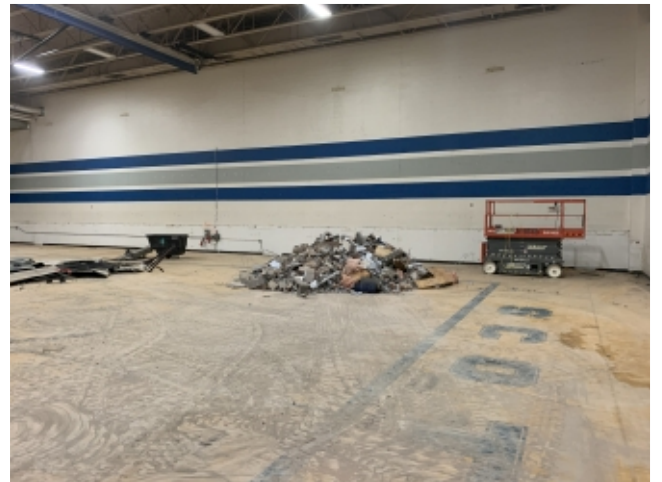
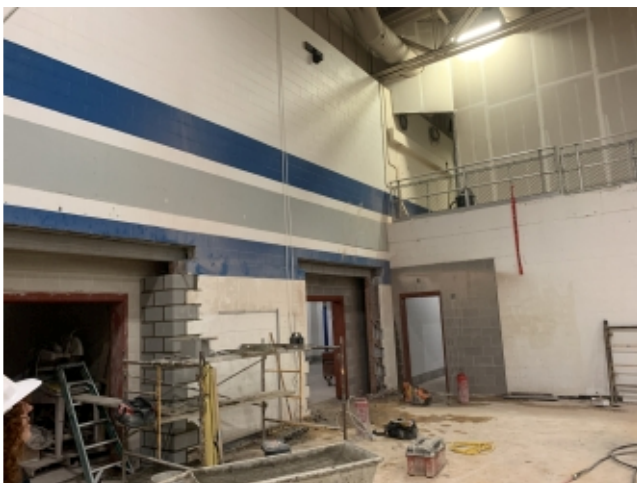
02.01: 2023.03.22 – Demolition activities were well underway at the first floor of Area A. Basketball goals and scoreboards had been removed in the main gym. Corridor walls were actively being removed under the auditorium seating tiers. Former band room walls and former concession stand walls were already removed. Demolition was actively occurring at the stage. Brick veneer had been removed on the exterior wall north of the stage. It was reported that dumpster swaps have been a limiting factor due to a driver shortage.

2023.03.22 – Main gym demolition.

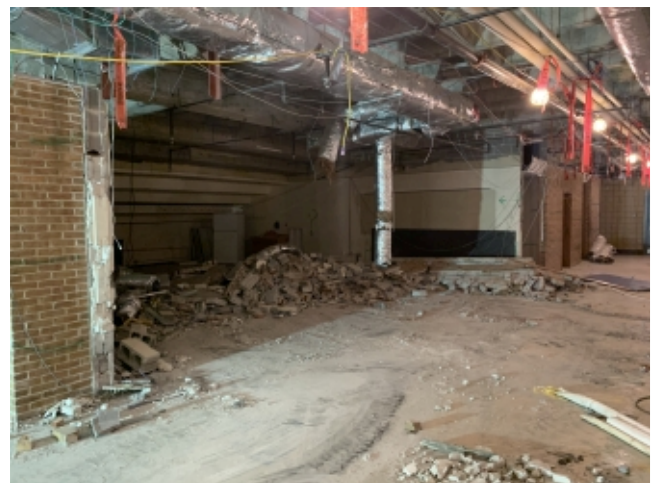
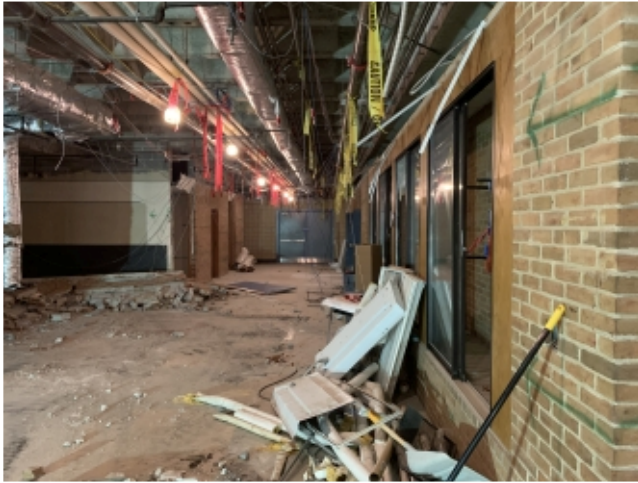
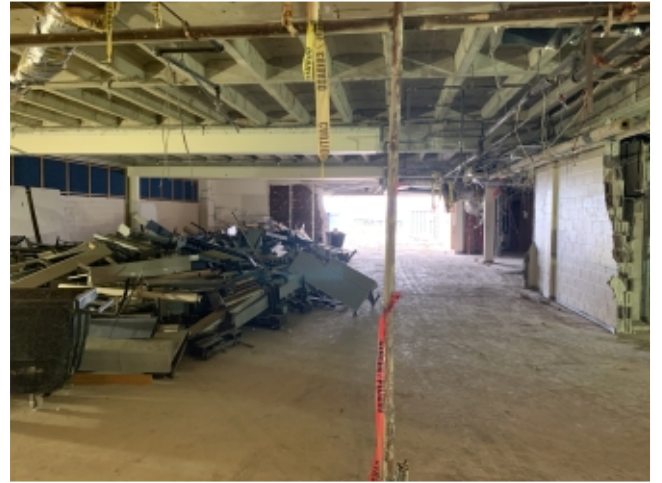
2023.03.22 – First floor demolition.

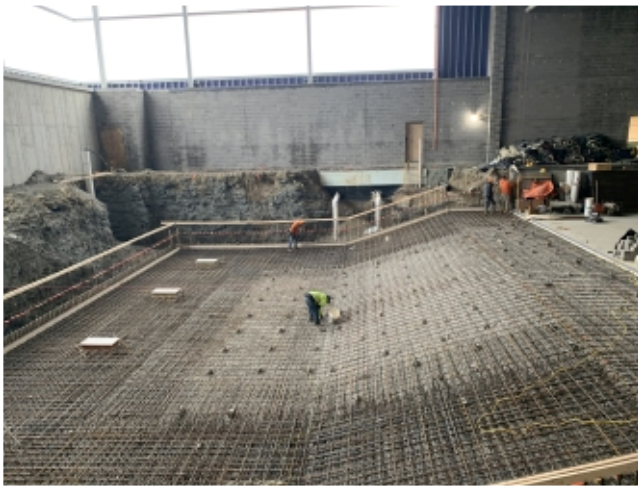
13.01: 2023.03.22 – The rebar mat for the deep end pool floor appeared complete and ready for inspection by Aldo with WTI. Pool equipment room piping had progressed.

2023.03.22 – Pool deep end.

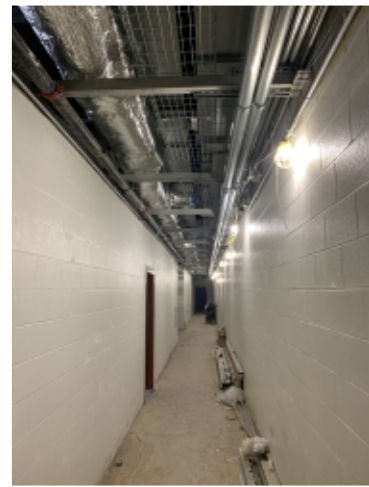
20-28.04: 2023.04.05 – Fire suppression piping had been installed at Corridor 2800C and connecting spaces.

2023.03.22 – Corridor 2800C.

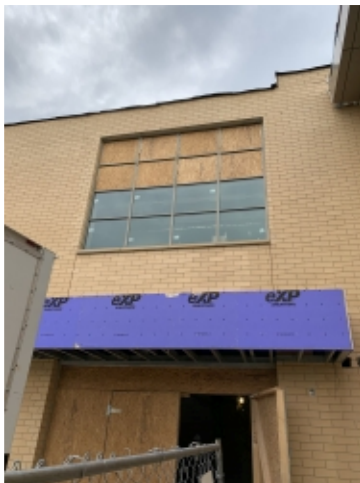
08.01: 2023.04.05 – Aluminum storefront window at 2nd floor of monumental stair had been installed, with clear glass and plywood.

2023.04.05 – Storefront window.

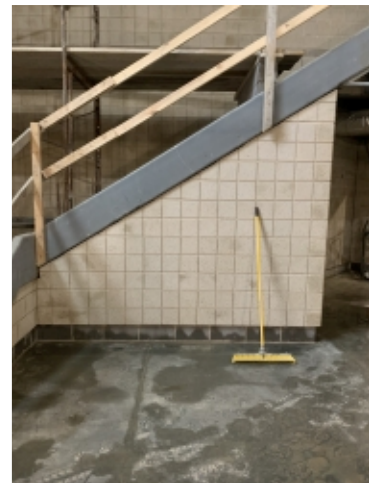
04.02: 2023.04.05 – Cleaning of interior burnished block had recently occurred in advance of sealing.

2023.04.05 – Cleaned CMU at monumental stair.

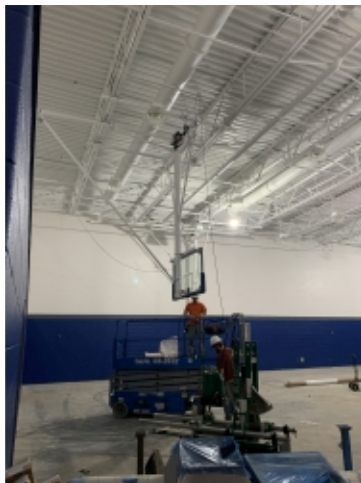
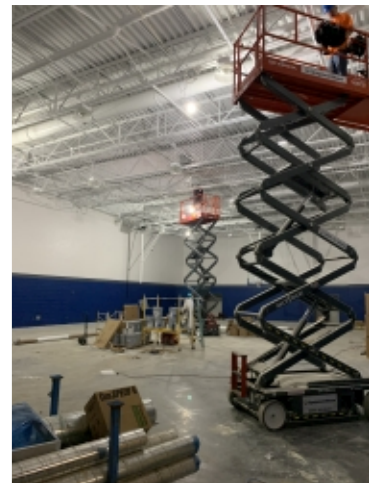
11.01: 2023.04.05 – A crew was installing basketball goals in the practice gym

2023.04.05 – Basketball goal installation in practice gym.

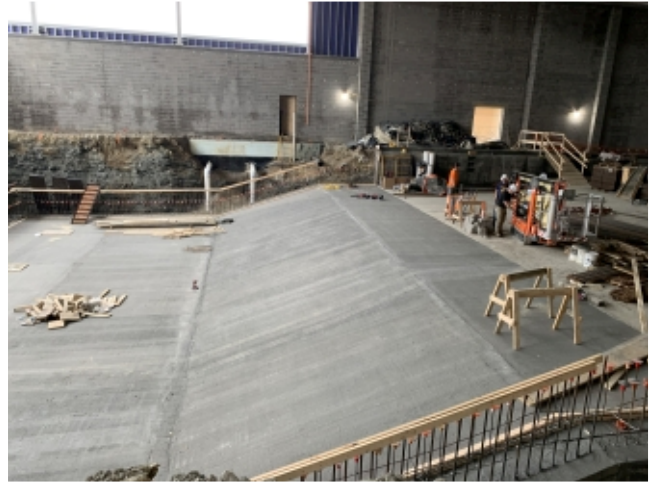
13.02: 2023.04.05 – The deep end floor had been poured. Wall forms were being staged for installation

2023.04.05 – Pool deep end.

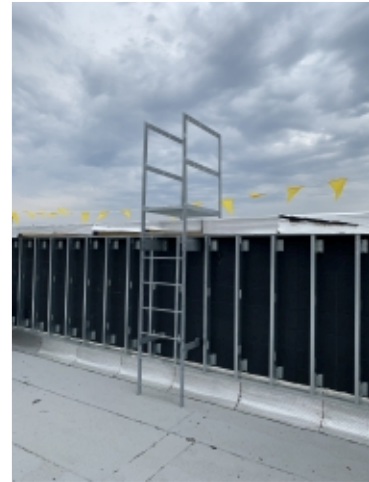
05.01: 2023.04.05 – Roof access ladder had been installed in concession storage but not the pool equipment room.

2023.04.05 – Roof ladder up to high roof.

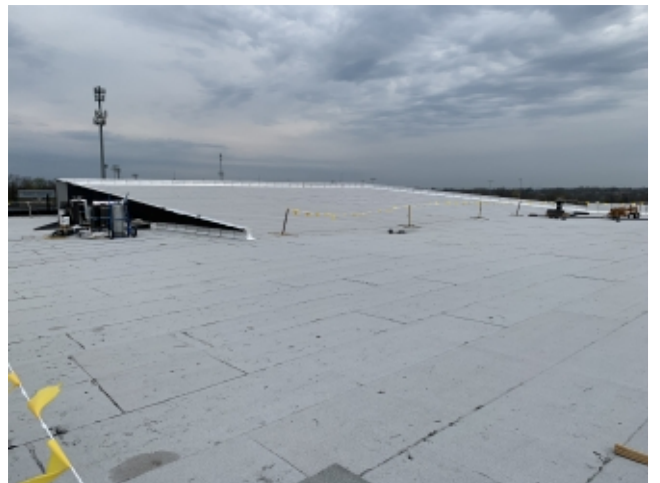
07.02: 2023.04.05 – Re-roof was apx. 20% complete at the high roof.

2023.04.05 – High roof.

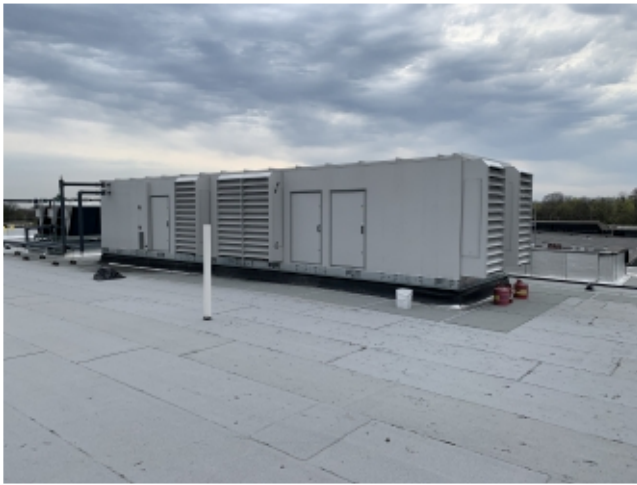
20-28.01: 2023.03.22 – 2nd floor ductwork appeared largely complete in the addition. Dehumidification unit has been ducted and insulated.

2023.04.05 – Dehumidification unit.

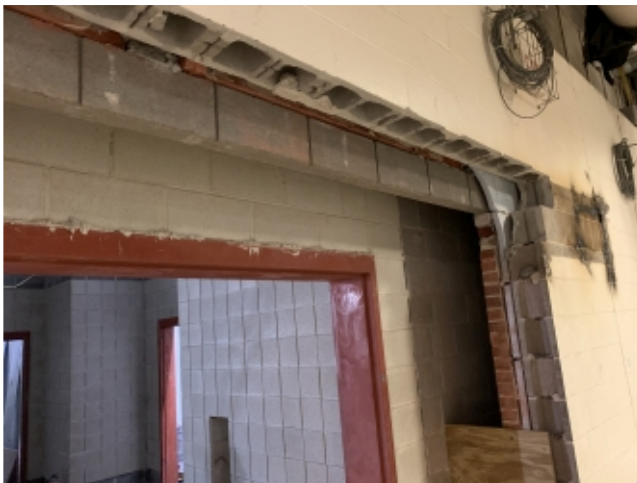
02.02: 2023.04.05 – The main gym floor had been removed. The contractor was actively removing the balance of 1st floor interior walls which were in a pile under the tiered seats of the auditorium. Seats had been removed from the auditorium. The temporary partition at the East end of Corridor 1800C had been removed. The winch beam at the main gym mezzanine seating had been removed.

2023.04.05 – Former winch beam location.
