## FIELD OBSERVATION REPORT

### 2023-05 (Scott Phase V)

■ TO:	Kenton County Board of Education 1055 Eaton Drive Ft. Wright, KY 41017	■ DATE:	2023.05.25
ATTENTION:	Mr. Rob Haney / Mr. Matt Rigg		
■ FROM:	Mark Perry mperry@pca-arch.com 906 Monmouth Street Newport, KY 41071 V: 859.431.8612 • D: 859.578.6013	■ PROJECT:	Kenton County School District Scott Phase V
COPIES TO:	Mr. Kevin Pfefferman; Ms. Carrie Hooten	PROJECT NO.:	20-032

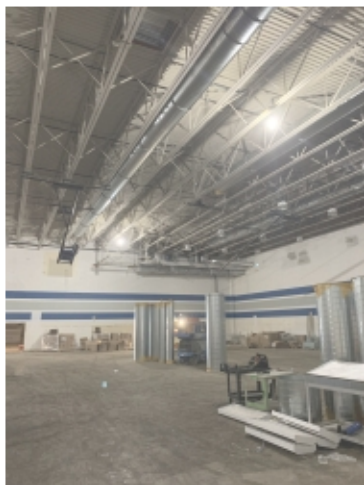
2023.04.19 – Main gym

20-28.01: 2023.04.19 – Several rows of new light fixtures had been installed in the main gym. New ductwork was apx. 65% complete in the main gym as well. Roof leader piping appeared complete in the main gym.

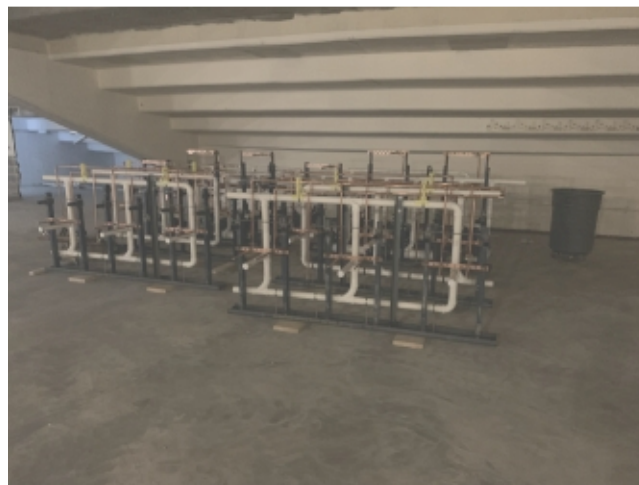
*Plumbing carriers were staged at the first floor corridor in Area A. A series of light fixtures had been installed in the pool space. Fixture color was noted as being a concern. Light fixtures had been energized in Corridor #1800C. Geothermal wells were actively being bored with two drill rigs being utilized.*

2023.04.19 – Carrier assemblies staged for installation

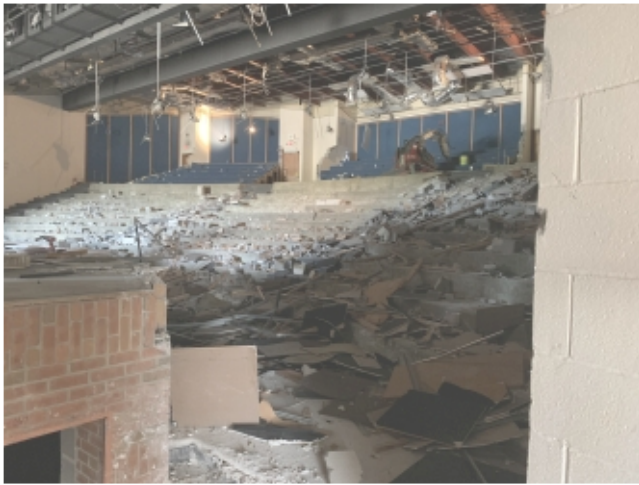
2023.04.19 – Auditorium demolition

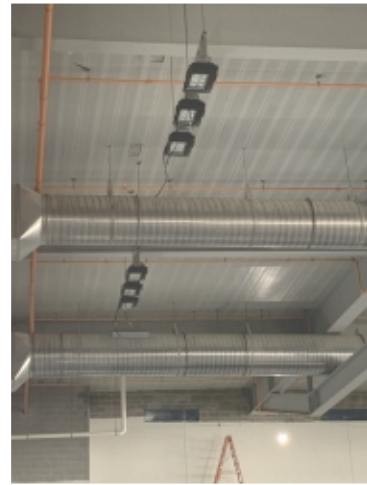
2023.04.19 – Pool light fixtures

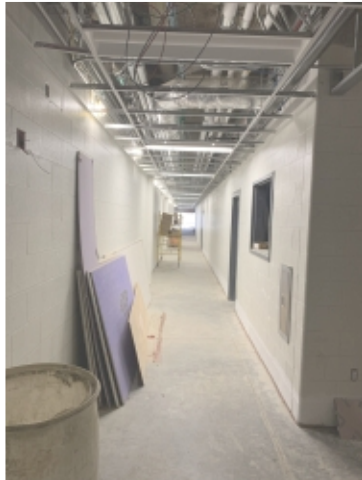
2023.04.19 – Corridor 1800C

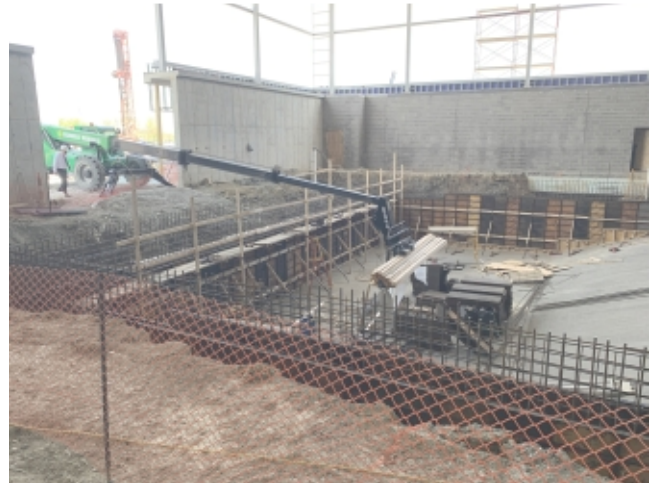
13.01: 2023.04.19 – Deep end wall forms were being installed in advance of an upcoming pour. Wall reinforcing was largely complete.

2023.04.19 Pool deep end

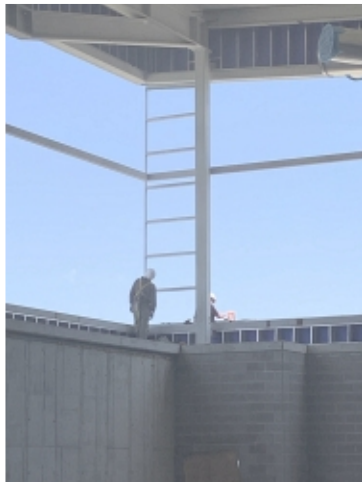
08.01: 2023.04.19 – A crew was actively installing curtain wall at the East wall of the pool.

2023.04.19 – Curtain wall installation

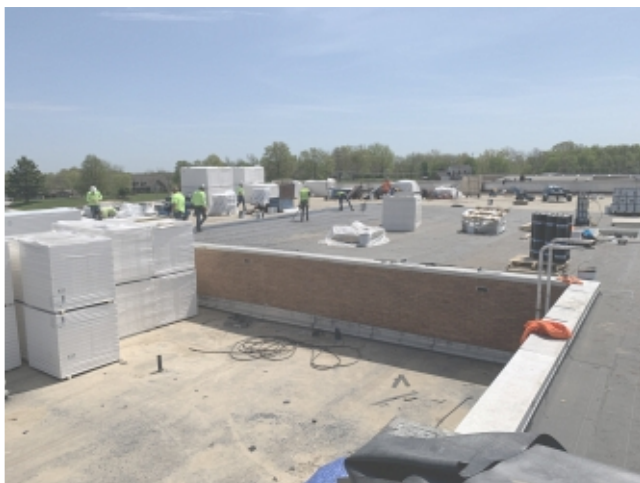
07.01: 2023.04.19 – A roofing crew was actively working on re-roof over the Auditorium. The manufactured canopy had been installed over the exterior exit doors in the East pool wall.

2023.04.19 – Roof over existing auditorium

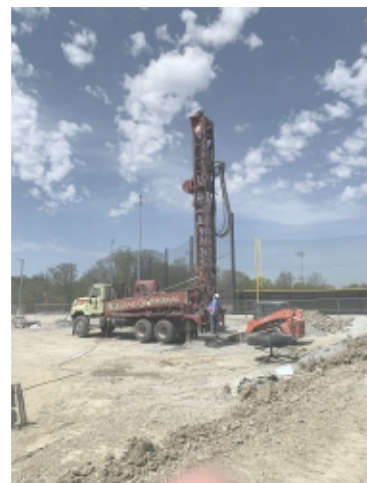
2023.04.19 – Geothermal well field boring

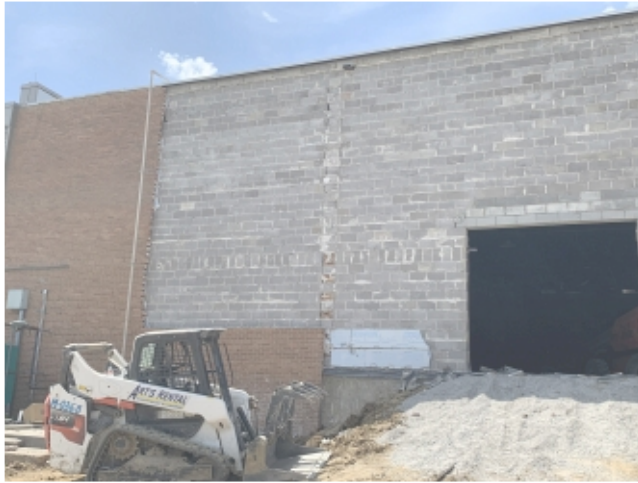
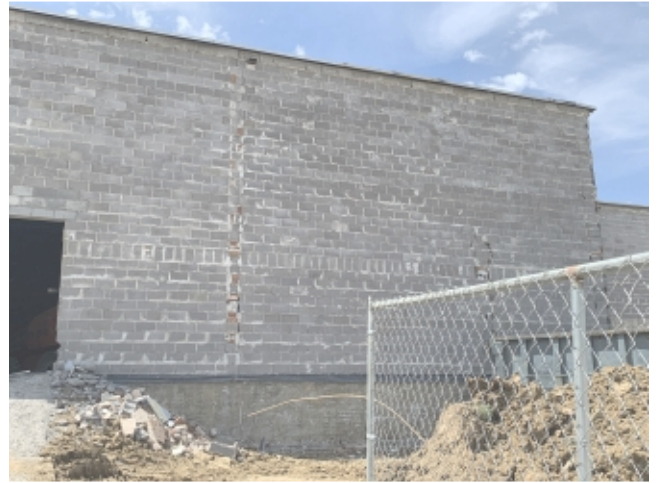
02.01: 2023.04.19 – The temporary partition at the main gym spectator seating area had been removed, as had existing lights and wiring. The louver opening in the West masonry wall appeared complete. First floor demolition appeared to be largely complete outside of the Auditorium. Crews were actively removing materials in the Auditorium. Brick veneer had been removed at the East exterior wall of the Auditorium. The condition of the CMU was noted as very poor all along the East elevation. Corrections will have to be made or the wall replaced.

2023.04.19 – East wall of auditorium

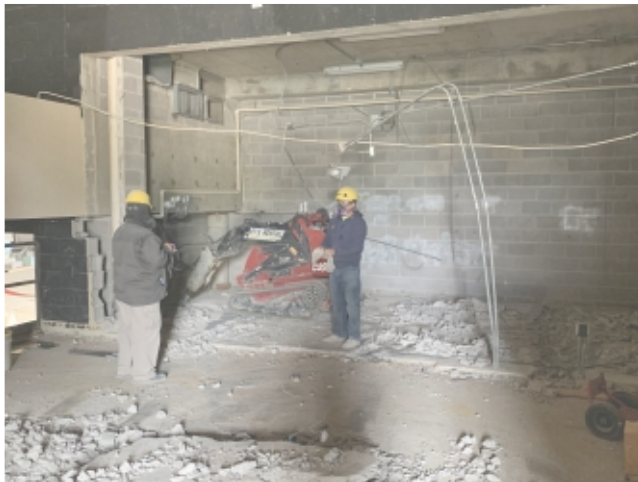
02.02: 2023.05.03 – Demolition crews were actively removing concrete at the stage area. 2<sup>nd</sup> floor seating riser demolition was complete as was ceiling demolition over the seating area. Concrete removal at the thrust stage was largely complete with deck removal 50% complete.

2023.05.03 – Stage demolition

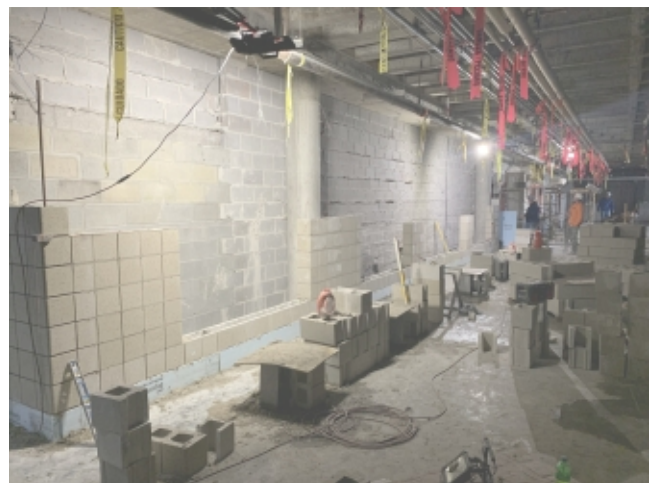
04.02: 2023.05.03 – Masons had erected apx. 65% of the West wall of the first floor corridor since the last visit and were active at the display case area.

2023.05.03 – Display cases outside Main Gym

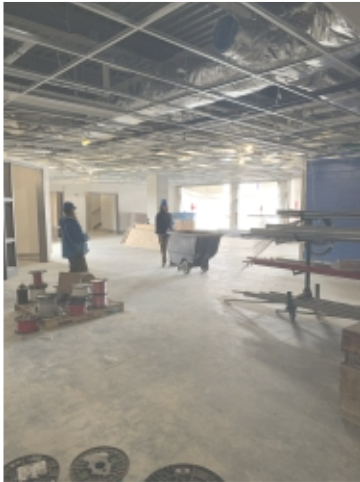
09.02: 2023.05.03 – Priming had occurred in the main gym, including steel and ductwork. Mosaic floor tile installation was on-going. Ceiling grid had been installed in the pool lobby. A crew was actively hanging gypsum board ceilings in pool locker rooms. Ceiling grid had also been installed at the weight and cardio rooms.

2023.05.03 – Ceiling grid in Pool Lobby

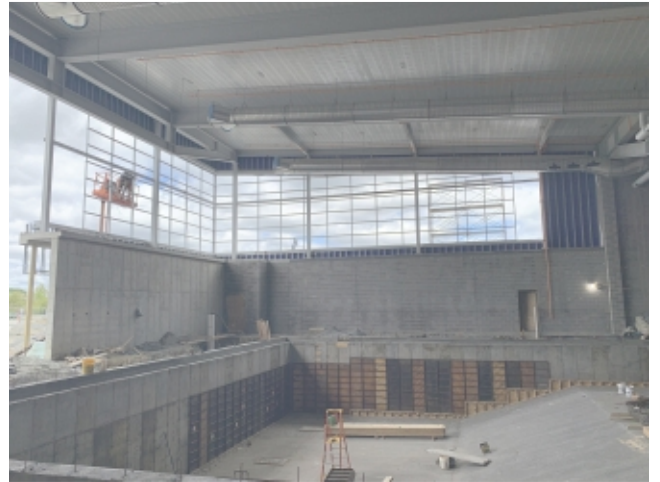
13.02: 2023.05.03 – Wall forms were being stripped at the deep end of the pool. House keeping pads had been poured in the chemical rooms.

2023.05.03 – Pool deep end

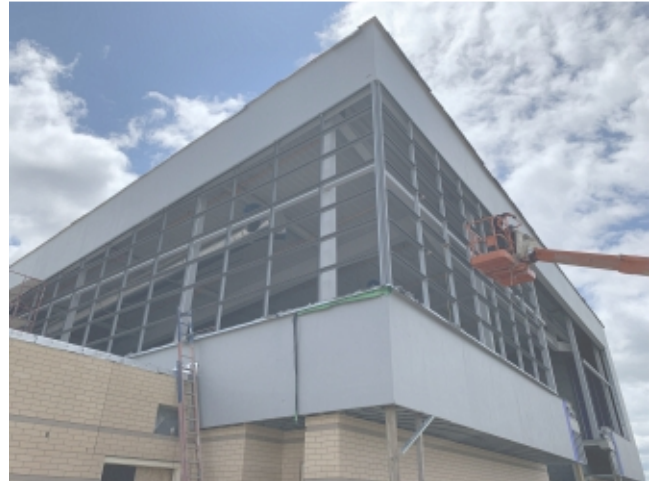
08.02: 2023.05.03 – Curtain wall framing was approximately 90% complete at the East wall of the pool and the crew was actively working at the North wall. Another crew was actively installing glass at 2<sup>nd</sup> floor corridor windows.

2023.05.03 – Curtain wall installation

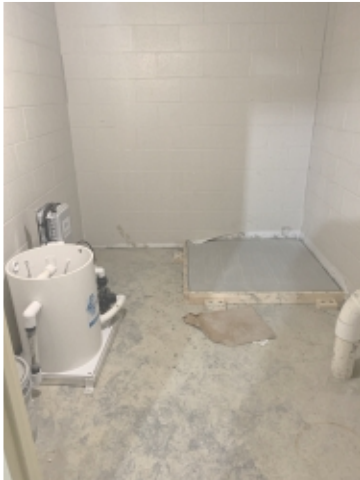
2023.05.03 – Housekeeping pad in Chem 1991

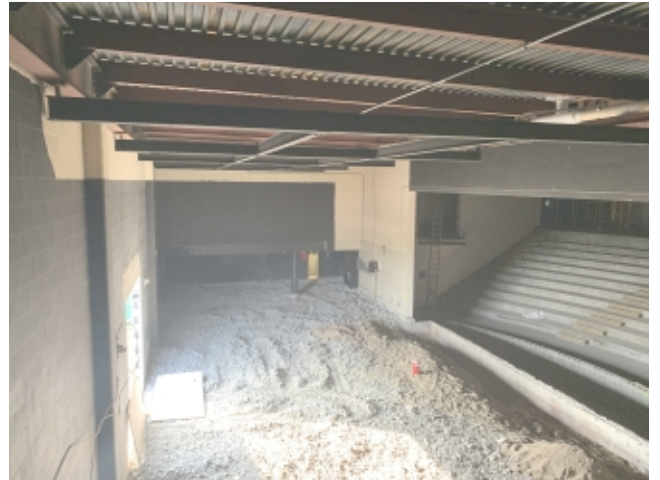
02.03: 2023.05.17 – The former sound control booth cantilever had been removed. Stage slab remove was complete. 2<sup>nd</sup> floor classroom demolition was on-going. First floor slab removal for plumbing trenches was complete. Removal of exterior 6" CMU walls had begun.

2023.05.17 – Stage demolition

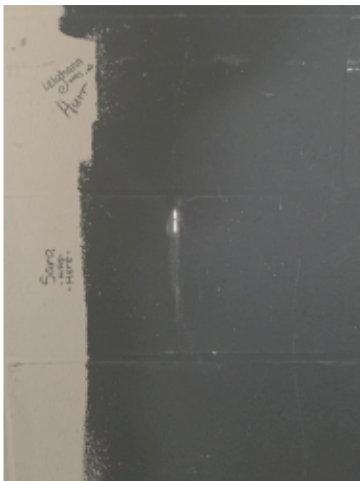
2023.05.17 – Daylight coming through North wall of Stage

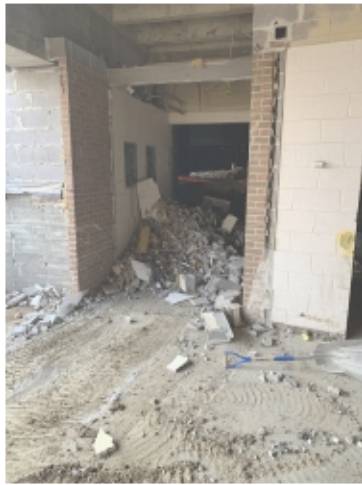
01.01: 2023.05.17 – PCA and Advantage Group Engineers assessed existing CMU at the Auditorium and 2<sup>nd</sup> floor classrooms. It had already been determined all 6" CMU at the 2<sup>nd</sup> floor exterior classroom walls must come down as it is reinforced and showed signs of previous and active movement. It was determined the North wall of the stage was also 6" CMU and must be removed. The East wall, while 10" CMU, is also not reinforced. Two concepts were later given to the general contractor for budget pricing. The first concept was to leave the CMU in place, adding reinforcing and parging the wall such that it can receive an air/vapor barrier (or stay in place, and installing fiber reinforced gypsum board to applied studs which would then receive the air/vapor barrier). The second concept is removal of the CMU and replacing with cold form metal framed walls. Budget pricing will determine the direction.

2023.05.17 – Debris from 2<sup>nd</sup> floor demolition

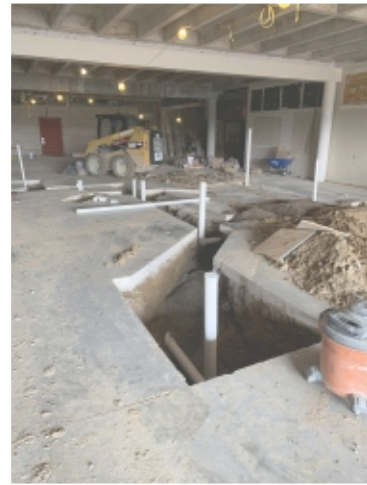
*20-28.03: 2023.05.17 – Under slab plumbing was on-going at the first floor. Corridor lights had been energized at Corridor 1900C*

2023.05.17 – Under slab plumbing

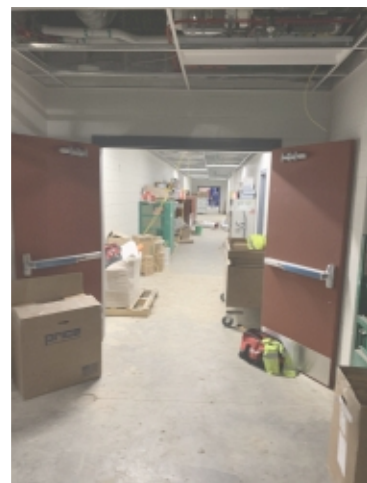
2023.05.17 – Corridor 1900C

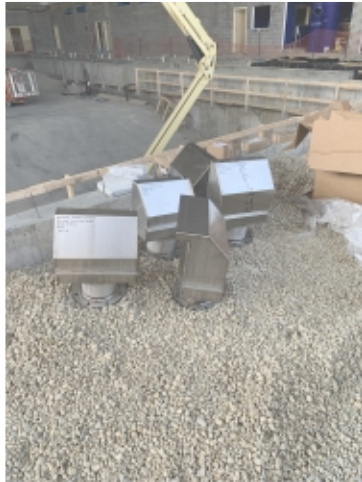
13.03: 2023.05.17 – Stainless steel gutter parts had started arriving on site. Temporary scaffold for installation of the gutter was being installed.

2023.05.17 – Stainless steel pool gutter components

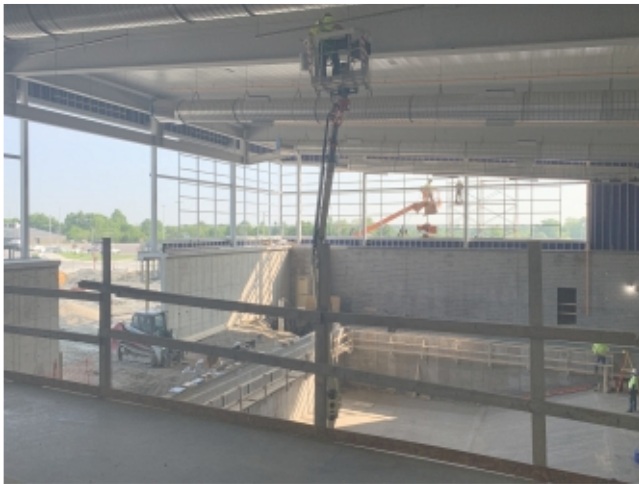
09.03: 2023.05.17 – Finish paint had been applied at the main gym. Painters were active in the pool space. Ceramic tile floors in several locations had been protected, suggesting grouting was complete. Framers were working at the 2<sup>nd</sup> floor window at the monumental stair. Ceiling grid had been installed at the main 2<sup>nd</sup> floor corridors and the 2<sup>nd</sup> floor restrooms had been boarded.

2023.05.17 – Painting pool structure
