FIELD OBSERVATION REPORT

Central Hardin High School, Cecilia, KY

2019111 - CA8

Report No: 44

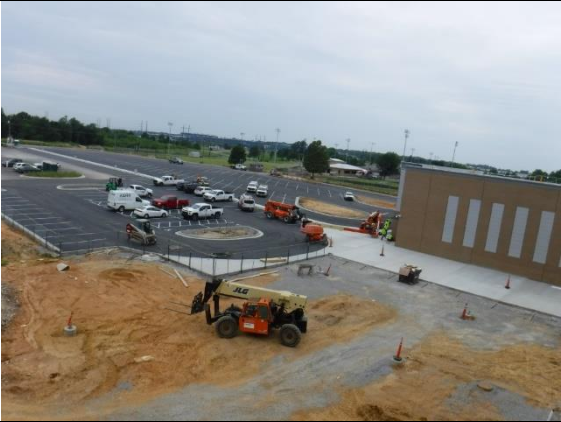
Item No.	Location	Description/Correction	Image	Action
1	Site to West of Area A Exterior Auxiliary Gym.	Base course of asphalt paving was installed in the bus loop. Temporary fencing was being extended to separate student access from the construction area.

Complete temporary fence separating student access from construction area.
2	Areas A and B Exterior Auxiliary Gym and Gym Lobby.	Sheet metal trim was being completed on the Auxiliary Gym.

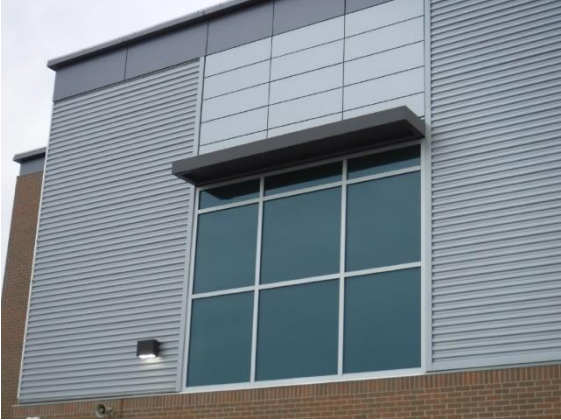
Seal joints to be water - proof.
3	Area A Canopies over Auxiliary Gym Windows.	The canopies were installed but the scuppers were not cut in.

Complete canopy drainage work.

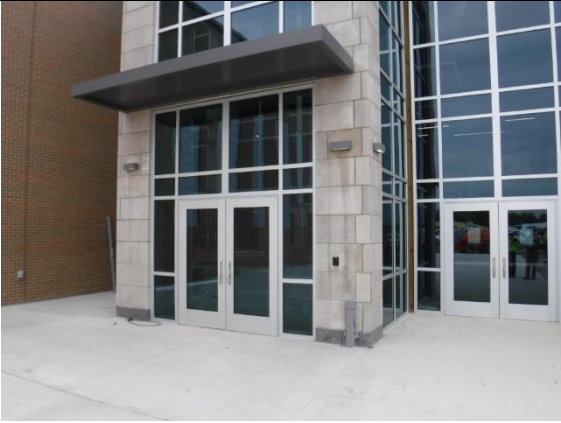
Item No.	Location	Description/Correction	Image	Action
4	Area A Stone at Gym Entry.	The steel downspout boot was positioned to miss the light fixture which put is outside the edge of the canopy. The downspout will have to jog at the top to connect to the canopy.

Make offset in downspout.
5	Area A Gym Lobby.	The wood flooring was installed over the concrete base for the bench. The glass railing was mostly complete. The terrazzo was not installed due to high moisture in the slab.

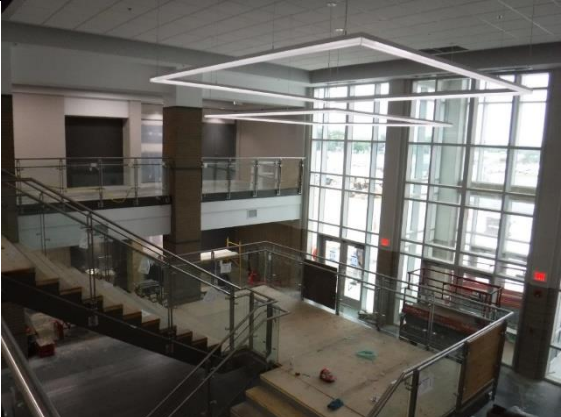
Monitor slab moisture levels and report when it is acceptable.
6	Area A Gym Lobby.	Most of the finish materials were in place.

Protect finishes from construction activities.

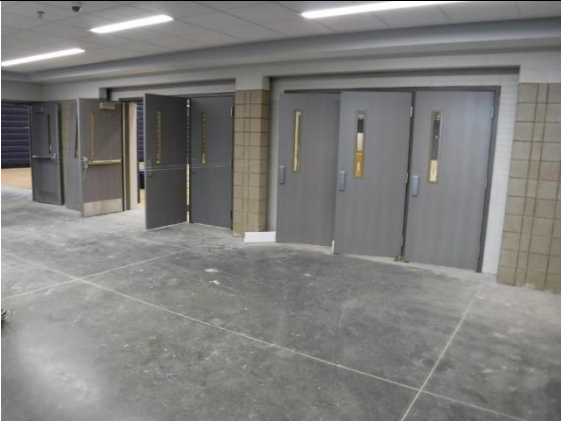
Item No.	Location	Description/Correction	Image	Action
7	Area A Gym Lobby.	The doors to the gym were installed but some of the hardware was missing.

Complete hardware installation before students occupy the area.
8	Area A Gym Lobby.	The defibrillator cabinet will be recessed in the west face of the brick pier.

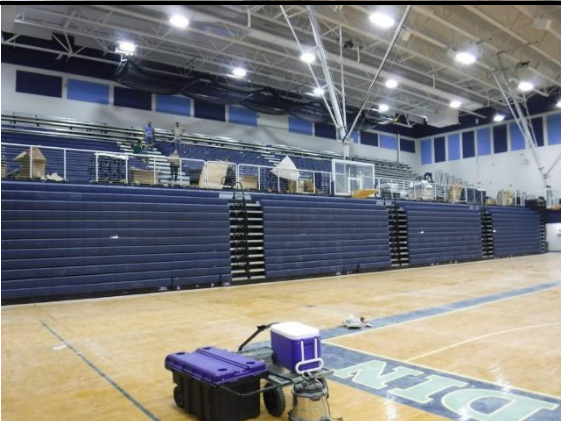
Install cabinet to be flush with face of brick.
9	Area C Main Gym.	The last of the bleachers were being installed on the north side of the gym mezzanine.

Test all bleachers for proper operation. Conduct training for the school staff.

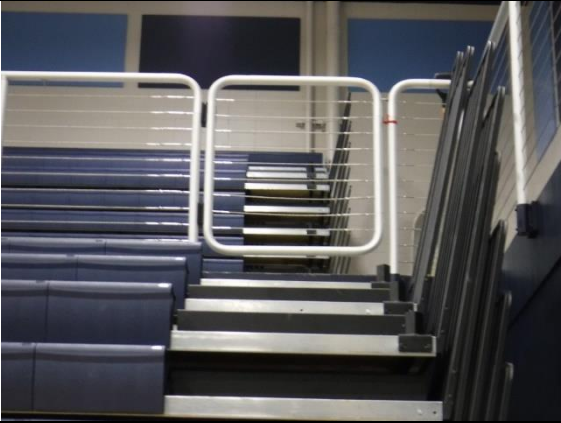
Item No.	Location	Description/Correction	Image	Action
10	Area C Main Gym.	The aluminum railing and gates were installed around the mezzanine.

Complete gate installation including latches.
11	Area C Main Gym.	The stainless steel handrails had been installed on the stairs to the mezzanine.

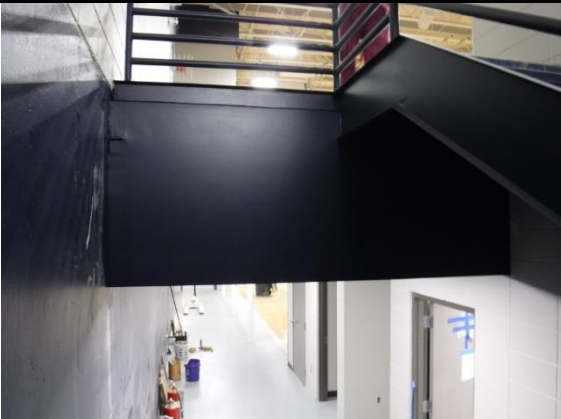
Protect railings during construction . Clean dust off the walls.
12	Area C Main Gym.	The bulkheads at the mezzanine stairs were installed.

Clean dust off paint.

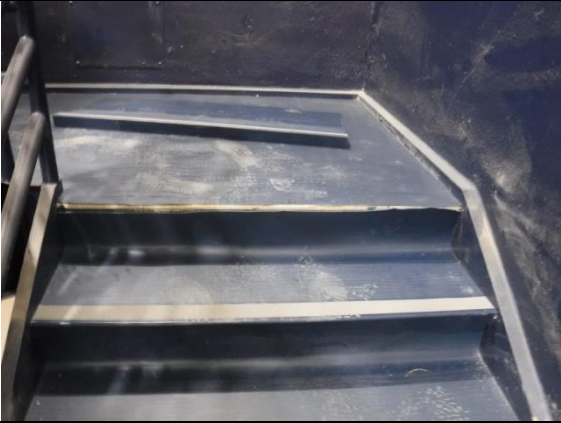
Item No.	Location	Description/Correction	Image	Action
13	Area C Main Gym.	Rubber treads were being installed on the stairs to the mezzanine.

Clean steps and landings after installation.
14	Area C Main Gym Locker Rooms.	The basketball lockers were placed in the area. John said that these will be adjusted to provide room at the corners for two players to get to their lockers.

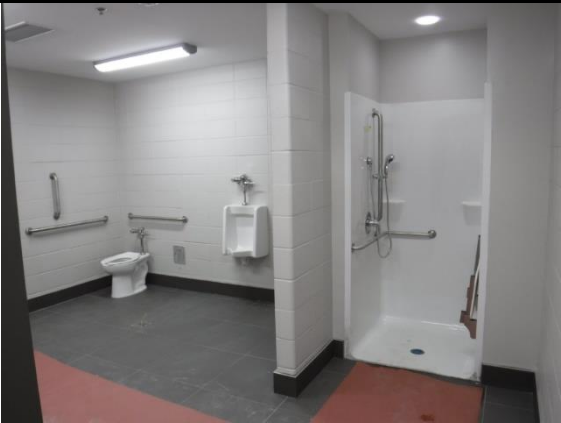
Revise lockers as directed.
15	Area C Locker Rooms - Toilets	The rooms are mostly complete.

Install all specified accessories.

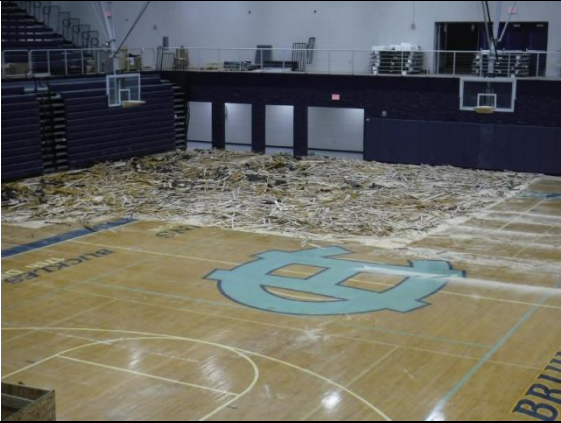
Item No.	Location	Description/Correction	Image	Action
16	Area C – Main Gym	The maple flooring was being removed.

Protect finishes, doors and frames as the flooring is removed.
17	Area C - Main Gym.	With the bleachers open, the exhaust ducts are accessible to the public.

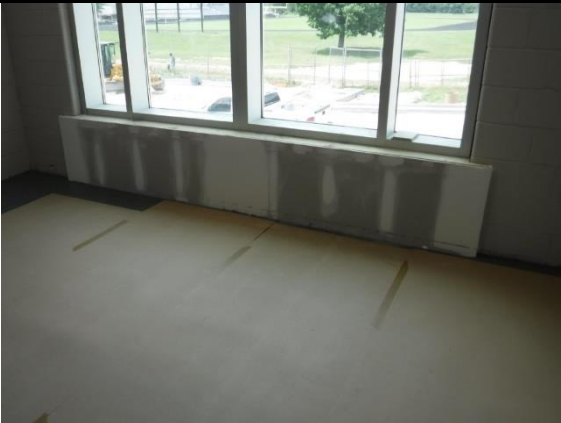
Seal duct to wall to prevent access to the wall cavity.
18	Area A – North End of Sub Level Corridor	A floor-to-floor fire resistant joint detail is required at the curtainwall. It was confirmed with Bennet's that the insulation was not installed as detailed.

Remove wall board and install mineral fiber insulation as detailed.

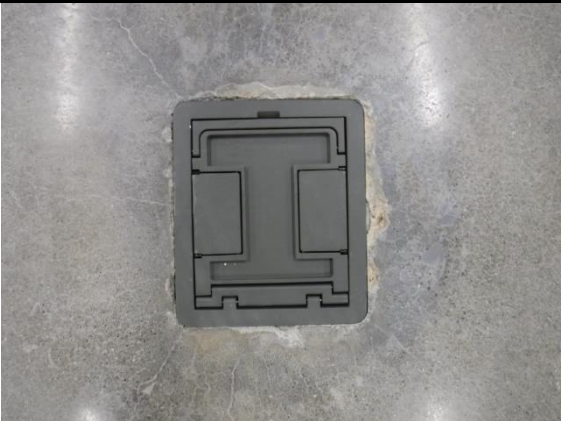
Propose a fix to make the slab uniform in appearance.
21	Area A – PLTW Room – Electrical Floor boxes.	The opening around the floor boxes is ragged.

Repair concrete to provide a uniform appearance.

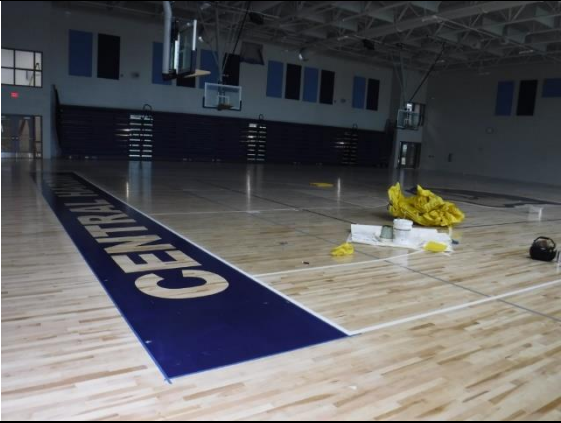
Item No.	Location	Description/Correction	Image	Action
22	Area A – Auxiliary Gym.	The blue paint caused the finish to bubble. The places where the bubbling occurred were sanded and new paint was applied.

Confirm that there is no bubbling of the finish.
23	Area A- Corridors at Bench.	Bare plywood was showing above the base.

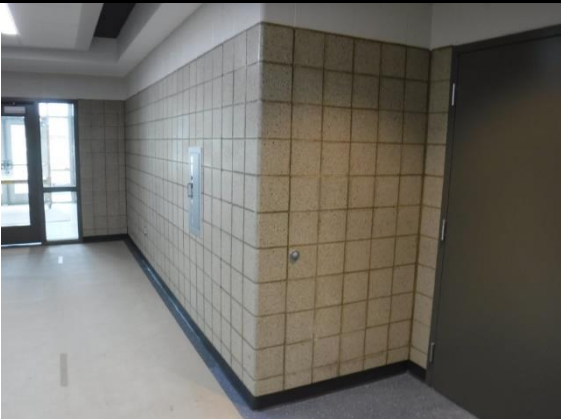
Paint the plywood to match the base.
24	Area A – Gym Level Corridor.	Sealer was applied to the ground faced block.

Reapply sealer where the finish is uneven.

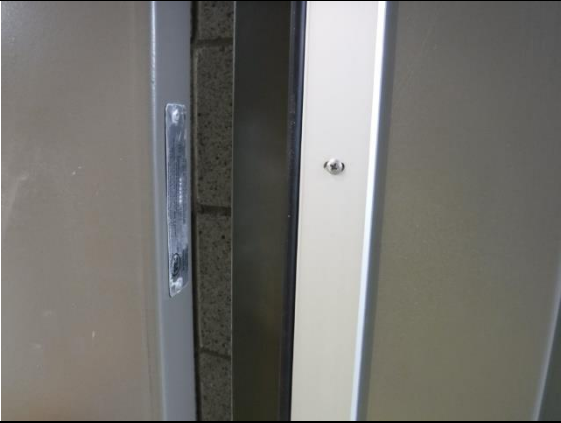
Item No.	Location	Description/Correction	Image	Action
25	Area A – Mech. Room Doors and Frames	The doors have a label for a fire resistant rating but the frames do not.

Have the frames inspected, certified and labelled.
26	Area B and E – Cafeteria - Second Level.	Exposed ductwork will be suspended from the cafeteria ceiling.

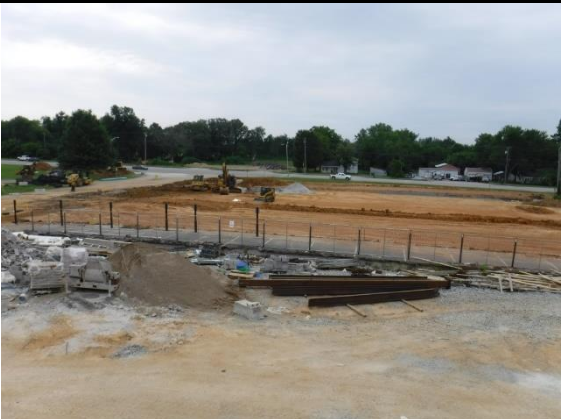
Coordinate ductwork with the basketball goal standards.
27	South Parking Area.	Mike Billings reported that the City Water Co. would be reinstalling the water line because the existing line was too shallow after the lot was graded.

Coordinate the utility work with the parking lot grading.

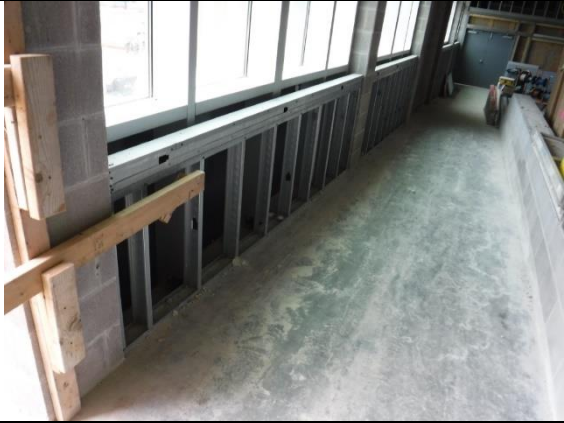
Item No.	Location	Description/Correction	Image	Action
28	Area B – Sloped Floor.	An ASI will be issued to add a fire barrier between the sloped floor and the curtainwall.

Follow the directions of the ASI.
29	Area A - Exterior.	Check sills and flashings at the west elevation to make sure that rainwater will not streak the facade of the building.

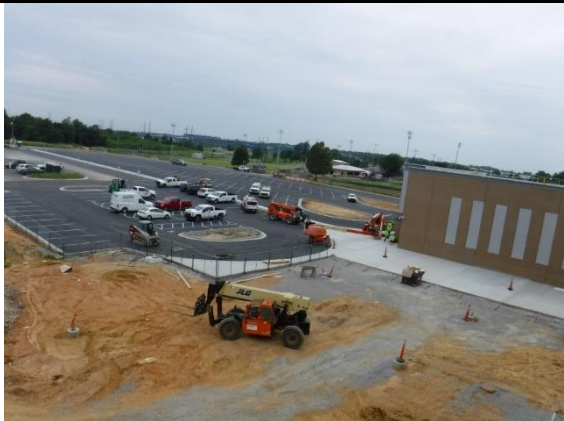
Take corrective actions to prevent water from streaking on the brick.
30	View to Utility Building Area.	Concrete walks were being poured around the Utility Building.

Protect concrete from construction activities.
