### FIELD OBSERVATION REPORT

### **2023-08 (Scott Phase V)**

TO:	Stre City,	ne npany et Address State Zip Matt Rigg	■ DATE:	2023.08.30
FROM:	Marl mpe 906 New	rry@embossdesign.com  Monmouth Street  port, KY 41071  59.431.8612 • D: 859.578.6013	■ PROJECT:	Kenton County School District Scott Phase V
COPIES T	O: Mr. I	Kevin Pfefferman; Ms. Carrie Hooten	PROJECT NO.:	20-032
■ WE TRANSMIT THE ATTACHED ITEMS VIA: eComm				
PURPOSE		For your use As requested For review and comment For information For record For approval	DISPOSITION	No exceptions noted Exceptions noted, Revise as indicated. REJECTED: REVISE AND RESUBMIT
COPIES	DATE	DESCRIPTION		PAGES
1	2023-08	Field Observation Report		11

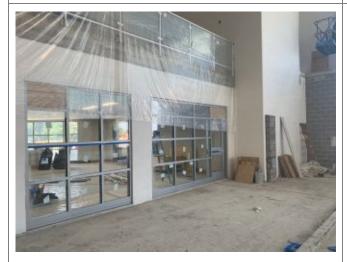
2023.08.03 - Pool looking Southeast.

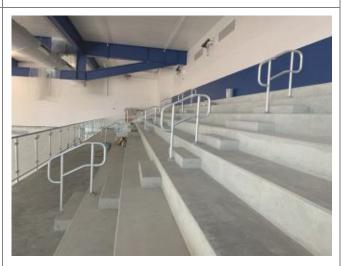
2023.08.03 – North stair in pool addition.

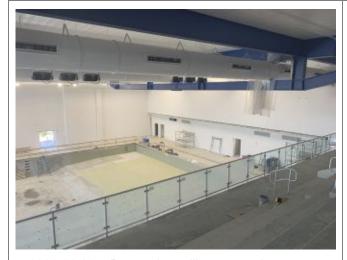
2023.08.03 – Decorative railings at pool spectator seating.

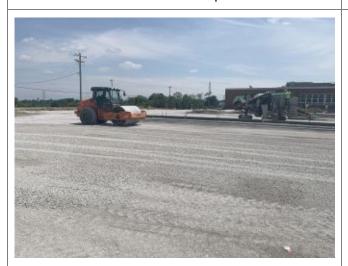
2023.08.03 - Taylor Mill site looking North.

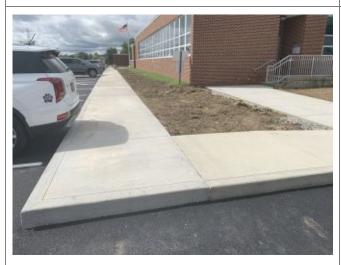
2023.08.15 - Taylor Mill Site.

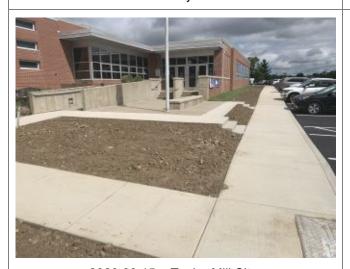
2023.08.15 - Taylor Mill Site.

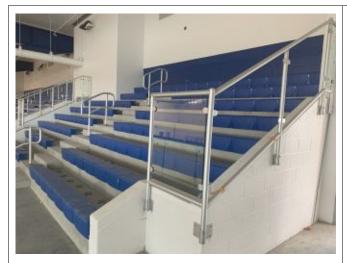
2023.08.15 - Pool spectator seating.

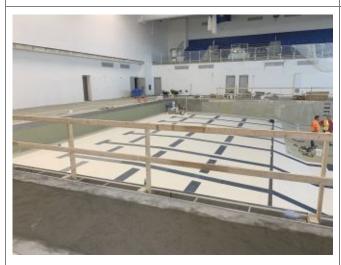
2023.08.23 - Pool.
