## FIELD OBSERVATION REPORT

Central Hardin High School, Cecilia, KY

2019111 - CA8

Report No: 46

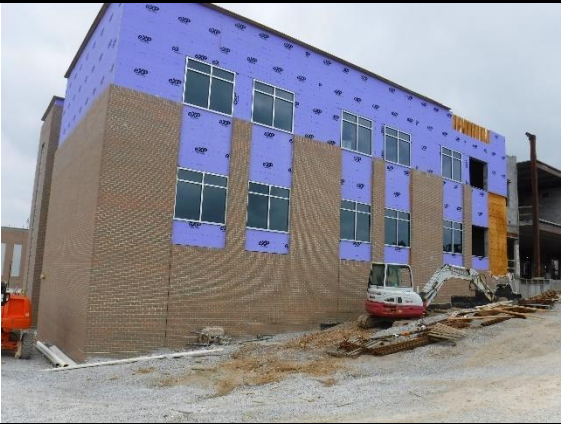
Item No.	Location	Description/Correction	Image	Action
1	Area B	Gypsum sheathing and windows were in place.

Apply sheet metal siding.
2	Areas B	Media Center and Classrooms.

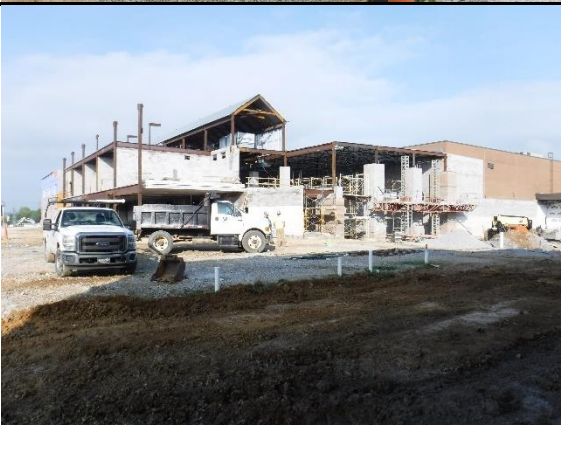
Install footings and extend structure to the south.
3	Area B and E.	The mechanical penthouse was extended to the end of the constructed area.

Enclose building as soon as possible to provide conditioned areas for interior work.

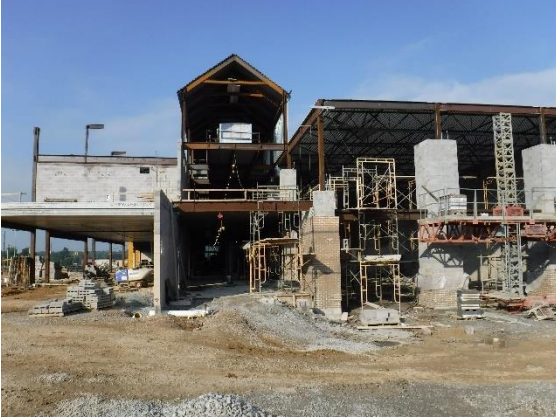
Item No.	Location	Description/Correction	Image	Action
4	Area B and E.	Media Center and Classrooms to the south and Cafeteria to the north.

Enclose areas to dry in for interior work.
5	Area E.	Kitchen slab was poured.

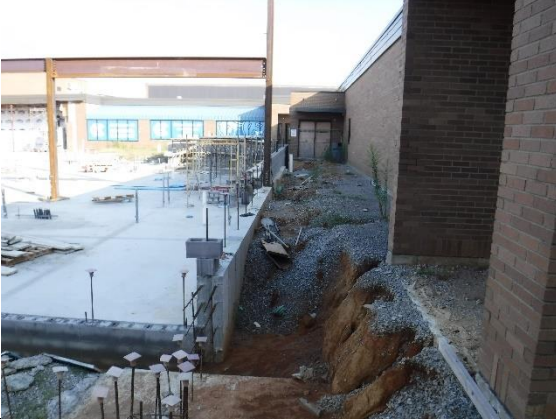
Verify in slab utilities for kitchen equipment.
6	Area E.	Foundations between Area E and the existing building to be removed.

Maintain area for hand off to Phase 2 contractors.

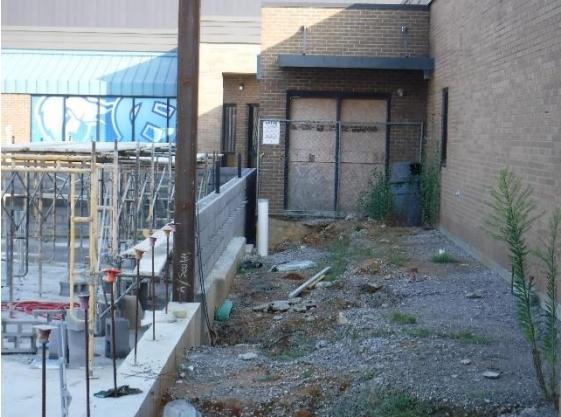
Item No.	Location	Description/Correction	Image	Action
7	Area E.	Original entry.

Coordinate Phase 1 work with Phase 2 drawings provided by JRA.
8	Area E.	New foundation at existing wall.

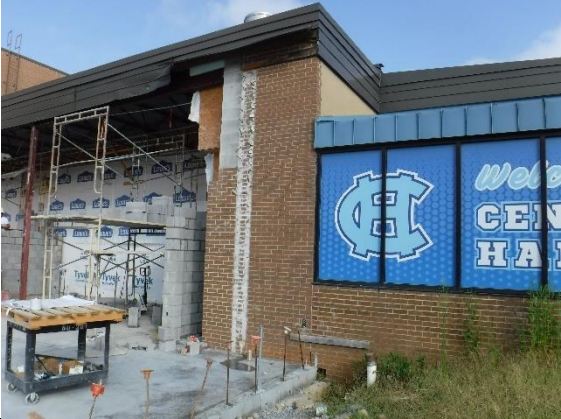
Coordinate Phase 1 work with Phase 2 drawings provided by JRA.
9	Area E.	Connection of new work to gym lobby.

Coordinate Phase 1 work with Phase 2 drawings provided by JRA.

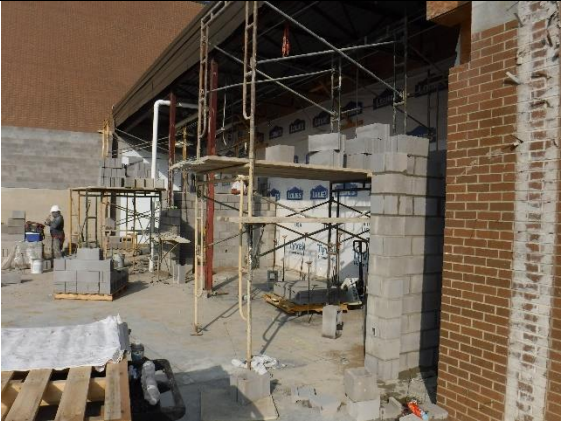
Item No.	Location	Description/Correction	Image	Action
10	Area E.	Ongoing work at original gym entrance.

Coordinate Phase 1 work with Phase 2 drawings provided by JRA.
11	Area F.	Alliance was laying out the foundations and walls at the interface with existing wall on the freshman wing.

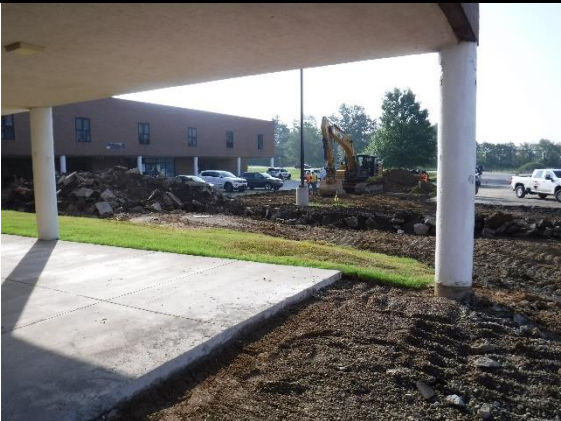
Coordinate Phase 1 work with Phase 2 drawings provided by JRA.
12	Area F.	The new work intersects the existing overhang.

Coordinate Phase 1 work with Phase 2 drawings provided by JRA.

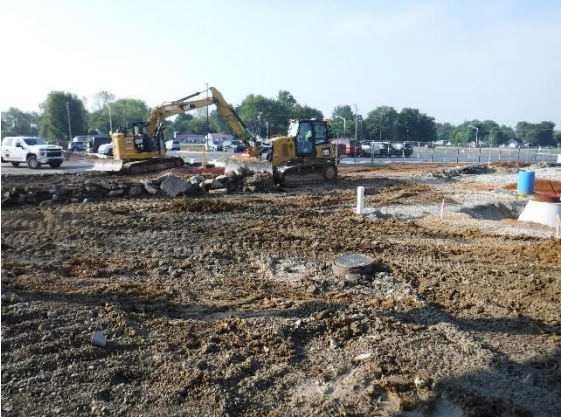
Item No.	Location	Description/Correction	Image	Action
13	Site by Freshman Wing.	New parking lot.

Complete this work as soon as possible to maintain access to the current entry point to the school.
14	Area A North Elevation.	Work continues to complete this area.

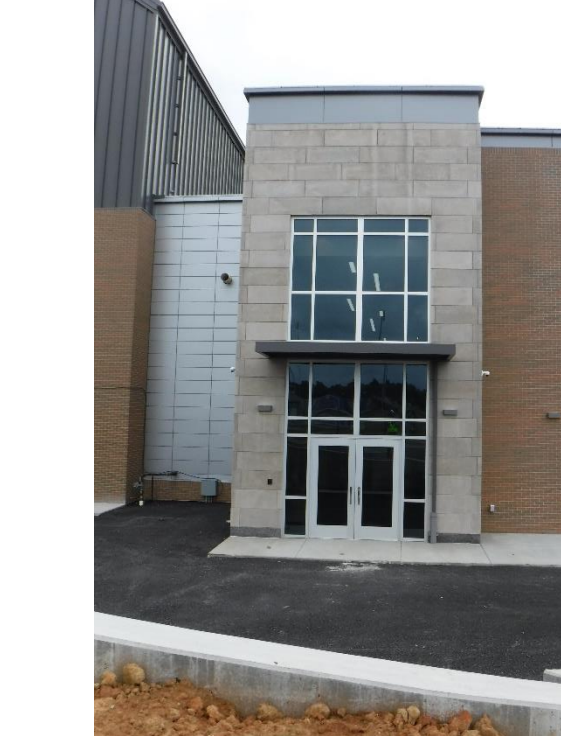
Rub the retaining wall. Complete the sheet metal trim at the roof. Complete the site work.
15	Area A North Entrance.	Limestone at the north entrance continues to be streaked.

Clean limestone to be even in appearance.

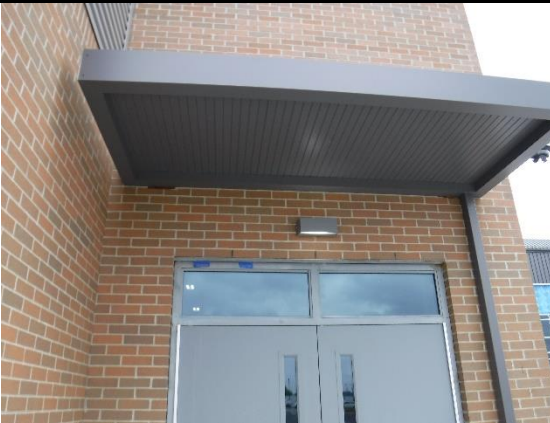
Item No.	Location	Description/Correction	Image	Action
16	Area A Canopies.	Mounting plates are visible.

Use sheet metal trim and/or sealant to cover exposed steel.
17	Area A Gym Entrance.	The limestone is still streaked. Tuck pointed mortar joints do not match original joints.

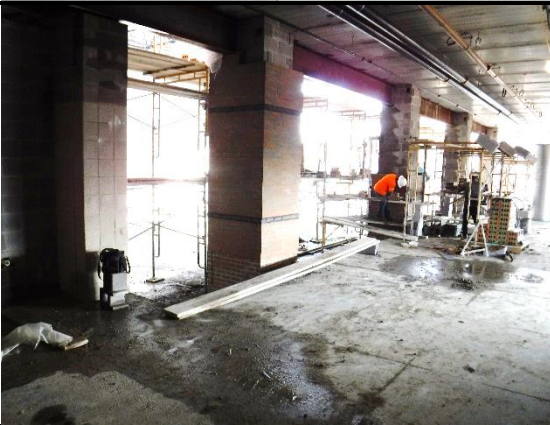
Clean stone. Monitor tuck point mortar to confirm a match.
18	Area E First Level.	Brick piers at cafeteria.

Clean brick.

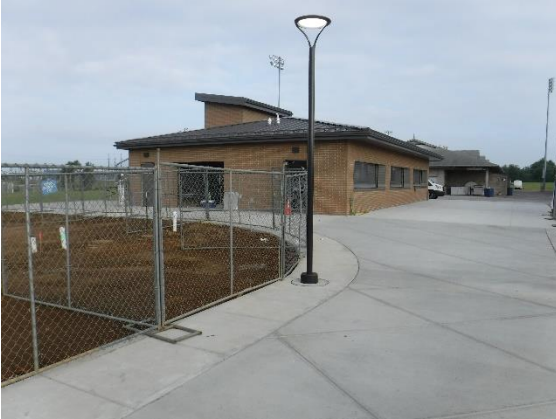
Item No.	Location	Description/Correction	Image	Action
19	Utility Building.	The sheet metal roof is mostly complete.

Submit report from Zach Hadden.
20	Utility Building.	Stainless steel counter doors at concessions.

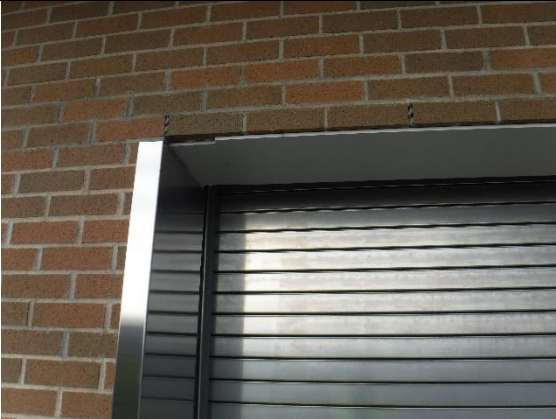
Clean doors.
21	Utility Building.	Brick cores are showing at head of opening.

Add stainless steel trim or a SS drip.

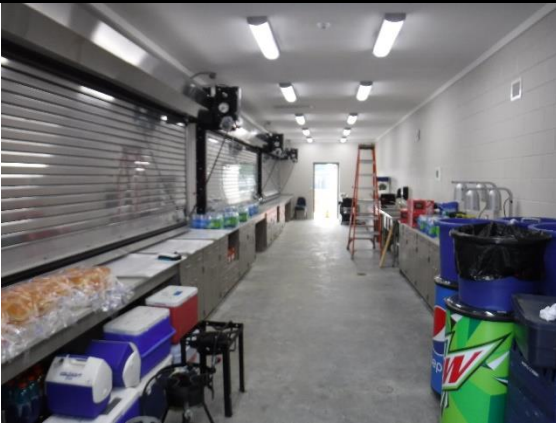
Item No.	Location	Description/Correction	Image	Action
22	Utility Building.	Concession area.

Notify JRA when area is ready for a punch list inspection.
23	Utility Building.	Three compartment sink.

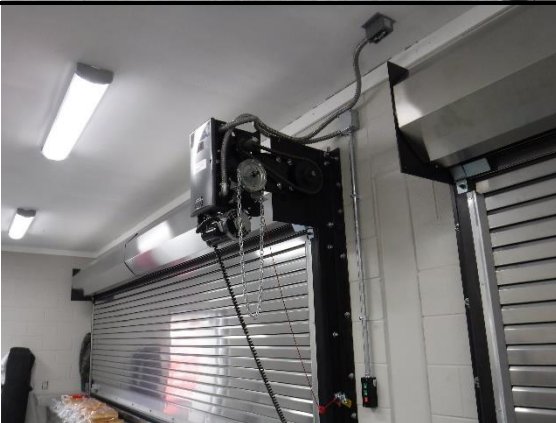
Investigate water supply at sink.
24	Utility Building.	Counter door motors.

Cover motors with matching housings.

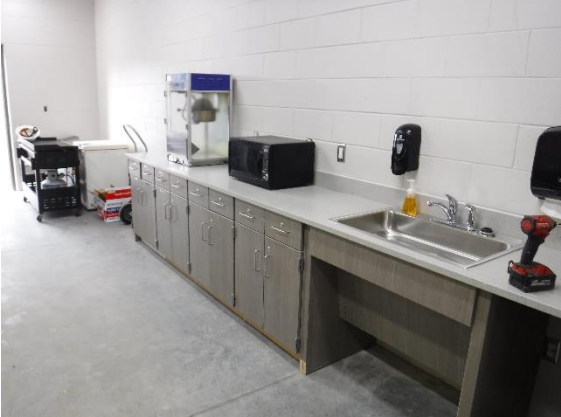
Item No.	Location	Description/Correction	Image	Action
25	Utility Building.	Plastic laminate cabinets.

Install base on the cabinets.
26	Utility Building.	Storage area.

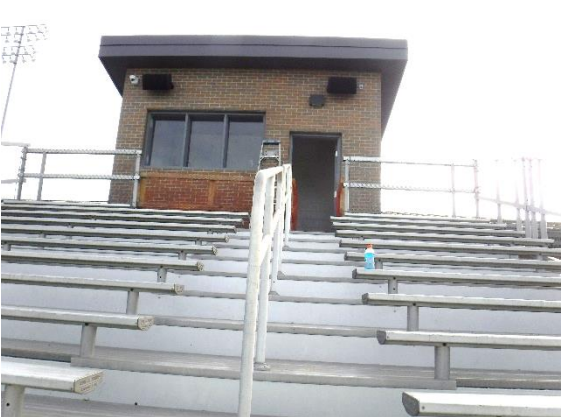
Finish and paint ceilings.
27	Utility Building.	Press box.

Connect bleachers to pressbox. Change windows to sliders if PR is approved.
