## FIELD OBSERVATION REPORT

Central Hardin High School, Cecilia, KY

2019111 - CA8

Report No: 47

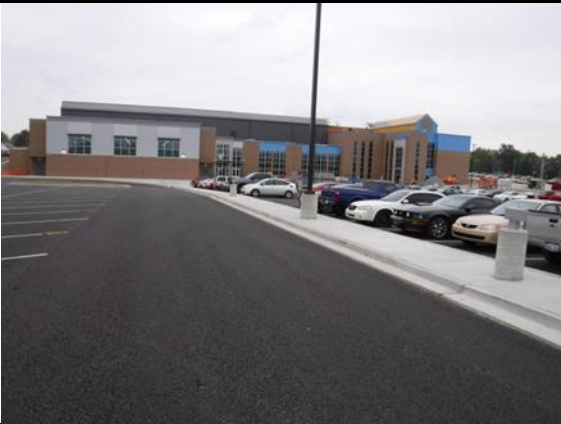
Item No.	Location	Description/Correction	Image	Action
1	Areas A and B	The west elevation of the addition is nearing completion. The blue areas at the tops of the walls will be covered with sheet metal siding.

Apply sheet metal siding to close the exterior walls.
2	Areas A and B	Looking past the Auxiliary Gym to Area B. Paving and concrete walks and curbs were in place. A fence separates the area open to students from the construction area.

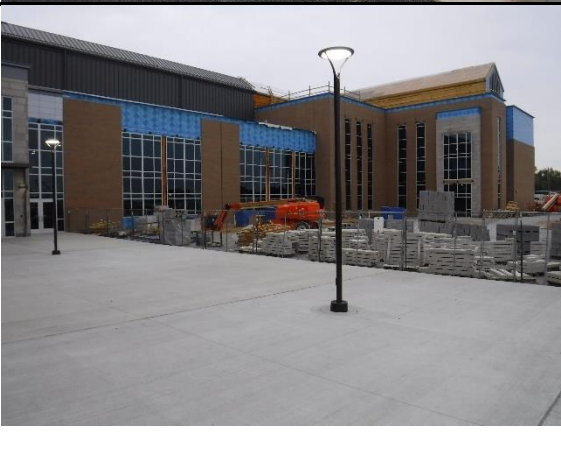
Maintain strict separation between school functions and construction.
3	Area B	The mechanical penthouse was extended to the west end of the constructed area. The louver was installed.

Enclose building as soon as possible to provide conditioned areas for interior work.

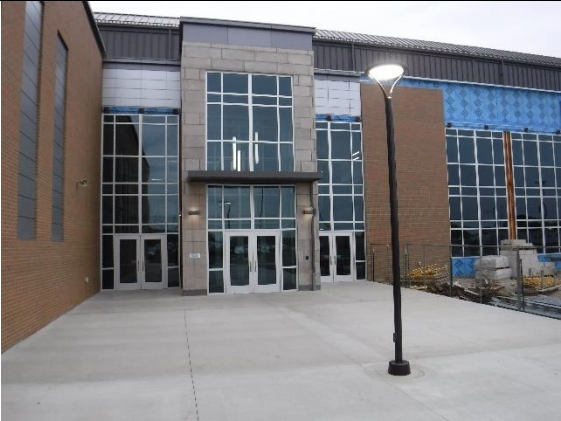
Item No.	Location	Description/Correction	Image	Action
4	Exterior at the Gym Lobby.	The stone at the lobby entrance is still stained after cleaning. Note the metal panels installed at the tops of the walls at the entrance.

Consult with the stone manufacturer for cleaning methods to be used on stone.
5	Area B.	Brick and Curtainwalls were in place.

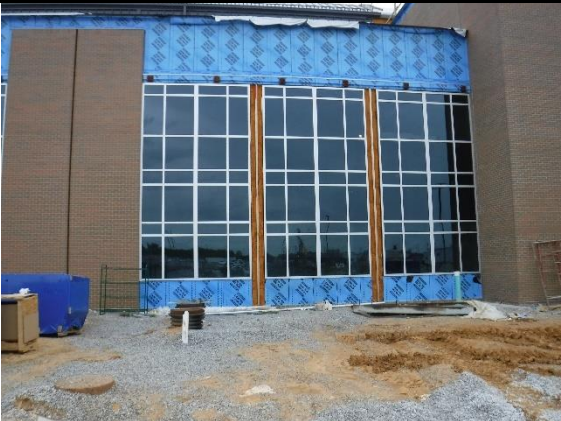
Complete metal panels installation to seal walls.
6	Area B.	Some of the glass units on this wall covers steel beams that have missing spray fire resistive materials.

Remove glass and repair fireproofing.

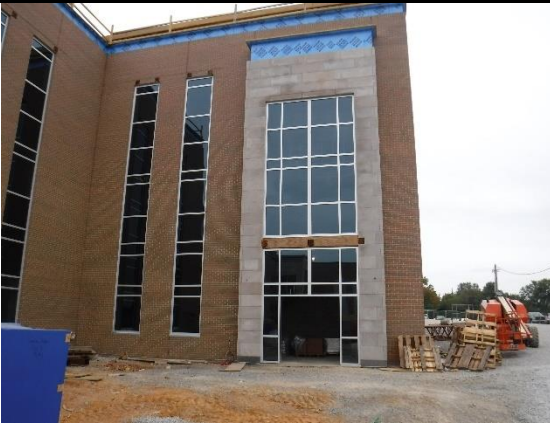
Item No.	Location	Description/Correction	Image	Action
7	Area B.	Stair B Entry.

Take steps to prevent staining of stone.
8	Area B, Gym Level.	Block walls were covered with block filler.

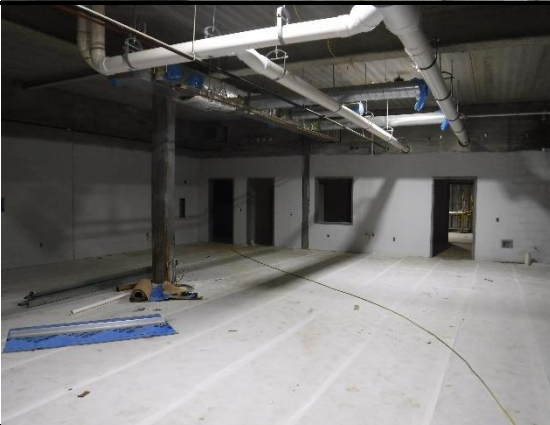
Apply block filler to provide an even texture with the final coat of paint.
9	Area B, Gym Level.	Block walls were covered with block filler.

Use hand held lights to examine block filler and touch up as needed.

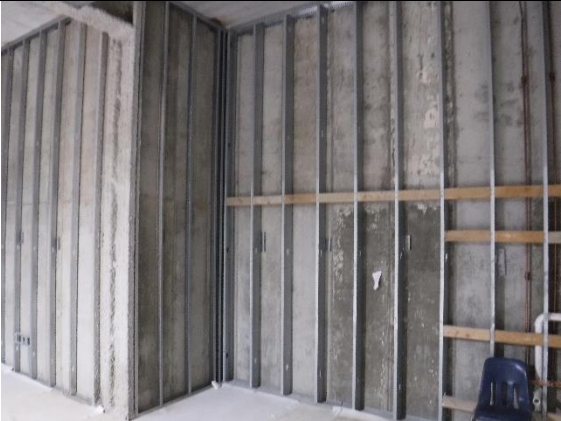
Item No.	Location	Description/Correction	Image	Action
10	Area B Foundation Wall, Gym Level.	This area had water intrusion earlier in the project.

Continue to monitor for leaks.
11	Area B, Gym Level.	Block fill was applied to block.

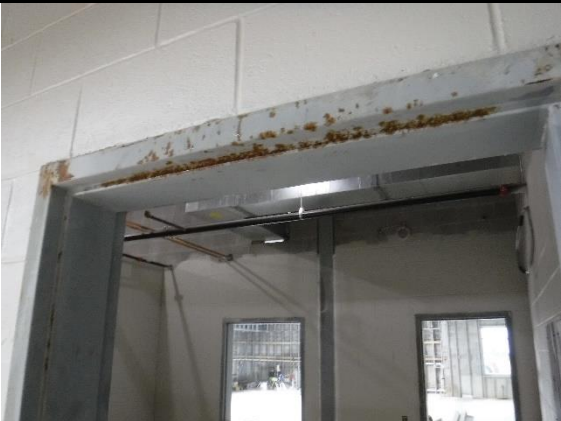
Repair block damage before finish coats are applied.
12	Area B, Gym Level.	Some of the hollow metal frames were heavily corroded.

Remove corrosion, repair metal, apply primer and finished coats.

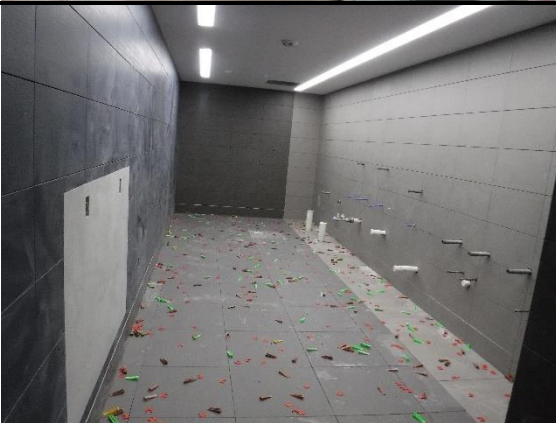
Check walls and floors for flatness to insure acceptable tile installation.
15	Area B, Gym Level, Student Toilets.	Wall and floor tiles were installed. The joints were not grouted.

Apply grout so that joints have a uniform appearance. Clean grout off tiles.

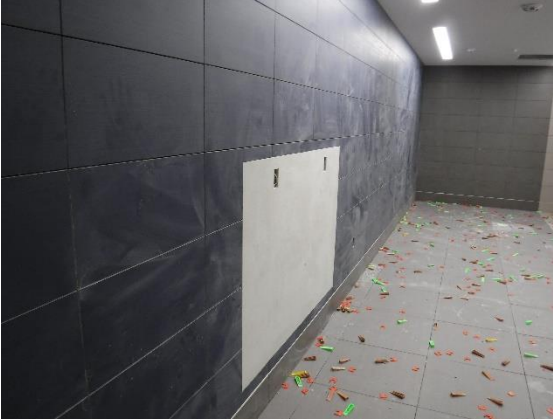
Item No.	Location	Description/Correction	Image	Action
16	Area B, Gym Level, Student Toilets.	Note spacers on the floor. Unlike the previous HCS projects, this tile setter used spacers to set the joint widths. Cliff noted that he had Carmicle grind the block faces.

Install grout while keeping the tile surface clean.
17	Area B, Gym Level, Student Toilets.	The large tiles with a matt finish appear to be flatter than the gloss finished tiles on the other HCS projects.

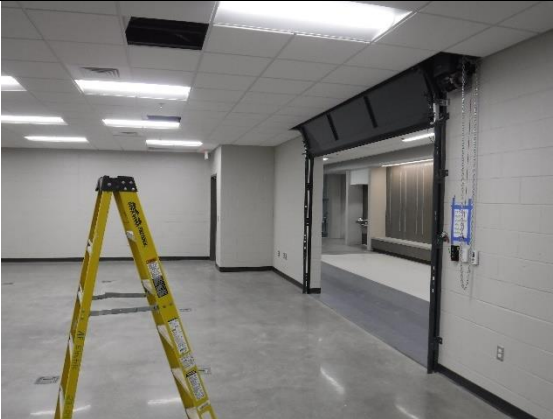
Tile will be reviewed after the joints are grouted.
18	Area A, PLTW Classroom.	The overhead door at the corridor is not operational. The "L" brackets on the door hits the supporting Unistrut. Cliff is working with Overhead Door for a solution.

Submit door fix for review.

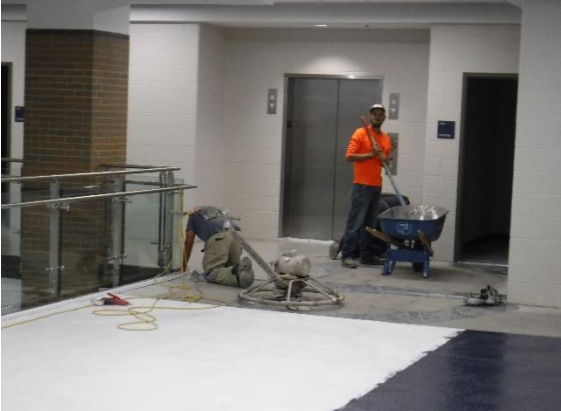
Item No.	Location	Description/Correction	Image	Action
19	Area A, Sub Level.	The terrazzo installers were mixing, pouring, and leveling the terrazzo in the upper gym lobby.

Do not damage any other material during the installation of the flooring.
20	Area A, Sub Level.	The unground terrazzo had a textured appearance.

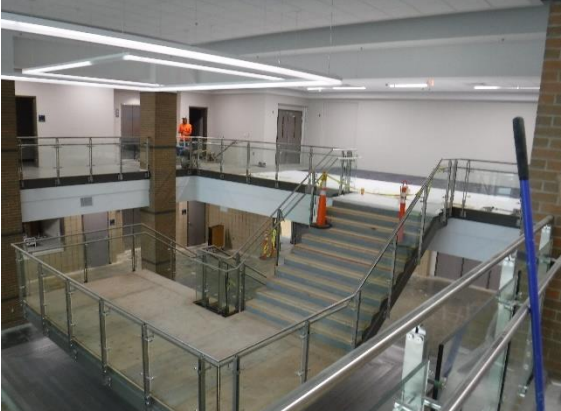
Limit foot traffic in the area until the floor is complete.
21	Area A, Sub Level.	The gym lobby was closed to all other trades and the school while the terrazzo was being poured.

Limit foot traffic in the area until the floor is complete.

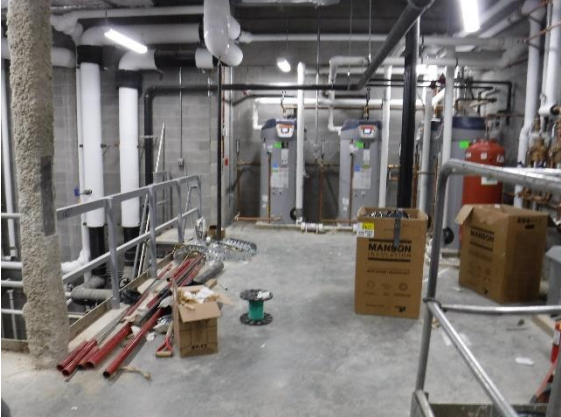
Item No.	Location	Description/Correction	Image	Action
22	Area A, Mech. Room	The area was littered with construction debris, excess materials, and tools.

Clean the room ASAP!
23	Area A and B Mech Platform	The area was littered with construction debris, excess materials, and tools.

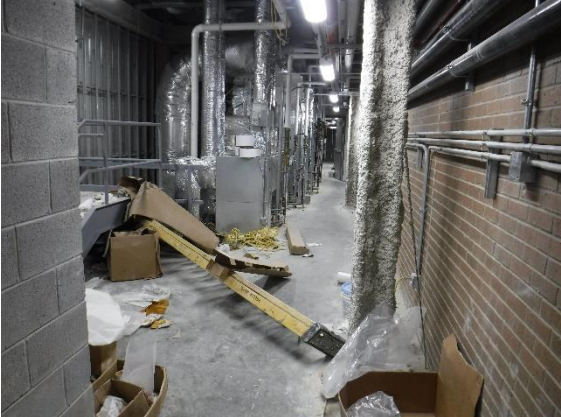
Clean the area ASAP!
24	Area B Mech Platform.	The area was littered with construction debris, excess materials, and tools.

Cliff notified JRA that all Mech. areas have now been cleaned.

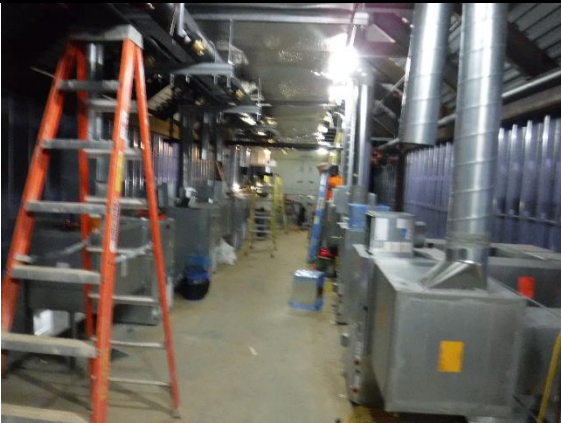
Item No.	Location	Description/Correction	Image	Action
25	Area B, Mech. Platform	The east-west platform area was receiving piping and ductwork.

Keep area clean.
26	Area B and E Roofs.	Both built-up and sheet metal roofing was under way.

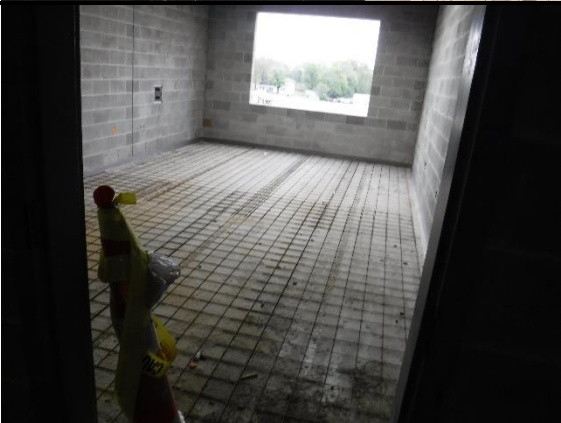
Refer to Zach Hadden's roof report.
27	Area B, Second Level.	Welded wire fabric was in place to receive the concrete topping.

Meet the spec for floor levelness and flatness.

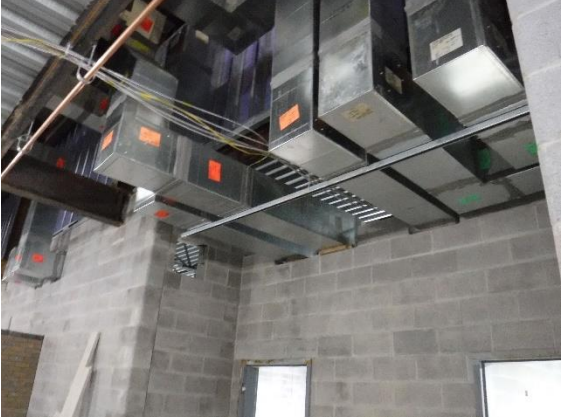
Item No.	Location	Description/Correction	Image	Action
28	Area B, Second Level.	Ductwork was being installed.

Sela all joints in duct work and in insulation.
29	Area B, Second Level.	Ducts were penetrating the slab.

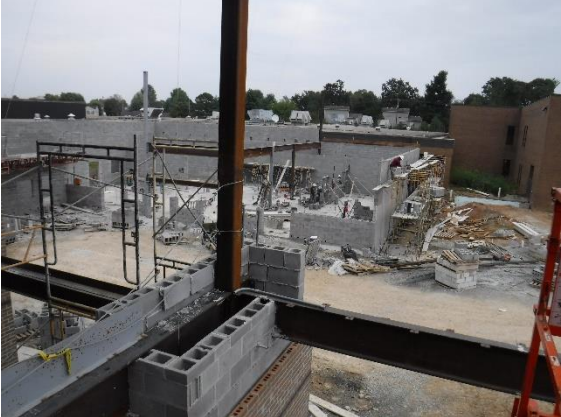
Follow Mech. Drawings for fire damper locations.
30	Area E, Second Level, Looking at the Kitchen Area	Concrete block walls in the kitchen were being laid.

Prepare block for the specified finishes.

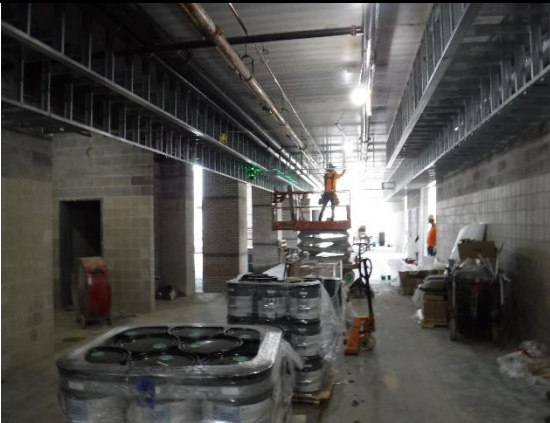
Item No.	Location	Description/Correction	Image	Action
31	Area B, Second Level	Light gauge steel framing for soffits was being installed.

Coordinate soffits with duct runs.
32	Area C, Gym	Mr. Isaacs reported the wheels for the bleachers in one area fell out of their mounting causing the bleachers to bind when they were being closed.

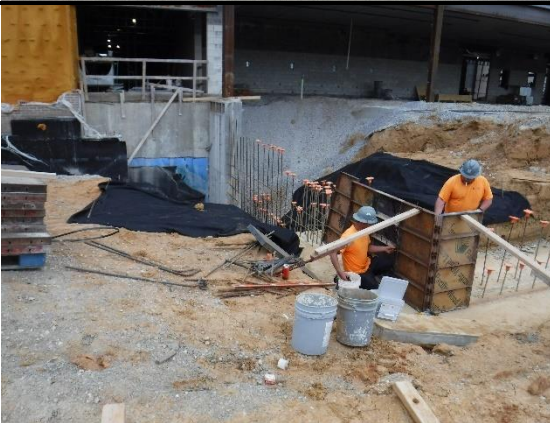
Have Irwin Seating examine all connecting pins to make sure that they are held in place with the "C" spring retainers.
33	Area B, Exterior	Formwork was being installed for the projection of the southern portion of the addition.

Comply with comments, if any, in the SPIN report.

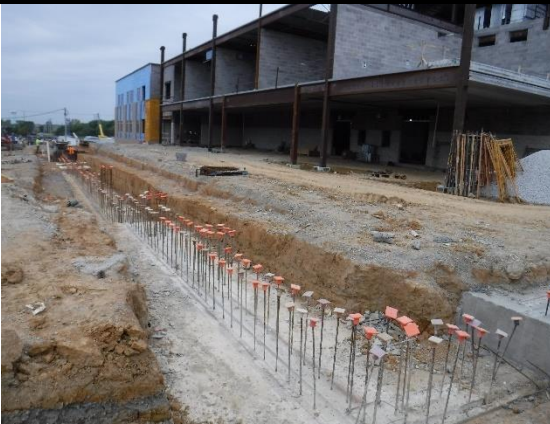
Item No.	Location	Description/Correction	Image	Action
34	Area B, Exterior	Footings were poured for the southern face of the addition.

Comply with comments, if any, in the SPIN report.
35	Area E, Kitchen	Block was being laid at the kitchen. Note steel framing that was also in place.
