FIELD OBSERVATION REPORT

Central Hardin High School, Cecilia, KY

2019111 - CA8

Report No: 49

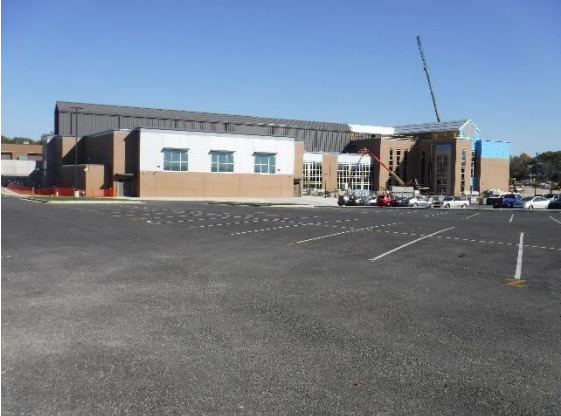
Item No.	Location	Description/Correction	Image	Action
1	Areas A and B	Area A exterior is mostly complete. Area B west exterior had sheet metal roofing and siding on going.

Always maintain separation of construction from students.
2	Area B	The southwest corner is nearing completion of the exterior enclosure.

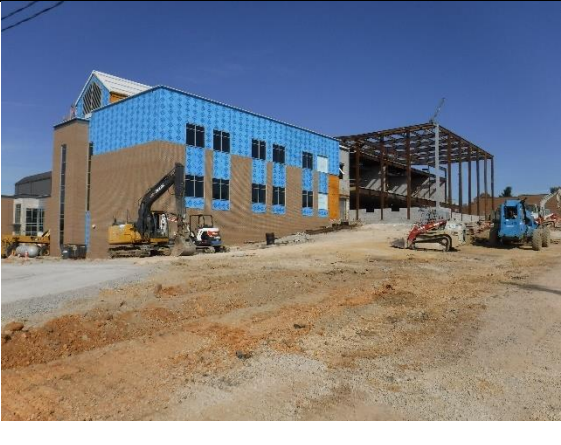
Stay ahead of interior finishes with enclosed spaces to control temperature and wet conditions around finishes.
3	Area B	Sheet metal siding will make the classroom area more complete. The Library/ Media Center framing was on going.

Enclose the LMC as soon as possible to meet the completion schedule.

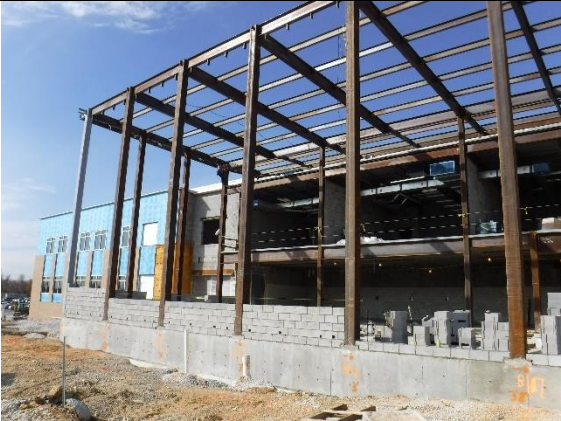
Item No.	Location	Description/Correction	Image	Action
4	Area B – South Elevation.	Concrete block was being infilled between the steel frame.

Verify that steel frame is remaining square and plumb.
5	Area B.	The foundation for the LMC was complete.

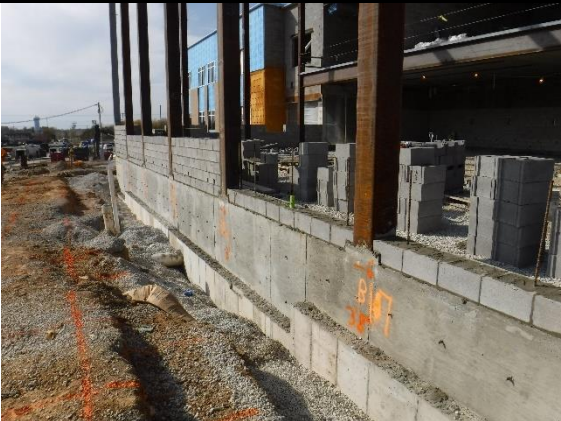
Prepare the foundation as directed in the structural and architectural details.
6	Area B.	Concrete block was stockpiled to fill in the exterior walls of the LMC.

Keep chipped block to a minimum where exposed in the LMC.

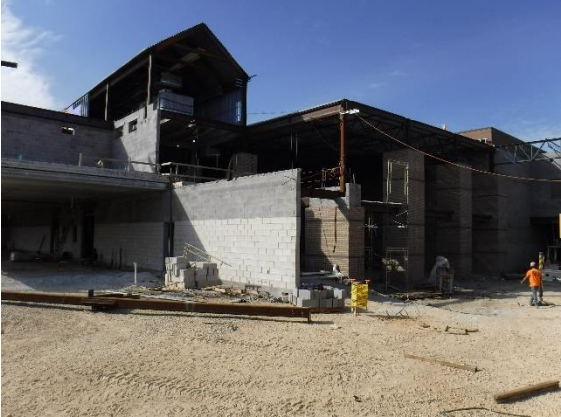
Item No.	Location	Description/Correction	Image	Action
7	Area E.	The platform has almost been extended to end of the cafeteria.

Tie Area E into Area F to completely enclose the building.
8	Area E.	Looking down at the cafeteria and kitchen; steel framing was being erected to the front of the building.

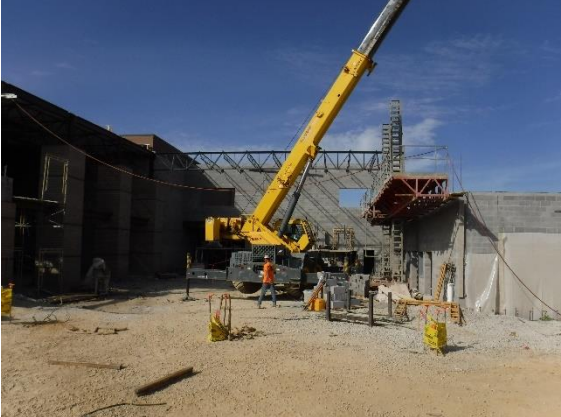
Maintain dimensions for the structure so that the work in this area remains as detailed.
9	Area E.	A large girder truss had been erected. Cliff reported that the truss fit perfectly into the space between the columns.

Continue to maintain the dimensional accuracy of the structure.

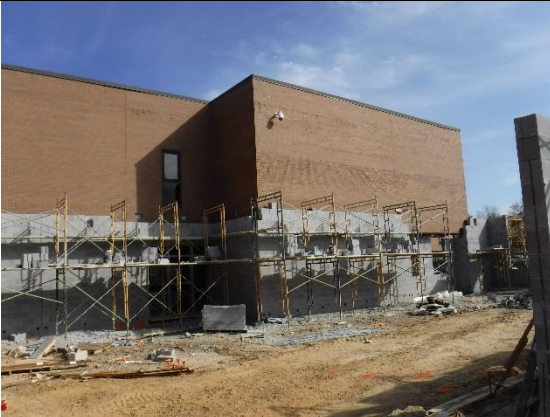
Item No.	Location	Description/Correction	Image	Action
10	Area E.	The new concrete block wall was being laid against the Phase 2 area. Cliff noted that the gap between Area F and the existing building may be wider than the 2" gap called for in the Phase 2 drawings.

Modify the edge of the second floor slab so that the 2" gap is maintained at the existing slab.
11	Area F, Lobby	The elevator pit was being formed.

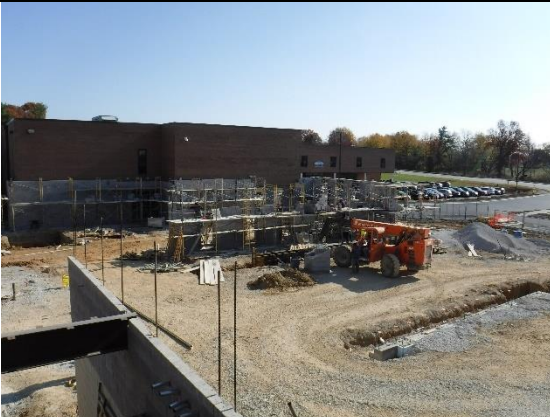
Follow the structural drawings for the placement of reinforcing steel and the vapor barrier.
12	Area B, Gym Level – ROTC Area.	Concrete block walls were being laid in the administrative area.

Minimize chipped block in exposed areas, especially at the front lobby!

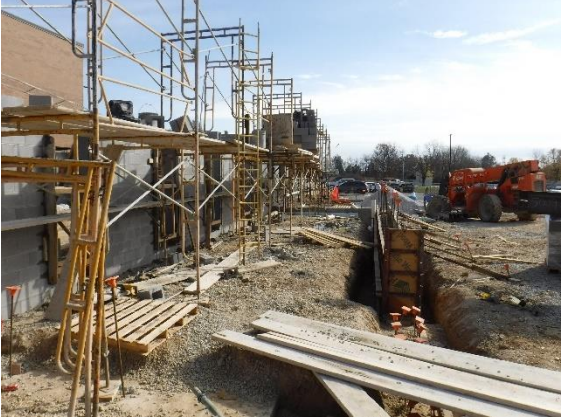
Item No.	Location	Description/Correction	Image	Action
13	Area F.	Concrete block was being laid next to the Phase 2 area.

Coordinate the locations of openings into Phase 2.
14	Area E.	A part of Area E at the kitchen is located next to the original entry vestibule at the kitchen.

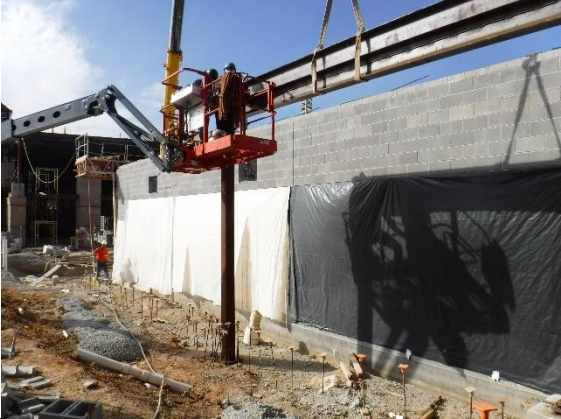
Report on temporary measures for the protection of the exterior wall for Area E at the vestibule.
15	Area E.	Steel framing was being erected.

Coordinate steel framing with masonry work.

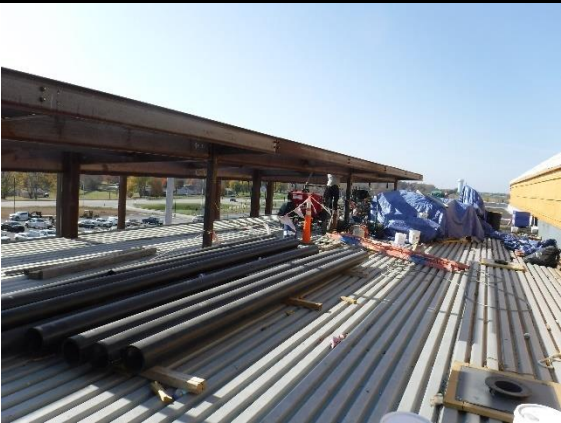
Item No.	Location	Description/ Correction	Image	Action
16	Area B, Roof over the LMC.	Steel roof deck was being placed on steel framing. The upper roof over the LMC was being erected.

Coordinate decking with roofing and roof drains.
17	Area B, Roof over the LMC.	The roof over the LMC will project over the lower roof.

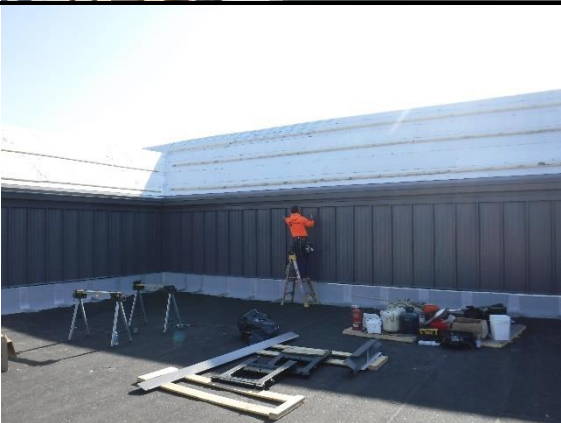
Coordinate the roof areas with roof drains and roof details.
18	Area B Roof over Classrooms.	Sheet metal siding was being installed over the low sloped modified bitumen membrane roofing.

Always protect membrane roofing when working above it.

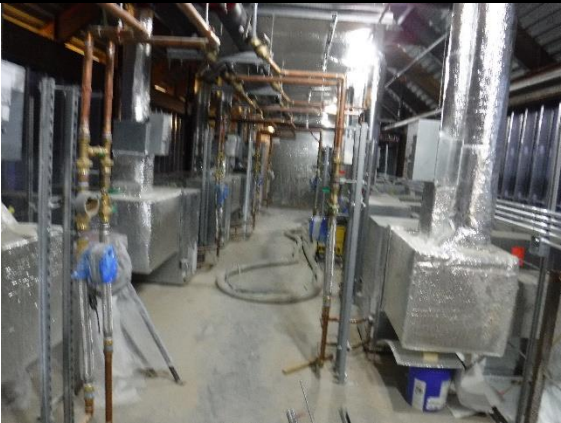
Item No.	Location	Description/ Correction	Image	Action
19	Area B – East/ West Platform.	Heat pumps, piping, ductwork and electrical work all were in progress. The area was clean.

Maintain clean work areas on the platforms.
20	Area B – East/ West Platform.	Electrical work was underway.

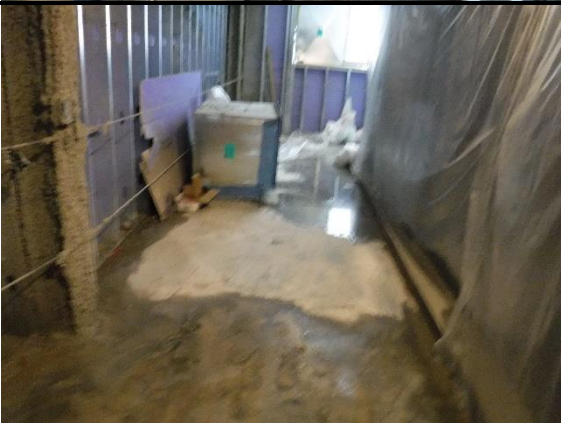
Again, the platform needs to be kept as clean as possible.
21	Area B – East/ West Platform.	Water was entering the building through the large louver at the west end of the platform.

Put plastic over the louver.

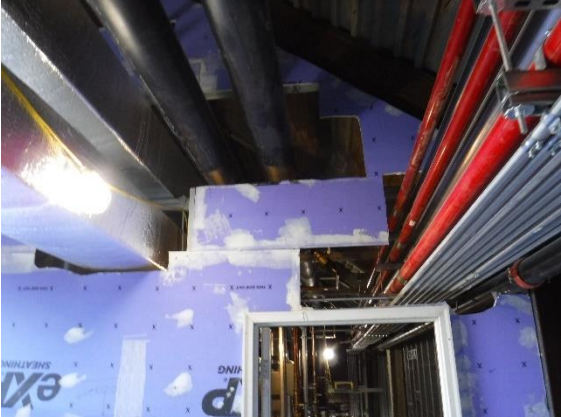
Item No.	Location	Description/Correction	Image	Action
22	Area B Platform at Barricade into Construction Area.	The barricade has been cut up with no regard for maintaining separation to the finished areas.

Use plastic or whatever materials necessary to maintain separation with the finished area. KEEP THE DOOR CLOSED!
23	Area A Platform.	A cleanup of the platform did occur, but there are still trash piles like this one.

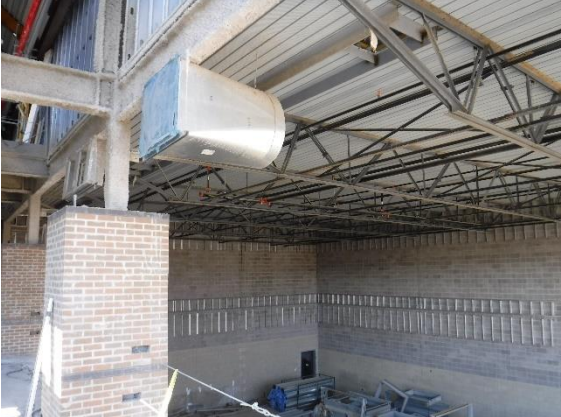
Clean up all trash every day!
24	Area B and E, Second Floor at the Cafeteria.	R&S has figured out how to run the ductwork into the cafeteria area.

Execute!

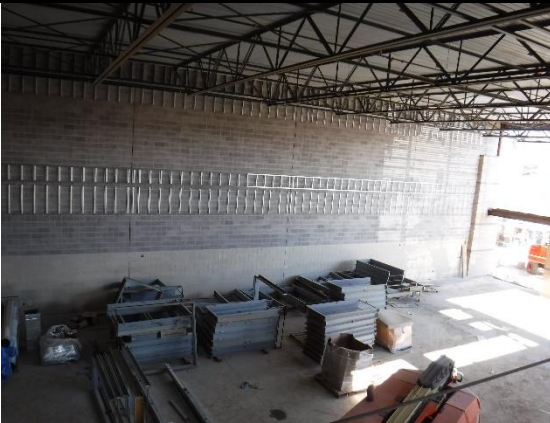
Item No.	Location	Description/Correction	Image	Action
25	Area E, Cafeteria.	Metal framing for the soffits was being installed.

Keep storage areas clean.
26	Area B, First Floor.	Corridor was relatively clean.

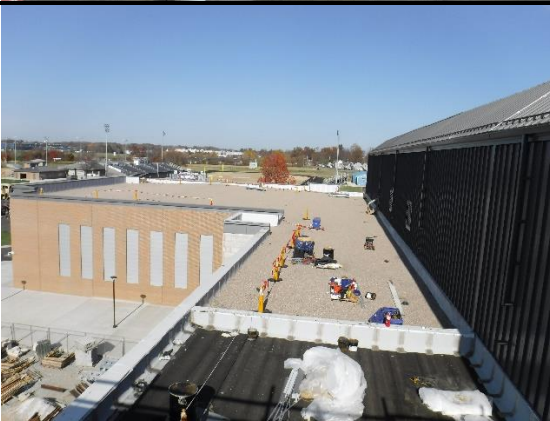
Keep the corridors clean and dry.
27	Area B and A Roof	Gravel has been placed on the low sloped roofing membrane.

Prepare a punch list for the roof.

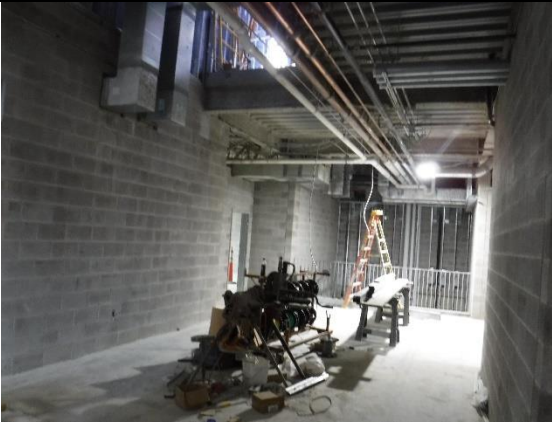
Item No.	Location	Description/Correction	Image	Action
28	Area B, First Floor.	Due to the structure and the above ceiling piping and units, the ceiling in this area will need to be lowered about 2". A wallboard soffit will be added to separate this area from surrounding corridors.

Show the change on the As-Built Drawings.
29	Area A, Sub Level in the Gym Lobby.	The clean up of the terrazzo after grinding is a messy process.

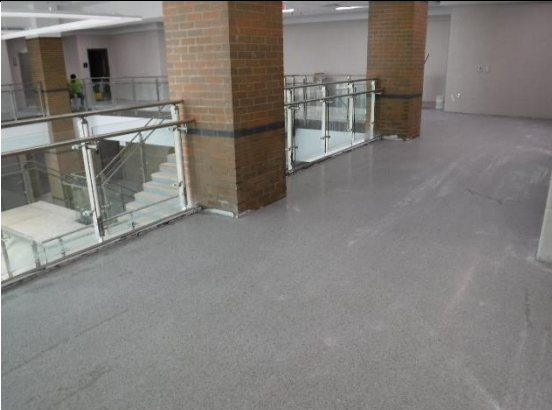
Protect existing finishes and replace any finish if damaged.
30	Area A, Sub Level at the Gym Lobby	A lot of water has been introduced during the grinding process.

Consider different phasing for terrazzo flooring work in other areas.

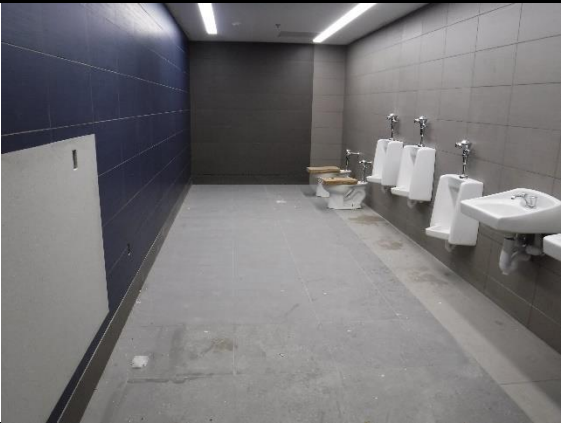
Item No.	Location	Description/Correction	Image	Action
31	Area A at the Gym Level, Student Toilets.	Ceramic tile walls need to be grouted before the toilet partitions can be installed.

Grout the tile.
