# Site Visit - Construction Observation

PROJECT:	5056-01 Trans District Sup Fac 5056-01	DATE:	11/8/2023
VISIT NAME:	Construction Progress Site Visit	REPORT NO:	009
AUTHOR:	David Vaught	STATUS:	Final

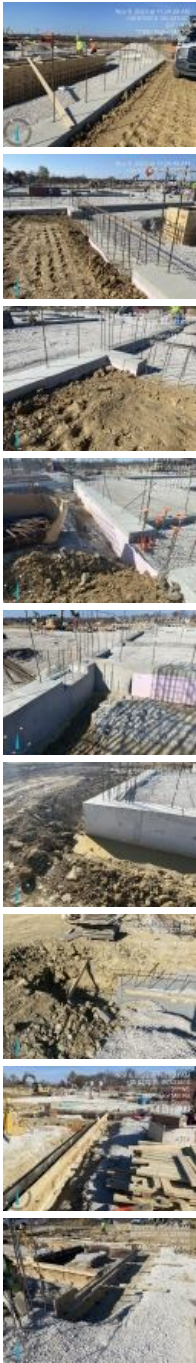
ITEM	REMARKS	DISCUSSION	PHOTO
009-130	Footers, stem walls, and insulation.

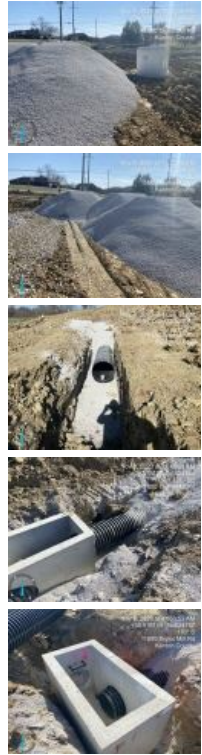
ITEM	REMARKS	DISCUSSION	PHOTO
009-132	Bedding material, pipe in trench

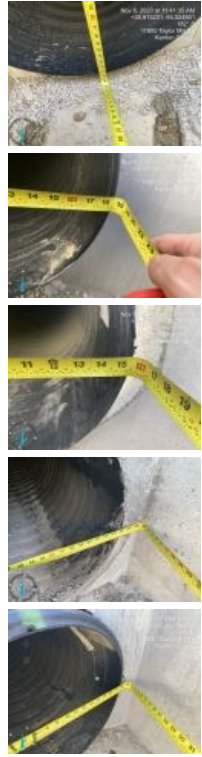
ITEM	REMARKS	DISCUSSION	PHOTO
009-134	Storm sewer sizing appears to conform to plans

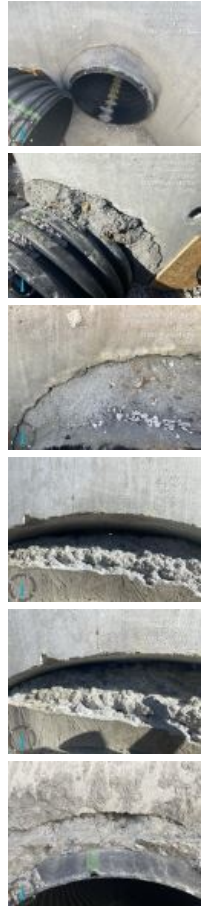
ITEM	REMARKS	DISCUSSION	PHOTO
009-136	Structure cores shall be large enough to accommodate the pipe and fittings. Pipe to be connected to structures with either HDPE N-12 Structure Connection with PVC Adapter; N-12 Hancor Dual Wall Sanded Manhole Adapter; or non-shrink grout free of seams, cracks and voids.

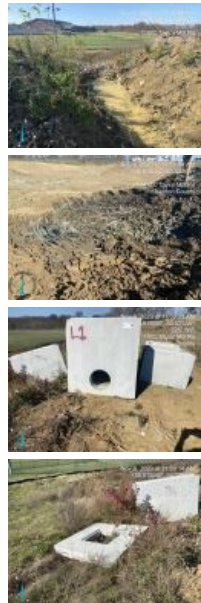
ITEM	REMARKS	DISCUSSION	PHOTO
009-137	Site preparation for outlet structure

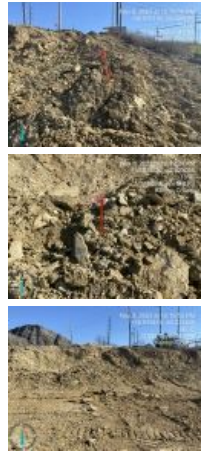
ITEM	REMARKS	DISCUSSION	PHOTO
009-141	Slope north of building
