August 7, 2023

Re: Structural Observation at Estill County Middle School

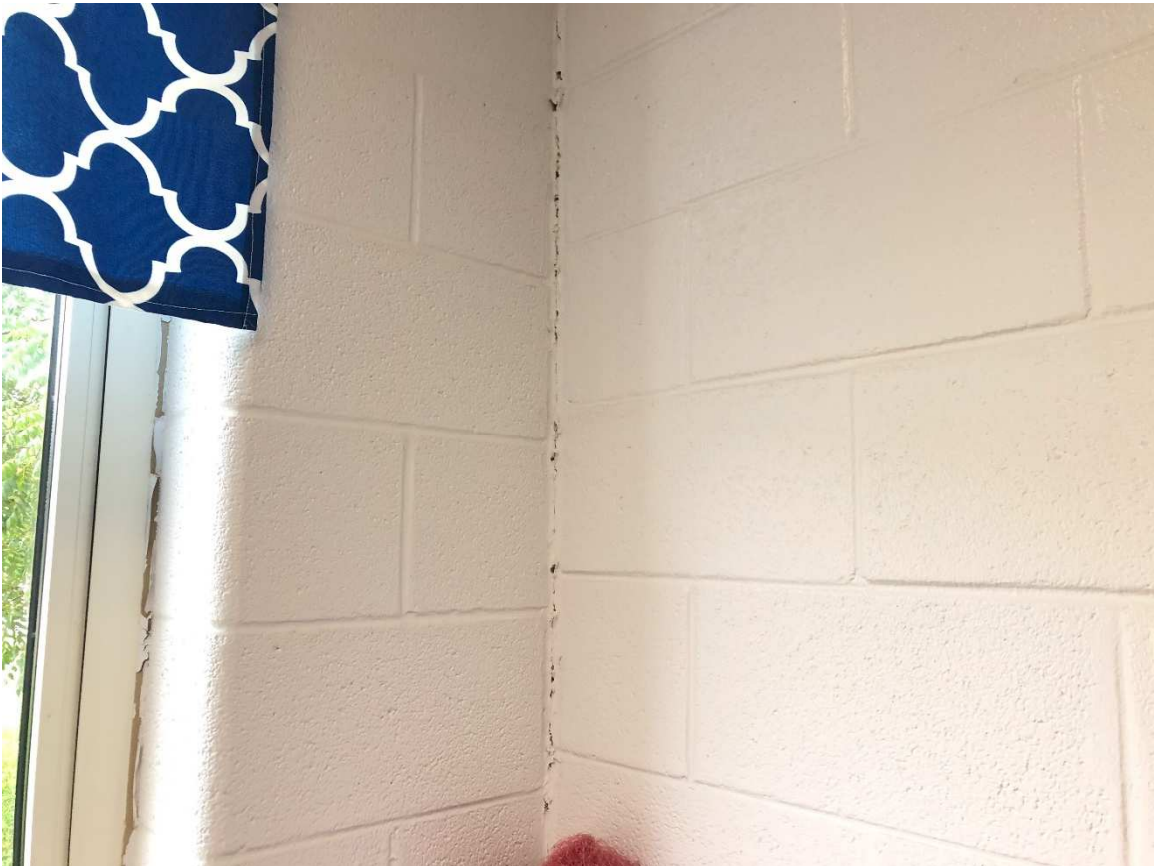
Interior partition heave

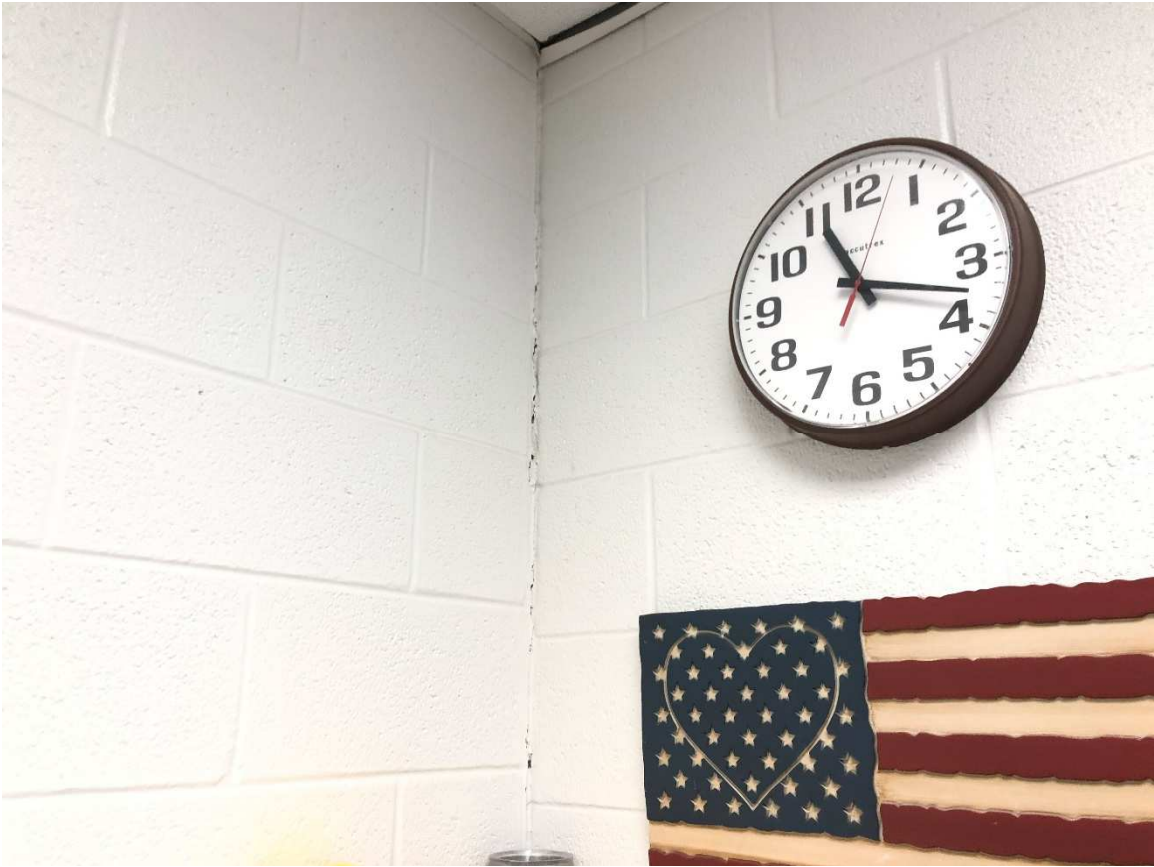
Interior partition heave

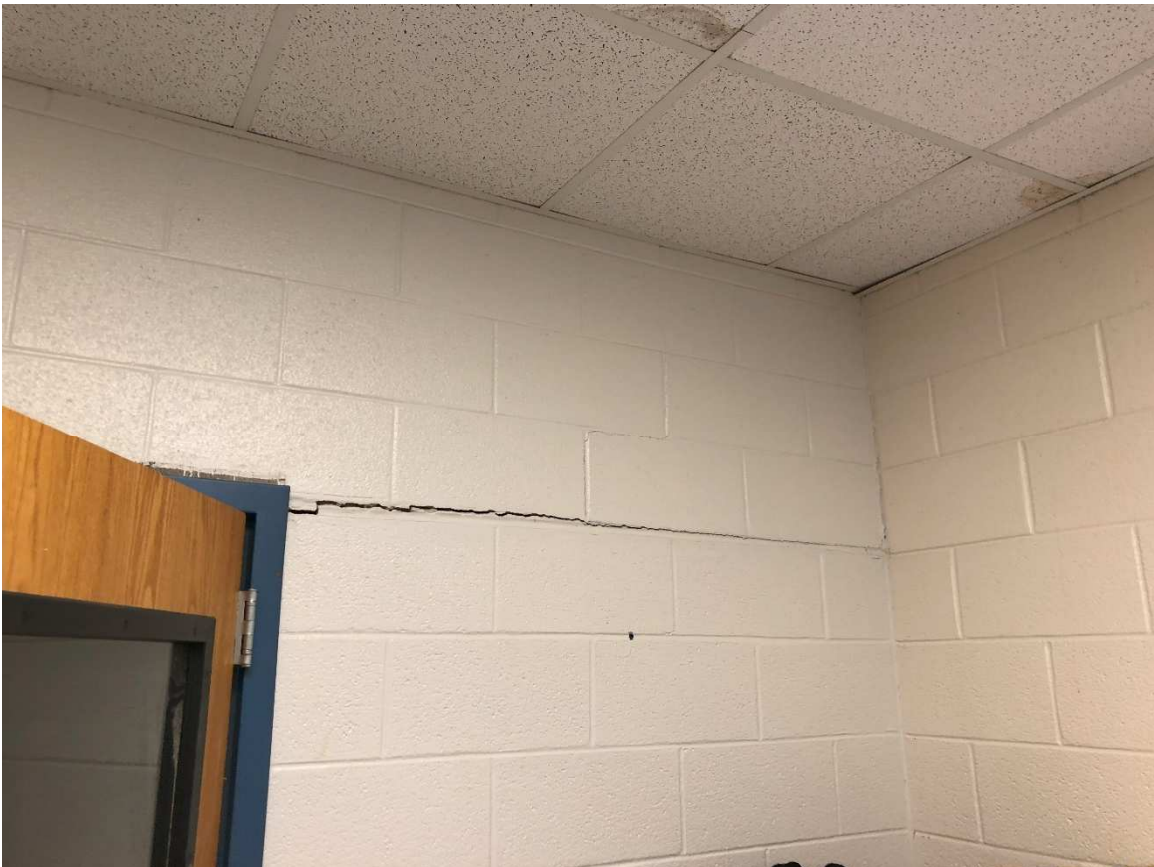
Horizontal crack in CMU

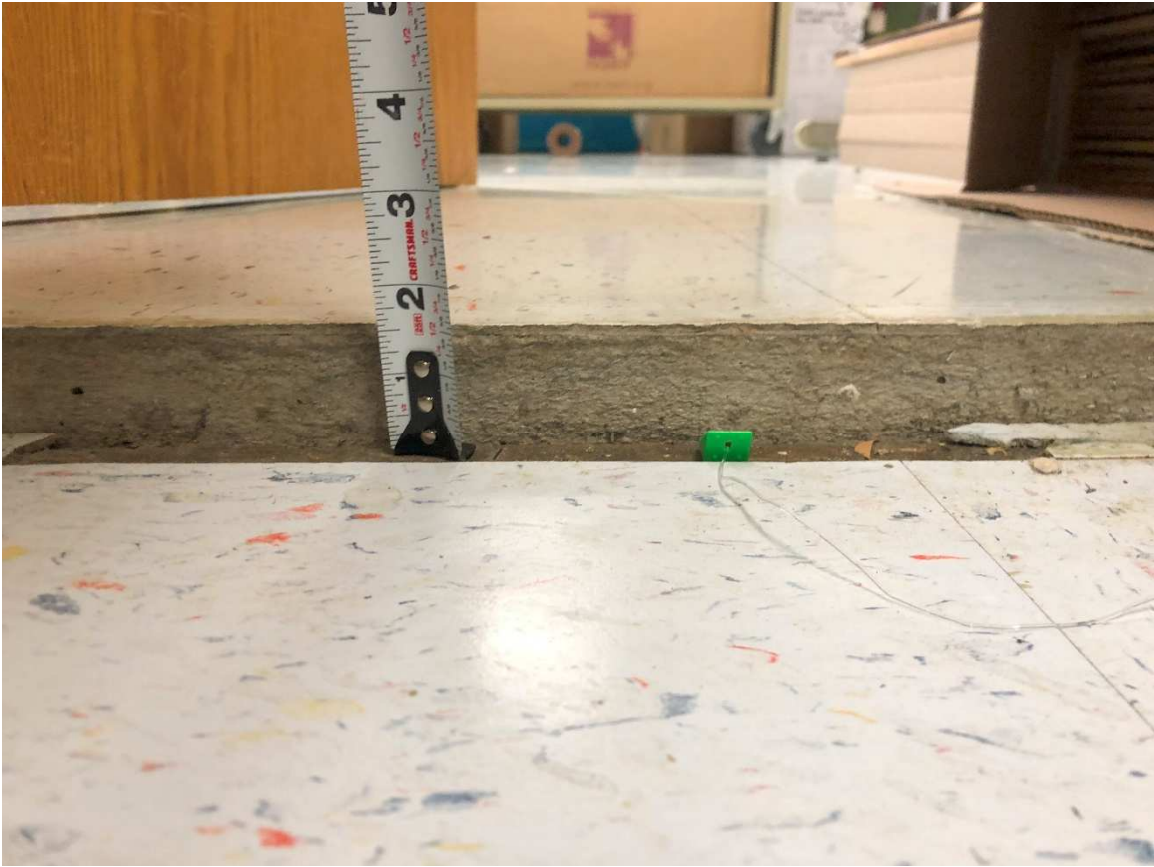
Slab heave @ construction joint

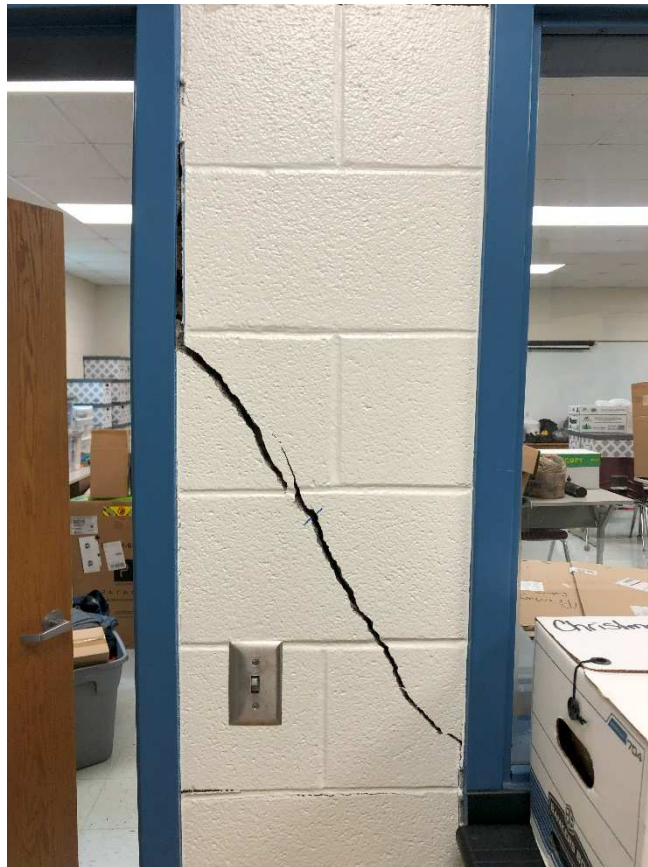
Significant crack in partition wall

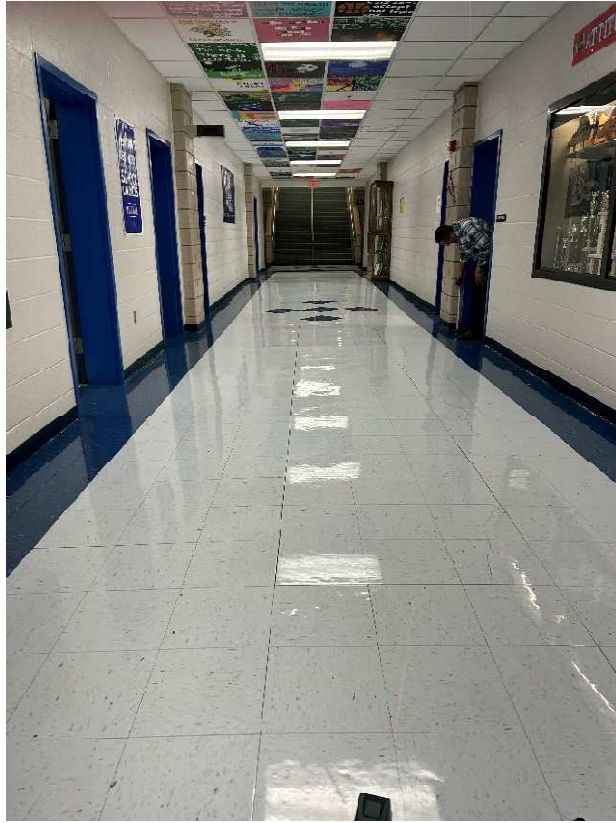
As stated, there were many problematic areas observed within the facility. The worst of the movements had occurred in the area of the building from the main foyer, down Corridor 102, and the classrooms tied to this corridor. We used a laser auto-level to measure approximately 5 ¼” of heave in this main corridor hallway. The load-bearing corridor walls had not seen this amount of movement, measuring somewhere between 1 ½” – 2” of total heave of these walls. Again, this would be due to the corridor wall footings extending down to a less active soil layer. Other areas of the building have also seen significant heave, but this portion of the building was the most notable.

View of hallway w/ slab heave

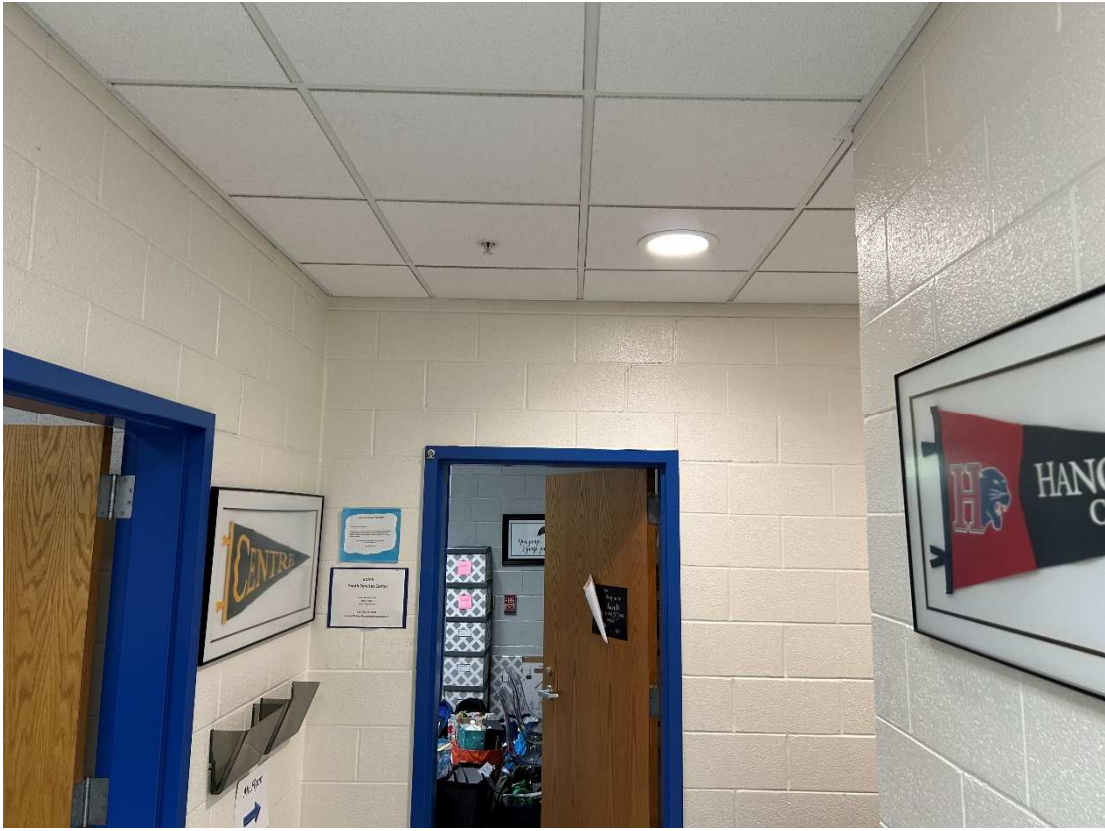
Crack in CMU near youth service center room

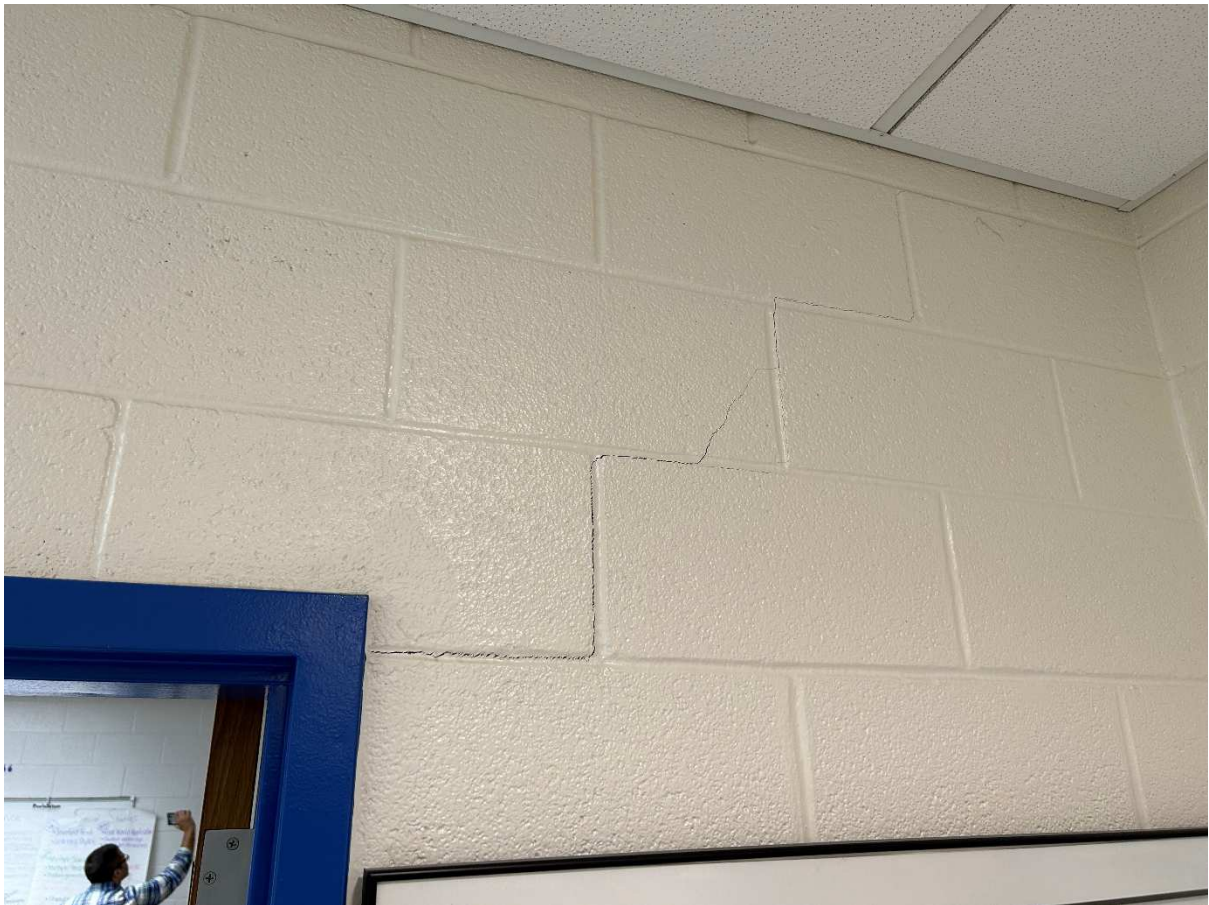
Crack in CMU near youth service center room

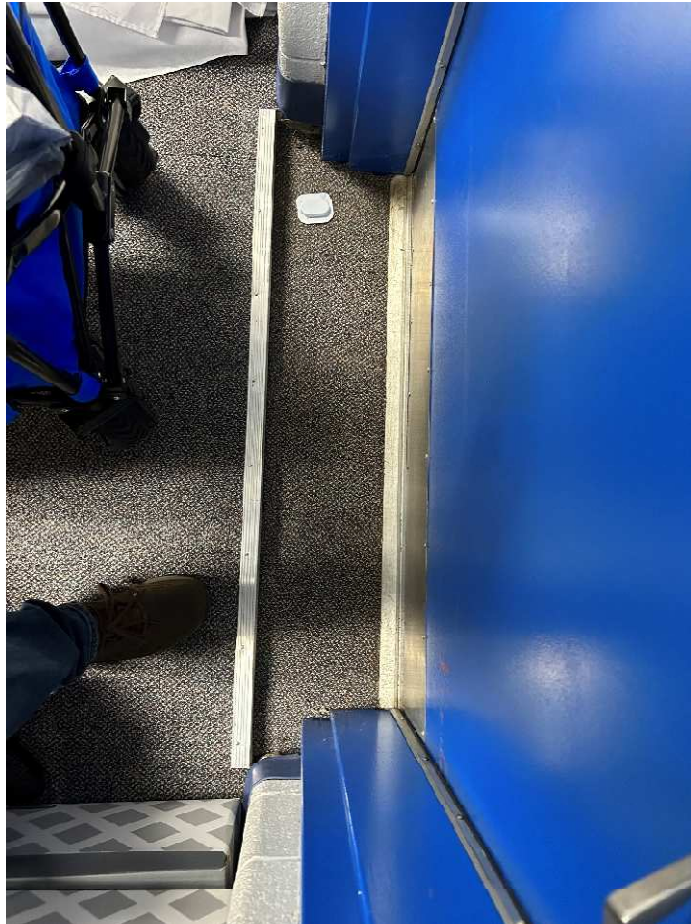
Visible heave in concrete slab near exterior door of youth service center

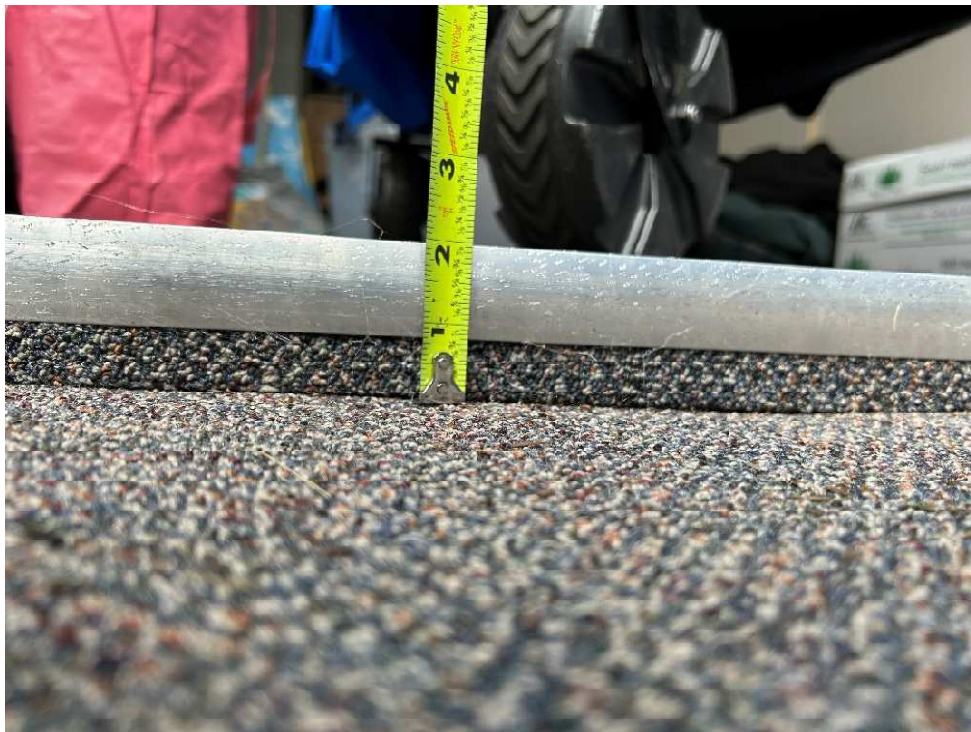
Visible heave in concrete slab near exterior door of youth service center, measuring approx 2".

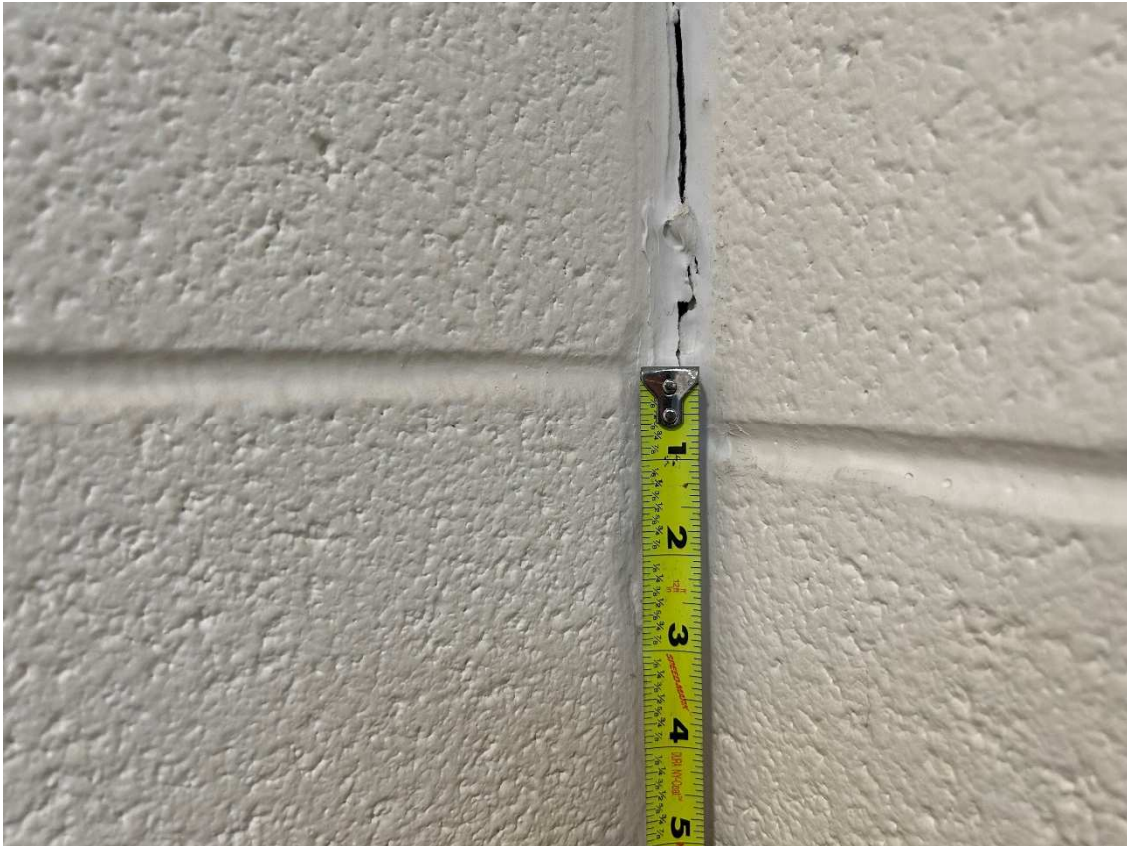
CMU coursing in counselor office measures approx $\frac{3}{4}$ " differential heave in interior wall (exterior wall on right side of photo).

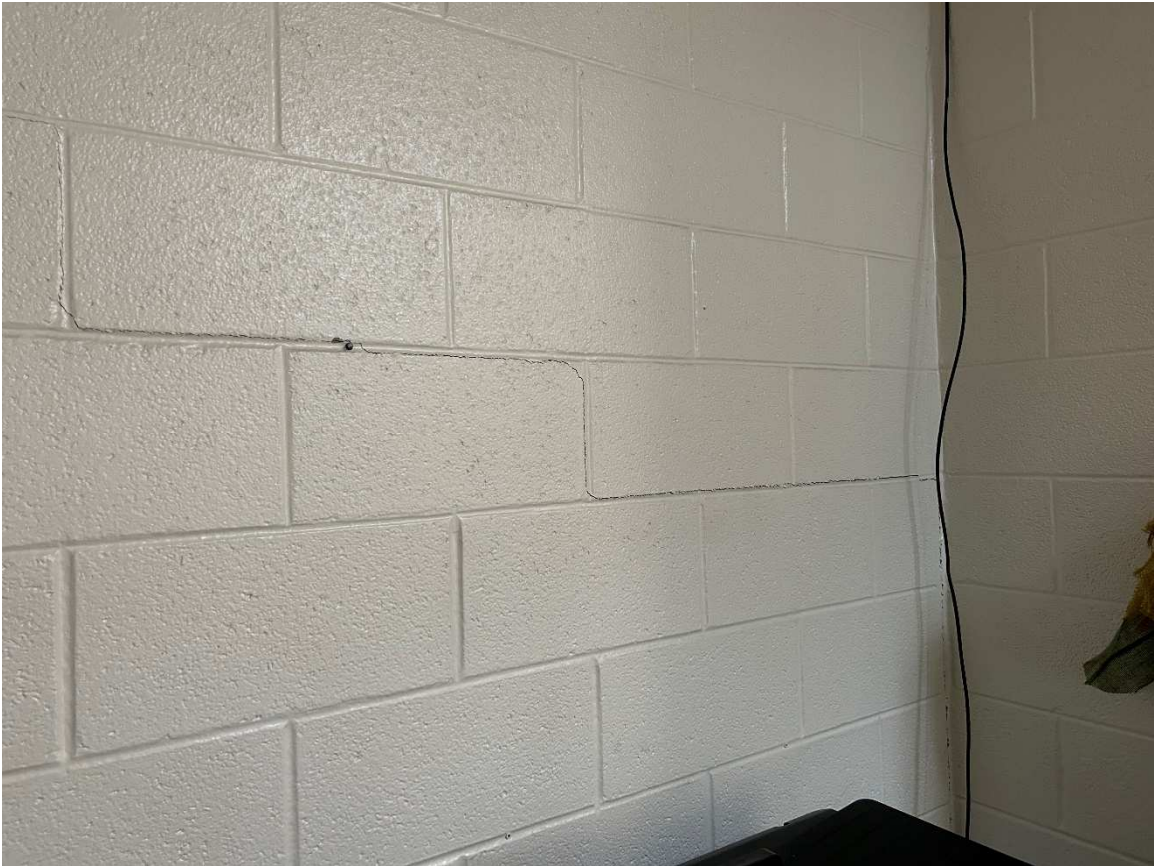
Crack in CMU coursing in counselor office

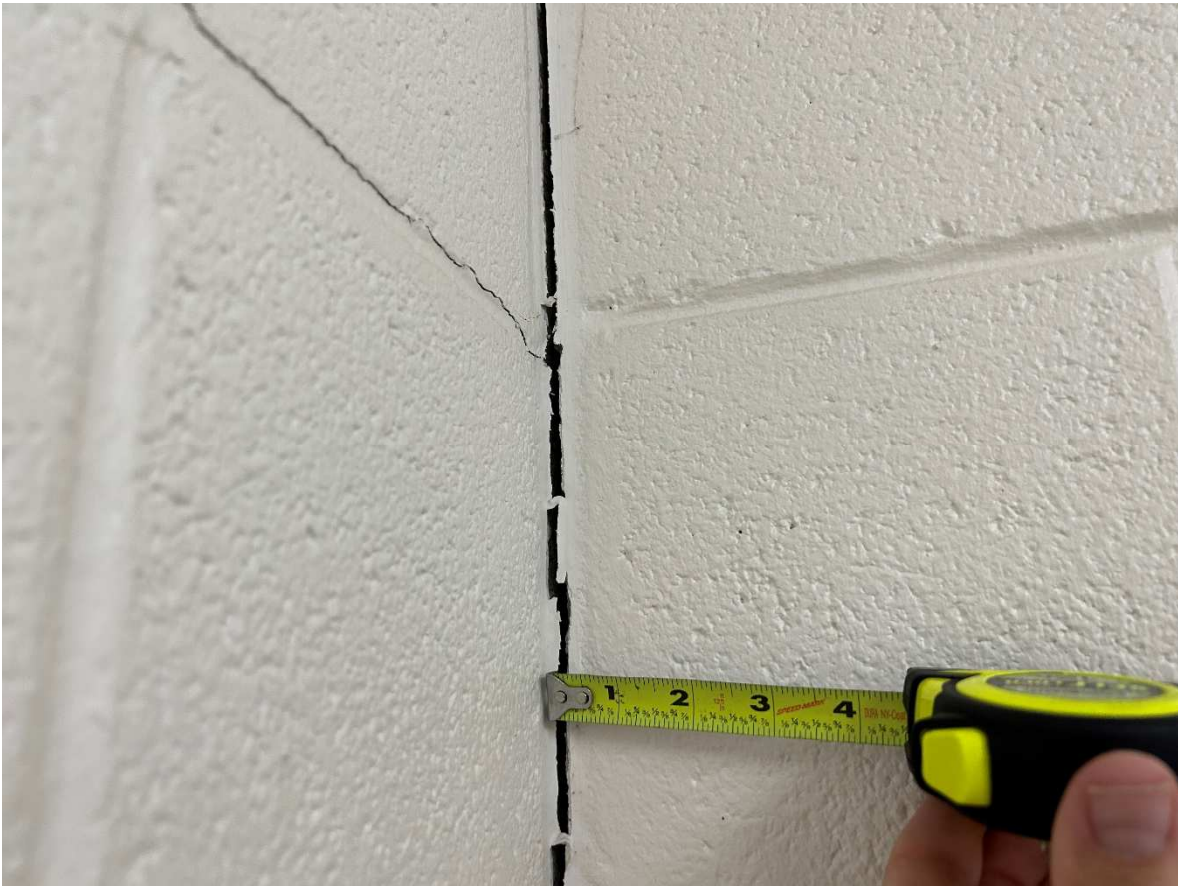
Nurse's office, separation of CMU at wall corner.

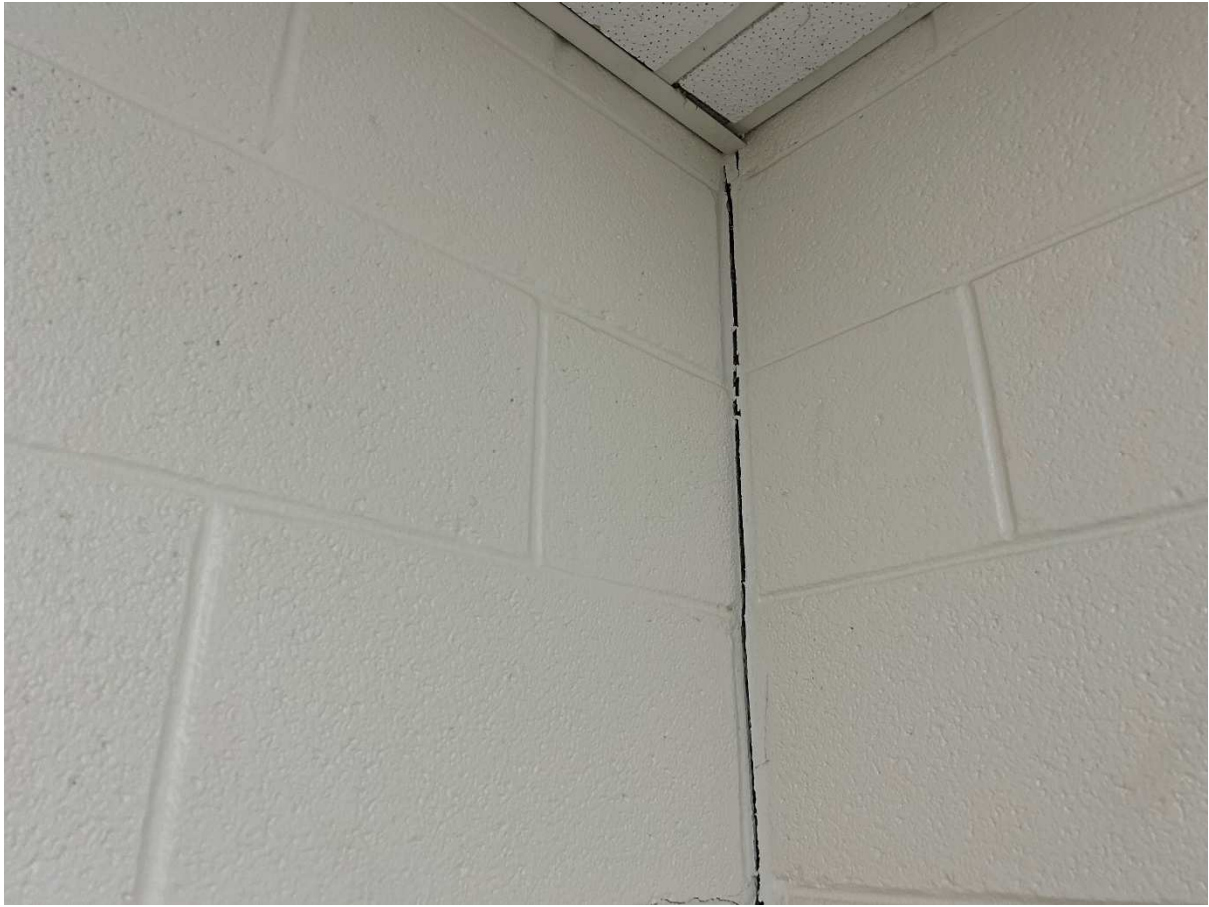
Nurse's office, separation of CMU at wall corner

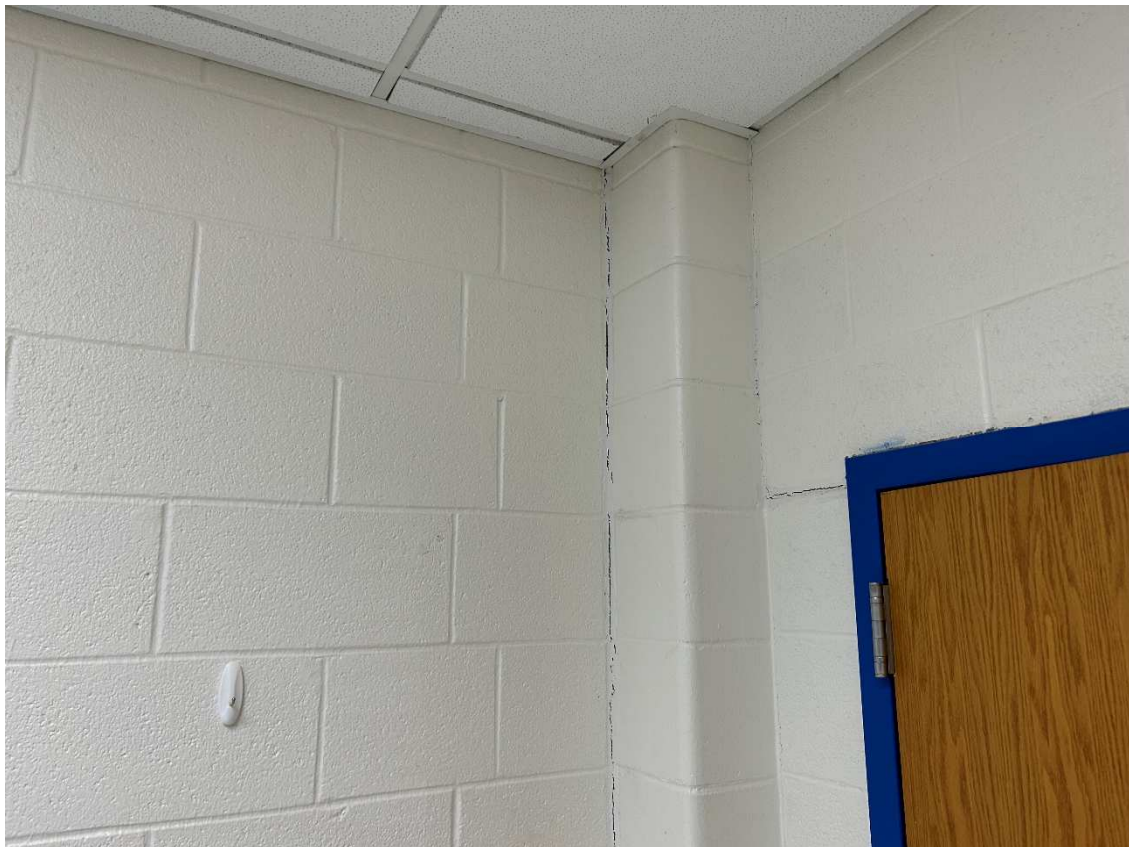
Nurse's office, separation of CMU at wall corner and crack near door.

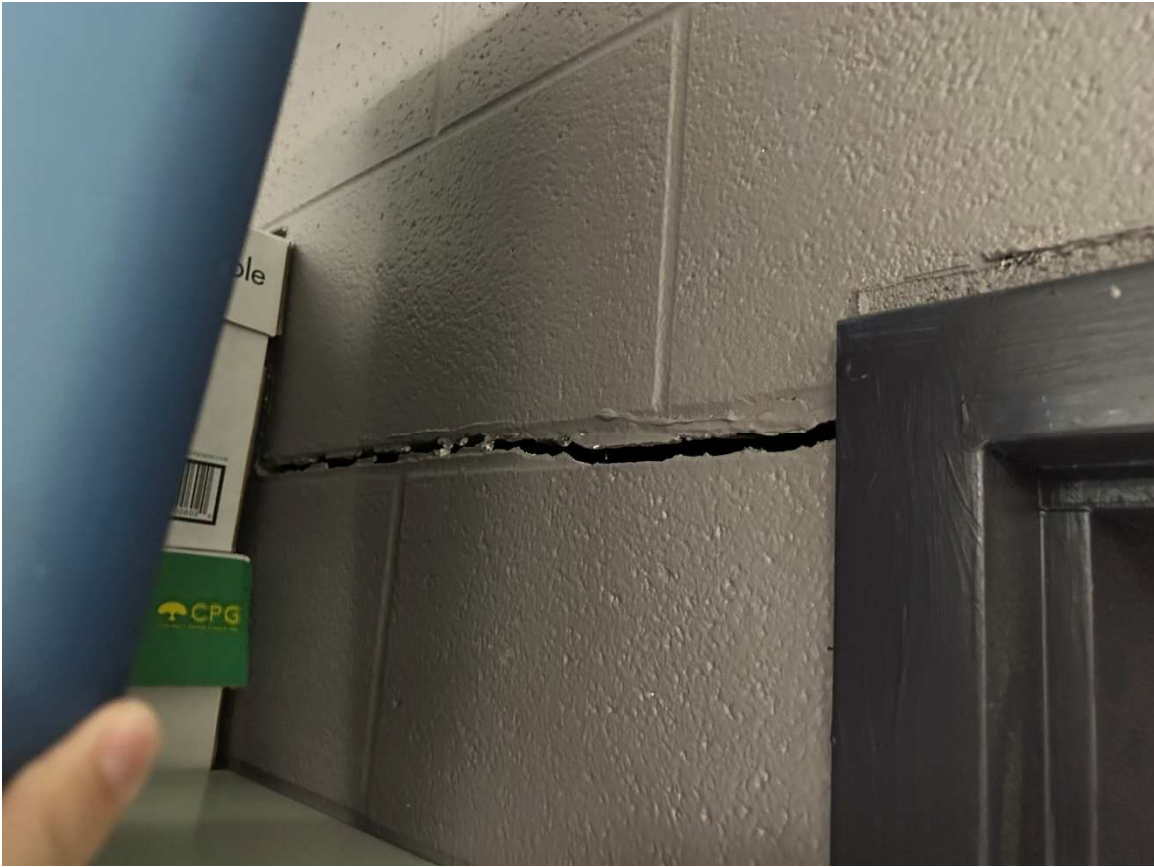
Room 105, CMU crack at door frame.

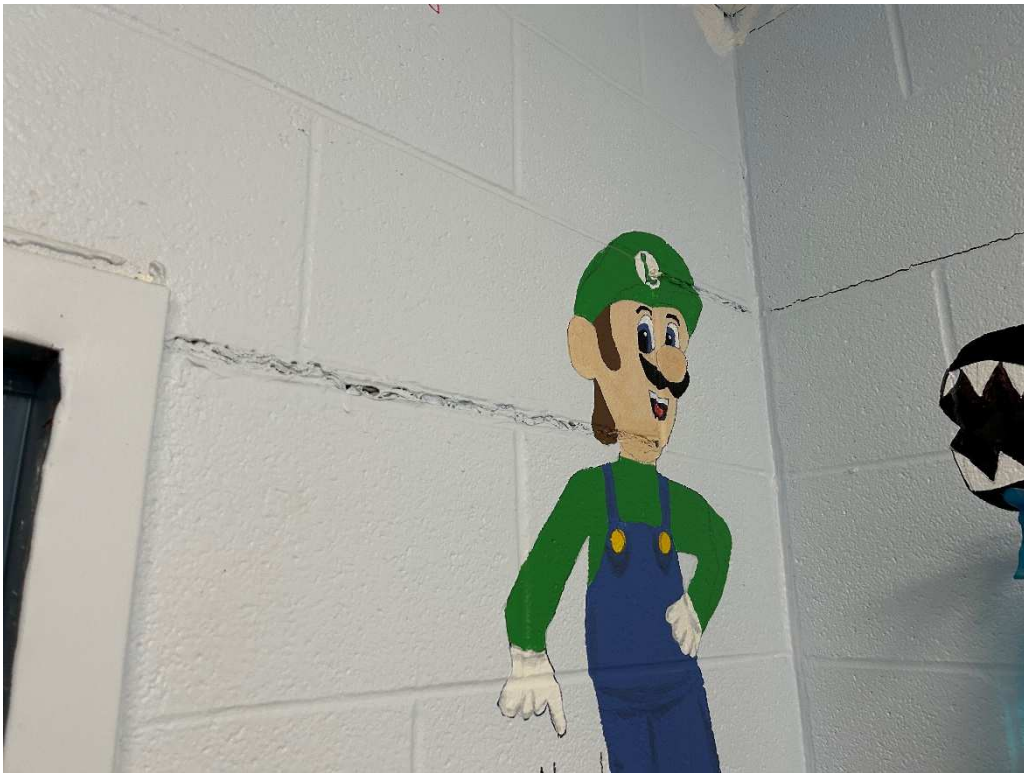
Room 105, CMU cracks in closet area.

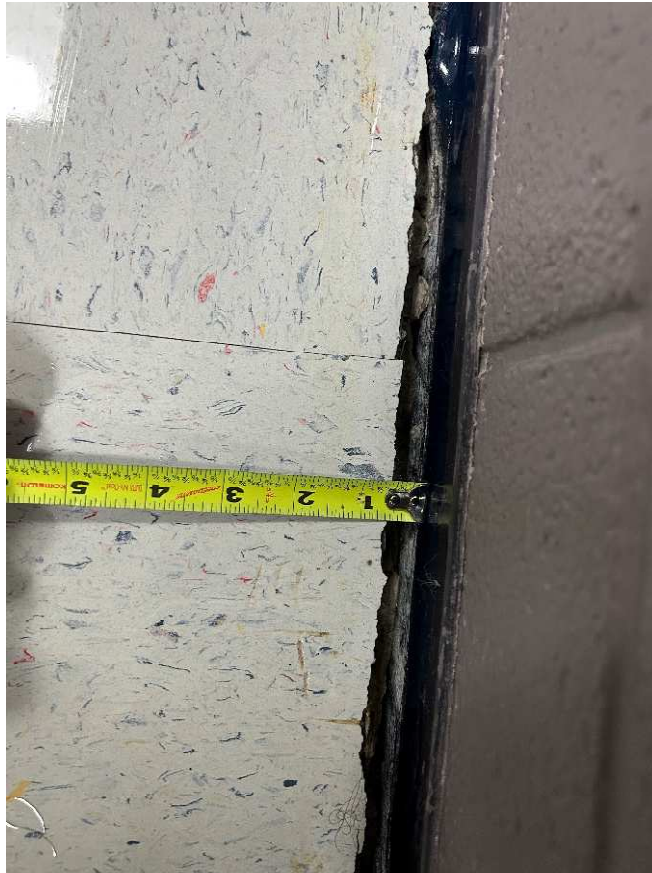
Room 105 slab heaved and showing gap from CMU interior wall.

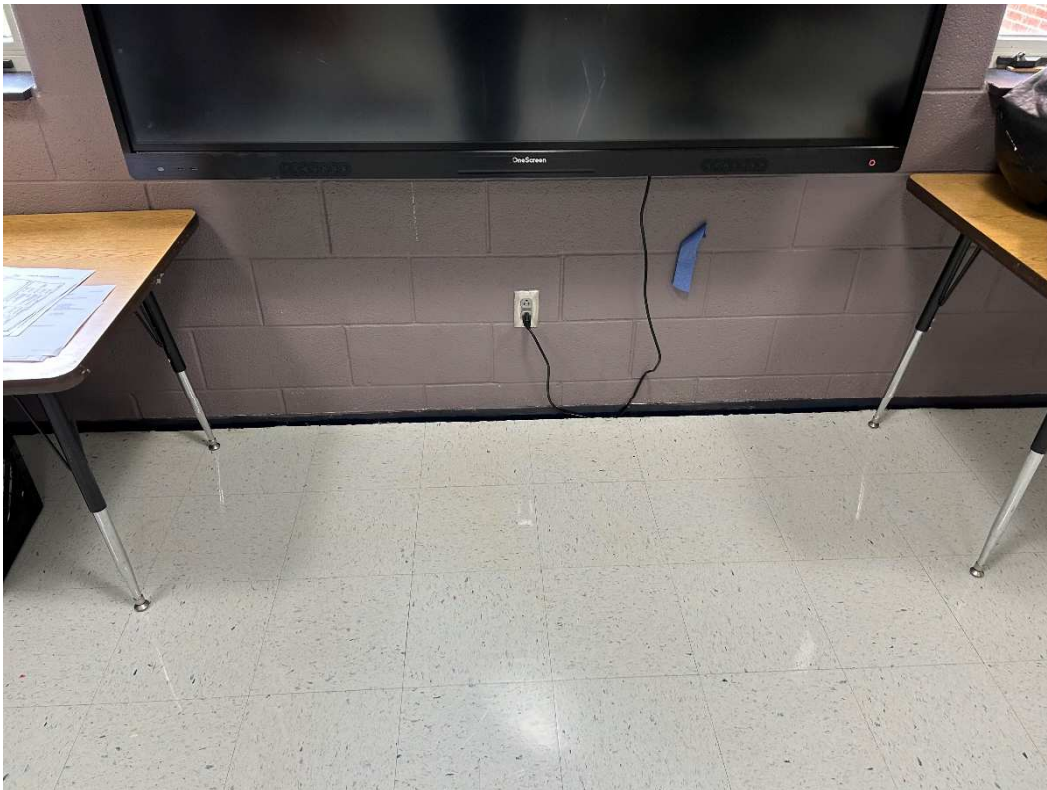
Room 105 slab showing heave in slab, approx. 3"

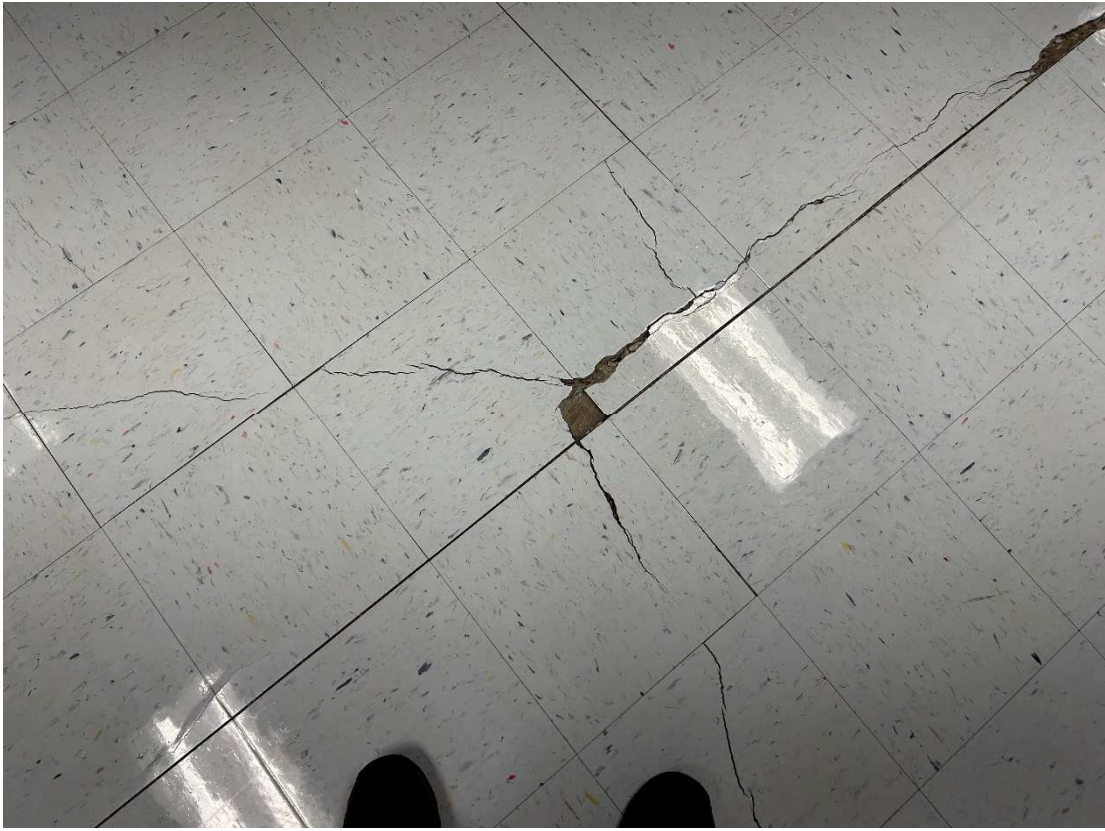
Cracks in slab of hallway

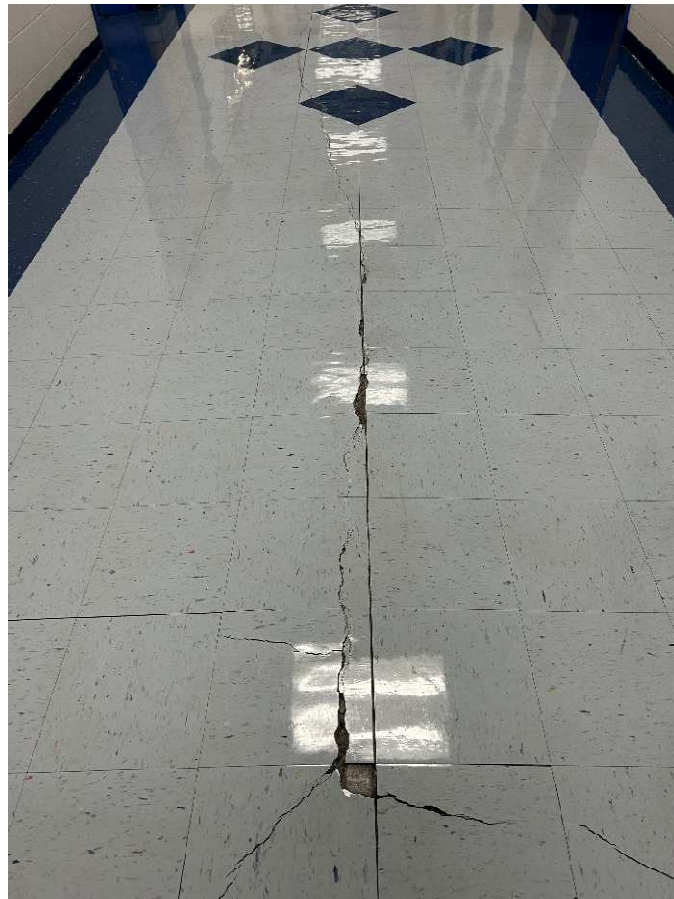
Heaving of slab on grade

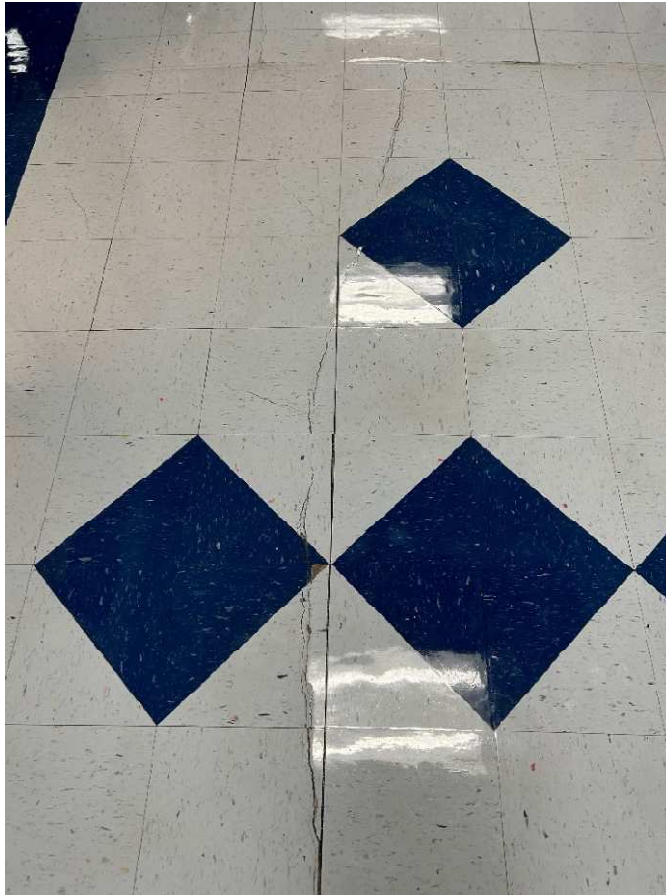
Heaving of slab

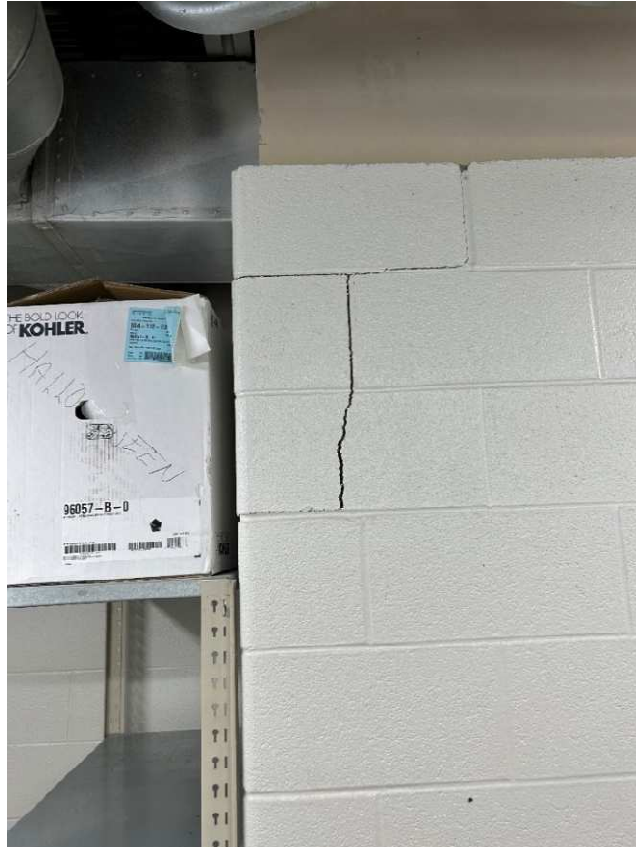
Electrical room (1st floor) with visible cracks in CMU walls.

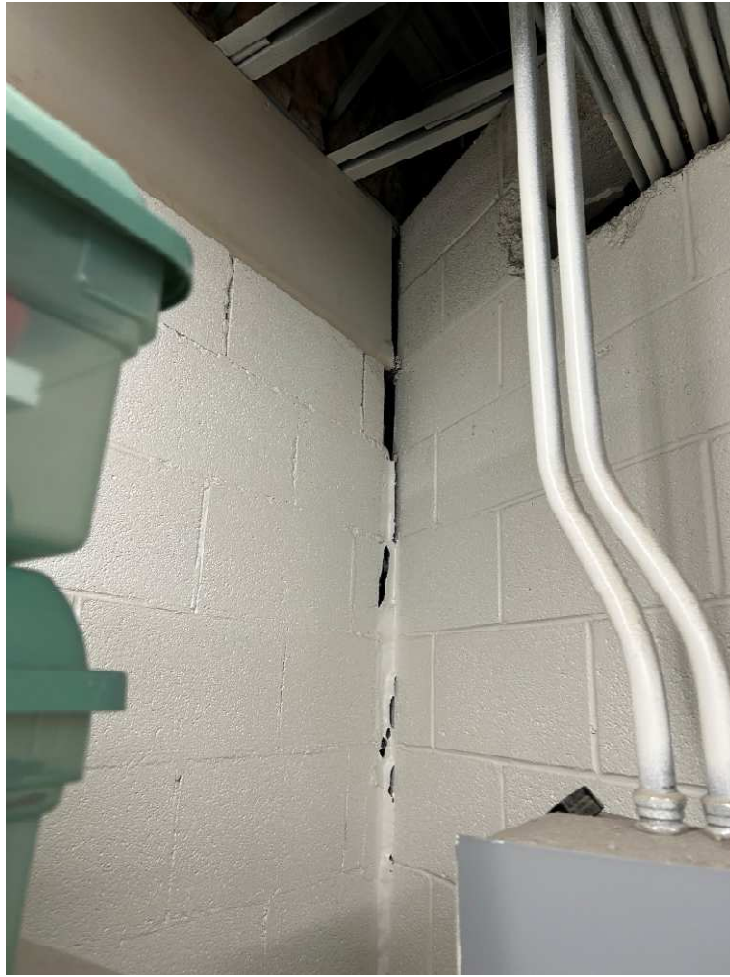
Electrical room (1st floor), visible cracks/gaps in CMU walls.

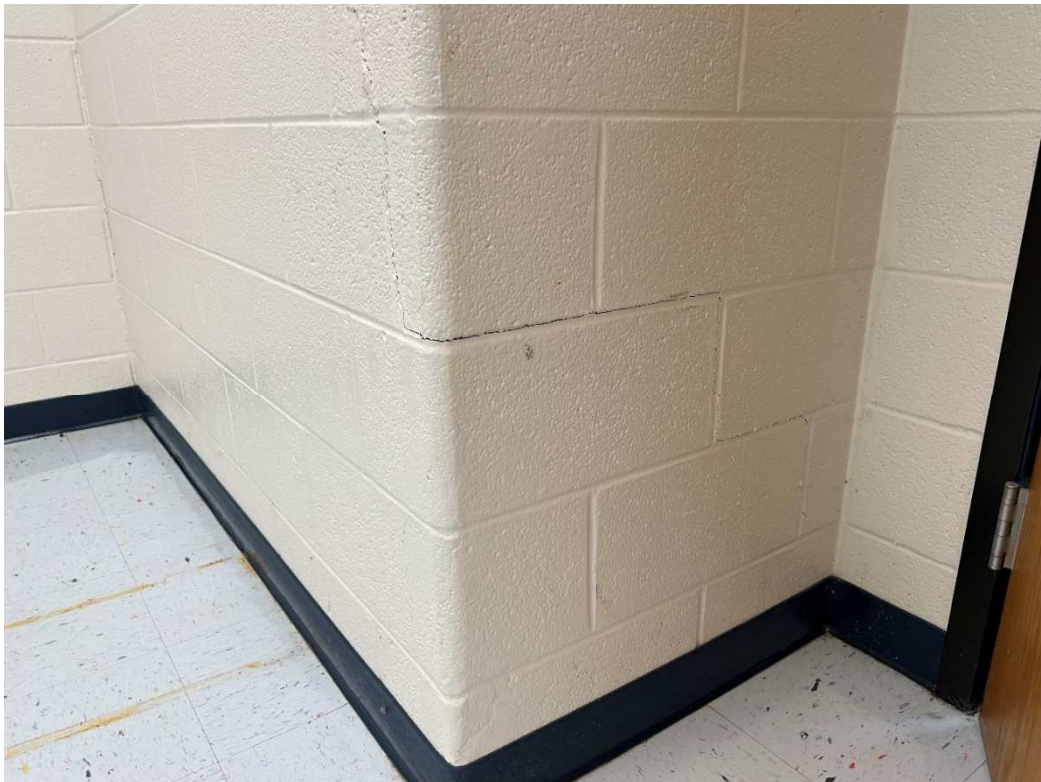
Room 119 with visible cracks in CMU wall.

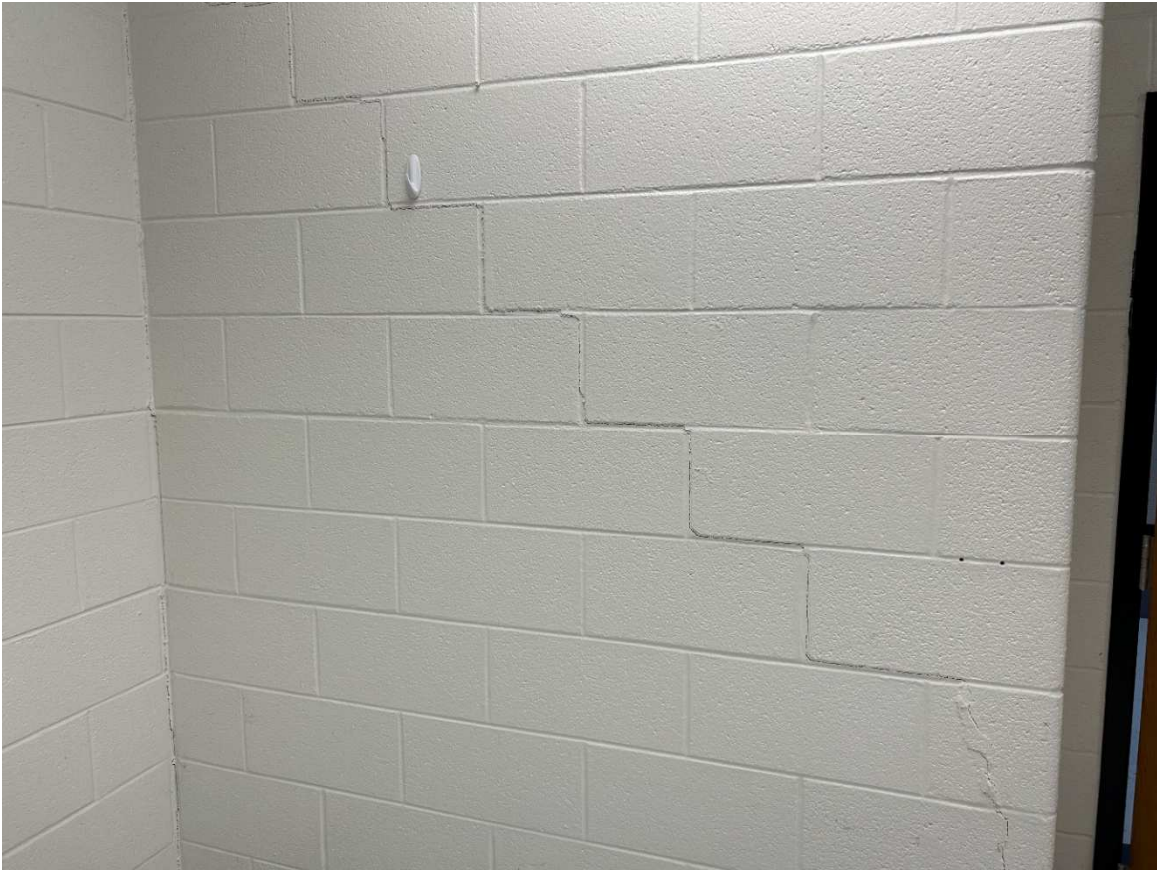
Room 119, with visible cracks in CMU wall.
