August 7, 2023

Re: Structural Observation at Estill County Middle School

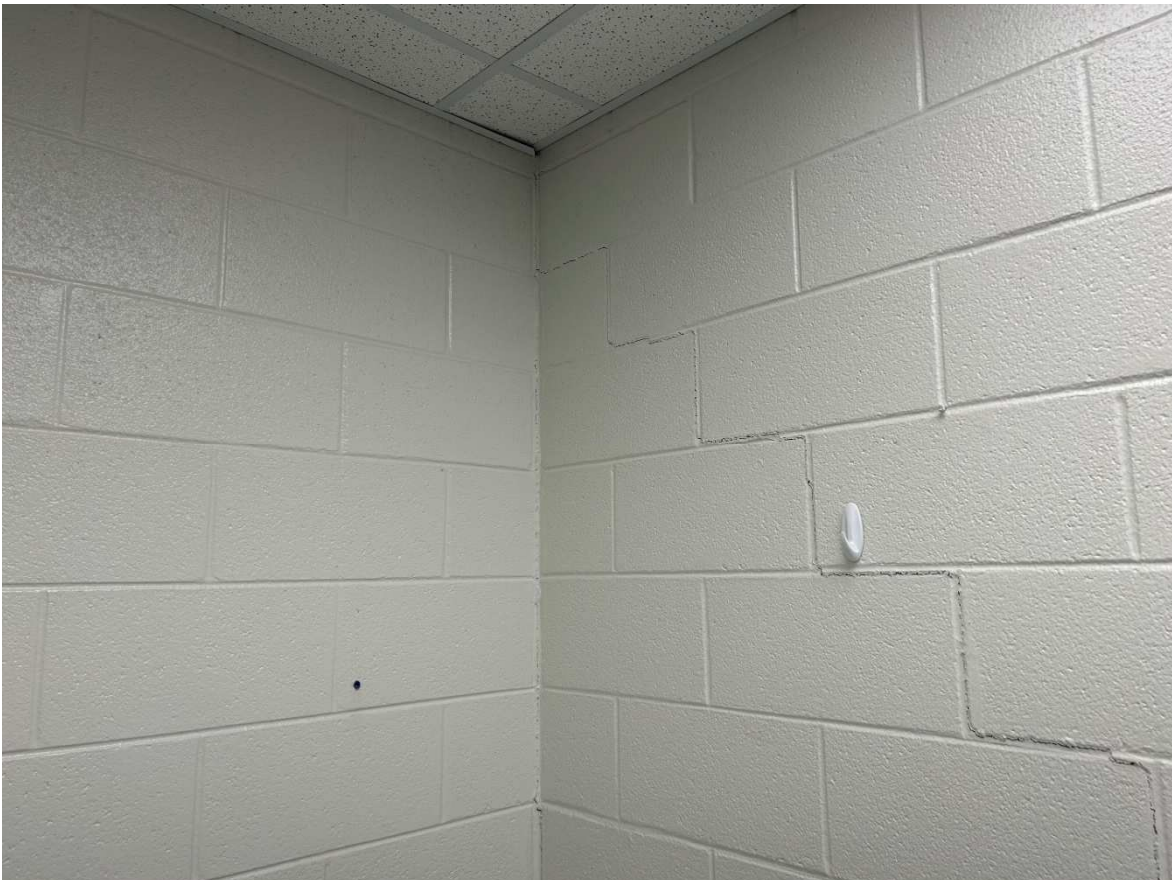
Room 119, with visible cracks in CMU wall.

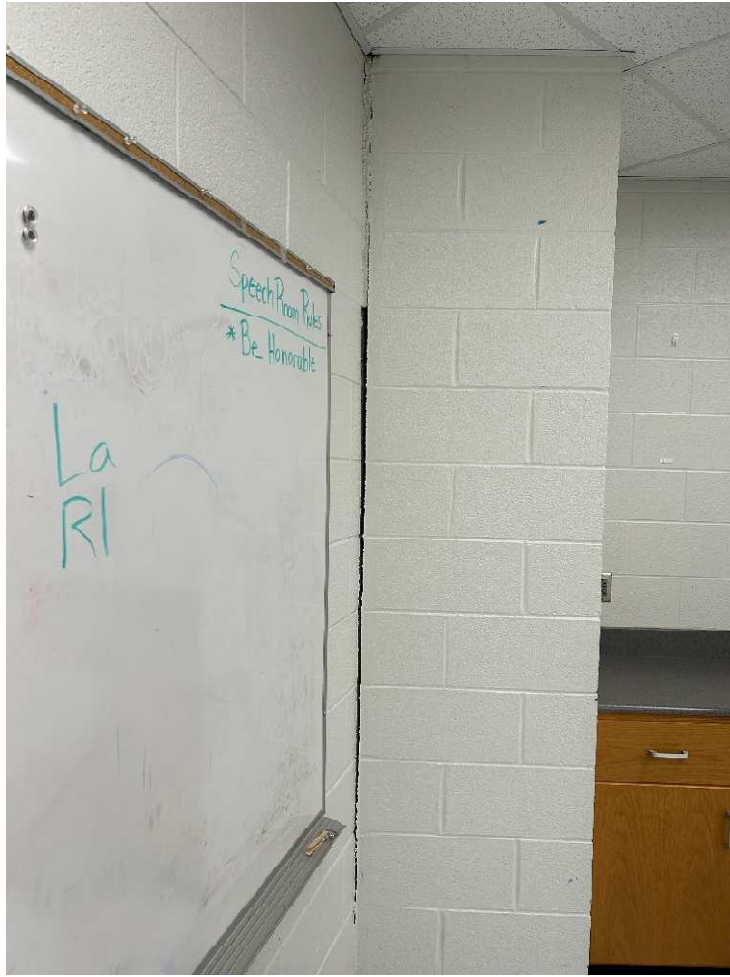
Room 119, visible gap in CMU wall (approx $\frac{3}{4}$ ").

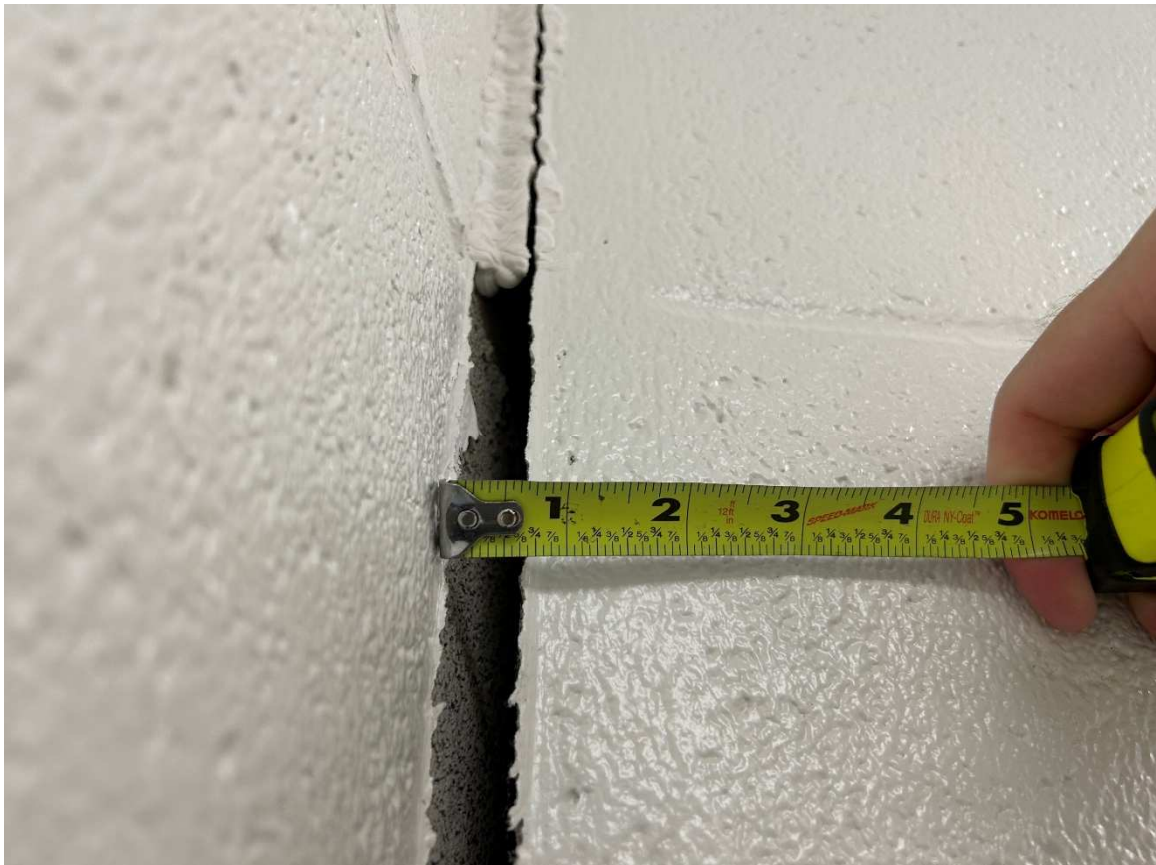
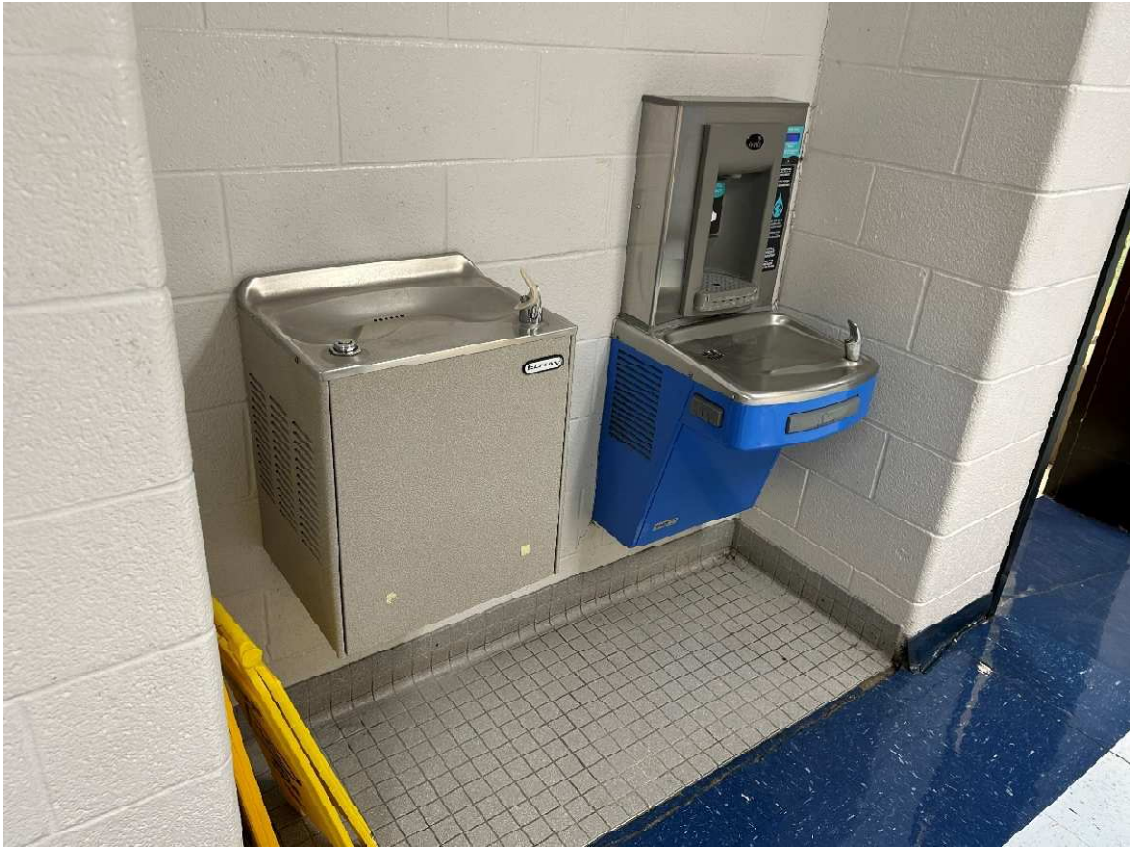
Crack in slab at water fountain (near Room 119)

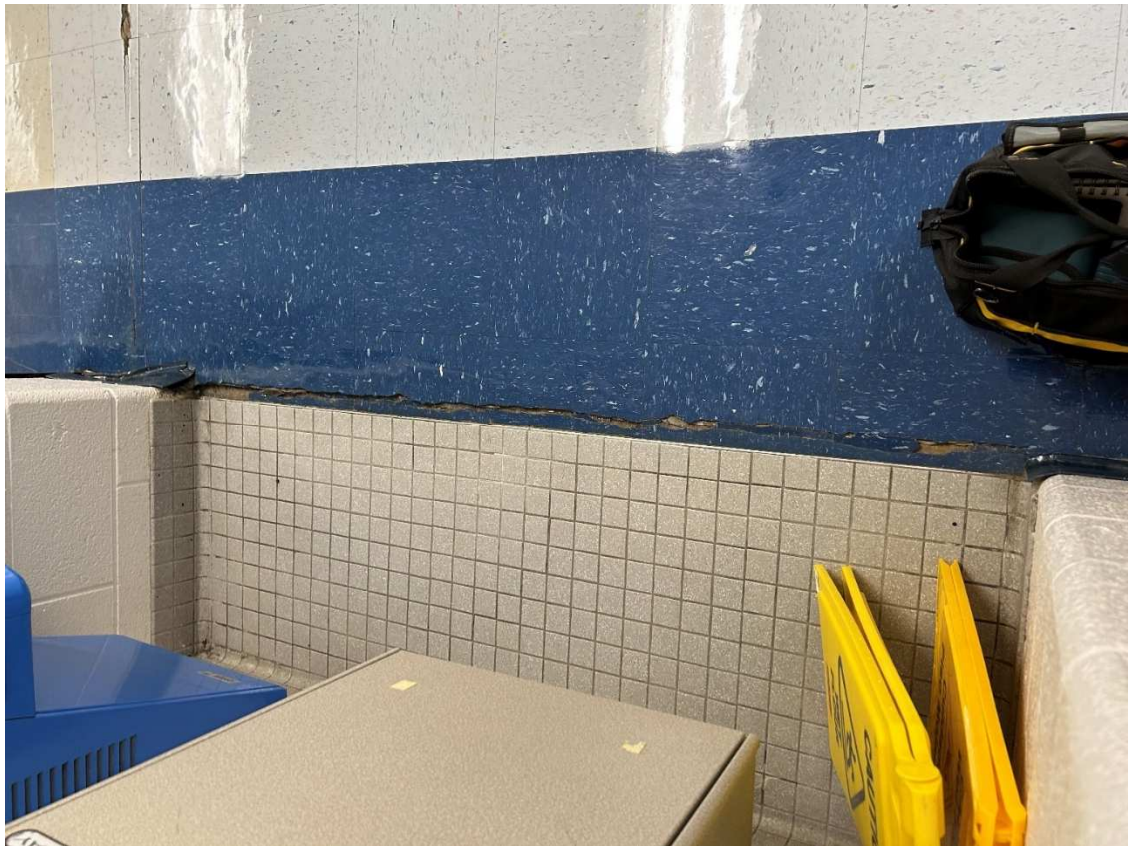
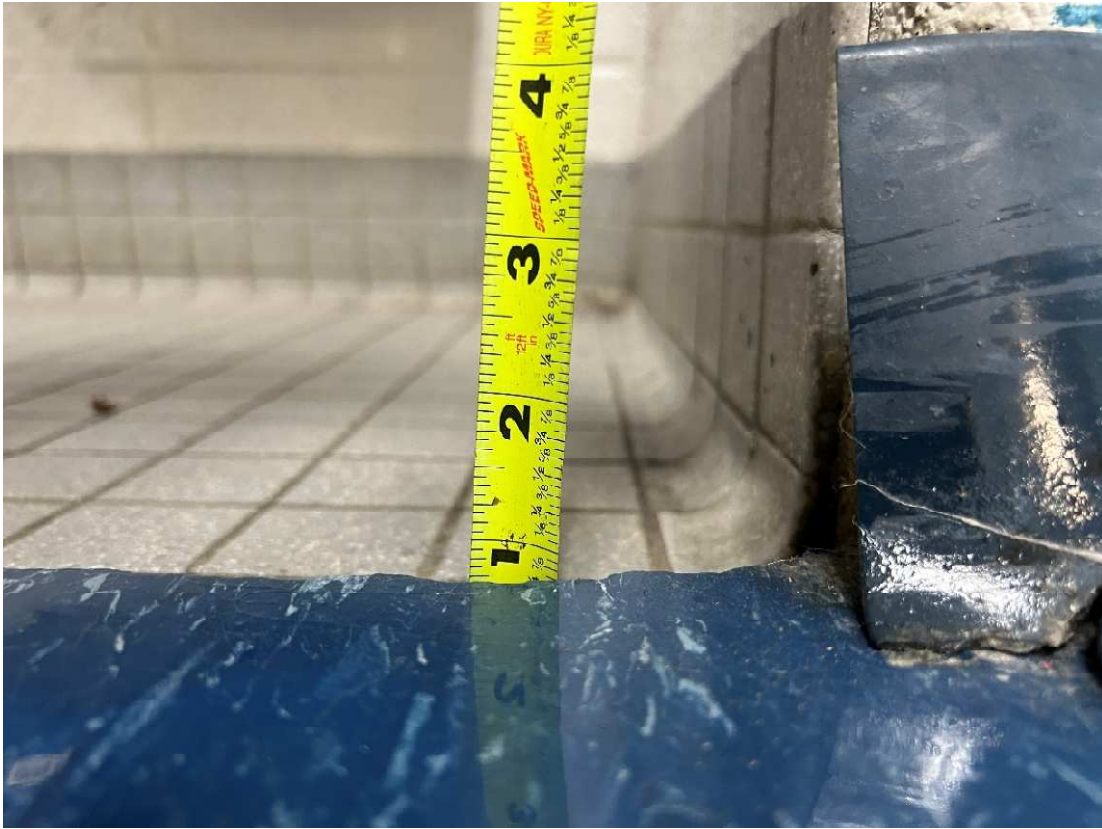
Slab crack at water fountain showing visible heave (3/4" differential).

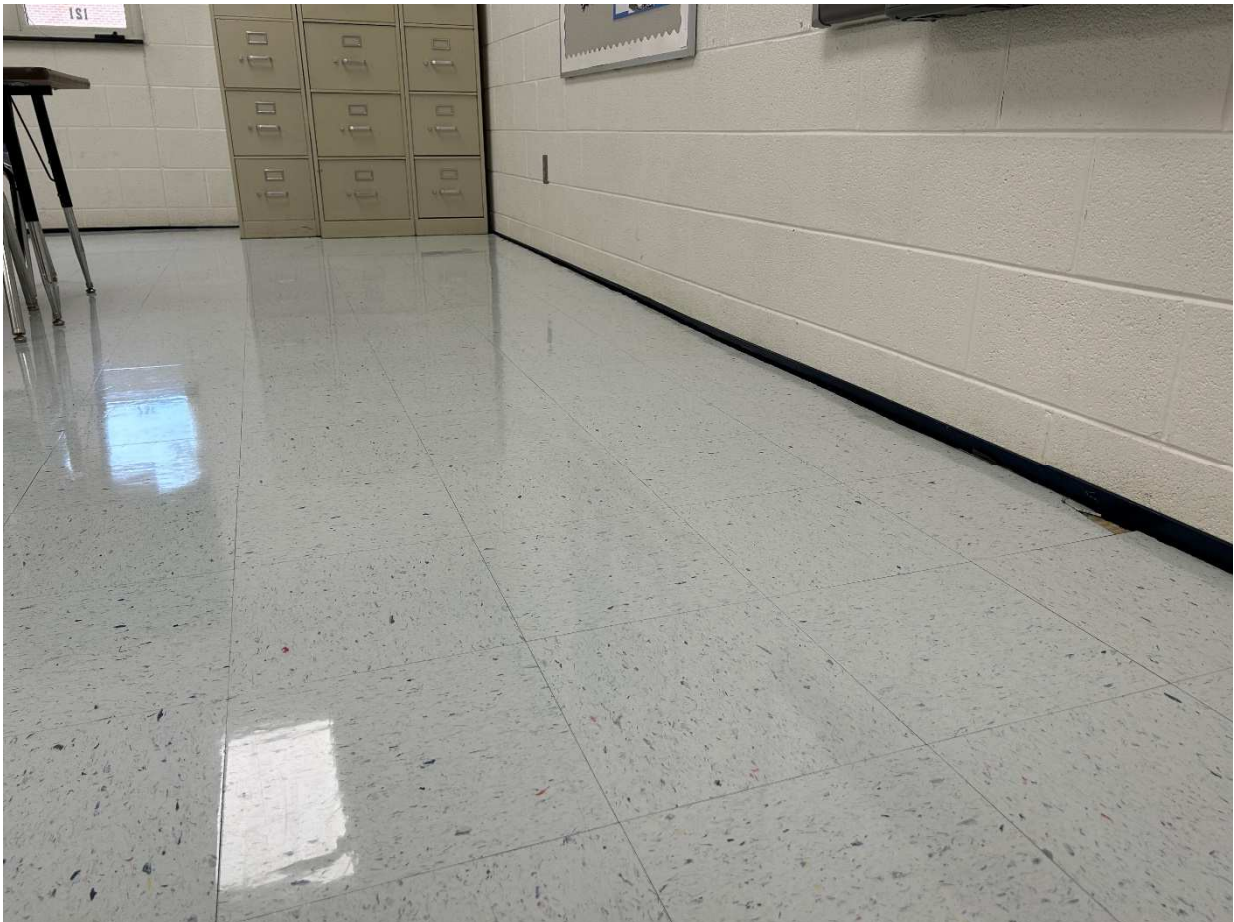
Room 121 showing slab heave. Up to 3 1/2" +/- heave.

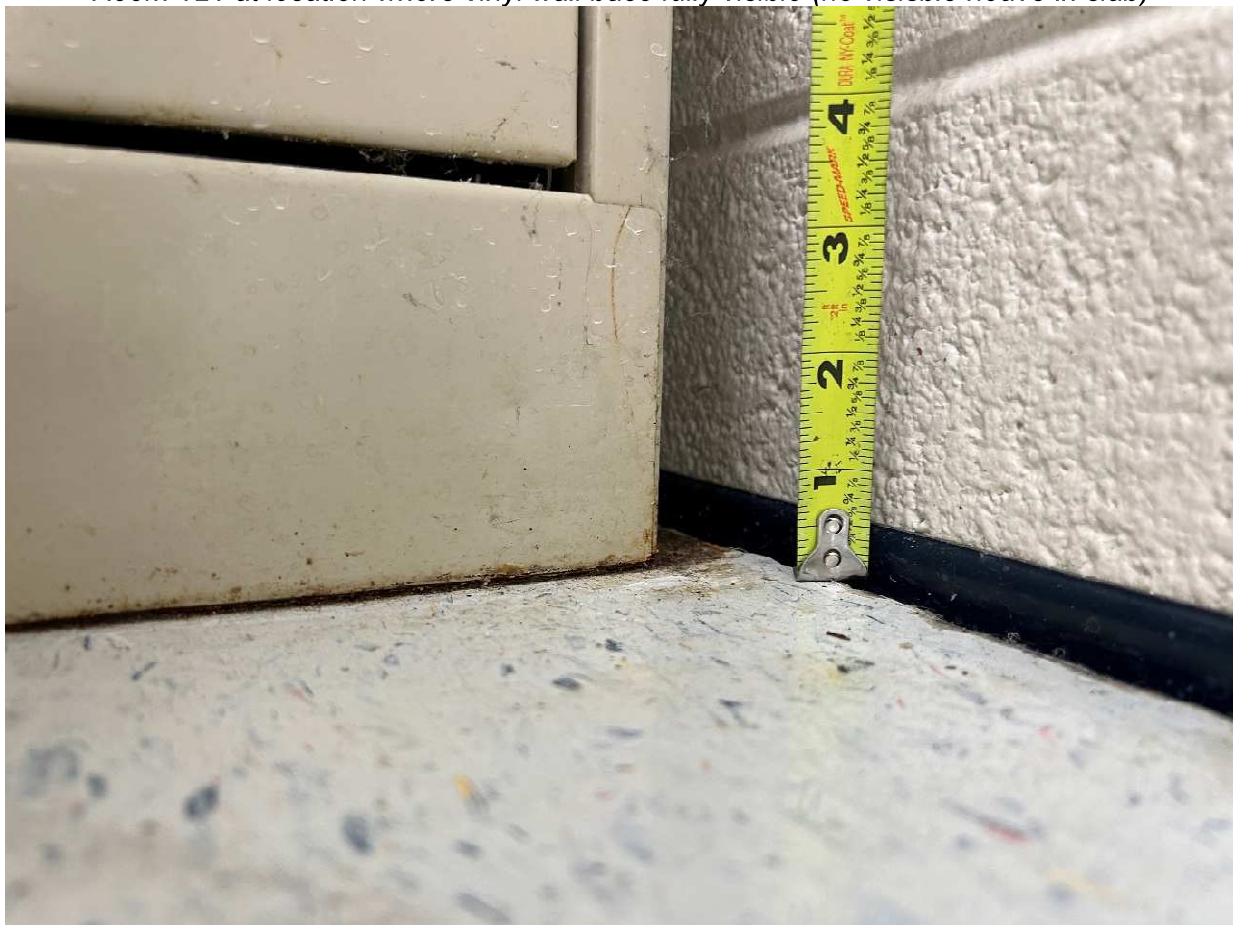
room 121 at slab location where heave is roughly 3 1/4" +/-.

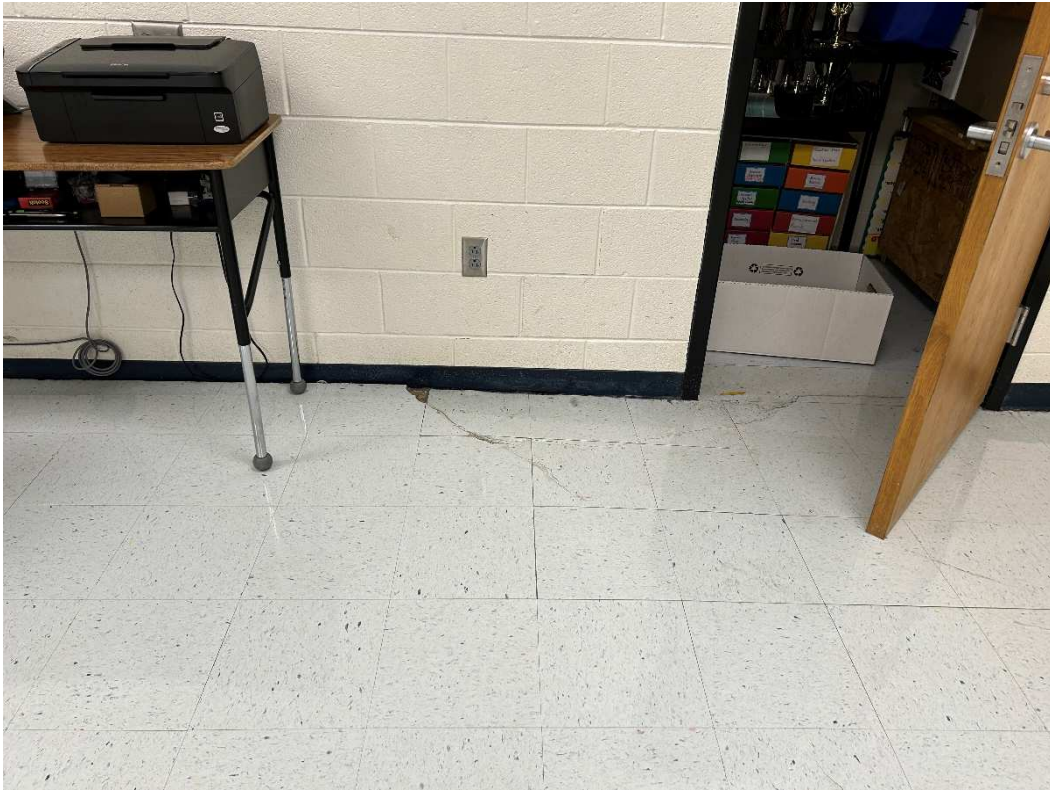
Room 121, visibly different elevations between door area and surrounding slab.

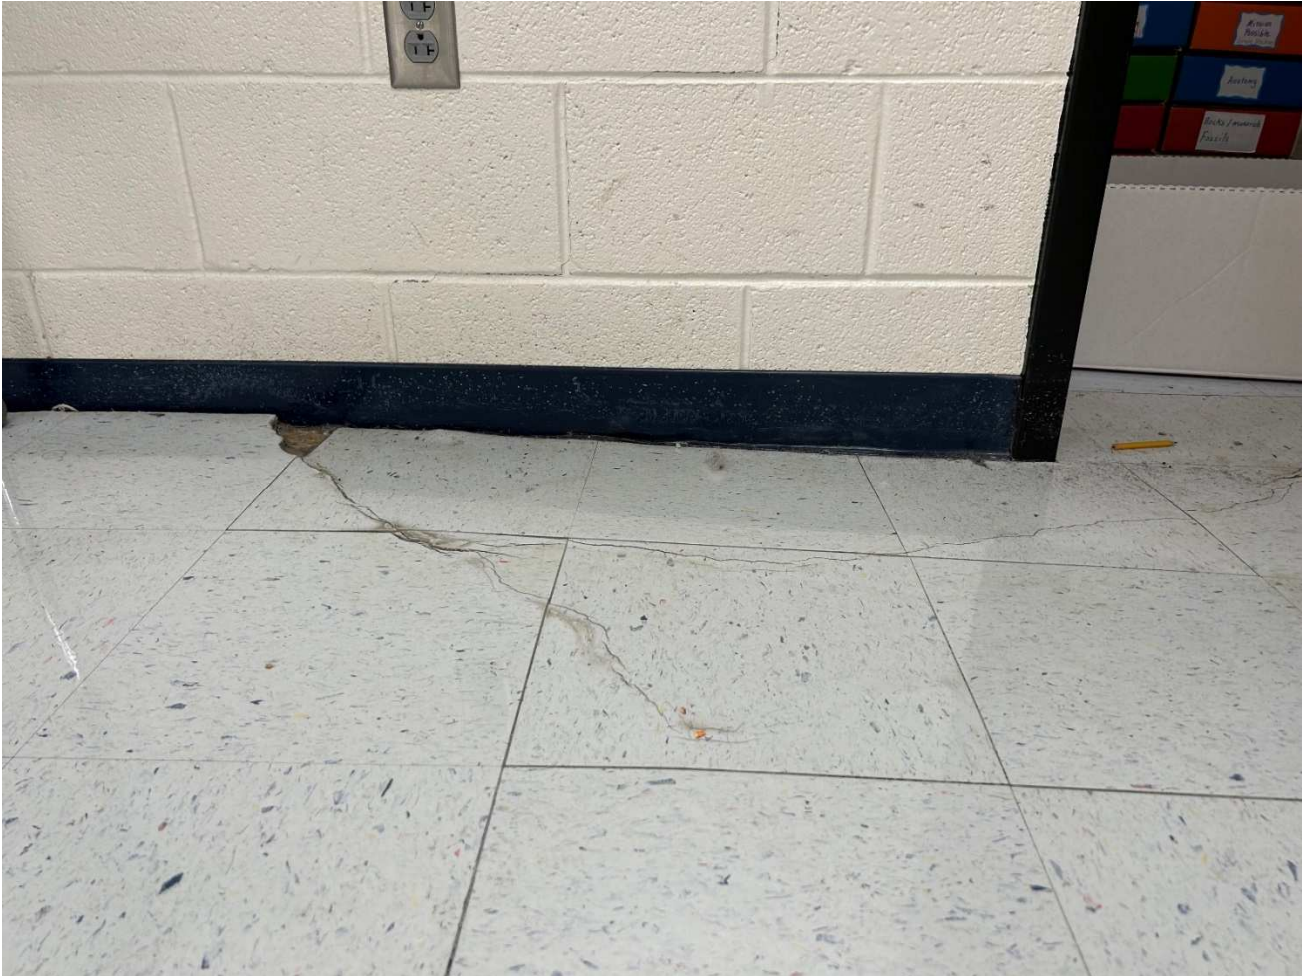
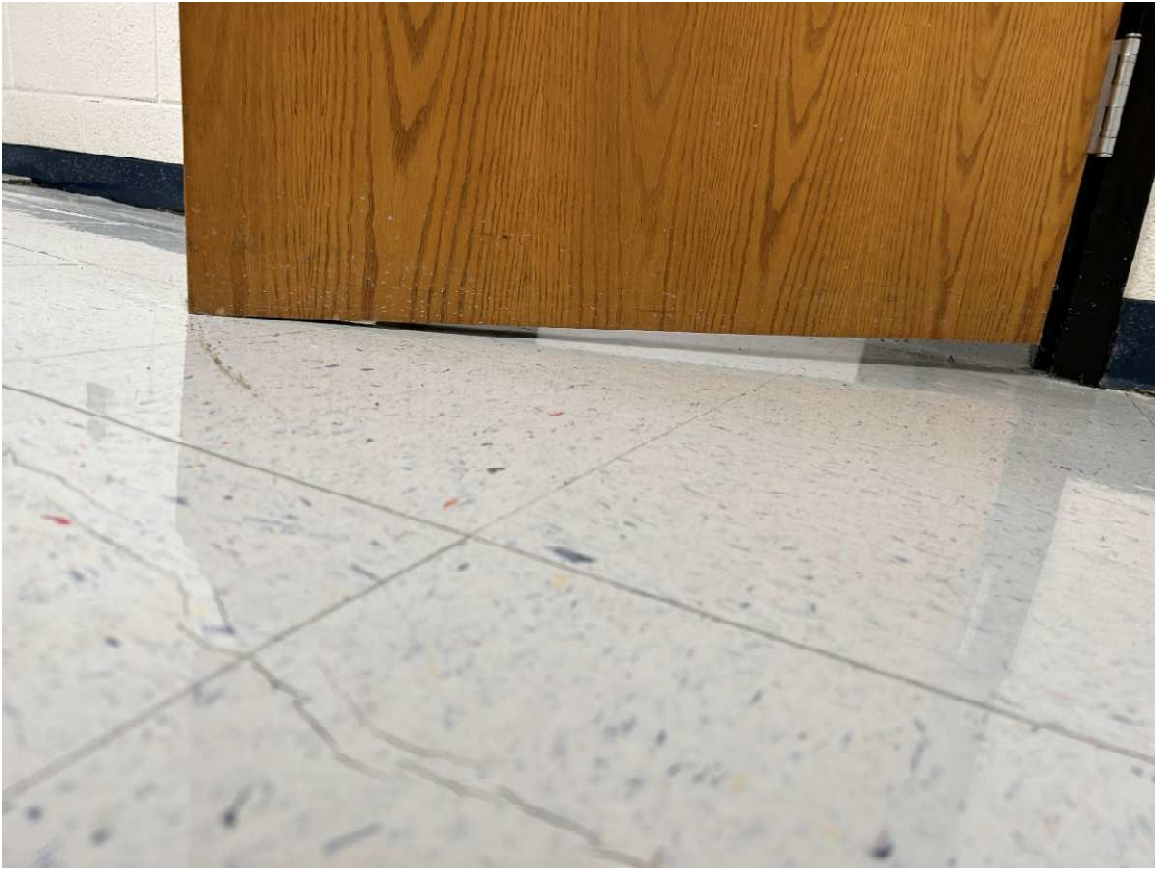
Gap under door displaying slope in floor elevation.

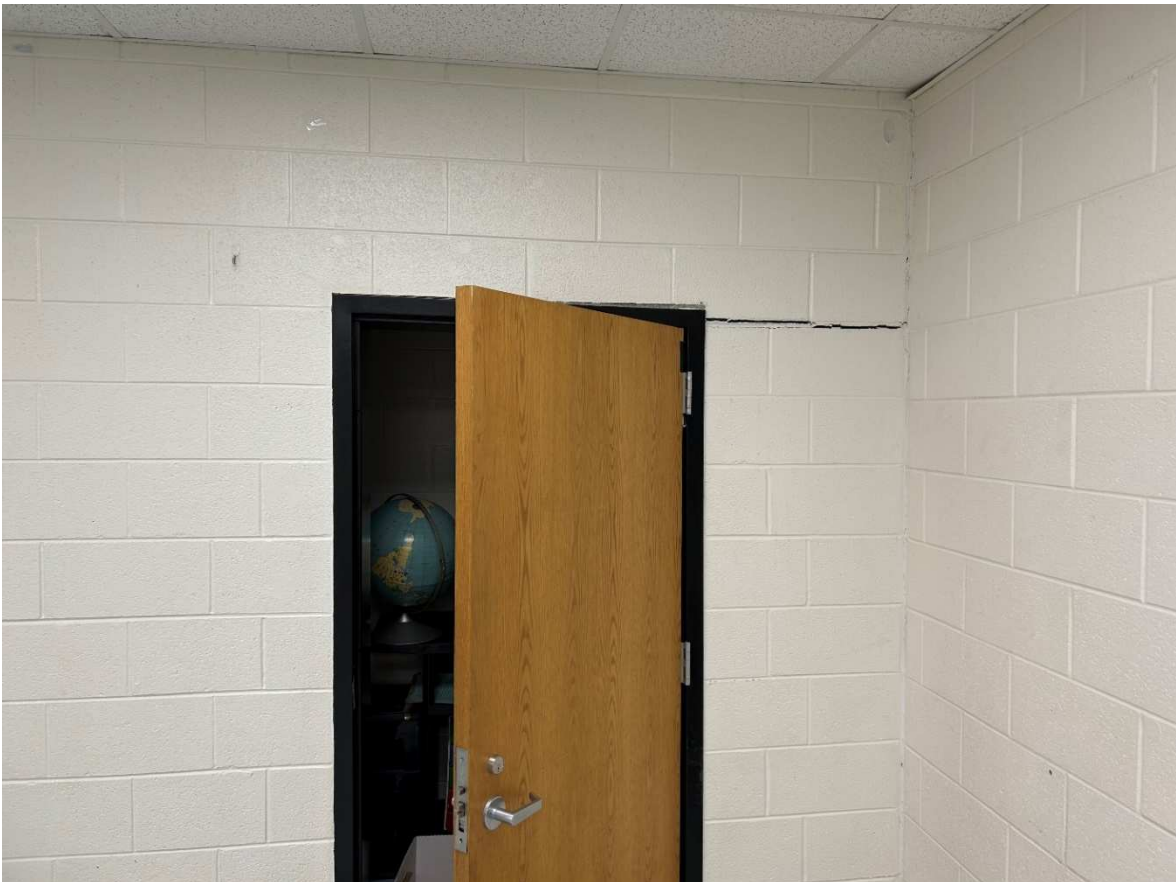
Crack in CMU to the right of closet door. Door frame out of square.

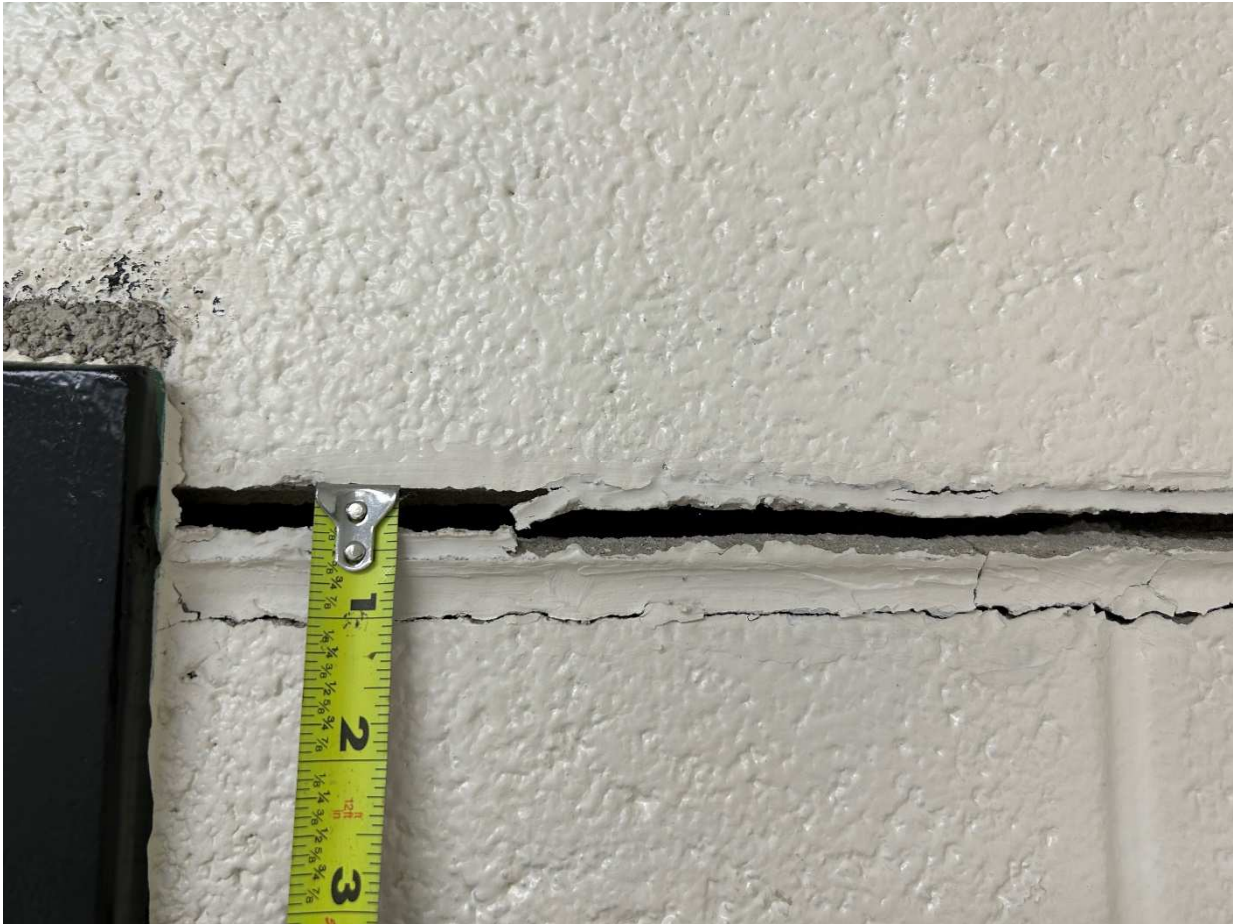
Room 121, closeup view of gap in CMU (measuring approx 3/8").

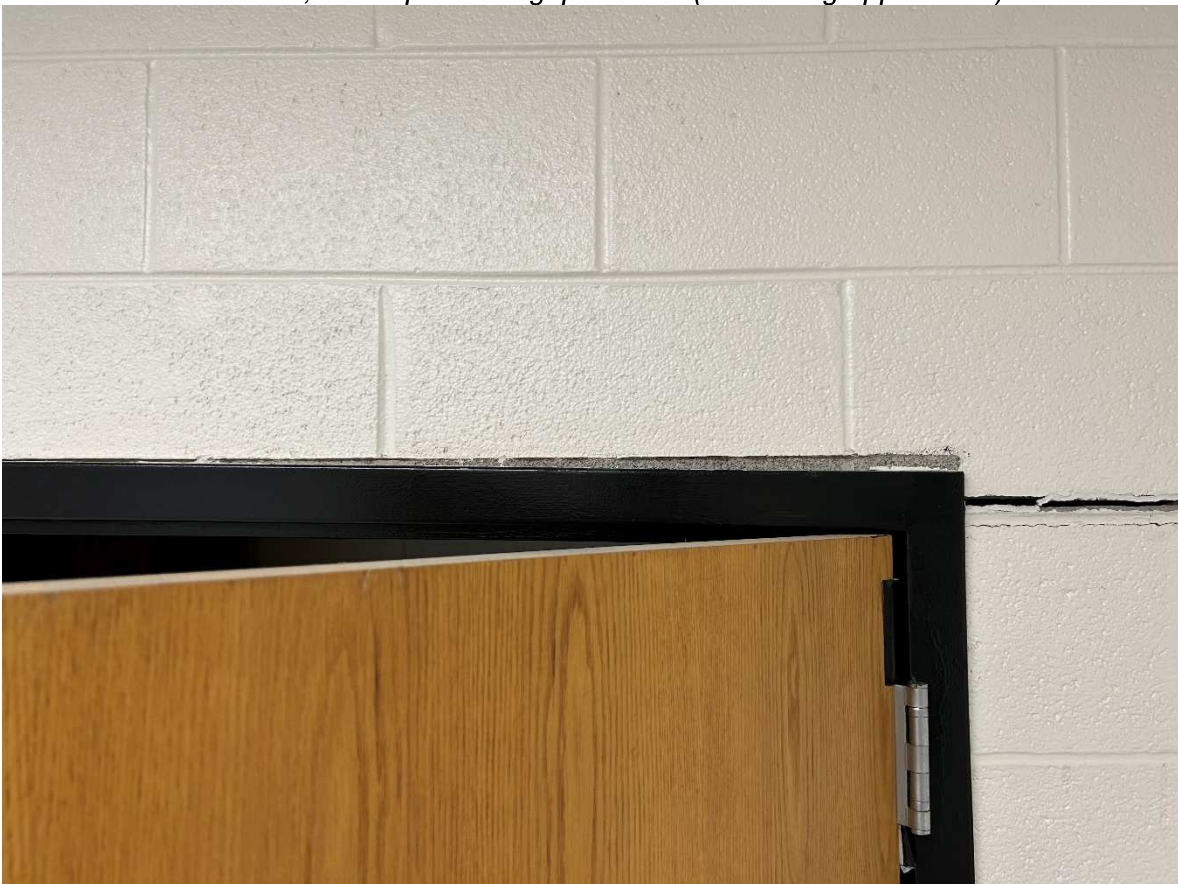
Closet door out of level/square. Closeup view.

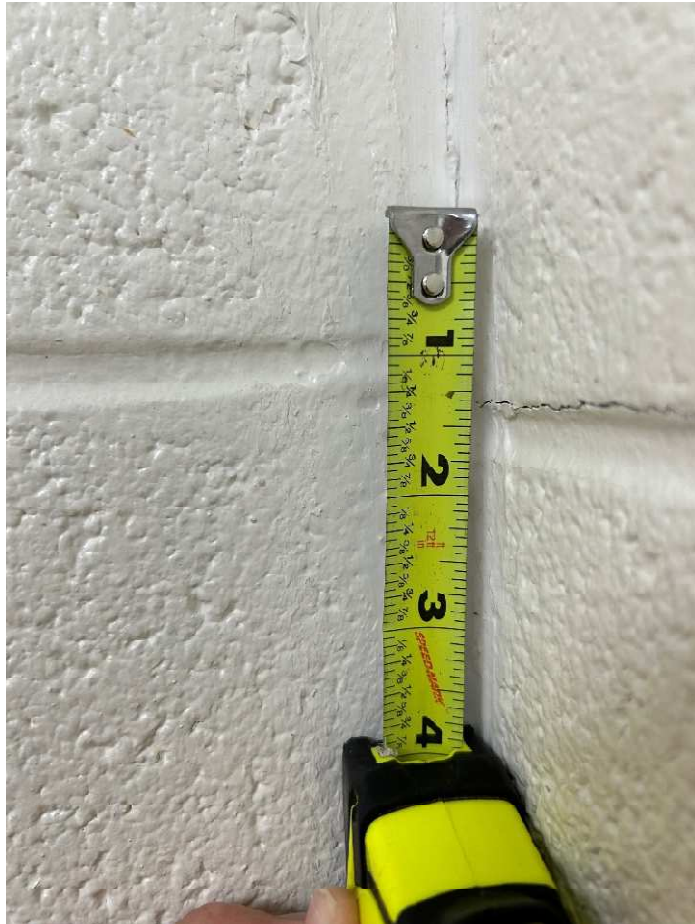
Room 121, CMU coursing showing approx 1/2" heave between exterior and interior walls.

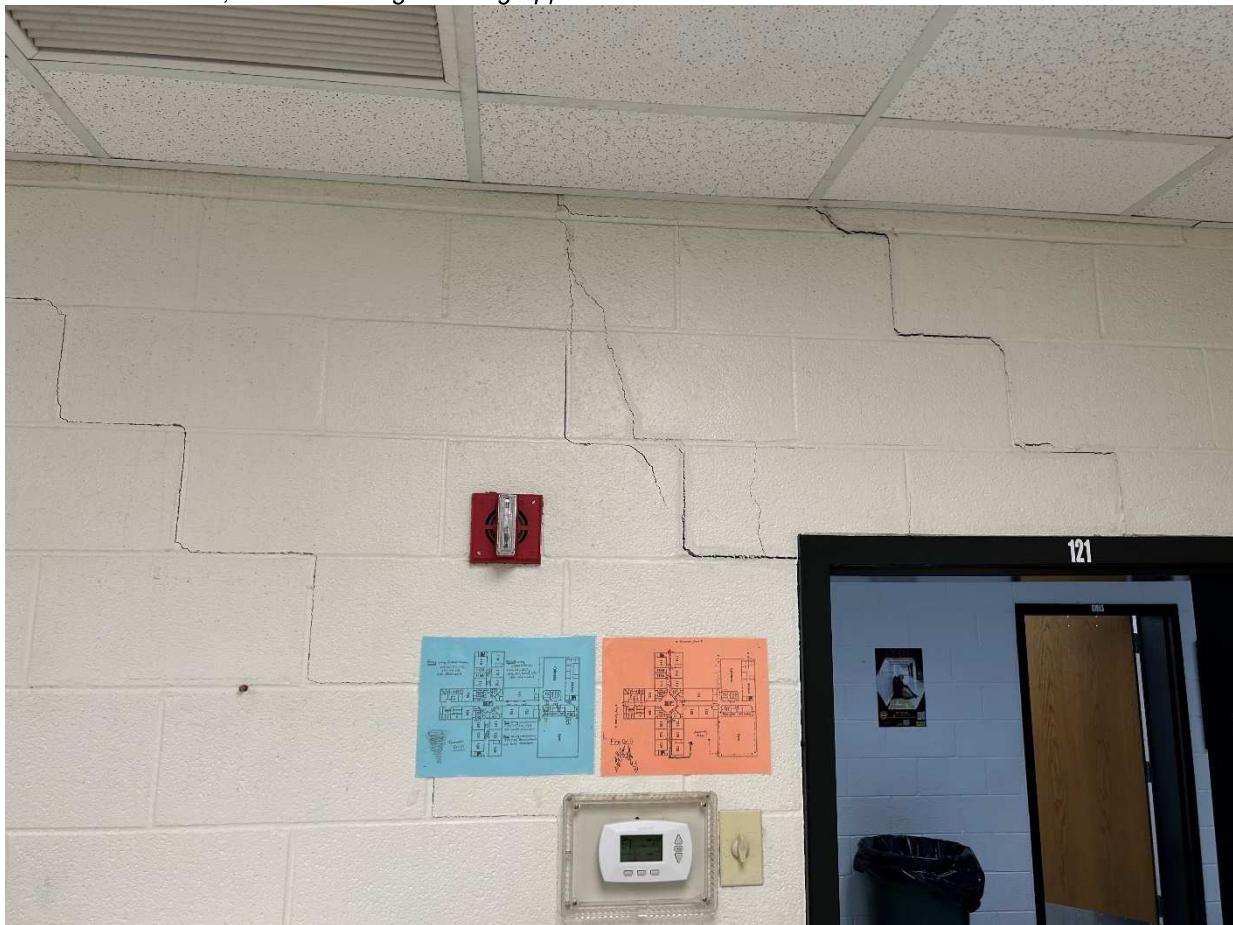
Room 121, cracks in CMU wall near hallway door. Load bearing wall.

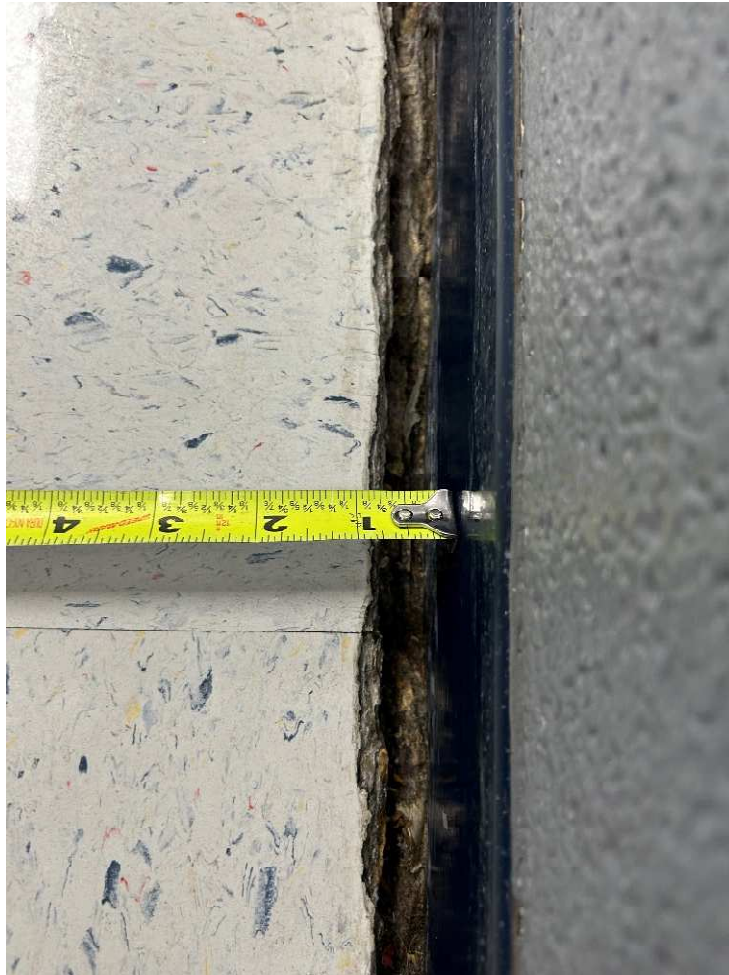
Room 123 shows visible heave.

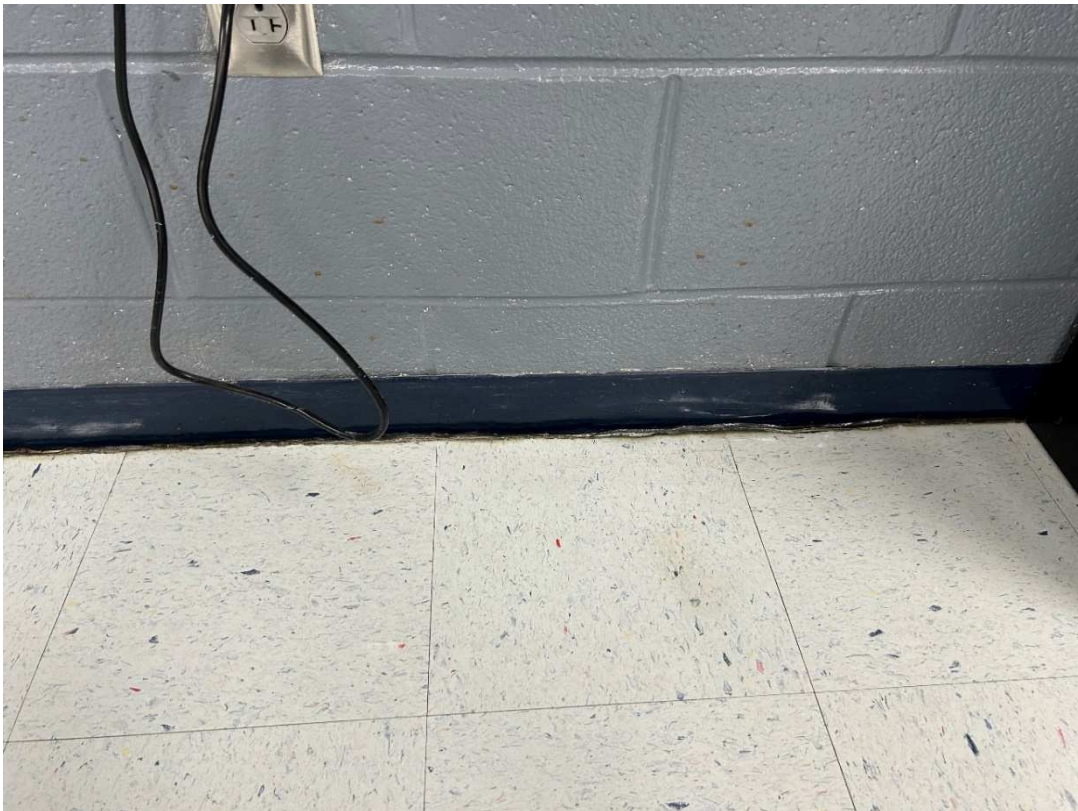
Room 123 showing visible heave in floor slab.

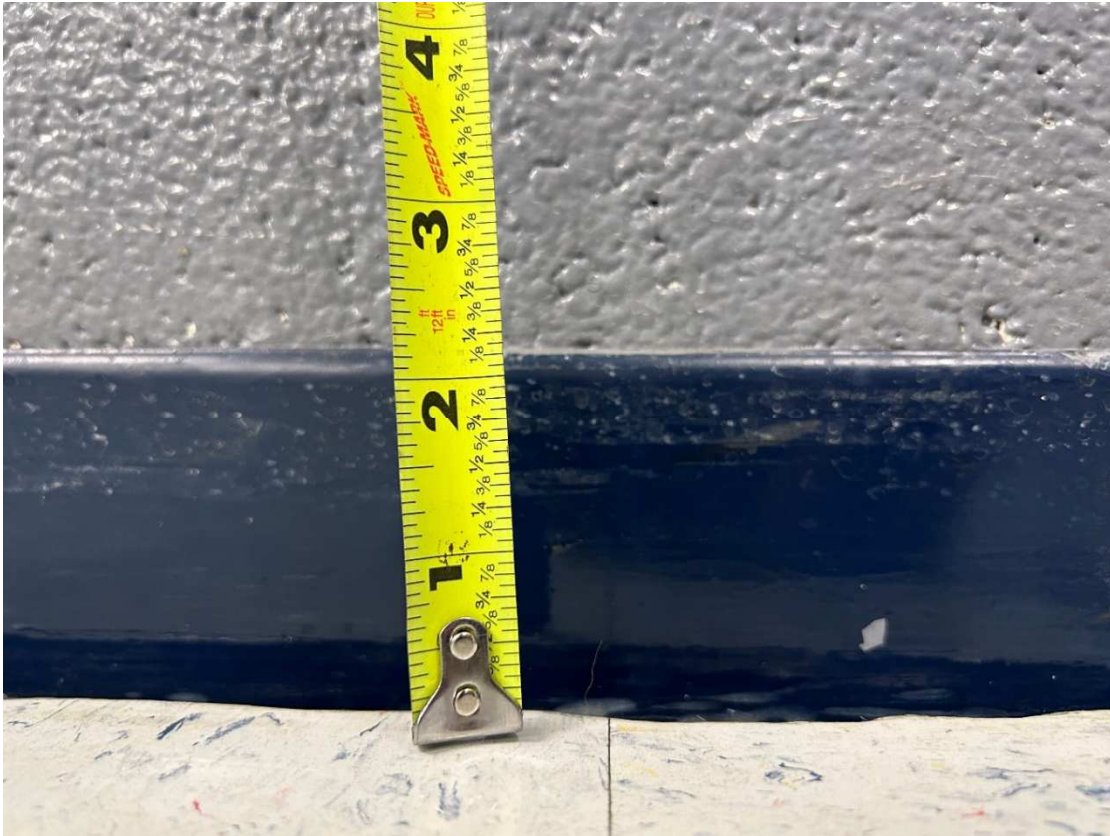
Room 123 showing approx. 2" of heave in areas.

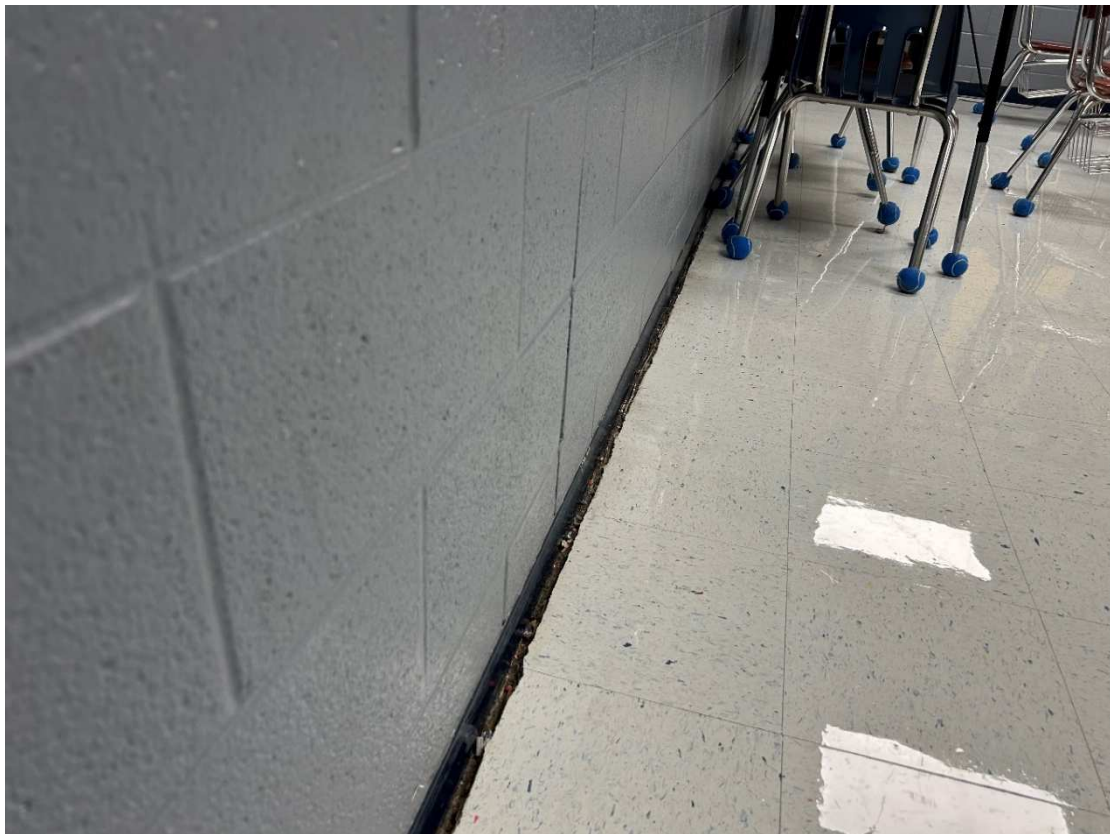
Room 123 slab heave.

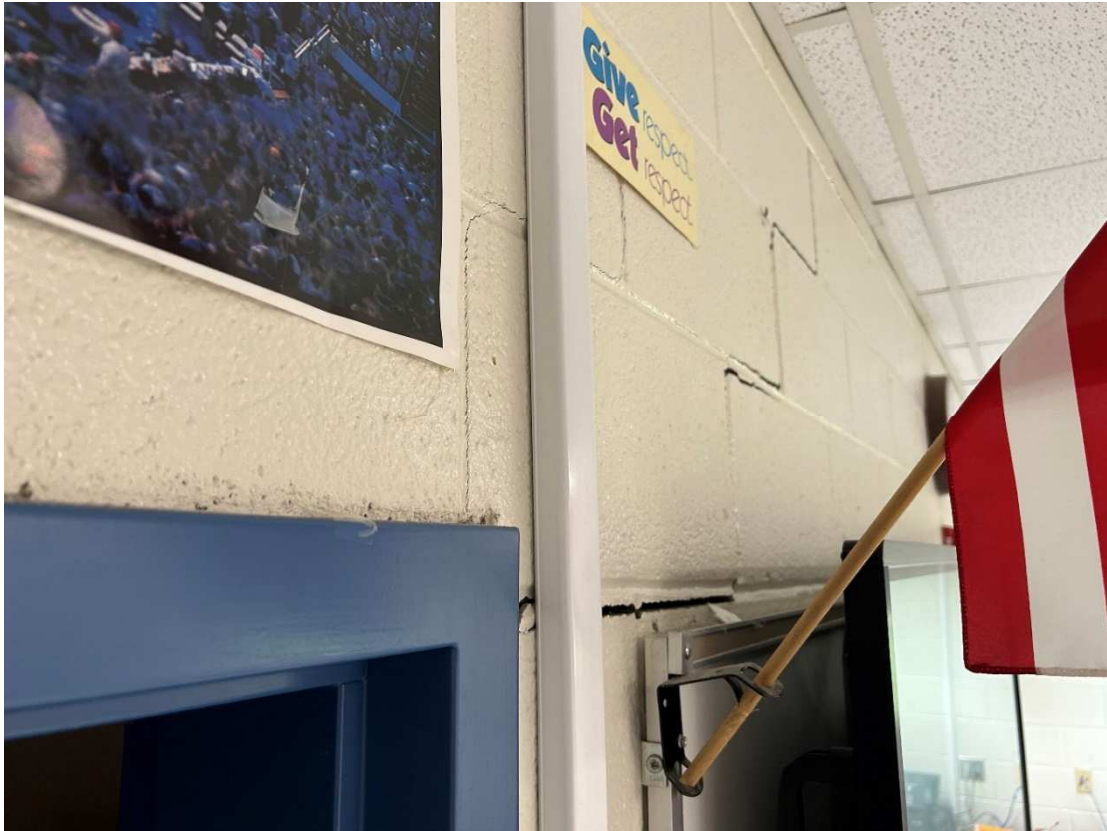
Room 131, cracks in CMU wall.

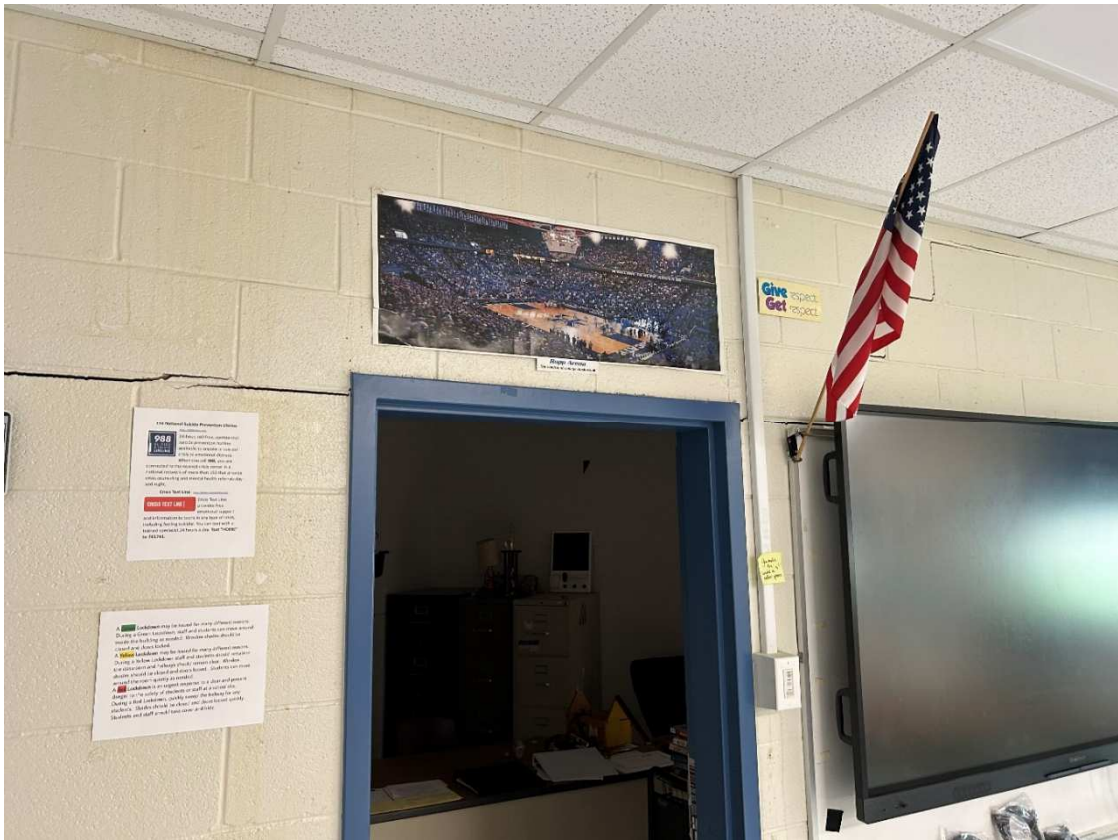
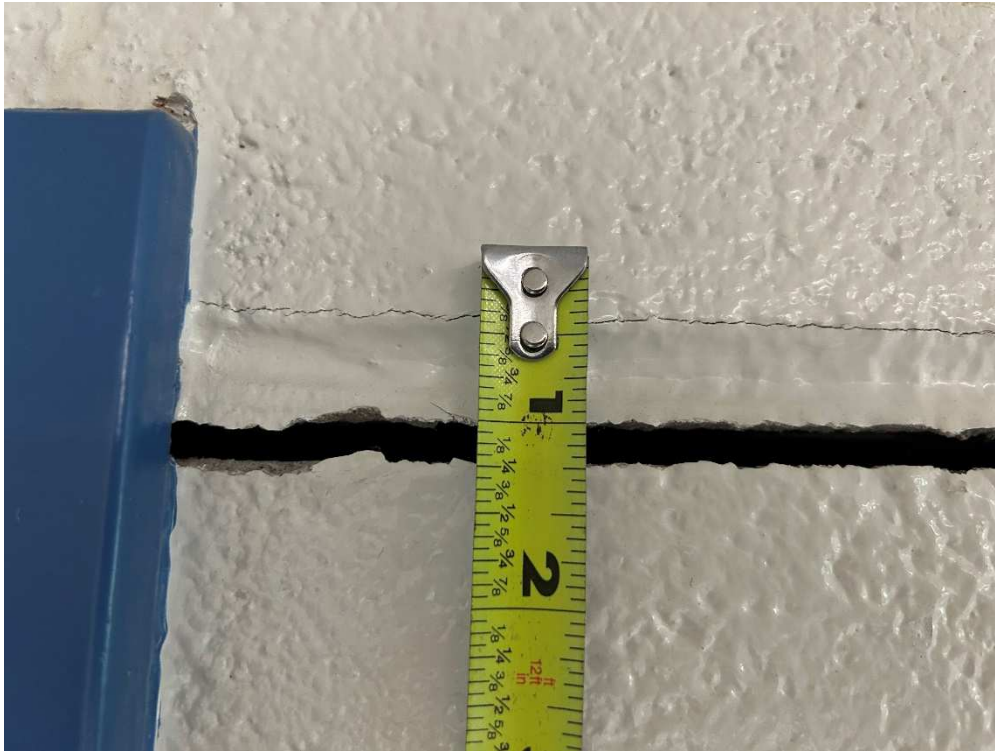
Approx 1/4" gap in CMU course, Room 131

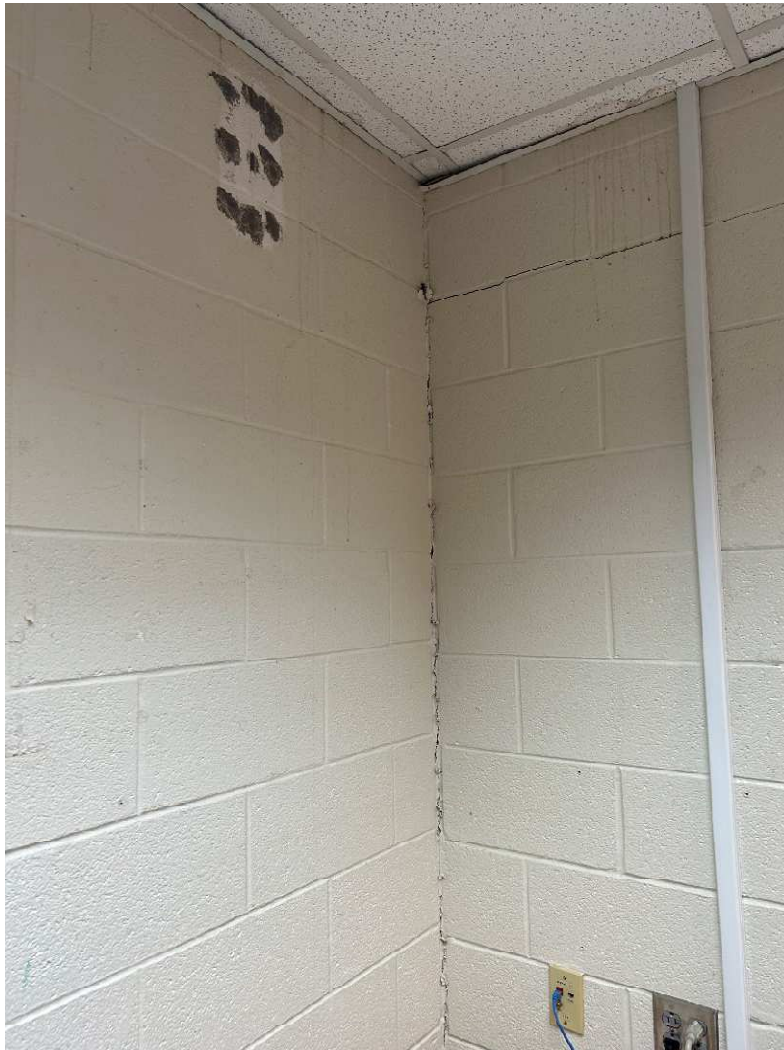
Room 131, cracks in CMU wall with heave visible in coursing.
