August 7, 2023

Re: Structural Observation at Estill County Middle School

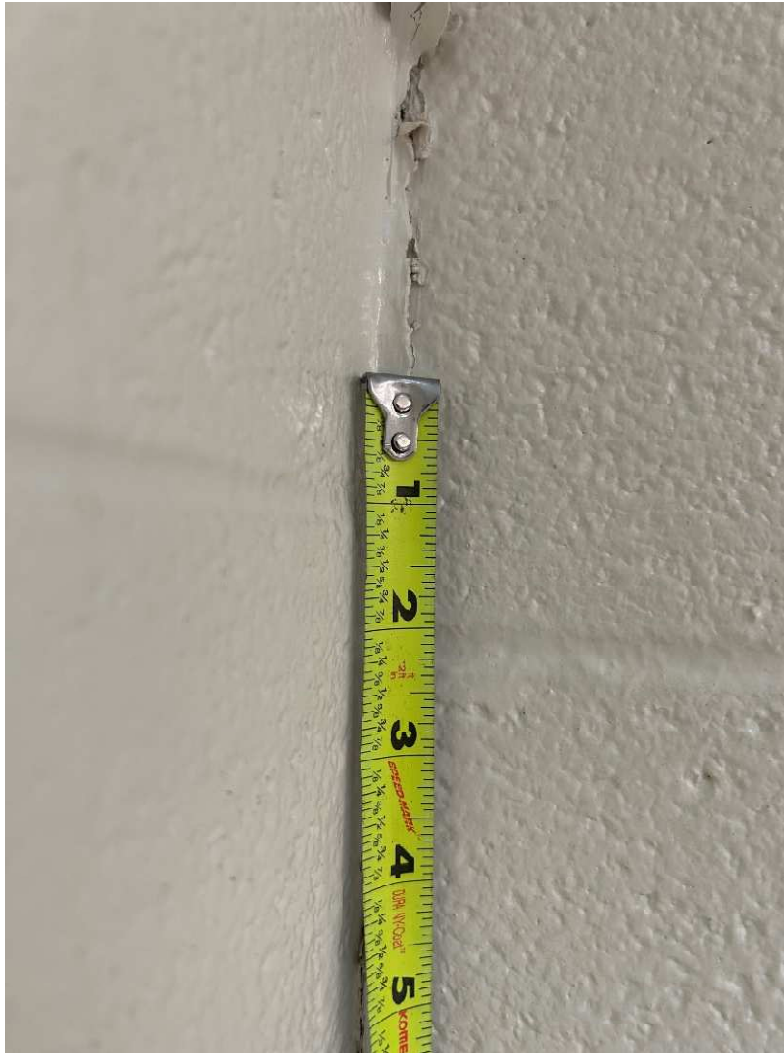
Room 131, showing approx. 1"+ heave between interior and exterior walls.

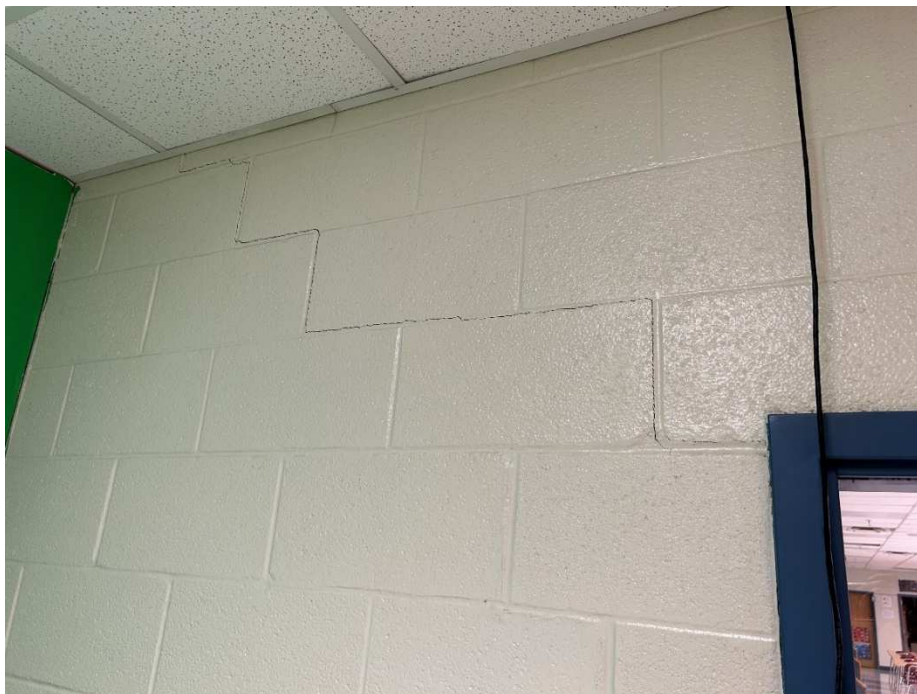
Room 131, cracks in CMU near door of green screen room.

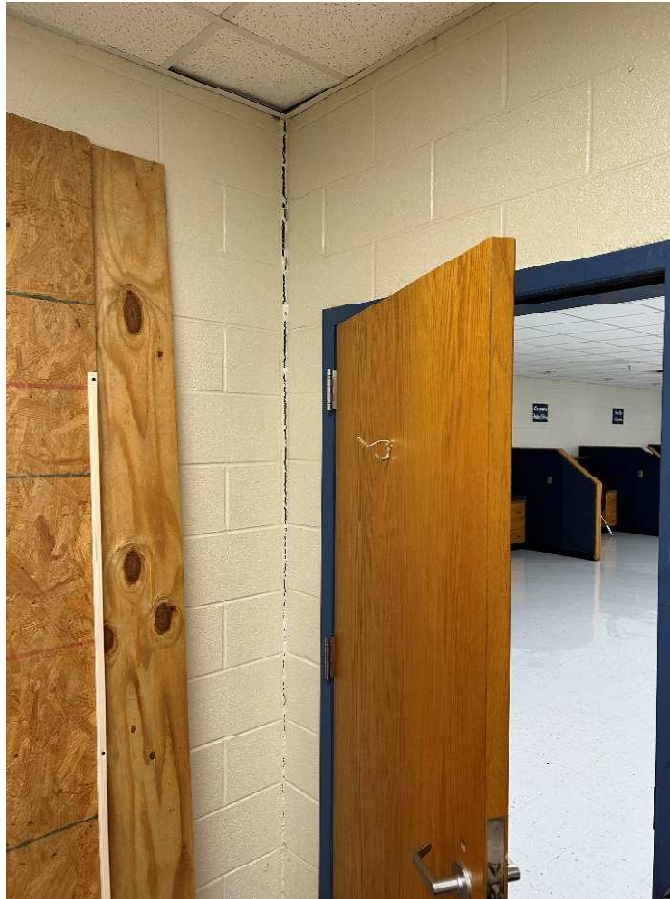
Room 131, gap in CMU walls in closet

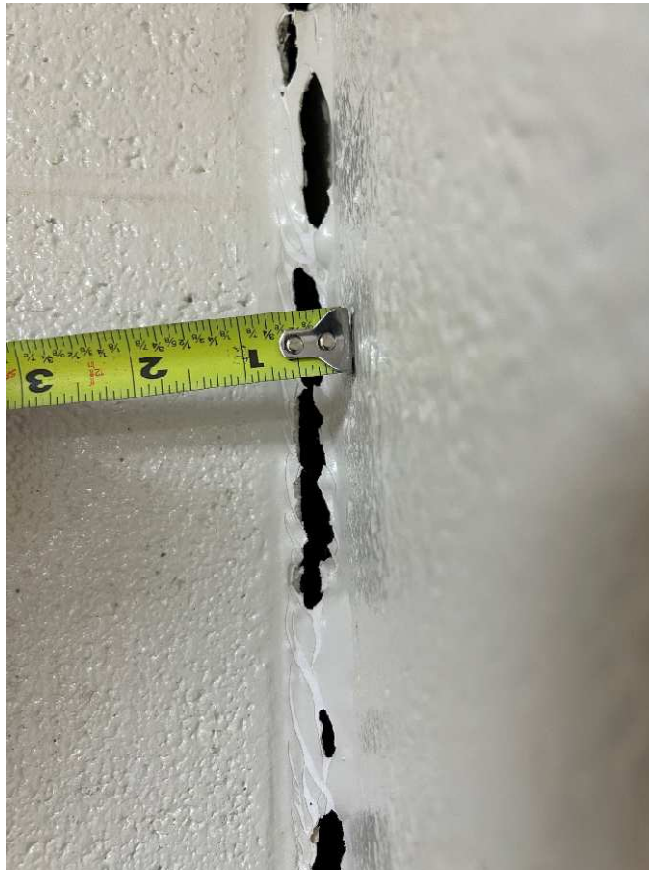
Closeup of Room 131 gap, approx 1/2" wide.

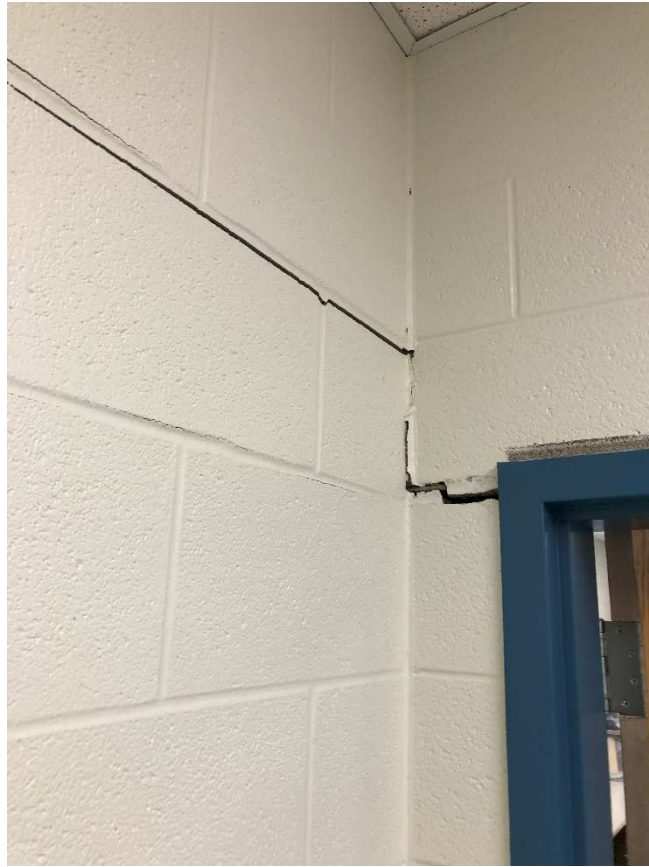
Significant crack in CMU wall

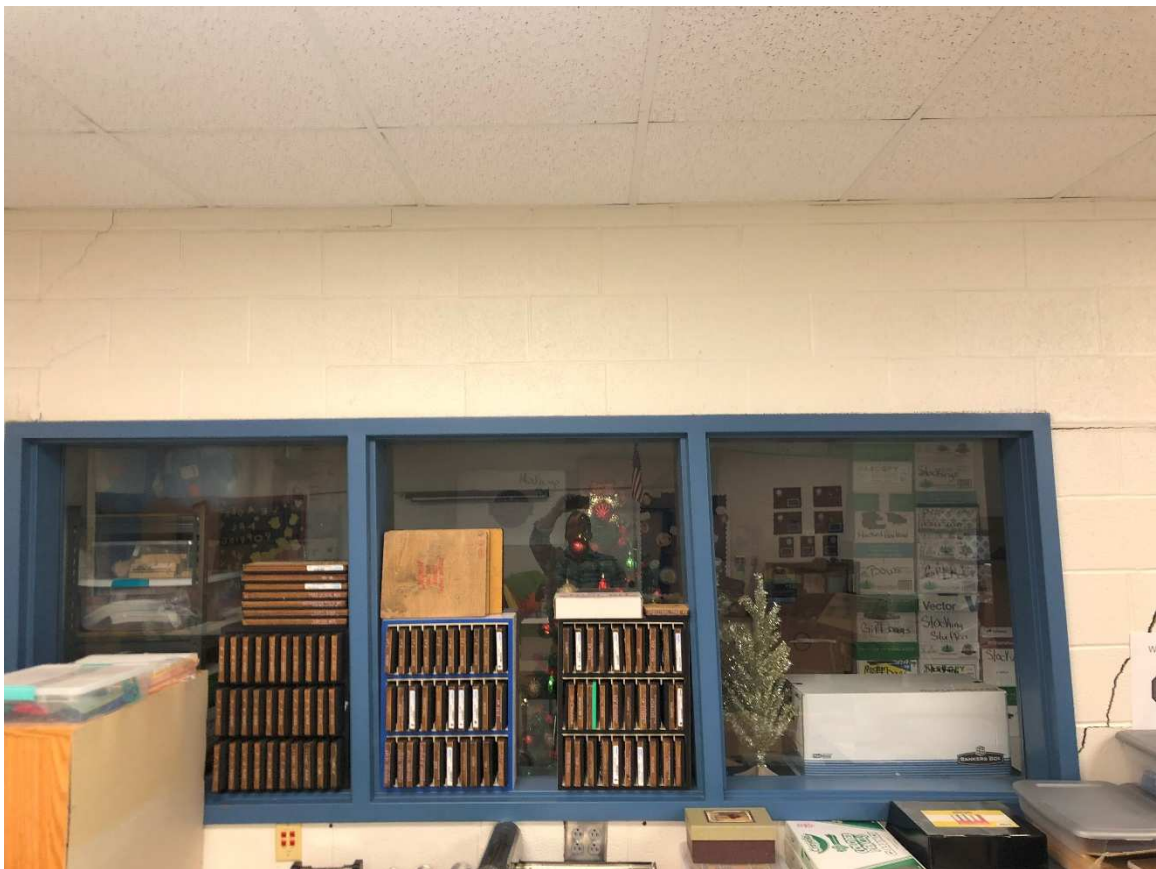
Cracking in partition wall. Window frame significantly out of level.

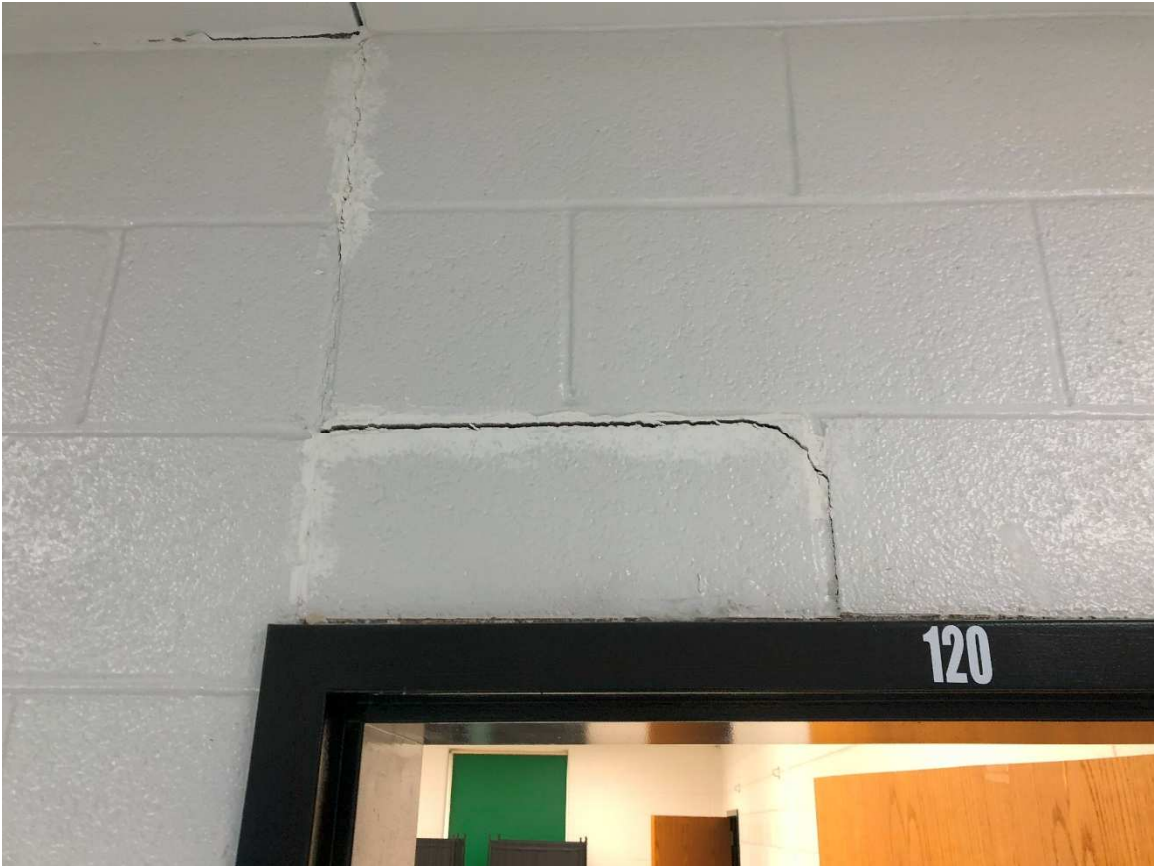
Cracking and deflection of lintel at load bearing wall.

There are some areas of lintels at corridor walls that we consider in need of repair and should be placed on your maintenance plan.

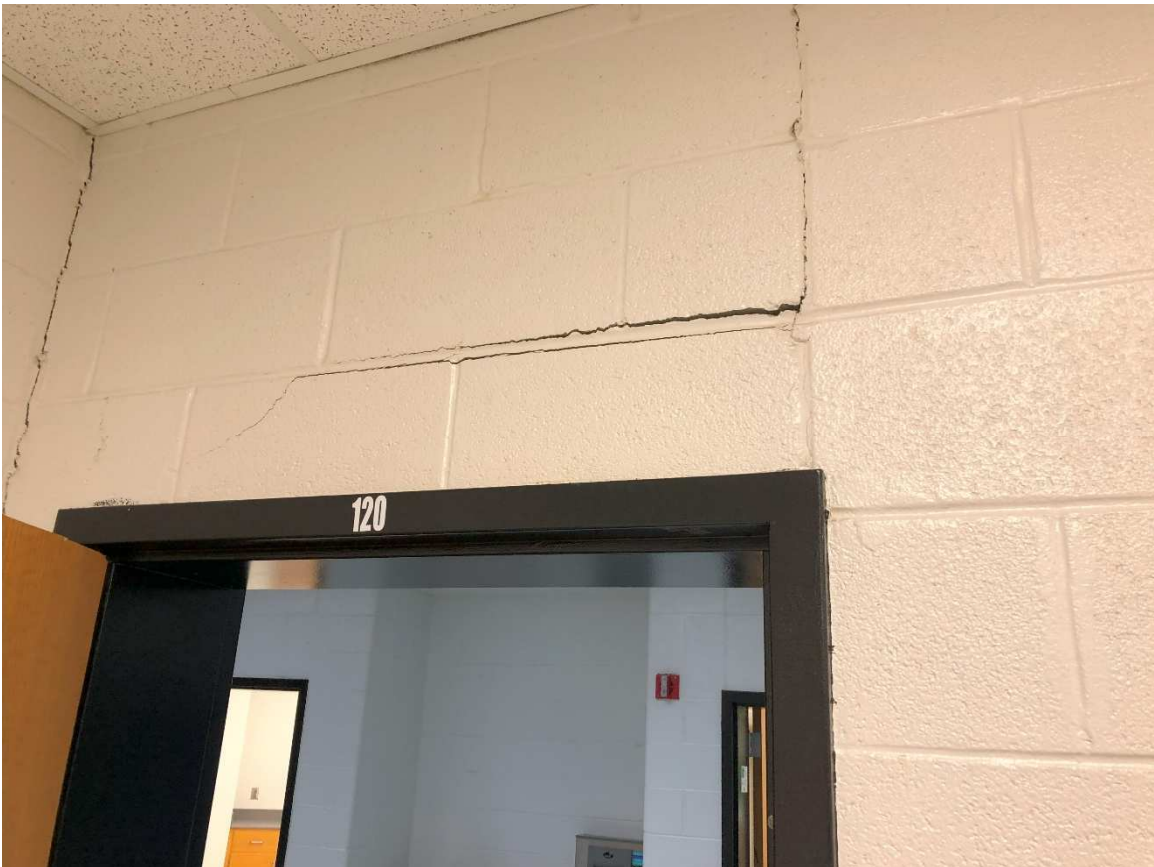
Cracking and deflection of lintel at load bearing wall.

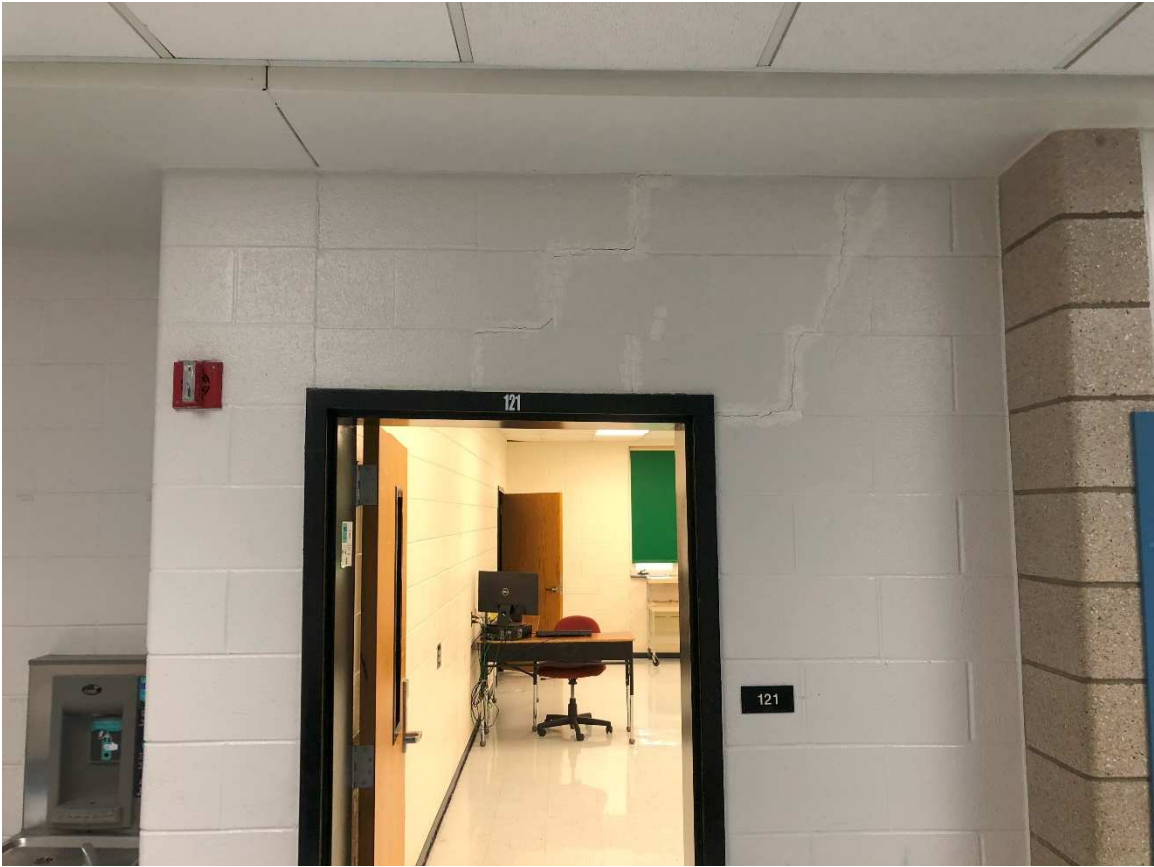
Cracking and deflection of lintel at load bearing wall. Door frame out of square.

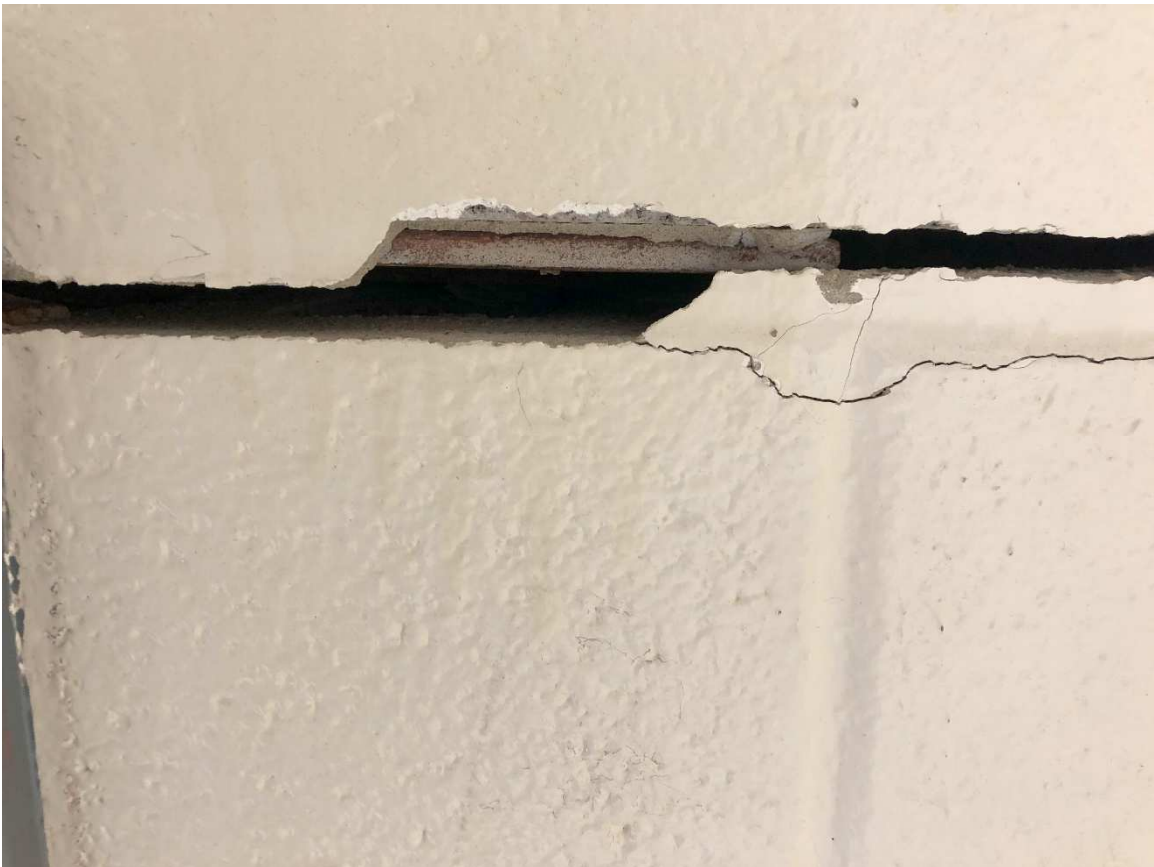
Significant cracking at steel lintel

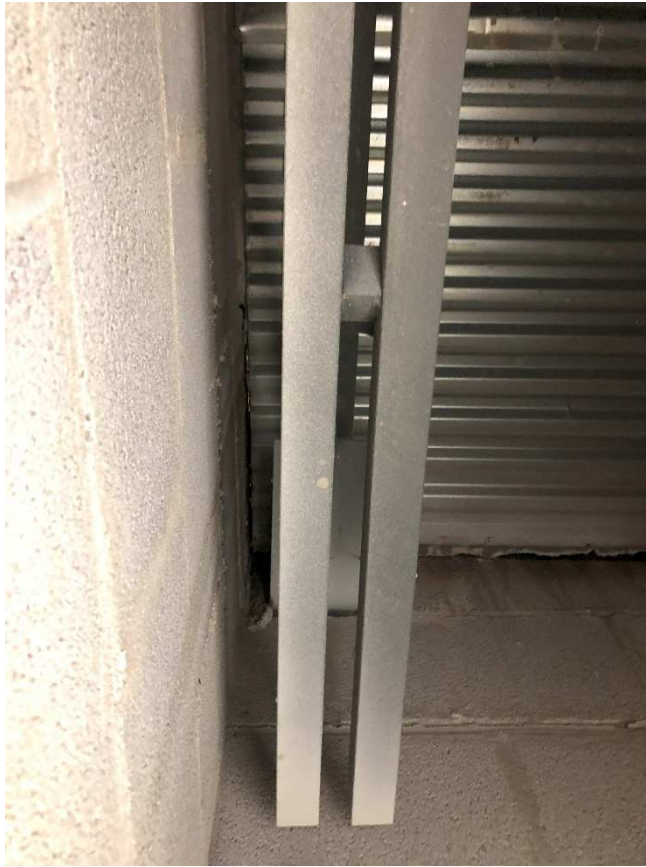
One detail we found to be unlike current construction techniques was the lack of a connection between the second floor slab and continuous CMU walls. The slab appeared to have no mechanical connection between it and the CMU walls that penetrated the floor. We observed a continuous strip of 1/2" +/- foam expansion joint between the wall and slab and no deck edge angle was observed. Typically, these CMU walls would be used as shearwalls to resist lateral forces from wind and seismic loads. However, there are no notable lateral force system details in the original project drawings. At this time, we are unsure of the original design intent for the transfer of lateral loads into shearwalls.

Edge of deck condition at continuous CMU wall (assumed shearwall). No connection to shearwall observed.

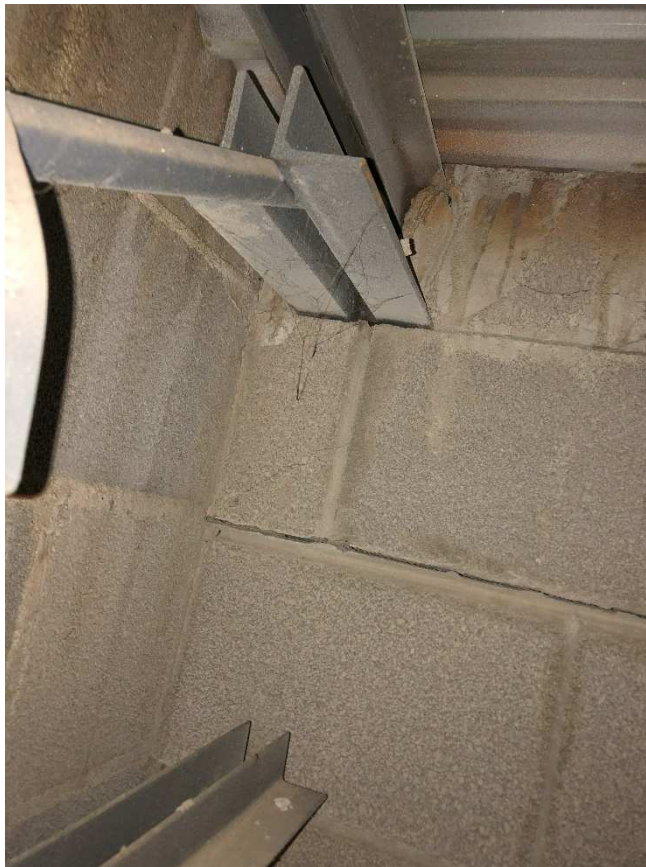
Joist bearing at continuous CMU wall. Some uplift on joist observed and cracking of exterior CMU.

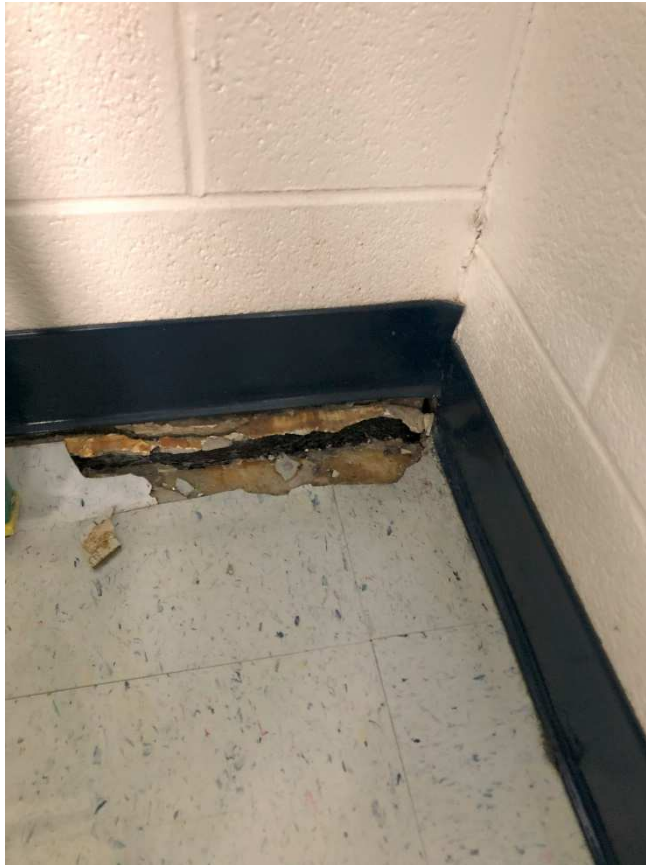
Some of the CMU classroom walls are continuous from first floor to the bottom of wood roof trusses. As mentioned, these walls are not connected to the second floor slab, which has allowed them to move freely relative to the floor. Considering the affects of wall heaving only, this is a good condition as the second floor would be in worse condition had it been mechanically attached to the CMU walls. However, the lack of a structural connection remains a concern for lateral force resistance of the building.

Heaving of continuous CMU @ 2nd floor level. Suspended concrete slab has not heaved with wall. Some areas appear to have separation of slab from wall, but upon further inspection slab has not significantly separated from CMU wall.

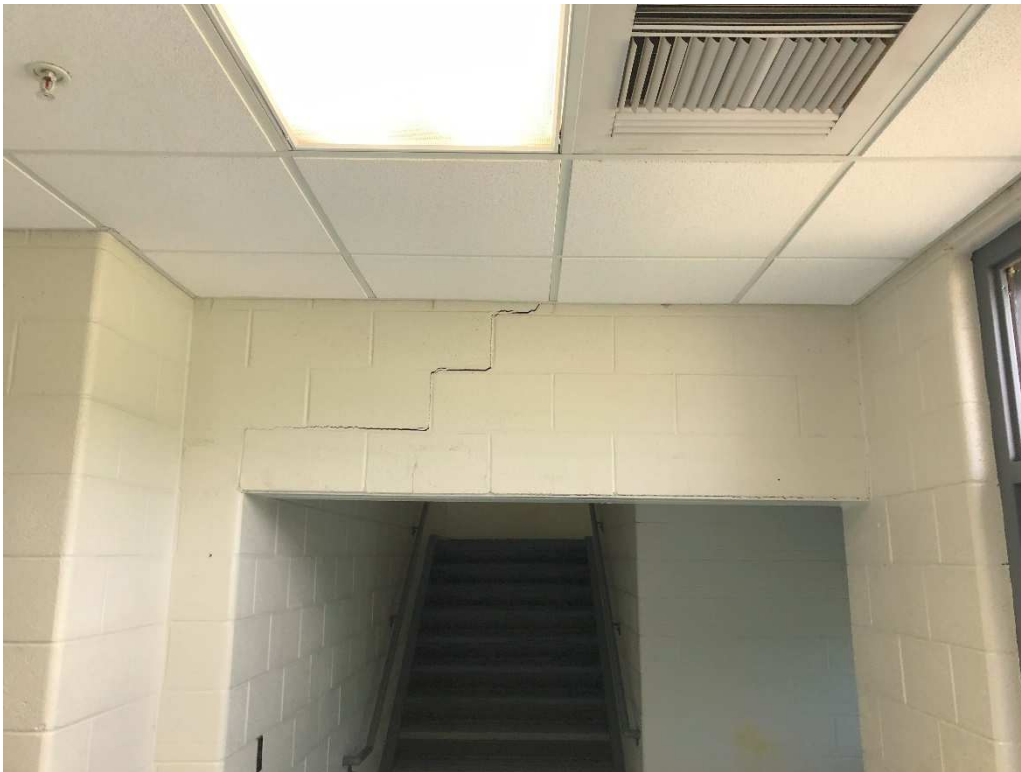
Heaving between jambs of steel lintel. Distortion of steel lintel and cracking of CMU has occurred.

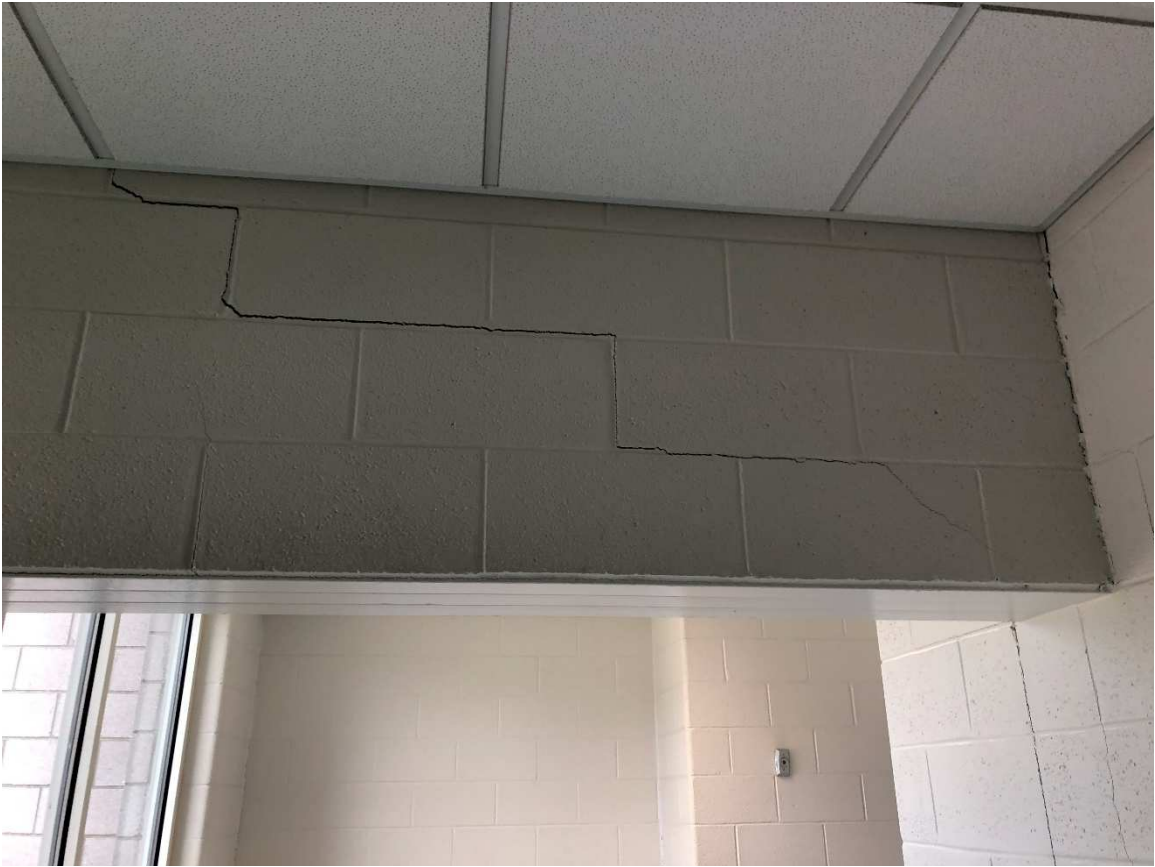
Stress cracks in CMU over heaving of steel lintel.
