August 25, 2023

TO: Mr. Charlie Brock, Superintendent
Estill County Schools

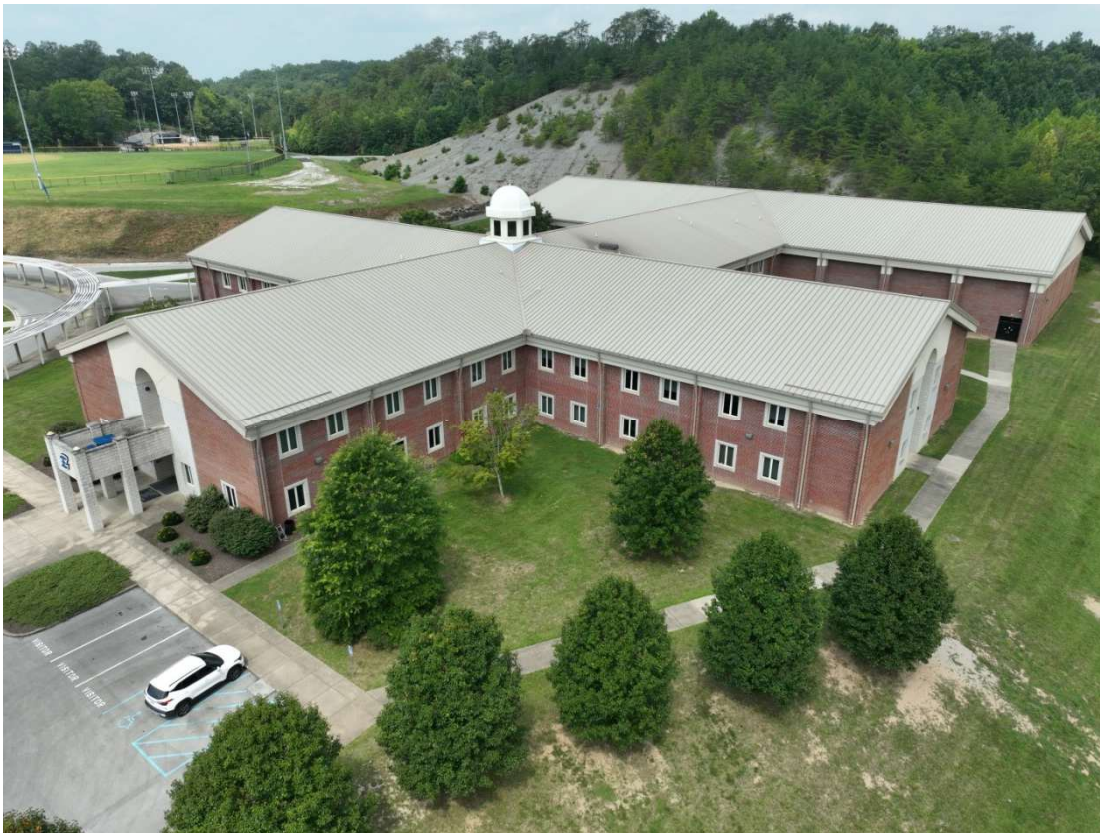
View of Estill County Middle School from the air, with High 89 behind and the baseball field in the background.

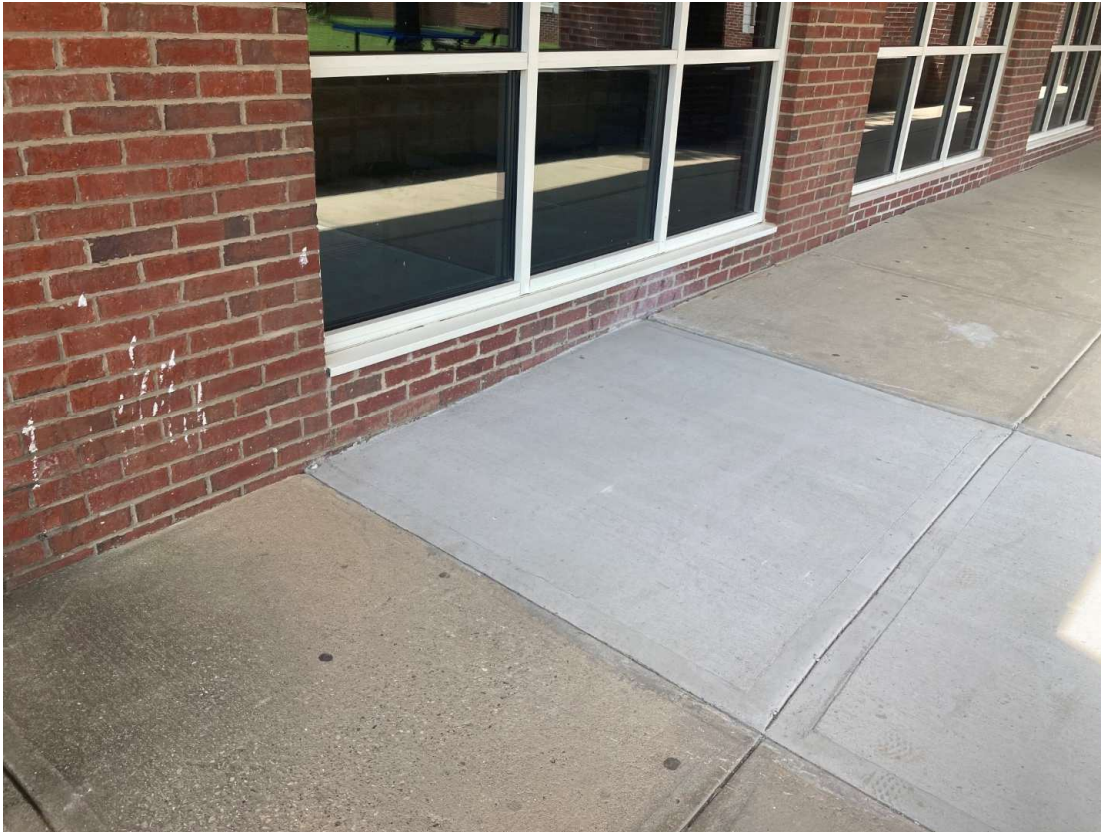
Exterior Sidewalk has heaved creating a tripping hazard.

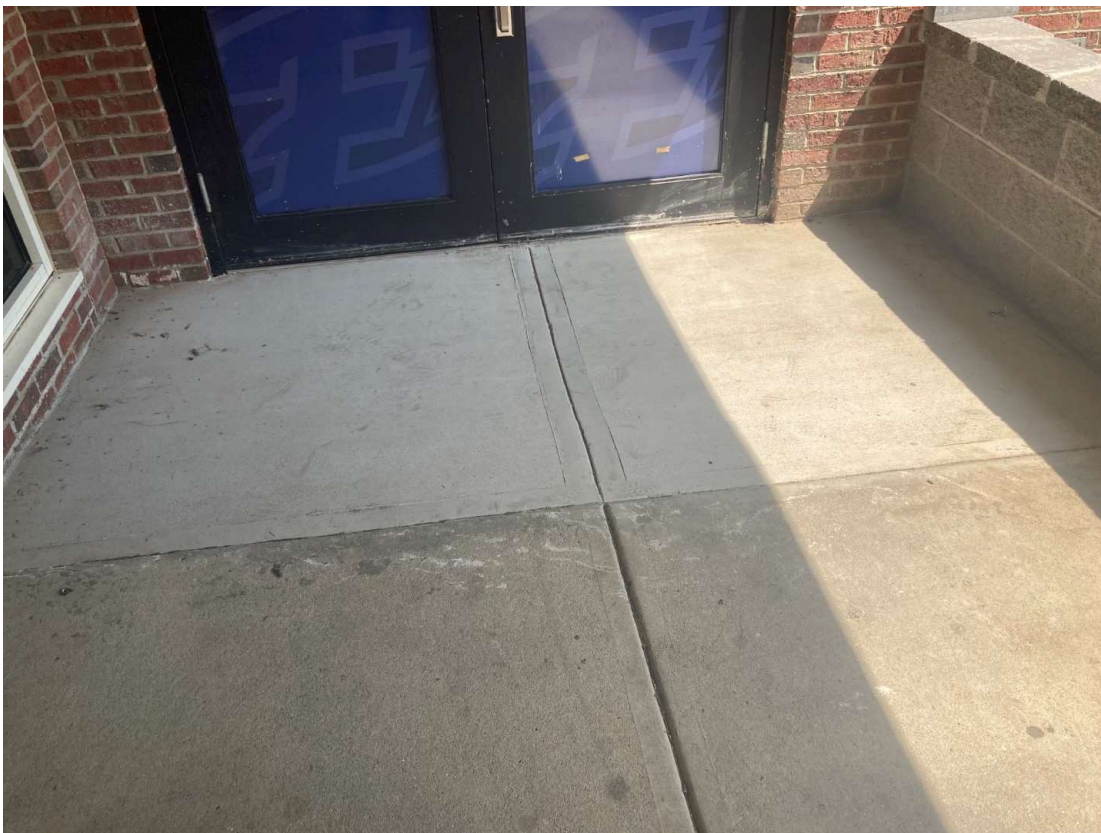
Exterior walk at egress door causing positive slope toward building and door.

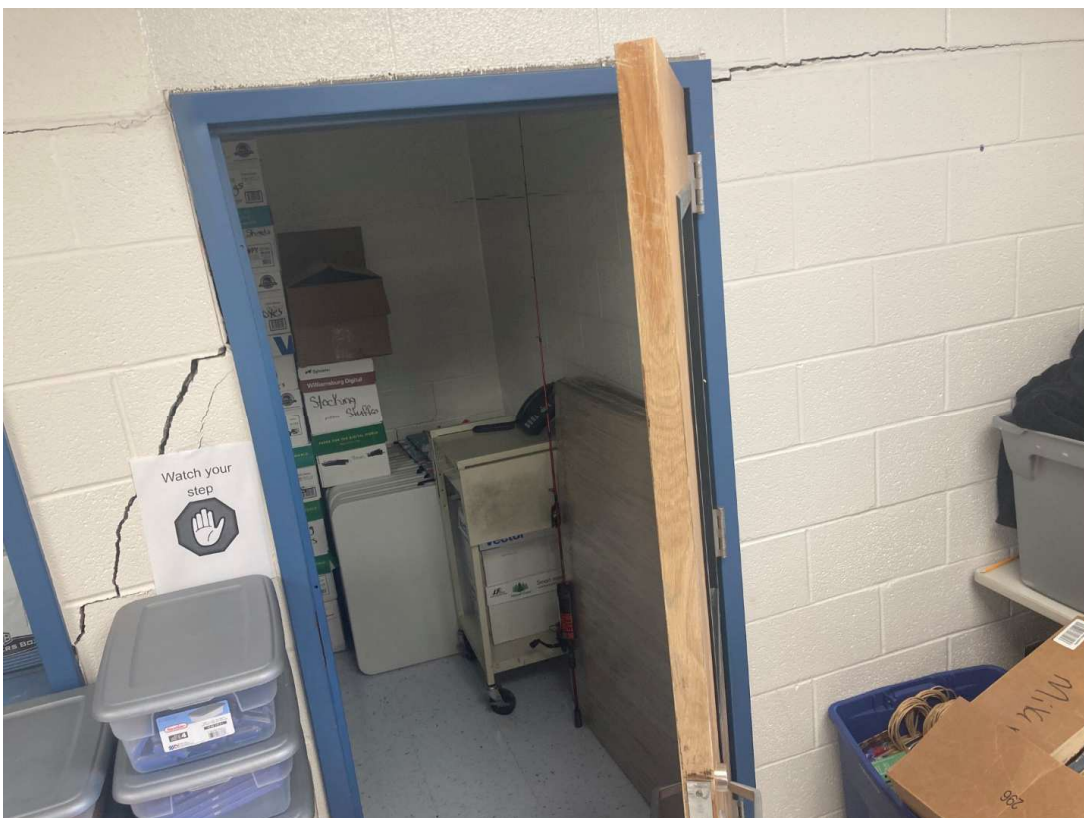
Displaced wall with significant cracking causing inoperability of door due to 'racked' frame.

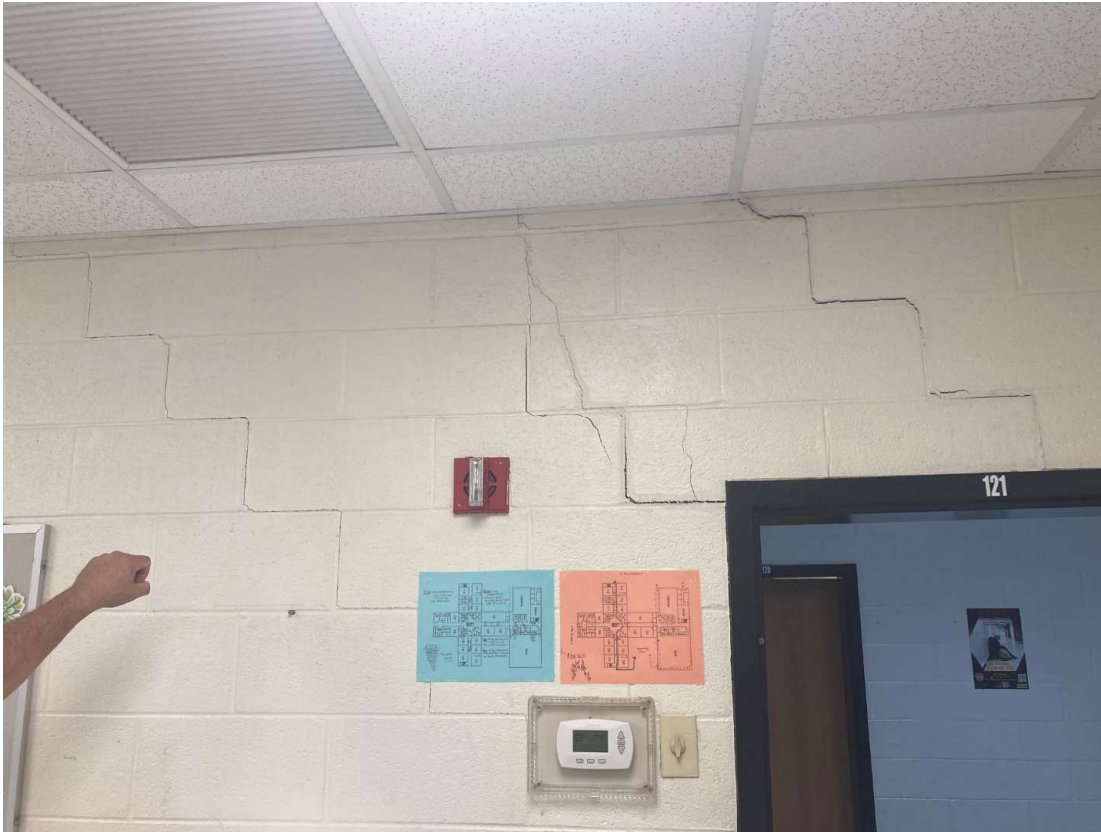
Cracked interior load-bearing CMU wall at corridor, typical throughout building.

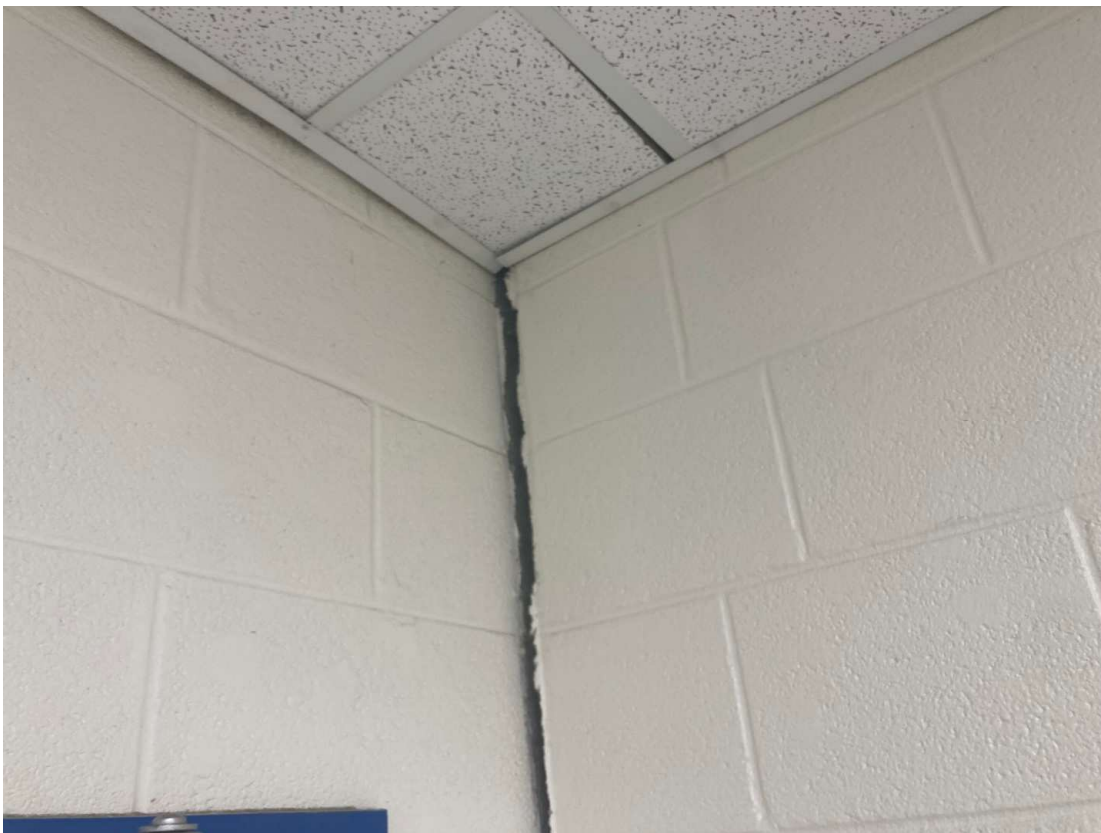
Separation of masonry walls and horizontal displacement of masonry walls, typical throughout building.

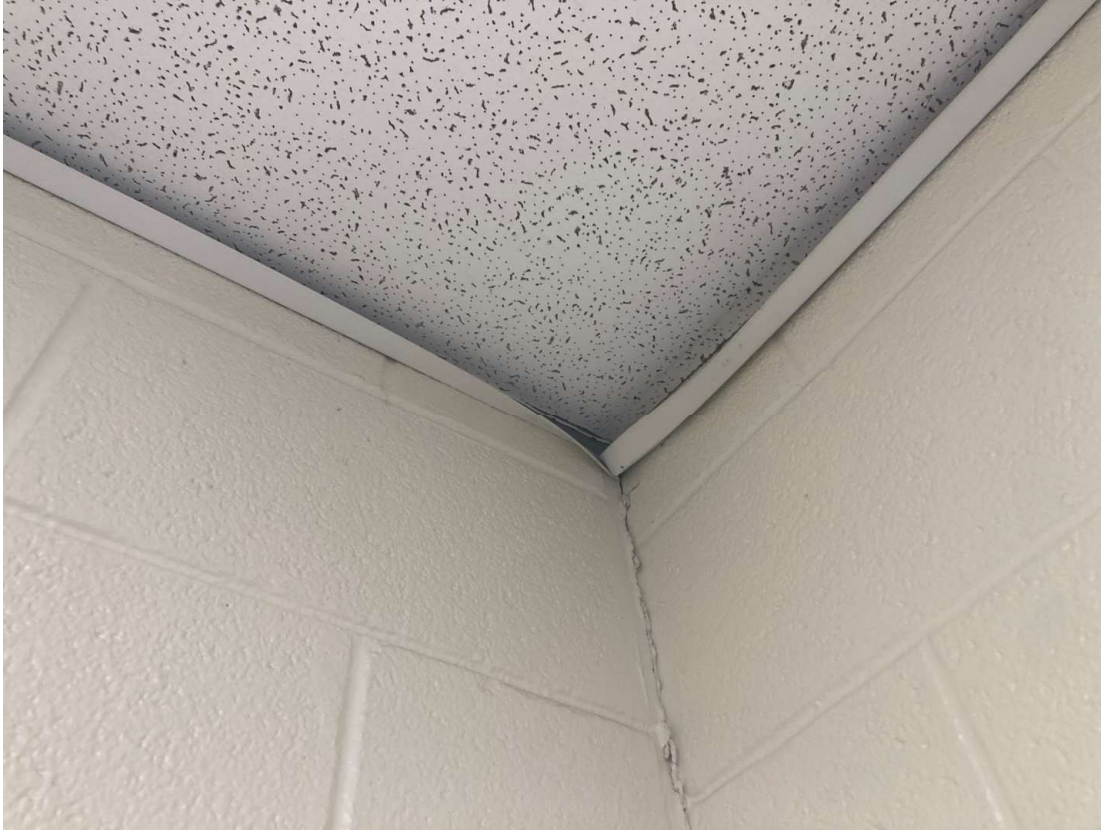
Vertical displacement of walls causing damage to interior finishes.

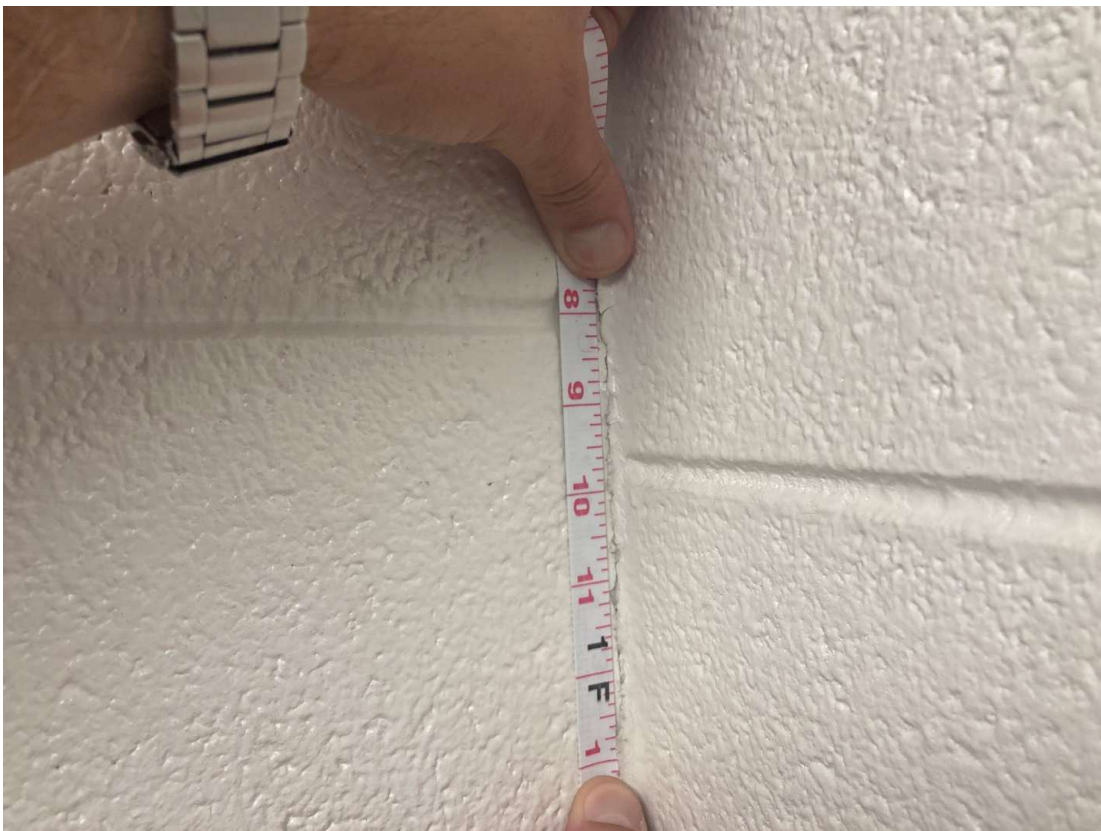
Vertical displacement of masonry walls as measured in inches. Note that the horizontal joints should align.

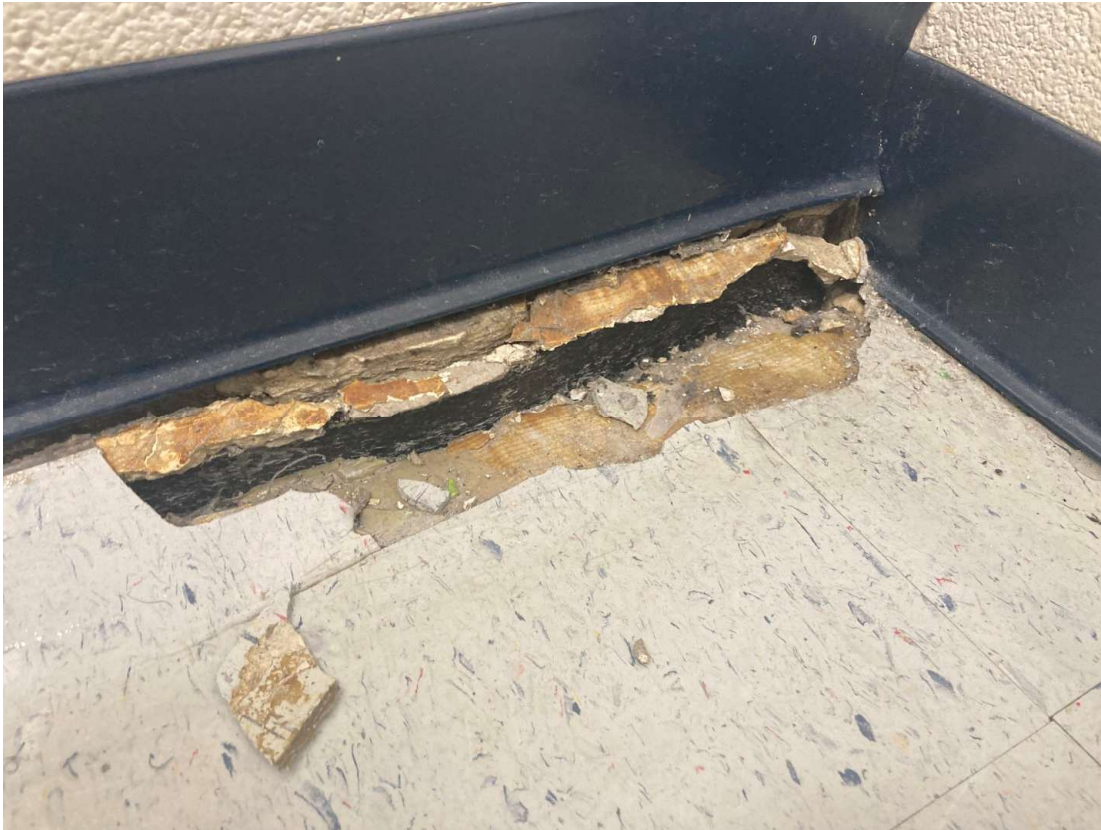
Vertical displacement of masonry walls causing a 'gap' at the floor and damage to interior finishes.

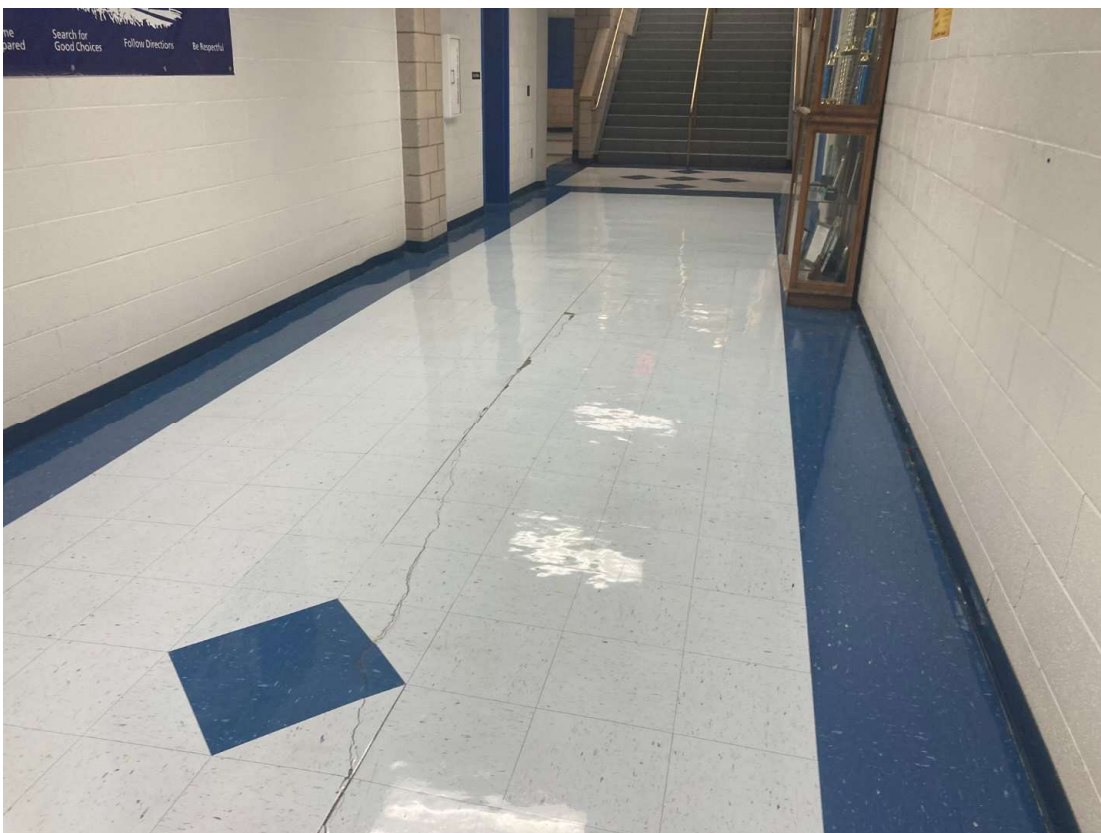
Interior 'heaved' slab at Main corridor causing uneven slope and damaged floor finishes.

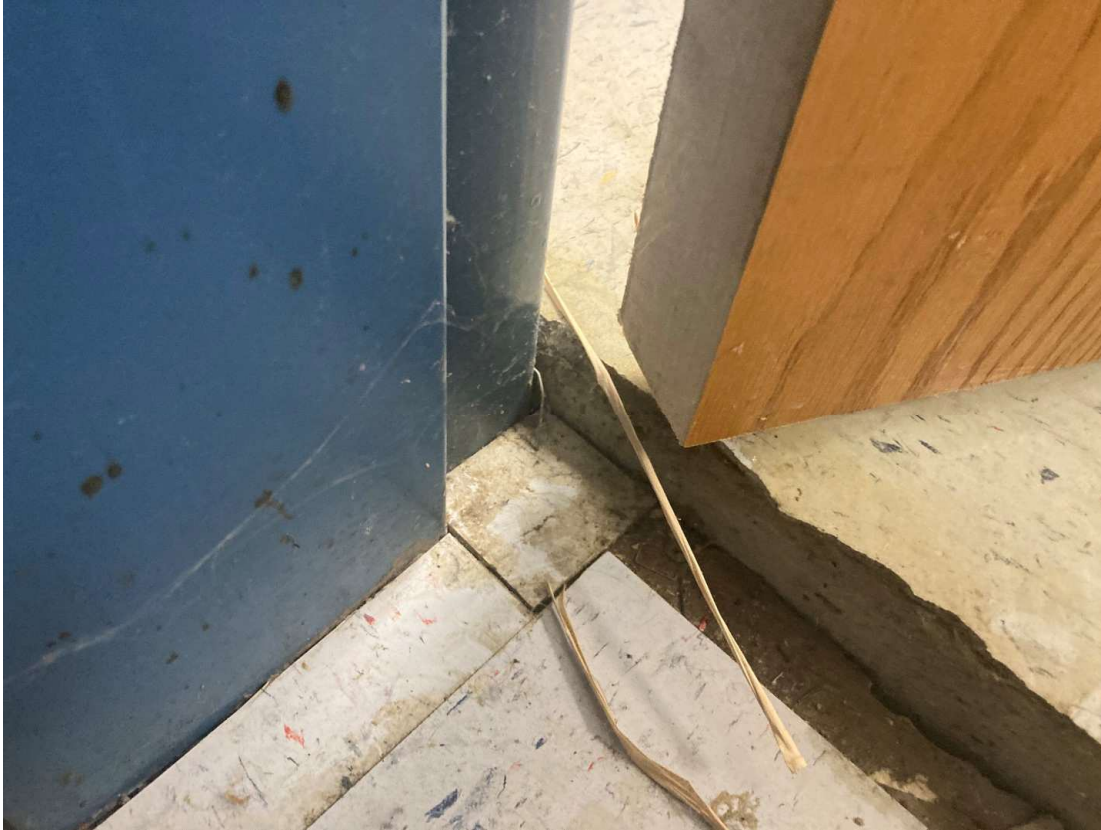
Vertical displacement of floor slab causing tripping hazard and inoperable door.

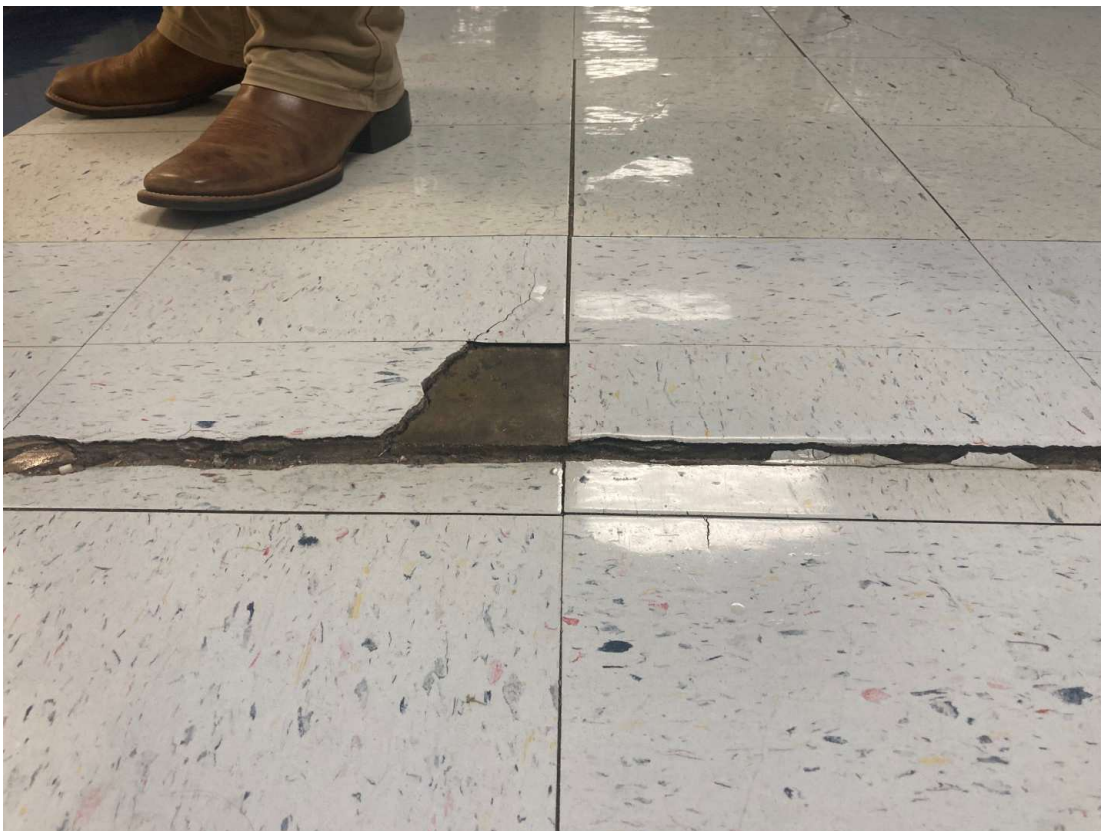
Vertical displacement of slab at primary classroom wing corridor causing tripping hazard and damaged flooring.

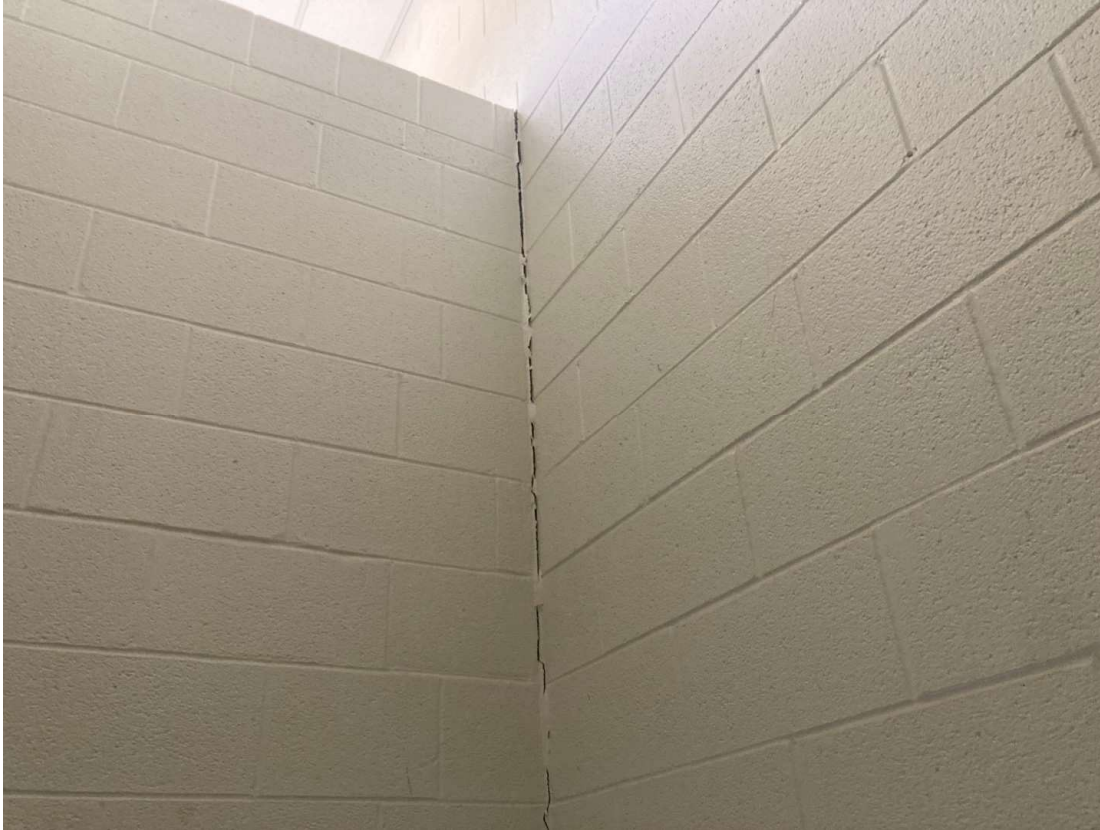
CMU guardrail at Stair has broken away from adjacent wall and is cracked on the opposite side.

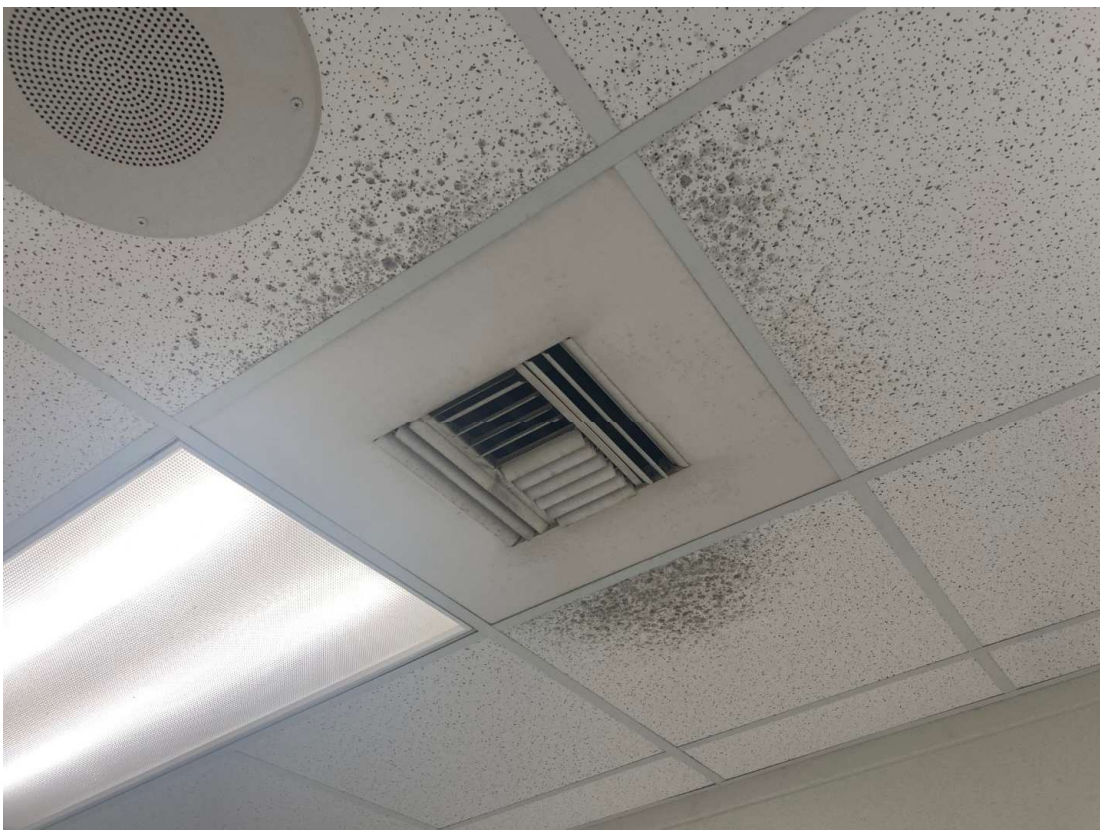
Abnormal organic growth on ceiling tile potentially due to air infiltration and damage to the duct.

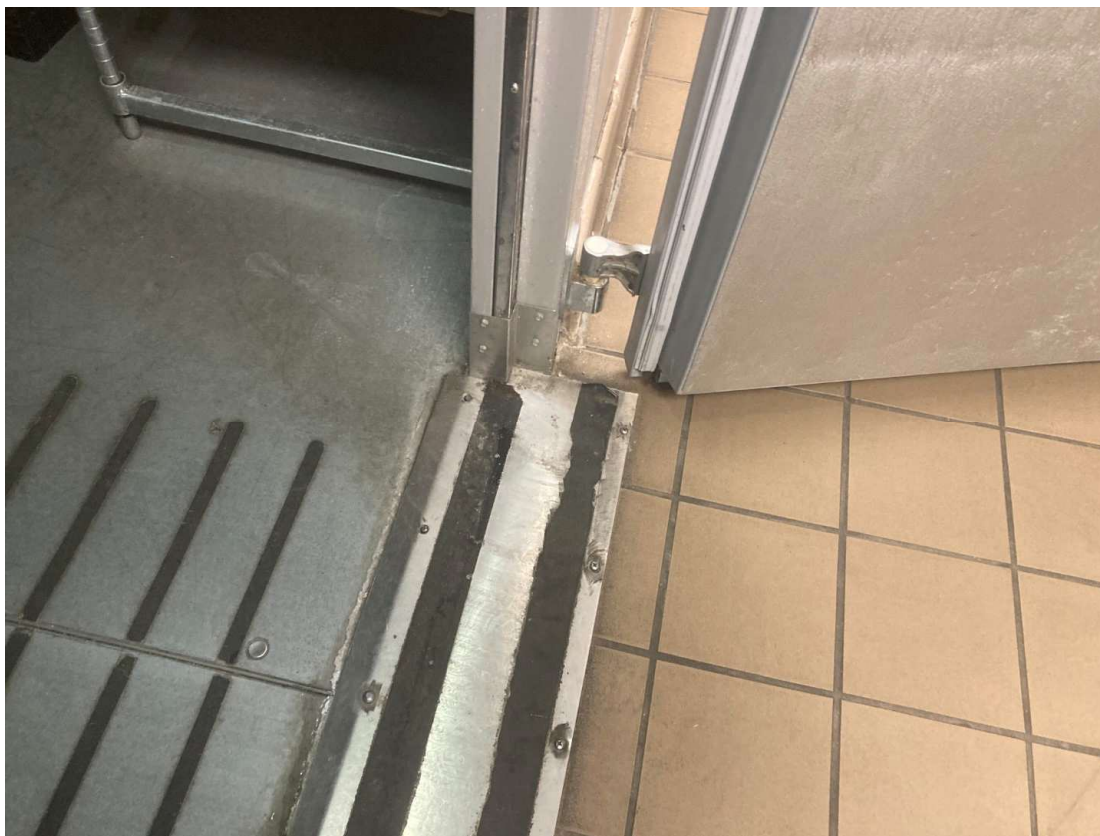
Damaged cooler/freezer box with misaligned doors, due to heaving floors and walls.
