FIELD OBSERVATION REPORT

Central Hardin High School, Cecilia, KY

2019111 - CA8

Report No: 50

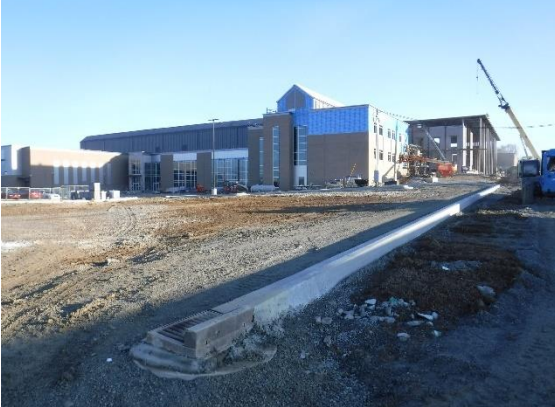
Item No.	Location	Description/Correction	Image	Action
1	Areas A and B	Area B was being clad with metal panels at the classroom are and the LMC was being enclosed with concrete block.

Continue to install siding and trim so that the area is completely enclosed and weather tight.
2	Area B – Classrooms and the LMC	Flat metal panels were installed around the windows.

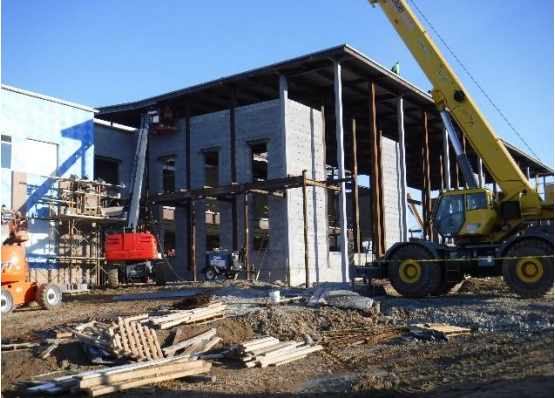
Complete the metal panels and trim so that Area B is completely enclosed.
3	Area B - LMC	Masons were laying block to infill the steel frame.

Refer to the SPIN report for grouting and reinforced walls.

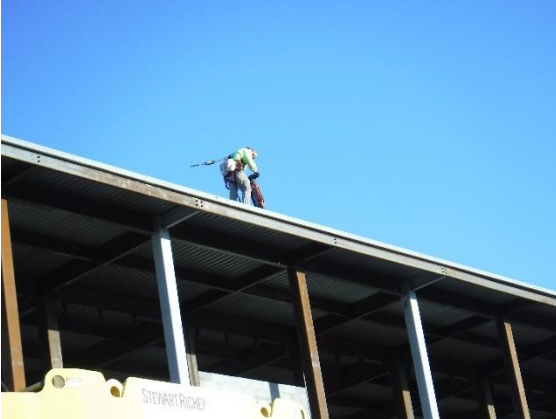
Item No.	Location	Description/Correction	Image	Action
4	Area B – LMC Roof	Erectors were fastening the metal roof deck to the steel frame.

Refer to the SPIN report for the attachment of the deck.
5	Area B - LMC.	Masons were laying concrete block between the steel frame. The open areas are for windows.

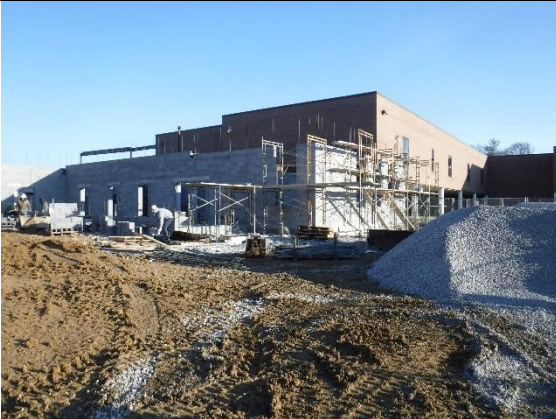
Refer to the SPIN report for reinforced masonry.
6	Area F.	The administrative area was being formed with concrete block walls.

Use cold weather precautions when laying masonry in winter conditions.

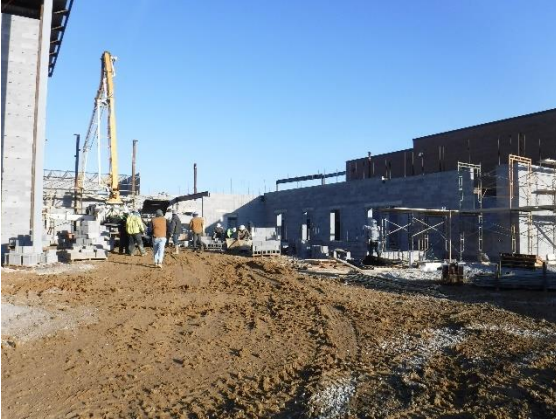
Item No.	Location	Description/Correction	Image	Action
7	Area F – Main Entrance.	The main entrance will be located along the path into Area E. All construction materials for Area E must pass through this opening.

Continue to push the work in this area so that the building is fully enclosed as quickly as possible.
8	Area B - LMC.	The LMC was being enclosed with concrete block. The roof structure overhangs the area.

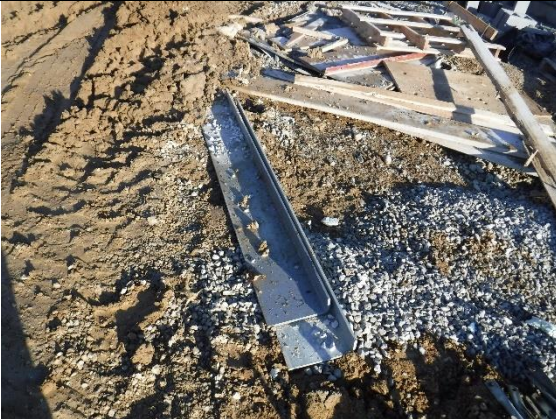
Refer to the SPIN report for reinforced masonry.
9	Area F.	A loose lintel was laying in the mud.

All steel components must be cleaned before installing in the building.

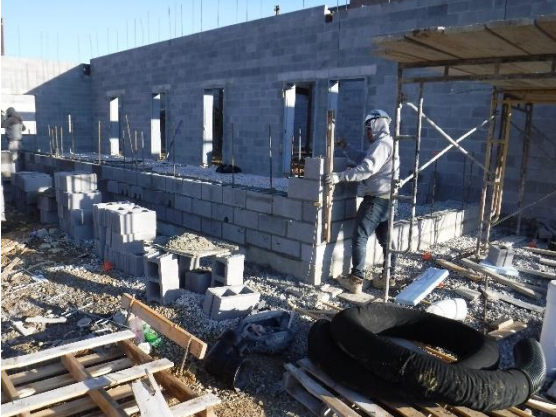
Item No.	Location	Description/Correction	Image	Action
10	Area F.	Masons were laying concrete block walls in the administrative area.

Follow cold weather precautions when laying masonry in winter conditions.
11	Area B, LMC	Electricians were placing conduits and floor boxes ahead of the slab pour.

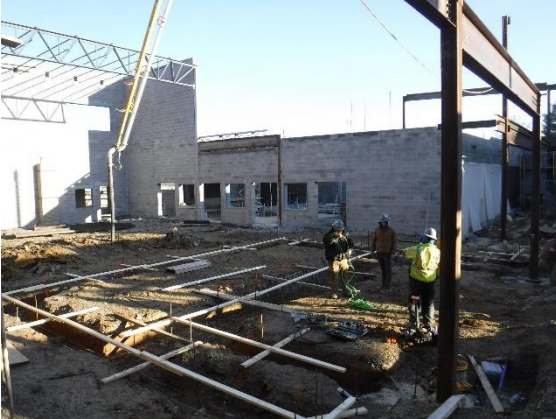
Install floor boxes so the tops are level with the floor.
12	Area B, Cafeteria	The concrete crew was pouring footings for the social stair.

Coordinate social stair dimensions to meet the specified layout.

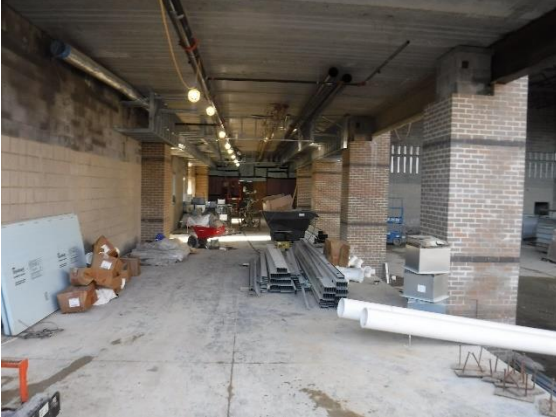
Item No.	Location	Description/Correction	Image	Action
13	Area B, First Level.	Materials were stored along the east-west corridor. The cafeteria is to the right and the LMC to the left.

Keep stored materials in neat piles and protect from damage.
14	Area B, First Level.	Drywallers were installing wallboard at ceiling soffits.

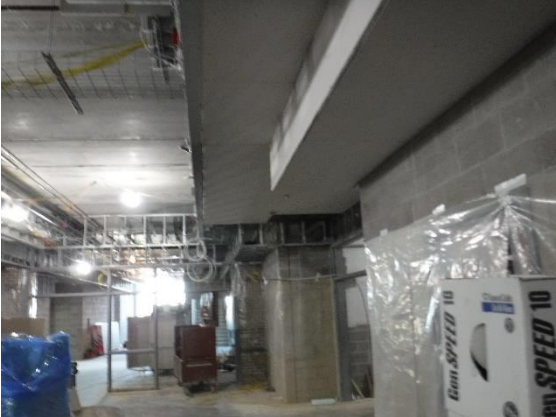
Do not finish wallboard until area is temperature controlled.
15	Area B, First Level.	Some wallboard was already installed for the soffits.

Do not finish wallboard until area is temperature controlled.

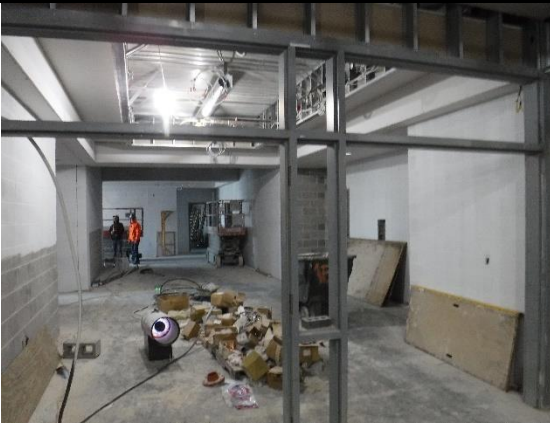
Item No.	Location	Description/Correction	Image	Action
16	Area B, North-South Corridor	The connecting corridor leading to Area A was progressing now that the area is dried in to allow finishes to be installed.

Protect walls and door frames from construction traffic damage.
17	Area B, Classroom.	Excess fire resistant material was laying on the floor.

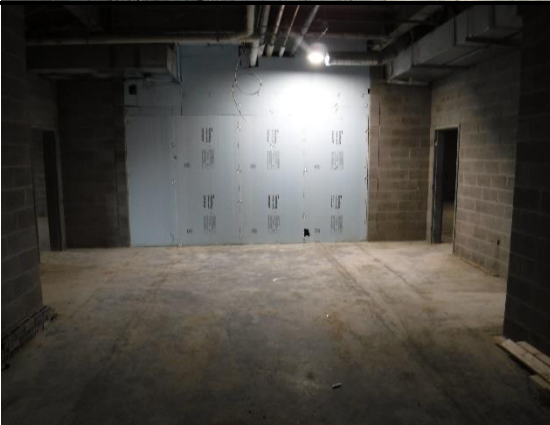
Clean rooms ahead of finish work.
18	Area B North-South Corridor, Second Level.	Rigid insulation board was placed at the opening to enclose the area.

Seal all openings so that heat can be applied to areas where finishes are being installed.

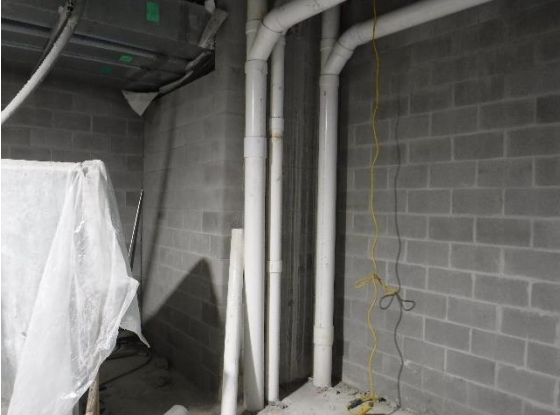
Item No.	Location	Description/Correction	Image	Action
19	Area B – Classroom at Chase.	Storm and waste piping will be located in a wallboard chase.

Install piping in a wallboard chase.
20	Area B – LMC from the Second Level.	Preparation for the slab pour was progressing on the first level below.

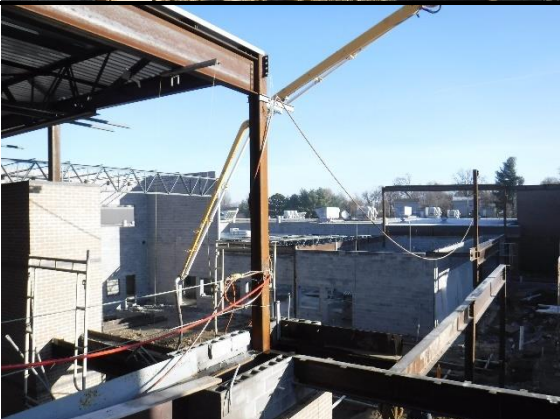
Install vapor barrier under the slab area. Seal all edges at walls and penetrations.
21	Area B – Looking into Area E.	Steel framing, roof deck, roofing, precast concrete planks and concrete block will need to be installed in this area.

Coordinate work to meet the dimensions indicated.

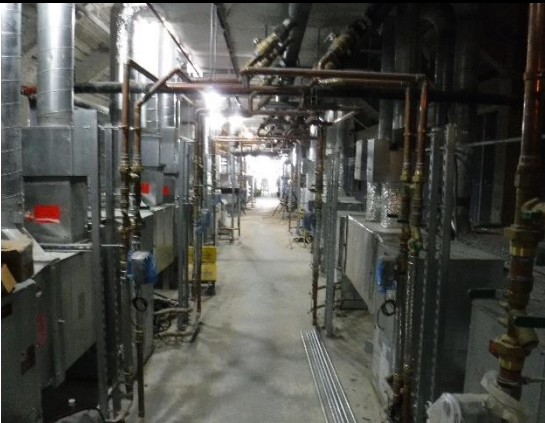
Item No.	Location	Description/Correction	Image	Action
22	Area B Platform.	Mechanical units were installed and connected to hydronic lines and electrical circuits.

Refer to the mechanical field report.
23	Area B Roof over the LMC	The metal deck was being fastened to the steel frame.

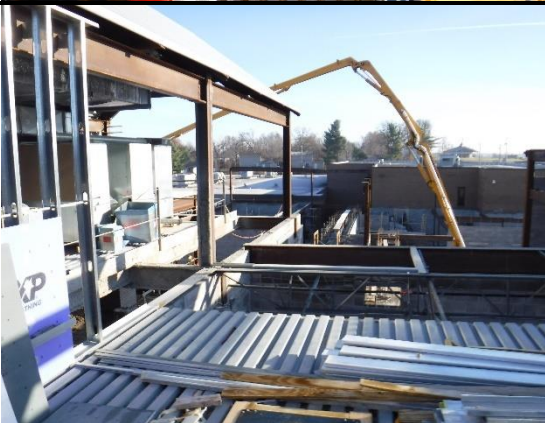
Limit foot traffic on the roofing system after it is installed.
24	Area B and E, Second Platform, Roof Level.	Concrete was being poured into the forms for the footings for the social stair.

Refer to the mechanical field report concerning equipment on the platform exposed to the weather.

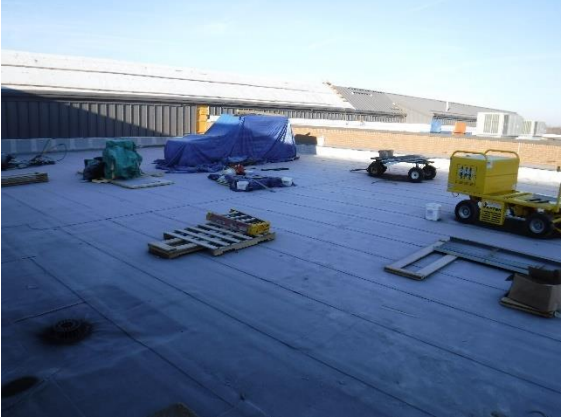
Item No.	Location	Description/Correction	Image	Action
25	Area E, Cafeteria Roof.	Materials were stockpiled on the roof membrane.

Continue to store material on membrane by placing it on dunnage or insulation boards.
26	Area B, Roof.	Materials were stockpiled on the roof membrane.

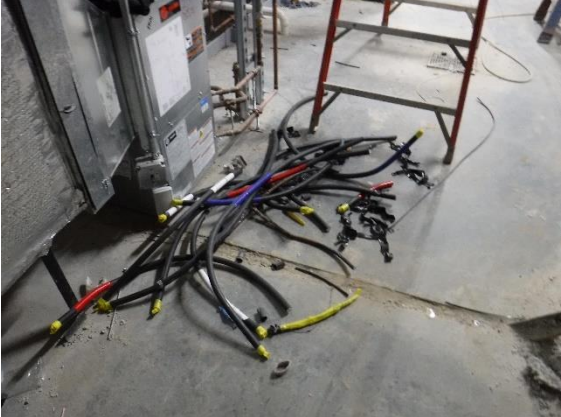
Continue to store material on membrane by placing it on dunnage or insulation boards.
27	Area A and B - Platform	Excess materials were laying on the floor.

Clean all excess material, trash and dirt from the platform ASAP.

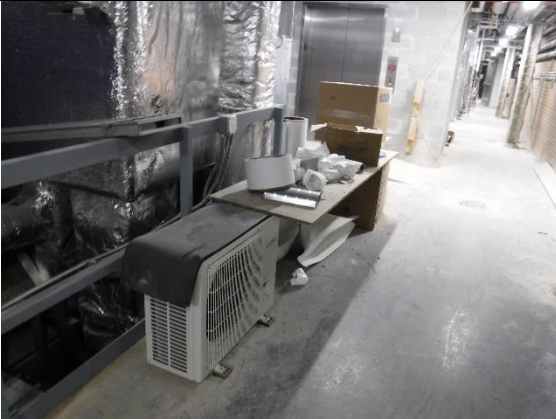
Item No.	Location	Description/Correction	Image	Action
28	Area A, Platform	The split system unit was being used as a work table.

Refer to the mechanical report. Do not use the owner's equipment for tables and platforms for construction.
29	Area A, Mechanical Room Door.	The fire-rated doors were propped open. This is a violation of the fire code for a building occupied by the owner.

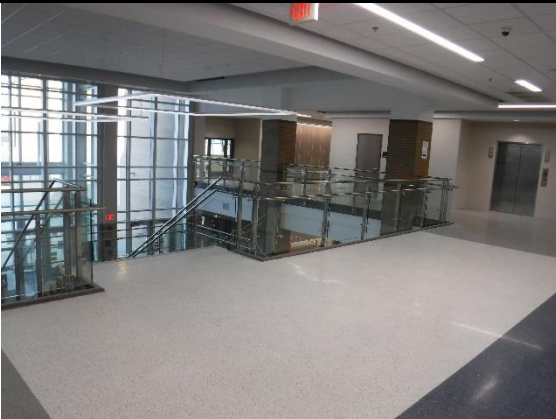
Keep fire rated doors in occupied areas, closed at all times.
30	Area A, Second Floor.	The terrazzo flooring was nearing completion. Dust from the installation was on the railings, brick and other materials surrounding the floor.

Clean all surfaces affected by the dust from the terrazzo grinding operations.

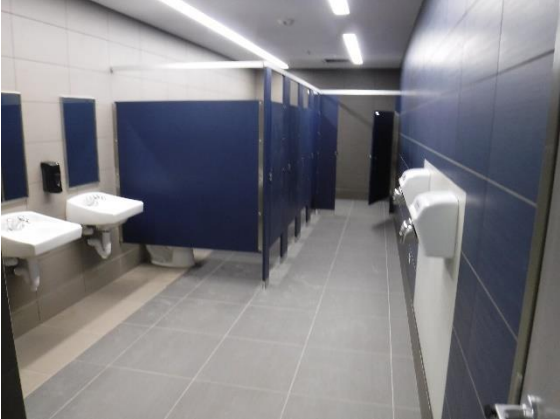
Item No.	Location	Description/Correction	Image	Action
31	Area A at the Gym Level, Student Toilets.	Toilet partitions and fixtures were installed. The walls, floors, partitions, accessories and fixtures were not clean.

Completely clean all surfaces.
32	Area A at the Gym Level, Student Toilets – Accessible Stall.	Toilet fixtures, partitions, and accessories must be installed to meet the dimensional requirements of the ADA.

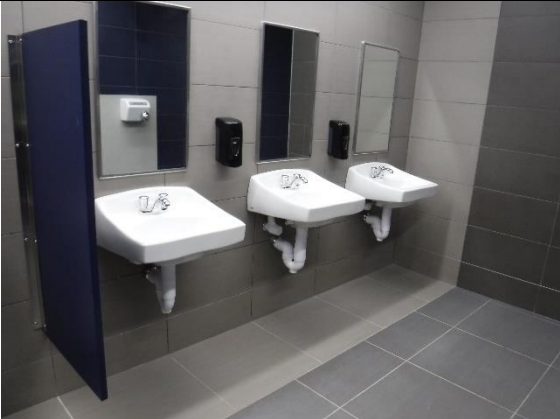
Refer to Sheet G-103. Relocate fixtures and accessories that do not comply with the specified dimensions.
33	Area A at the Gym Level, Student Toilets – Wall Lavatories.	Toilet fixtures, partitions, and accessories must be installed to meet the dimensional requirements of the ADA.

Refer to Sheet G-103. Relocate fixtures and accessories that do not comply with the specified dimensions

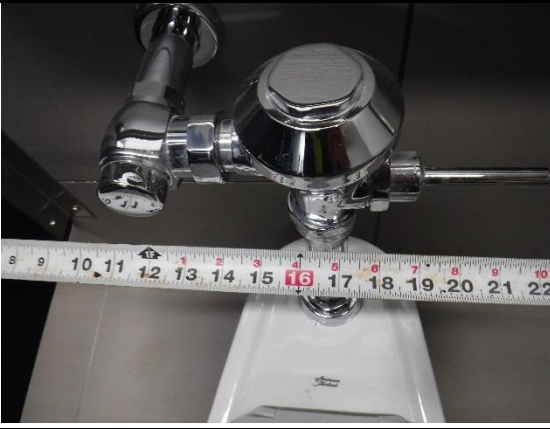
Item No.	Location	Description/Correction	Image	Action
34	Area A at the Gym Level, Student Toilets – Accessible Water Closet	On Sheet G-103 the centerline of the water closet is indicated to be 17" off the partition. The ADA allows the WC to be installed 16" to 18" from the partition.

Install all WCs to meet the dimensional requirements indicated on Sheet G-103.
35	Area A at the Gym Level, Student Toilets – Accessible Water Closet	On Sheet G-103 the centerline of the water closet is indicated to be 17" off the partition. The ADA allows the WC to be installed 16" to 18" from the partition.

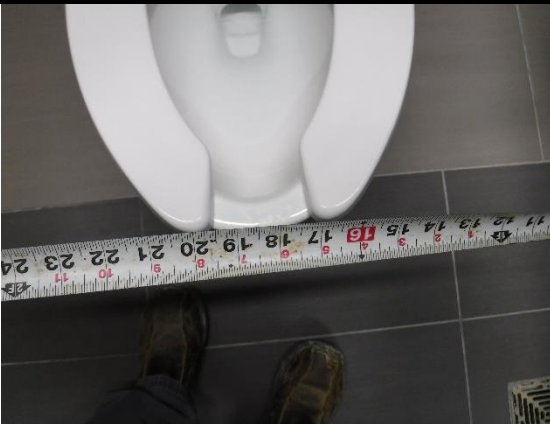
Install all WCs to meet the dimensional requirements indicated on Sheet G-103.
36	Area A at the Gym Level, Student Toilets – Accessible Water Closet	This WC exceeds the dimension allowed by the ADA between the centerline and the partition.

Install all WCs to meet the dimensional requirements indicated on Sheet G-103. This WC exceeds the allowable dimensions by the ADA and must be relocated.

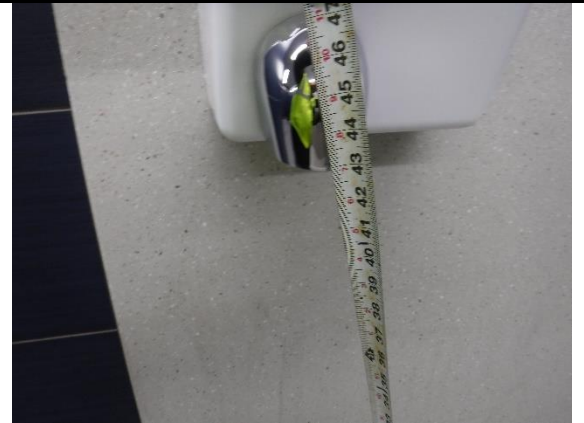
Item No.	Location	Description/Correction	Image	Action
37	Area A at the Gym Level, Student Toilets – Hand Dryer	Sheet G-103 indicates that The centerline of the hand dryer shall be 48" above finish floor.

Verify that all hand dryers meet the required dimension.
38	Area A at the Gym Level, Student Toilets – Accessible Urinal	Sheet G-103 indicates that the lip of the urinal at the front edge shall not exceed 17" above finish floor.

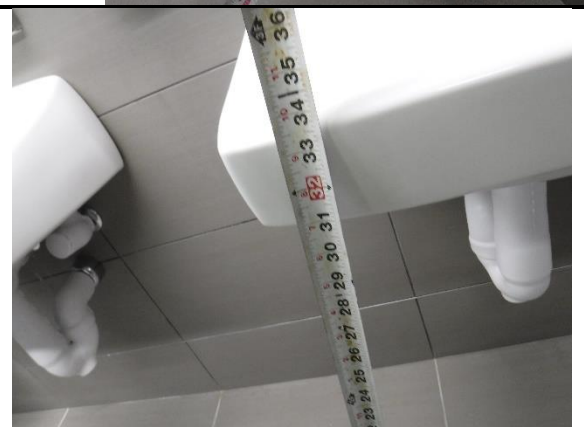
Relocate urinals that do not meet the required dimensions indicated on sheet G-103.
39	Area A at the Gym Level, Student Toilets – Lavatory	Sheet G-103 indicates that the front edge of the lavatory shall not exceed 34" above the finished floor.

Verify that all requirements for lavatory dimensions indicated on Sheet G-103 are met.

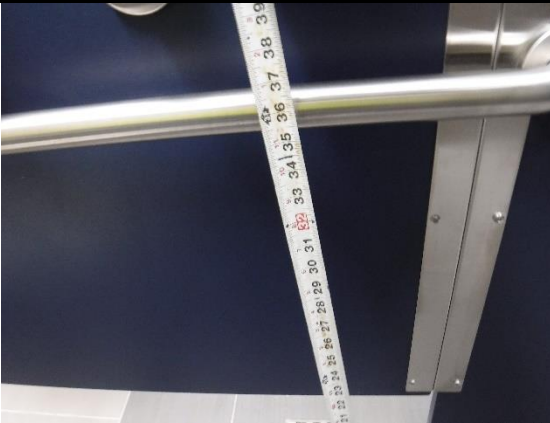
Item No.	Location	Description/Correction	Image	Action
40	Area A at the Gym Level, Student Toilets – Accessible Stall - Grabbars	Sheet G-103 indicates that the centerline of the grabbars shall be 35" AFF.

Relocate grabbars to meet the dimensional requirements indicated on Sheet G-103.
41	Area A at the Gym Level, Student Toilets – Accessible Stall.	The latch was installed so that the rubber bumper does not engage the latch causing a metal to metal sound.

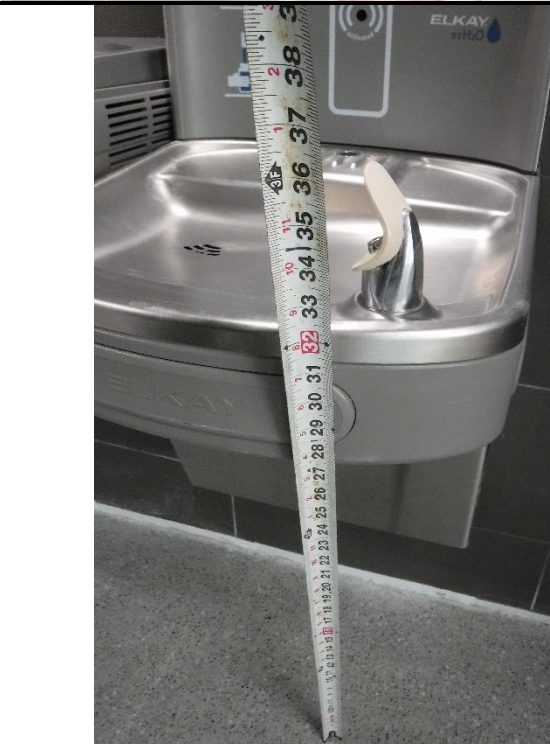
Reinstall latch so that the rubber bumper hits the latch.
42	Area A – Gym Lobby – Electric Water Cooler.	Sheet G-103 indicates that the top of the spout shall be 36" AFF.

Install at EWCs to meet the dimensional requirements on Sheet G-103.

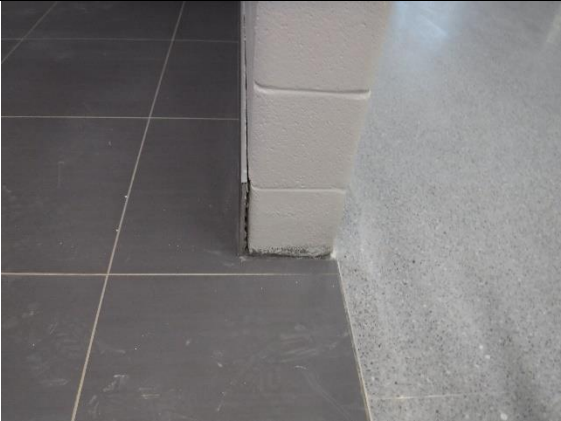
Item No.	Location	Description/Correction	Image	Action
43	Area A at the Gym Level, Student Toilets – Base Condition	The terrazzo base was not installed.

Install terrazzo base to close to the ceramic base. Cover the raw edges. Caulk the gap at the bullnose block.
44	Area A at the Gym Lobby – Brick Pier	The brick was covered with dust from the grinding operation for the terrazzo flooring.

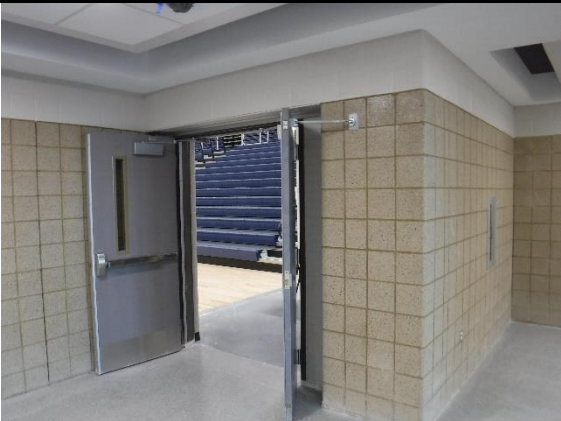
Clean terrazzo dust off brick and other wall materials.
45	Area A – Gym Level – Doors to Area C – Main Gym.	These doors were properly held open by magnetic hold open devices.

Check all doors that do not have hold opens to make sure that they remain close.

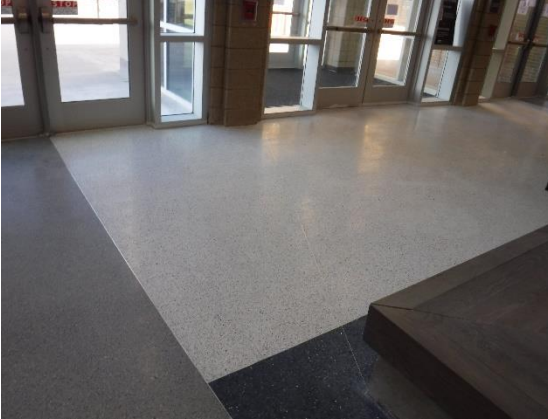
Item No.	Location	Description/Correction	Image	Action
46	Area A at the Gym Level – Gym Lobby Floor	The dividers in the terrazzo flooring were installed at odd angles creating a displeasing appearance for the floor.

Propose a solution for the improper divider strip installation.
47	Area B – Intumescent Coating on Steel Column.	The coating was not uniform.

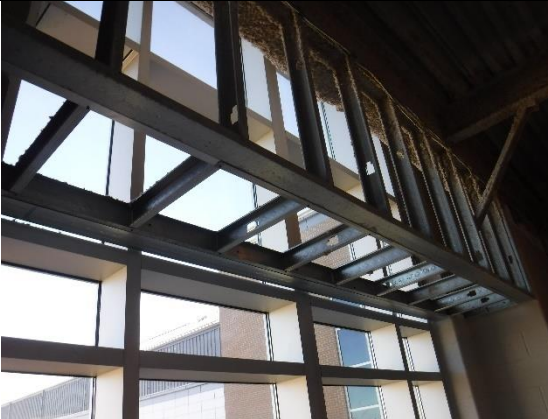
Fill and sand the coating surface to make it uniform.
48	Area B – Stair B Soffit Framing.	The framing and wallboard will show through the exterior windows.

Black out framing and the back of wall board within the soffit.

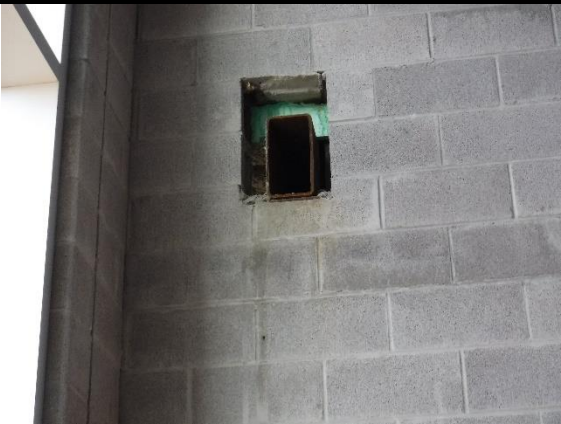
Item No.	Location	Description/Correction	Image	Action
49	Area B – West End of Corridor.	The steel tube beam was too long to be concealed in the block wall.

Cut the tube steel back and install block so that the hole is not visible.
50	Area A – North Entry.	The limestone was heavily stained by runoff from above.
