M/E/P FIELD REPORT

Date of Visit: 12/7/2023
Date Submitted: 12/11/2023
Project Name: Central Hardin High School
Project No.: 20009
Location: Hardin County, Ky
Time In/Out: 9:30am- 3:30pm
To: Inga Hardman
From: Michael Warren
Copy: Joe Jones; Brandon Cecil; David Epperson; Ethan Kelly

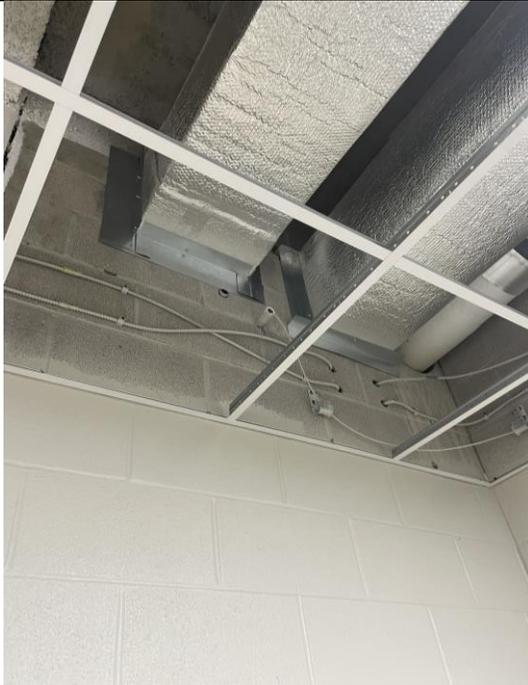
Duct penetrations have been flashed at through-wall penetrations. This is to be done at all duct penetrations through-wall.

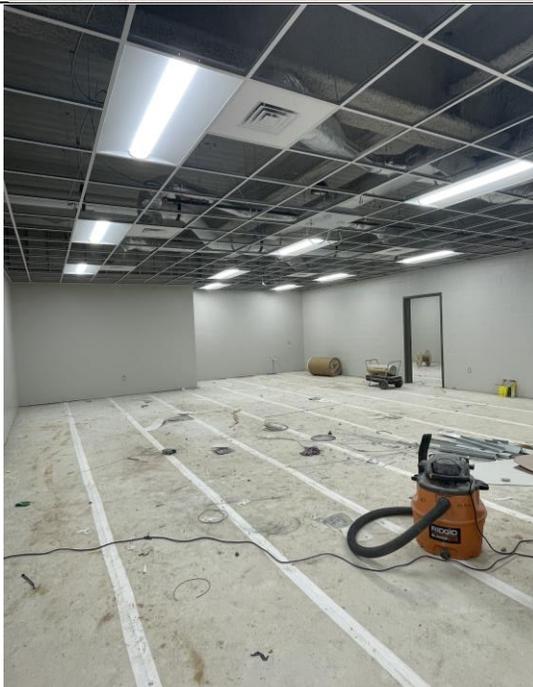
Installation of light fixtures has begun in the lower level of Area B. The fixtures will need to be cleaned prior to being turned over to the Owner.

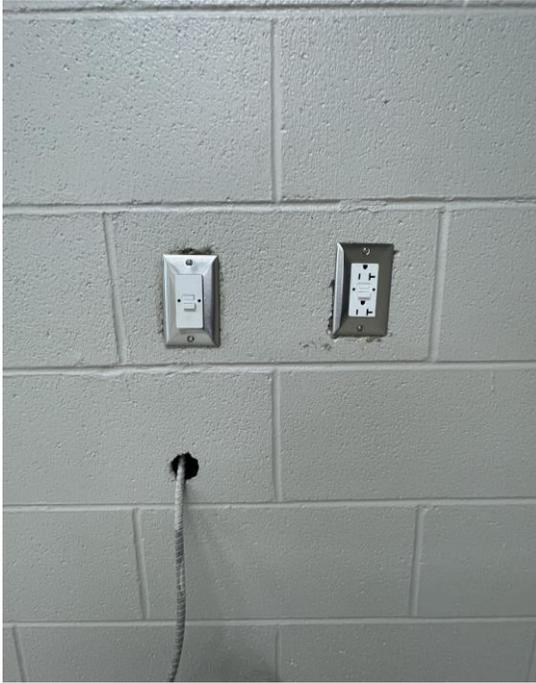
Faceplates are being installed in the F&CS Food Lab in Area B lower level. There are a few on the Plan East wall that will require touch up.

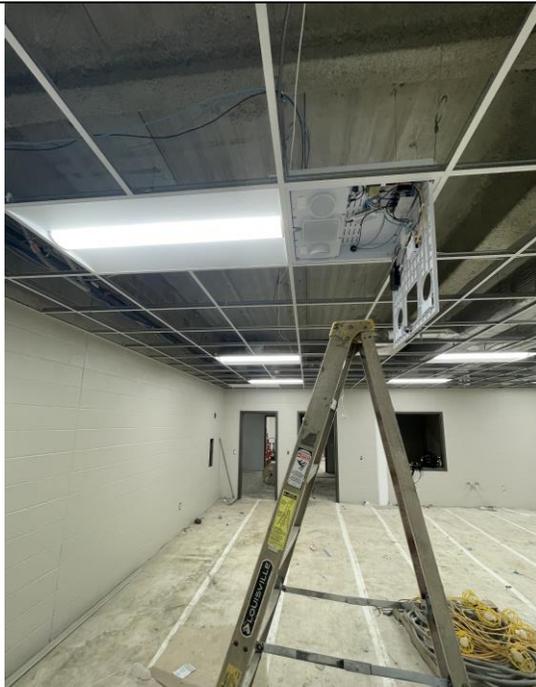
Low voltage cabling is being pulled to ceiling mounted devices as they are installed in Area B lower level.

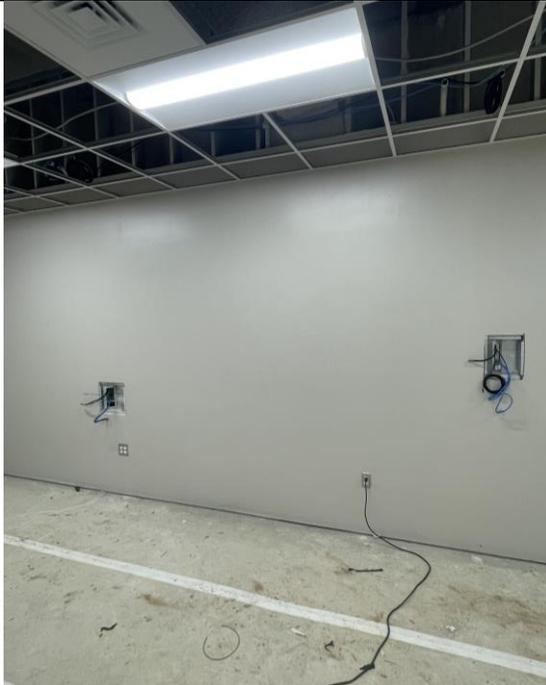
Data and HDMI cables are being pulled to the FSR boxes in the lower level of Area B.

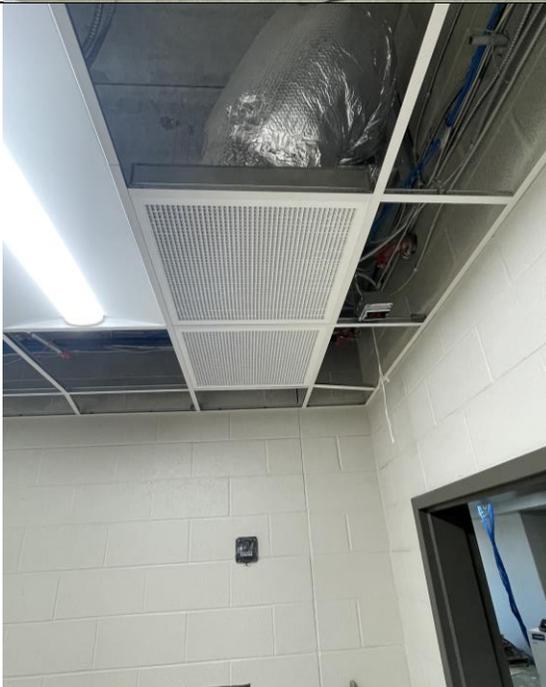
Return air registers will need to be covered with filter media prior to running any heat pumps.

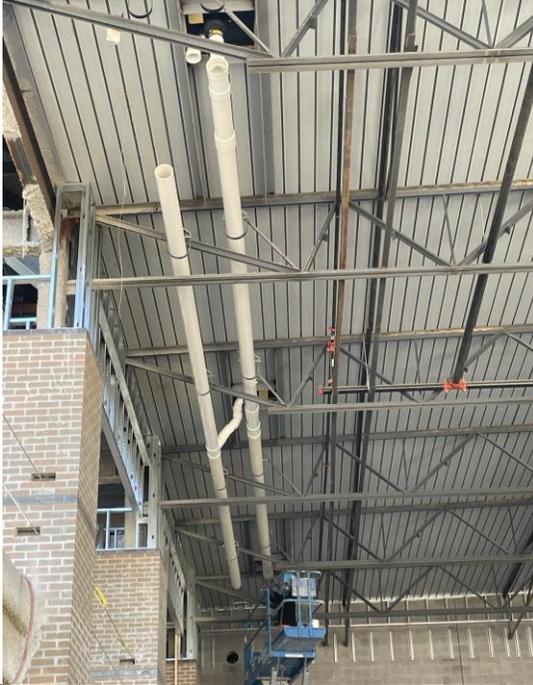
7. Roof leaders are being set in the Café/Commons Area while on site today.
8. Plumbing, Sheet metal, and fire protection are nearly caught up in Area B. Insulation can't be installed in Areas where it will be exposed to the weather. Ductwork can be installed and covered with plastic, but it cannot be insulated or sealed until the areas are dried-in.

Roof leaders are being installed in the Café/Commons area.

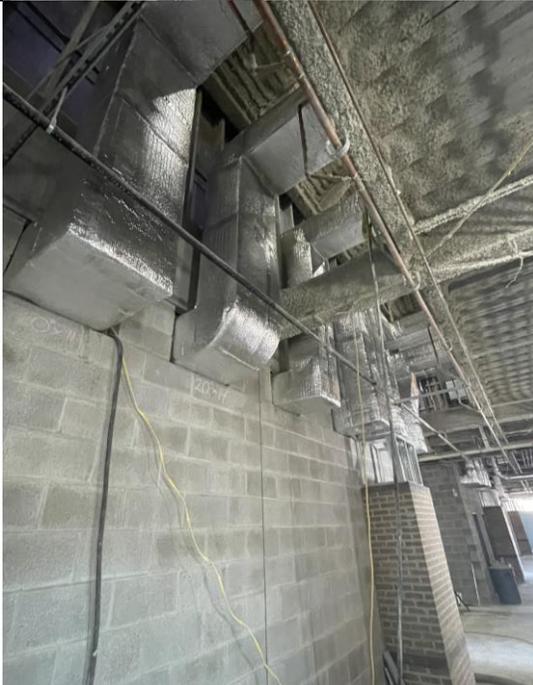
6. Nearly all the ductwork that has been installed in Area B has been insulated from the mezzanine down into the Classrooms on the 1st and 2nd floor. Insulation has not started in the Classrooms because the spaces haven't been dried-in.

The duct from the mezzanine has been insulated to the classrooms. Ductwork in the classrooms has not been insulated.

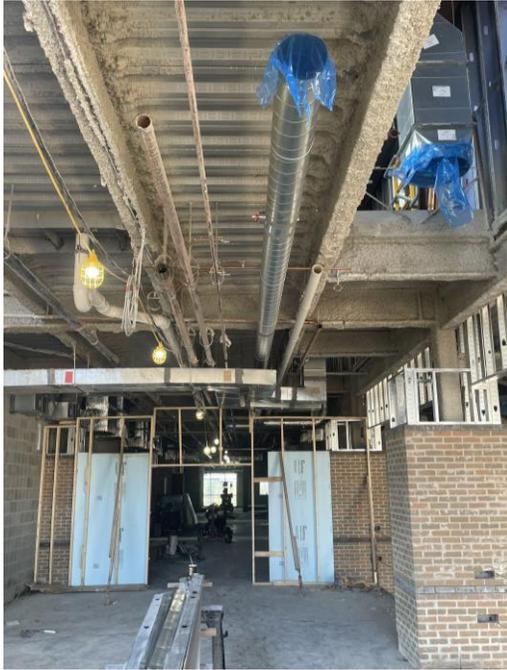
Installation of ductwork, plumbing, and sprinkler lines, is caught up to Areas that haven't been dried-in.

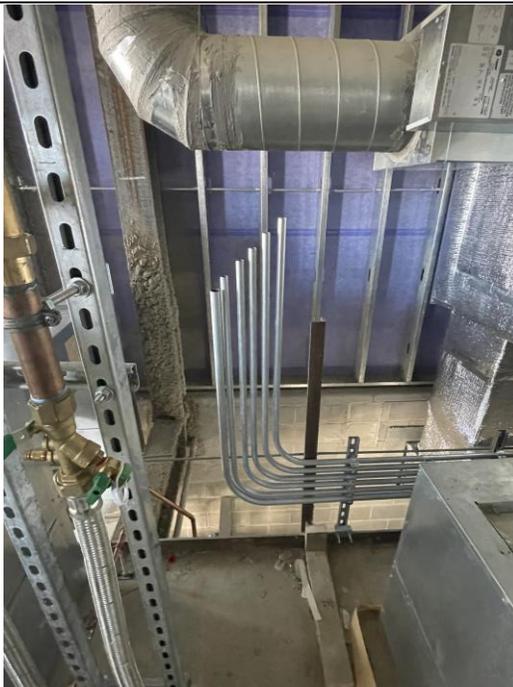
Installation of conduit and conductors is ongoing at the mezzanine.

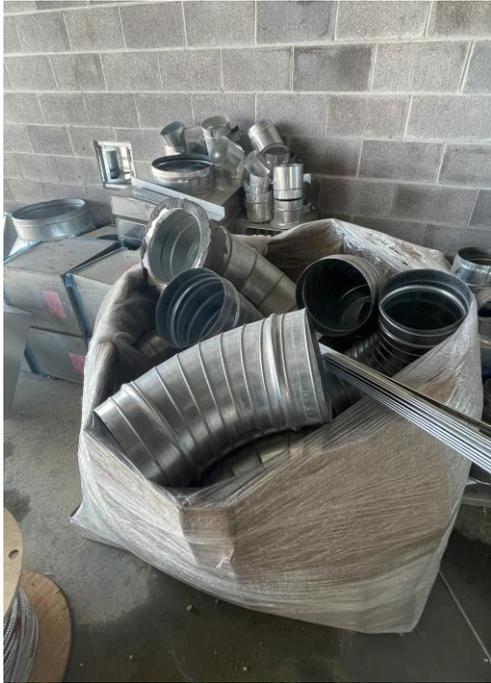
9. Throughout the project, there is significant equipment and material that has not been covered with plastic for protection from dust, dirt, and debris. It is important that all these items are cleaned, and then covered with plastic. Please see photos in this report for examples of what was observed during this site visit.

Duct fittings that have not been covered on the first floor of Area B.

- a. **Clean all components of equipment and material that have become dirty because of not being properly covered with plastic. Equipment and material must be covered for protection. This includes but is not limited to: Ductwork openings (both duct that has been hung, and duct that is being staged), open ends of VAV boxes, openings to Heat pumps (both coils and squirrel cages) and ERUs, electric trap primers.**

***All equipment will need to be cleaned prior to being covered from dust and debris**

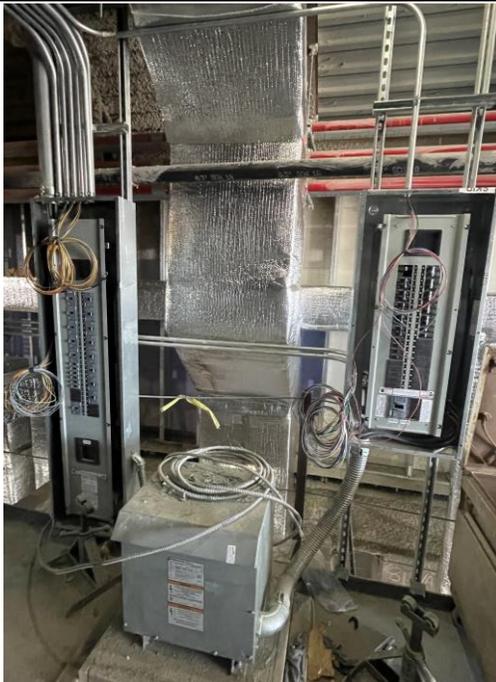
Conductors are being pulled to the panels on the mezzanine.

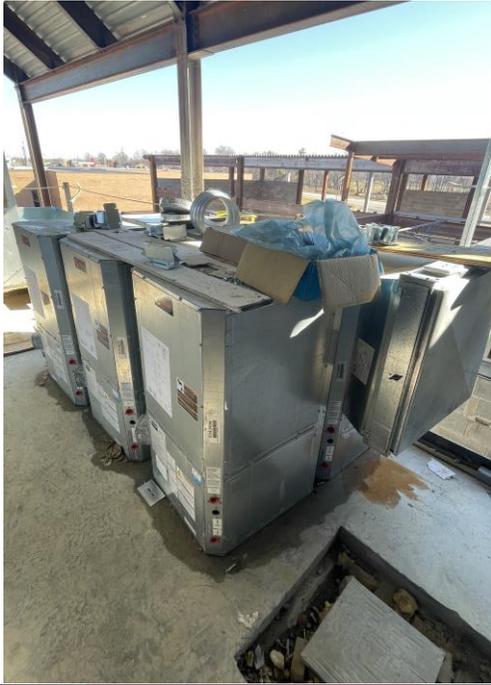
Several heat pumps are not covered from protection from the elements. These units need to be covered and not used as a working surface. Also, the coils haven't been covered, see next photo.

***All equipment will need to be cleaned prior to being covered from dust and debris**

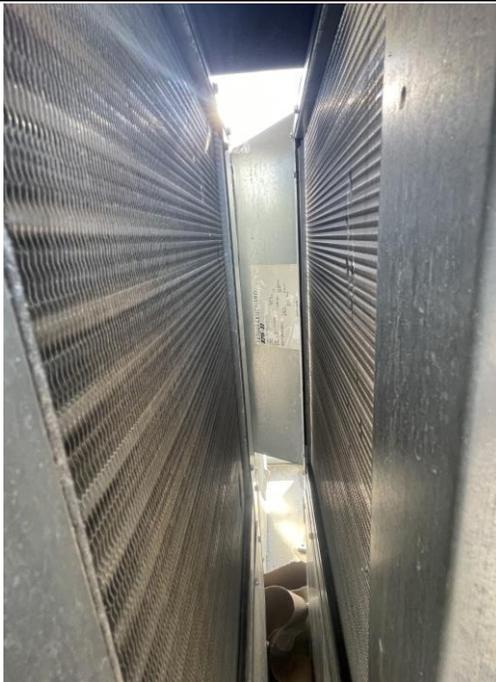
Heat pump coils that haven't been covered.

***All equipment will need to be cleaned prior to being covered from dust and debris**

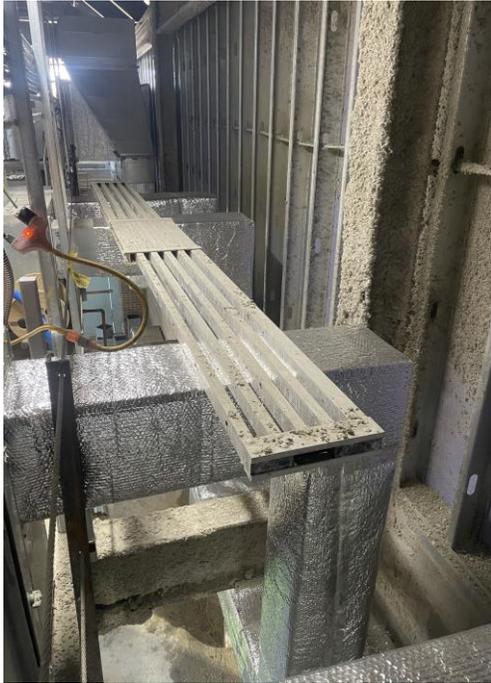
It was observed that a contractor is using the ductwork (which has been insulated) as a platform for scaffolding. Any damage to duct or insulation will need to be addressed by the responsible party.

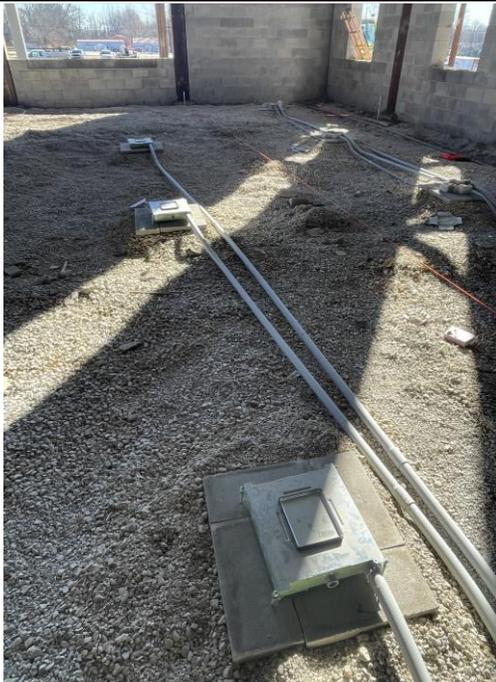
1. Light fixtures have been installed in the lower level of Area B, including the ROTC Classroom B006, ROTC Office B004, Corridor B000, F&CS Classroom B007 and F&CS Food Lab B008.
2. Conduits are being installed on the Mezzanine and conductors are being terminated at the panels where conduit runs are completed.
3. Ceiling mounted devices are being installed as the ceiling grid has been installed. Low voltage cabling is being ran to the devices as they are being set in place.
4. Data and other low voltage cables are being pulled in Area B. In the lower level of Area B, several of the FSR boxes have data cable routed to them already.
5. Electricians have begun underslab rough-in in the Media Center. Floor boxes are being laid out. There are over 50 floor boxes in this space: coordination is critical.

Underslab conduits are being laid in the Media Center. There are over 50 floor boxes in this space: coordination is critical.

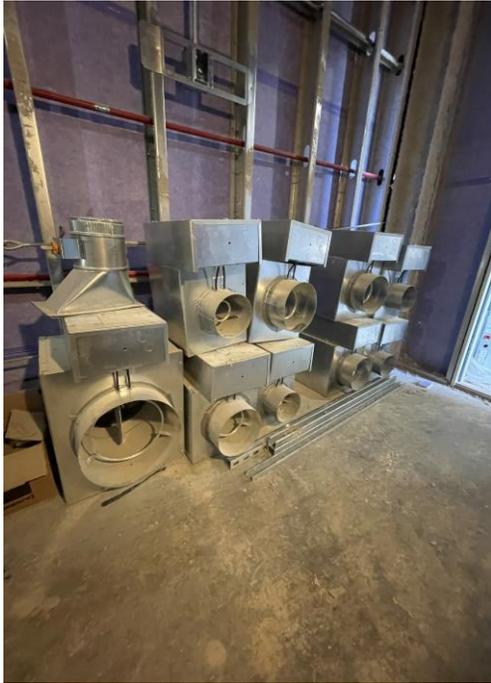
Group of VAVs that haven't been covered on the mezzanine.

***All equipment will need to be cleaned prior to being covered from dust and debris**

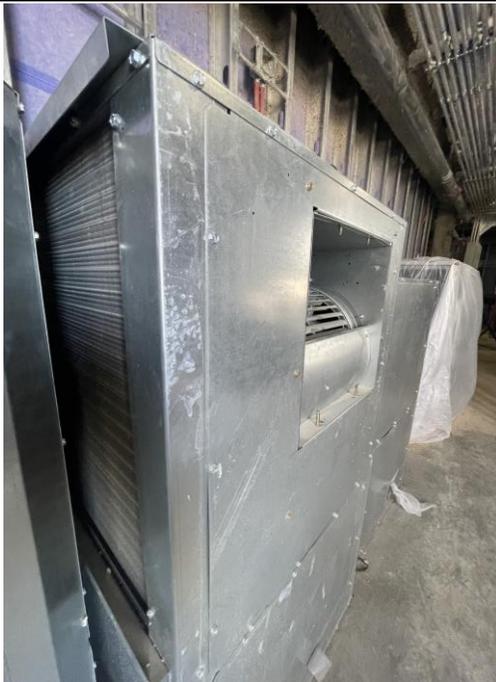
Heat pump coil and squirrel cage that has not been covered.

***All equipment will need to be cleaned prior to being covered from dust and debris**

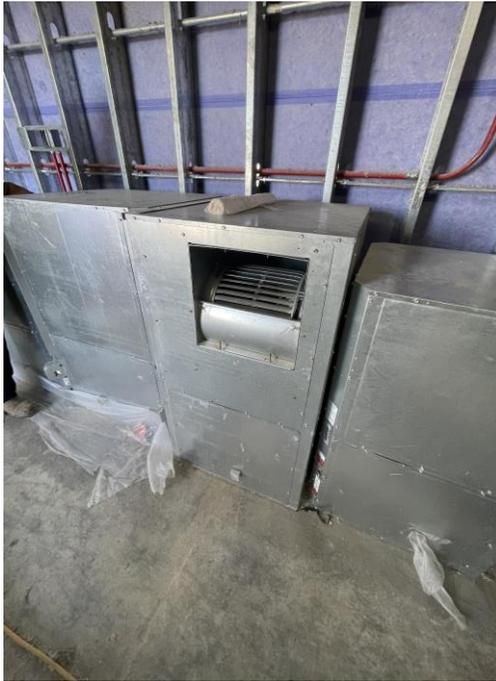
Heat pump squirrel cage that has not been covered.

***All equipment will need to be cleaned prior to being covered from dust and debris**
