FIELD OBSERVATION REPORT

2023-12 (Scott Phase V)

■ TO:	Kenton County Board of Education 1055 Eaton Drive Ft. Wright, KY 41017	■ DATE:	2023.12.14
ATTENTION:	Mr. Matt Rigg		
■ FROM:	Mark Perry mperry@embosssdesign.com 906 Monmouth Street Newport, KY 41071 V: 859.431.8612 • D: 859.578.6013	■ PROJECT:	Kenton County School District Scott Phase V
COPIES TO:	Mr. Kevin Pfefferman; Ms. Carrie Hooten	PROJECT NO.:	20-032

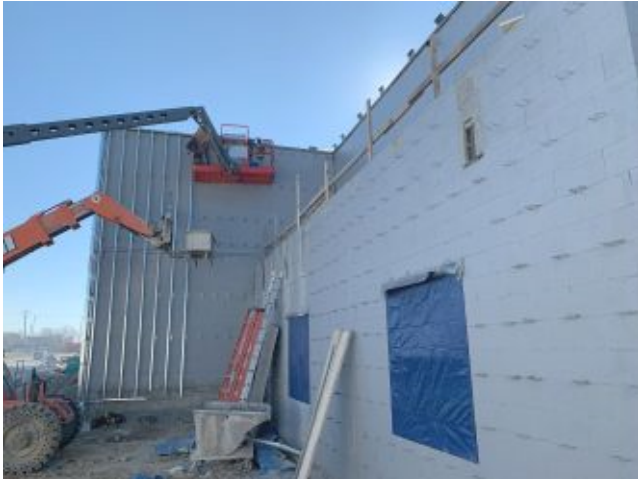
2023.11.29 – North wall of auditorium, east wall of office addition

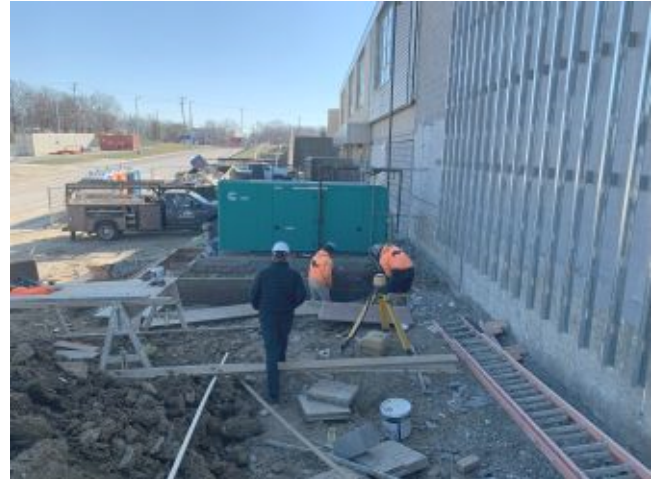
03.01: 2023.11.29 – Ramp issue was reviewed. Green Room steps had been re-formed and were ready to be poured. Forming and reinforcing was underway at generator screen wall foundations.
03.02: 2023.12.13 – Concrete foundation walls were observed around the generator.

2023.11.29 – Generator foundation work

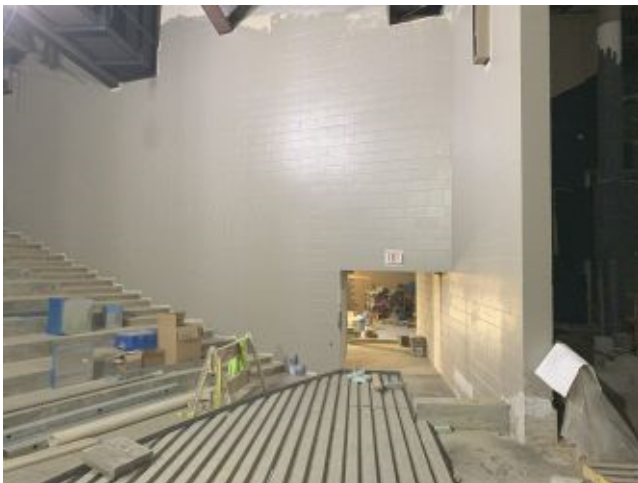
2023.11.29 – Interior north wall of auditorium

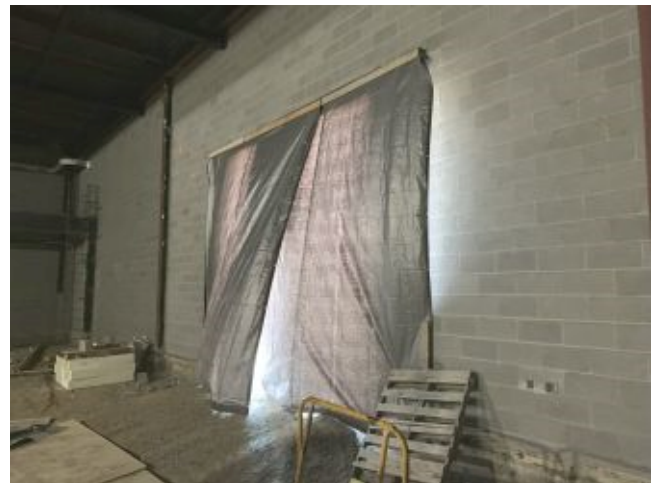
2023.11.29 – Weather protection stage

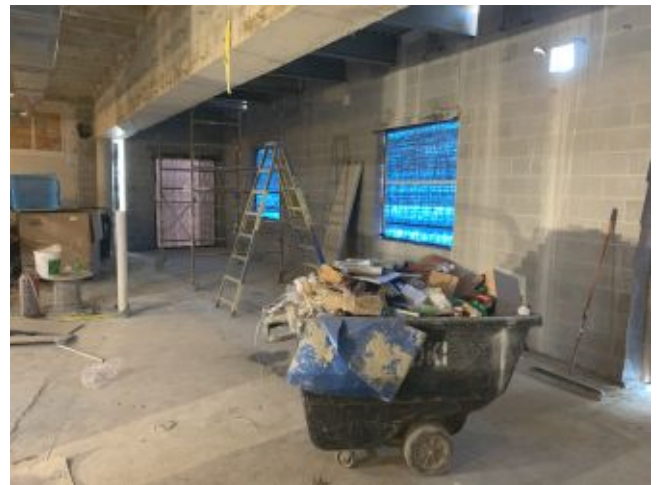
2023.11.29 – Interior at office addition

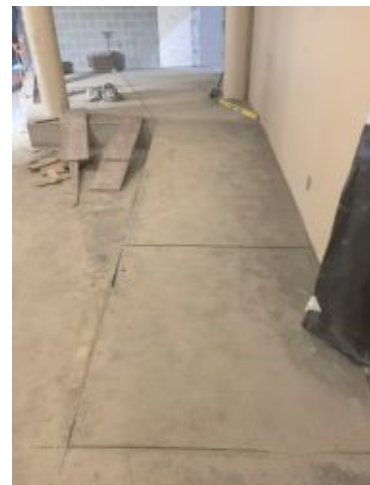
2023.11.29 – Ramp to auditorium

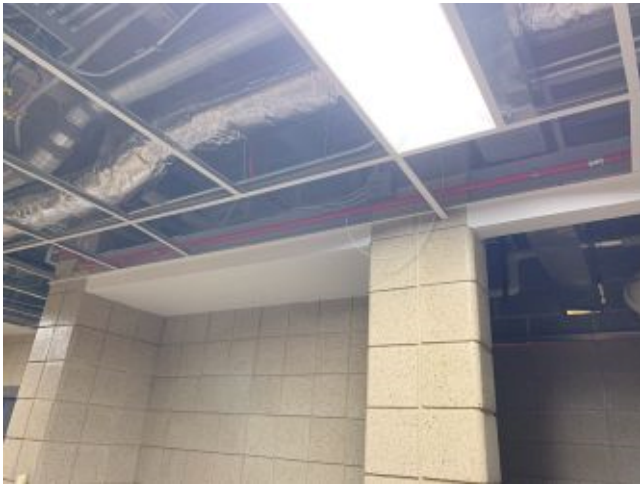
09.01: 2023.11.29 – Some ceiling grid had been installed outside of first floor restrooms. Ceiling framing was underway in Men #1005.

20-28.01: 2023.11.29 – Some light fixtures had been installed in grid outside of first floor restrooms and were energized. MC cable was observed and discussed with Kevin Pfefferman.

2023.11.29 – Outside of Men #1005

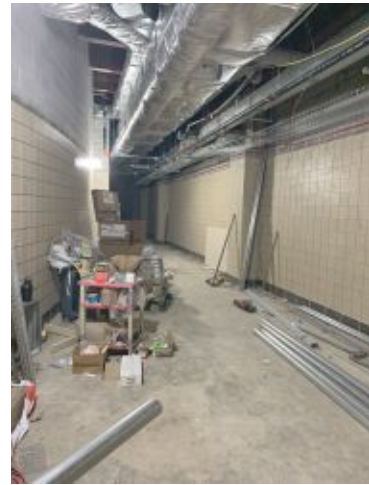
2023.11.29 – Corridor #2000B

20-28.03: 2023.11.29 – Second floor corridor ductwork had been insulated.

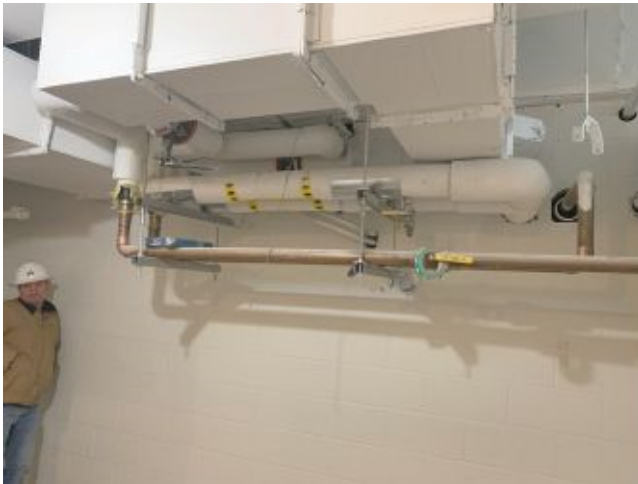
2023.12.13 – Area to be re-worked in #1235B

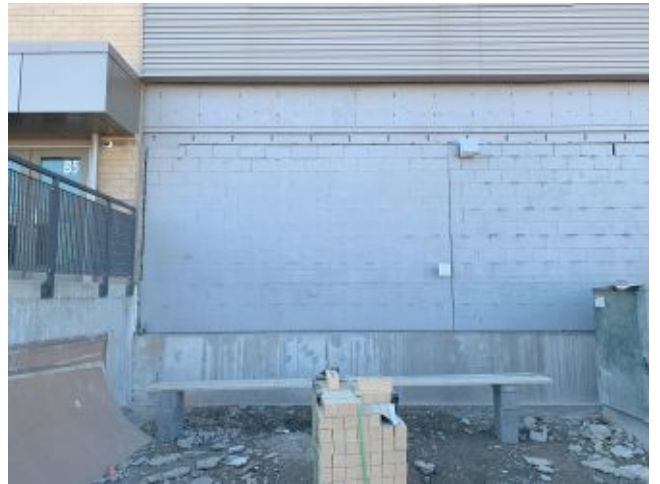
07.01: 2023.12.13 – Spray-applied air/vapor barrier had been applied at the exterior wall of the Green Room.

2023.12.13 – Exterior of Green Room

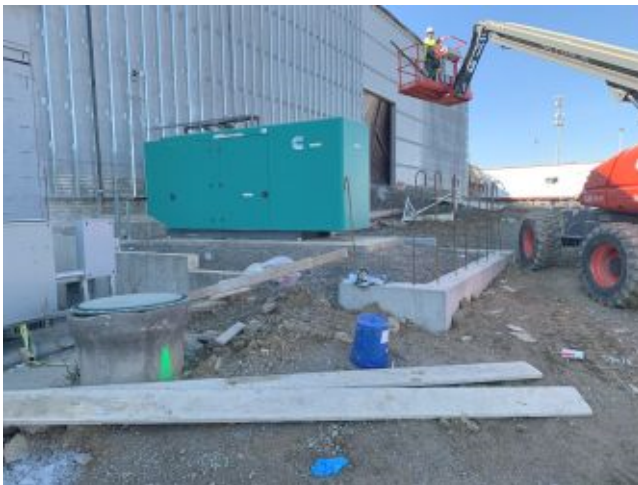
2023.12.13 – Screen wall foundations

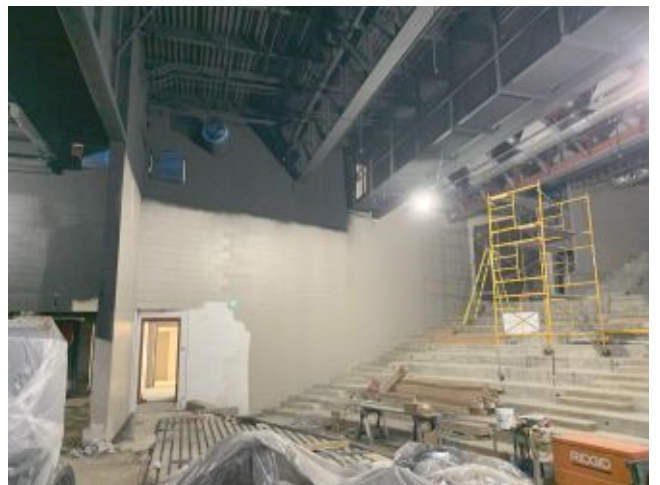
2023.12.13 – South wall of auditorium

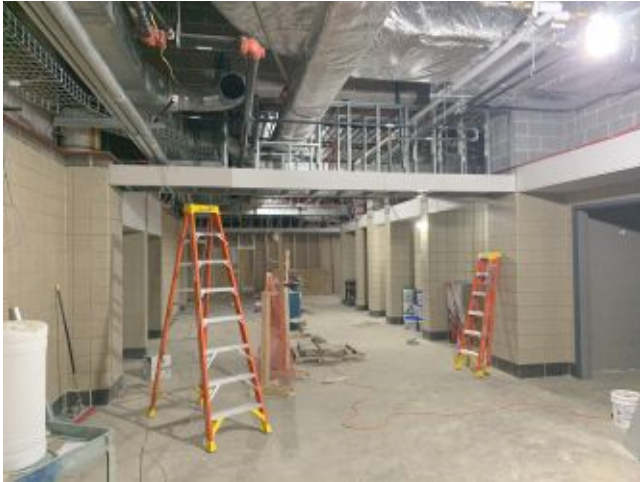
2023.12.13 – Corridor #2000B

09.03: 2023.12.13 – Bulkheads across the second floor corridor had been framed and boarded. Ceilings had been framed at first and second floor restrooms.

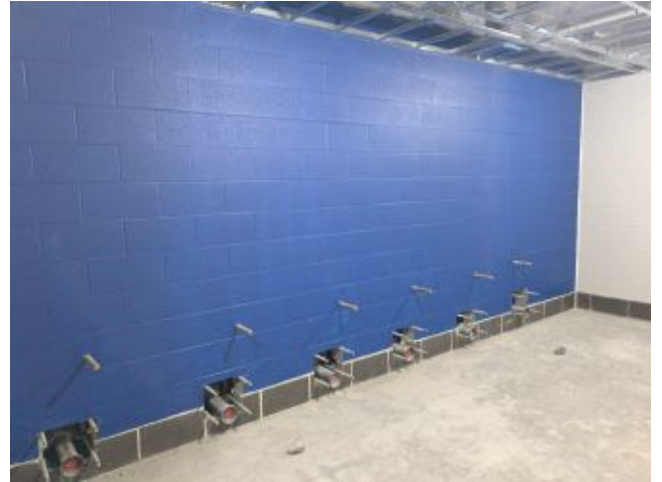
2023.12.13 – Female #2006

20-28.05: 2023.12.13 – A hydronic piping issue in the Green Room area was reviewed as were several conflicts between lights and exhaust fans. The latter two were resolved on-site. The first issue was resolved later in the day after determining additional contract work was yet to be completed. A lighting conflict with hydronic piping was reviewed at Female #2006 was reviewed and resolved.
