PROJECT: 5056-01 Trans District Sup Fac 5056-01      DATE: 12/6/2023

VISIT NAME: Construction Progress Site Visit      REPORT NO: 011

AUTHOR: David Vaught      STATUS: Final

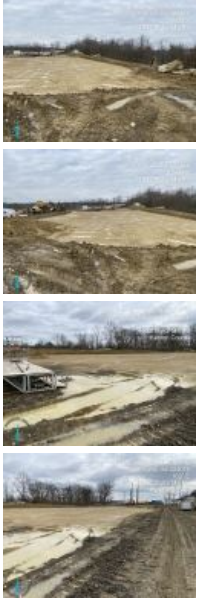
ITEM	REMARKS	DISCUSSION	PHOTO
011-095	Earthwork in progress

SPACE: 005 - SITE - NORTH	SUBJECT: Bus Parking	
	CATEGORY: Earthwork	REFERENCE: 312000

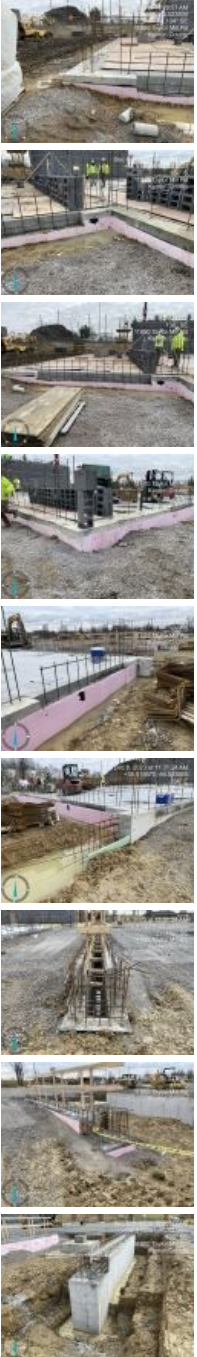
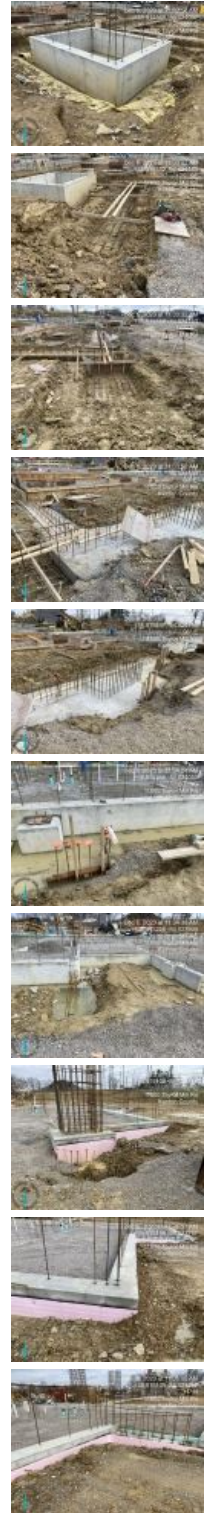
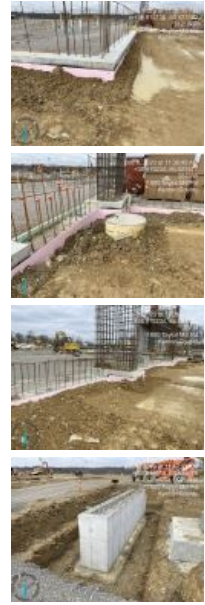
ITEM	REMARKS	DISCUSSION	PHOTO
011-097	Building foundation installation in progress

SPACE:	007 - SITE - EAST	SUBJECT:	Building Foundations
CATEGORY:	Cast in Place Concrete	REFERENCE:	033000

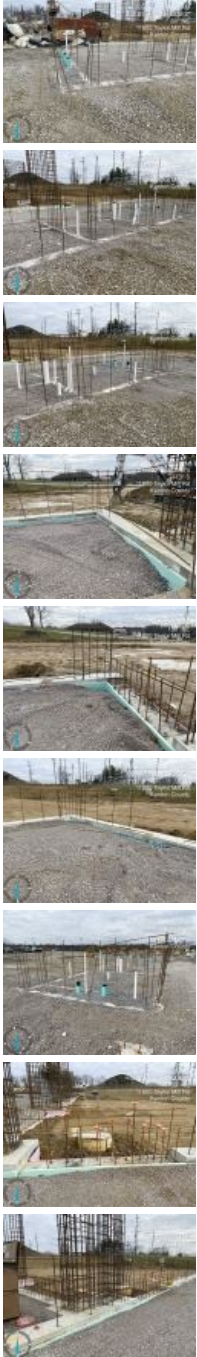
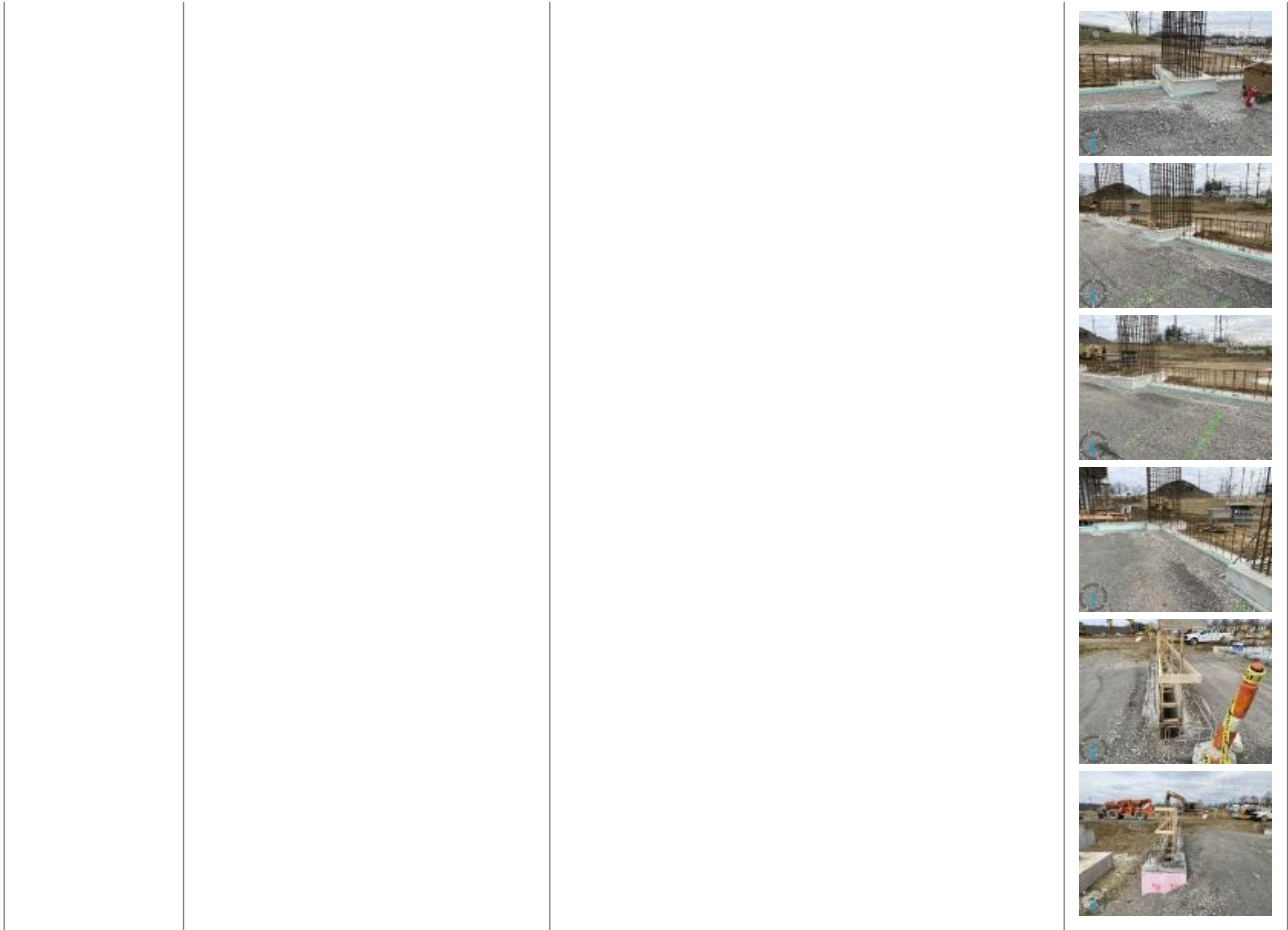
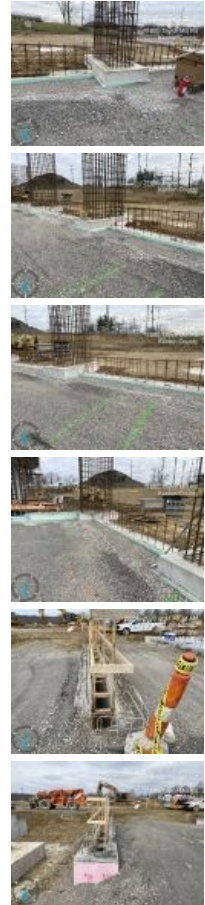
ITEM	REMARKS	DISCUSSION	PHOTO
011-098	Building stem wall installation in progress

SPACE:	007 - SITE - EAST	SUBJECT:	Stem Walls
CATEGORY:	Cast in Place Concrete	REFERENCE:	033000

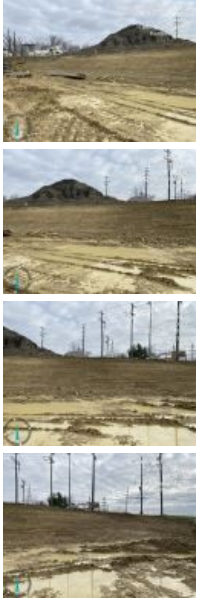
ITEM	REMARKS	DISCUSSION	PHOTO				
011-101	Earthwork installation in progress

SPACE:	005 - SITE - NORTH	SUBJECT:	Grading Fill Slope
				CATEGORY:	Earthwork	REFERENCE:	312000

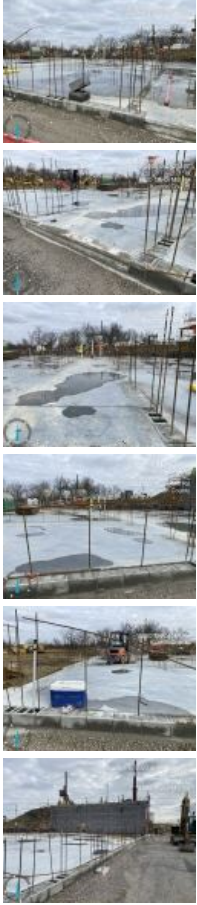
ITEM	REMARKS	DISCUSSION	PHOTO
011-103	Concrete floor slab installation in progress

SPACE:	007 - SITE - EAST	SUBJECT: Slab
	CATEGORY:	Cast in Place Concrete	REFERENCE: 033000

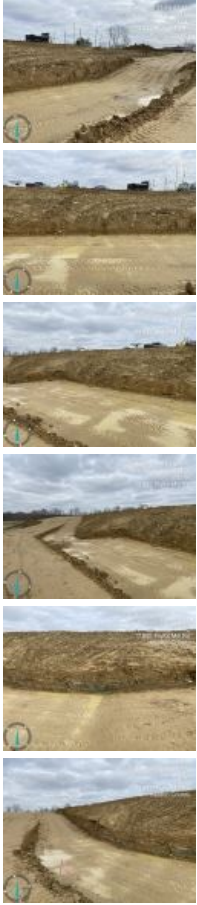
ITEM	REMARKS	DISCUSSION	PHOTO
011-105	Earthwork installation at retaining wall system in progress

SPACE:	006 - SITE - SOUTH	SUBJECT:	Retaining Wall
CATEGORY:	Earthwork	REFERENCE:	312000
