## FIELD OBSERVATION REPORT

Central Hardin High School, Cecilia, KY

2019111 - CA8

Report No: 52

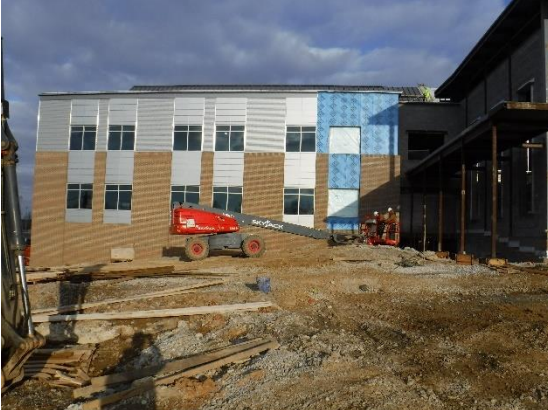
Item No.	Location	Description/Correction	Image	Action
1	Area B from the South	Aluminum composite material had been installed above and below the windows.

Coordinate ACM work with other materials to provide a weather tight enclosure of the building.
2	Area B - LMC	Concrete block back up walls were laid between the steel framing.

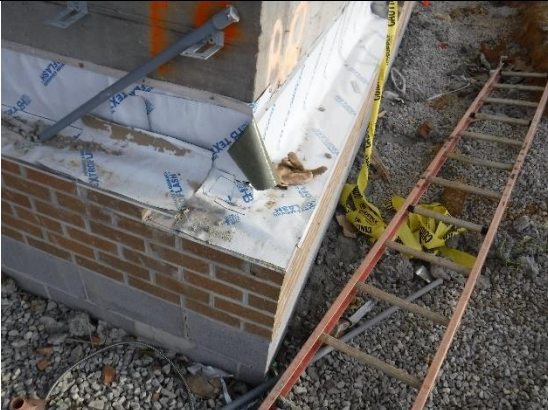
Complete roofing, brick veneer, sheet metal, and curtainwall to enclose the LMC.
3	Area B – Library Media Center Exterior Wall	The through wall flashing at the base of the walls was installed.

Cut the front edge of the flashing back 3/8" to prevent asphalt runs down onto brick.

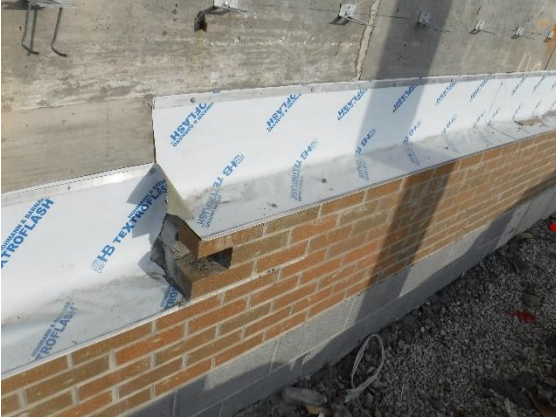
Item No.	Location	Description/Correction	Image	Action
4	Area B – LMC Through Wall Flashing	The through wall flashing steps with the grade.

Lap the flashing to provide continuous protection.
5	Area B – LMC – Exterior Wall	As work above is complete the brick veneer will be extended up to the roof.

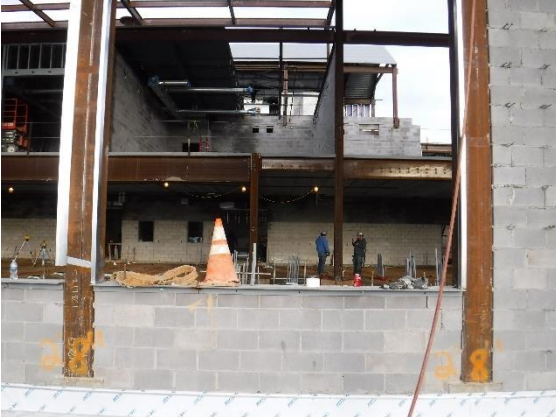
Lay brick with uniform joints and random colors of brick.
6	Areas B – LMC Looking at the Second Floor Structure	Steel that is not prime painted will receive spray fire resistive insulation material.

Protect SFRM from damage from rain and construction activities.

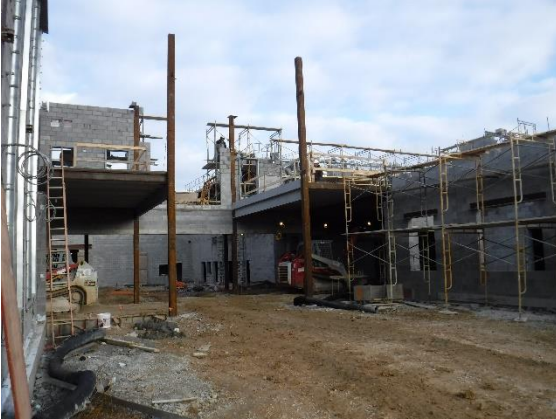
Item No.	Location	Description/Correction	Image	Action
7	Area E Cafeteria	Steel columns had been erected for the roof structure over the area.

Use cold weather procedures for steel erected in cold weather conditions.
8	Area E Cafeteria	The cafeteria is connected to the main gym lobby in Phase 2.

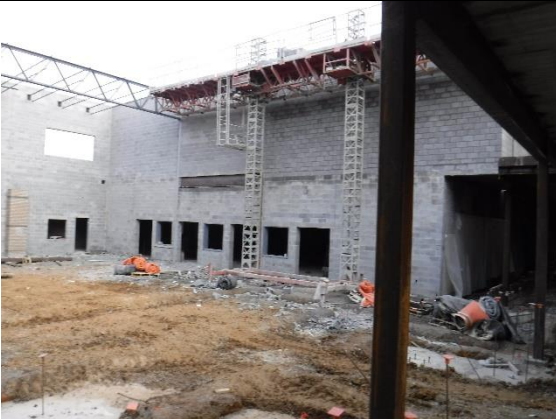
Coordinate access for lifts through the gym lobby into the cafeteria with school staff.
9	Area E	Concrete block above the kitchen was being laid for the art classrooms over the kitchen.

Take special care with the finish of the block wall for open area of the cafeteria.

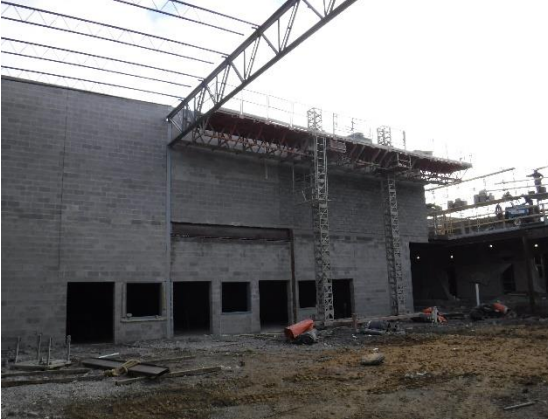
Item No.	Location	Description/Correction	Image	Action
10	Area E Cafeteria	The steel framing for the roof structure ties into the concrete block walls.

Plan for thermal changes at connections to the walls.
11	Area E Connecting Corridor to Gym Lobby	The new double door openings will be the access point for lifts to be used in the cafeteria.

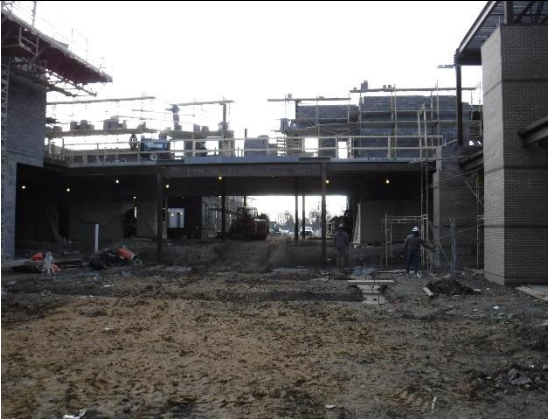
Coordinate lift access through the openings to avoid damage to the frames.
12	Area E Looking to Area F	Concrete block was being laid on the second floor.

Take special care with the block finish for walls exposed to the new main entry.

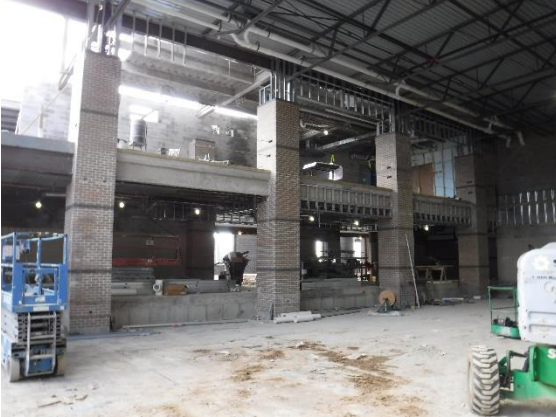
Item No.	Location	Description/Correction	Image	Action
13	Cafeteria/ Multi-purpose Area	The area was becoming enclosed and systems were being installed.

Protect brick piers from damage as other work is installed.
14	First Floor Main Corridor	Wallboard was being hung over light gauge metal framing for the soffits.

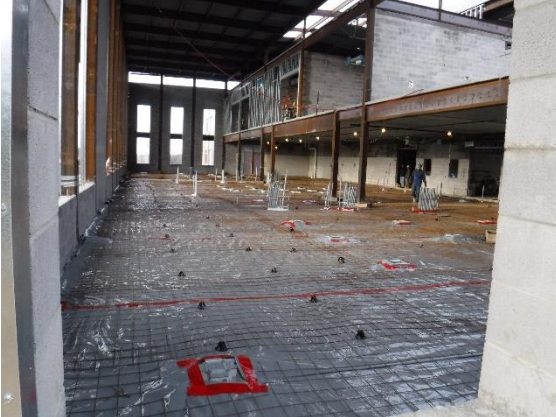
Stabilize environmental conditions before finishing wallboard.
15	LMC Interior	The under-slab vapor retarder was placed and slab temperature reinforcement was located on chairs.

Make sure that all in-slab devices such as outlets are protected from concrete filling boxes and conduits.

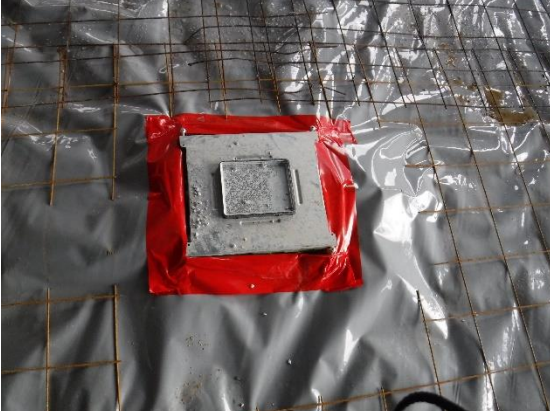
Item No.	Location	Description/Correction	Image	Action
16	LMC Floor Box	The vapor retarder abuts walls, penetrations, and devices.

Tape all edges and penetrations. Make sure that the tape provides a seal to the penetrations. Confirm this in the SPIN reports.
17	First Floor Main Corridor in Area B	Wallboard was being hung on soffits. Temperature control for the area was being provided by propane heaters.

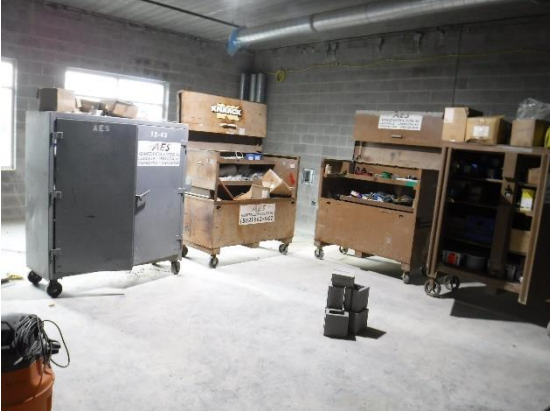
Maintain specified temperatures for wallboard work.
18	Area B	A classroom was being used for tool cabinets.

Protect slabs scheduled to have a polished concrete finish from damage from stored tools and materials.

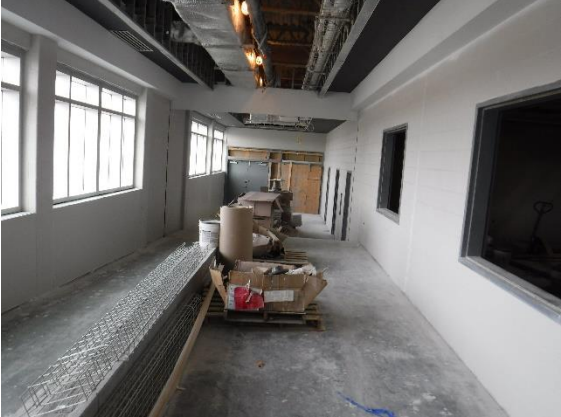
Item No.	Location	Description/Correction	Image	Action
19	Corridor to the Gym Area	The walls were painted the first coat.

Correct defects in block walls before applying block filler and additional coats of paint.
20	Typical Classroom	Rooms were being used to store materials.

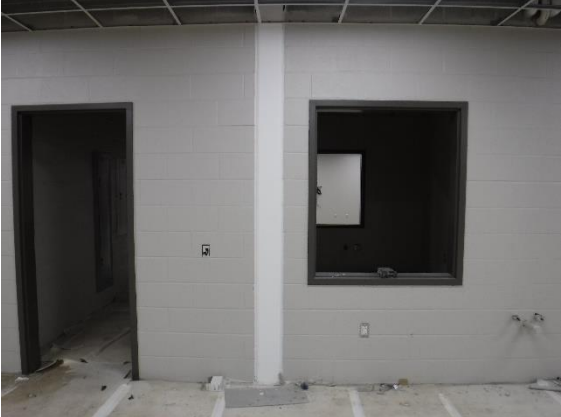
Protect slabs scheduled to have a polished concrete finish from damage for stored tools and materials.
21	Typical Exposed Steel Column with Intumescent Coating.	The coatings have some cracks.

Repair cracks with materials approved by the coating installer. Paint columns to match the wall color.

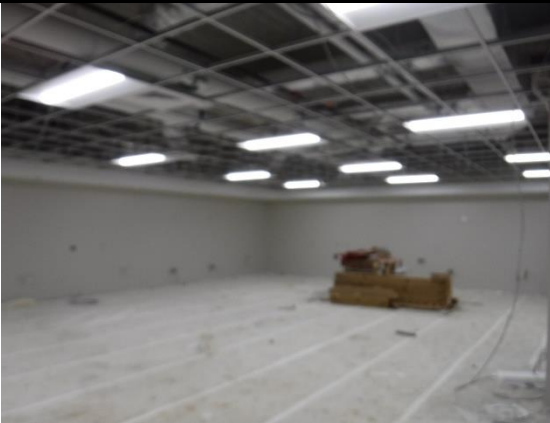
Item No.	Location	Description/Correction	Image	Action
22	Area B Gym Label	Ceiling grids and light fixtures are in place.

Conduct an above ceiling inspection.
23	Area B Corridor at Student Toilets	The area was clean. The area was enclosed to allow for temporary heat.

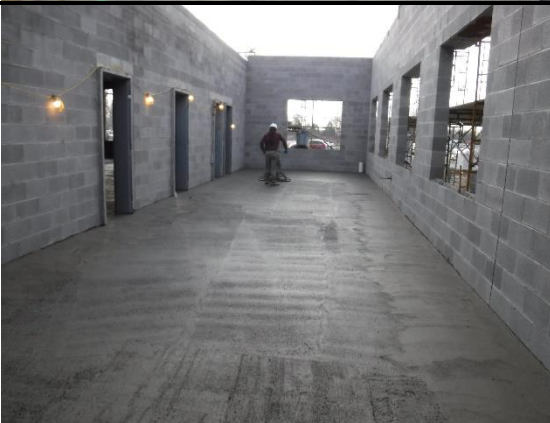
Maintain enclosures and clean surfaces as finishes are installed.
24	Area F First Floor Offices	The concrete slab was being finished.

Protect slabs during curing per cold weather requirements.

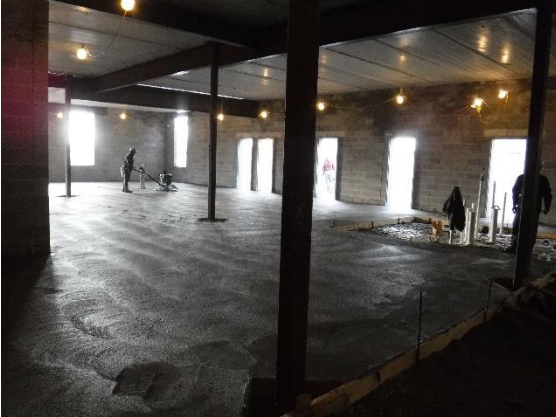
Item No.	Location	Description/Correction	Image	Action
25	Area F First Floor	The concrete slab was being finished.

Protect slabs during curing per cold weather requirements.
26	Second Floor Main Corridor in Area F and E	Concrete block was being laid.

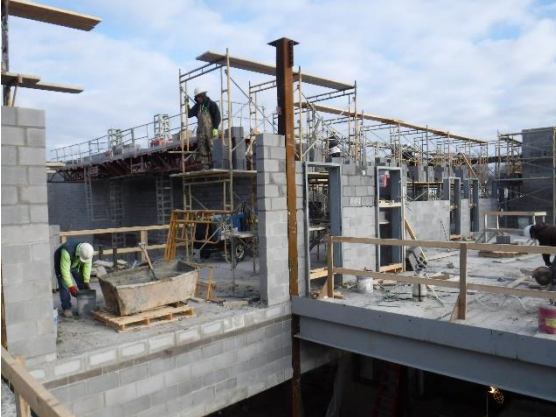
Confirm location of corridor on As-Builts for coordination with Phase 2.
27	Area E Second Floor Classroom	Hollow metal frames were being incorporated into walls.

Keep mortar off the heads of the frames. Remove any mortar on frames without damaging the finish.

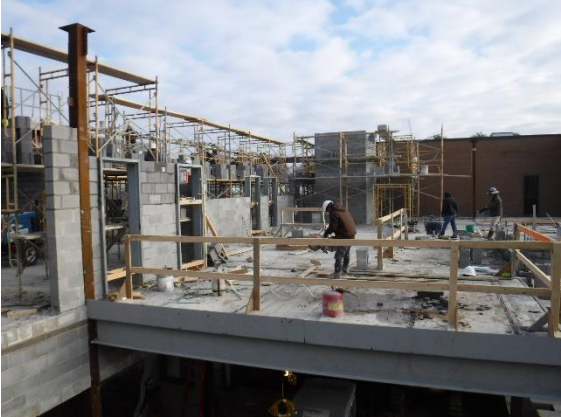
Item No.	Location	Description/ Correction	Image	Action
28	Area F Resource Room	Wall adjoining the entry lobby will be glass.

Coordinate glass wall with revised outlet drawing.
29	Area E Second Floor	Concrete block walls were closing in the interior spaces.

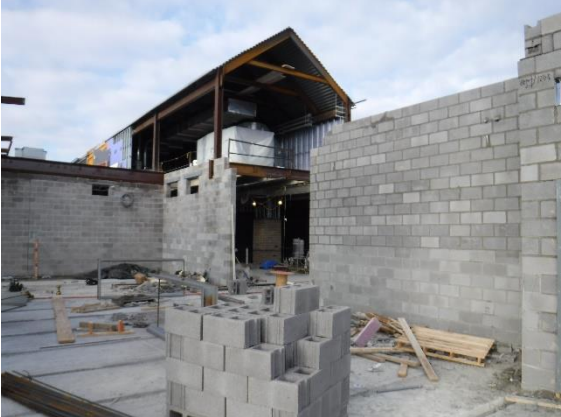
Continue to have uniform joint patterns. Clean mortar off the block.
30	Classroom in Area B with Platform Level above	The platform was being extended to the east end of Area B.

Continue to protect HVAC and electrical equipment exposed to the weather.

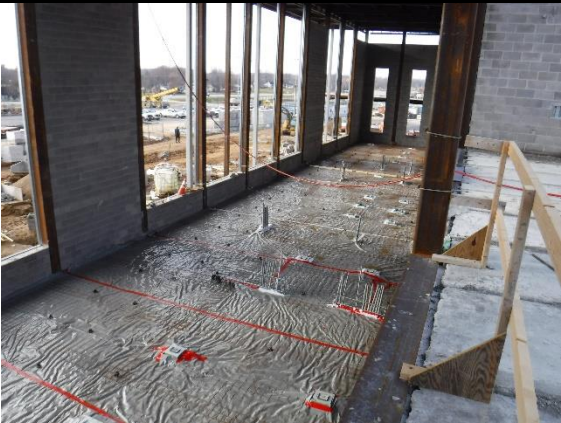
Item No.	Location	Description/ Correction	Image	Action
31	Looking down on LMC from Classroom on the Second Floor	The LMC slab was being prepared for concrete pours.

Follow comments in the SPIN reports.
32	Area B Second Floor Main Corridor looking at Cafeteria / Multi-purpose Area	Most of the area in the Multipurpose Area is under roof.

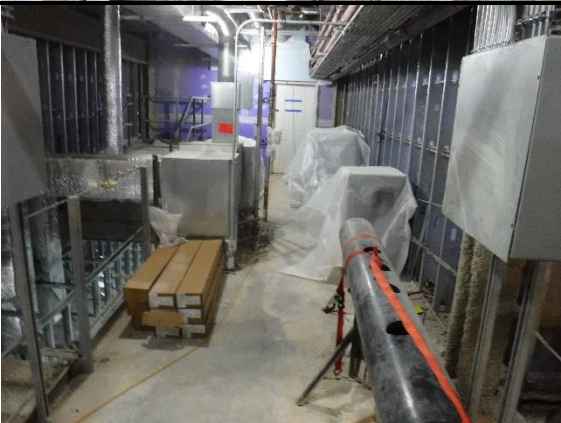
Complete structure and tie in roof areas as soon as possible.
33	Area B Platform.	The area had been cleaned and the equipment protected with plastic.

Continue to take precautions with equipment as the platform is extended to the east.

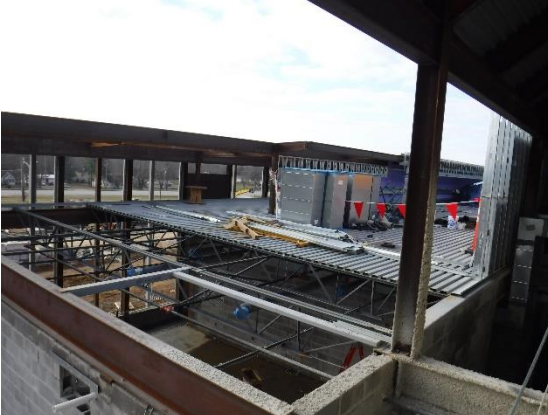
Item No.	Location	Description/Correction	Image	Action
34	Second Floor Area B looking at the LMC Roof Structure.	Roof deck was partially in place.

Complete roof deck and install roof system as soon as possible.
35	Area A Gym Level Student Toilet	Wall tile had been cleaned but some hazing persisted. Some floor tile joints were uneven in color.

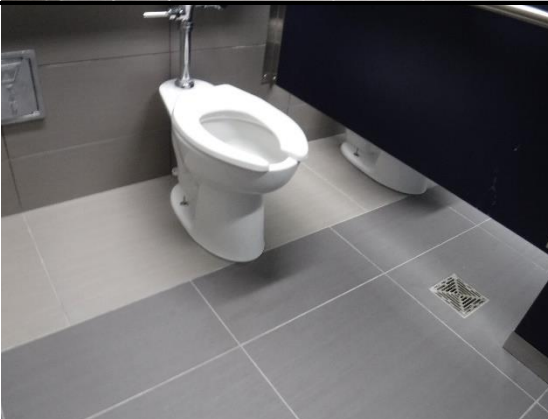
Clean wall tile and replace grout in floor tile joints.
36	Area A Gym Level Student Toilet	The toilet fixtures were not caulked to floors and walls. Some water closets were not installed with proper clearances to meet ADA requirements.

Caulk fixtures to floors and walls after dimensional clearances have been confirmed.

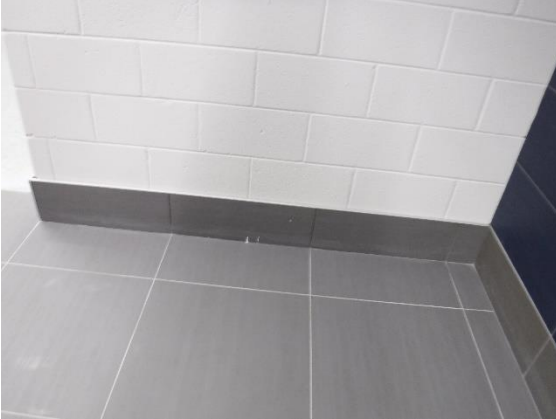
Item No.	Location	Description/ Correction	Image	Action
37	Area A Gym Level Student Toilet	Tile base was installed.

Clean base with the walls.
38	Area A Gym Lobby	The dark blue area was refinished to match the approved sample.

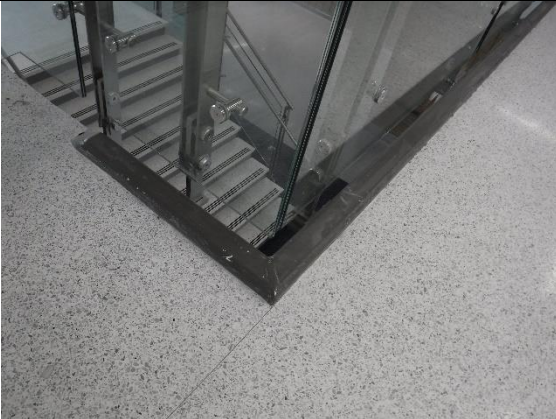
Protect finishes until turned over to the owner.
39	Area A Gym Lobby Stair	Paint on the steel stair was damaged by the grinding process for the terrazzo.

Repaint steel stair.

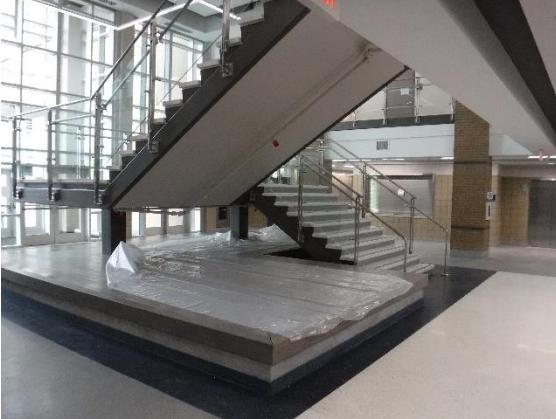
Item No.	Location	Description/Correction	Image	Action
40	Area A Gym Lobby Stair	The concealed heads for the added soffit were installed.

Complete the framing and the wallboard soffit to conceal the sprinkler piping.
41	Area C Main Gym	The wall protection pads for the columns were not installed.

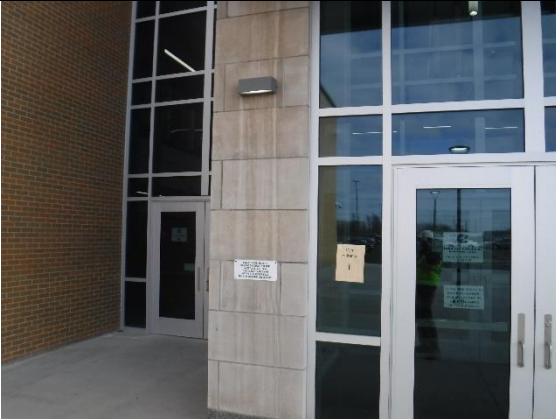
This is a student safety issue. Install pads as soon as possible.
42	Area A Entry	The limestone is still streaked.

Continue remediation of staining until the limestone is clean.

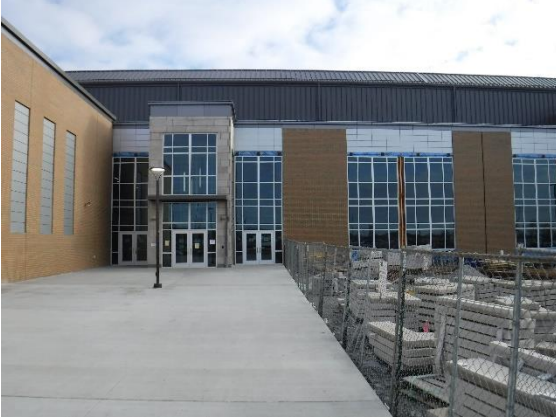
Item No.	Location	Description/Correction	Image	Action
43	Gym Lobby Entrance	The area to the south of the walk is construction area.

Maintain chain link fence to keep students out of the construction area.
44	Area A and B Exterior	The west elevation is closest to being complete.

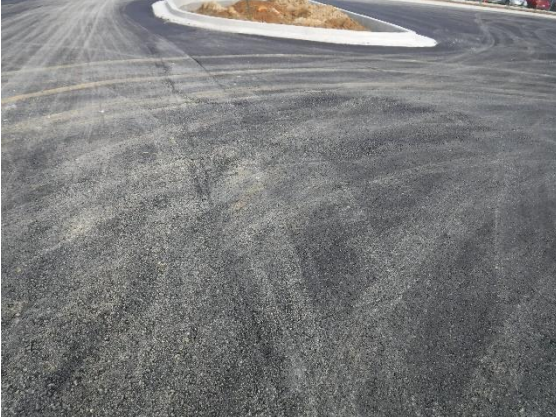
As the rest of the building is being completed, complete the missing items on the west elevation.
45	Parking Lot by Temporary Toilets	There is a soft spot in the pavement.

Remediate the underlying soils and reinstall pavement.
