PROJECT: 5056-01 Trans District Sup Fac 5056-01 DATE: 1/17/2024

VISIT NAME: Construction Progress Site Visit REPORT NO: 014

Site Visit - Construction Observation

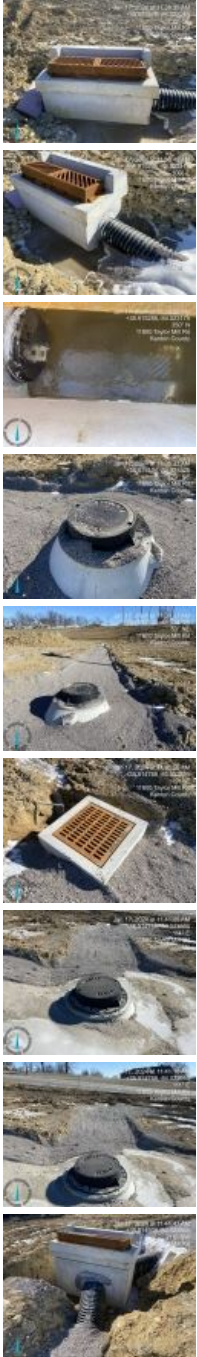
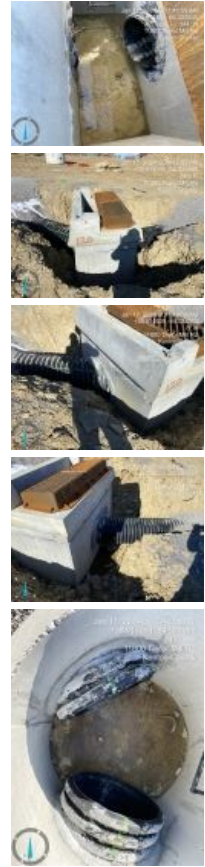
ITEM	REMARKS	DISCUSSION	PHOTO
014-045	Contractor shall install storm sewer manhole covers on storm sewer manholes.

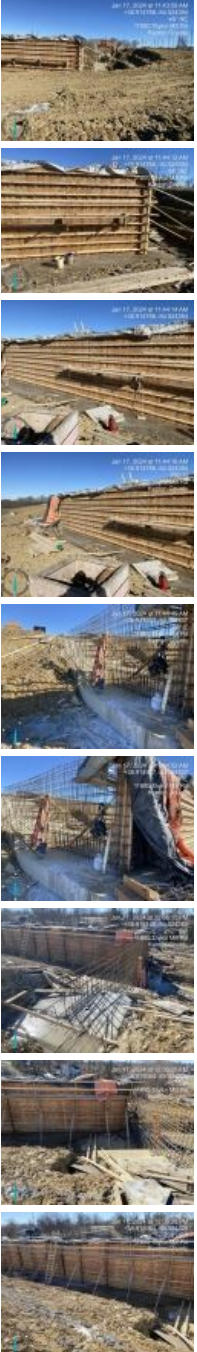
ITEM	REMARKS	DISCUSSION	PHOTO
014-046	Retaining foundation footing and wall installation in progress.

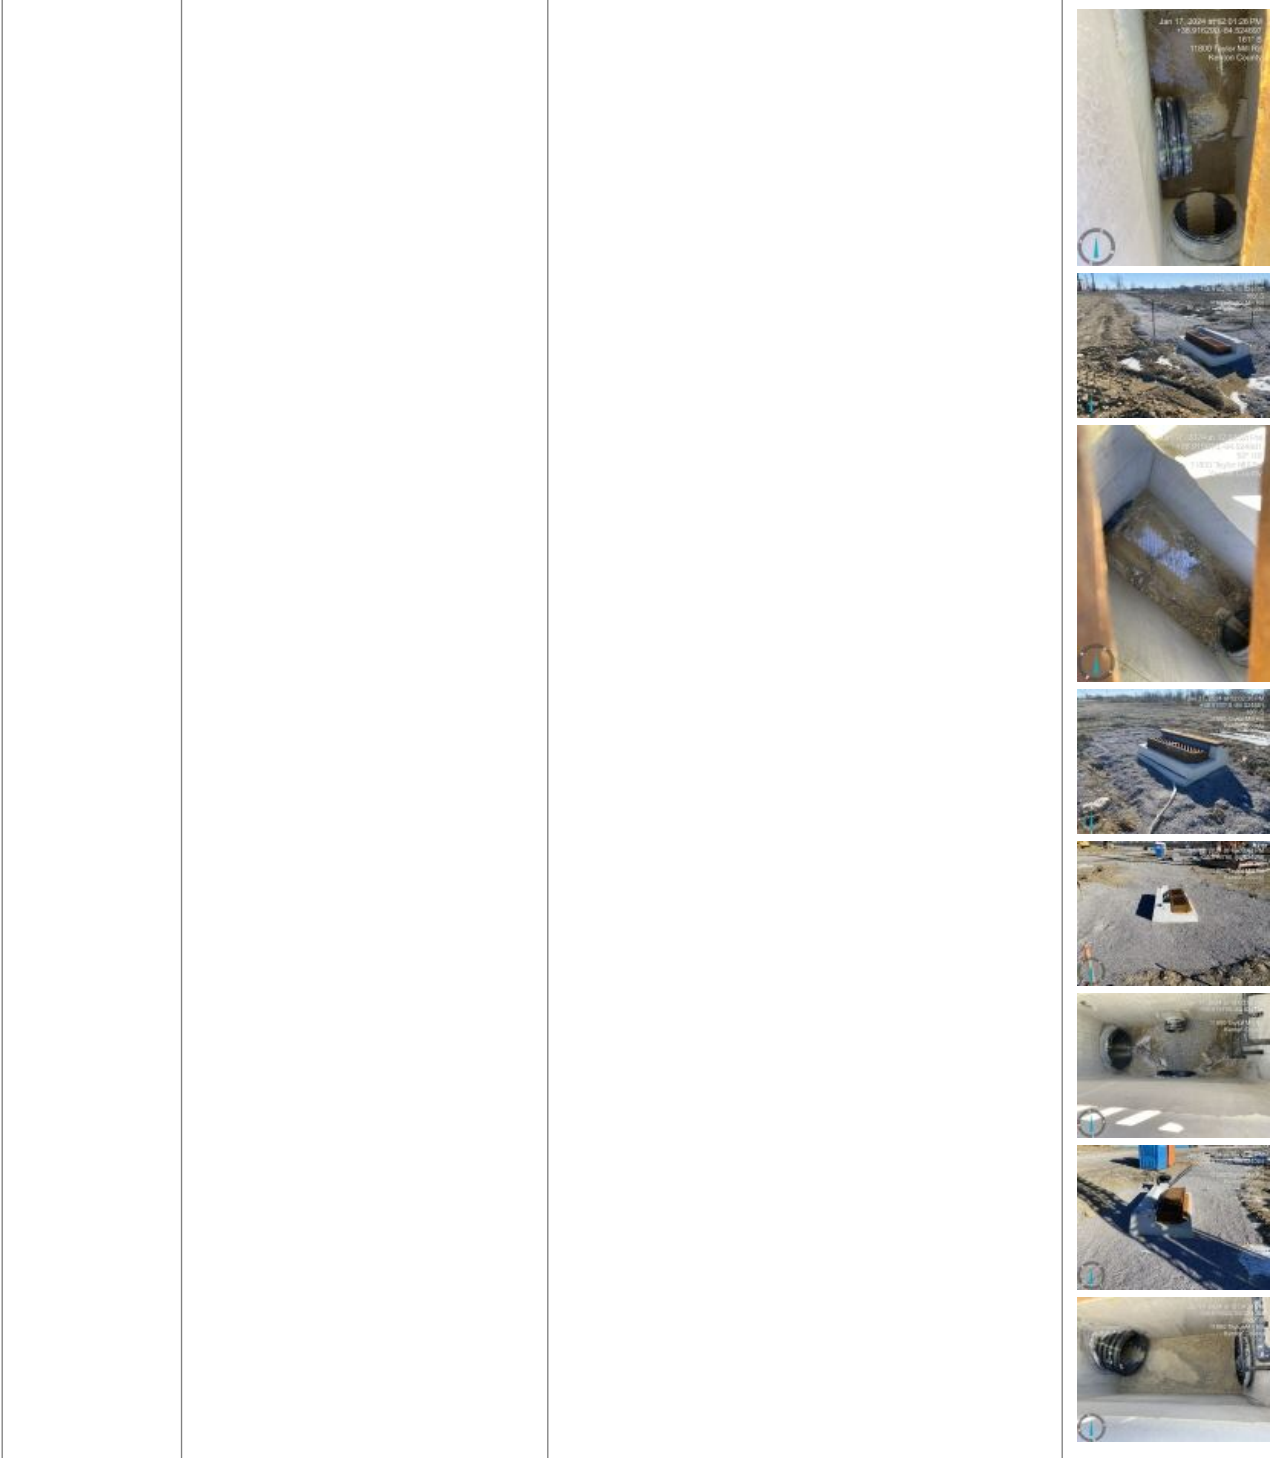
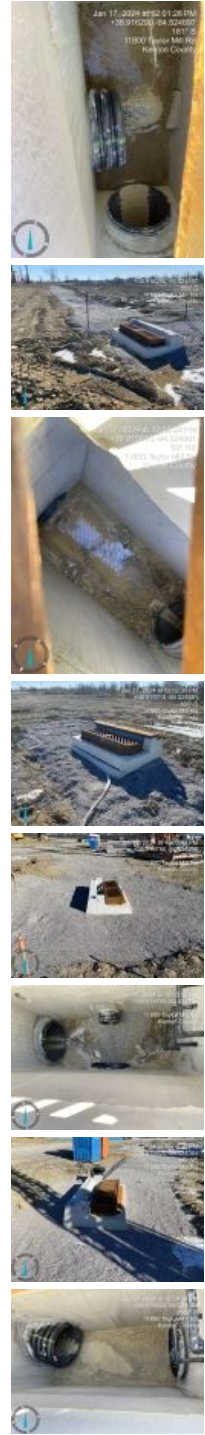
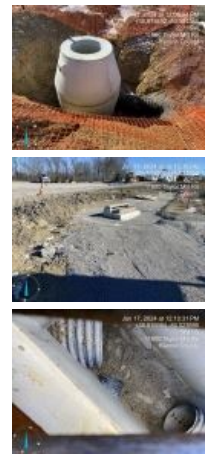
ITEM	REMARKS	DISCUSSION	PHOTO
014-050	Contractor shall install storm sewer manhole covers on storm sewer manholes.

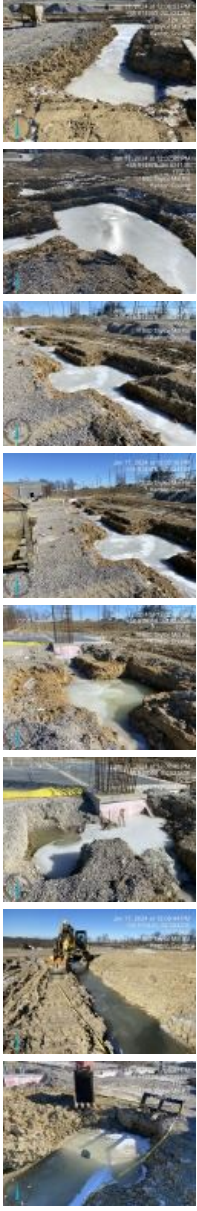
ITEM	REMARKS	DISCUSSION	PHOTO
014-054	Footing excavation.

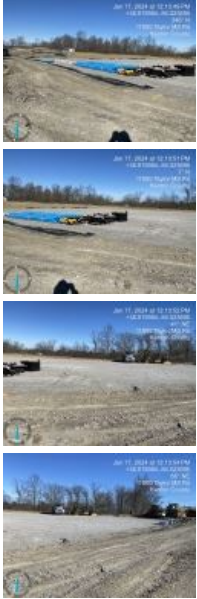
ITEM	REMARKS	DISCUSSION	PHOTO
014-055	Stored materials.
