## FIELD OBSERVATION REPORT

Central Hardin High School, Cecilia, KY

2019111 - CA8

Date: 2/15/2024

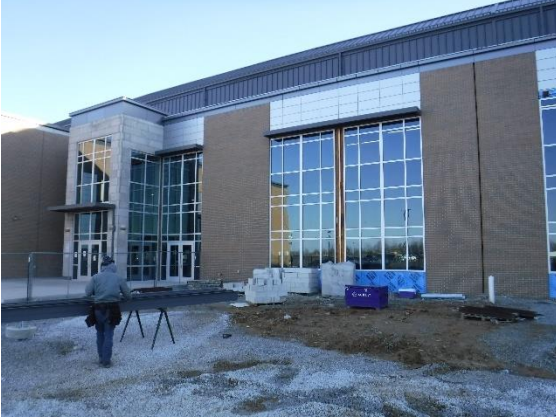
Item No.	Location	Description/Correction	Image	Action
4	Area B – Connector	Awnings had been placed at the tops of the curtain wall along the connector. With these in place the elevations are almost complete.

Install sealants and metal trim to complete the exterior. Test the curtainwall in this area as instructed by JRA.
5	Area A and B	Awnings were being installed at the tops of the curainwalls.

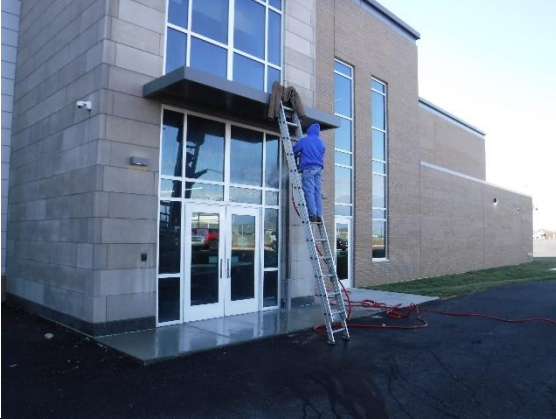
Install sheet metal work so the elevation is completely weather sealed.
6	Areas A – North Doors	A Lake Cumberland Glass crew was water testing the curtainwall for leaks after water entered the vestibule during the recent storm.

The LCG crew reported that the leak had been fixed. They also tightened seals holding the glass in place.

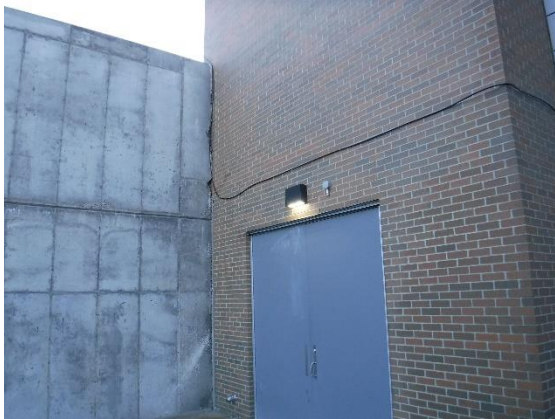
Item No.	Location	Description/Correction	Image	Action
7	Area A Retaining Wall	Thus far no corrections have been made on the concrete including gaps in the concrete at the brick, a cold joint in the wall and removal of fins.

When crews are available, make corrections to the wall.
8	Area A – Gym Lobby Stair Bench	New wood was installed. It looked much better than the original installation. There were a few places where the unstained sides and ends of the boards were visible.

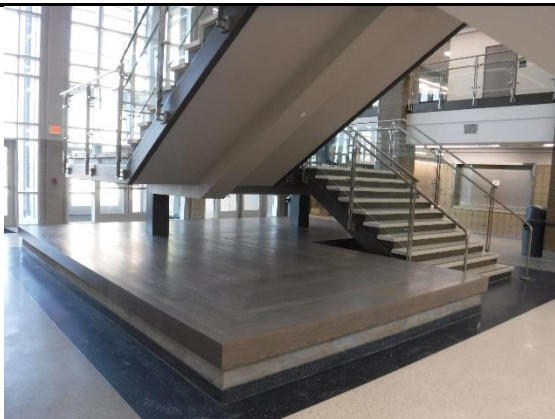
Stain unstained ends and edges of boards.
9	Area A – Gym Lobby Stair Bench	Overall the bench joints were tighter than the first attempt. The enclosures for the sprinkler piping were complete and painted.

Continue to monitor wood bench for warpage and distortion. Be prepared to make corrections as needed.

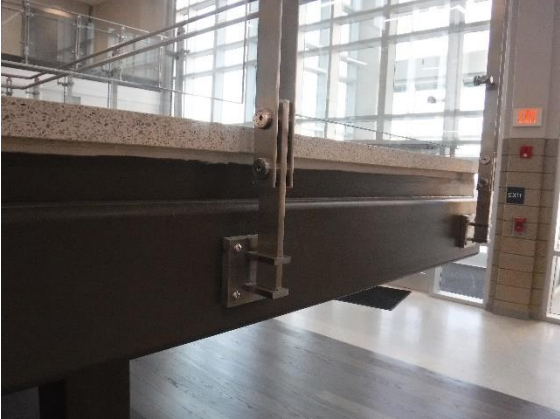
Item No.	Location	Description/Correction	Image	Action
10	Area A – Gym Lobby Stair	The paint at the junction with the terrazzo is not even.

Correct paint at junctures with the terrazzo creating straight lines.
11	Area A – Gym Lobby Stair Bench	The stair and terrazzo flooring work has left cementitious residue on many of the surrounding surfaces.

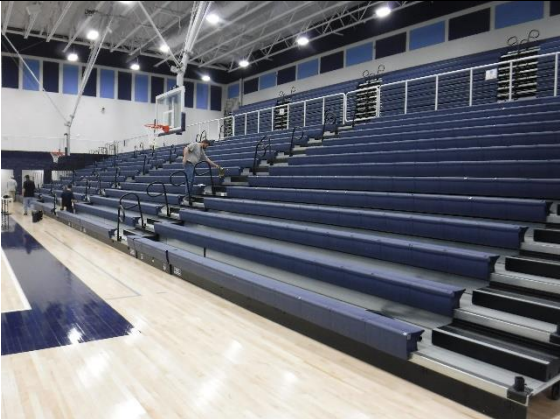
Clean all residue off the stair parts, brick, accessories and the terrazzo itself.
12	Area C Lower Bleachers	The intermediate risers on the lower level were too high to provide a uniform height in relation to the platforms for the benches.

All intermediate risers on the lower level were replaced.

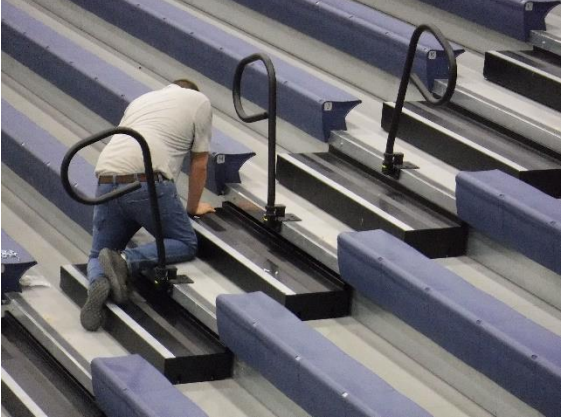
Item No.	Location	Description/Correction	Image	Action
13	Area C Lower Bleachers	The intermediate risers were being fastened into place.

Verify that all new risers are firmly attached.
14	Area A Toilets	There is still cementitious residue from the tile installation on the floor and wall tile. The joints were recently reworked. Cliff reported that John Stith did not approve the repairs.

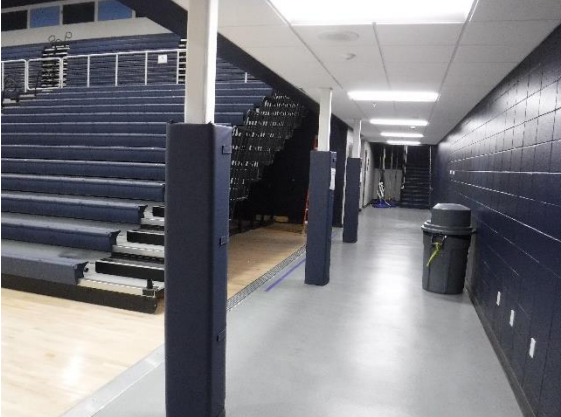
Clean all residue off the tile. Make repairs to the floor tile grout joints so they are uniform in color.
15	Area C – Gym Mezzanine Support Columns	Pads had been installed on the columns as specified.

Verify that repairs to fire proofing are complete especially above the pads.

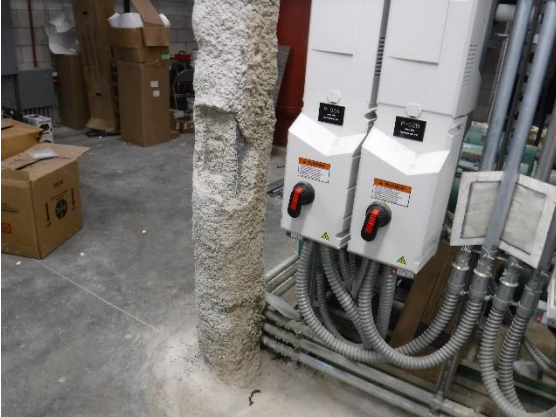
Item No.	Location	Description/Correction	Image	Action
16	Area A – Mechanical Room	Fireproofing materials had not been repled to structural steel where they were removed.

Inspect all fire proofing and restore to the specified thicknesses.
17	Area B Classroom Chase Wall	Wallboard had been hung on the chase wall extension.

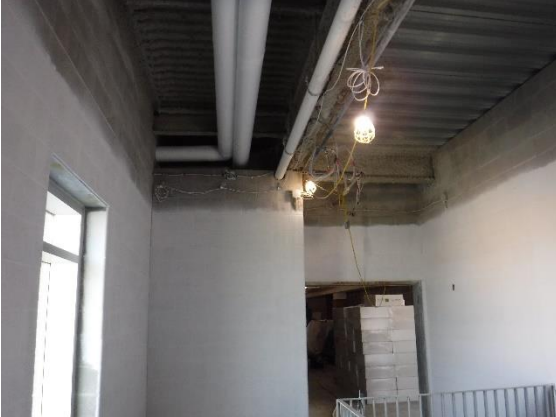
Refer to the ASI concerning modifications to the chase wall to ensure that the fire ratings have been achieved.
18	Area B Stair B Second Floor	The concrete block chase wall was extended near the floor deck above.

Refer to the ASI concerning modifications to the chase wall to ensure that the fire ratings have been achieved including sealing the chase to the deck.

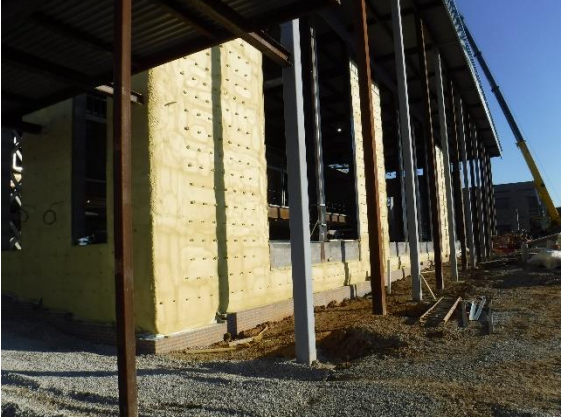
Item No.	Location	Description/Correction	Image	Action
19	Area B LMC Exterior	Spray foam insulation had been applied to the concrete block.

Install brick and metal panels as soon as possible to protect the insulation.
20	Area F South Exterior Wall	Concrete block had been laid to the top of the parapet at roof level.

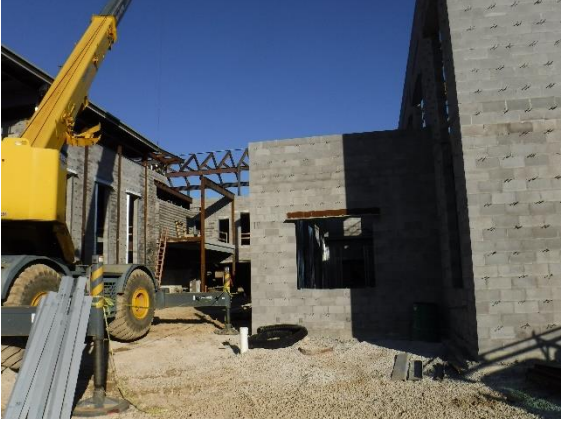
Install the roofing system over the area as soon as possible to dry it in.
21	Area F – Main Entrance	With all the materials including concrete and steel structural elements still needing to be placed in the building in this area, it will be the last area to be completed.

Install exterior finishes as soon as possible to enclose the building.

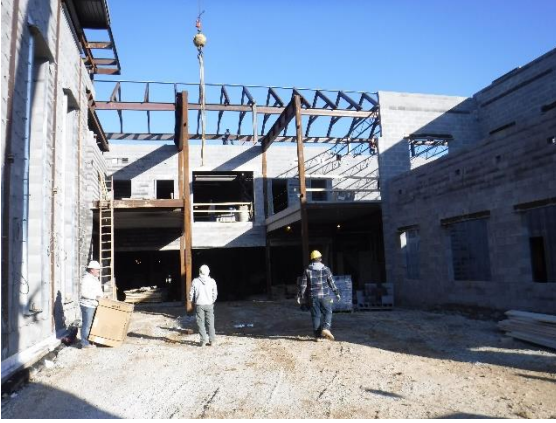
Item No.	Location	Description/Correction	Image	Action
22	Area F Main Entrance	The steel structure for the platform over Area F was in place.

Cover the framing with exterior finish materials to prevent water from flooding the First and Second Floors. Pour the platform slabs as soon as possible.
23	Area F First Floor Admin Area	Metal studs had been installed for the wallboard walls in the admin area.

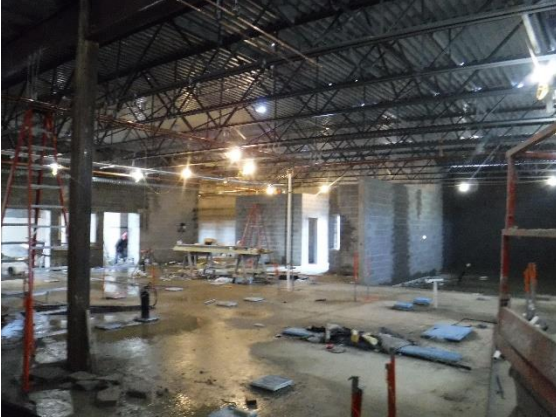
Install steel studs with the specified slip track detail at the deck.
24	Area E Kitchen	Roof deck was over the area. Rough ins were being installed.

Due to the length of time for rough ins and equipment installations, concentrate efforts on this area.

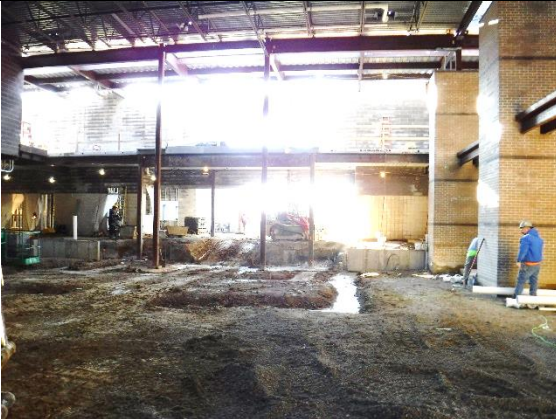
Item No.	Location	Description/Correction	Image	Action
25	Area E Commons	The social stair was being laid out. This is a large space with many finishes and details.

Pour the concrete slab as soon as possible with this being the last of the concrete pours for the project.
26	Area E Social Stair	The floor changes height at the social stair. This is also the main path to get materials into the Commons area.

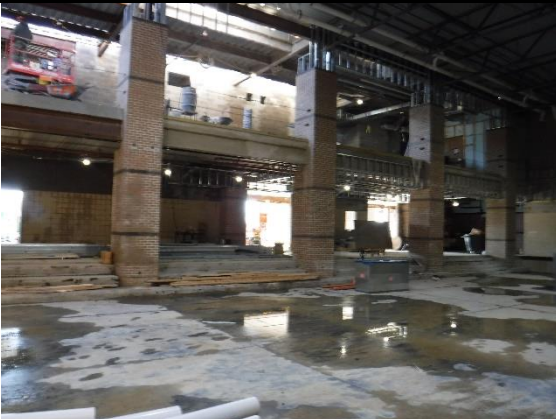
Plan for the flow of materials as the social stair is being constructed.
27	Area E Multipurpose Area	The bulk of the structure is in place in this area with the finishes to be installed.

Complete the roof system and the enclosure of the building in this area, so finishes can be installed.

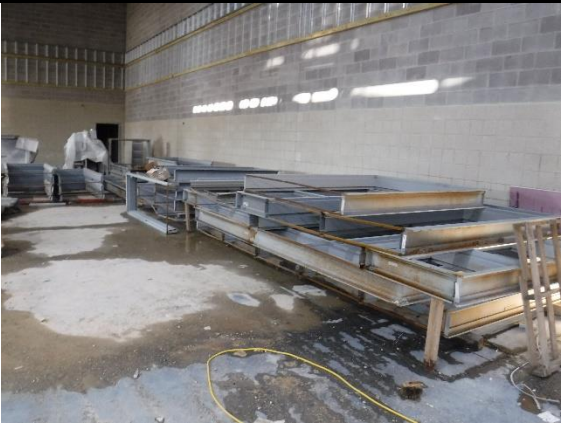
Item No.	Location	Description/Correction	Image	Action
28	Area E Multipurpose Area	Hollow metal door frames had been moved from the parking lot into the more or less dry area.

Repair frames that were damaged in shipping and handling before they are installed in walls.
29	Area F Second Floor And Platform Above	The steel framing for the platform and the connecting roof structure was being completed.

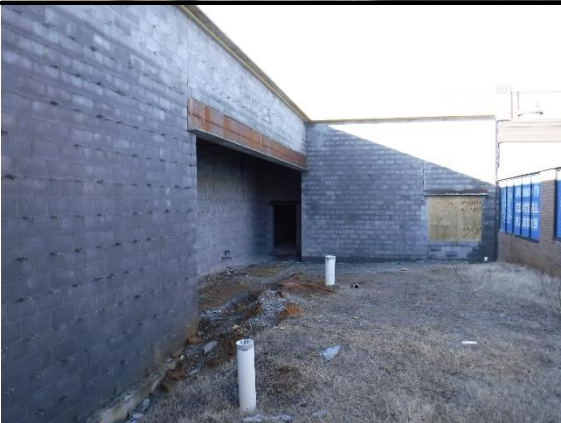
Roof the area as soon as possible to allow for work below.
30	Area E Loading Dock	The loading dock at the kitchen will be completed in Phase 2. The grade will be cut down so dock height can be achieved.

Prepare the area for Phase 2 work to take over.

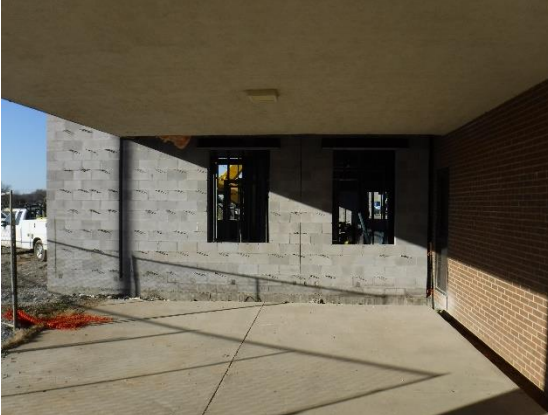
Item No.	Location	Description/Correction	Image	Action
31	Area F at Existing Building South Side	Concrete block had been laid up to the face of where Phase 2 will take over.

Coordinate joints with the existing building that are required in Phase 1.
32	Area F Second Floor Art Classroom	There is a steel pour stop along the edge of this slab that will be in the center of the room after the Phase 2 work is complete.

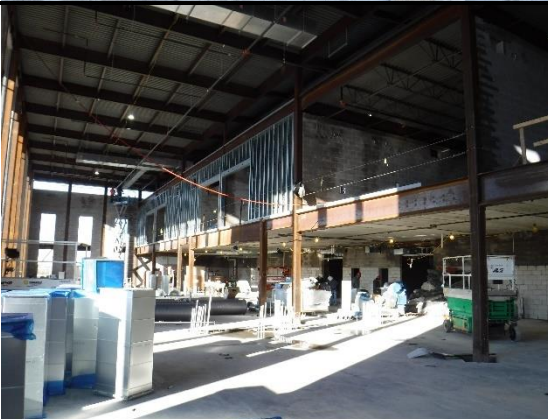
Grind the pour stop to be level with the slab.
33	Area B LMC	The concrete slabs were poured. Steel studs were being installed at the second floor classrooms that look down into the LMC.

Install the roofing system over this area to dry it in for finish work.

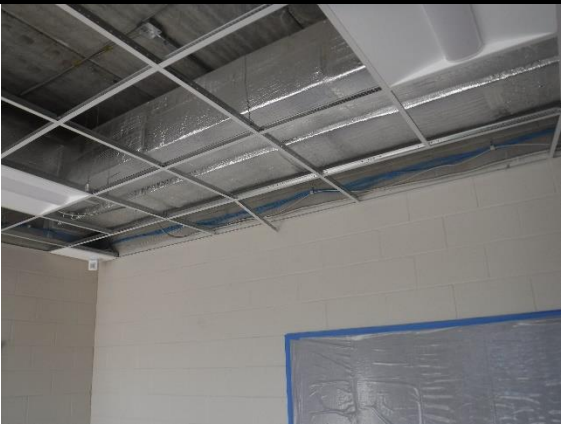
Item No.	Location	Description/Correction	Image	Action
34	Area B Classrooms	Corrections were being made to the hanger wires as noted in the above ceiling punch list. Wire were being hung with 4 tight turns and additional wires were being hung where required.

Continue to follow the specification, the mfgs. Instructions and the guide spec for the installation of the ceiling suspension system.
35	Area B Classrooms	Additional hanger wire are required at the perimeters of ceilings to meet the seismic requirements.

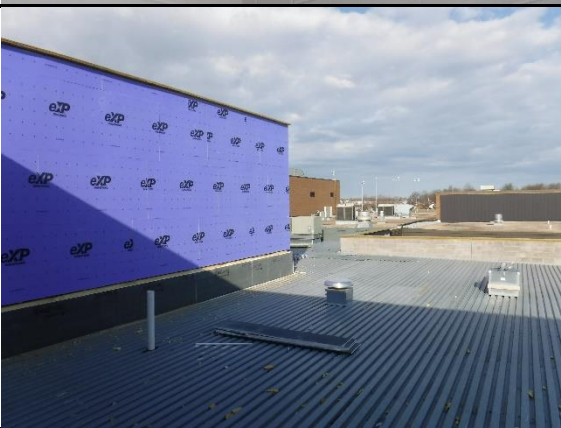
Add wires per the spec.
36	Area E Roof	Roof deck was yet to be covered with the roofing system. Exterior walls were yet to be coved with metal panels.

Complete roofing systems and siding to enclose the building so finishes can be installed.

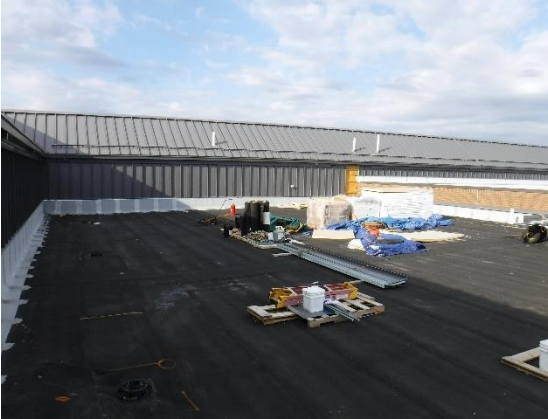
Item No.	Location	Description/Correction	Image	Action
37	Area B – Platform Exterior	Metal siding will be installed around the top of the gym walls above the new roof areas. A great deal of roofing and siding work remains in this area. The gym roof is speced to be restored.

Plan roofing and siding operations for completion by the scheduled date.
38	Area E – North Roof	All of Area E and F including the built-up roofing system and the metal siding and roofing system over the platform are yet to be done.

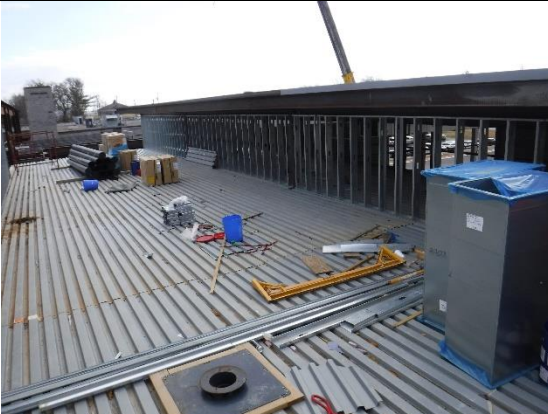
Plan roofing and siding operations for completion by the scheduled date.
39	Area B LMC Roof.	The roof over the LMC is on two levels. The wall system between these levels needs to be completed before the roofing.

Install exterior wall materials and install the roofing system on the low roof.

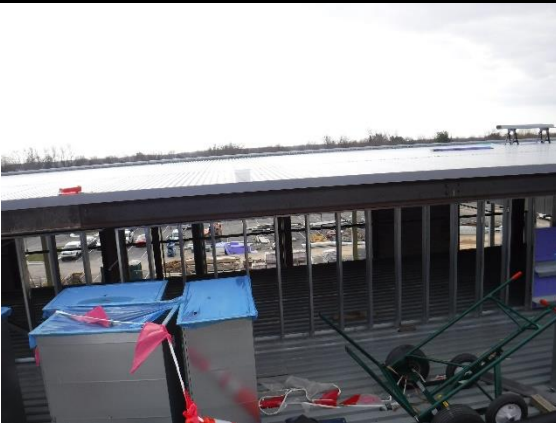
Item No.	Location	Description/Correction	Image	Action
40	Area B LMC Roof	The vapor barrier was installed on the high roof.

Use vapor barriers to dry in interior spaces as soon as possible.
41	Exterior Hollow Metal Doors Typical	Sealed top edge closures are required at all hollow metal doors.

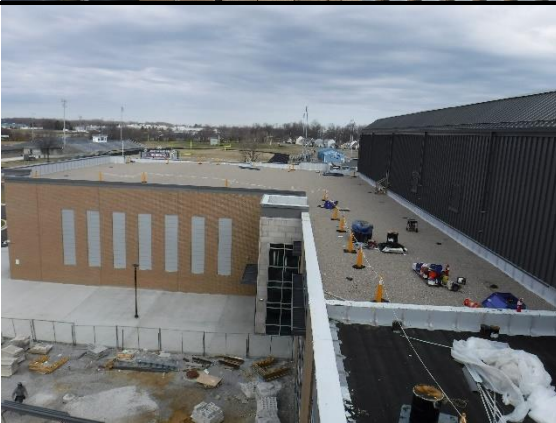
Seal top edges of exterior doors to prevent water penetration.
42	Area B Roof	Roofs installed over parts of Area B still require the gravel coating.

Install gravel coating and complete other components of roofing systems.

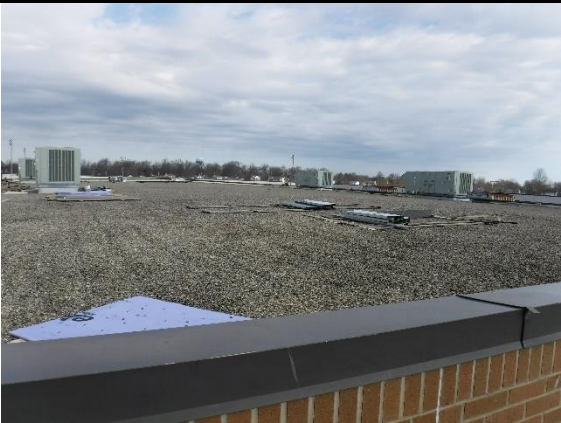
Item No.	Location	Description/Correction	Image	Action
43	Area C Gym Roof	The entire gym roof is scheduled to be restored. The parapet walls will be raised and new copings applied.

Plan roofing operations for the restoration of the gym roof.
44	Area C Gym Roof at Platform	Other than the tie into the restored gym roof, the siding is in place.

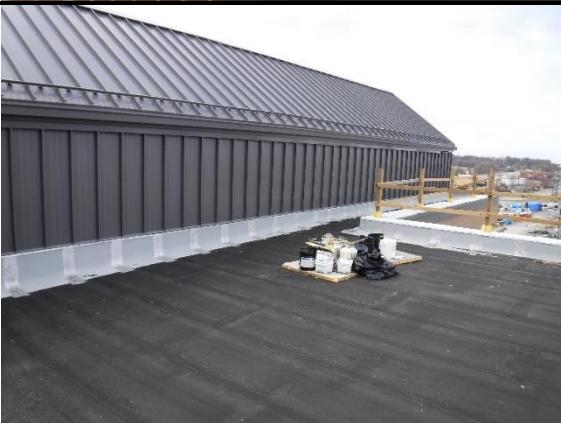
Coordinate tie into the restored gym roofing system.
45	Area B Roof	Sheet metal copings and gravel are yet to be installed on the Area B roofs.

Install gravel coating and complete other components of roofing systems.
