Site Visit - Construction Observation

PROJECT:	5056-01 Trans District Sup Fac 5056-01	DATE:	1/31/2024
VISIT NAME:	Construction Progress Site Visit	REPORT NO:	015
AUTHOR:	David Vaught	STATUS:	Final

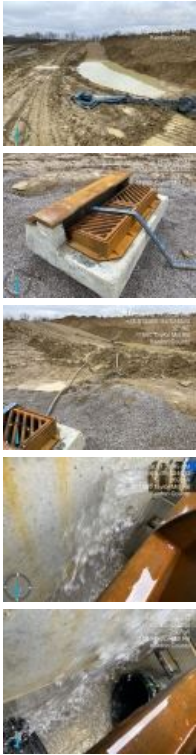
ITEM	REMARKS		DISCUSSION		PHOTO
015-040	<p>The site shall be kept free of surface water at all times. The Contractor shall install drainage ditches, dikes and shall perform all pumping and other work necessary to divert or remove rainfall and all other accumulations of surface water from the excavations.</p> <p>Follow Specifications 312319 - Dewatering; 312000 - EARTHWORK</p>

SPACE:	006 - SITE - SOUTH	SUBJECT:	Dewatering	
	CATEGORY:	Earthwork	REFERENCE:	312000

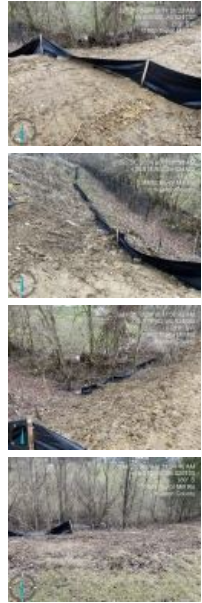
ITEM	REMARKS	DISCUSSION	PHOTO
015-041	<p>Erosion and sedimentation controls shall be inspected weekly and after rain events of 0.5 inch or greater. Replace silt fencing as needed, filter stone which is dislodged, erosion control blanket which is damaged, and make other necessary repairs.</p> <p>Remove sediment from fences and barriers when it accumulates to half the height of the barrier, or more often as needed.</p>

SPACE:	006 - SITE - SOUTH	SUBJECT: ESC
	CATEGORY:	Erosion Control	REFERENCE: 312502

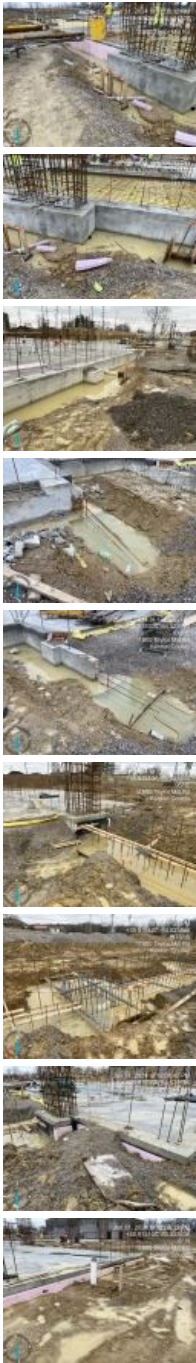
ITEM	REMARKS	DISCUSSION	PHOTO
015-052	Foundation installation in progress.

SPACE:	007 - SITE - EAST	SUBJECT:	Foundation	
	CATEGORY:	Concrete	REFERENCE:	033000

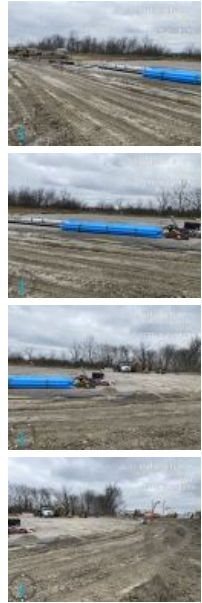
ITEM	REMARKS	DISCUSSION	PHOTO
015-054	Staging / lay down area installed.

SPACE:	005 - SITE - NORTH	SUBJECT: Staging/Laydown Area
	CATEGORY:	General	REFERENCE: 000000
