FIELD OBSERVATION REPORT

Central Hardin High School, Cecilia, KY

2019111 - CA8

Report No: 55

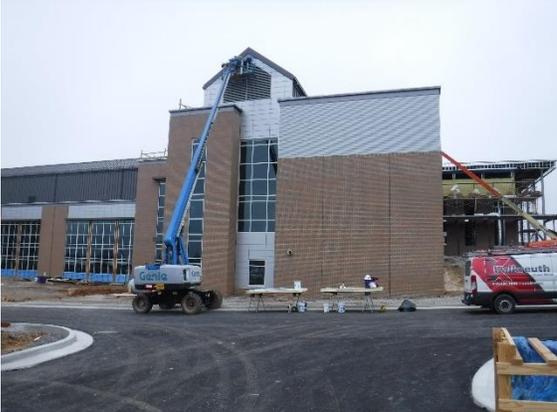
Item No.	Location	Description/ Correction	Image	Action
1	Southwest Corner of Area B	ACM panels were being applied to the area around the intake louver for the ERV.

Seal all joints for a weather – tight installation.
2	West Side of Area B	All metal panels were in place except the column covers and the bottom panels. The concrete needs to be poured before the panels are installed.

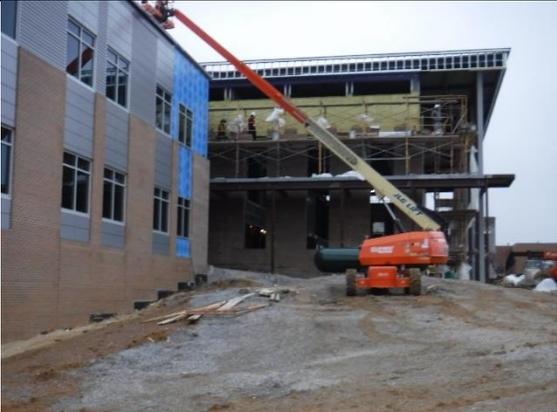
Complete the site work so the elevation can be completed.
3	West Side of the LMC	Brick was being laid over the exterior of the Library Media Center.

Complete brickwork so windows can be installed to enclose the LMC.

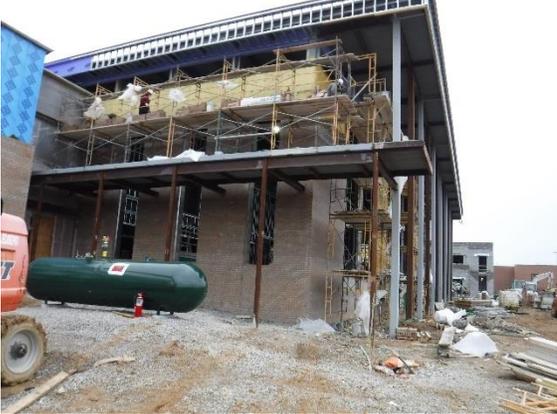
Item No.	Location	Description/Correction	Image	Action
4	West side of the LMC	The steel frame and roof deck for the entry canopy was in place.

Complete the west wall of the LMC so the canopy can be completed.
5	Interior of the LMC	Mechanical and electrical rough ins were being installed. The windows were yet to be installed.

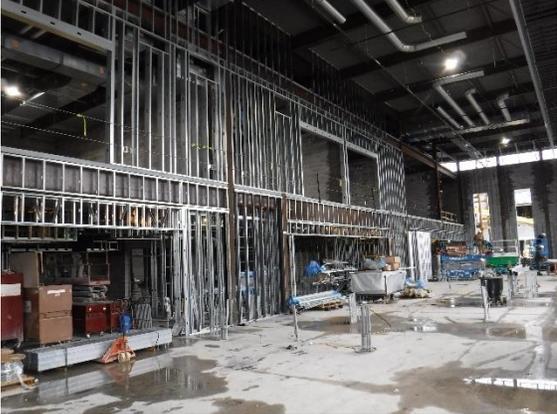
After the roofs over the area are complete, complete the rough ins and window installation so the area can be dried in for the installation of finishes.
6	Interior of the LMC	Light gauge metal framing was installed in the LMC and at the classrooms on the Second Floor.

Complete the LMC enclosure so wallboard can be installed.

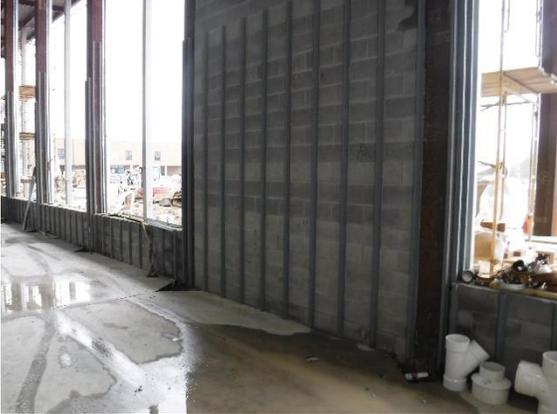
Item No.	Location	Description/Correction	Image	Action
7	Exterior Wall of the LMC	Concrete block walls were furred with light gauge metal furring strips.

A photograph showing the interior of a room where concrete block walls are being prepared. Light-colored metal furring strips are attached to the exterior surface of the concrete blocks. The floor is concrete and appears to be under construction.	Complete exterior work so wallboard can be hung on the interior.
8	First Floor East-West Corridor by the Cafeteria	Above ceiling rough ins were being installed but cannot be completed until the area is fully enclosed.

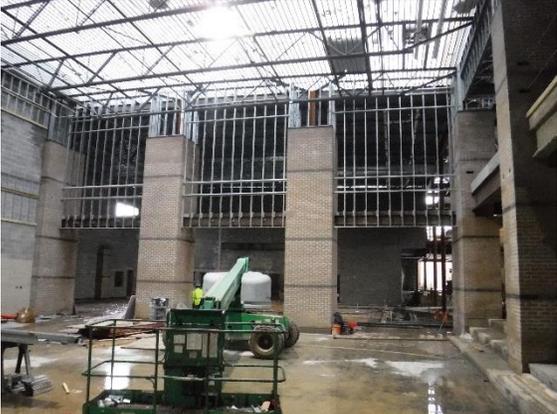
9	Cafeteria/ Court	Light gauge metal framing was installed to form the upper walls for the area. The roofing system was not installed over this area.

A photograph of a large, open area, likely a cafeteria or court, under construction. The ceiling is a complex metal truss system. The walls are made of brick and metal framing. A green scissor lift is visible in the foreground.	Install the roof and enclose the area so finish materials can be installed.

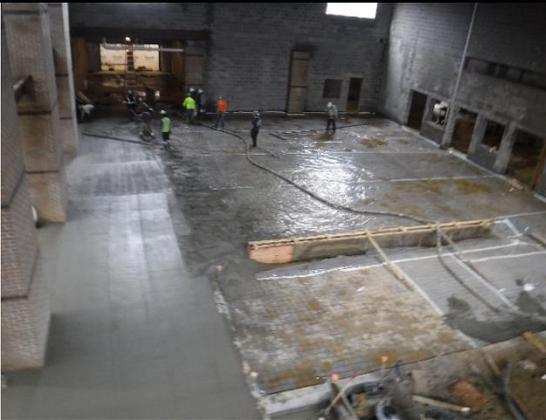
Item No.	Location	Description/Correction	Image	Action
10	Cafeteria Commons Area	The concrete floor slab was being poured.

Refer to SPIN for confirmation of the proper installation of components for the slab.
11	Cafeteria Commons Area	The light gauge metal framing separates the upper portion of the wall between the commons and court area.

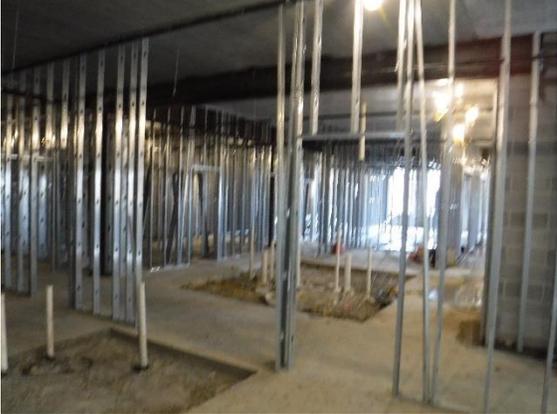
Item No.	Location	Description/Correction	Image	Action
13	Admin. Area	Light gauge metal studs were installed for wallboard walls. Plumbing rough ins were in place for staff toilets in the area.

Complete framing and in wall rough ins.
14	Admin. Area	Water was visible on the concrete block and the floor slabs.

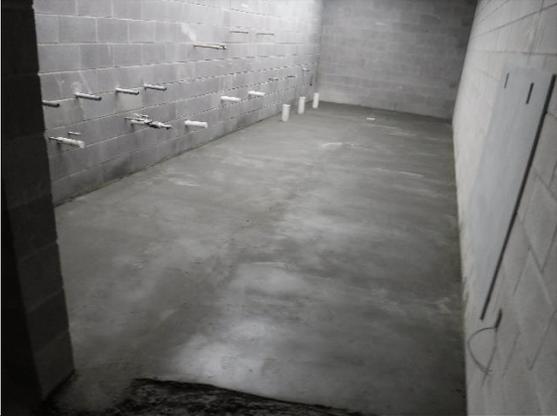
Install the roofs so that interior finish work can begin.
15	First Floor Boys Toilet	The mud bed for the floor tile had been poured and leveled.

Complete floor and wall tile work so fixtures can be installed.

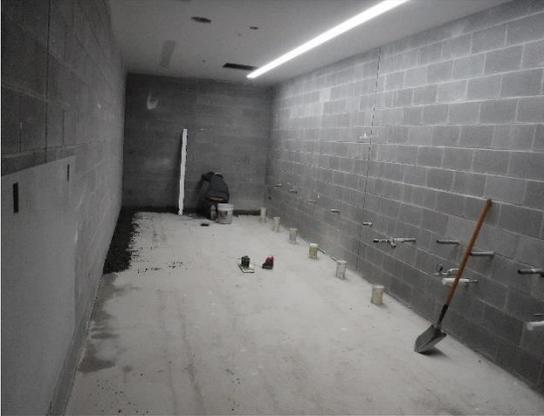
Item No.	Location	Description/Correction	Image	Action
16	First Floor Girls Toilet	The room was prepared for the mud bed pour. The solid surface panel for the hand dryers were adhered to the concrete block wall.

Pour mud bed.
17	Classroom	The room was ready for an above ceiling inspection so that the rest of the ceiling tiles can be dropped into the grid.

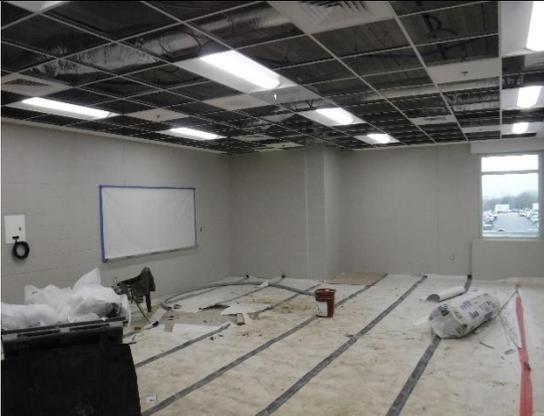
Conduct above ceiling inspection when Alliance says it is ready.
18	Classroom	Display boards were installed and covered with protection. The floors will be polished after the ceiling is installed.

Install the ceiling and polish the concrete floor slabs.

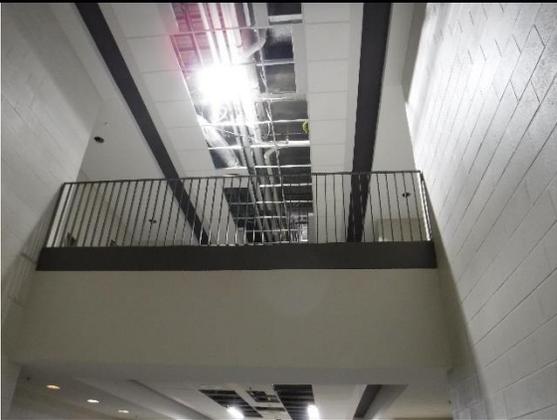
Item No.	Location	Description/Correction	Image	Action
19	Connecting Corridor	Ceilings are open pending an above ceiling inspection.

Alliance to notify the design team when these areas are ready for an inspection.
20	Stair B – First Floor	Additional hanger wires are needed for the ceiling.

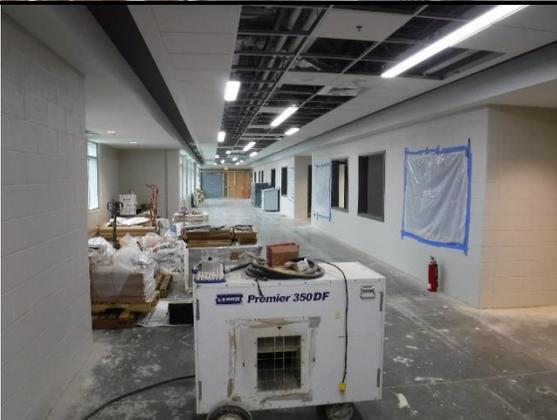
Add hanger wires to meet ceiling grid installation standards.
21	Gym Level Connecting Corridor	The above ceiling area needs a back check before files are dropped into the grid.

Alliance to notify the design team when these areas are ready for an inspection.

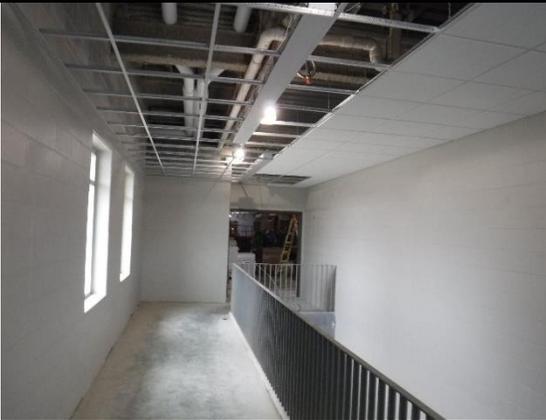
Item No.	Location	Description/Correction	Image	Action
22	Stair B Second Floor	Additional hanger wires are needed for the ceiling. The fire rating of the chase needs to be verified.

Provide evidence that the top of the chase is sealed with 2-hour fire rated construction.
23	Second Floor East – West Corridor	The wall is wet because the roof around the LMC is not in place.

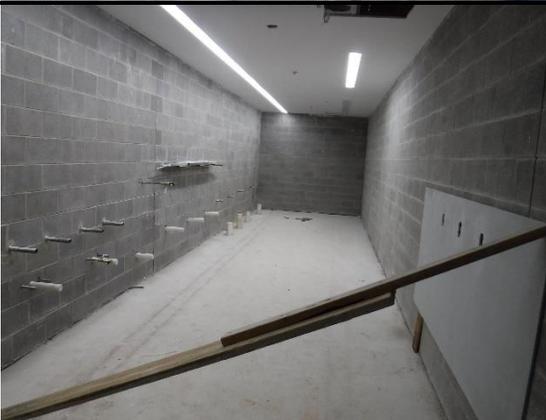
Install the LMC roof.
24	Second Floor Boys Toilet	The mud bed and floor tile were not in place.

Pour the mud bed and install the floor tile.

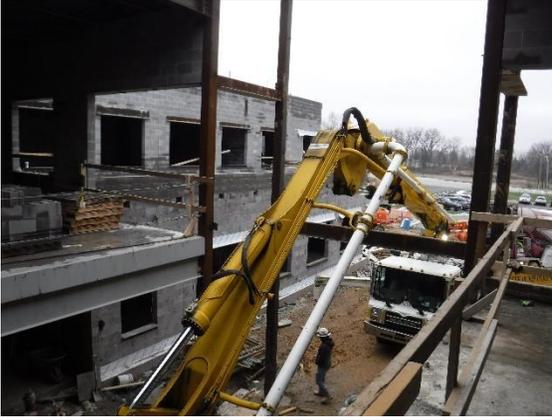
Item No.	Location	Description/ Correction	Image	Action
25	Main Entrance	Once materials and processes such as concrete being pumped into the interior are complete, the area needs to be enclosed by the roof and curtain wall.

Complete interior work that requires the opening to be used for the passage of materials.
26	Second Floor East – West Corridor	The penthouse is overhead. It was being enclosed.

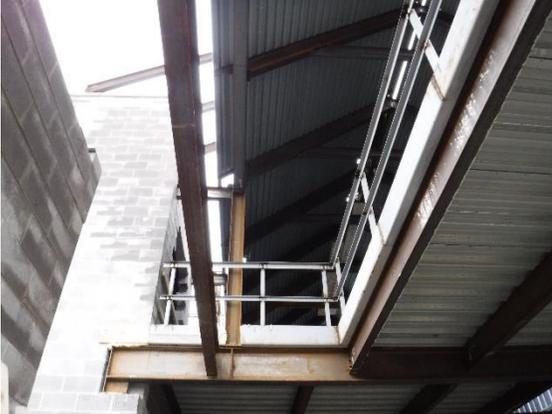
Complete the enclosure of the penthouse to dry in this area.
27	On the Platform looking up to the Roof Framing for the Elevator Shaft	This area will need to be roofed over to dry in the platform and the area below.

Complete the roof and dry in the area.

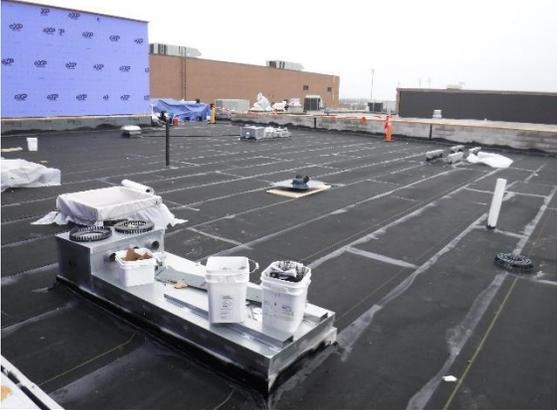
Item No.	Location	Description/Correction	Image	Action
28	Roof over the Cafeteria Court Area	A portion of the roof was in place.

Complete the roof over the Cafeteria.
29	Penthouse leading to the Penthouse on Phase 2	A temporary barricade is required at the end of the Phase 1 section of the platform.

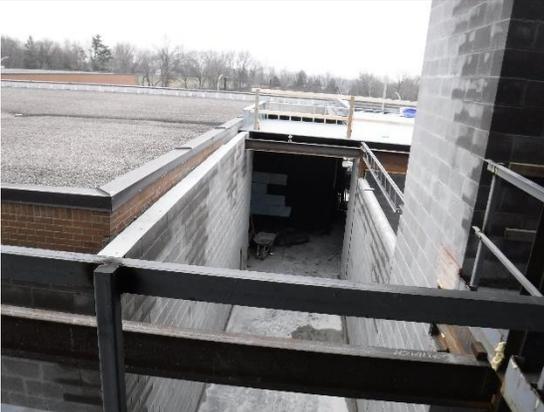
Item No.	Location	Description/Correction	Image	Action
31	Looking South from the Platform with Phase 2 to the Left	The concrete block wall parallels the existing brick wall for Phase 2. This area of Phase 1 does not have the roof structure in place.

Install roof framing and roofing.
32	Platform over Area B	The area was relatively dry and clean.

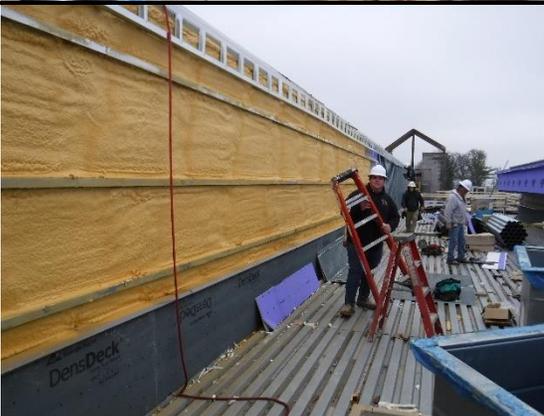
Continue to keep work areas clean as they are completed.
33	Penthouse Roof and Wall	Metal furring was being installed to carry the sheet metal panels that will cover the exterior walls.

Cover the roof and walls of the penthouse with sheet metal siding.

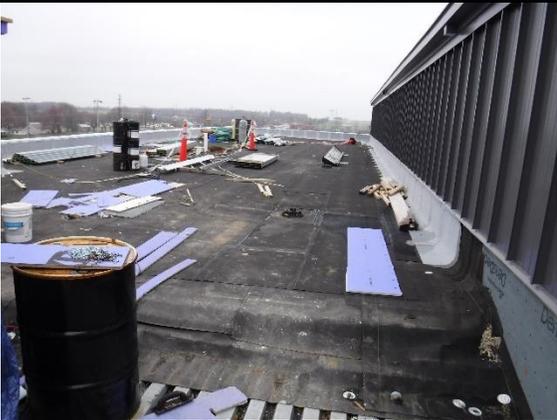
Item No.	Location	Description/Correction	Image	Action
34	Roof over Area B Classrooms and Penthouse Wall	The base layer of roofing was in place to dry in the area below. The sheet metal siding was on the penthouse walls.

Keep roof areas clean.
35	Fascia for High Roof over LMC	The fascia needs to be covered with sheathing and siding to dry in the area.

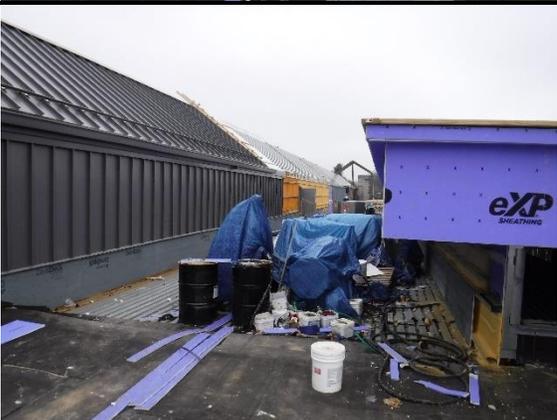
Complete the exterior of the LMC to dry in the area.
36	Low Roof Area around the LMC and Roof and Side Walls of the Penthouse	The roof area was not complete.

Complete the exterior of the LMC to dry in the area.
