M/E/P FIELD REPORT

Date of Visit: 4/4/2024
Date Submitted: 4/9/2024
Project Name: Central Hardin High School
Project No.: 20009
Location: Hardin County, Ky
Time In/Out: 9:30am- 3:30pm
To: Inga Hardman
From: Michael Warren
Copy: Joe Jones; Brandon Cecil; David Epperson; Ethan Kelly

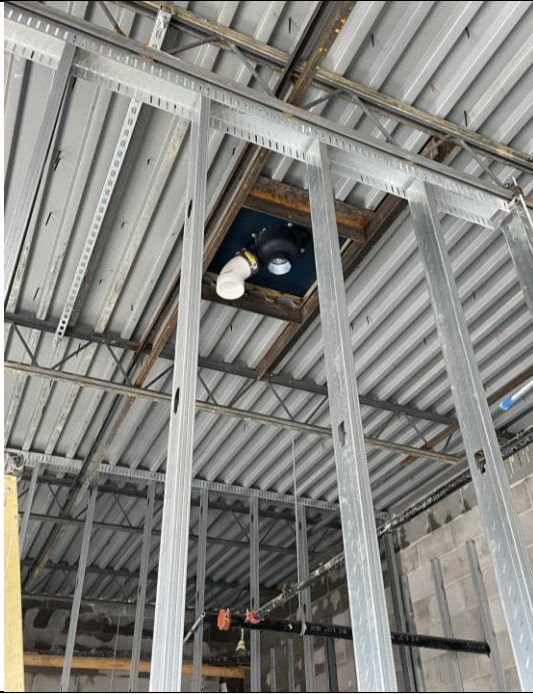
Roof drain in Area F. The roof drains in Area F need to be tied in as soon as possible for the roofer to continue his work.

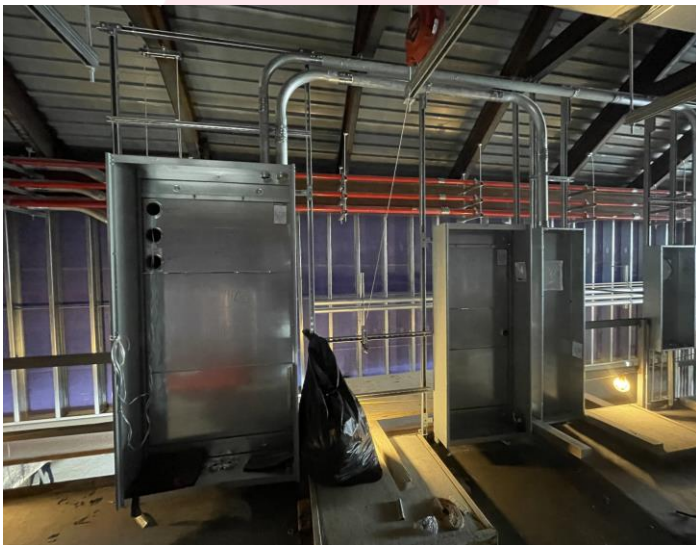
AES is continuing rough-in on the platform of Area B and Area F.

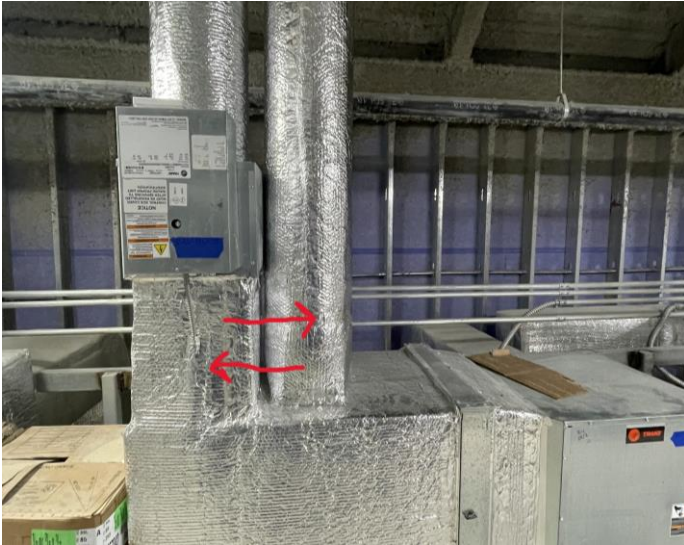
9. There are still several heat pumps that need to have the VAV (outside air) and Exhaust take-off swapped on the return air plenum. This needs to occur to ensure that Outside Air reaches the spaces served and doesn't short cycle out through the Exhaust. See Action Items below.

Photo shows an example of takeoffs for VAV Outside Air and Exhaust Air being installed backwards. In this installation the Outside Air will be pulled through the Exhaust Air duct, instead of reaching the spaces served.

In the photo, the VAV serving outside air is the box/duct on the left, and the exhaust duct is to the right. The heat pump is shown sitting on the floor, to the far right.

This installation was observed on several heat pumps and will need to be corrected.

1. There are several heat pumps on the mezzanine that will need to have the VAV Outside Air and Exhaust take-offs swapped on the return air plenum of the heat pump. The VAV outside air connection needs to be closest to the HP fan. In several cases, the Exhaust takeoff is closest to the HP fan, which will cause the outside air to short-cycle and not reach the occupied spaces. This was discussed after the progress meeting with Randy Dillard, Steve Turner, and Michael Warren. Examples were pointed out on the mezzanine.
 - a. **Correct take-offs for Outside Air and Exhaust Air take-offs at Return Air plenums for heat pumps on the mezzanine.**

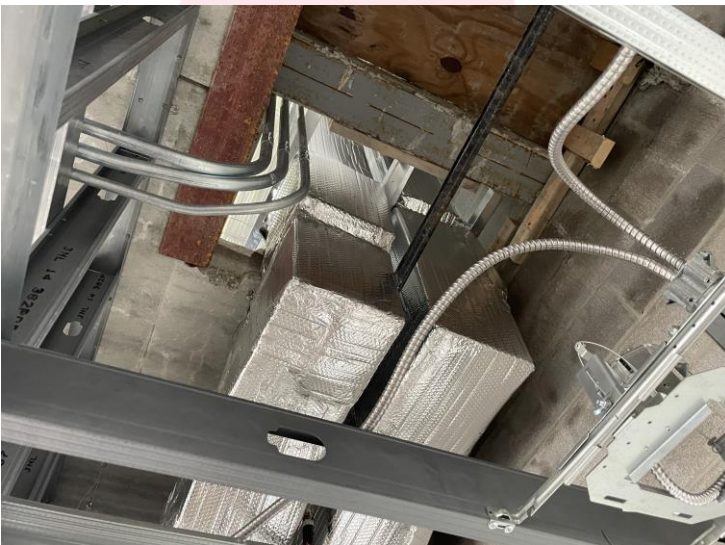
6. Joe Jones raised a question regarding the fire-dampers in Area B, where the ducts penetrate the second-floor slab down to the first floor. While these fire-dampers are installed in the ducts, the opening around the ducts is much larger than what was needed for the duct routing. This opening will need a shaft wall to maintain the required 2-hour fire-rating.

Photo of ducts penetrating the Second-floor slab in Area B. Note that the opening provided for the ducts is much larger than necessary. While the ducts do have the required fire-dampers, the remaining opening will need to be closed in via a shaft wall to maintain the 2 hour fire-rating. Access to the fire dampers must be maintained per code.

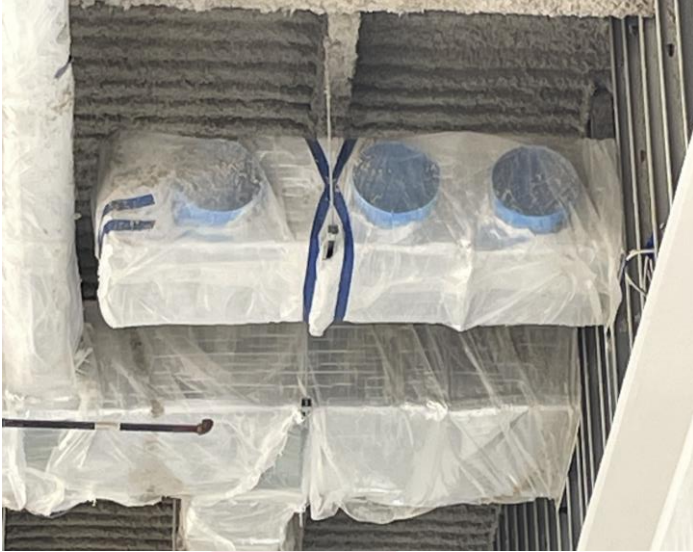
Installation of rigid ductwork in the Media Center and the Café is complete. Photo of the ductwork in the Media Center. Note that the ductwork has been wrapped with plastic to protect it from fireproofing of the structure overhead.

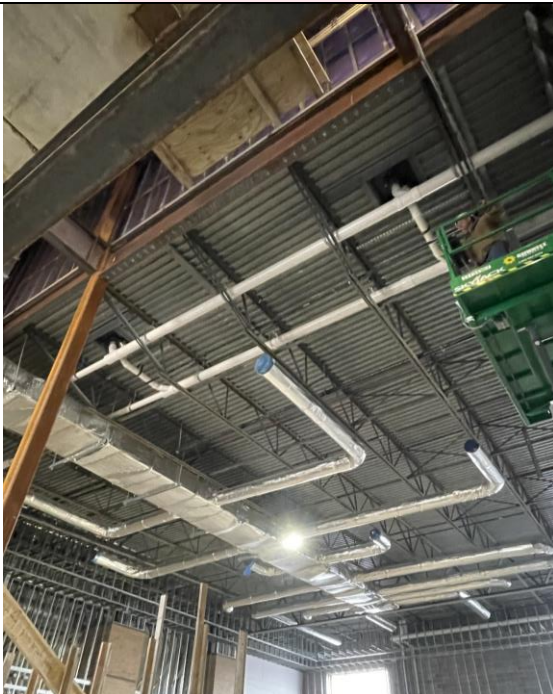
S&R is connecting the roof drains to the leaders in Area E Commons.

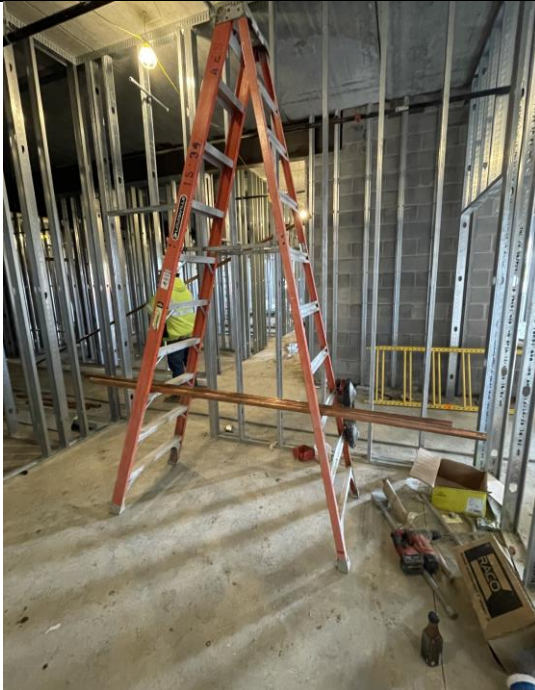
Plumbers are installing copper lines in the Admin Area F.

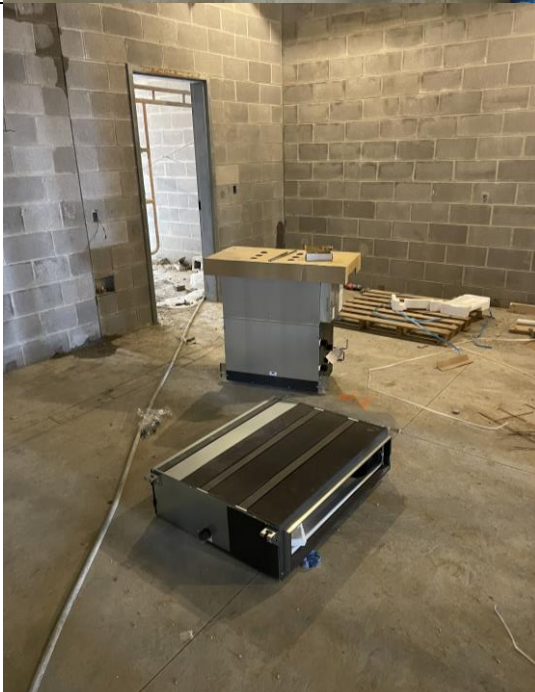
FCU-F102 was found laying on the floor of Work Room F127. This unit needs to be stored properly until installation. It needs to be off the slab and wrapped with plastic.

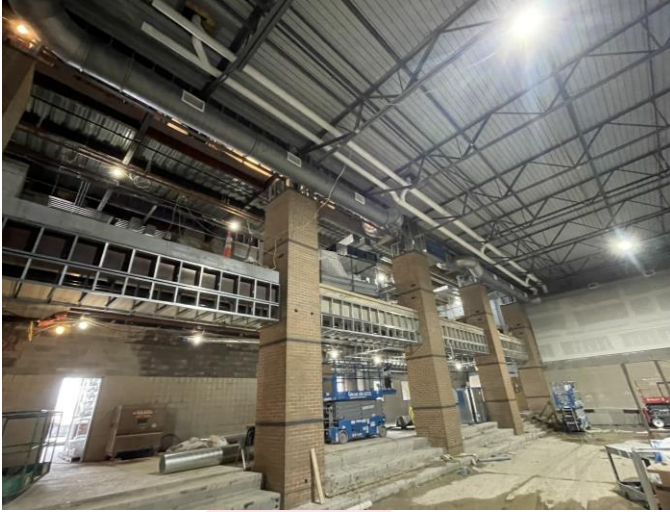
Supply air registers have been installed in the Café area. Roof leaders have been connected to the roof drains.

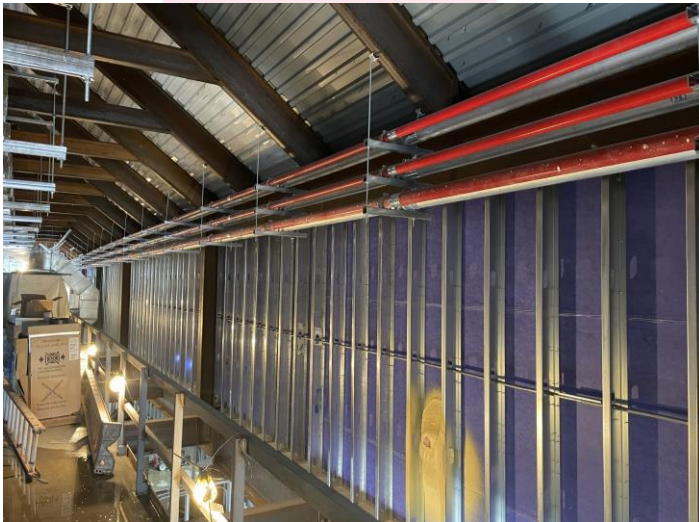
Conduit for fire-alarm on the platform of Area B.

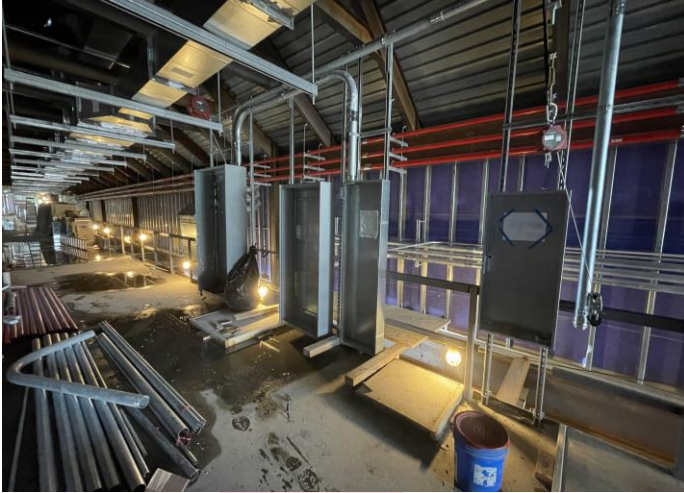
Panels have been set and conduits connected on Area B platform. Installation of conductors is set to begin.

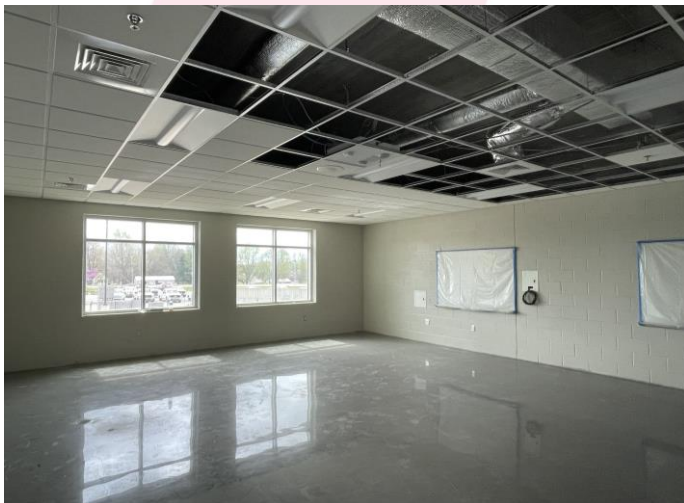
Area B (in partial) has passed above ceiling inspection for Lower Level, 1st floor, and 2nd floor. Installation of Ceiling tiles is ongoing.

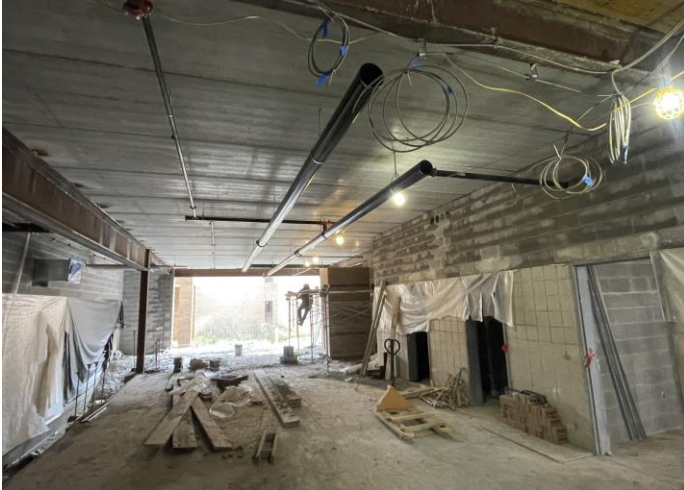
Rough in of sprinkler lines is ongoing in Area F.

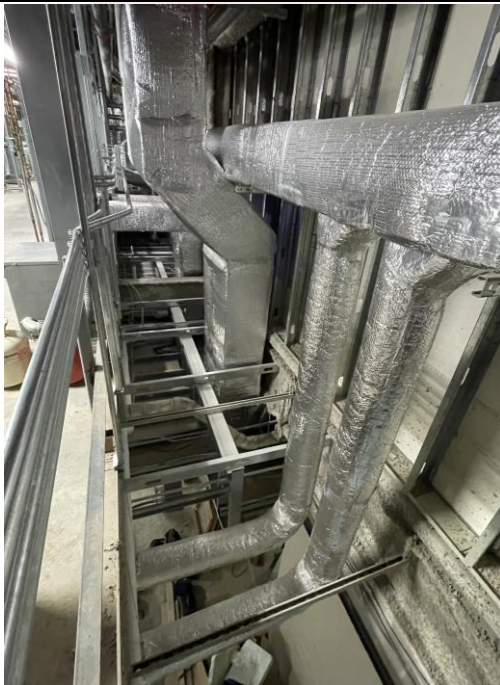
Insulation of ductwork has maintained pace with duct installation. Photo of insulated duct from the platform to below.
