FIELD OBSERVATION REPORT

Central Hardin High School, Cecilia, KY

2019111 - CA8

Date: 4/4/2024

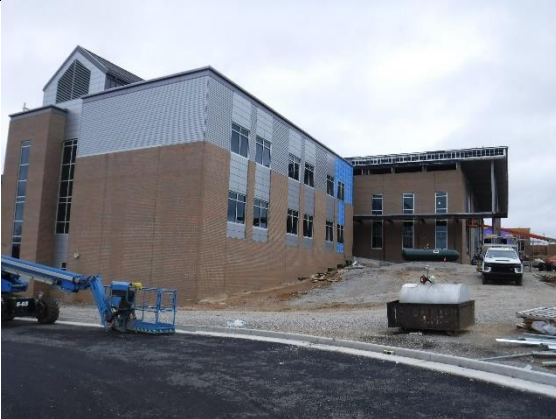
Item No.	Location	Description/ Correction	Image	Action
1	Southwest Corner of Area B	Metal panels were in place for most of the area.

Seal all joints per the specs for a weather – tight installation.
2	West Side of LMC	Brick was laid. Curtainwall windows were installed. The structure for the entry canopy was in place.

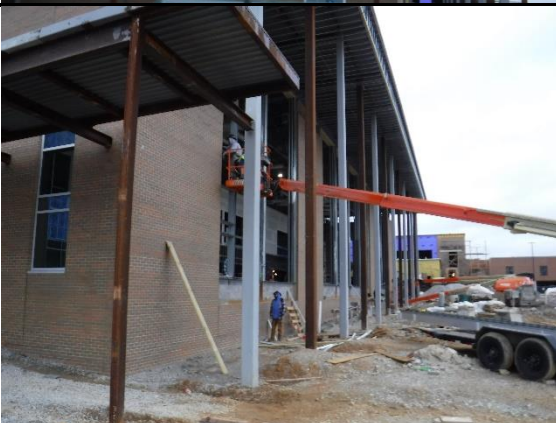
Complete the window installation and the metal fascia so the elevation can be completed.
3	West Side of the LMC	Curtainwall windows were being installed on the south elevation of the Library Media Center.

Complete windows so the LMC can be enclosed.

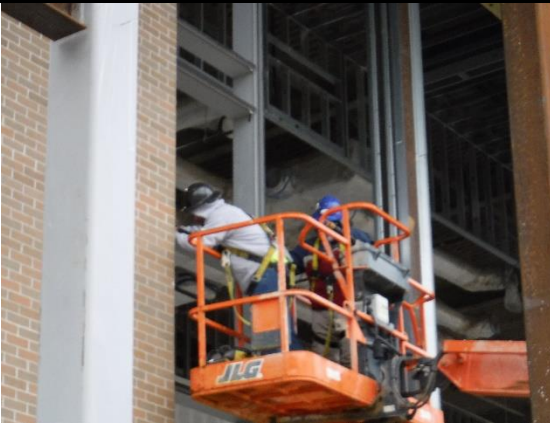
Item No.	Location	Description/Correction	Image	Action
4	South side of the LMC	Glazers were installing the curtainwall window system.

Assemble the curtainwall so there are no leaks.
5	Interior of the LMC	Mechanical and electrical rough ins were being installed. The windows were being installed.

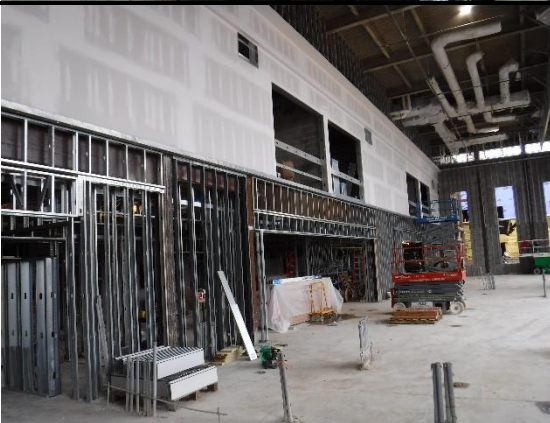
Enclose the LMC so interior finishes can be installed.
6	Interior of the LMC	Wallboard had been installed in the LMC and at the classrooms on the Second Floor.

Enclose the LMC so wallboard can be finished. Replace any damaged wallboard, if any.

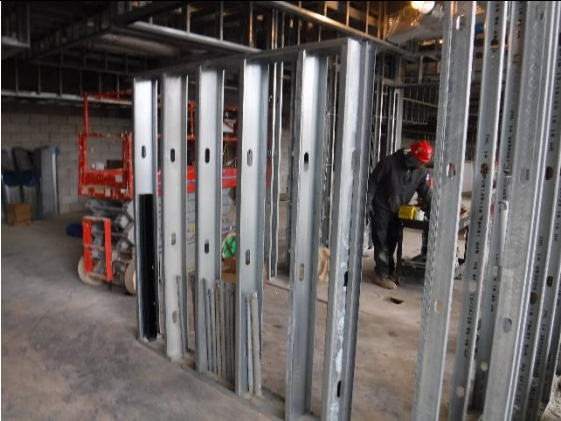
Item No.	Location	Description/Correction	Image	Action
7	Interior Wall of the LMC	Steel stiffeners were installed in the metal stud pony walls.

Coordinate the framing with the aluminum window framing.
8	Interior of the LMC under the Second Floor Classrooms	Light gauge framing was installed for wallboard soffits.

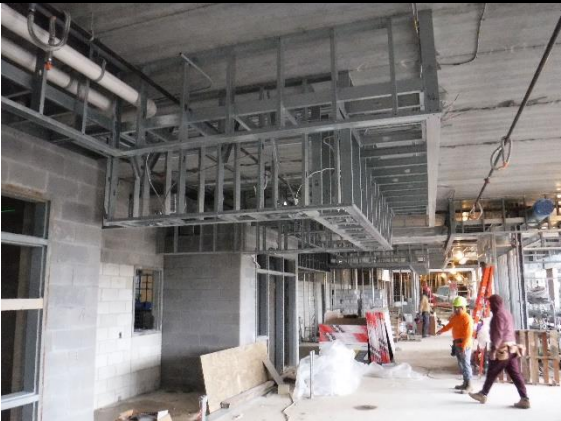
Install soffits when the area is environment ally controlled.
9	LMC Interior	Light gauge metal framing was installed to form the soffits at the entries to the LMC.

Coordinate soffits with surrounding finishes.

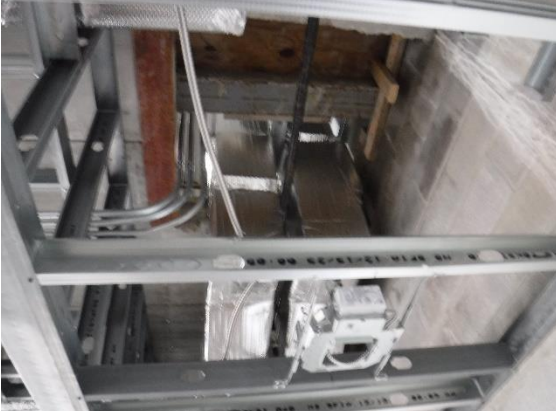
Item No.	Location	Description/Correction	Image	Action
10	Duct Penetration in Second Floor Slab from below	The ductwork was installed with 2 hour fire rated dampers but the floor was not infilled with a 2 hour fire rated shaftwall assembly.

Install shaftwall and fire rated sealants to create a 2 hour fire barrier at the floor slab.
11	Duct Penetration in Second Floor Slab from above	Some of the work on the fire rated assembly can be installed from above.

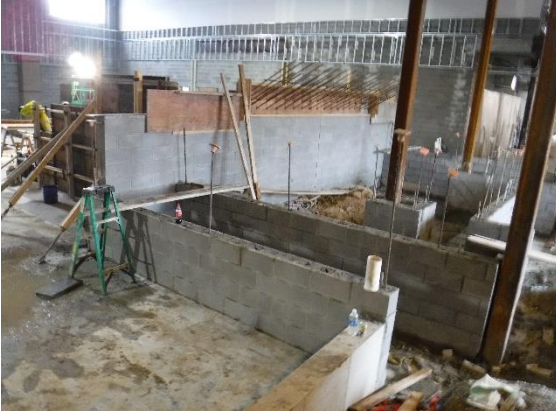
Install the shaftwall and fire rated sealant to seal the openings.
12	Social Stair	Concrete and block walls that will support the social stair.

Coordinate the structure for the social stair with adjoining stair framing.

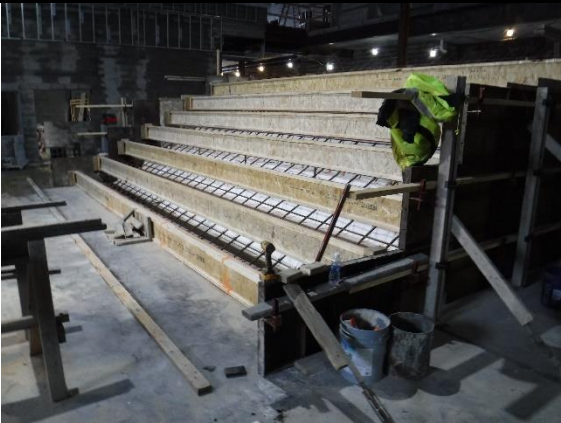
Item No.	Location	Description/Correction	Image	Action
13	Social Stair	Formwork and steel reinforcing was in place for the concrete sub-structure for the social stair.

Maintain dimensions and tolerances for the installation of the finish on the social stair.
14	Social Stair	This is the lower half of the stair structure.

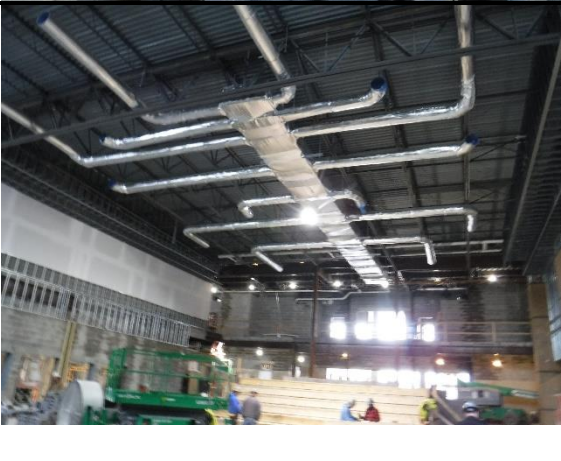
Install the stair structure so the finish is uniform in appearance.
15	Cafeteria	Ductwork and other mechanical/electrical rough-ins were mostly in place. The roof leaders were not connected resulting in flooding during recent rains.

Complete rough-ins so that ceilings can be installed.

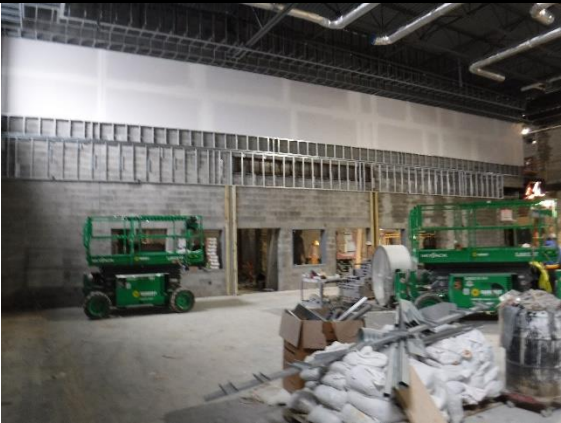
Item No.	Location	Description/ Correction	Image	Action
16	Cafeteria looking at the Kitchen Wall	Wallboard was being installed over light gauge framing

Finish wallboard after space is temperature controlled.
17	Cafeteria North Wall	Light gauge framing was in place.

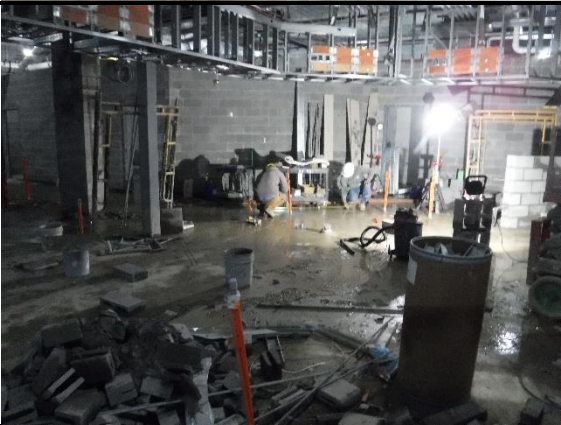
Install temporary protection at the window opening.
18	Kitchen	Rough ins were being completed for the installation of the food service equipment.

Coordinate utilities with the equipment submittals.

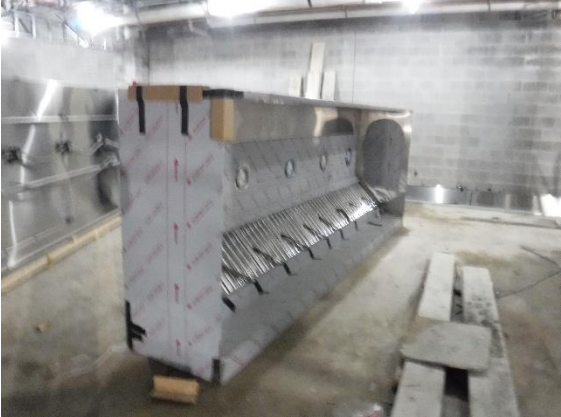
Item No.	Location	Description/Correction	Image	Action
19	Kitchen	The stainless steel hood was in the space.

Install the hood in compliance with code.
20	Area F West Side	Brick had been started over the exterior wall.

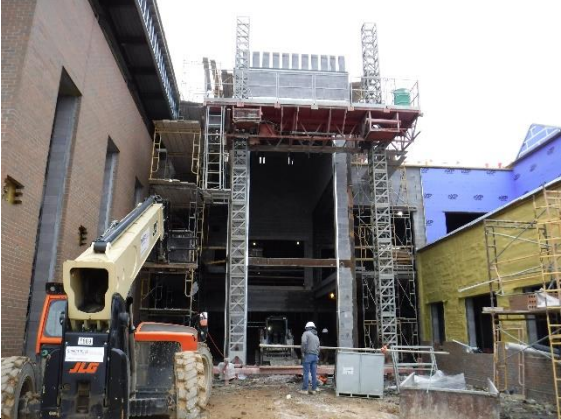
Take special care with the installation of finish materials at the main entrance.
21	Main Entrance	Scaffolding was in place to install the limestone at the entrance.

Install limestone so there is no streaking.

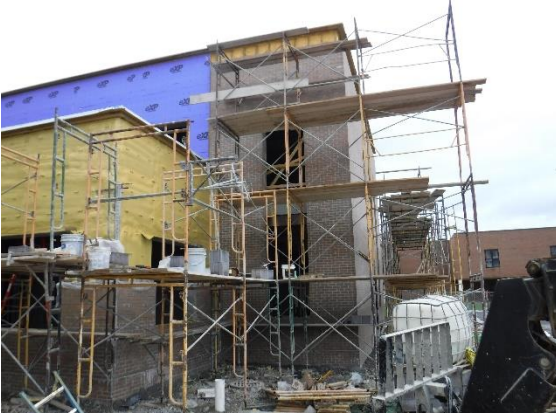
Item No.	Location	Description/ Correction	Image	Action
22	Area F South Wall	Brick was being laid over spray foam insulation.

Complete brick and clean the brick and joints.
23	Area F Admin Area	Metal framing was installed with slip tracks at the heads to allow for deflection.

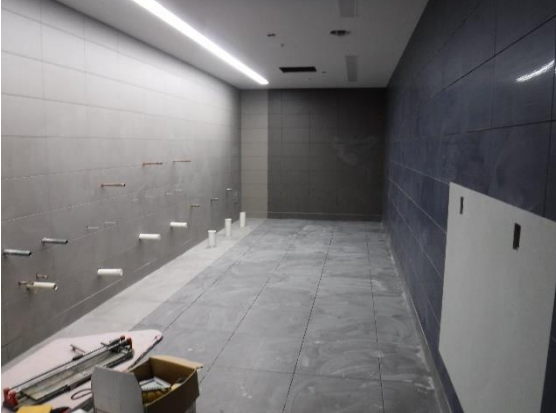
Install metal bridging in walls.
24	First Floor Boys Toilet	The room is close to being ready for fixtures, accessories and partitions.

Clean room before installing finished materials.

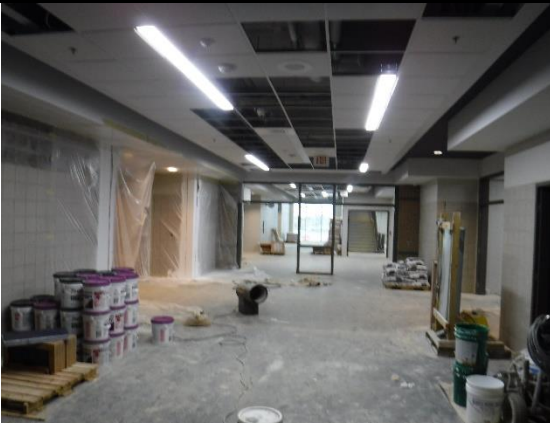
Item No.	Location	Description/Correction	Image	Action
25	Area B First Floor Corridor – Looking East	The area is getting close to being finished.

Complete interior finish work.
26	Area B First Floor Corridor – West End	The area was relatively clean.

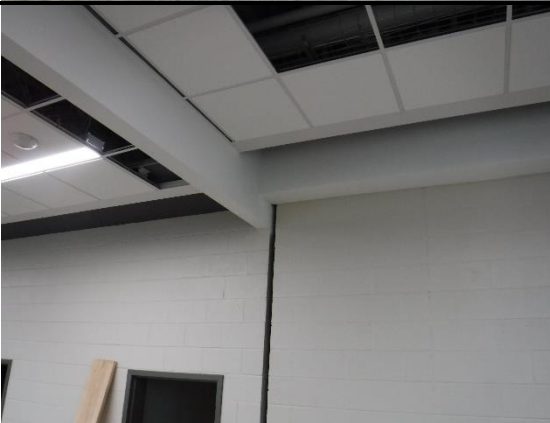
Ryan reported that he plans to bring in laborers to clean areas that are nearing completion.
27	Area B Expansion Joint in Connecting Corridor	The expansion cover was not installed on the wall or at the ceiling. The wallboard soffit was not installed to receive the expansion joint.

Install expansion joint covers per details.

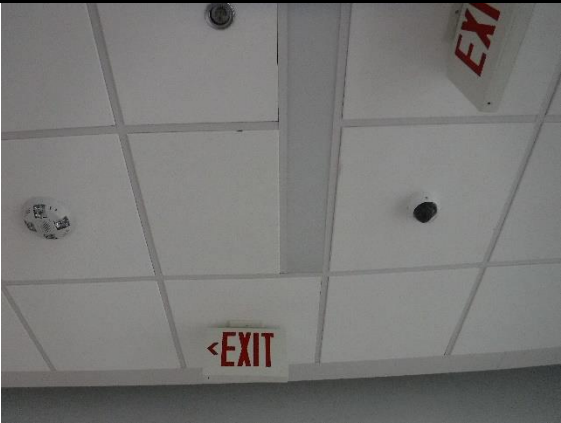
Item No.	Location	Description/Correction	Image	Action
28	Typical Acoustical Ceiling	Tile edges were damaged, grid was not straight.

Detail ceiling tile and grid before the punchlist inspection to minimize corrections.
29	Resource B122 Furring at Expansion Joint	Furring does not comply with the wall section. Stud wall is to be installed independent of the block wall for expansion joint.

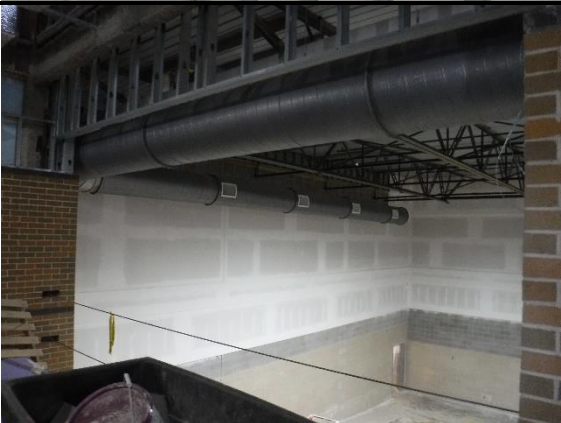
Remove furring and install stud framing.
30	Looking into Café/ Commons	The ductwork was installed. The wallboard soffits were in place.

Paint area when temperature is controlled.

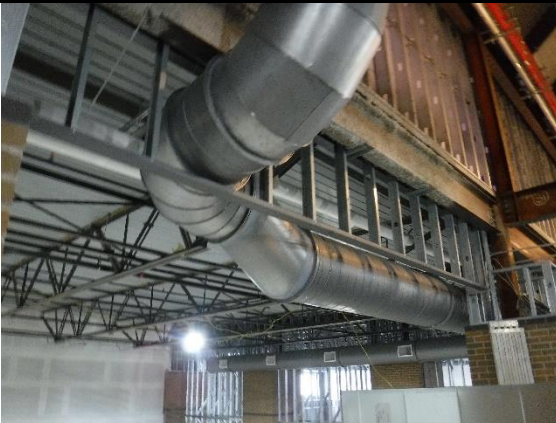
Item No.	Location	Description/Correction	Image	Action
31	Ductwork into Café/ Commons	Ductwork extends from the platform to the ceiling space.

Install basketball goal supports and goals.
32	Looking at Social Stair from Second Floor	Formwork for the lower half of the stair was in place.

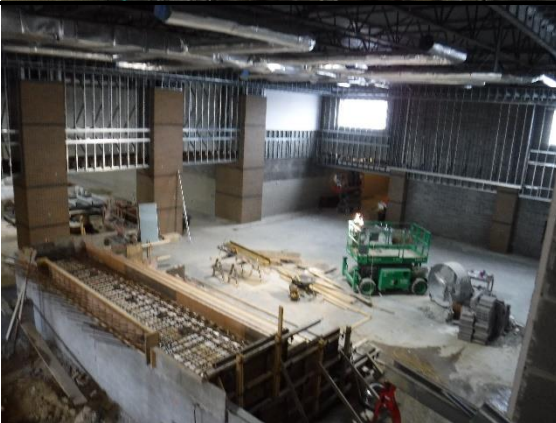
Coordinate stair structure with the finish material at the stair.
33	Cafeteria from the Second Floor	The social stair will provide access to the second floor.

Coordinate handrails and guardrails with the structure.

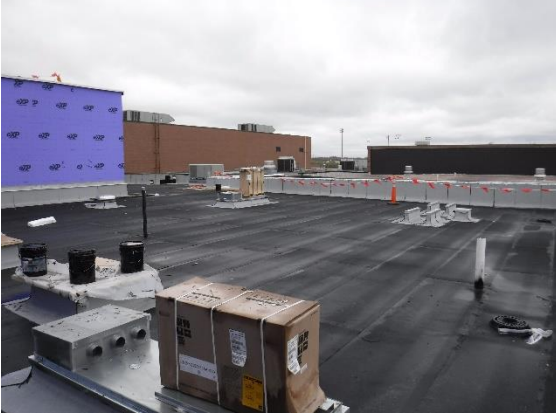
Item No.	Location	Description/Correction	Image	Action
34	Roof over Café Commons	The roof was installed in phases to coordinate with surrounding work to provide a weather tight seal. There has been discussions to modify the work on the gym parapet.

Revise the gym parapet detail to avoid opening the wall to the weather other than for the replacement of the coping.
35	Platform looking East	The platform is close to the point where it will connect to the continuation of the platform over Phase 2.

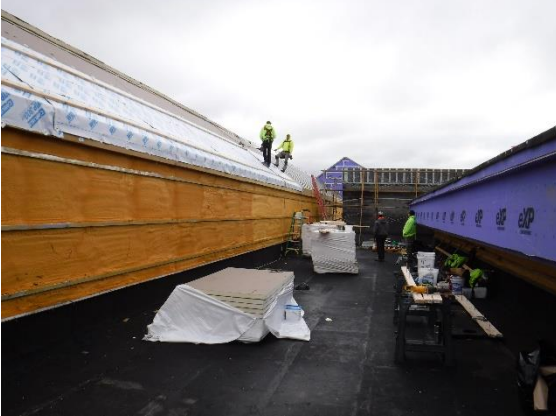
Provide temporary protection at the end of the platform.
36	Roof over the South Side of the Penthouse looking East	The roof area was dried in with the vapor barrier. Metal roofing will be installed over the vapor barrier and metal panels will be installed over the spray foam insulation.

Complete the metal siding and roofing.

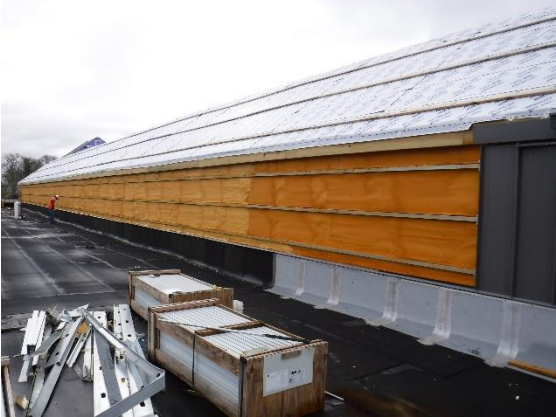
Item No.	Location	Description/ Correction	Image	Action
37	Roof over the North Side of the Penthouse looking East	Similar to the south side, metal roofing and siding was being installed.

Complete sheet metal work.
38	Area A and B Platform Steel Framing	There were several beams that were used to support scaffolding where the spray fire proofing was completely removed from the top flanges of the beams.

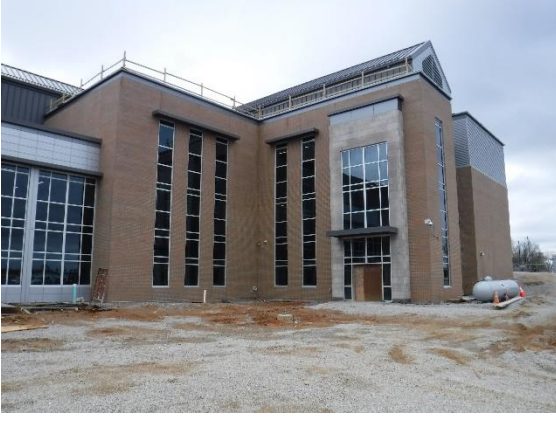
Apply spray fire proofing to achieve the required fire rating.
39	Southwest End of Area B	The exterior was mostly complete. The wood railing is for temporary fall protection for the roofers. The limestone is not steaked as bad as those at the other locations.

Clean brick and limestone for final inspection.

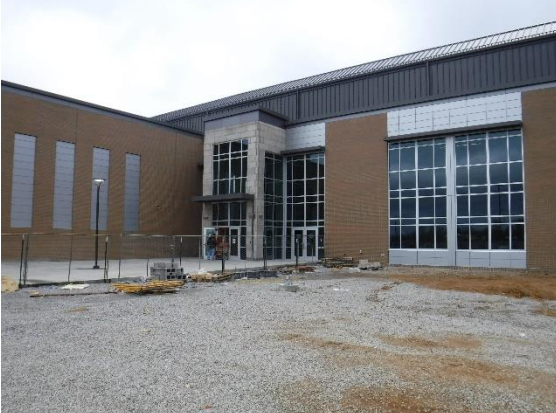
Item No.	Location	Description/Correction	Image	Action
40	Area A and B Gym Entrance and Connector	The curtainwalls in the area have been tested and leaks were found.

Repair leaks and retest.
41	FACS Food Lab B008	The room was being used for assembly of the casework.

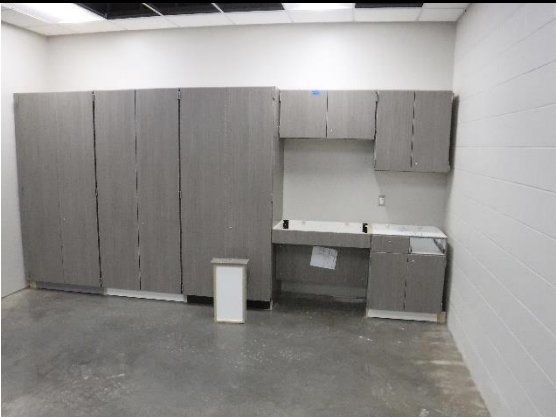
Take care to avoid damage to the polished concrete.
42	Typical Plastic Laminate Cabinets	Cabinets were being installed on rooms on the Gym Level.

Verify doors and drawer operation. Clean interior and exterior of cabinets.

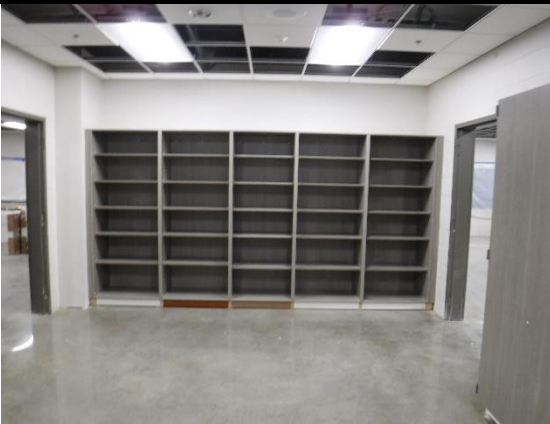
Item No.	Location	Description/Correction	Image	Action
43	Typical Shelving Units	Plastic laminate shelving was being installed on the Gym Level.

Clean shelving before final completion.
44	Area B FACS Food Lab B008	There were some defects in the polished concrete finish such as the area by the rear entrance to the room.
