FIELD OBSERVATION REPORT

Central Hardin High School, Cecilia, KY

2019111 - CA8

Report No: 58

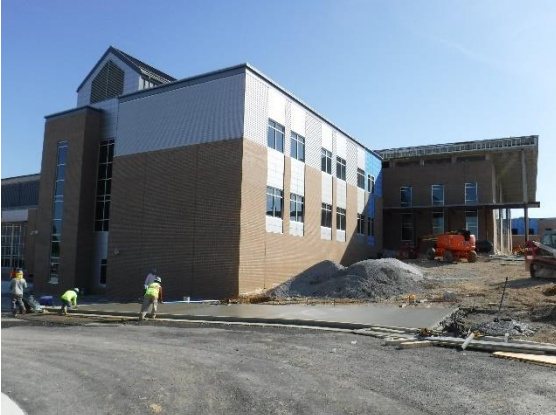
Item No.	Location	Description/Correction	Image	Action
1	Southwest Corner of Area B	Sheet metal copings were being installed at the parapet.

Submit roofing report when sheet metal is complete.
2	Main Entrance	Limestone was complete

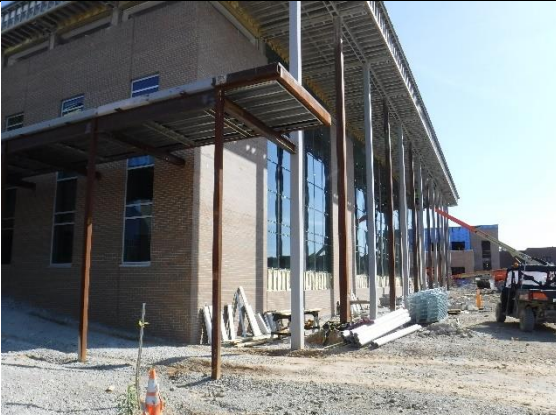
Protect limestone from staining.
3	South Side of the LMC	The curtainwall windows were installed. The upper windows were being installed.

Complete the enclosure of the exterior walls including exterior sealants.

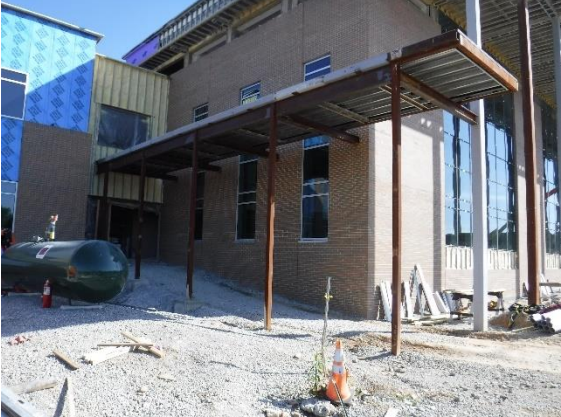
Item No.	Location	Description/Correction	Image	Action
4	Southwest corner of Area	Alliance was preparing to pour the steps to the entry.

Install sheet metal work to complete this area of the exterior enclosure.
5	South Wall of LMC	Upper windows were being installed.

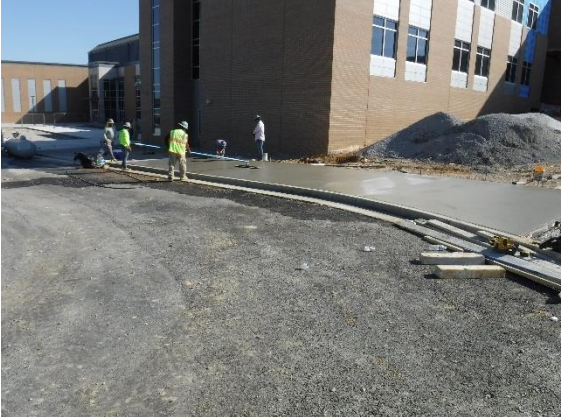
Complete the installation of the curtainwall system.
6	West Side of Area B	The concrete walkway was being poured.

Protect walks from damage.

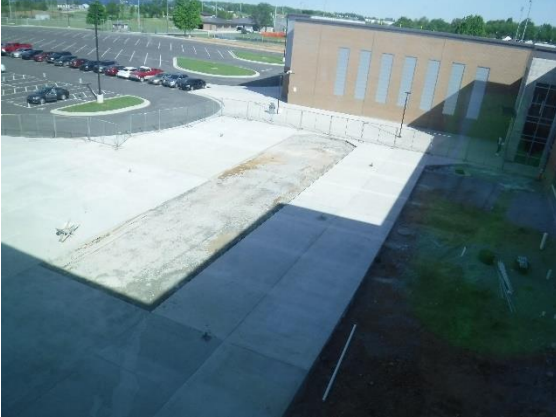
Item No.	Location	Description/Correction	Image	Action
7	Site in Front of the Gym Lobby	Concrete walks were poured. Lawn areas were yet to be graded and covered with topsoil and then seeded.

If lawn areas are not complete before graduation, provide transitions at walk edges.
8	Kitchen Roof	Curbs were in place for the kitchen equipment.

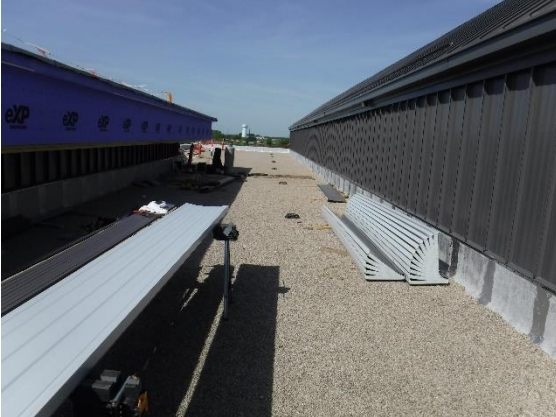
Complete roofing system so that kitchen equipment can be installed.
9	LMC Roof	Gravel was on the roof. Sheet metal panels were being installed over the platform.

Enclose platform walls and roof to prevent water infiltration.

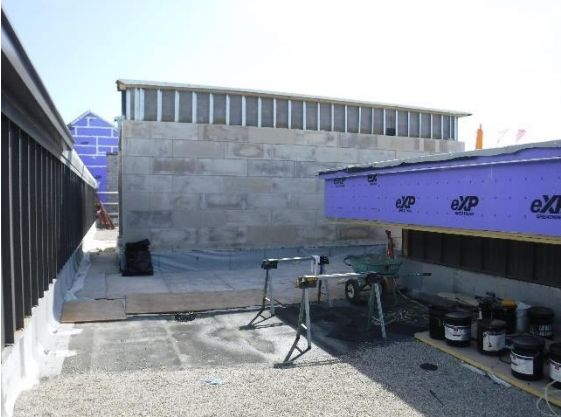
Item No.	Location	Description/Correction	Image	Action
10	Main entry Vestibule Exterior	Limestone was laid on the sides of the enclosure.

Do not damage stone during the completion of the roof edge work.
11	Upper Roof of LMC	Gypsum sheathing and siding place were not in place.

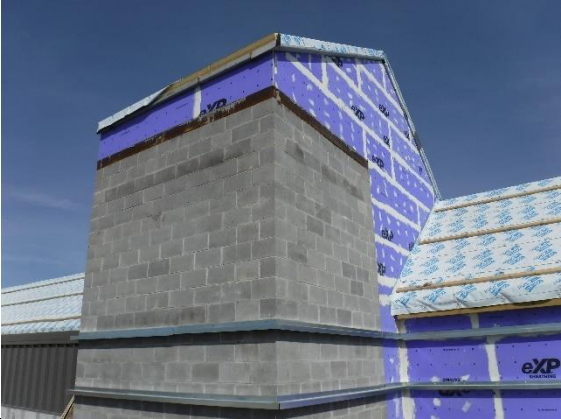
Complete metal panel and trim work.
12	Elevator Shaft	The enclosure was not covered with metal panels over spray insulation.

Completely cover the shaft with spray insulation and metal siding.

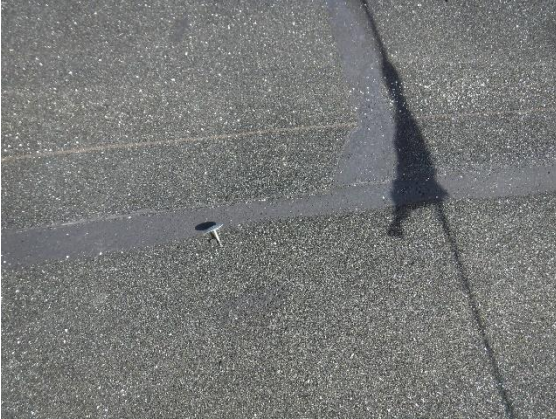
Item No.	Location	Description/Correction	Image	Action
13	Roof over Area E	The roof areas were mostly clean. This fastener could cause a leak.

Remove all fasteners and all other items that could damage the roof membrane.
14	Roof over Existing Gym	The gym roof is scheduled to be renovated. New sheet metal copings will be installed.

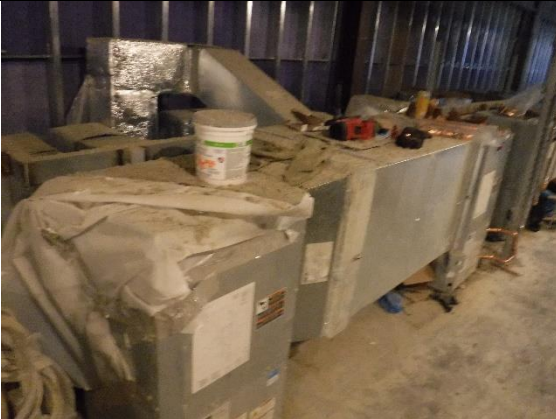
Complete roof renovation and the installation of sheet metal trim and the expansion joints.
15	Mechanical Platform	HVAC ductwork and units were being used as work counters.

Do not use mechanical units and ductwork as a work surface or a surface for food and drinks.

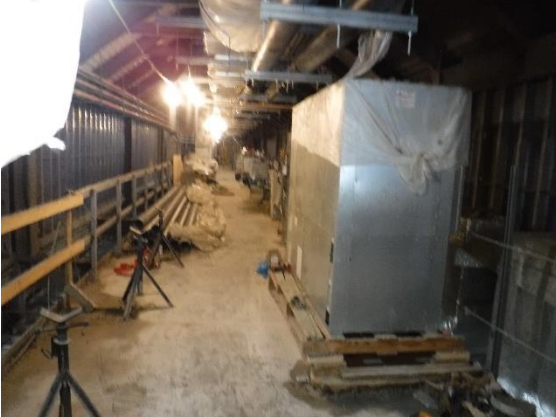
Item No.	Location	Description/Correction	Image	Action
16	Mechanical Platform	HVAC units, sprinkler piping, hydronic paining and electrical conduits and wiring were not installed.

Install all systems in this area to be able to complete Phase 1 work.
17	Mechanical Platform	Some of the spray fire proofing was missing on steel framing.

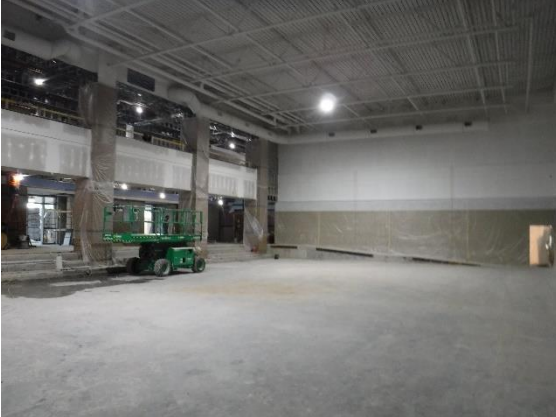
Replace all missing spray fire proofing on stall framing.
18	Café Commons	Much of the wall board had been painted. The roof structure and ductwork had been painted.

Complete painting of wallboard.

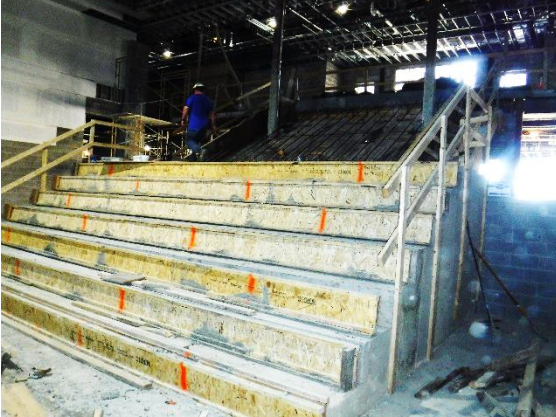
Item No.	Location	Description/Correction	Image	Action
19	Social Stair	The lower section of the concrete structure for the social stair had been poured.

Prepare concrete to receive the finish materials. Check concrete for moisture.
20	Social Stair	Steel reinforcement was being installed for the upper section of the social stair.

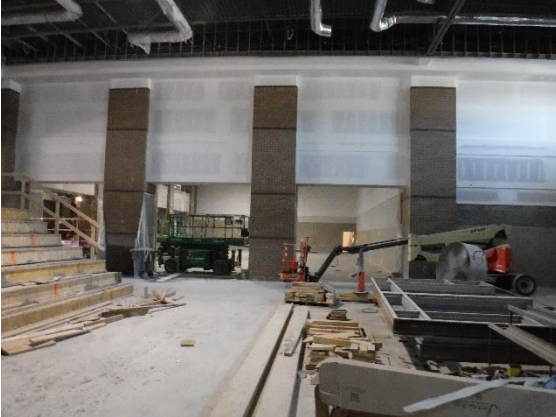
Refer to the SPIN report for final placement of reinforcing steel.
21	Café Commons	Wallboard soffits were in place.

Complete the painting of wallboard.

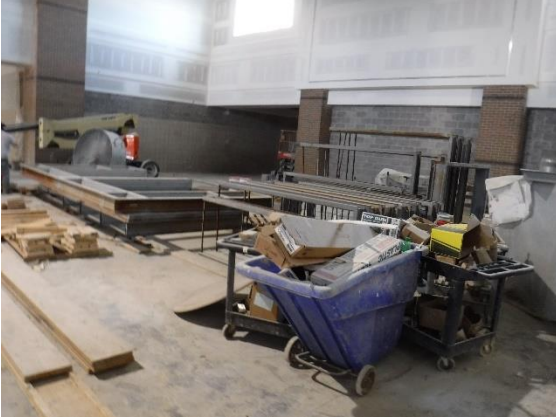
Item No.	Location	Description/Correction	Image	Action
22	Café Commons	The area was being used for stored materials.

Install all unused materials to free up space for overhead work.
23	Kitchen Entrance from the Commons	Ceramic tile is scheduled for the walls.

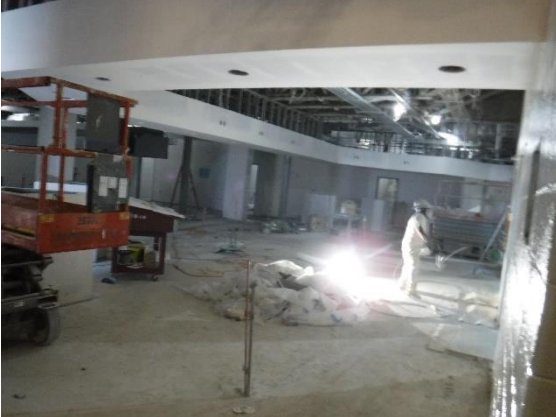
Prepare CMUs for the installation of the tiles.
24	Kitchen Cooking Area	The wallboard soffits were being painted.

Prepare soffits for the installation of the lay-in wallboard ceiling tile system.

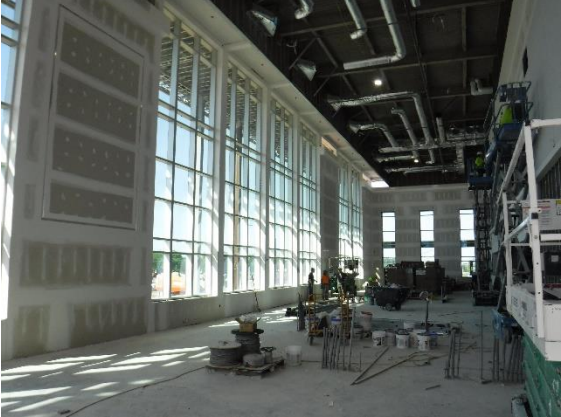
Item No.	Location	Description/Correction	Image	Action
25	LMC South Wall	The wallboard soffits and walls were in place.

Refer to the addendum for the installation of the sound boards.
26	LMC North Wall	Wallboard had been applied over metal framing for the second floor classrooms.

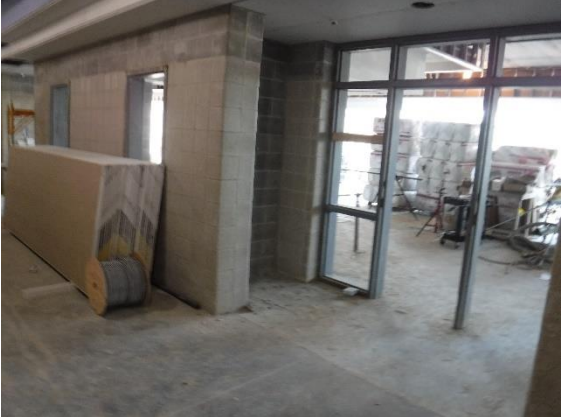
Install curtainwall windows at the second-floor.
27	LMC Entrance	Hollow metal frames were in place.

Prepare hollow metal frames for painting.

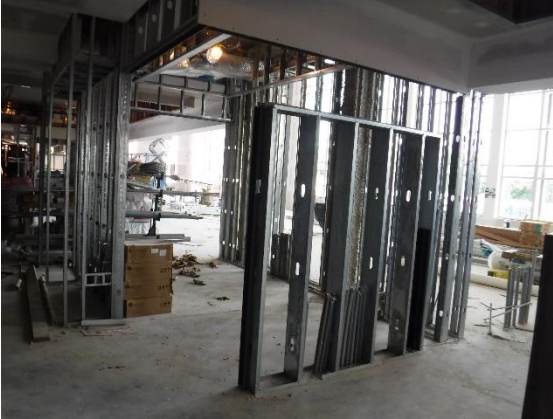
Item No.	Location	Description/Correction	Image	Action
28	LMC Study Rooms	The pony walls will be covered with glass visual display boards. These arrived on site too large for the walls.

Cut the glass visual display boards to fit.
29	Typical Painted CMU Wall	Some of the texture of the CMUs is not uniform.

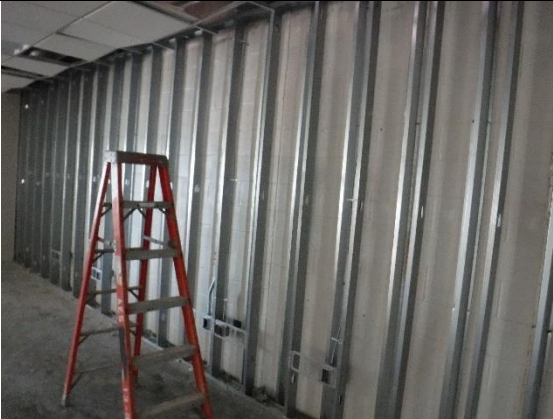
Paint additional coats where CMU finish is not uniform.
30	First Floor Resource Rooms in Area B	A stud wall had been installed past the expansion joint as detailed. The furring on the CMU wall will not be used.

Install wood blocking in the studs for the visual display boards.

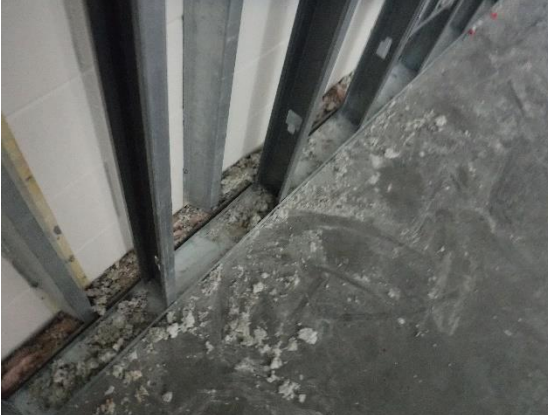
Item No.	Location	Description/ Correction	Image	Action
31	Resource Rooms in Area B	The stud wall was outside the expansion joint.

Install the fire rated expansion joint material per Wall Section C/A-317.
32	Typical Exposed Steel Column with Intumescent Fire Proofing Flush with Wall	Some of the texture of the finish was not uniform.

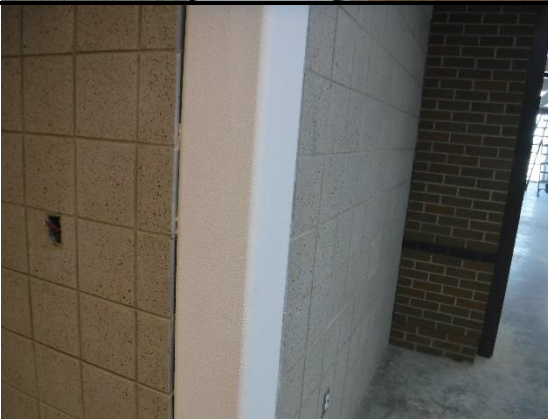
Repair intumescent paint that is not uniform.
33	Typical Steel Column with Intumescent Fireproofing at Corner	The joints between the columns and the CMUs were not caulked.

Caulk joints between CMU and steel columns.

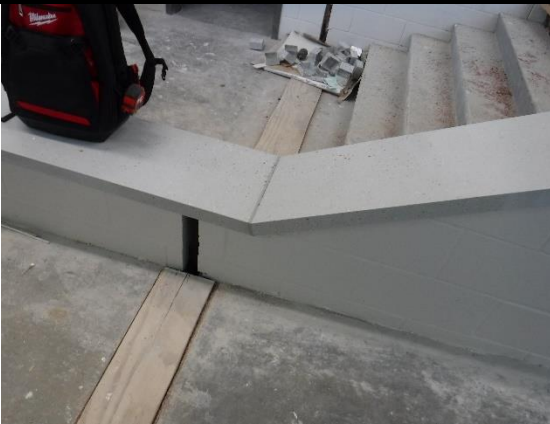
Item No.	Location	Description/Correction	Image	Action
34	Cap over Dividing Wall in Area B Connector	The solid surface cap was installed over the diving wall. The open joint was not caulked. The expansion joints in the wall and the floor were not installed.

Caulk joint in solid surface material. Install floor and wall expansion joints. <u>Floor joint must be continuous under the wall.</u>
35	F&CS Food Lab	The casework was installed.
