## FIELD OBSERVATION REPORT

Central Hardin High School, Cecilia, KY

2019111 - CA8

Report No: 61

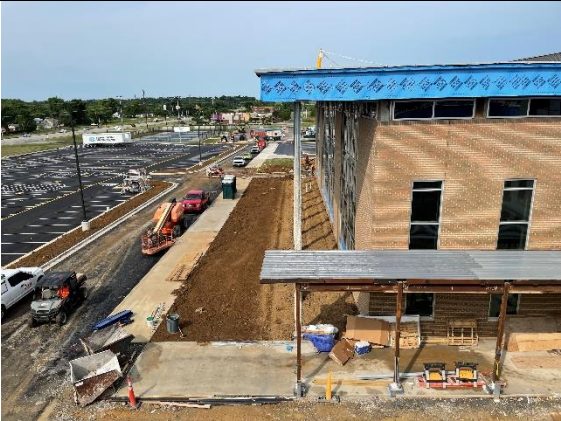
Item No.	Location	Description/Correction	Image	Action
1	Site at the Southwest Corner of Area B	The LMC is covered with brick and curtainwall assemblies, but the metal composite material panels have not been installed. These panels must be precisely measured and manufactured off site.

Install MCM panels to complete the exterior of the building.
12	Main Entrance	After some delay, the canopy structure was tied into the main structure of the building. The curtainwall framing was in place and was in filled with rigid insulation to close in the building.

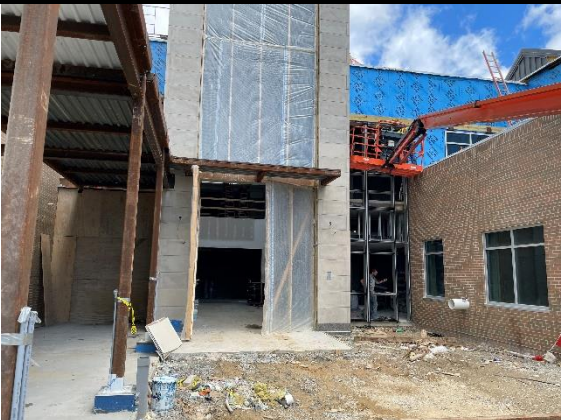
Complete the canopy and install the insulating glass units in the curtainwall system. Install MCM panels at the roof.
3	Main Entrance	Temporary doors are in place at the main entrance. The main walk was not poured.

Complete all aspects of the main entrance.

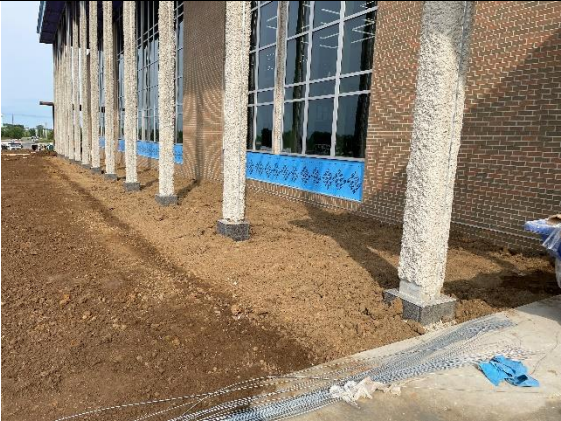
Item No.	Location	Description/Correction	Image	Action
4	South Side of the LMC	The columns are covered with spray fire resistive materials. These will be covered with MCM panels.

Install MCM panels over the columns.
5	Area E Second Floor at Top of Social Stair	The terrazzo flooring system was being installed at this area of the second floor.

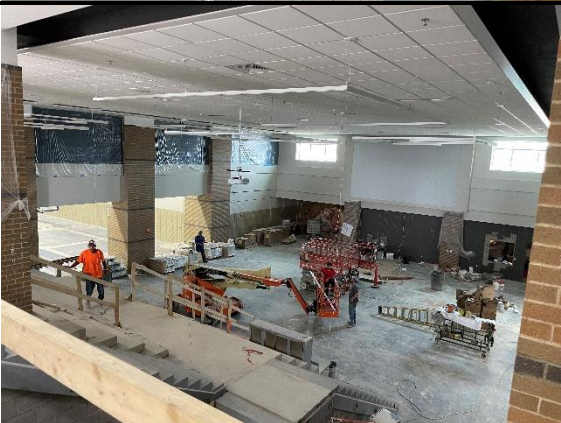
Complete the terrazzo flooring and clean up the area to prevent damage to other materials from the terrazzo dust.
6	Café Commons	Light fixtures were being hung from the ceiling over the area. These fixtures are composed of many pieces that must be fit together to form the square shapes.

Install the light fixture and then the floor finishes. Control the climate in the area so the wood can be installed on the social stairs.

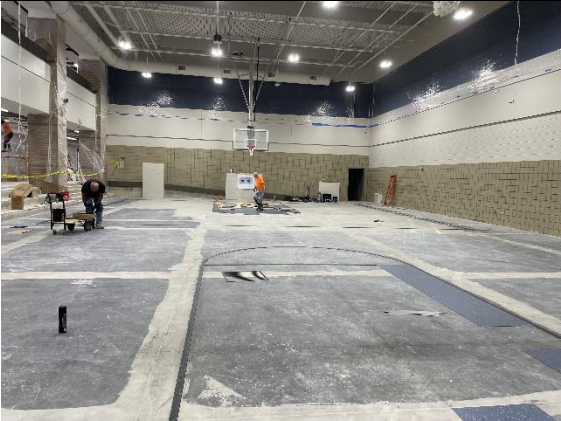
Item No.	Location	Description/Correction	Image	Action
7	Commons Court	The vinyl floor tile was being laid in the court configuration. It has been discovered that the wrong color tiles were installed in some areas.

Complete the floor and replace the wrong color tile when the correct tile is available.
8	Kitchen	It has been reported that most if not all the equipment is in the kitchen.

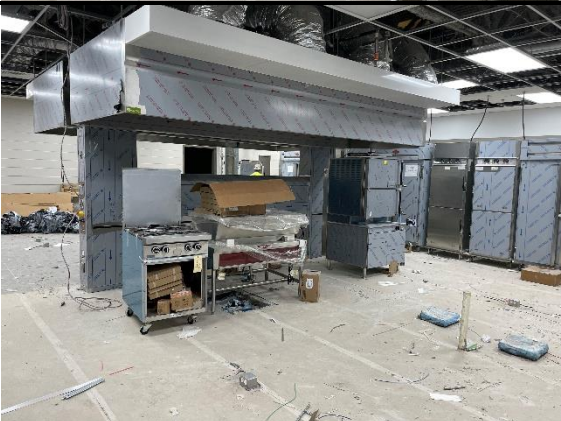
Install all the equipment and test it for proper operation.
9	Kitchen Cooking Area	Over the cooking equipment the exhaust hood has been installed.

Complete the installation of the hood and connections to the cooking equipment.

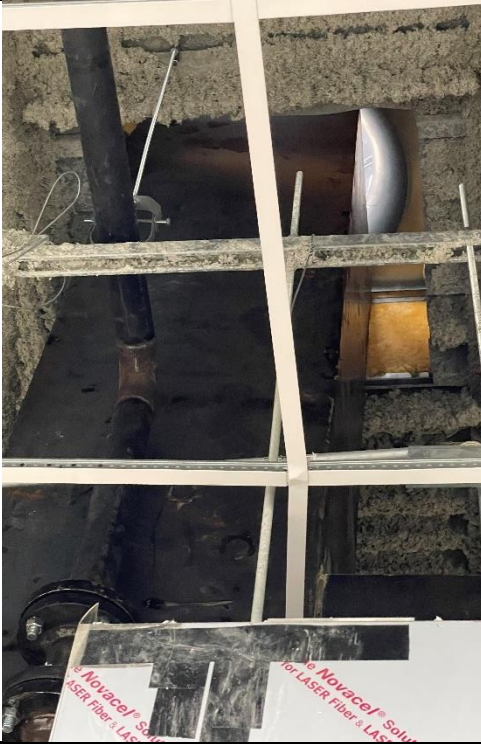
Item No.	Location	Description/Correction	Image	Action
10	Kitchen Grease Vent Through the Roof	Daylight could be seen coming through the curb for the cap over the exhaust.

Seal the cap to the curb and insulate so there are no condensation issues.
11	Roof over Kitchen	The exterior equipment serving the kitchen equipment was in place, but not connected.

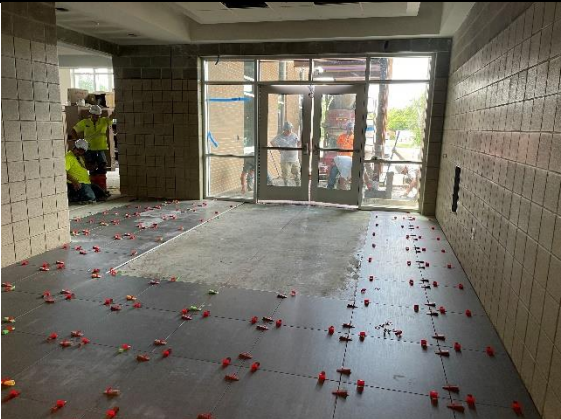
Connect all equipment and test it for proper operation.
12	Area B First Floor Entrance Vestibule	Tile pavers were installed. A walk off carpet will be installed in the center of the pavers.

Grout the tile joints and clean the tile. Install the walk off carpet when it will not be damaged by construction traffic.

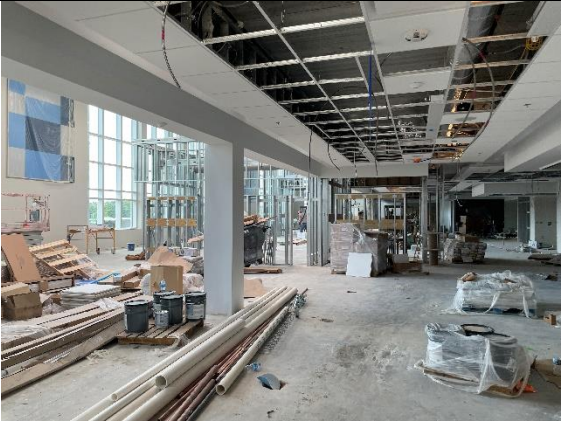
Item No.	Location	Description/Correction	Image	Action
13	Library Media Center	A significant amount of work is required to complete this area. Alliance has informed us that this area will not be completed until after the fall session begins.

Isolate the area from occupied areas and complete the work as soon as possible.
14	LMC Study Rooms	Before wallboard can be hung over the metal framing, electrical conduits, wiring and devices must be placed in the walls.

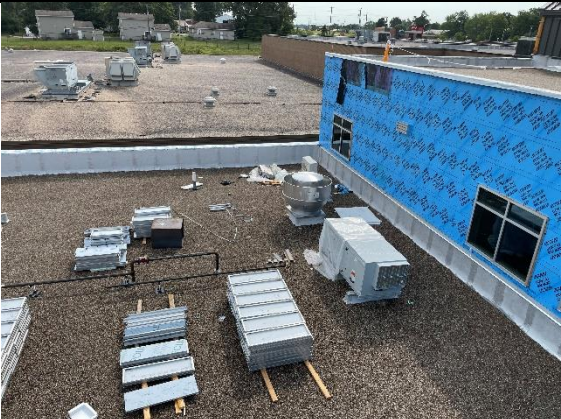
Complete electrical and Wallboard work. Paint the walls and install the storefront systems. Install the marker boards and tack boards.
15	Phase 1 Roof	The MCM panels were being installed. Although the MCM panels can cover a lot of wall area a day, there is a lot of wall to be covered.

Complete exterior walls, copings and trim.

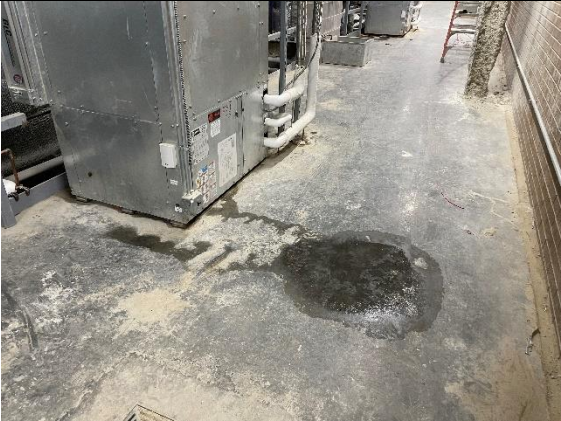
Item No.	Location	Description/Correction	Image	Action
16	Mechanical Platform	Water was on the floor by some of the units.

Investigate for leaks.
17	Mechanical Platform	The ERV was not connected to the exterior louver.

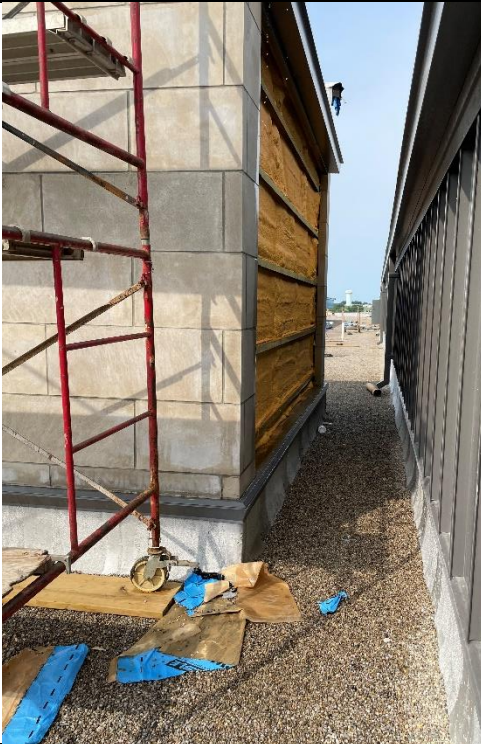
Item No.	Location	Description/Correction	Image	Action
18	Back of Entrance Lobby at Roof	The area at the back of the lobby above the roof was not covered with metal siding. The downspout was not installed.

Install siding to enclose the building. Install the downspout and splash pan.
19	Door from Penthouse to Roof	The sill and jambs of the opening were not covered allowing water to enter the wall and roof system.

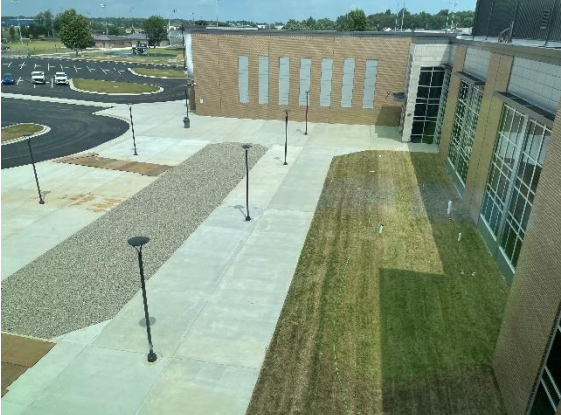
Item No.	Location	Description/Correction	Image	Action
20	West Side of the Site	Sod was laid next to the building. Stone was placed as mulch in the large planting area. The topping for the parking lot was being laid.

Mike Billings said that the planting of trees and shrubs will be delayed until more favorable weather arrives in the fall.
