FIELD OBSERVATION REPORT

Central Hardin High School – Phase 2, Cecilia, KY

2019111 - CA8

Report No: 02

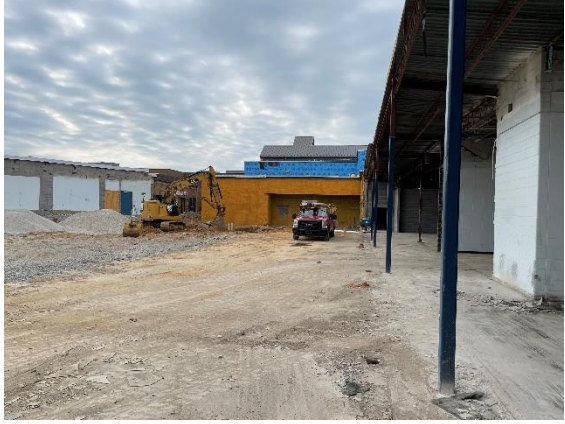
Item No.	Location	Description/Correction	Image	Action
1	North of Demolition Area 2A Looking South along the East Wall of Area D	The section of the building which had been demolished had been removed from the site.

As soon as possible, excavate the drive to the new loading dock at the Phase 1 Kitchen. Install sanitary sewer from grease trap to existing main line to the north of the building.
2	Demolition Area 2A (After removal of existing gym/cafeteria.)	Exposed inner wall. The top edge was not originally sealed to prevent rain from entering the building.

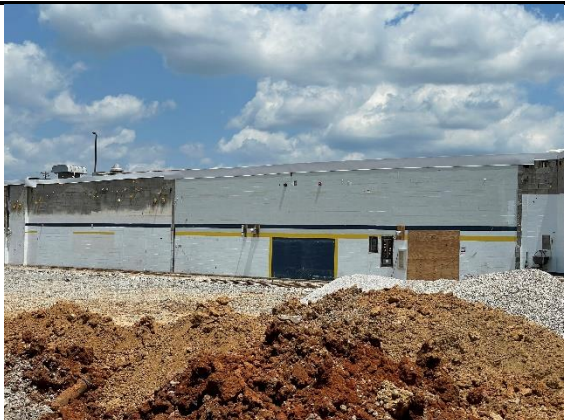
Close the roof edge to prevent rain from entering the building.
3	Demolition Area 2A (After roof edge had been repaired.)	The roof edge at the original interior wall was capped with roof flashing material.

Monitor the temporary roof edge to keep water out of the building.

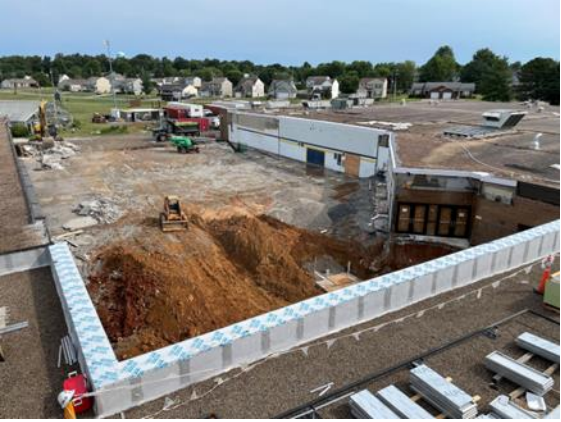
Item No.	Location	Description/Correction	Image	Action
4	Demolition Area 2A Looking to the North from Phase 1 Roof	The area of the building that was removed was available for the installation of the new drive and sewer. The old middle school wing is to the east. The excavation at the front edge is for the new kitchen loading dock.

Take necessary precautions to maintain existing construction to remain, as new construction progresses.
5	Gym Gathering	The quarry tile flooring was being removed. The existing gym doors and frames were scheduled to be replaced in Phase 1.

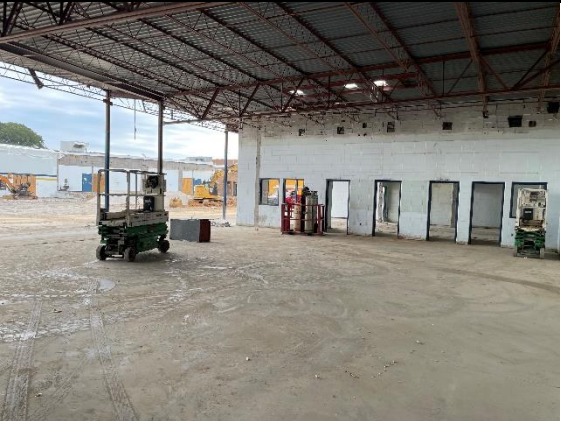
Consider moving the replacement of the gym doors and frames to Phase 2 to avoid damage to the doors while the area is not enclosed.
6	Band Room	The area was stripped of finishes, casework and mechanical-electrical equipment.

Protect structural elements and walls to remain during construction.

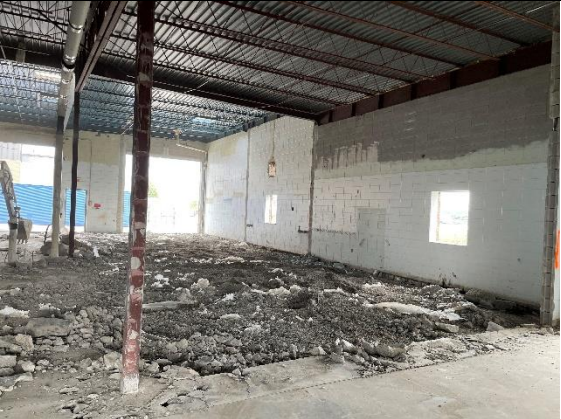
Item No.	Location	Description/Correction	Image	Action
7	Ag Shop	The existing slab had been removed to install new under-slab utilities.

Prepare the existing crushed stone to provide bearing for the new slab after the utilities are installed.
8	Area D Roof	Roof openings had been uncovered as equipment was removed. Curbs were removed. This roof will be recovered while maintaining most of the existing system.

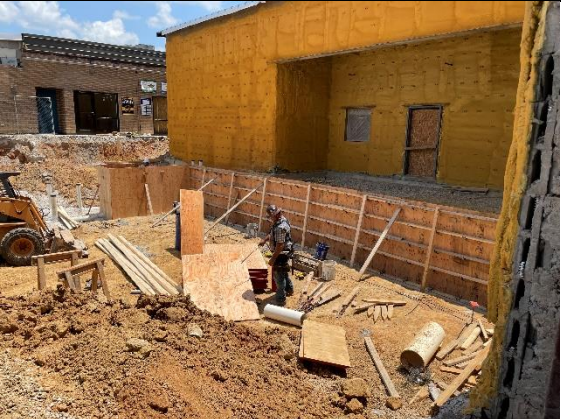
Run a thermal scan of the roof to check for damage to the insulation and roofing plies before restoring the roof.
9	Kitchen Loading Dock	The front of the dock was being formed for the concrete pour.

Plan for the dock levelers and other built-in items.

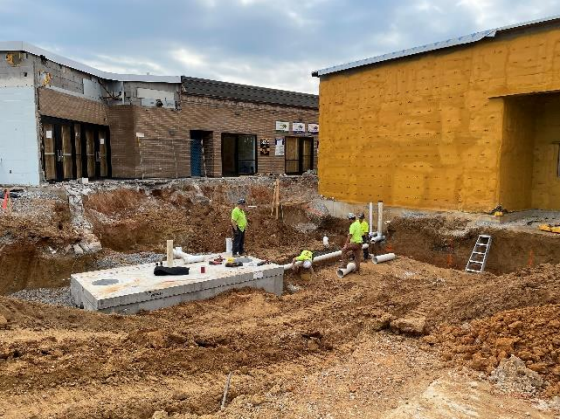
Item No.	Location	Description/Correction	Image	Action
10	Grease Trap	The grease trap is constructed with precast concrete.

Connect the sanitary sewer lines to the grease trap and test it for proper operation.
11	Phase 1 Storm Sewer	The PVC line under the Music Room runs to the southwest and outfalls at the front of the site.

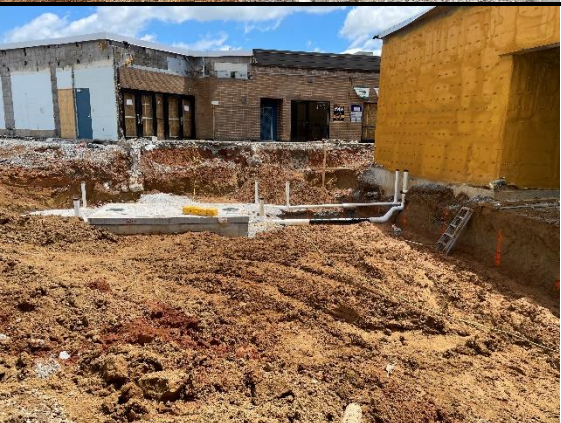
Connect the trench drain in front of the loading dock to the storm line.
12	Looking at Old Middle School Wing	The old middle school wing was presenting some problems due to the flow of roof drainage into the original courtyard.

Divert roof drainage so that it does not present problems to the new construction.

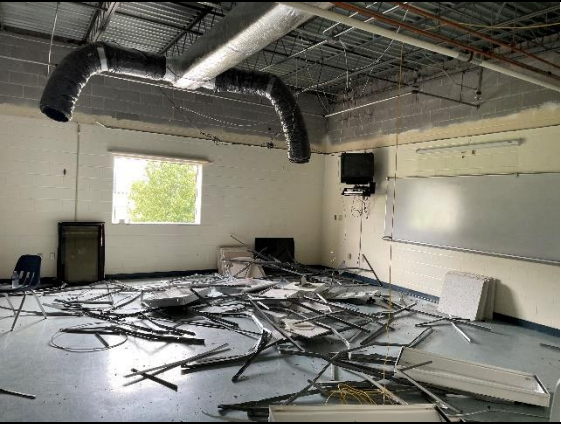
Item No.	Location	Description/Correction	Image	Action
13	Area J Second Floor	The area was being stripped of finishes and mechanical-electrical equipment. Windows were removed.

Complete demolition of the area so that new work can begin.
14	Area J First Floor	Asbestos containing floor tile mastic was being removed by the removal contractor.
