Oldham County High School HVAC Assessment Report

Building: Oldham County High School
Location: Bedford, KY
Assessment Date: June 6th – July 10th, 2024
Report Issued: July 18th, 2024

Report Prepared by:
Brett M. Lawson – CMTA Consulting Engineers, Inc.

Oldham County High School Plumbing Assessment Report

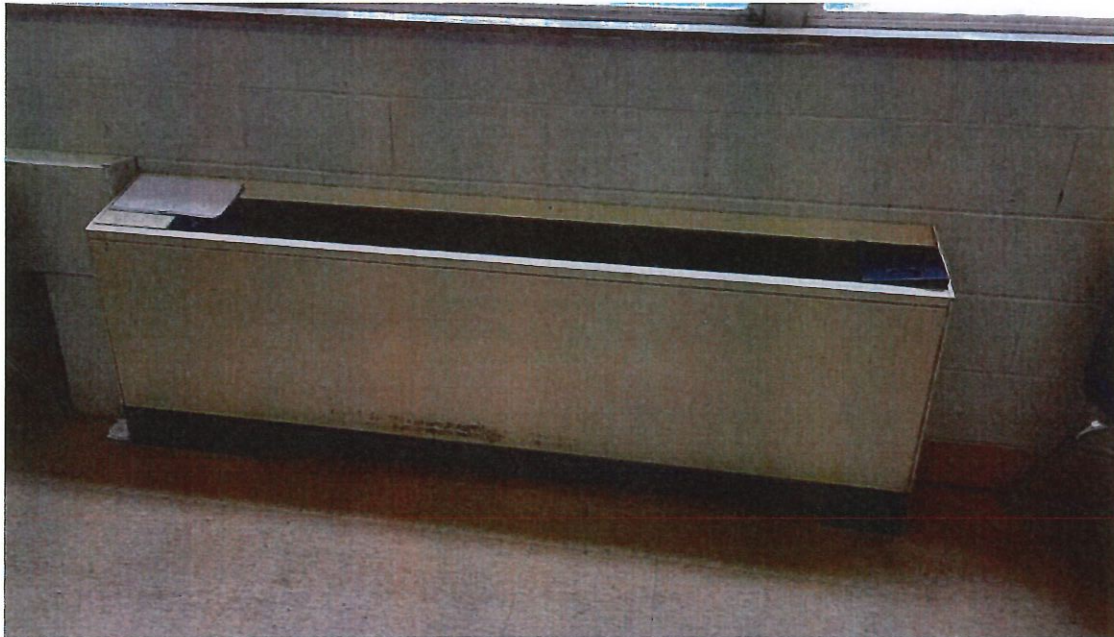
The fan coil units located in The Core, while well maintained, are showing their twenty-six years of usage. Access doors are bent, access panels difficult to take off and put back on, making maintenance challenging and timely. The heating/cooling coils are also in poor shape.

Figure 5 | The Core Fan Coils General Conditions – Installed 1997

Replace all fan coils with new console or vertical four pipe fan coils, replace energy recovery ventilators in The Core classrooms and '84 Wing with new four-pipe units. Installing new piping and insulation to accommodate new four-pipe design, minimal electrical work to install new units, removal and replacement of the ceilings as required to replace all heating/cooling piping as well as adjusting sprinkler heads for the new ceiling. This recommendation utilizes the equipment installed during the mechanical room renovation that occurred in the Summer of 2023.

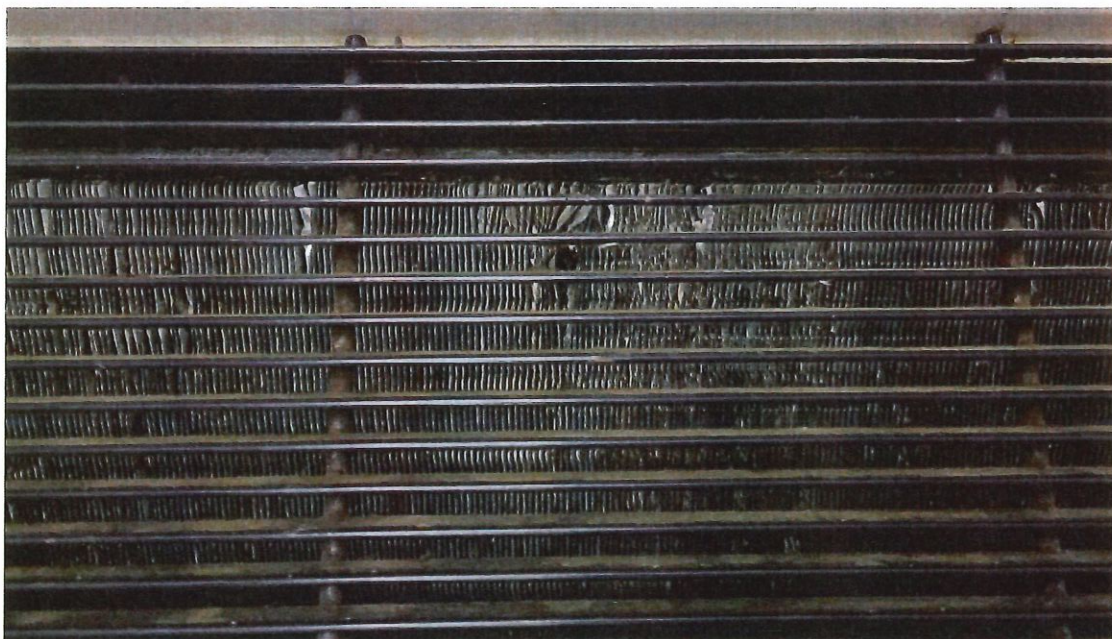
Figure 6 | Heating Cooling Coils

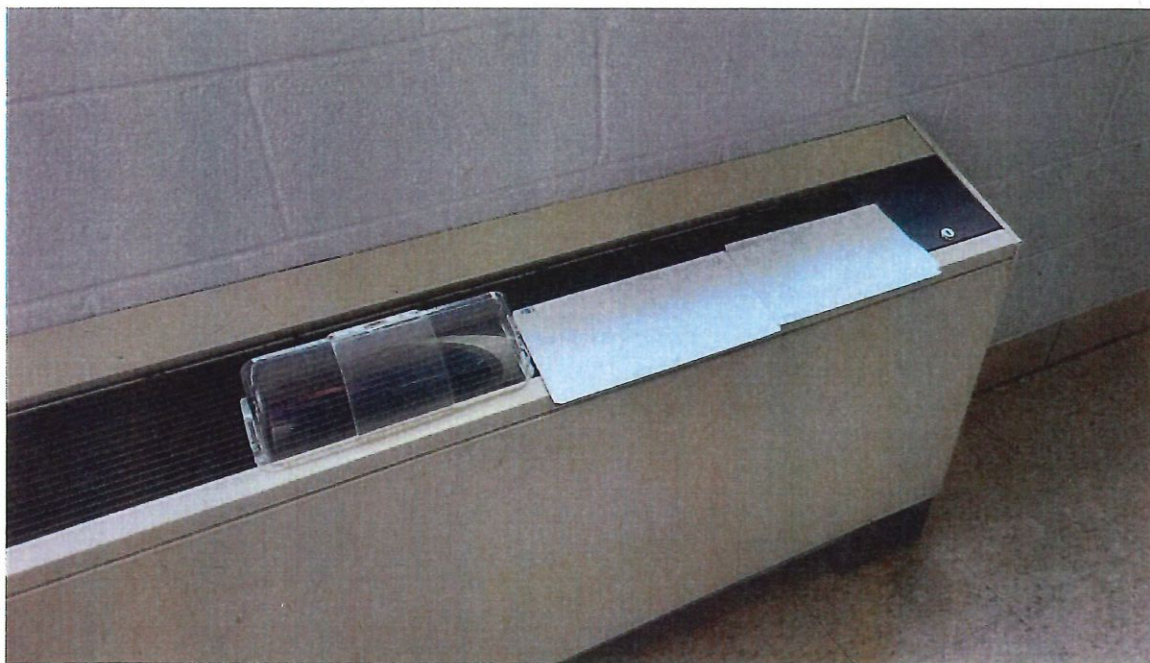
Figure 7 | The Core – Lack of Occupant Comfort Evidence

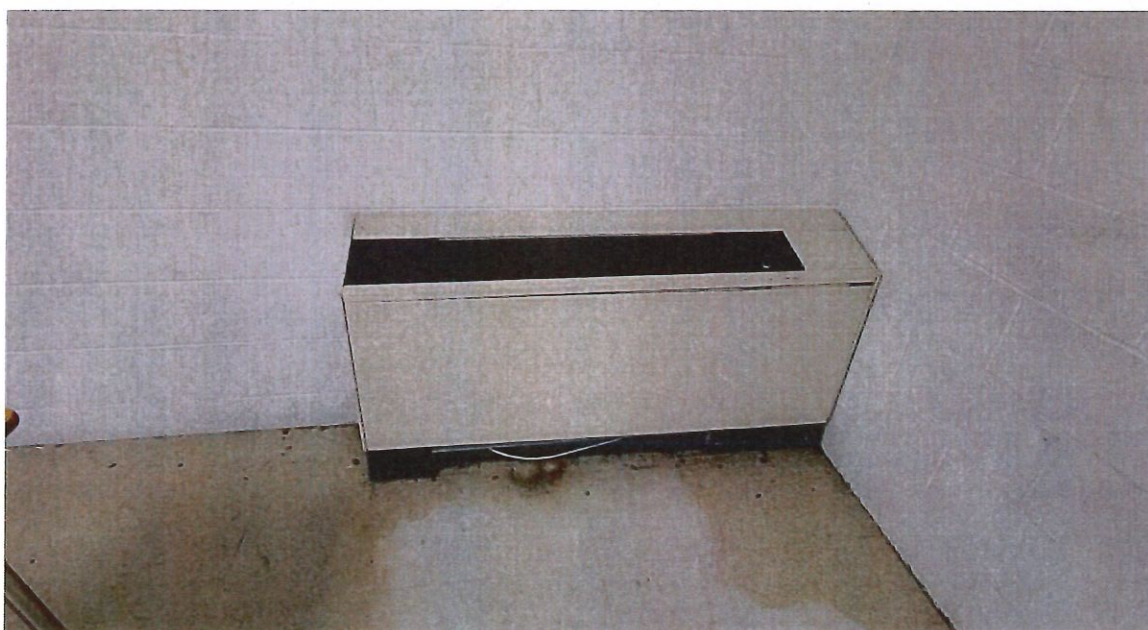
Fan coils throughout the building installed in 2007 are in better condition, which is to be expected from a unit ten years newer than in The Core; however, they still show evidence of lack of comfort in the spaces they are conditioning due to be two-pipe.

Figure 8 | 2007 Fan Coil

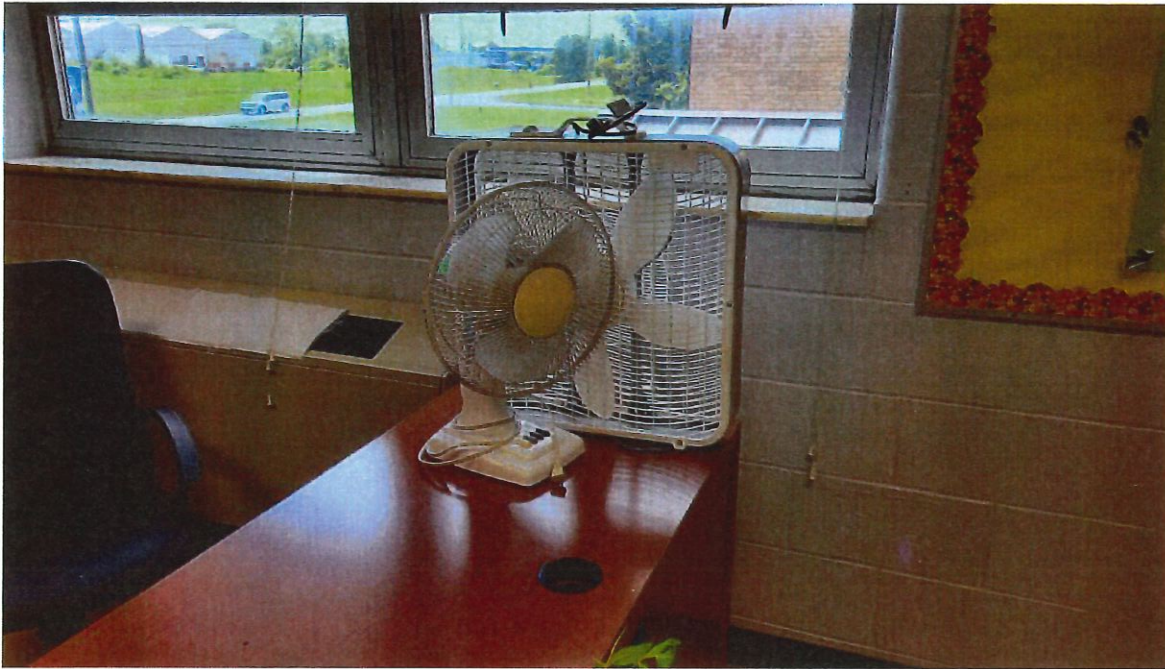
Figure 9 | '84 Wing Fan Coil – Lack of Occupant Comfort Evidence

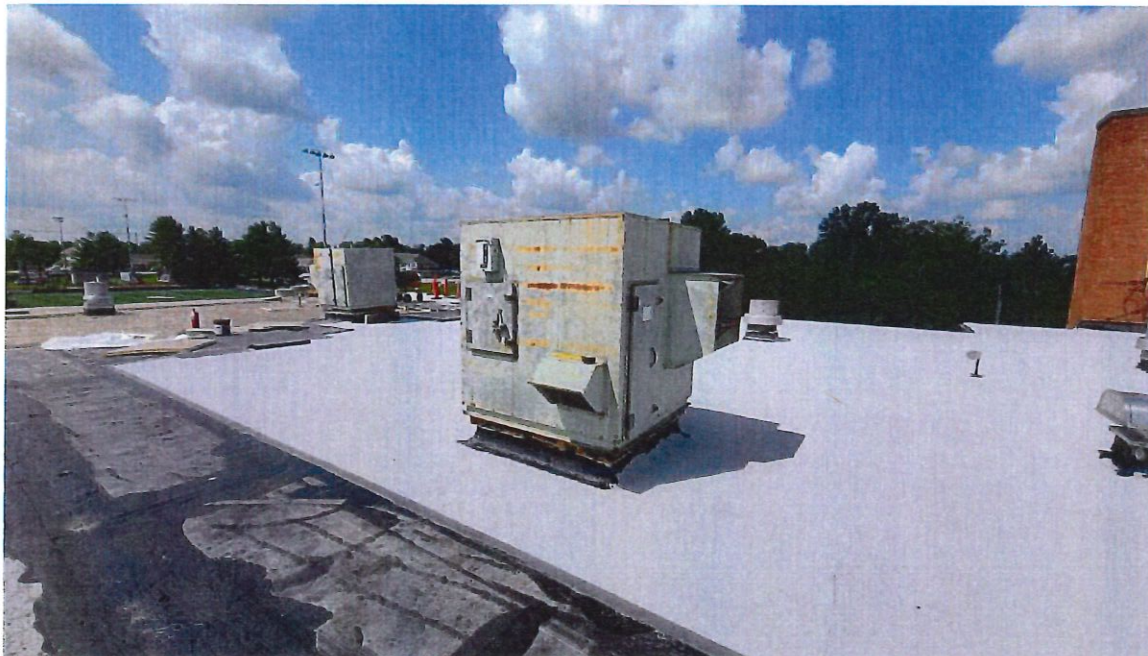
Energy Recovery Ventilators installed in 1997 have also been maintained for twenty-six years, but exposure to the elements for a quarter century of use is showing.

Figure 10 | The Core ERVs – Installed 1997

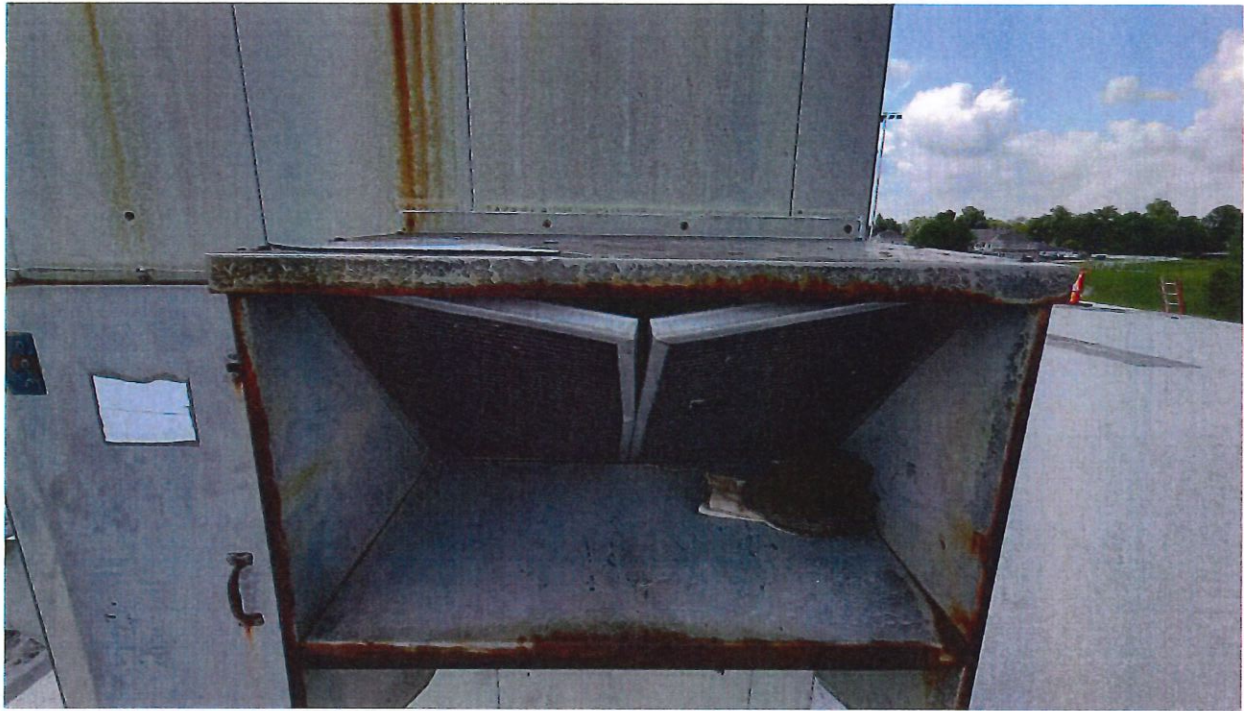
Figure 11 | The Core ERV Intake Screens

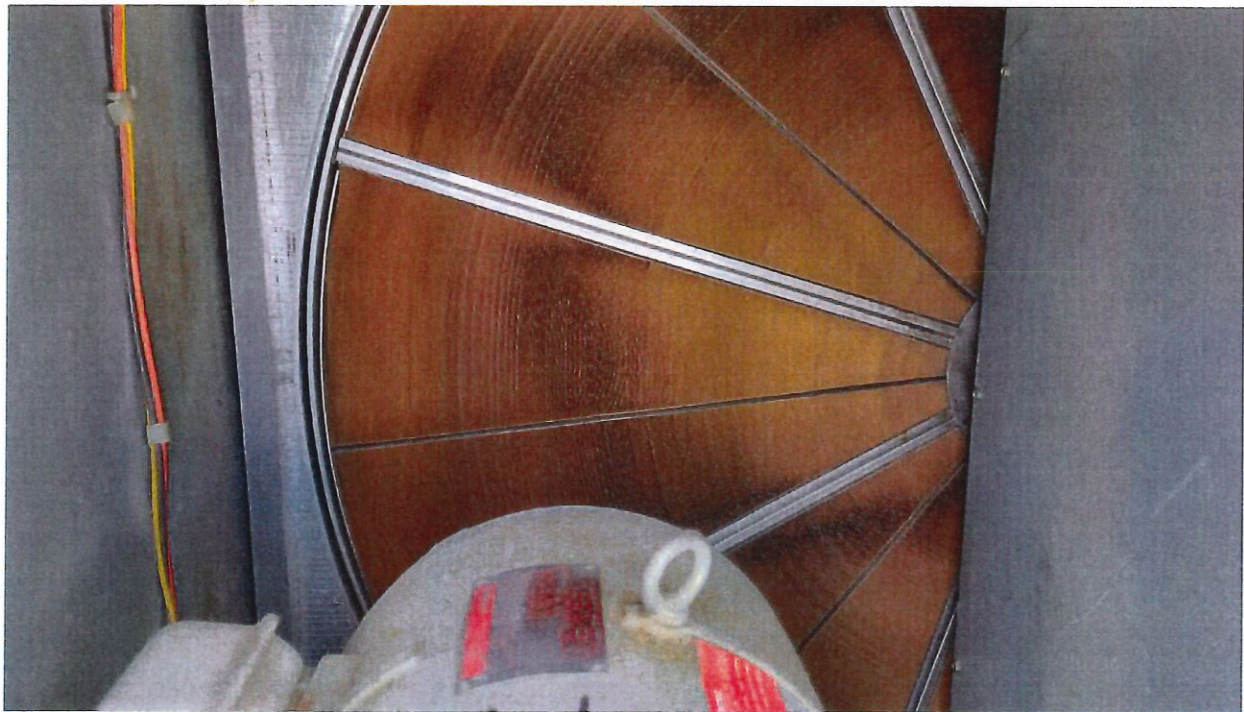
Figure 12 | The Core ERV Energy Recovery Wheel Conditions

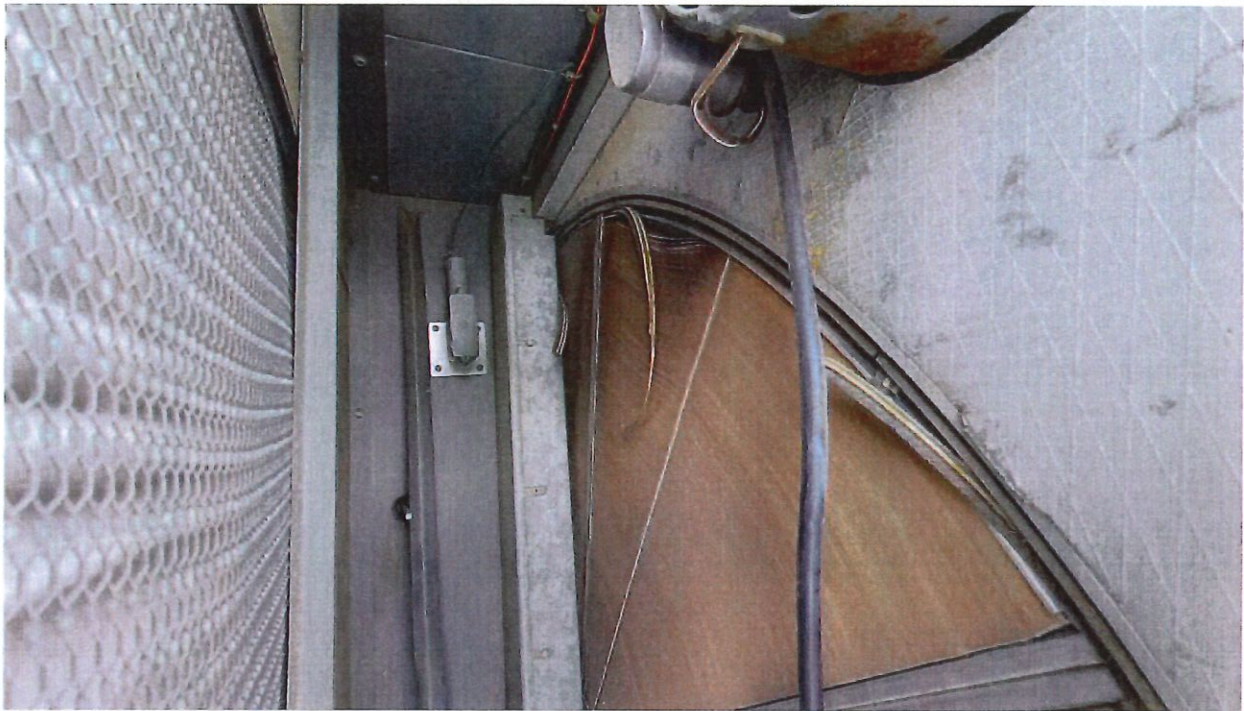
Figure 13 | The Core ERV Energy Recovery Wheel Conditions

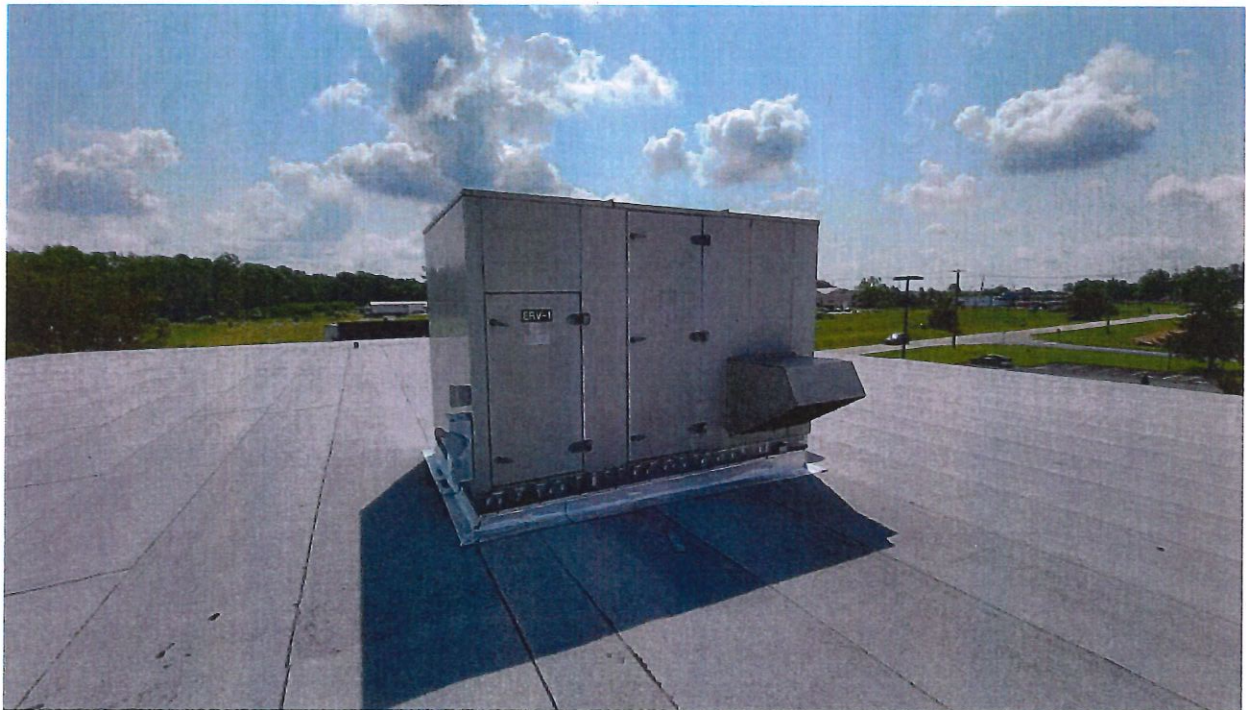
Figure 14 | '84 Wing ERV Exterior – Installed 2007

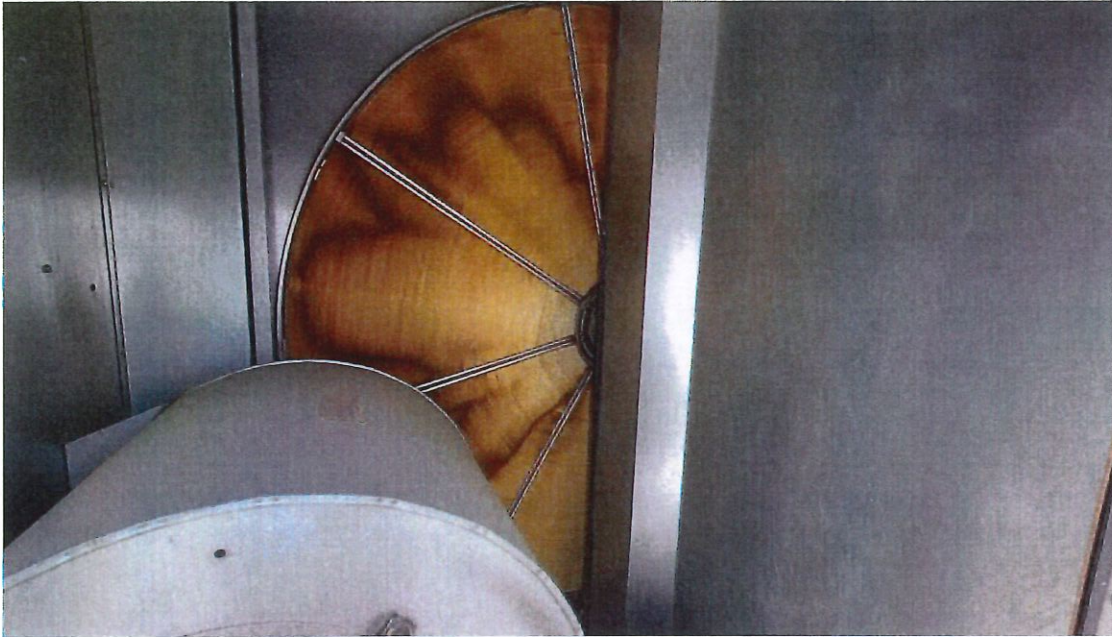
Figure 15 | '84 Wing ERV Energy Recovery Wheel Condition

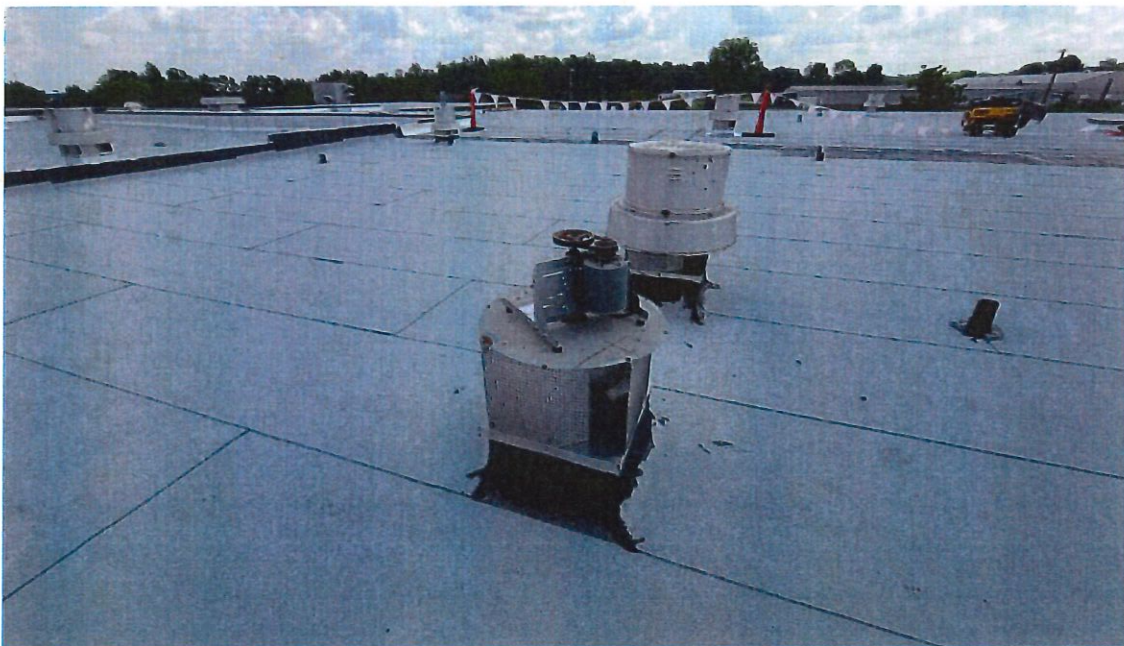
There are twenty-three exhaust fans on The Core and '84 Wing roofs that are seventeen years old. There was considerable damage noted on the fan/motor covers, potentially caused by the April 2nd tornado. One fan is missing the motor cover in its entirety.

Figure 16 | Damaged Fan

- All damaged systems will need to be replaced.

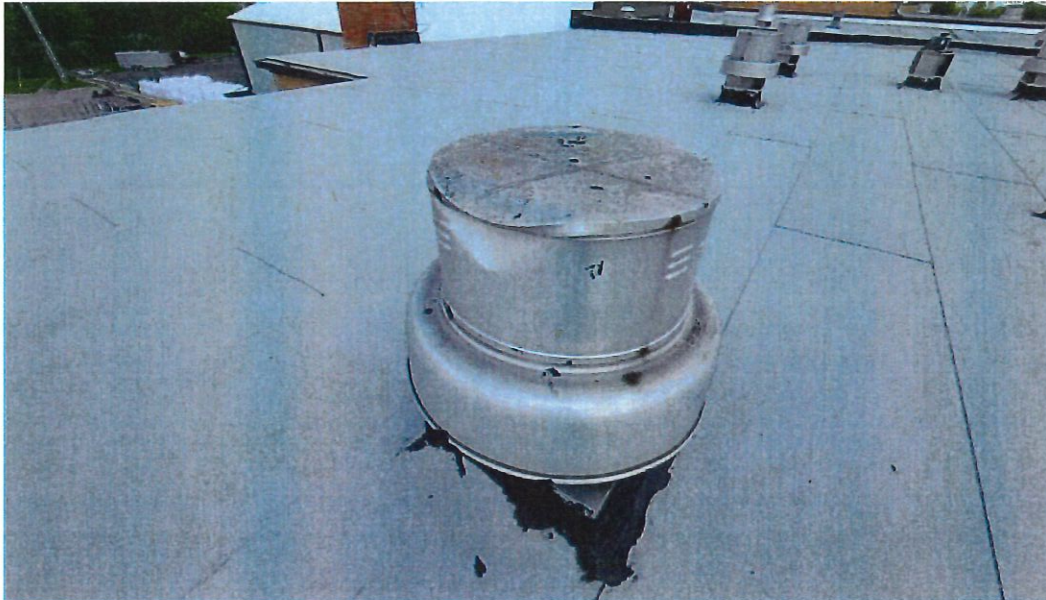
Figure 17 | Damaged Fan

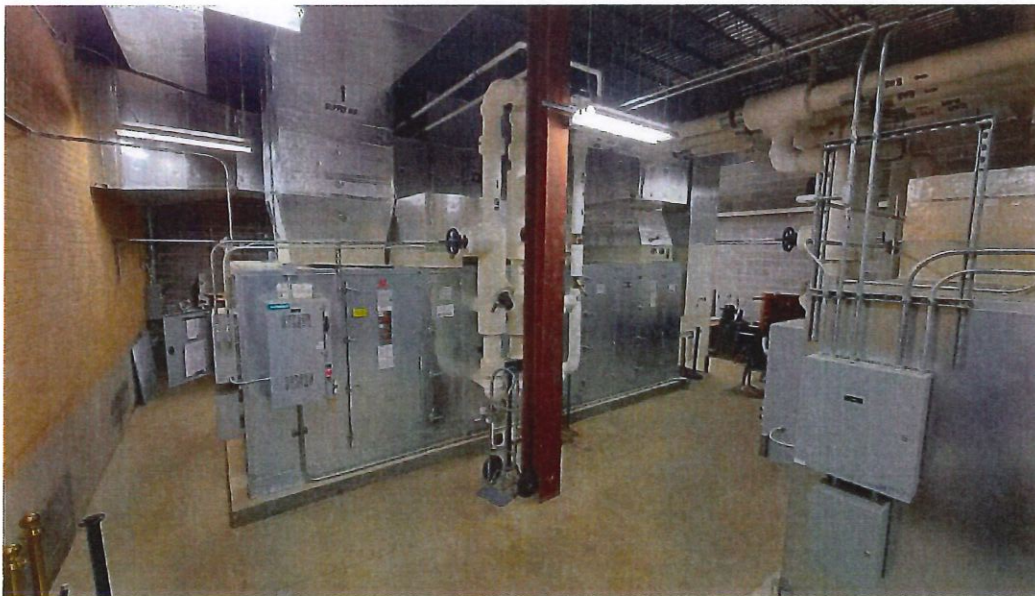
All of the Air Handling Units were installed in 2007 and are four-pipe units. There have been no complaints in the areas conditioned by these units. The units are currently seventeen years old with an ASHRAE life expectancy of twenty years. Historically, these units, due to being inside have lasted as long as thirty years before needing replacement. The air handlers in Oldham County High School are no exception. They are well maintained and look to be in good working order.

Figure 18 | Gym Air Handler 1A

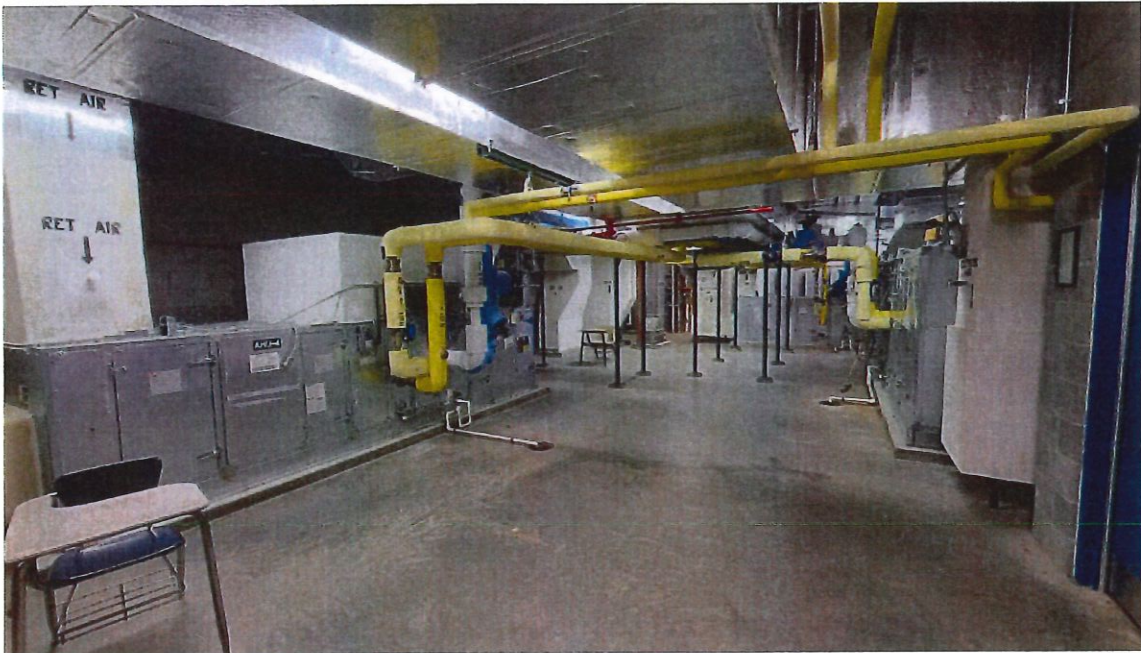
Figure 19 | Air Handlers Installed in 2007

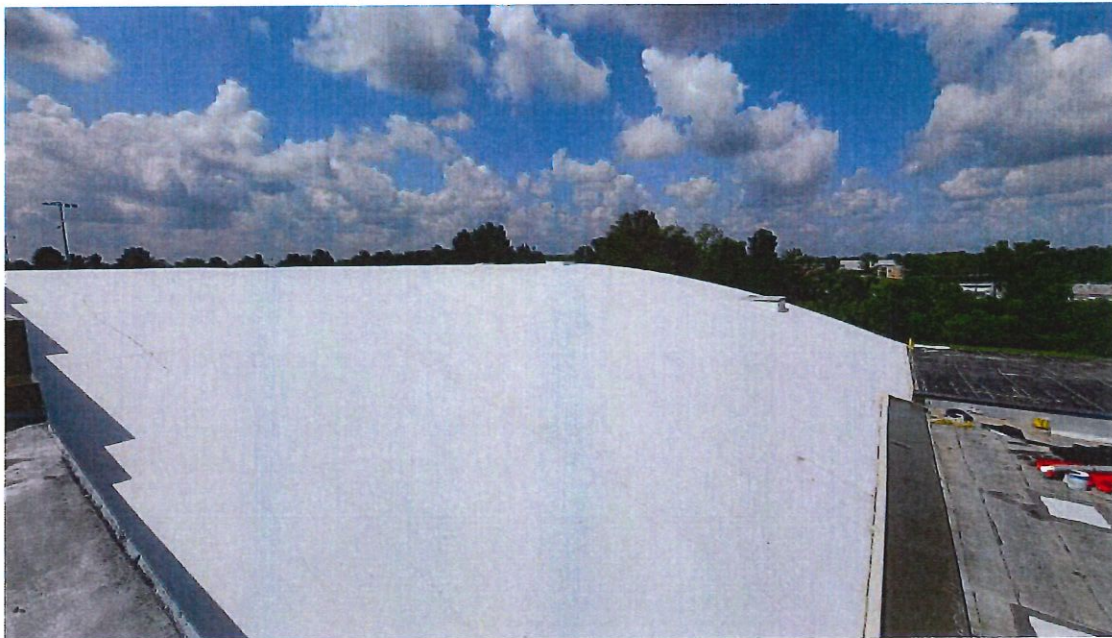
As noted in earlier sections, the Relief Air Fans on the gymnasium, which are integral for proper pressurization of the building were severely damaged, and in one case blown off the roof during the April 2nd Tornado. The remaining units on the building were subsequently removed and need to be replaced for proper building balance.

Figure 20 | Relief Air Fans

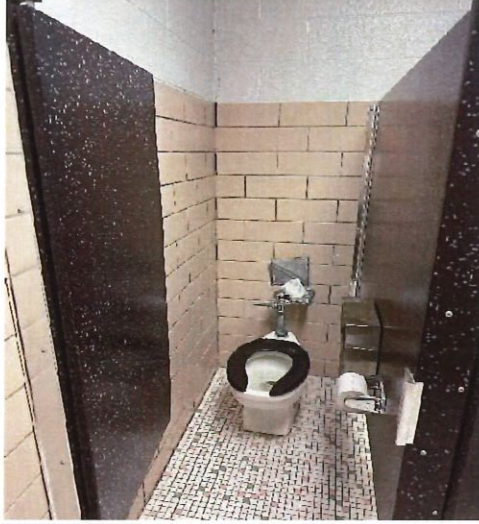
Holes behind fixtures from plumbing repairs

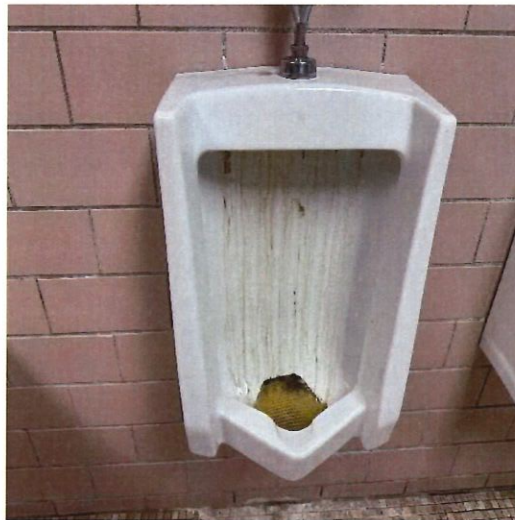
Stained Urinals

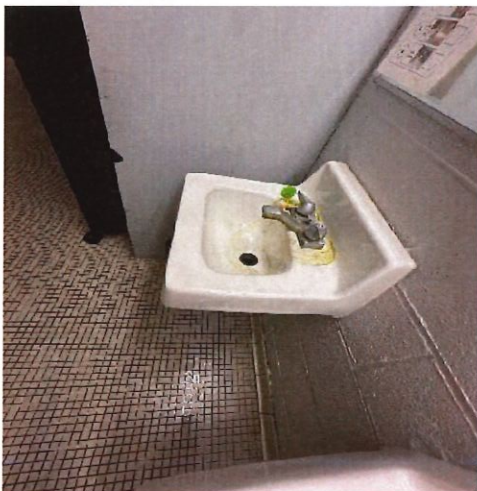
Non functioning sinks and stained sinks

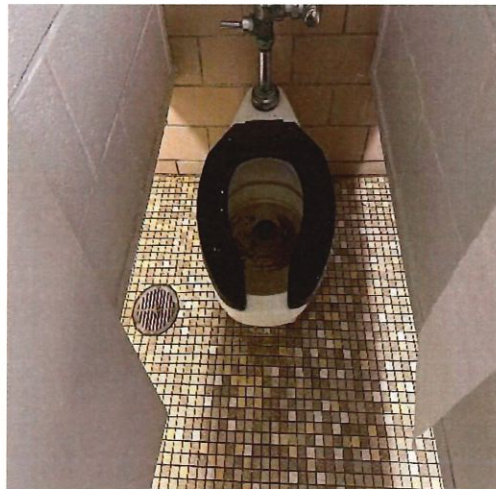
Stained Toilets

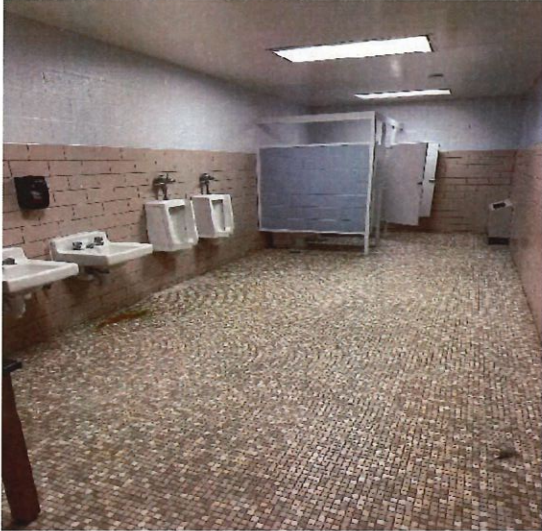
Room 207 (No functional fixtures).

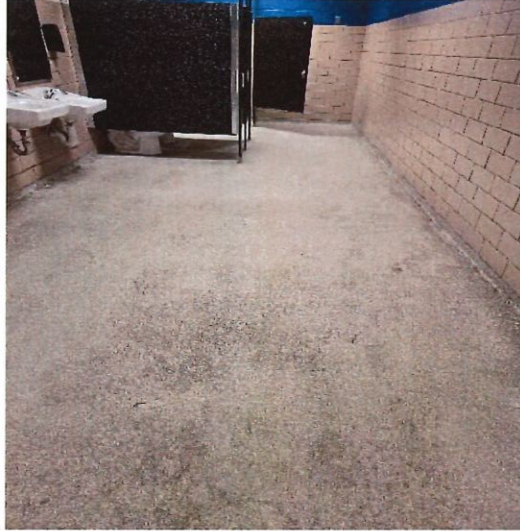
Unmaintained flooring and urine smell.

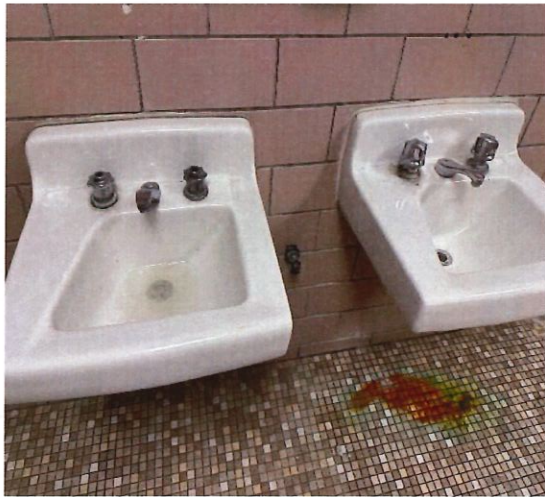
Leaking sinks, non-functioning or leaking faucets.

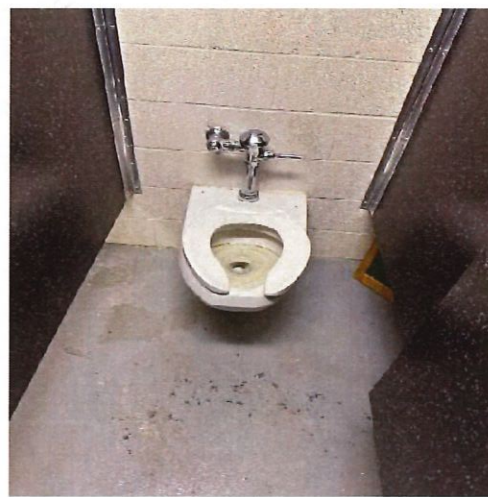
Stained and non-functioning toilets.

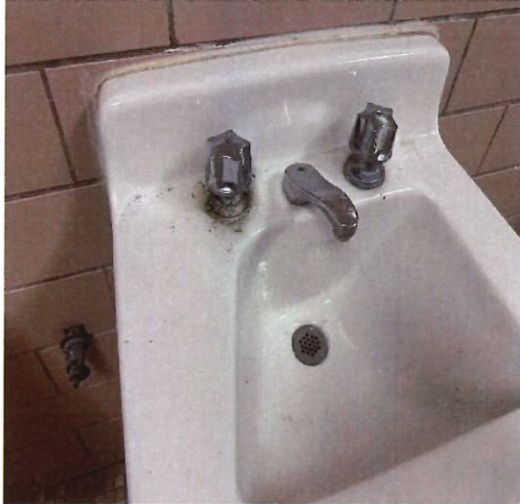
Stained, Leaking, and Non-functional sinks.

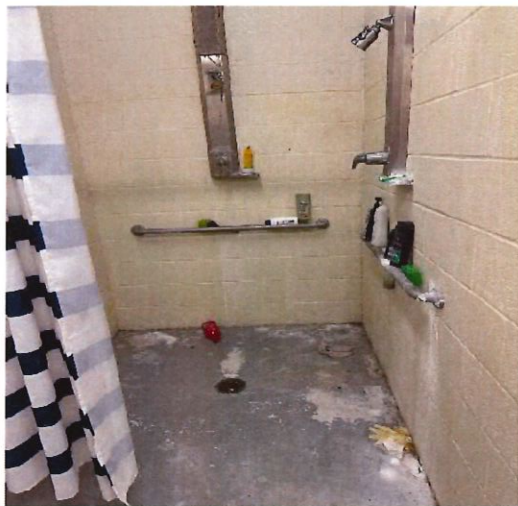
Leaking and poorly functioning showers.

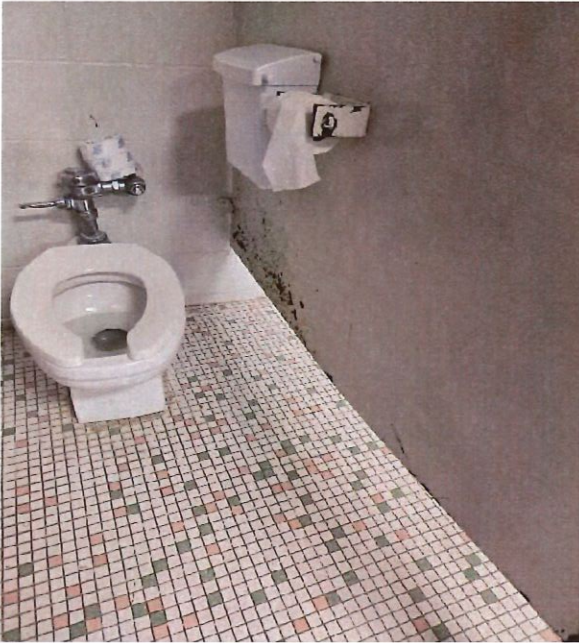
Rusting Partitions and accessories.

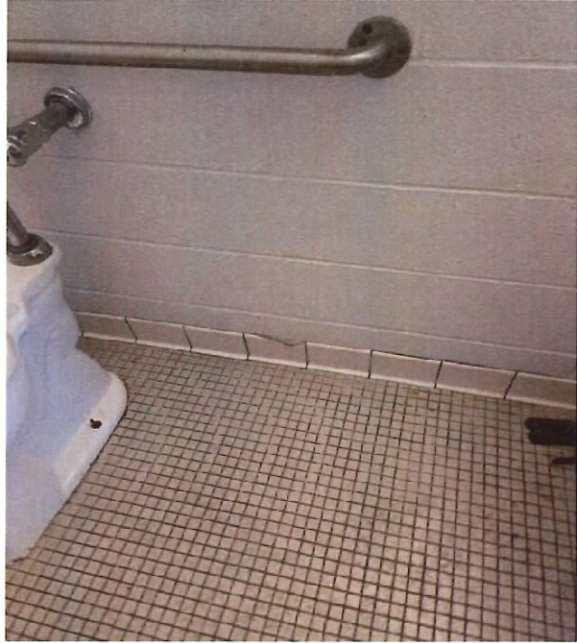
Broken or Chipped tile base.

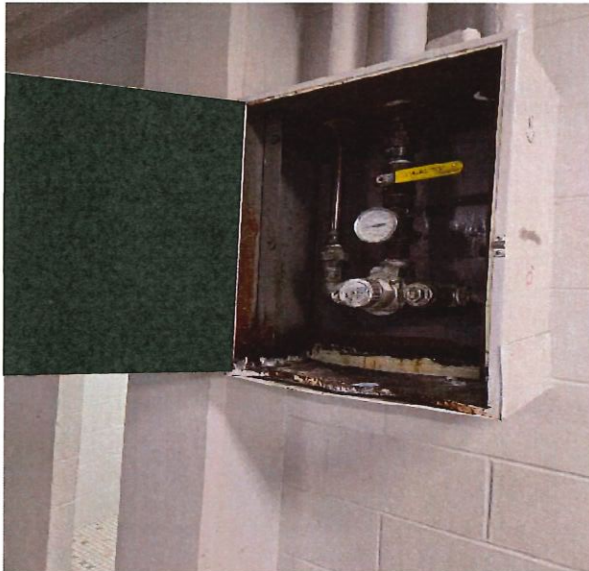
Single Valve for 8 Minimal functioning shower heads.

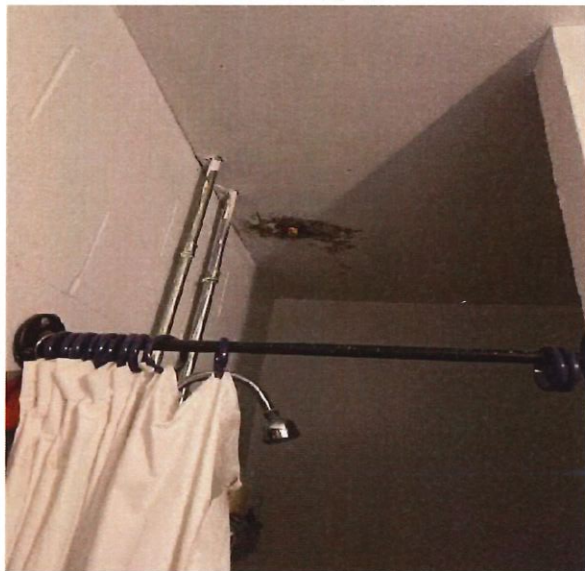
Leak above hard ceiling in the shower.
